A4067/A4217

AND CROSS VALLEY LINK AT PENTRECHWYTH

THE A4067/A4217 AND CROSS VALLEY LINK

Report on a Watching brief July to September 1990

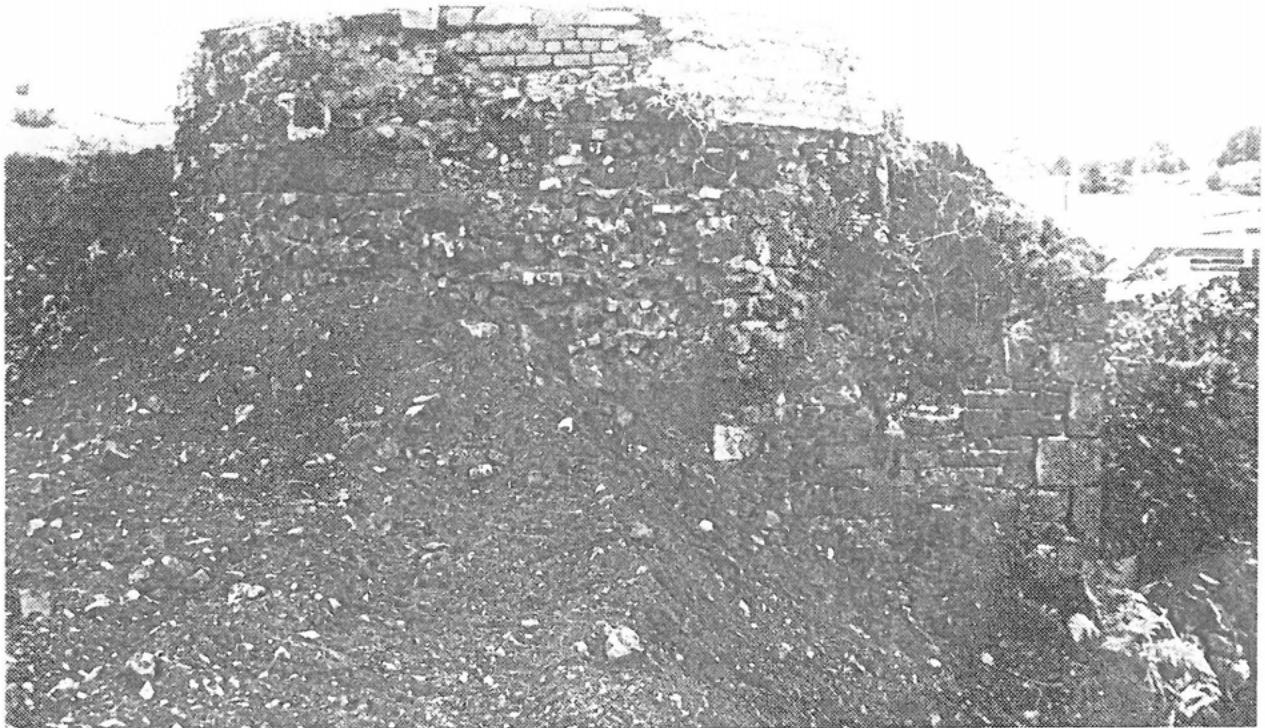
fig 9 Pit Head Shaft

4 Pit Head Shaft NGR 6617 9583 (2653 w) (fig 9)

This 10 ft (3 m) mine shaft of elliptical cross section was known as the Tir Glyn Dwr or Drews Pit and the date of sinking is unknown.
