Court Farm, Llanthony, Monmouthshire

Archaeological field evaluation

May 2008

GGAT report no. 2008/008

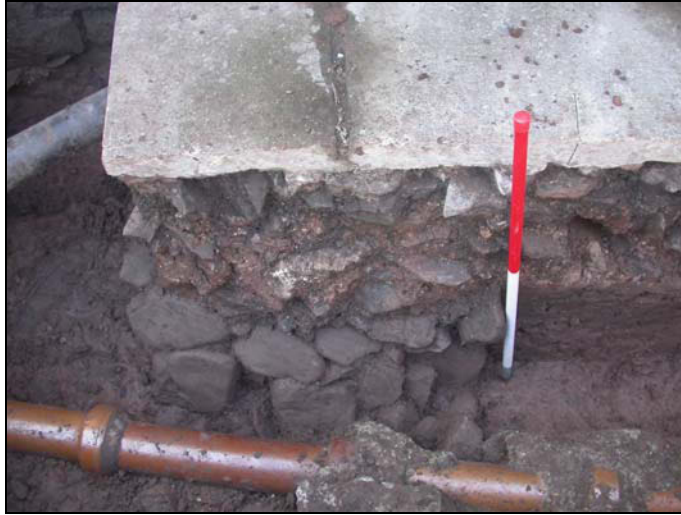
The basal deposit encountered was a natural sandy-clay (015). A negative feature (019) was cut into the natural clay (015) to a depth of 0.45m and contained a sub-rounded stone foundation 017 (Plate 1 and Appendix 2).

Plate 1. Showing stone foundation 017 cut (019) through natural deposit (015)

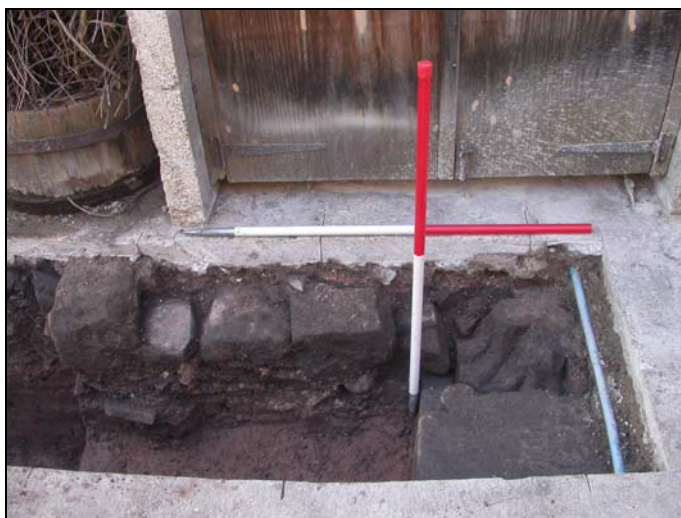
In the longer north-south running axis of the trench the foundation was overlain by a modern deposit (008) which contained angular and sub-angular stone, coal fragments and modern ceramics. This modern deposit contained within it a small coal rich lens (004). To the north of the large foundations (017), the modern deposit (008) physically overlay the natural (015). A cut (016) measuring 0.24m in depth was made vertically through this modern deposit and a re-used dressed stone floor (009) was laid as the floor for an outside toilet (Plate 2).

Plate 2. View to the west of re-used dressed stone laid floor of outside toilet.

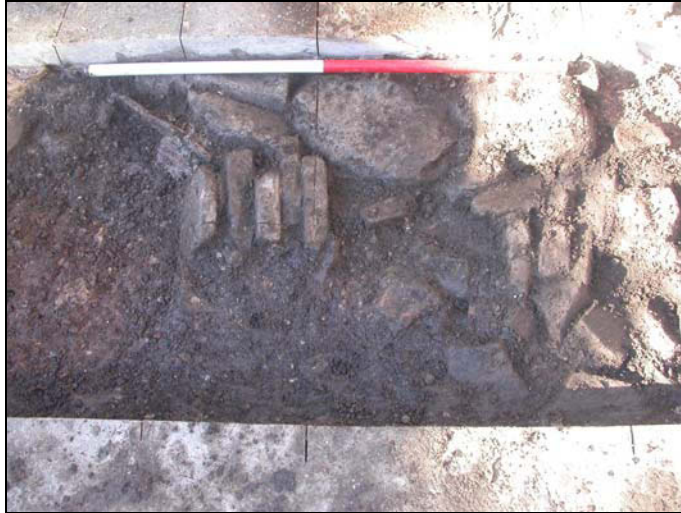
The modern deposit was sealed by a roughly laid cobbled surface (003) which was in turn overlain by a well laid stone surface (002). Stone surface (002) was overlain by a concrete surface (001). As the concrete was removed most of stone surface 002 became detached (Plate 3).

Plate 3. Showing remains of vertically laid stone surface 002 and more roughly laid surface 003

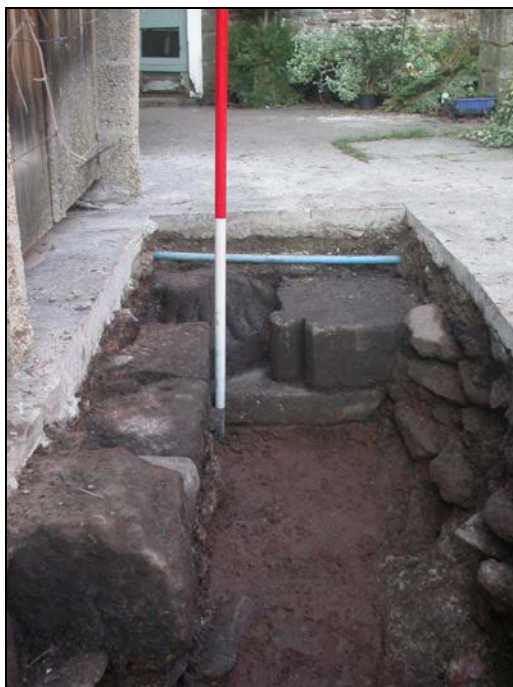
In the far north of the trench a wall (010) was partially exposed running east-west. This comprised of one square-cut basal course stone and a second course consisting of two decorated dressed stones, one being a capitol (laid invert) and another a column piece (Plate 4). This wall was cut on its east side by the trench cut (013) for water pipe 014.

Plate 4. View to north showing wall 010 in section

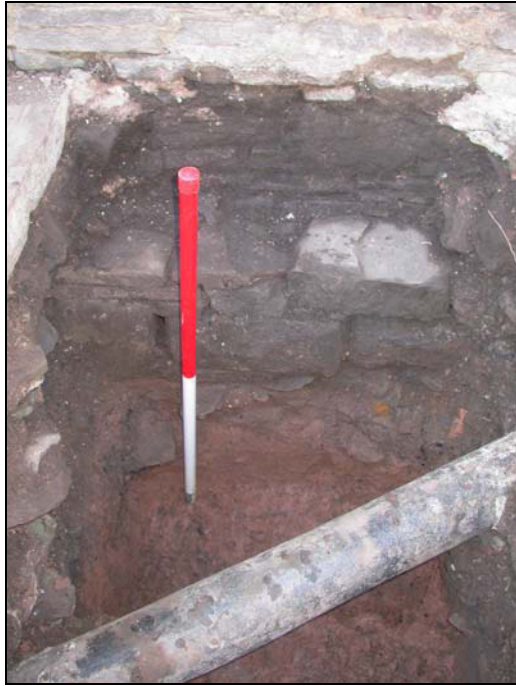
In the shorter east-west axis of the trench the natural clay was cut through in a north-south linear 018 to contain the dressed stone foundations 011 of the present eastern wall of Court Farm (Plate 5). Overlying the foundations and physically overlying the natural was a modern deposit 005, which contained large fragments of angular stone and modern ceramics and was cut through by 020 to contain water pipe 012. This deposit was capped by concrete surface 001.

Plate 5. View to west showing cut stone foundation 011 and natural deposit 015
