Margam Abbey (SAM Gm5),
Neath Port Talbot:
archaeological evaluation

A report for Neath Port Talbot County Borough Council
by Martin Locock BA MIFA

GGAT report no. 2001/031
Project no. A668
Excavation no. 439

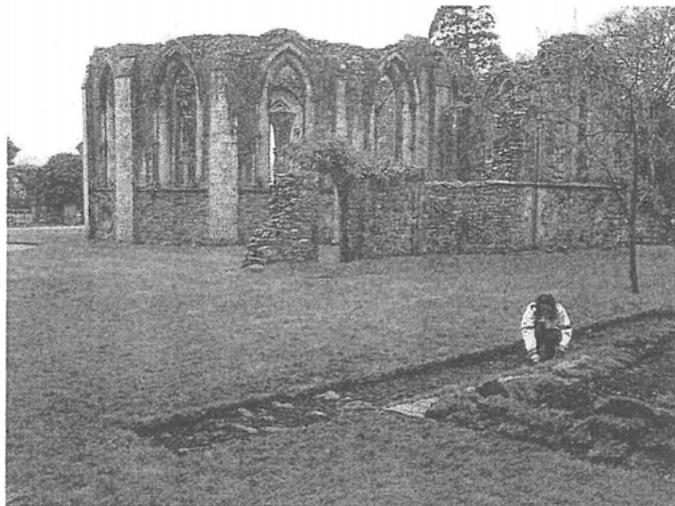
Trench 1 at the east end of the presbytery, looking southwest. The wall is visible in the left foreground.

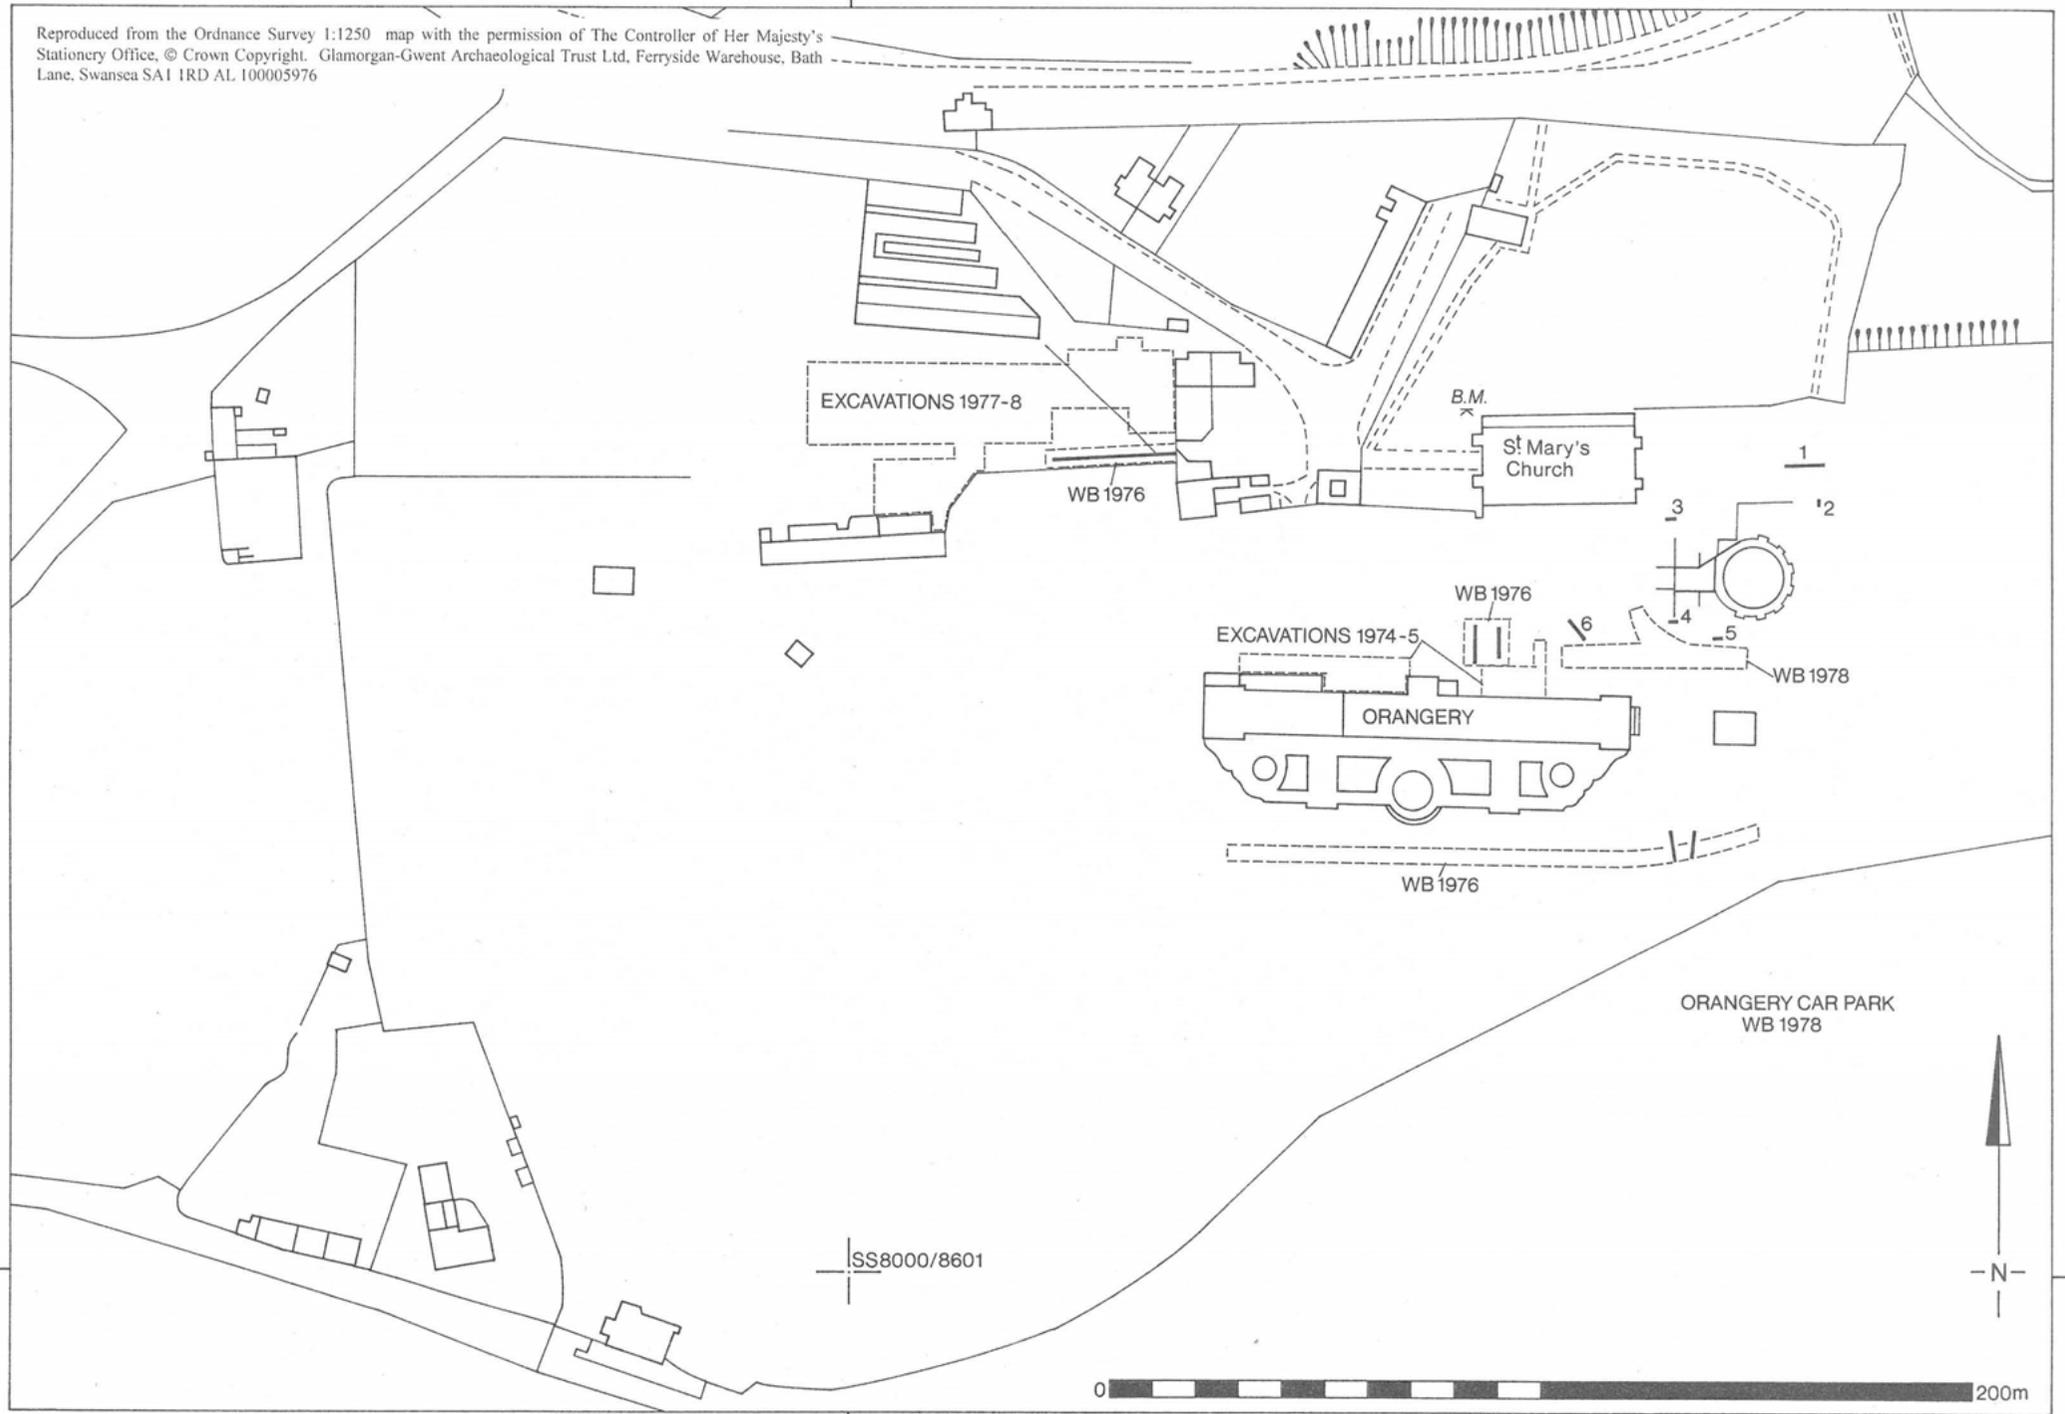
Figure 1: Margam Abbey showing location of excavations

The scoping of the works was set out in a letter from Cadw: Welsh Historic Monuments (A-CAM1/2/1593/1, 17/1/2001), based on an annotated 1/125 plan of the Abbey submitted by Capita (reference no. AL(94)007) showing the presumed wall lines. A total of 6 trenches were required: Trench 1 (8m x 1m), at the east end of the presbytery, in the location of the east wall, high altar and abbot's chair; Trench 2 (2m x 2m), at the southeast corner of the presbytery; Trench 3 (2m x 1m), on the west wall of the eastern range (sacristy); Trench 4 (2m x 1m), at the south end of the upstanding masonry on the west wall of the eastern range (dorter); Trench 5 (2m x 1m), on the east wall of the eastern range (dorter); and Trench 6 (4m x 1m), in the cloister (see fig. 1).

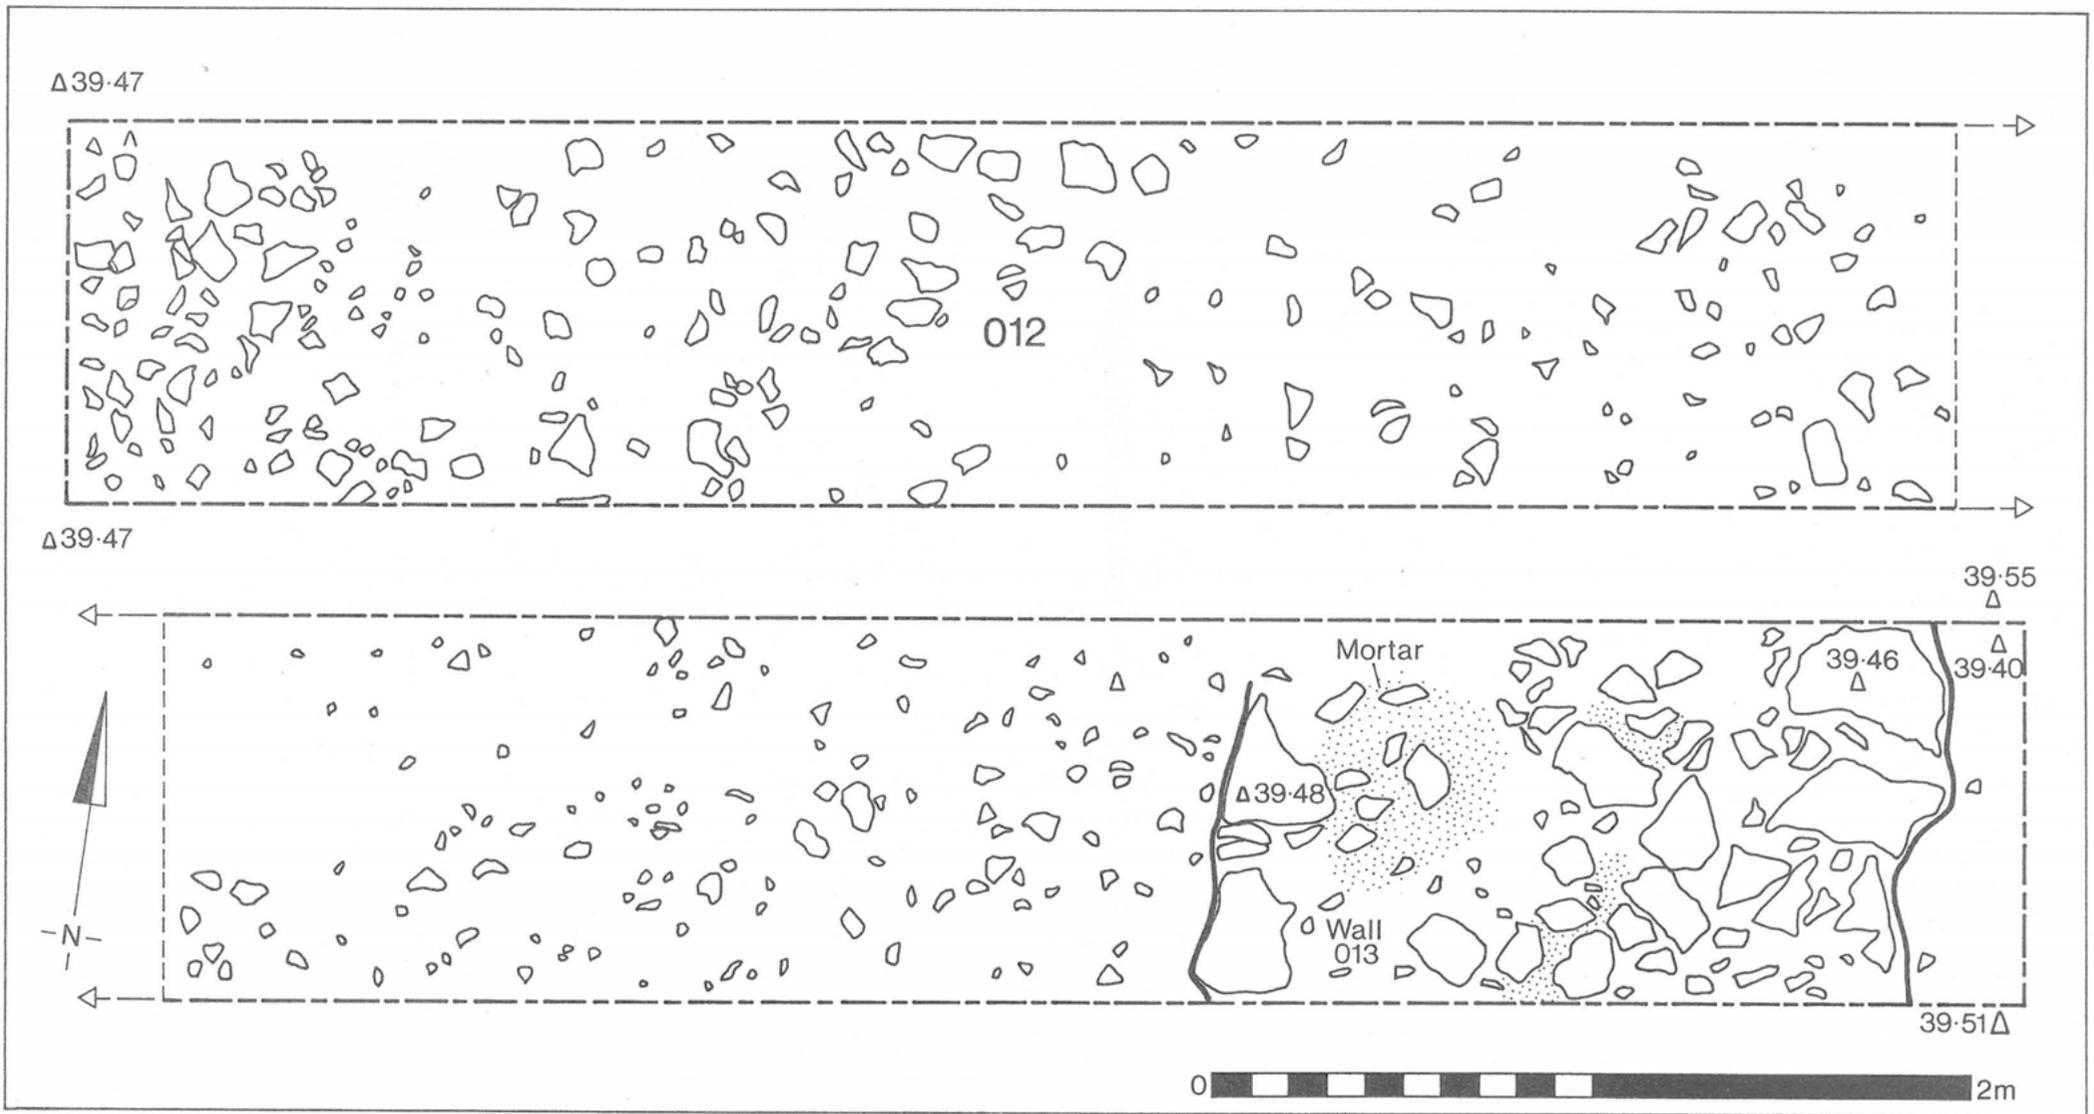
Figure 2: Trench 1 plan

Trench 1 was laid out east-west to examine the area of the altar and abbot's chair and the east wall of the church. After removal of turf and topsoil, undisturbed archaeological deposits were noted at a depth of 0.07m.

At the east end of the trench, wall 013 ran north-south. It was 1.5m wide, built of unshaped local stone, with some traces of decayed yellow-brown mortar. It would appear to be wider than the wall at a higher level implied by the surviving stub of masonry at the northeast corner of the church, and thus may represent a broader foundation. The remainder of the trench was covered by layer 012, a firm surface of brown sandy clay with numerous angular stones, dipping slightly in the middle of the trench. Overlying both was topsoil and turf (011).

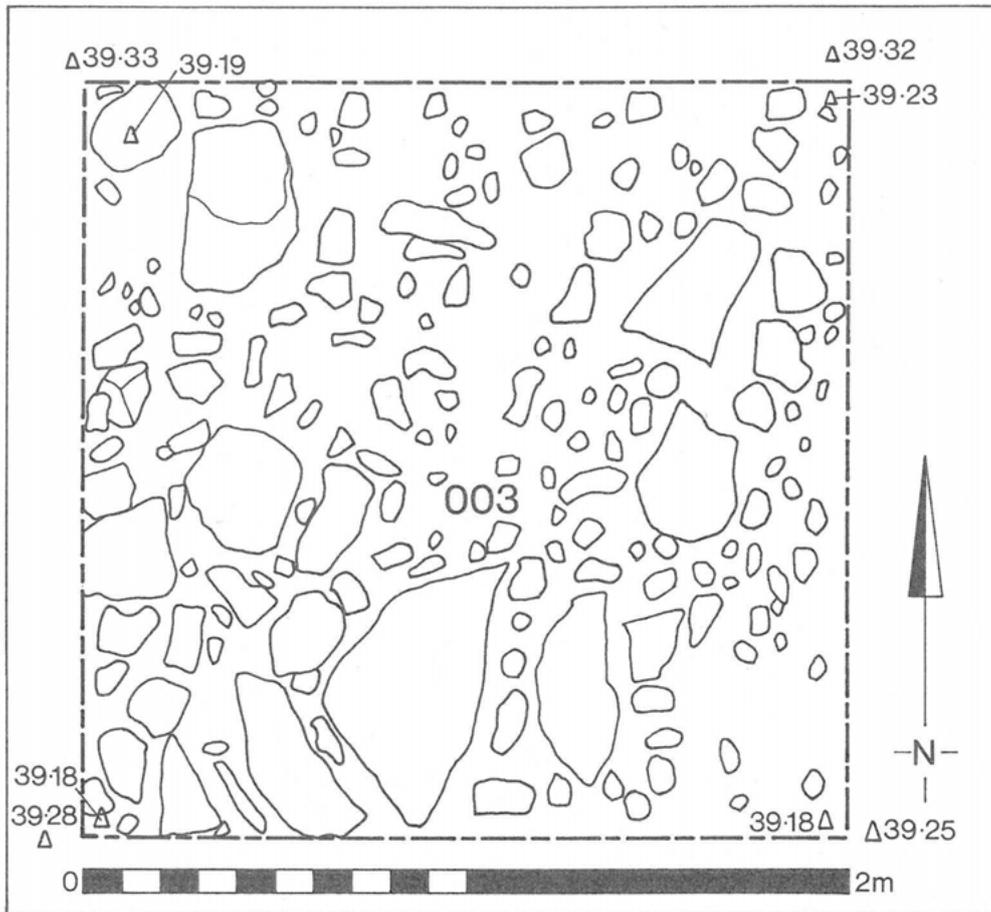
Figure 3: Trench 2 plan

Trench 2 was laid out over the presumed corner of the east and south walls of the presbytery. After removal of turf, topsoil and loose gravel 002, undisturbed archaeological deposits were noted at a depth of 0.07m.

The entire trench (which would have included an area of the internal church floor, the walls, and the external surface) was covered by an irregular surface (003), comprising large angular local stones in a moderately compacted sandy clay matrix. Overlying the surface lay a layer of loose gravel and pebbles (002) and turf and topsoil (001).

It is thought that layer 003 represents a yard surface (perhaps 18th century in date) over a part of the structure which has been comprehensively robbed; the gravel 002 is probably a deliberate levelling layer from landscaping.

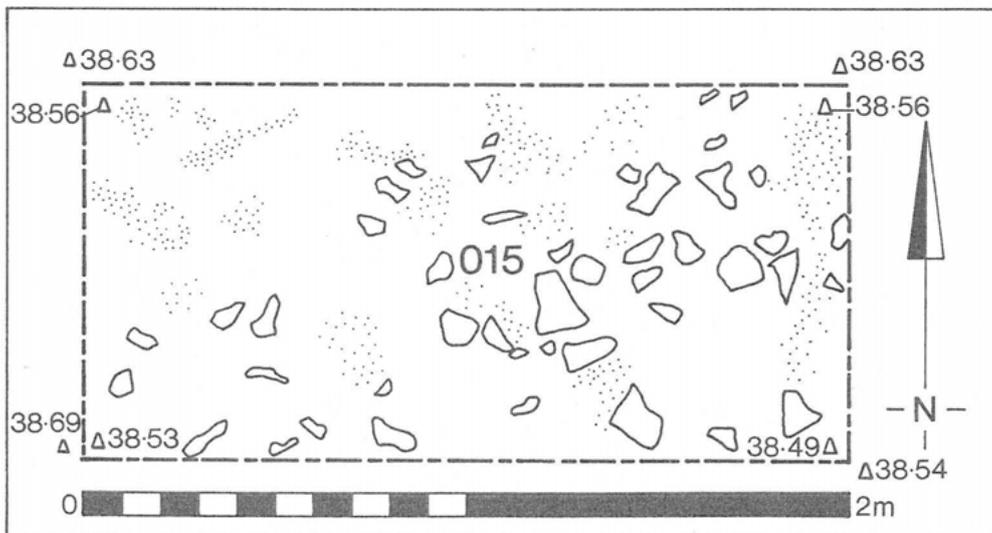
Figure 4: Trench 3 plan

One east-west trench was excavated on the line of the west wall of the dorter range, to the west of the sacristy, north of an area of walling and doorway of probably 19th century date. After removal of turf and topsoil, archaeological deposits were noted at a depth of 0.05m.

Layer 015 was a poorly-compacted surface of clay loam with some pale mortar patches and numerous small angular stones. It was overlain by turf and topsoil 014.

There was no trace of a wall-stub associated with either the modern wall or the medieval wall. The deposit 015 is interpreted as a demolition layer, possibly medieval, but more likely to be associated with the 19th century building works in the vicinity.

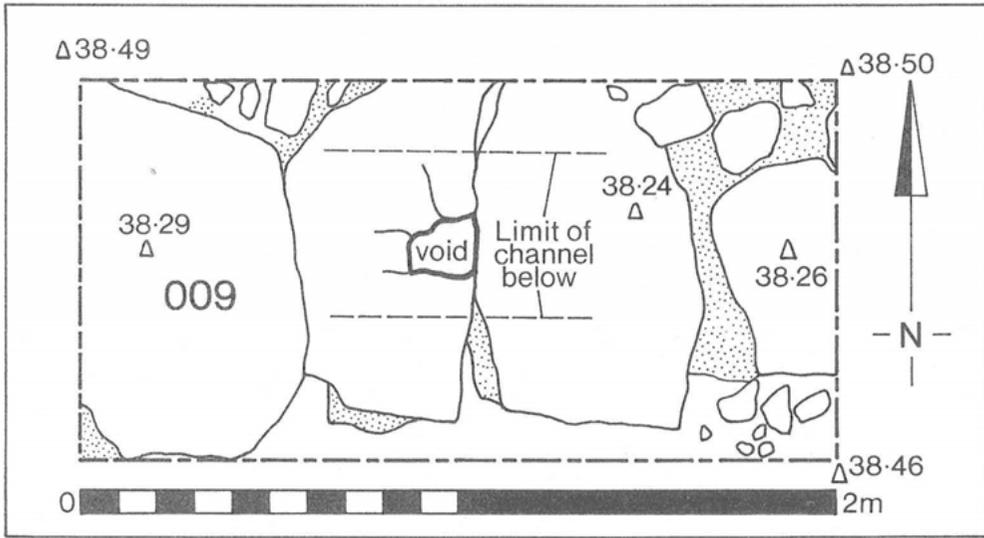
Figure 5: Trench 4 plan

Trench 4 was laid out east-west across the projected line of the west wall of the dorter range, immediately south of the standing stub of walling and its associated stone plinth. The trench was shifted slightly to the south to avoid the stonework. After removal of the turf, topsoil and layer 005, an archaeological structure was noted at 0.17m.

The entire area of the trench was occupied by a culvert (009) running east-west, built into the remains of the main wall. The culvert was 0.3m deep x 0.5m wide, capped by local stone slabs with some mortar (samples *001, *002: see Appendix 3). Internal flash photographs revealed the structure of the culvert as a neatly-faced stone structure with white mortar. Overlying the culvert was a layer of stony clay, with numerous mortar flecks (005), and turf and topsoil (004).

The culvert is probably at too high a level to have been of monastic origin. The style of construction and type of mortar would be consistent with an early post-medieval date, and the use of the vestibule as brewhouse for the Mansell manor house may suggest a function. Culverts of this type have been found in numerous locations (see fig. 1), forming a complex system of drainage.

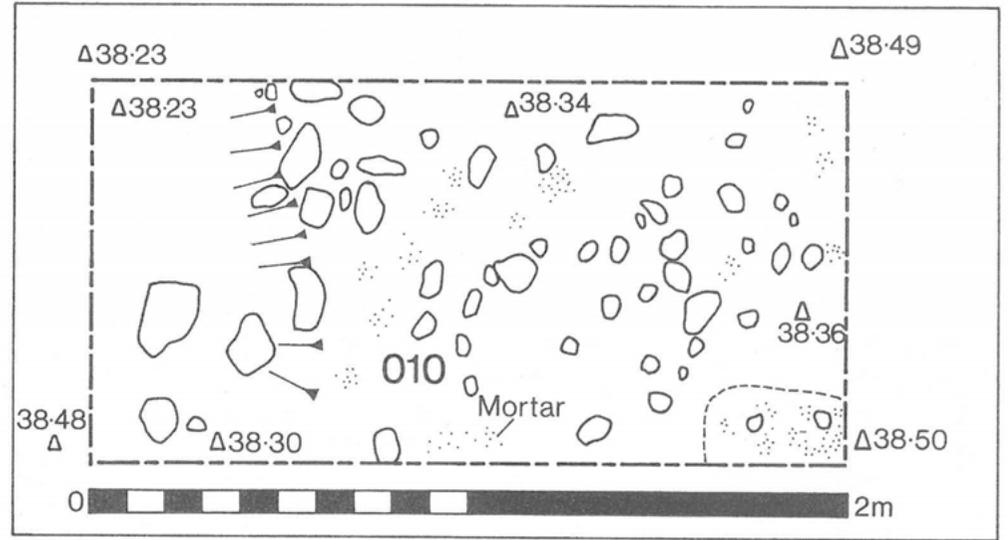
Figure 6: Trench 5 plan

Trench 5 was laid out east-west across the projected line of the east wall of the dorter range, well to the south of the standing masonry. After removal of turf, topsoil and layer 008, archaeological deposits were encountered at a depth of 0.14m.

Layer 010 was a compacted surface of small local stones with many mortar flecks; on the west side of the Trench, the level dipped, perhaps representing a shallow cut feature, in approximately the position of the projected west wall face. Overlying the surface was a layer of stony clay loam (008) and turf and topsoil 006.

The surface in Trench 5 may have been a cobbled yard surface north of the Mansell manor house; clearly the monastic wall had been cleared to a low level.

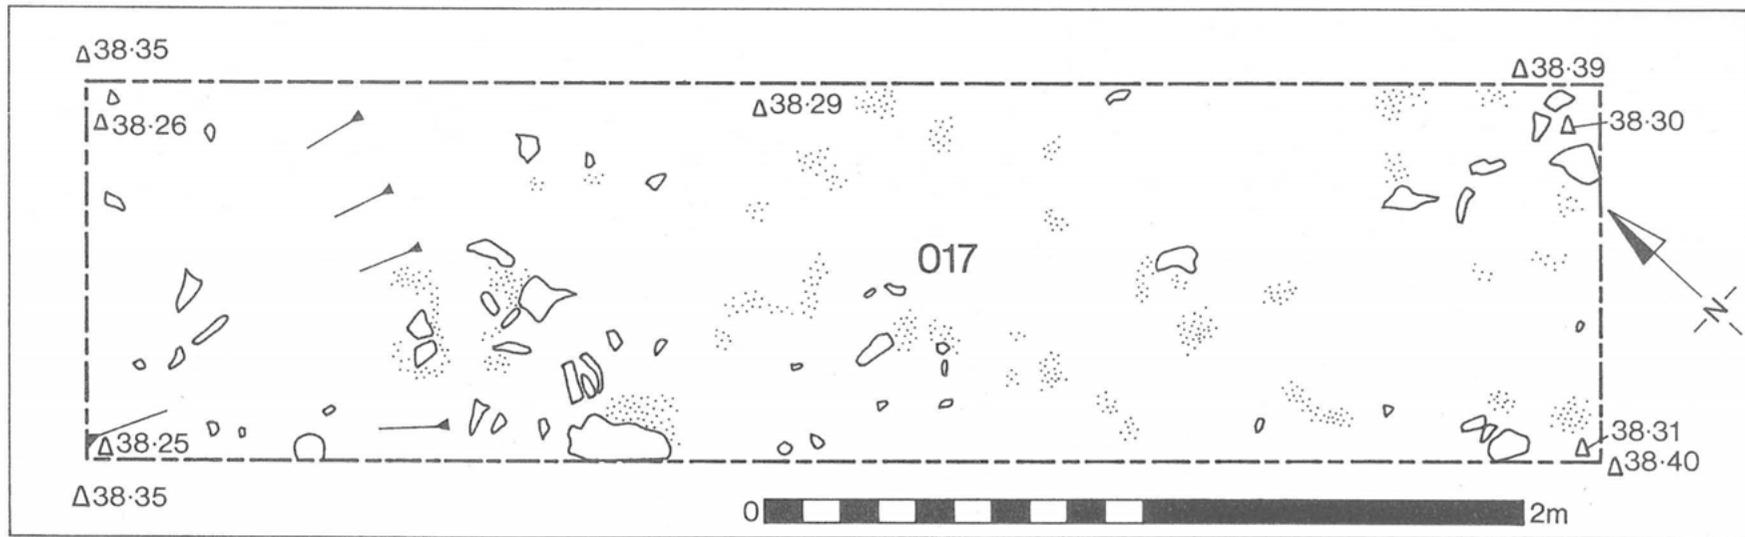
Figure 7: Trench 6 plan

Trench 6 was laid out northwest-southeast in the cloister area, in a location which may overlie the south arcade of the cloister. After removal of turf and topsoil, archaeological deposits were encountered at a depth of 0.10m.

Layer 017 formed a moderately compacted surface of stony clay loam marked by white mortar fragments and lumps, coal fragments and stones; at the northwest end, some of the layer had been cut away by more recent disturbance, exposing cleaner clay, perhaps an underlying layer. Overlying the surface was turf and topsoil 016. There was extensive root activity in the southeast end of the trench.

The layout of the cloister remains uncertain. The density of 18th-19th century finds from Trench 6 suggests that the surface encountered was exposed in the 17th century. It is possible that the medieval deposits survive below this surface.

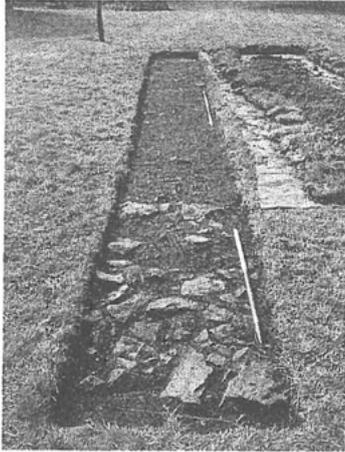
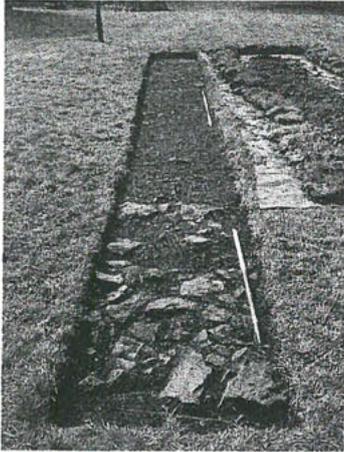
Plate 1: Trench 1 (012, 013), looking E

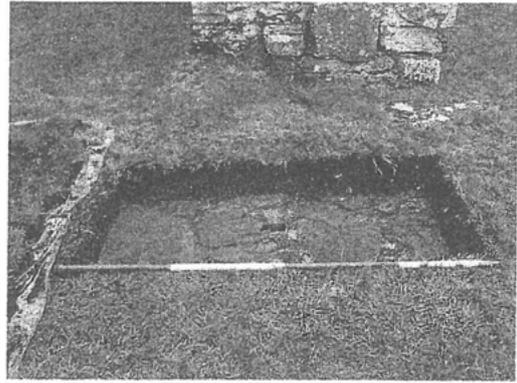
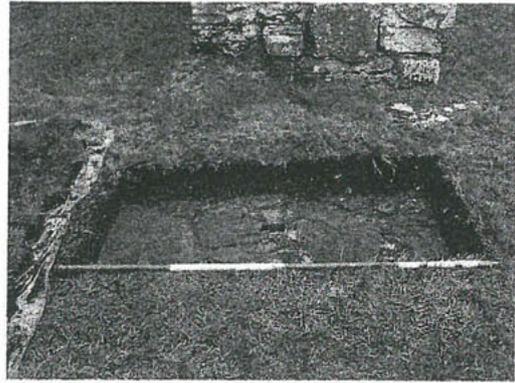
Plate 5: Trench 4 (009), looking N

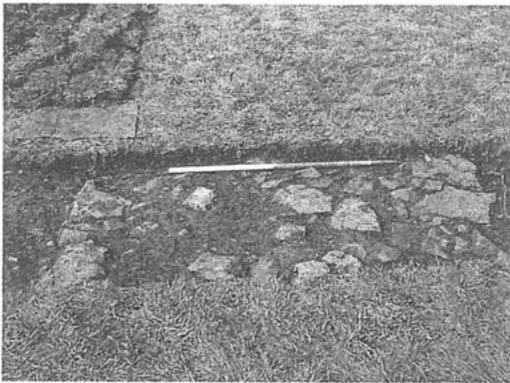
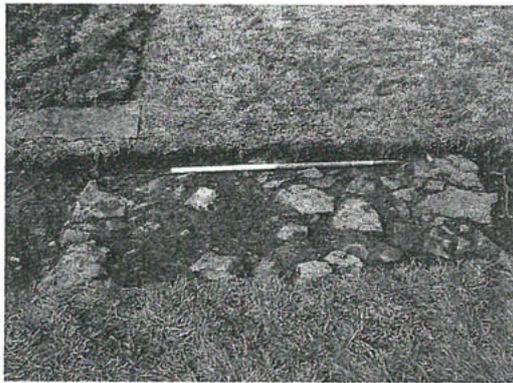
Plate 2: Trench 1 (013), looking N

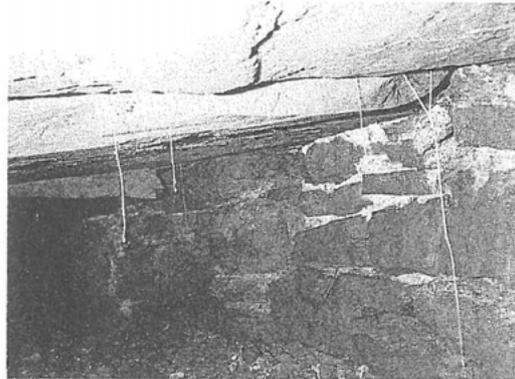
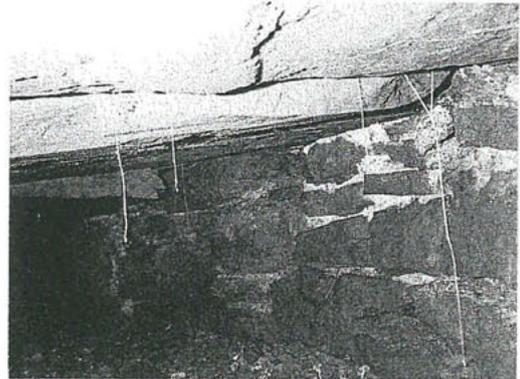
Critical to the chronology is the evidence of the culvert, which has elements of both mortars, perhaps best interpreted as a structure extensively rebuilt in the 18th century, using earlier materials (possibly largely *in situ*).

Plate 6: Trench 4 (interior of culvert 009), looking W

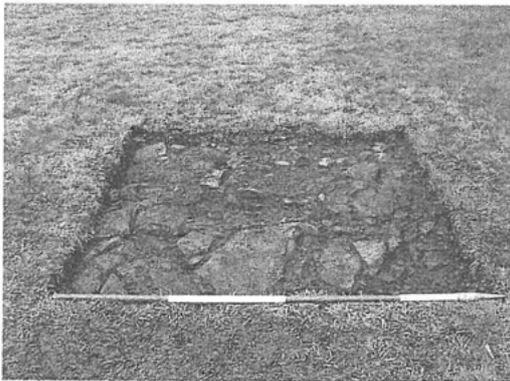
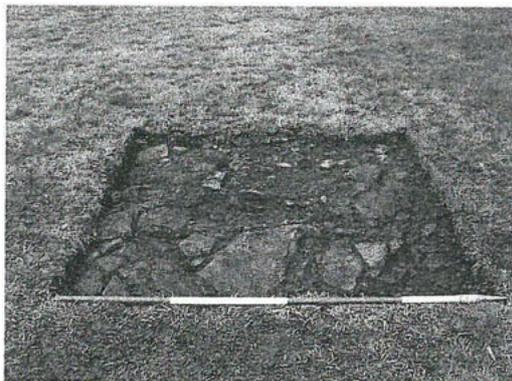
Plate 3: Trench 2 (003), looking N

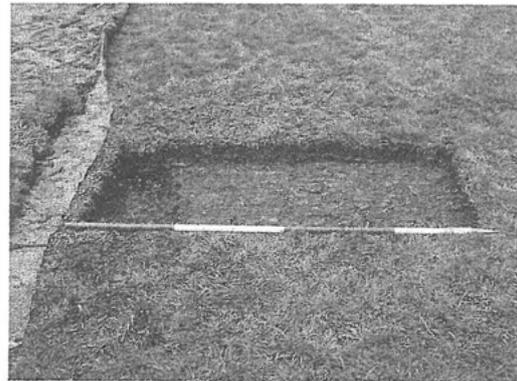
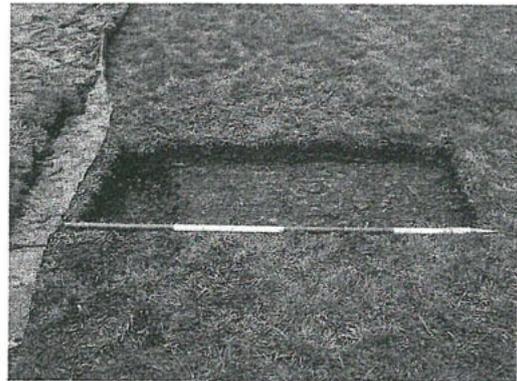
Plate 7: Trench 5 (010), looking N

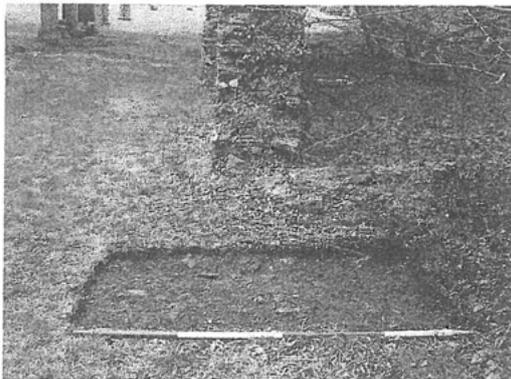
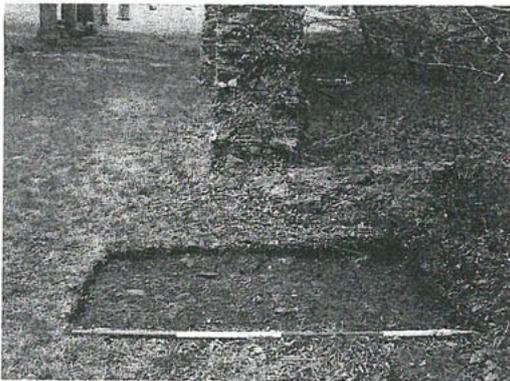
Plate 4: Trench 3 (015), looking S

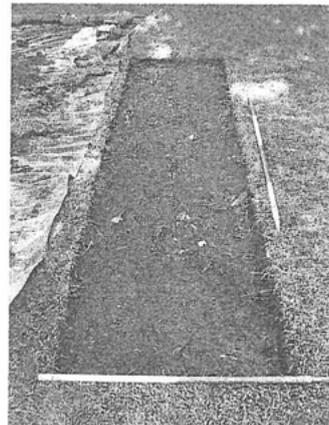
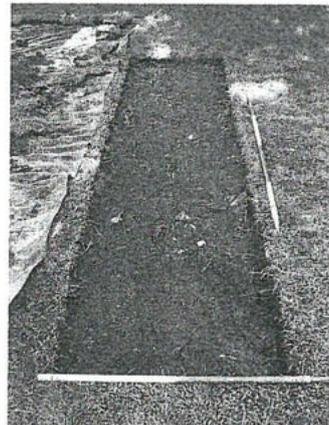
Plate 8: Trench 6 (017), looking SE
