Margam Abbey (SAM Gm5),
Neath Port Talbot:
archaeological evaluation

A report for Neath Port Talbot County Borough Council
by Martin Locock BA MIFA

GGAT report no. 2001/031
Project no. A668
Excavation no. 439

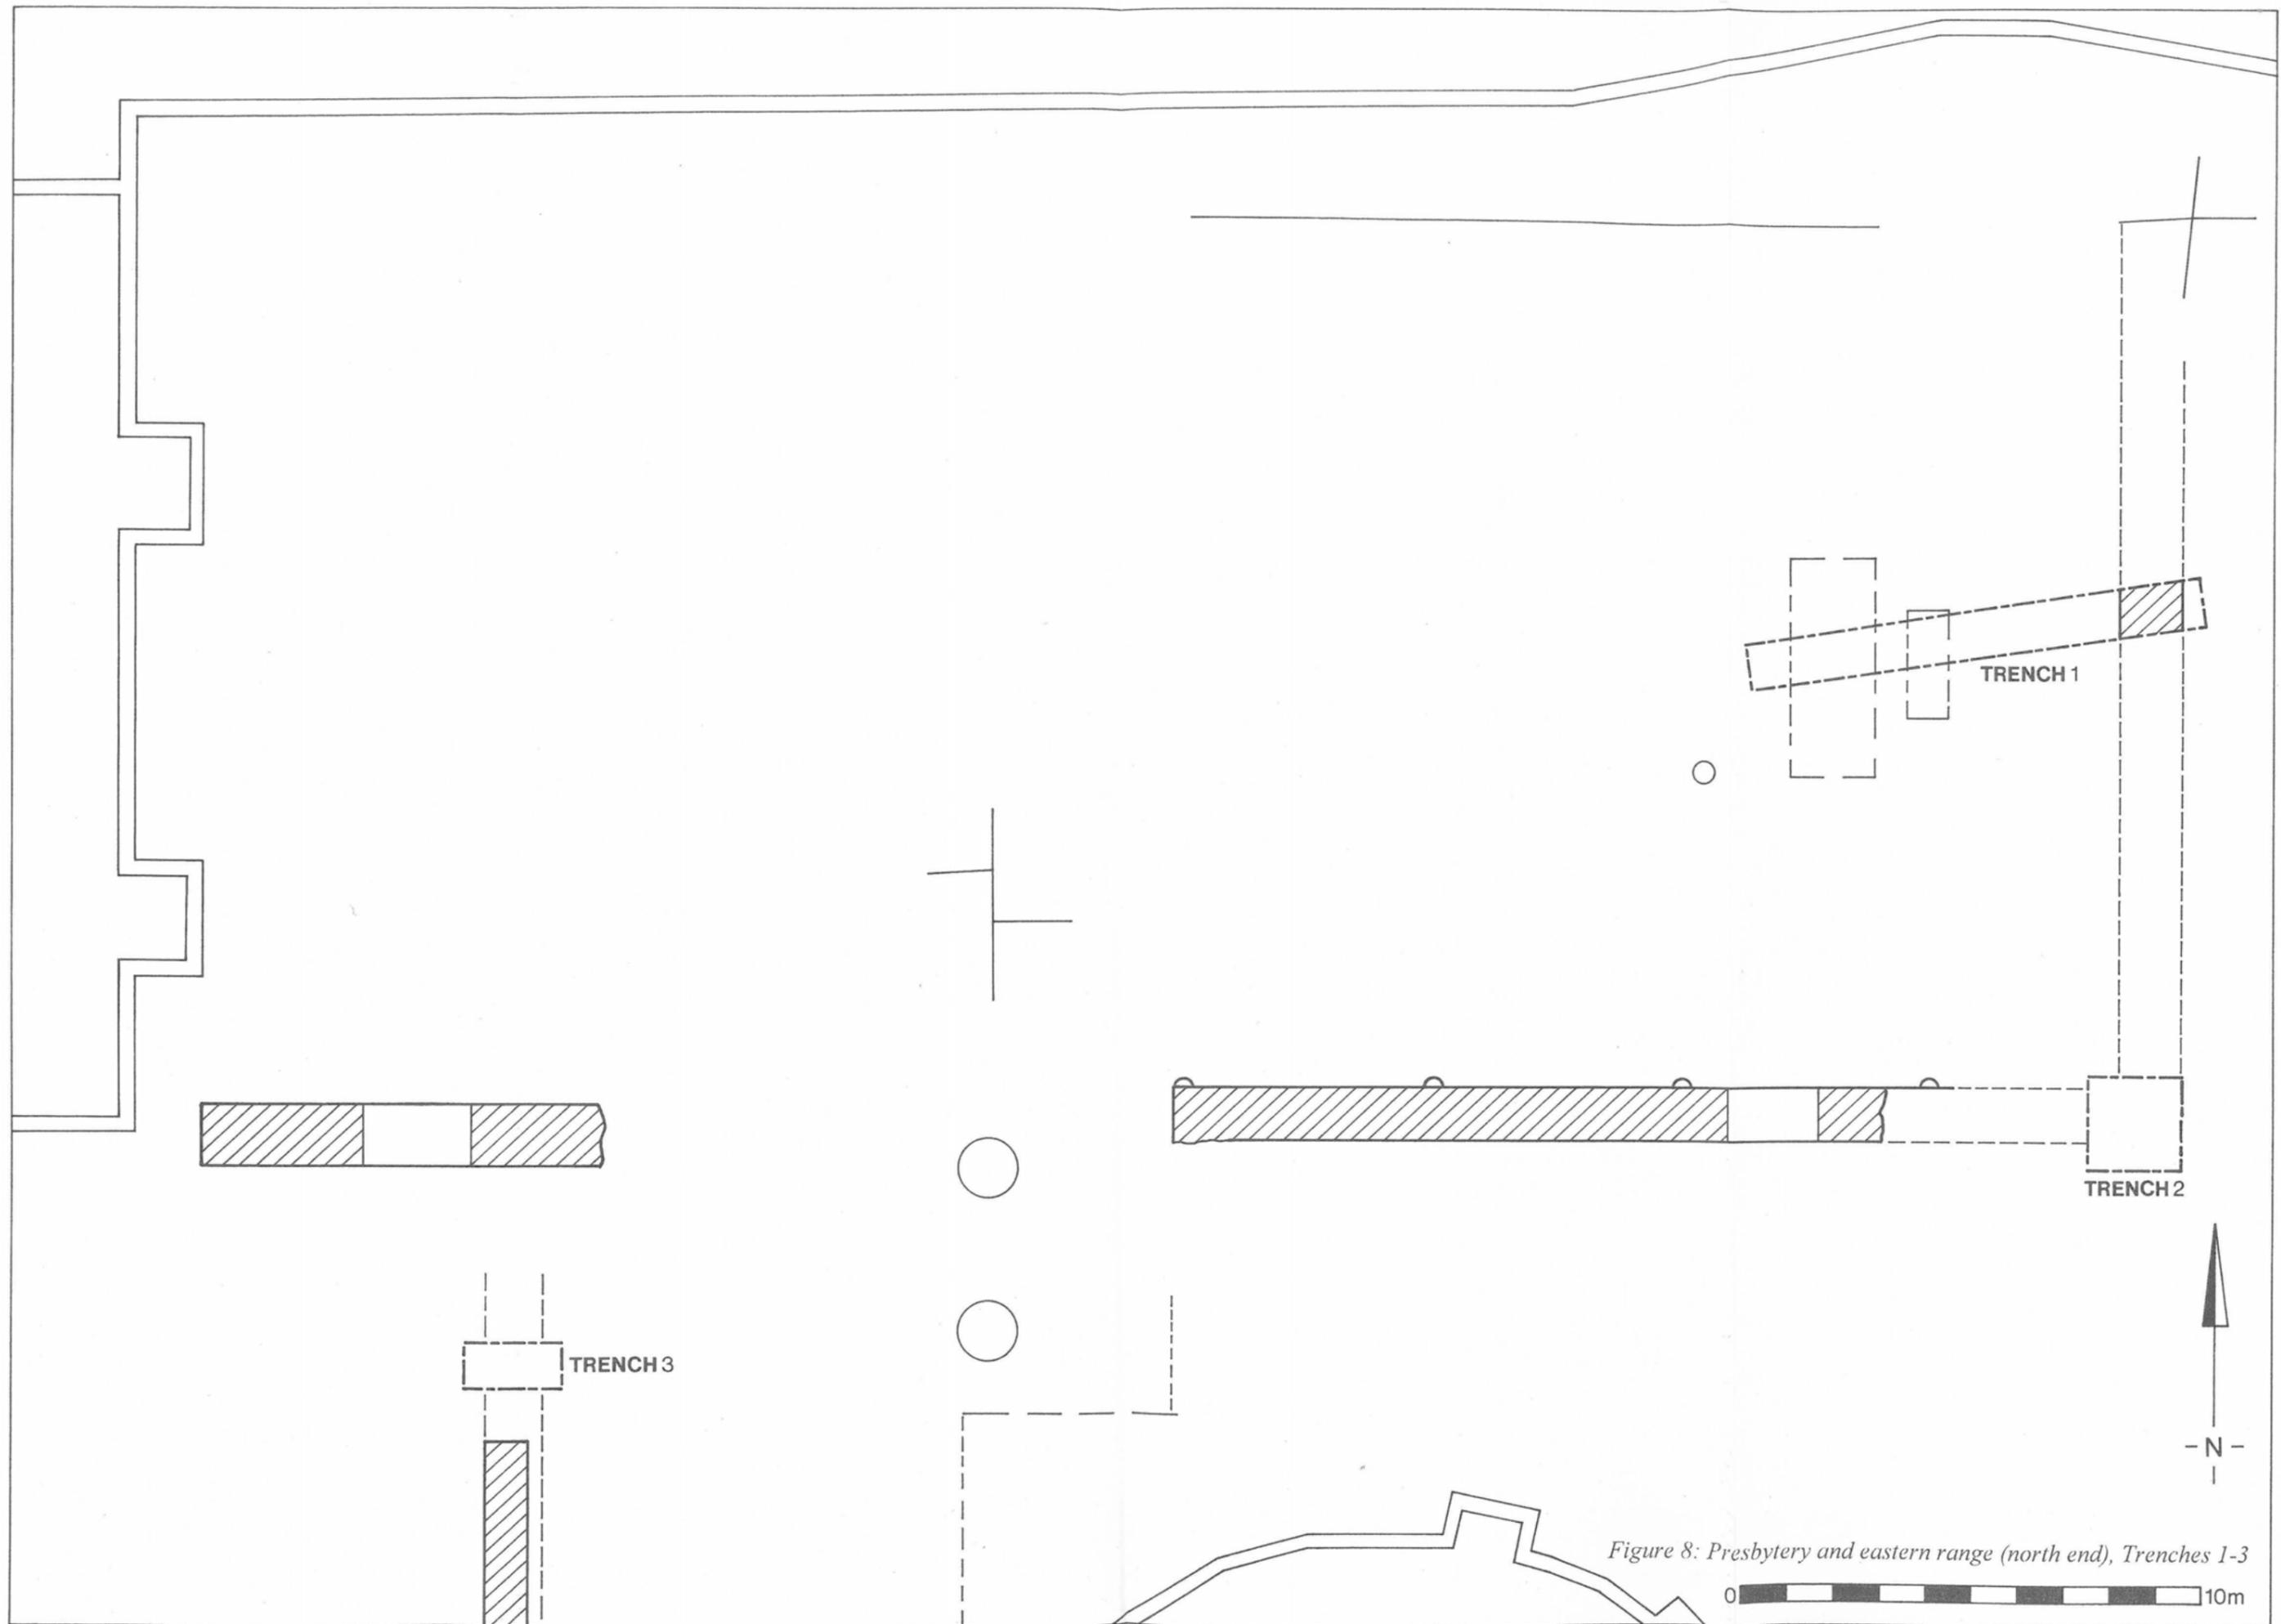
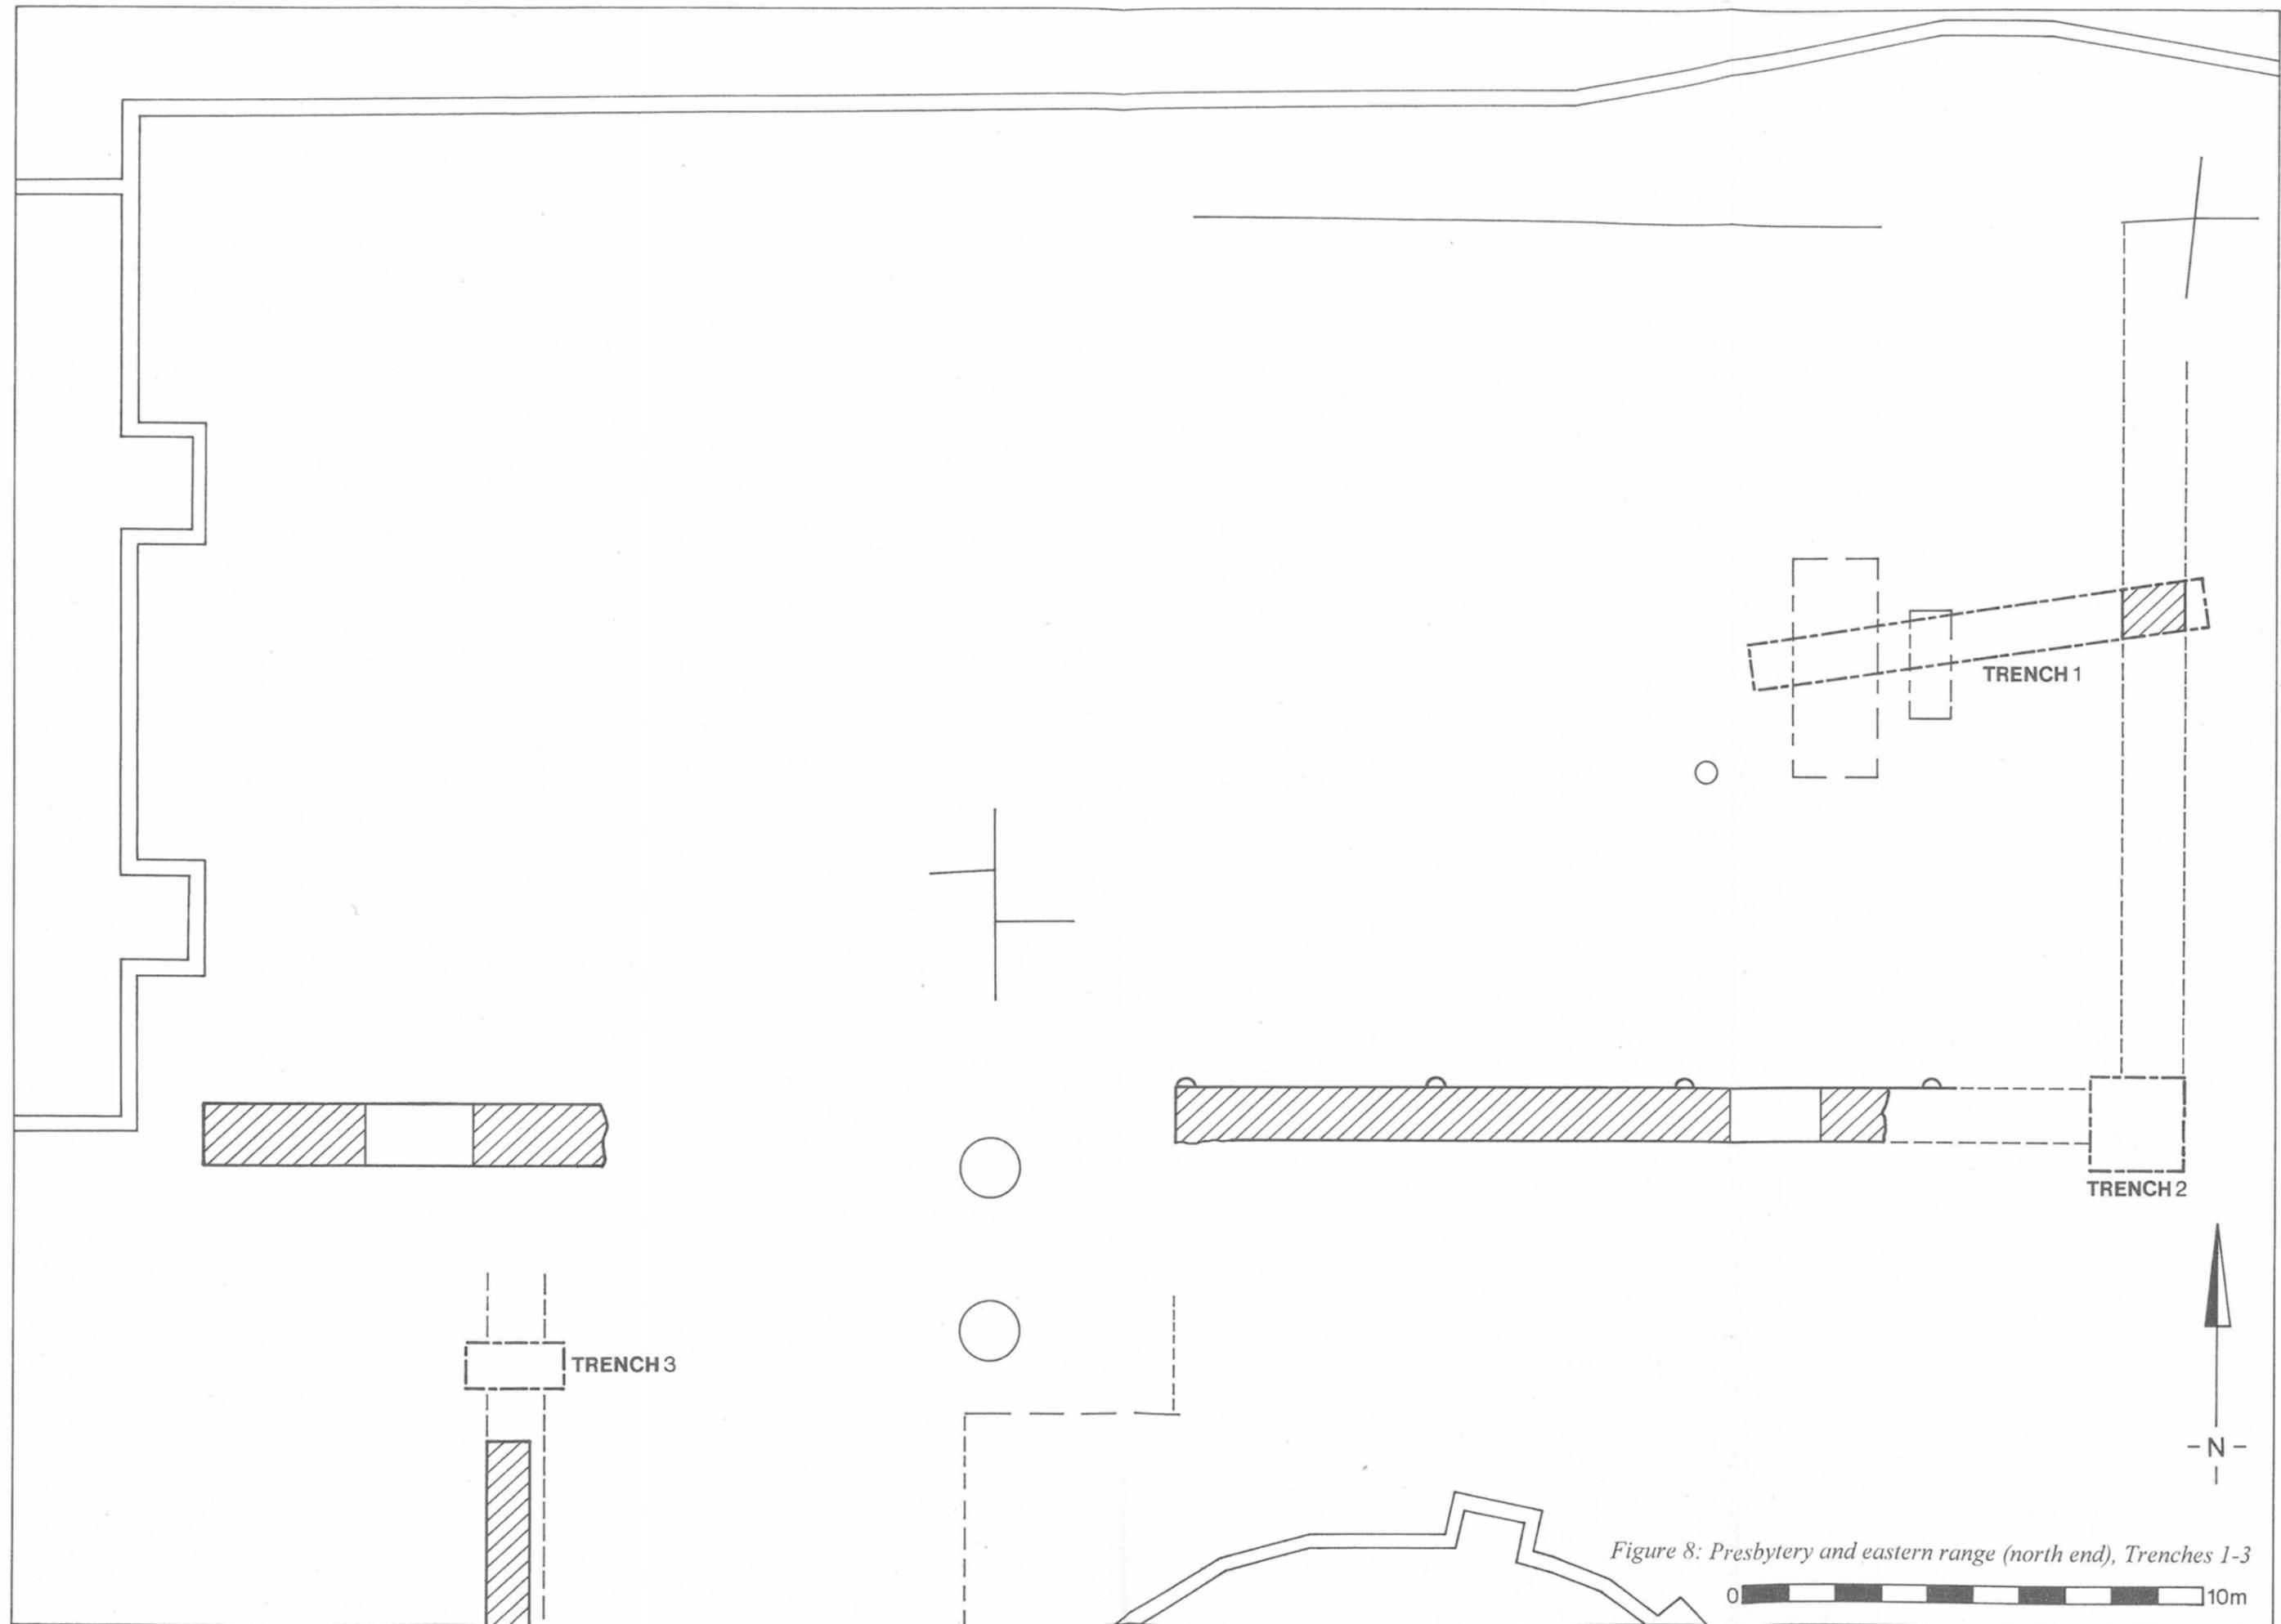
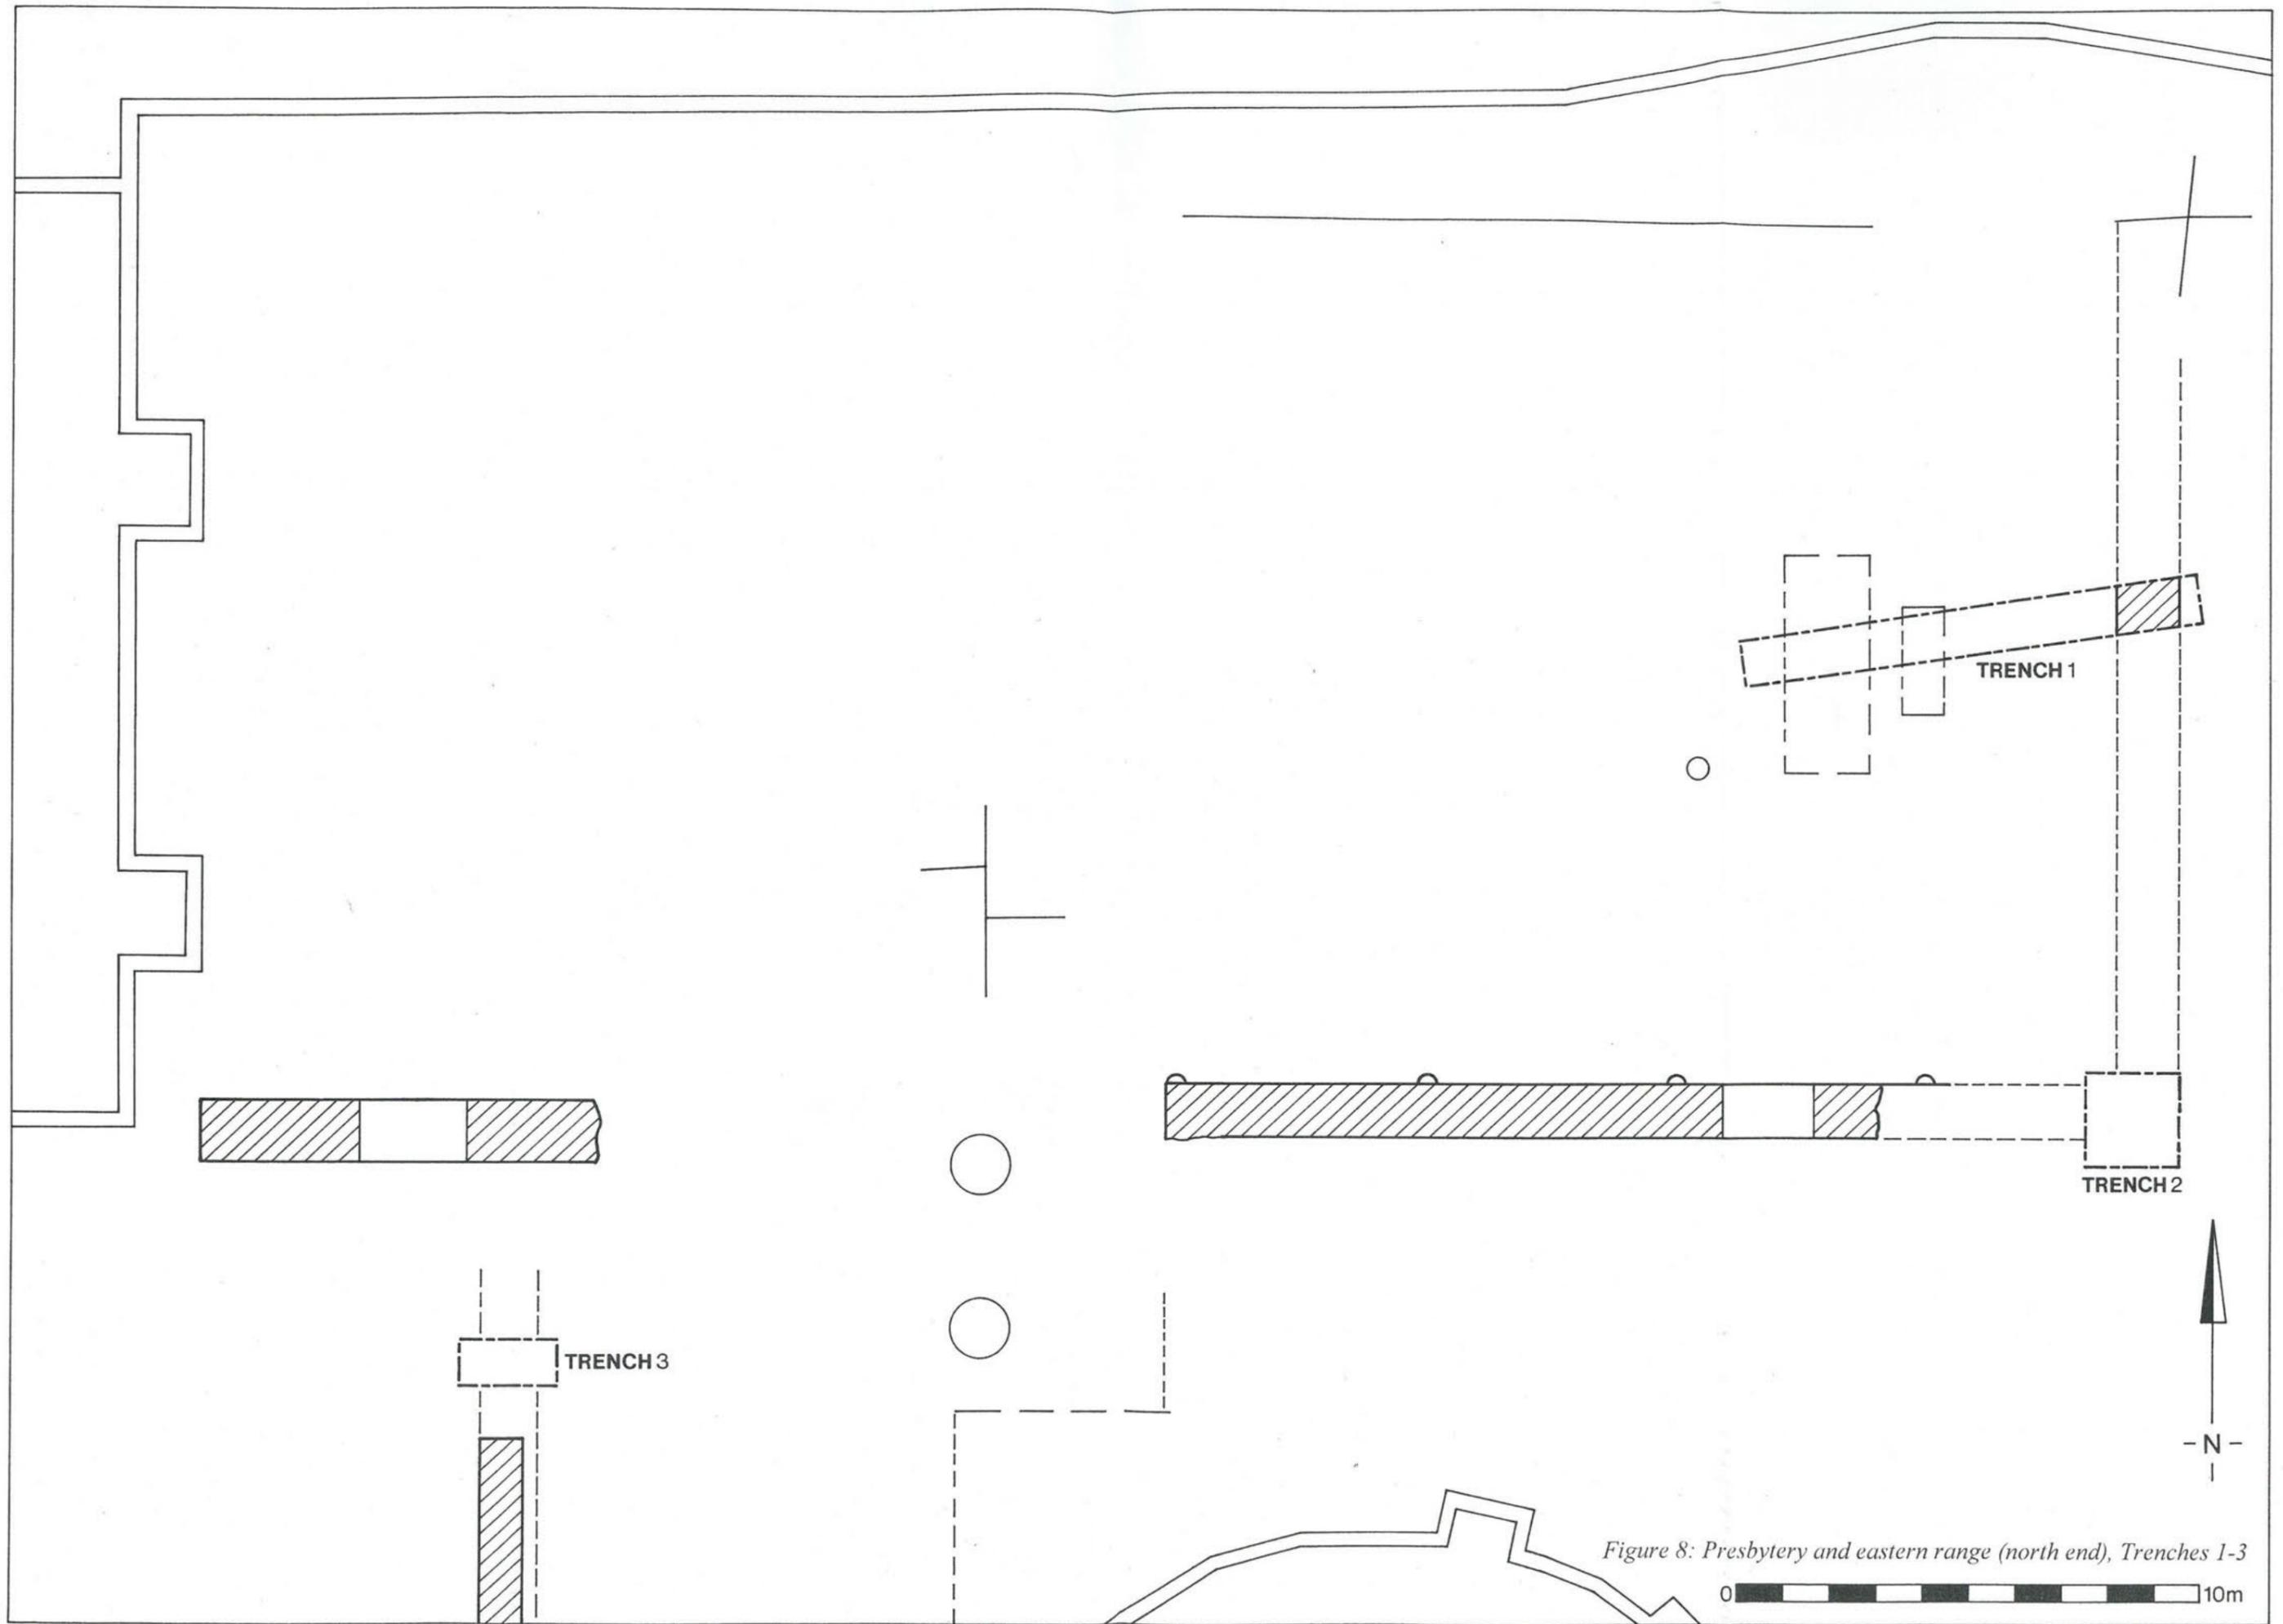
Figure 8: Presbytery and eastern range (north end), Trenches 1-3

Two trenches were excavated to establish the depth of deposits in the area of the presbytery, at the east end of the abbey church. The ground level in this area is significantly higher than that elsewhere, with a marked drop at the crossing. The north and south walls of the presbytery survive partially, with some of the pillars for the vaulting of the aisles visible. There are (apparently *in situ*) grave slabs in the church, and floor tiles have been noted along the south wall (not now visible). The east wall does not survive.

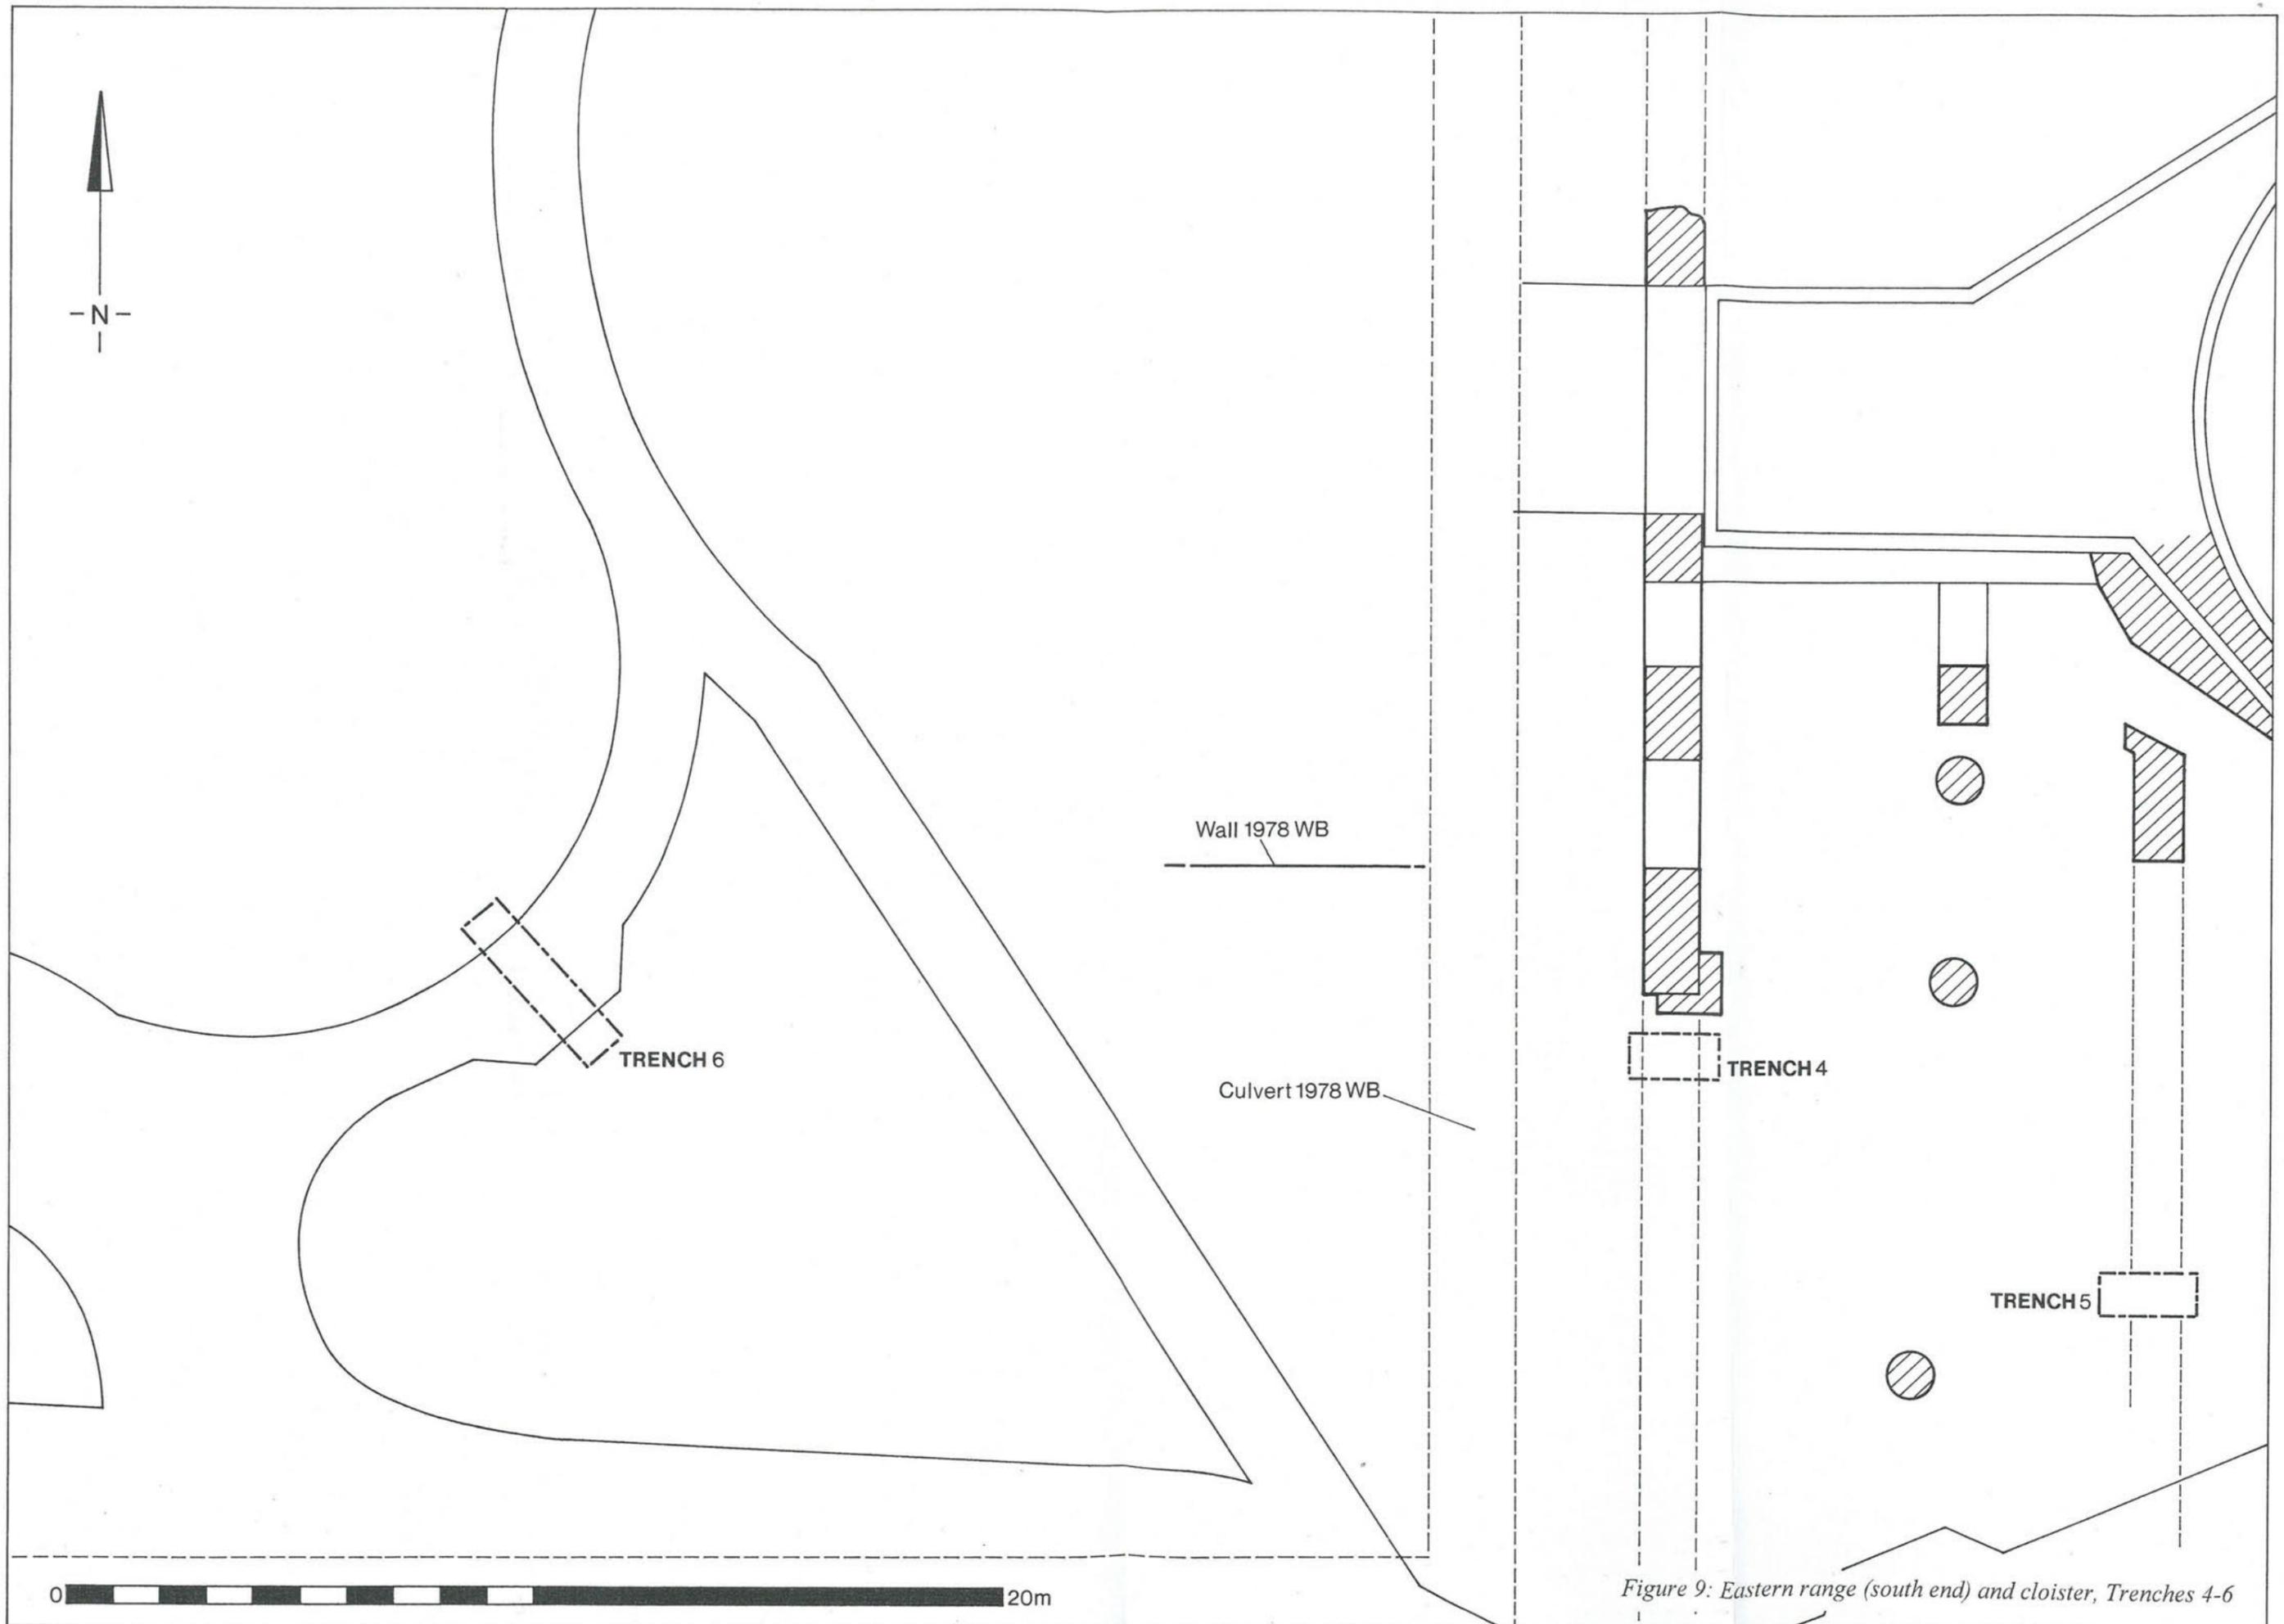
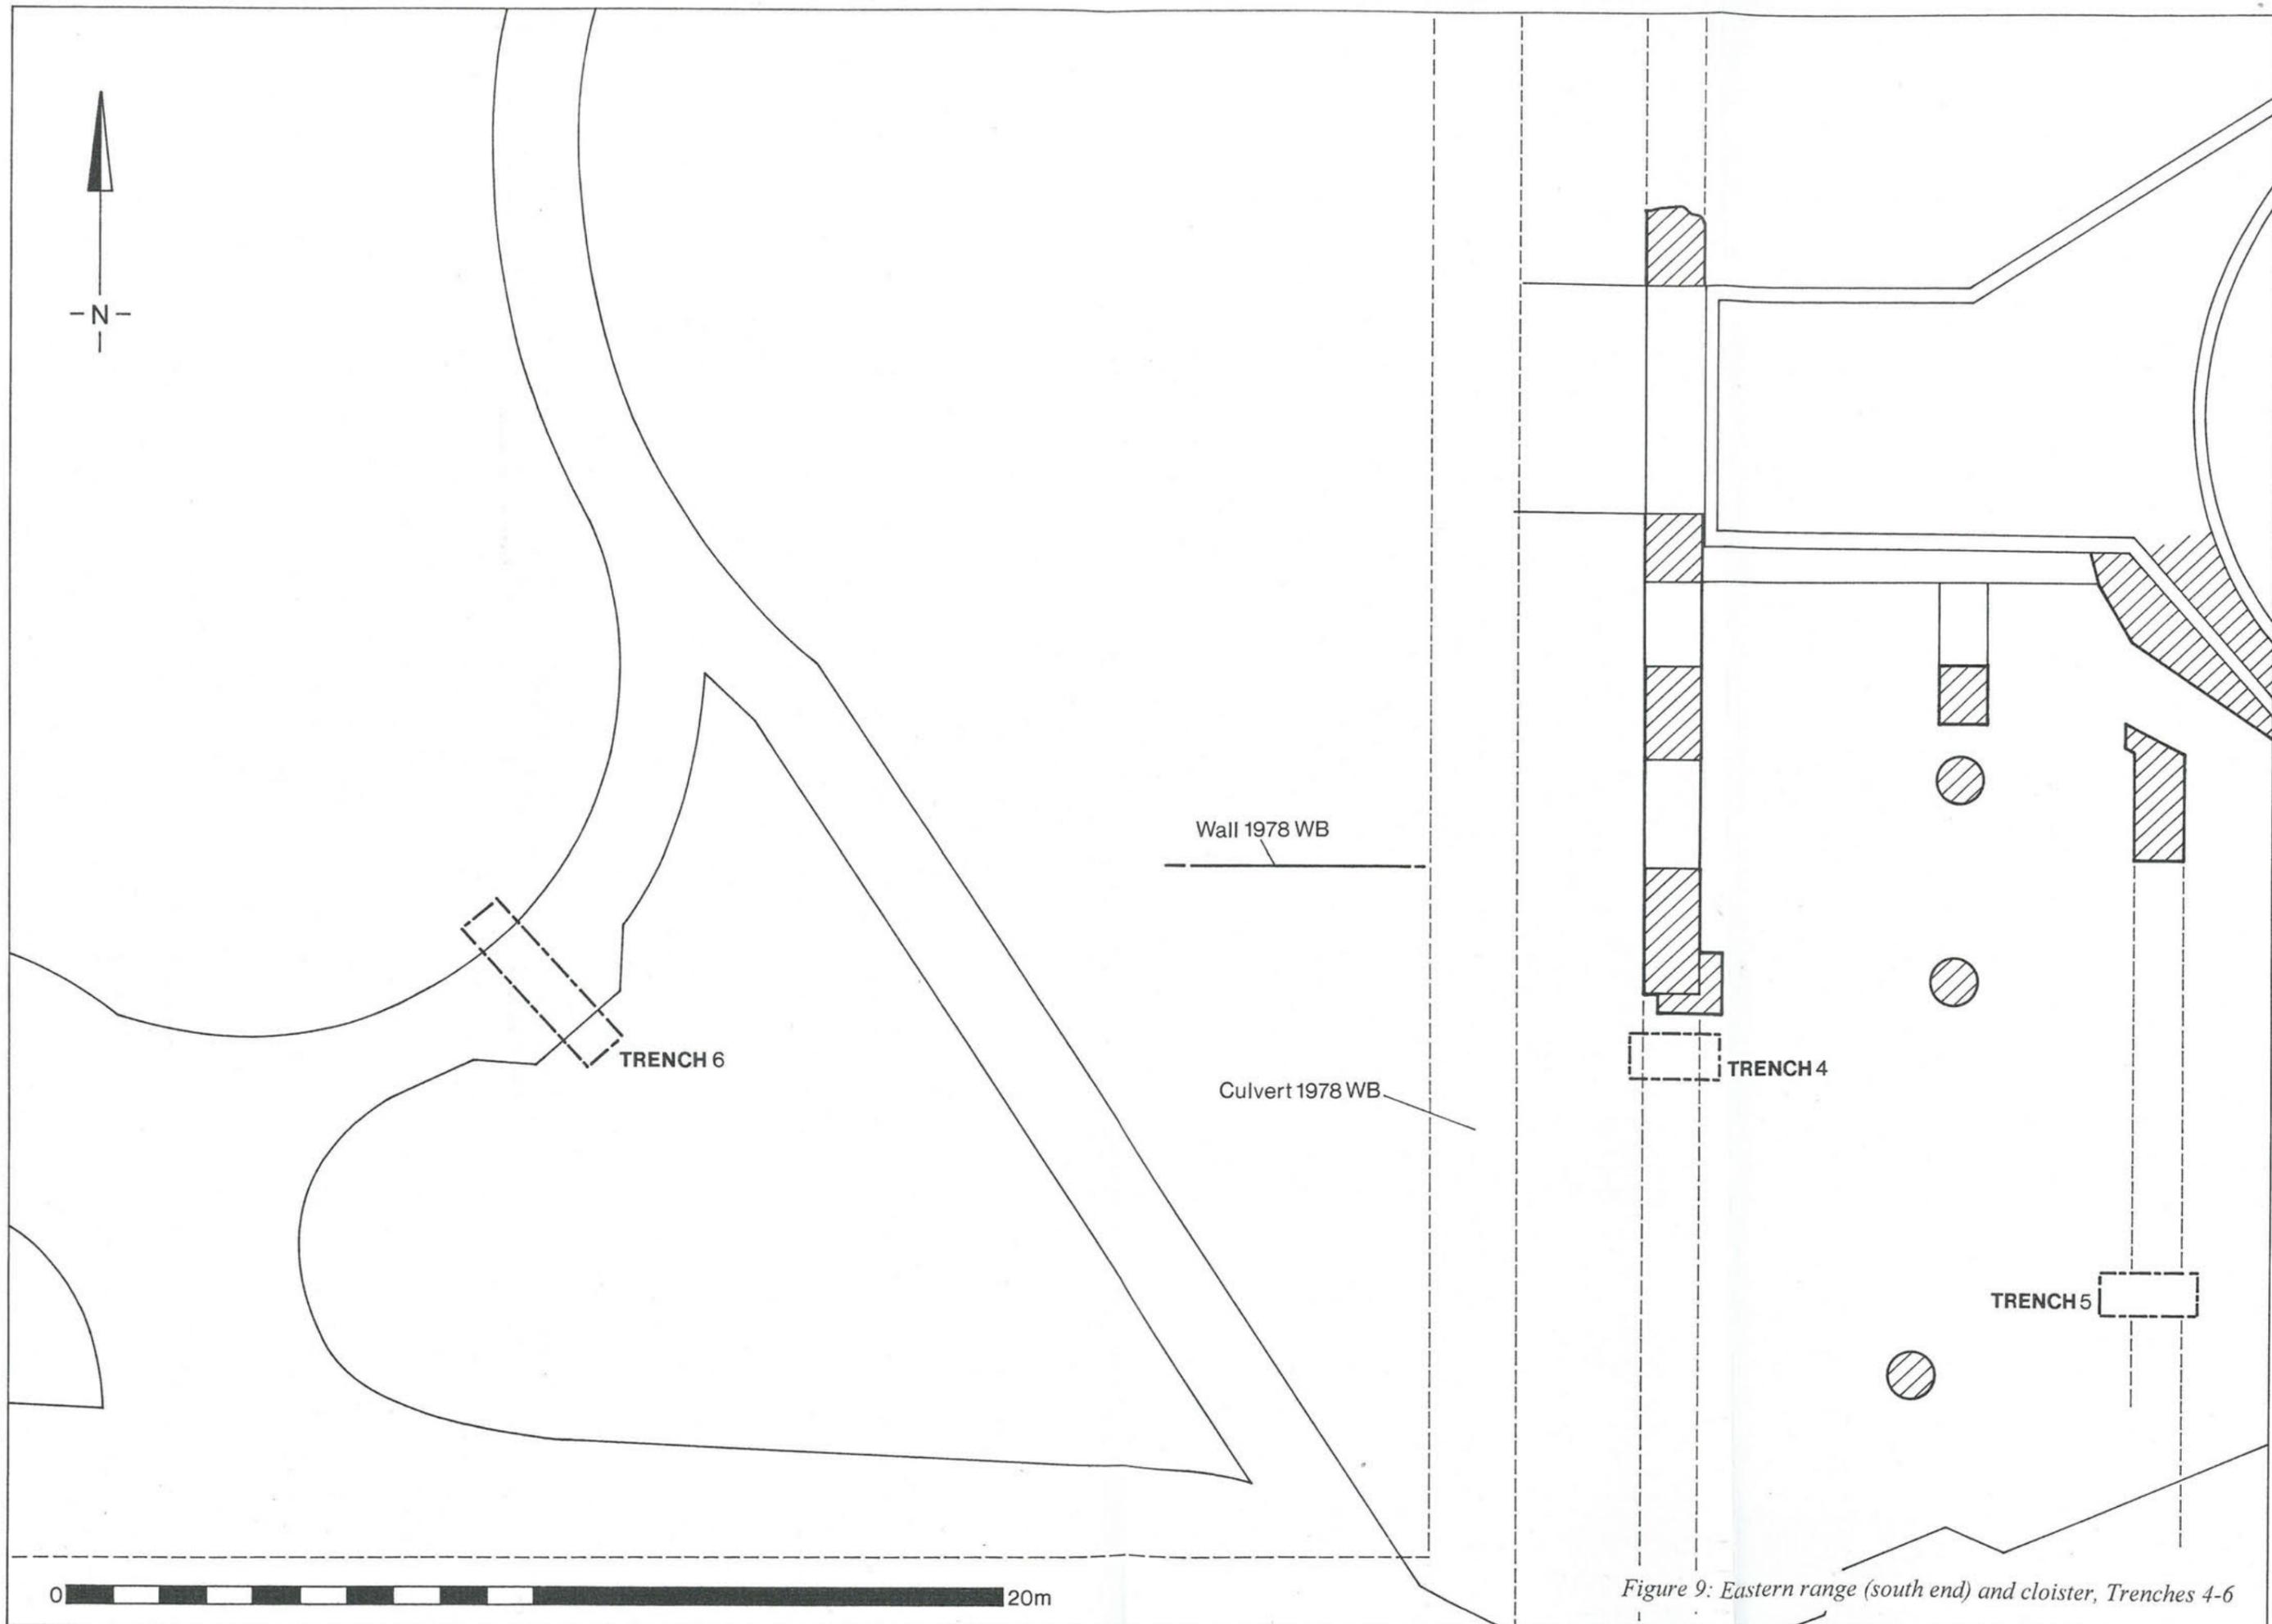
Figure 9: Eastern range (south end) and cloister, Trenches 4-6

Two trenches were excavated on the projected east and west wall-lines of the dorter range to the south of the standing masonry of the chapter house and vestibule, and one trench was excavated in the cloister area in the position of the proposed seat and information panel.
