# **Chepstow Castle Middle Bailey Excavations, Monmouthshire**

Archaeological Excavation

CAP Report No. 235

Date: May 2003

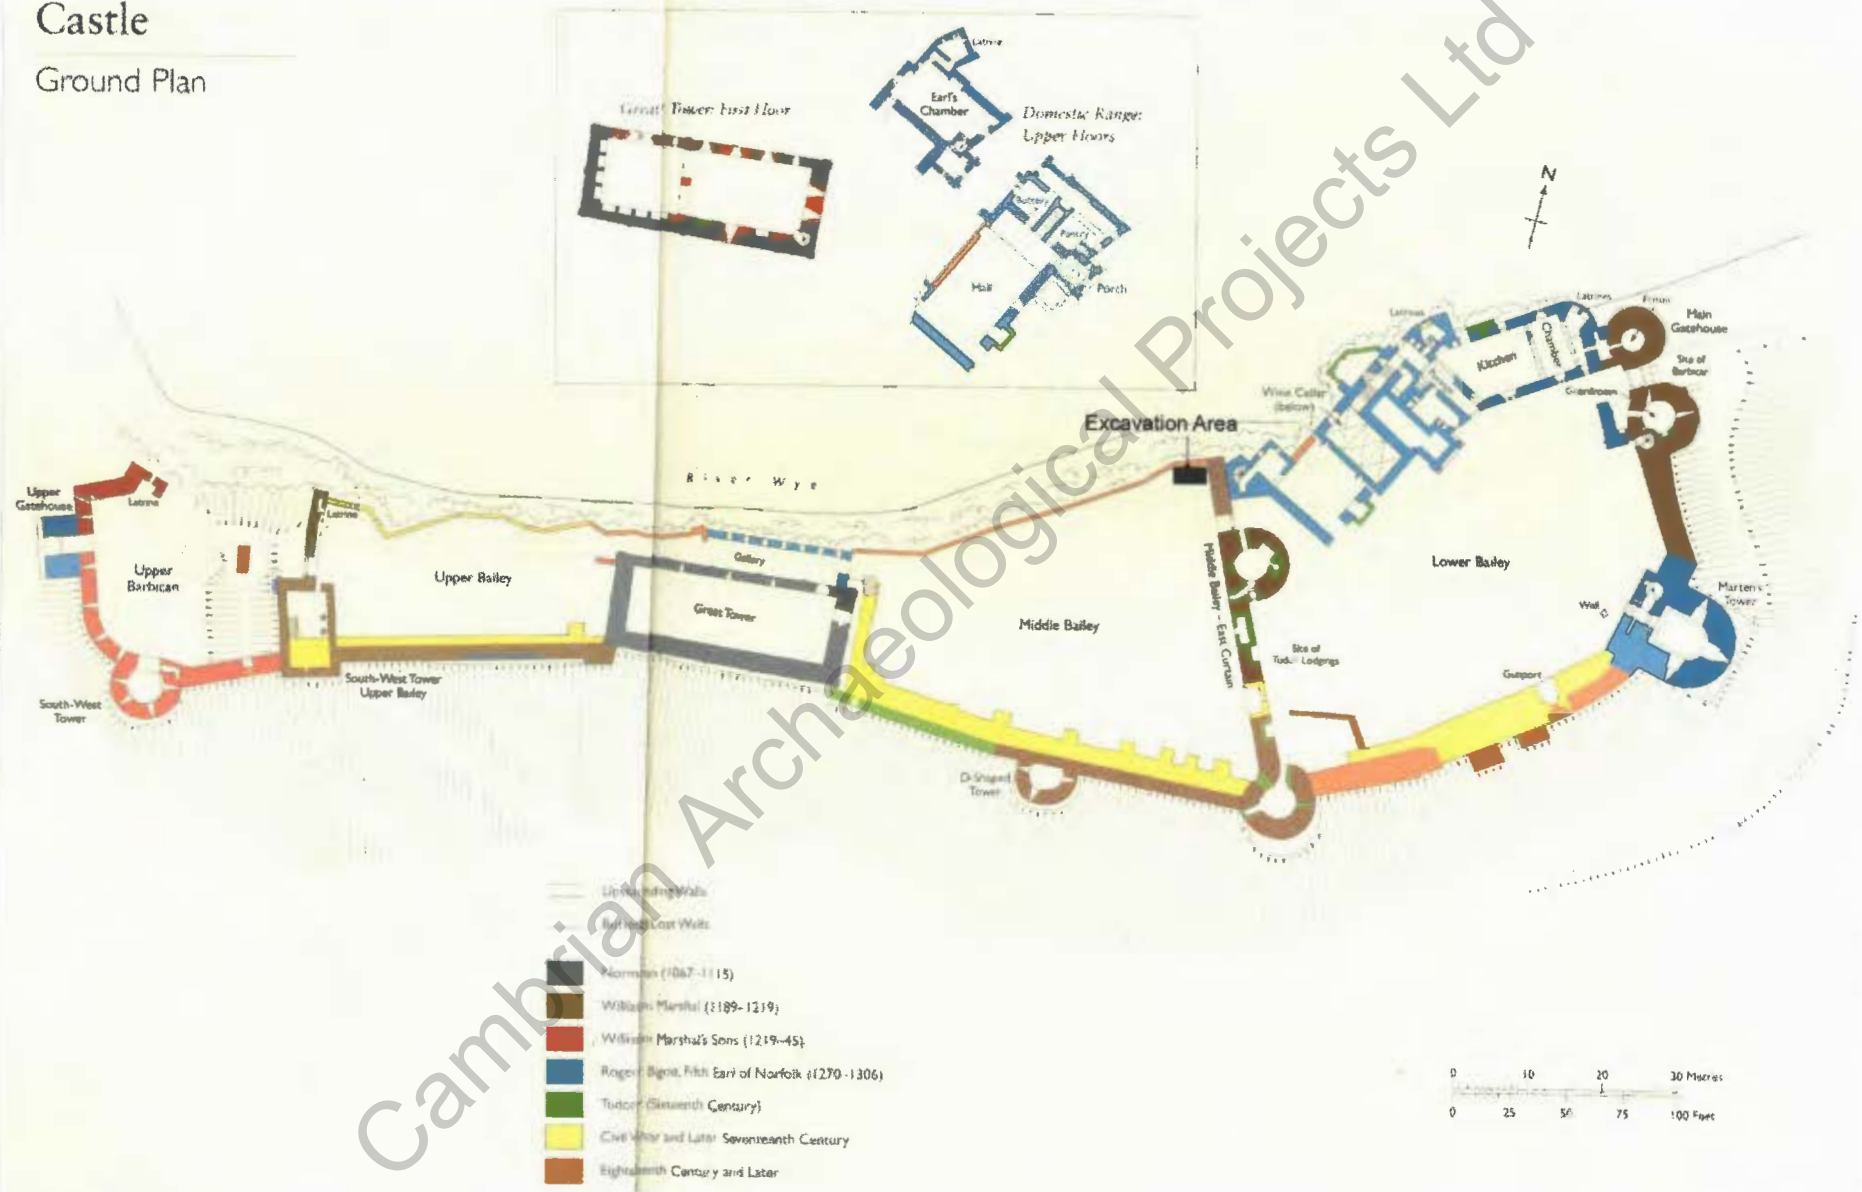
Figure 02: Ground Plan of Chepstow Castle detailing excavation area

Chepstow Castle lies on a lengthy Carboniferous limestone promontory on top of tall cliffs overlooking the river Wye (Fig 1). The site of the excavation is located within the north-eastern corner of the Middle Bailey (Fig 2). The topography of land within the Middle Bailey slopes gently away to the north and north-east. The Middle bailey is situated between the Lower Bailey to the east and the Great Tower and Gallery to the west.

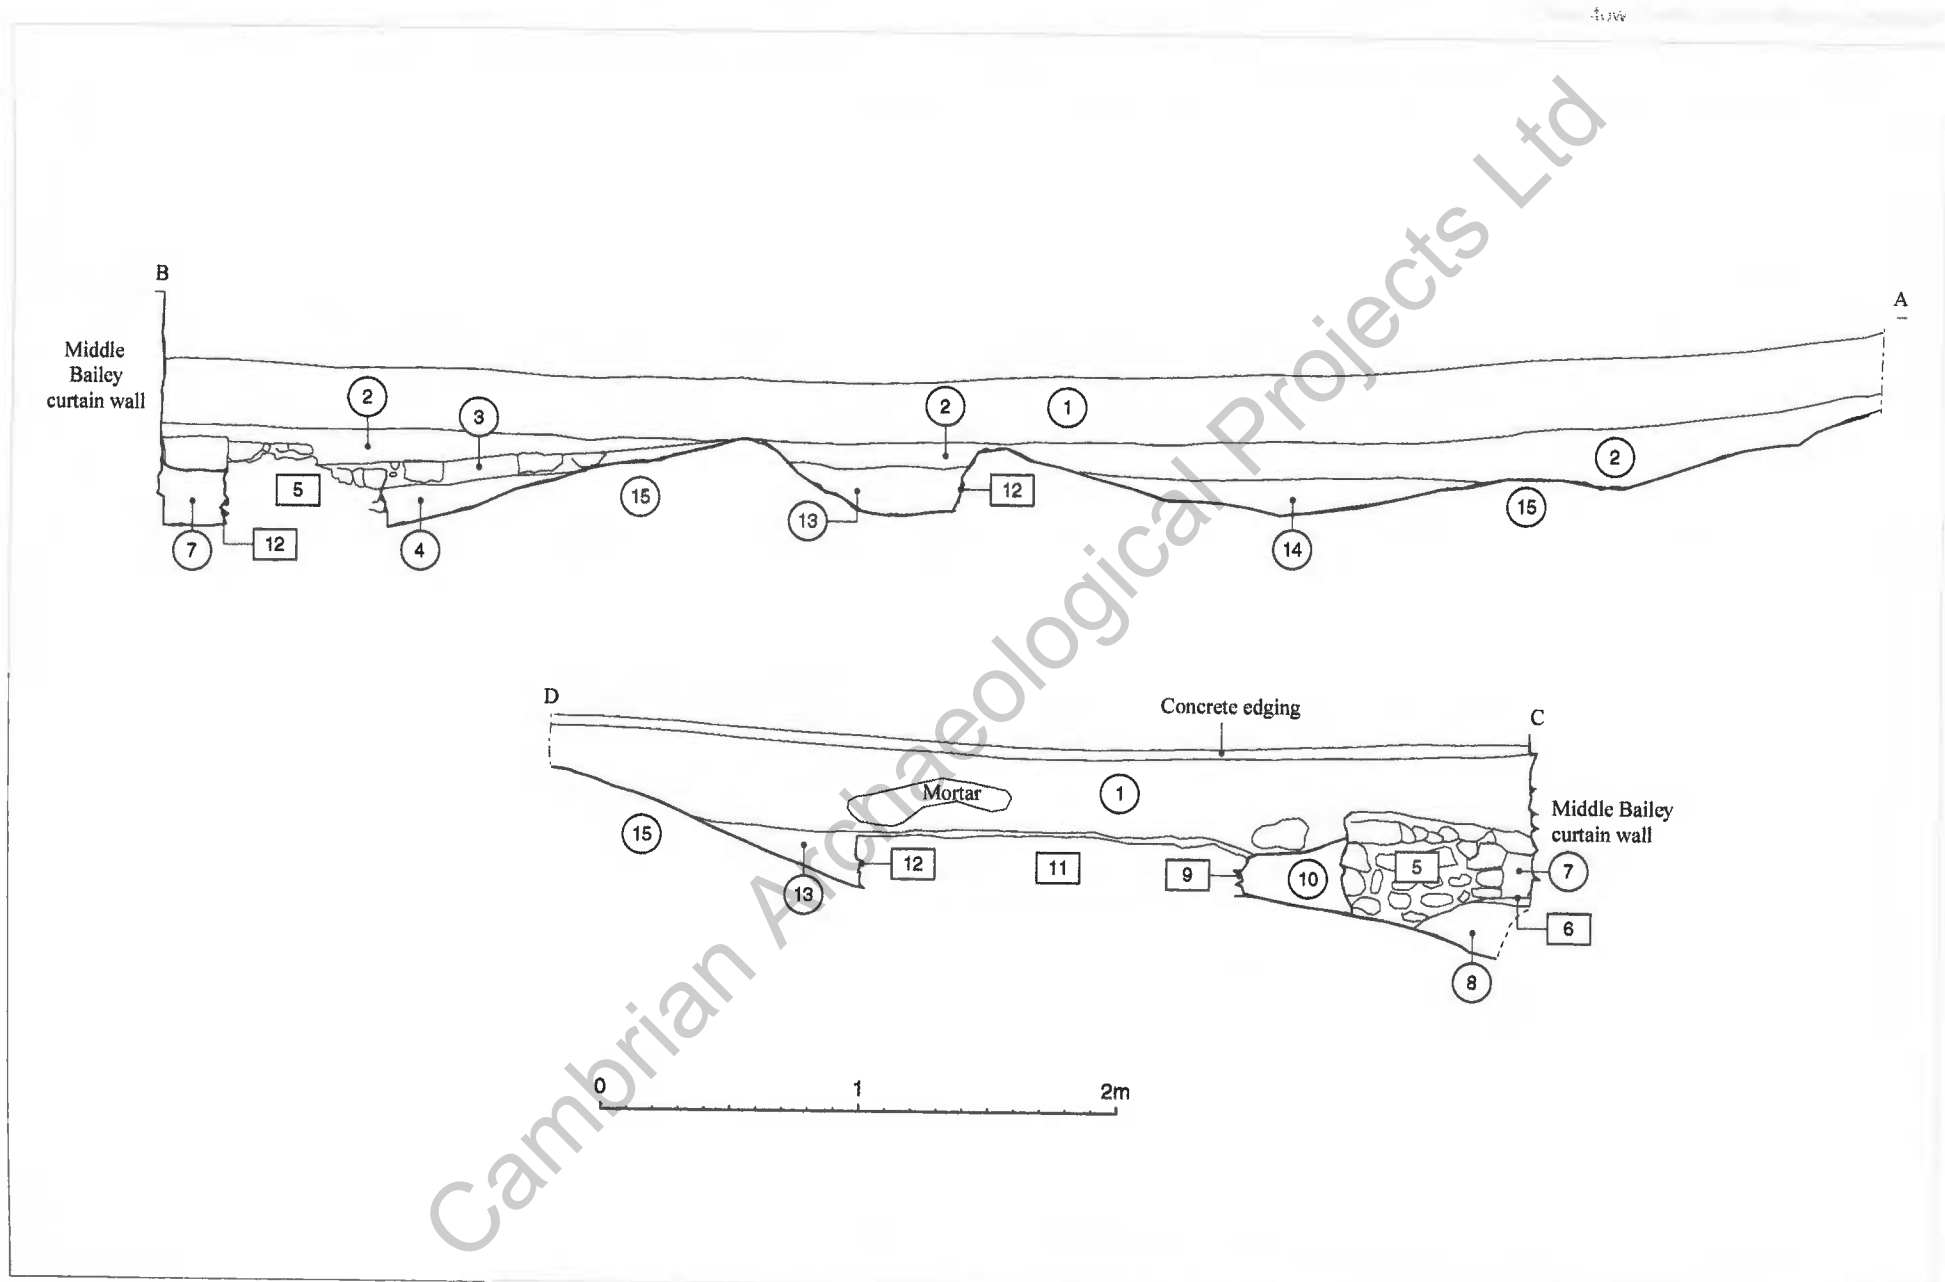
Figure 04: Section of Excavation Trench

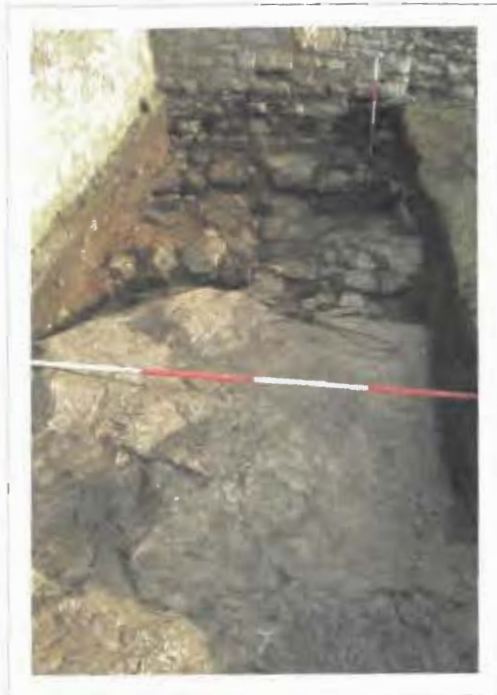
Plate 01: View of excavated area looking east. Scales: 1m x 2m

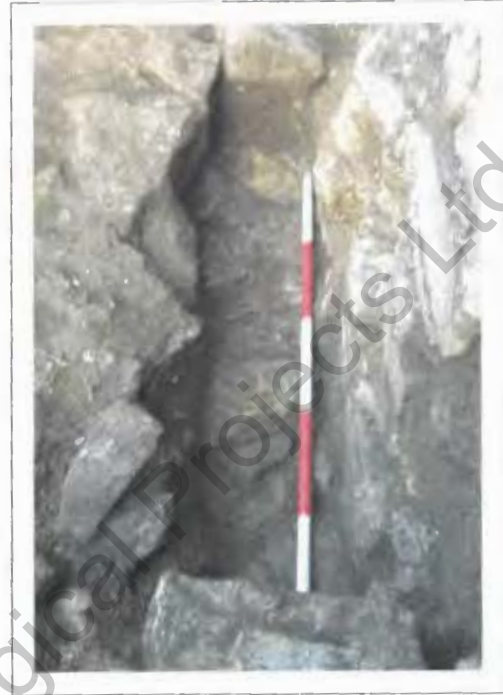
Plate 02: Stone lined drain [6], looking north. Scale: 2m

The eastern face of wall [5] formed the western side of drain [6] that used the middle bailey east curtain wall as its eastern side. This drain was capped with limestone blocks except on the southern portion of the exposed area where a void or drain was uncovered (plate 4). This void that could plausibly be a drain, was constructed into the bailey wall, if this was a functional water course it would have drained into [6] that then in turn would have carried water into the middle bailey (based on levels obtained on the base of the drain). The fill of [6] consisted of a medium brown silty sand-loam (7), during the sampling and excavation of this deposit a bronze decorated buckle plate of 14<sup>th</sup> century style was recovered alongside animal and bird bones; 12<sup>th</sup>-15<sup>th</sup> century pottery sherds and a slate counter. A small section was cut through the wall [5] and drain [6] to establish any construction phasing; it was recognised that both the wall and the drain were built on a thick deposit of hard mortar [8]. The mortar was laid upon the natural bedrock and the middle bailey east curtain wall was constructed onto this mortar, alongside wall [5] and drain [6].

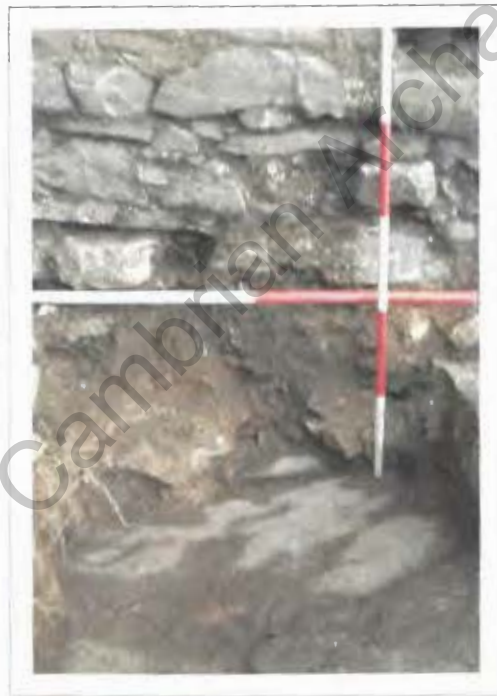
Plate 03: Mortar deposit (8), looking east. Scales: 1m x 2m

the late twelfth century as part of his complete remodelling of the castle's defences. It was during the construction of the east curtain wall that a thick deposit of mortar was used to level-out the natural slope of limestone. Onto this the east curtain wall was constructed and a structure associated with a stone capped drain followed during this construction phase 1. The buttress foundation and associated gullies could have been part of this phase of building based on the stratigraphical relationship and the pottery/metalwork dates. The demolition of the walled structure, and buttress is unclear in time scale but represents phase 2 activity, but the layer of soil sealing this demolition phase contained 17<sup>th</sup> century artefacts. It is possible that the two door jambs in the curtain wall are Tudor in date and may relate to the insertion of a pair of Tudor doors in the same wall. The excavation failed to identify any structural evidence to clarify the idea that this was part of the porter's lodge. Around the 17<sup>th</sup> century (phase 3) the curtain wall was thickened and the middle bailey tower was remodified to contain cannon. It is possible that the structures within the excavation area were demolished around the 16<sup>th</sup> or 17<sup>th</sup> centuries.

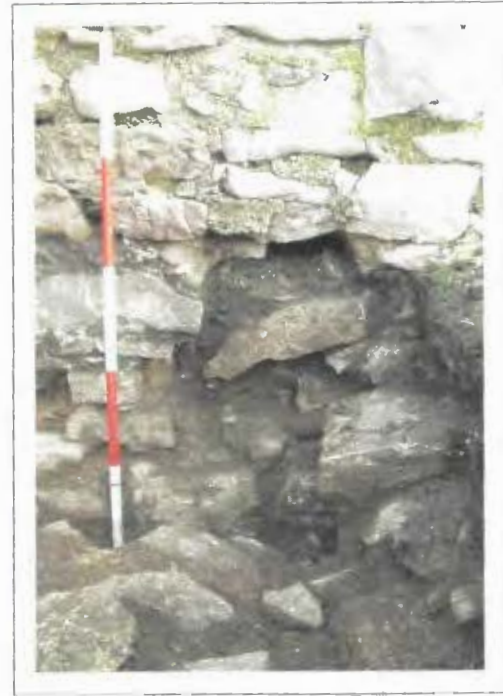
Plate 04: drain [6], void in curtain wall, looking east. Scale 1m

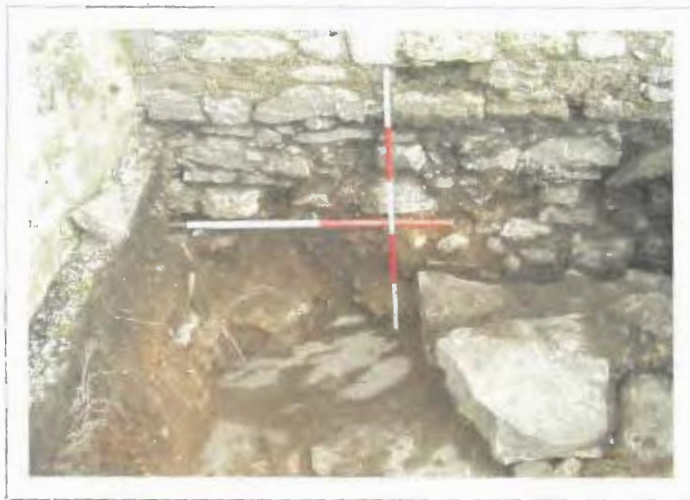
Plate 05: Gully [12], looking north. Scales: 2m

Situated to the north western part of wall [5] a narrow shallow gully was exposed [9] this gully used the part of the western face of wall [5] and the eastern face of buttress base [11]. The base used the natural limestone, and its fall (based on levels) ended within the exposed terminal portion suggesting the function was to retain water than divert it towards the cliff edge. The few finds retained from its dark grey sandy fill (10) consisted of animal and bird bone and a sherd of 12<sup>th</sup>-13<sup>th</sup> century pottery. A further gully [12] was exposed to the west of buttress [11], this gully used the western face of the buttress and a single set of mortared stones to form its eastern side. The western side utilised the steep incline of the natural limestone and where this was insufficient a course of mortared stones. The fall at the base of the gully indicated by the levels that it would have fed water towards the cliff edge unlike the gully [9] and drain [6]. The fill (13) consisted of

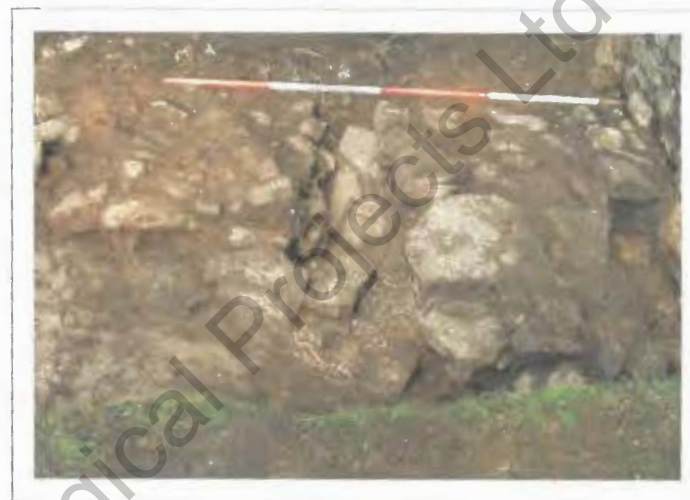
Plate 06: Buttress [11], Gully [9], Wall [5] & Drain [6], looking north. Scale: 2m

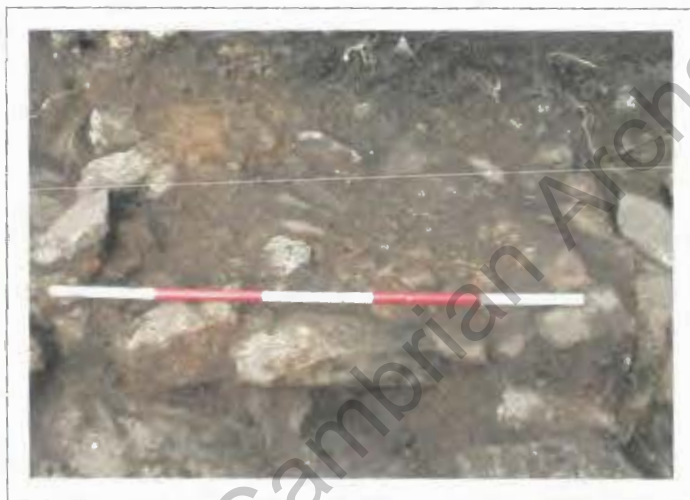
Plate 07: Buttress [11], looking north. Scale: 1m

The Buttress [11] was exposed on the northern area of the excavated area. The structure was built of sandstone and limestone rubble and held together with a decayed yellow mortar. The structure measured 0.85m in width and a 1m portion was exposed. The position of this structure in relation to the cliff edge and within the excavated area would suggest that this feature could represent a wall buttress.

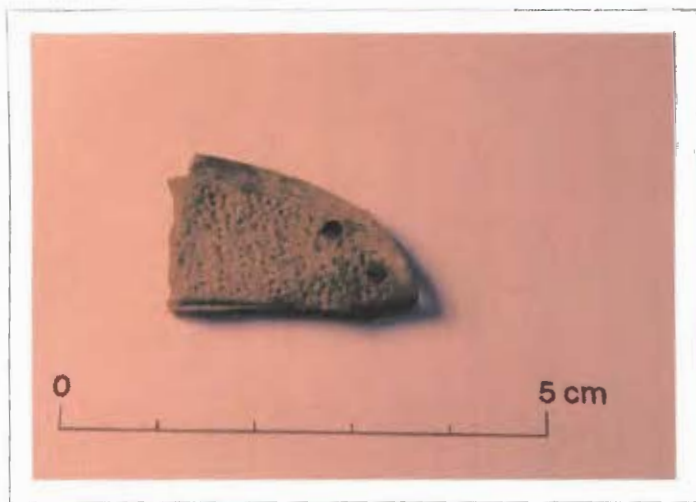
Plate 09: Dress Fitting?

Leather dress fitting? (plate 9) Upper surface has moulded band of plain relief on outer curved edge and traces on the broken straight edge. Punched rusticated decoration covers the central portion of this piece and two perforations are present on the curved edge. Layer 1 (phase 4).

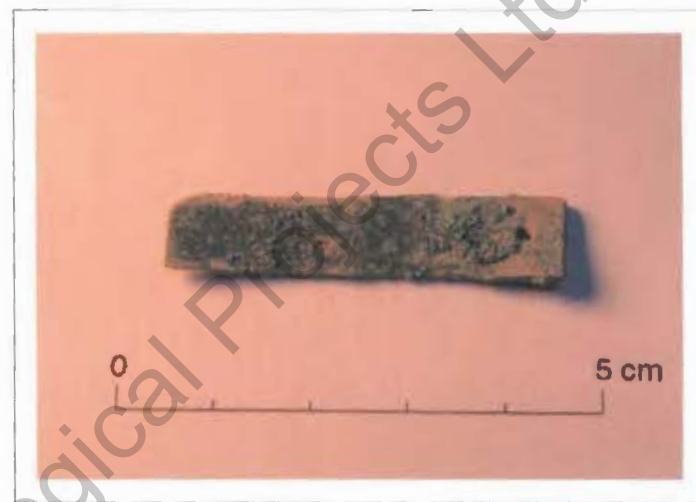
Plate 10: Decorated Bronze Buckle Plate

Decorated bronze buckle plate; (plate 10) upper surface engraved with zigzag ornamentation and has a hole at one end, which apparently attached the plate to a thin piece of leather. Fill of Drain [6] (phase 2), Length 43mm. Width 10mm. 14<sup>th</sup> century. (Shoemith. 1991, No 12 p. 147-8).

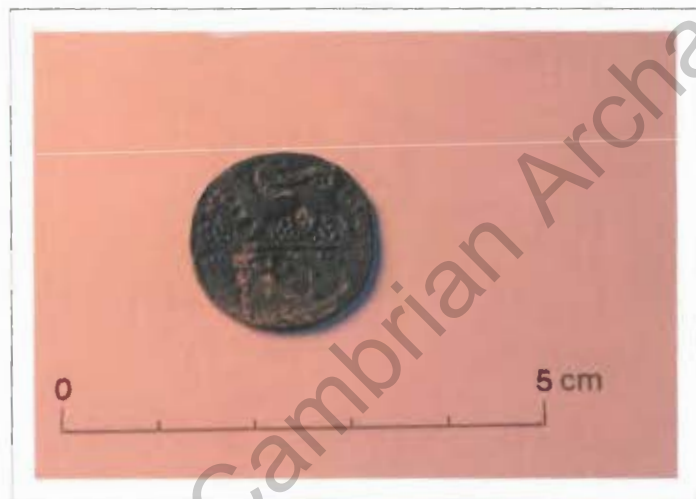
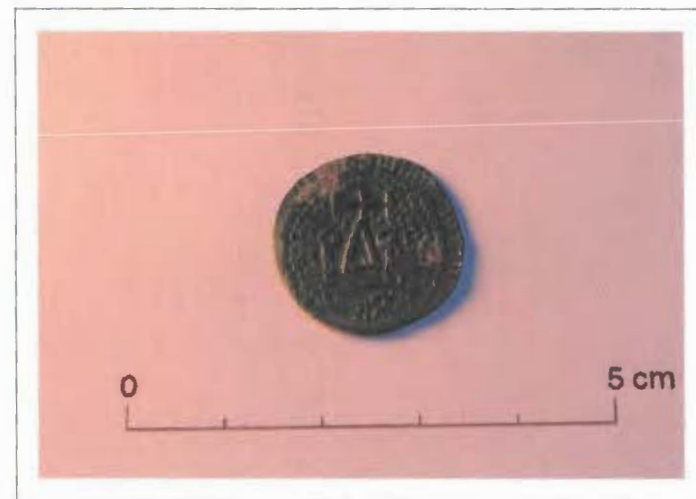
Plate 11: Obverse View of Jetton

Plate 12: Reverse View of Jetton

Jetton (French?) *o*. The Chatel-Tournois in a field semee of small dots; all within a granulated inner circle; a border of upright strokes. *R*. A shield containing three fleur-de-lies on the left separated with a moulded line the lion (right). This famous type of the Chatel-Tournois, for more than two centuries ubiquitous on European coins, is, by its presentment of a mixture of ground plan and elevation, illustrative of one of those confusions which are a feature of medieval art. The Chatel-Tournois is a conventional representation of the town, castle, and church of Tours, which originated on money of the Ducal Abbots of St. Martain there. At this abbey was one of the most celebrated mints of the Middle Ages. There are minor differences in the treatment of the chatel type: sometimes in the direction of curtailment, but a general similarity is maintained. Here town-walls are given in ground-plan as three sides of a square with two round towers at the unenclosed side; in the centre rises the elevation of the church spire, crowned with a cross potent, perhaps that from the arms of the Kingdom of Jerusalem. In front of the town is the ground plan of an outwork. The style of the walls and towers are related to the final and stereotyped Chatel-Tournois that occur on the French regal money in the reign of Louis IX (1226-70), and survives as late as that of Charles VII (1422-61) Barnard, 1916, 110-11). Phase 1 (unstratified).
