**RAGLAN CASTLE**  
**Monmouthshire**  
**Wales**  
**NPI 5**

A landscape survey

December 2005

**MUSEUM LONDON**  
**Archaeology Service**

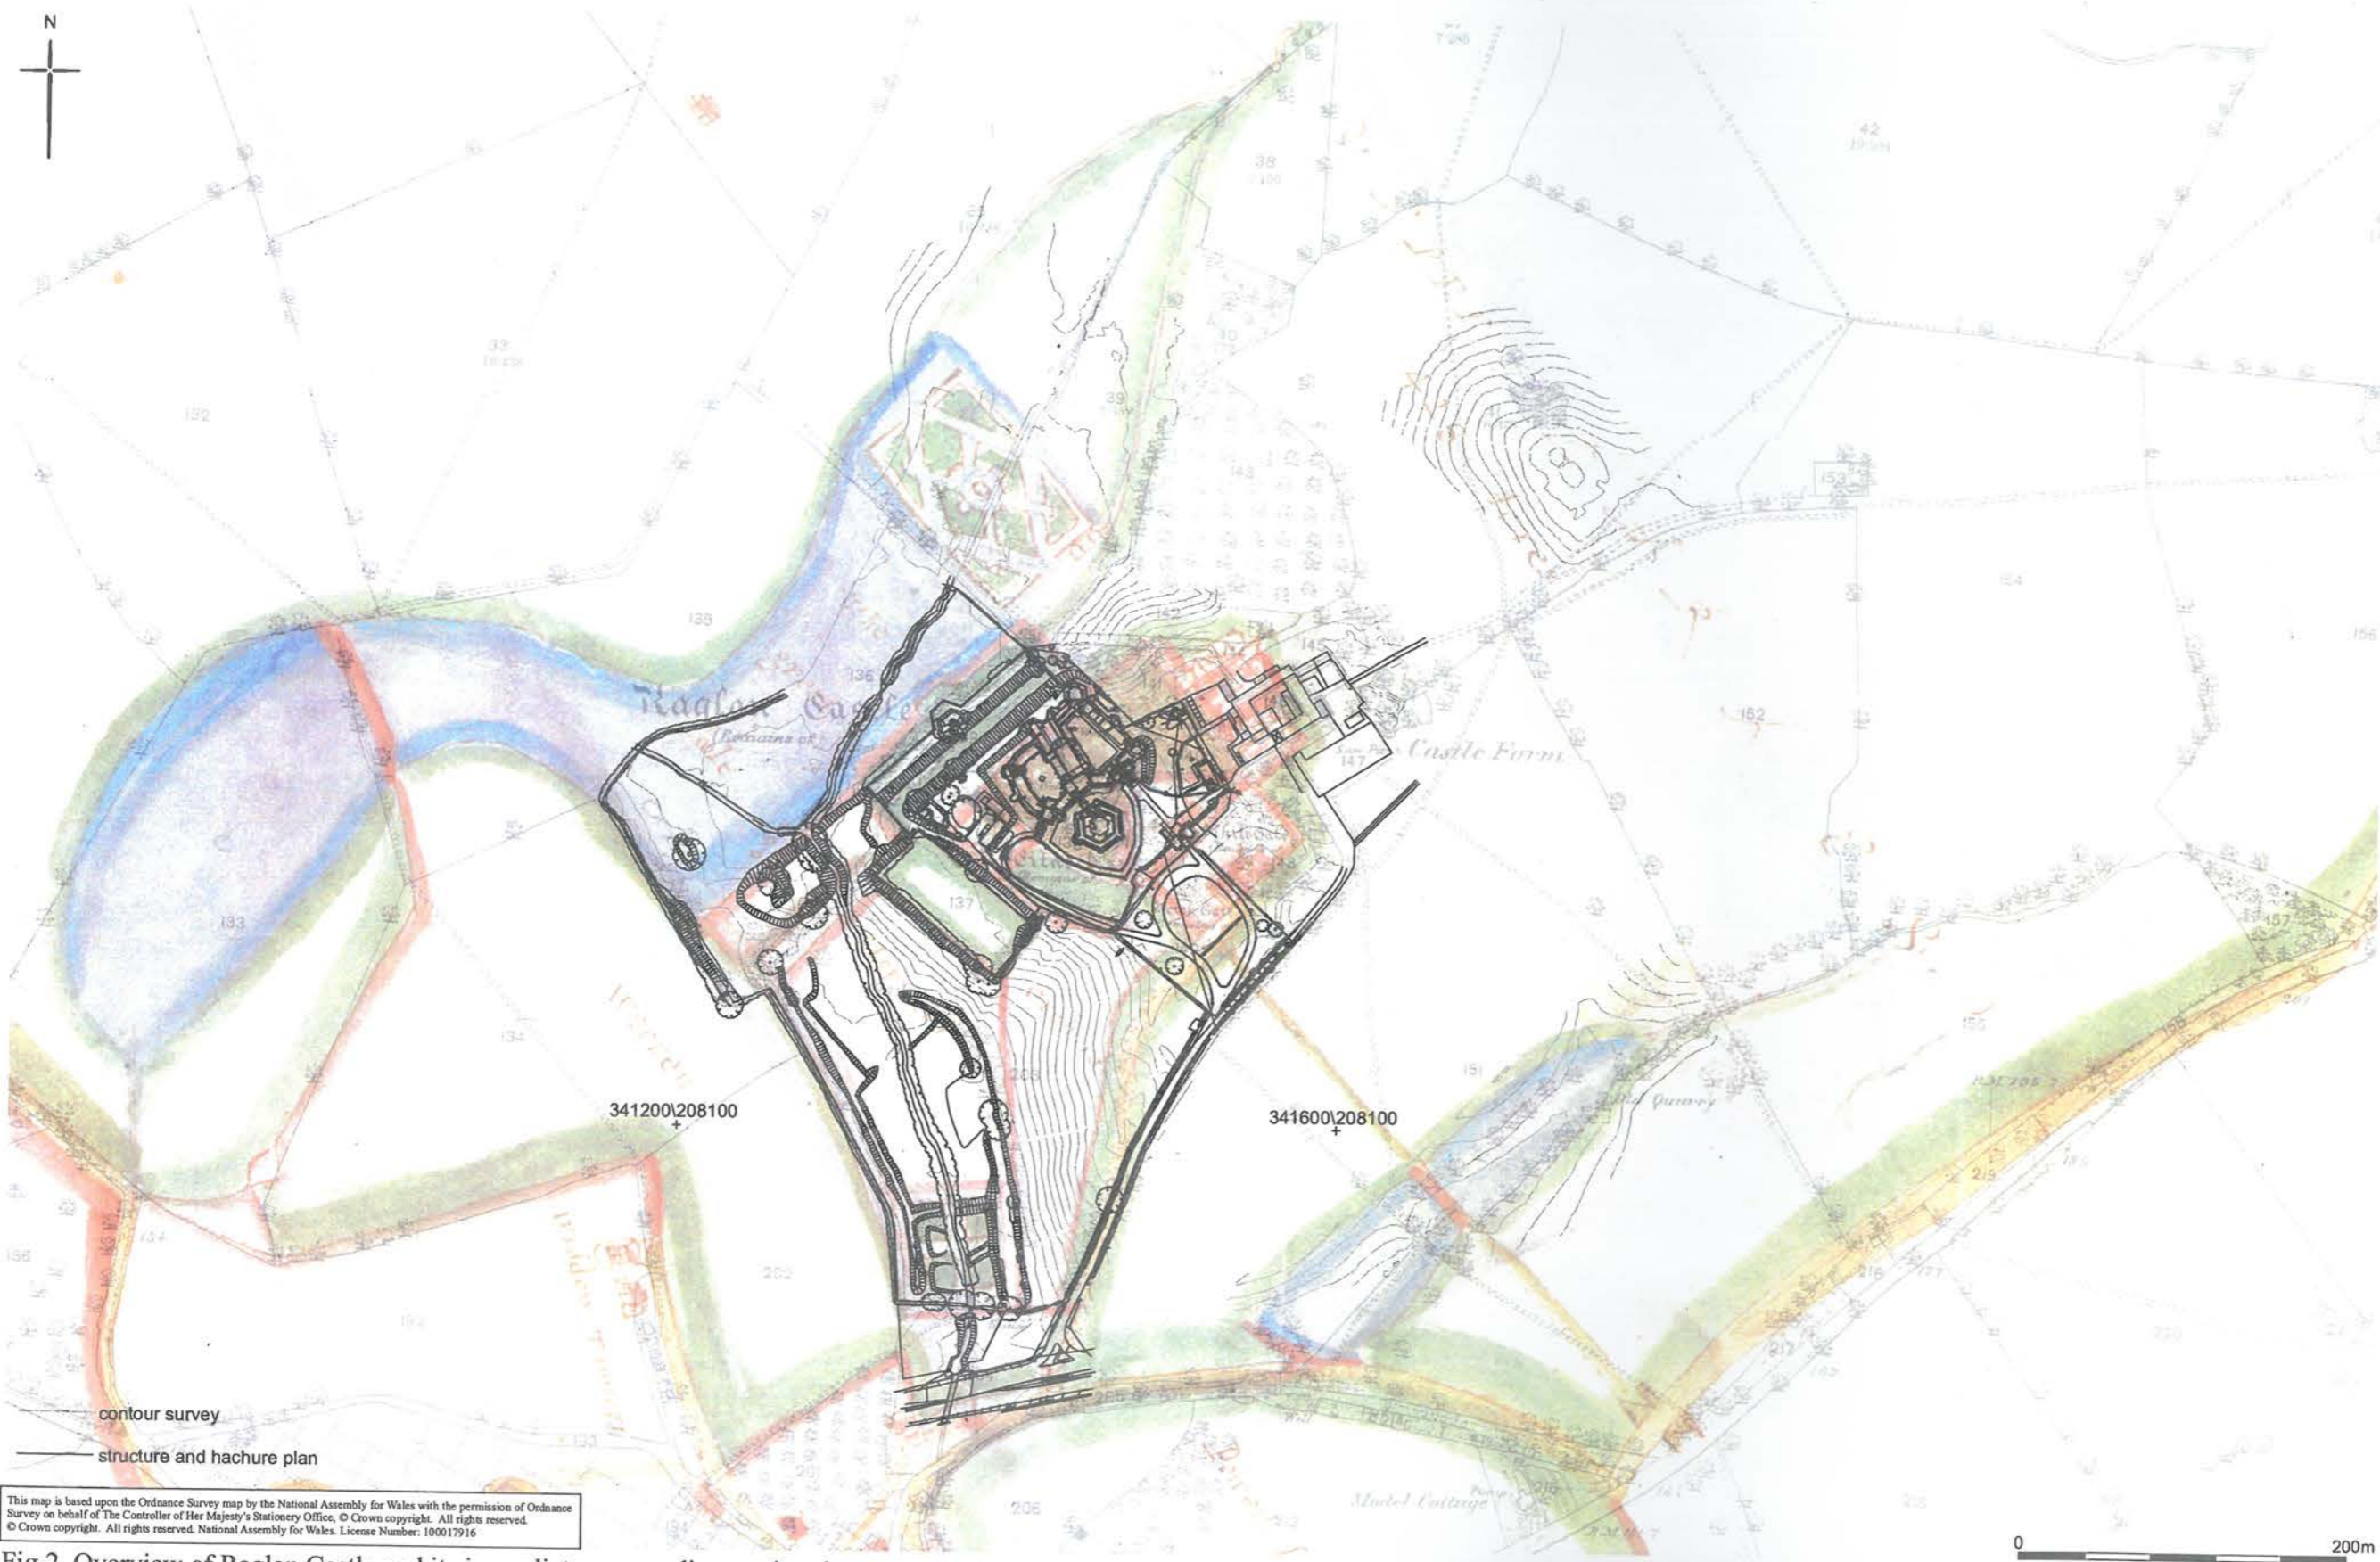
Fig 2 Overview of Raglan Castle and its immediate surroundings, using the contour survey (showing 1m contour lines), Smythe's 1652 map and the Landmark Epoch 1 OS map

The 'Great Poole' was formed and controlled by the construction of a large earthen dam to the west of the castle, which lay half-way along the edge of the lake. Behind this dam lay another series of water features, comprising a series of water channels, a simpler, possibly earlier water parterre, above which may have lain another fish pond. The upper water parterre and the 'Great Poole' were fed by two watercourses from the north-east and the western extent of the 'Great Poole' was crossed by a causeway or dam, shown on Smythe's map and now reflected in the route of the modern footpath. Close to the dam and within the 'Great Poole' was a small island with an ancient oak, which is still visible today, and can be clearly seen in Fig 2 and Fig 3.

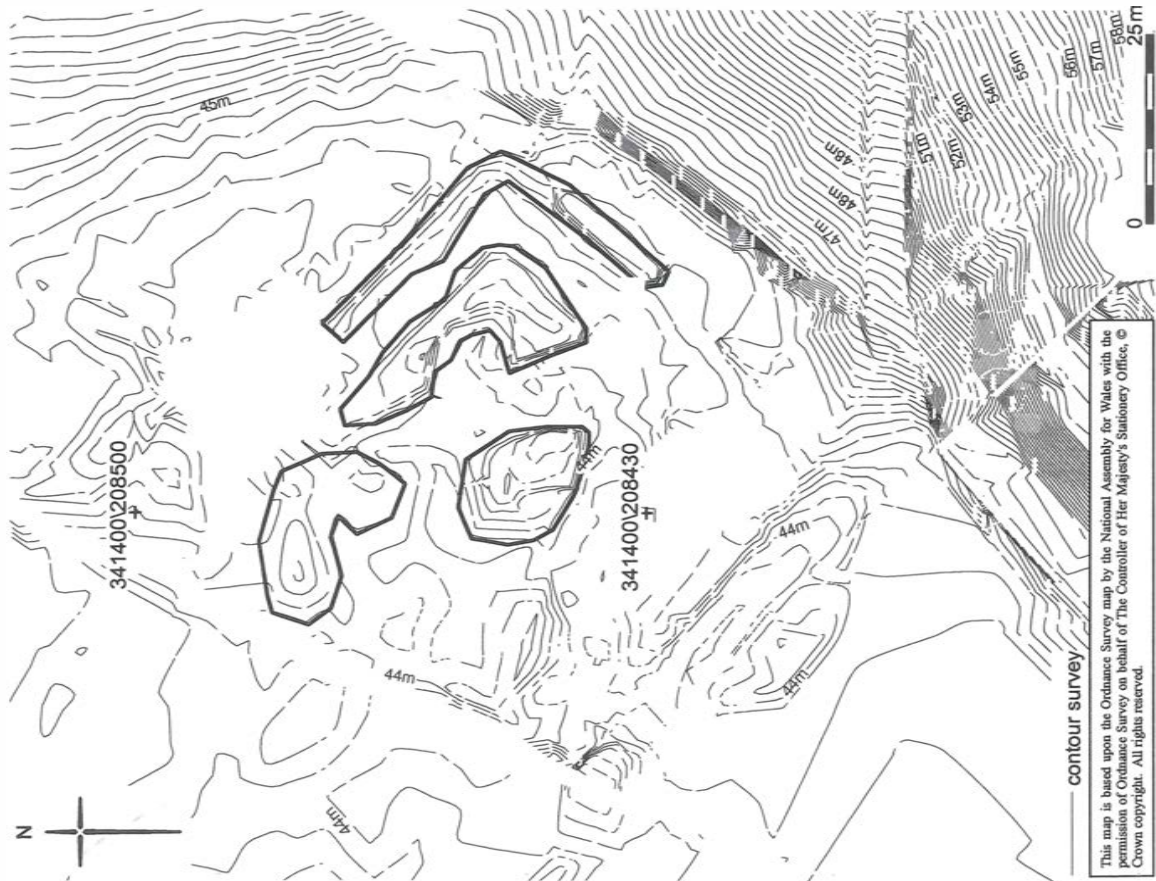
Fig 6 Upper water parterre

A complex water parterre of "*divers artificial islands*" was constructed by the fourth Earl of Worcester, Edward Somerset (1553-1628) at the head of the 'Great Poole'. The shape of this elaborate water garden was well recorded by Smythe in 1652 and to a certain extent can still be seen today in the reeds and tussocky grass that now cover its shape. Unfortunately the water garden has been partially reused and as a consequence the north-western extent is not as well preserved. Part of this reused area lies in the adjoining fields, which have been subject to ploughing, and part lies under a small area of managed woodland. The central area, although not under managed woodland is covered with trees and undergrowth of some age and so difficult to see, photograph or survey. Fortunately, the contour survey was able to pick out details of the surviving area that are not immediately discernible to the human eye (Fig 6). The features observed in the contour mapping can be compared with Smythe's map, which helps to identify the particular components of the surviving upper water parterre, which have been picked out for ease of comparison in (Fig 6).
