Land at The Barton, Trellech
Monmouthshire:
archaeological field evaluation

June 2004

**A report for Aspey Property Developments Ltd.
by Martin Tuck**

GGAT report no. 2004/057

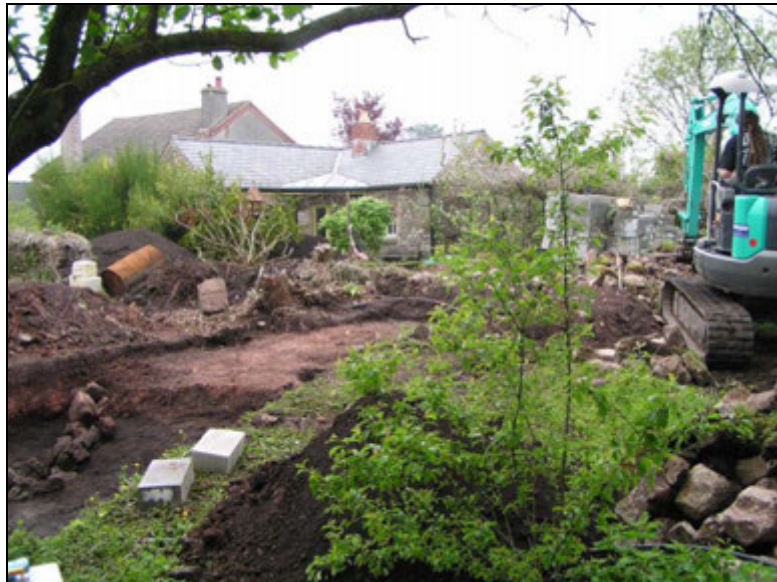
*The evaluation area showing Trench 1 to the left of foreground. View to the north
© GGAT*

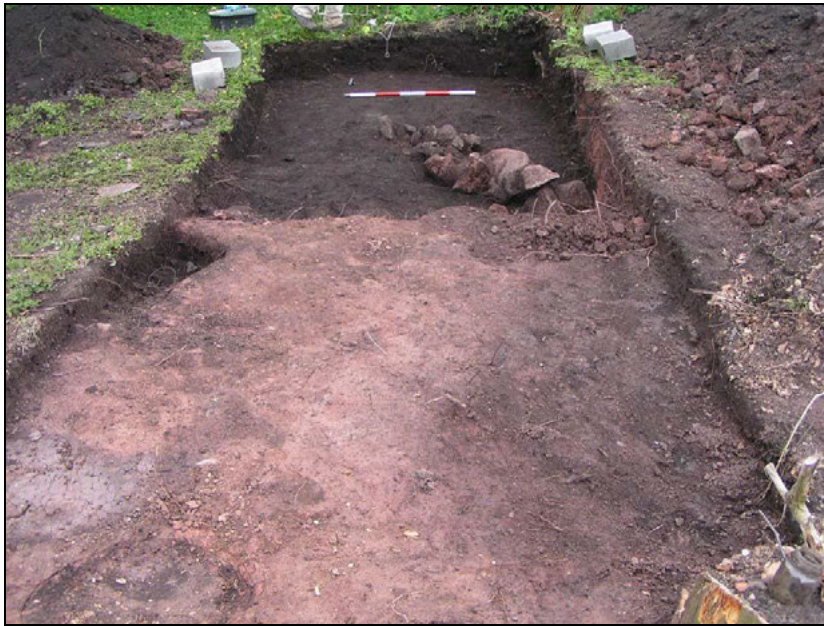
Plate 1: Trench 1 showing clay surface 102 and soakaway 108. View to the south. 1m scale in 0.2m divisions. ©GGAT

This trench around 8m in length was set out on ground that sloped gently from north to south. After the topsoil strip and initial cleaning, a baulk was left dividing the trench into north and south areas. The topsoil (100) was removed by machine to reveal a spread of hard pink clay (102) that extended over the northern two thirds of the trench; two sub-circular areas of clay loam, 104 and 105 were distinct within this spread. The remaining part of the trench showed as clay loam (101). Clay 102 may represent levelling of the garden or more likely with loam 105, the up-cast and backfill of a cesspit located adjacent to the northwest corner of this trench. Context 104 had the appearance of a tree hole; a distinct probability as the garden had standing trees and also showed signs of recent tree clearance (19th century OS mapping depicts an orchard in the evaluation area). Underlying 102 in the southern area was a stone-built soakaway (108, 109, 110) with a sub-circular terminal (111) filled with smaller stone

(103). Iron pipework in the terminal, glass sherds, and the direction of the soakaway all point to a fairly recent date and the soakaway would appear to be connected with drainage of the house or cess-pit. In the northern area deposit 106, a 0.25m depth of clay loam, equivalent to 101, underlies 102. Beneath loam 106 at around 208.9m OD was a fairly uniform compact surface of slag and sandstone (107). This surface was also proven in the southern area (below 101) at around the same depth. The natural subsoil (soft pinkish brown sandy clay), was established below 107 in the northeast corner of the trench at around 1.15m (208.58m OD) below ground level

The finds and features in Trench 1 are considered to be of post-medieval date with the more definite surface 107 possibly a path or yard, occurring at 0.8m below ground level.

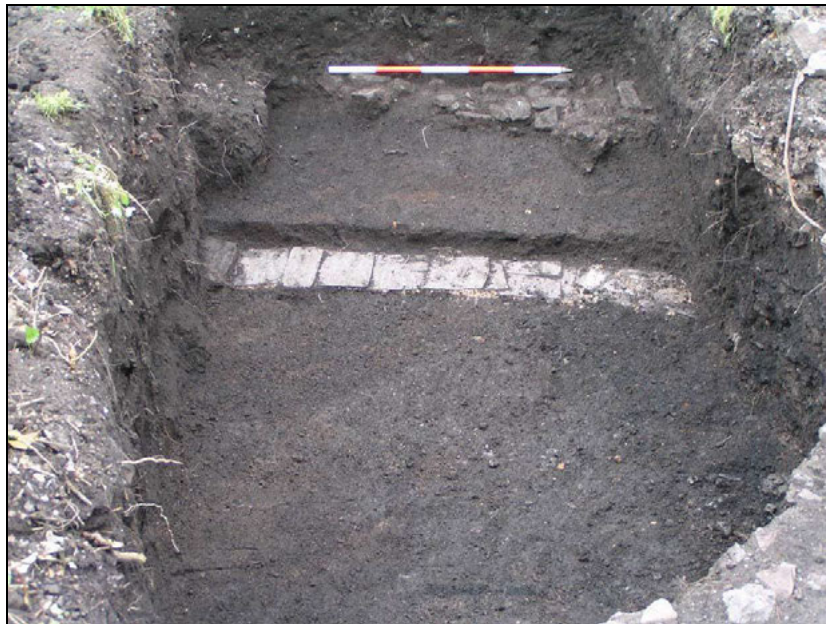
Plate 2: Trench 2 showing industrial surfaces 213 and 214 (foreground), drain 211 and stone spread 210 in background. View to the north. 1m scale in 0.2m divisions. ©GGAT

This 6m long trench was located on the higher part of the garden with its southern boundary limited by a cesspit and demolished wall. In the southern part of the trench the natural subsoil was established as being soft pinkish brown sandy clay at around 1.45m below the topsoil (208.50m OD). Above this was a series of deposits related to industrial processes (213, 214), working surfaces or rubble (215, 210) and post-medieval to modern features and fills (216, 212, 211, 209-201). Over-digging of deposit 214 suggested it was a pit filled with lenses of slag, fired clay and partly spent fuel in the form of charcoal. Surrounding 214 to the north, west and south was a friable spread of grit-sized sandstone, slag, charcoal fragments and fired clay (213). This was bounded by a northwest/southeast oriented stone spread (210) at the north end of the trench. Deposit 210 had a sandstone roof-tile amongst the stone; this may represent rubble from a building or, as its surface was uniformly flat, a working surface connected with the industrial debris. A similar working surface could be suggested for 215, an area of sandy clay with sandstone chips, slag and flecks of fired clay. Overlying the industrial surfaces was fill 206. An intrusive U-shaped drain (211,

212) with a slate lid capping had cut through deposit 213, the upper part of 214 and fill 206. The drain's uppermost cut level could not be determined but a pottery sherd of post-medieval date was recovered from the blocked drain channel. At around 0.3m (209.4m OD) below ground level on a northeast/southwest bearing, was a loose linear arrangement of stone and slag (205) interpreted as a sill beam or wall; evidence of its later demolition lay alongside the wall as a stone heap (216). Overlying 216 were fills 207 and 204, both of which had been cut by 208, a rubbish pit containing modern ceramics and glass bottles (209). Deposits 202 and 203 were fills of recent demolition rubble probably from a building shown on the second edition 1901 OS 25" map. Bounded by 202 and 203 and underlying topsoil 200 was another recent deposit 201, a refuse spread of 19/20th century broken ceramic and glass.

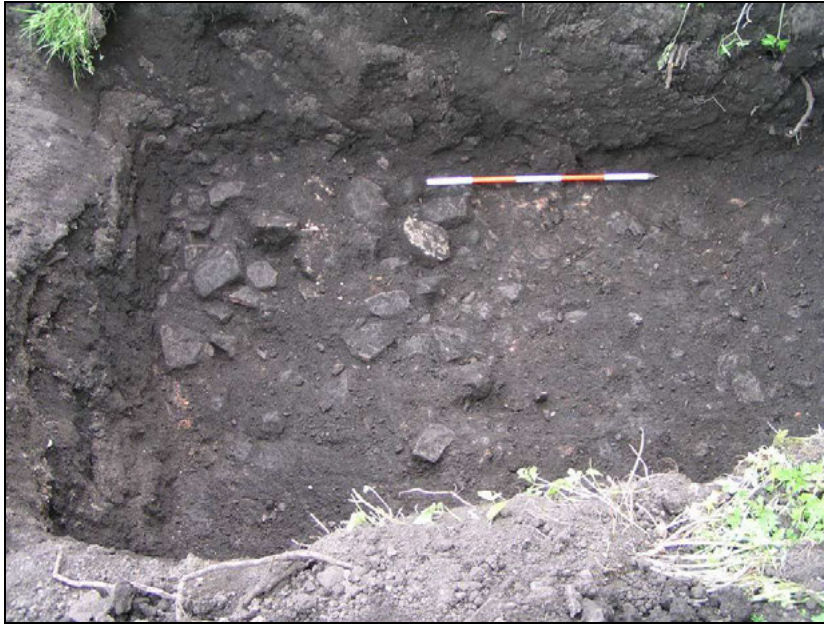
Plate 3: Trench 3 showing possible wall 303, and stone surface 304. View to the north. 1m scale in 0.2m divisions. ©GGAT

Trench 3 at around 3.5m in length was located parallel and adjacent to the Llandogo Road. A substantial quantity of large sized stone (303, 304) was seen to underlie loam containing post-medieval pottery and a modern rubbish dump.

Underlying topsoil was clay loam (302) to a depth of 0.85m. An intrusive rubbish dump (301) of bottles and rusting tins was centrally located on the south side of the trench with the base of 301 extending to an extensive spread of sandstone and occasional slag lumps (304), possibly representing rubble or a floor surface. A linear feature (303), slightly higher than 304 (around 208.7m OD), is possibly part of a dry-stone wall that culminates in a heap of stone at the trench corner. To the east of the possible wall was a deposit of loam and slag 305, (0.25m depth) which had an iron-rich lens on the interface with the natural subsoil. Underlying 305, in the southeast corner of the trench, natural subsoil as seen in Trenches 1 and 2 was established at around 1.23m below ground level (208.25m OD). The amount of stone within 303 and 304 suggests a building fronting the Llandogo Road, now probably demolished

perhaps as a result of re-surfacing or consolidation of the road. Indisputable structural or dating evidence for the possible wall (303) and surface (304) was not forthcoming but a single sherd of medieval date was recovered from 304.

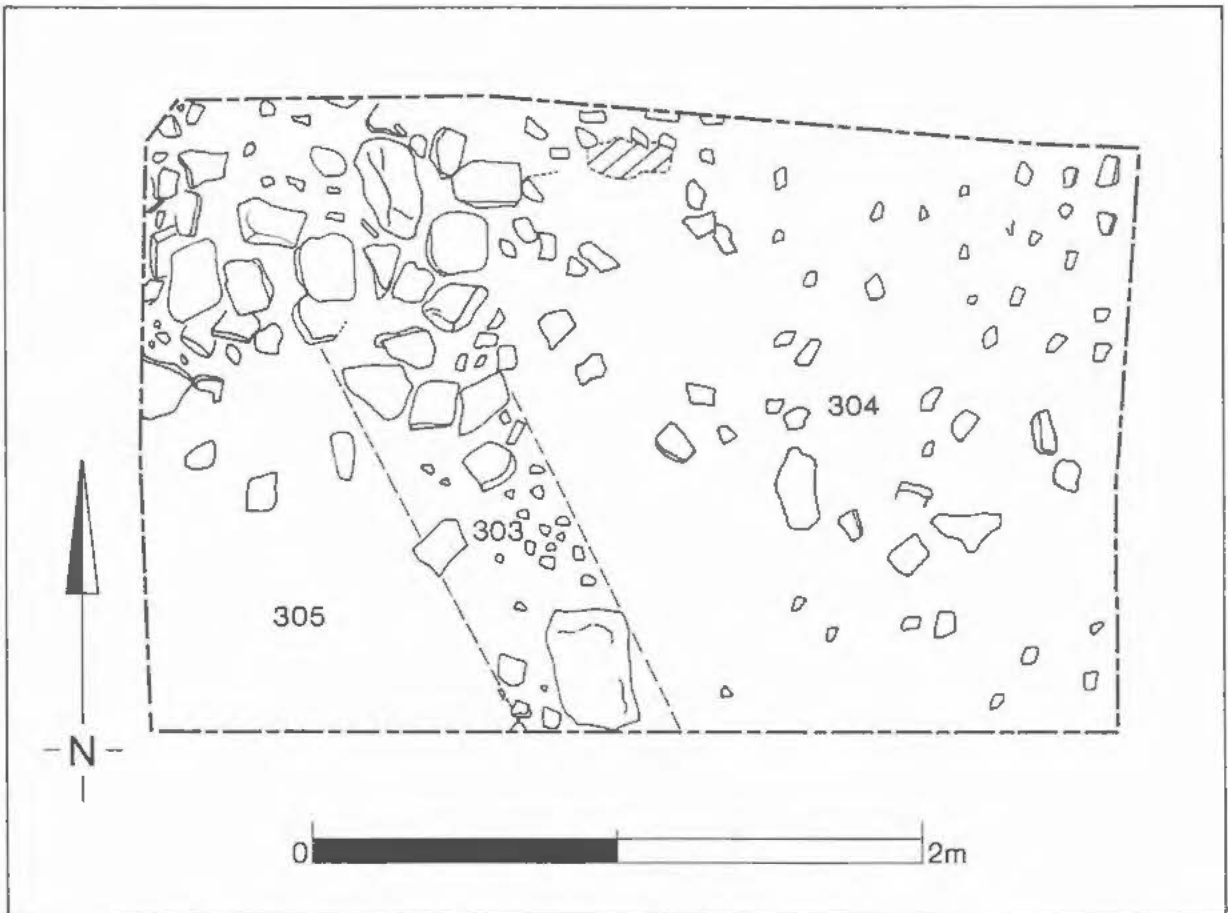
Figure 5. Trench 3 showing probable medieval features.
