Prepared by Dyfed Archaeological Trust

**RHIF YR ADRODDIAD / REPORT NO. 2011/18
RHIF Y PROSIECT / PROJECT RECORD NO. 100612**

**ARFORDIR
COASTAL HERITAGE
2010-2011**

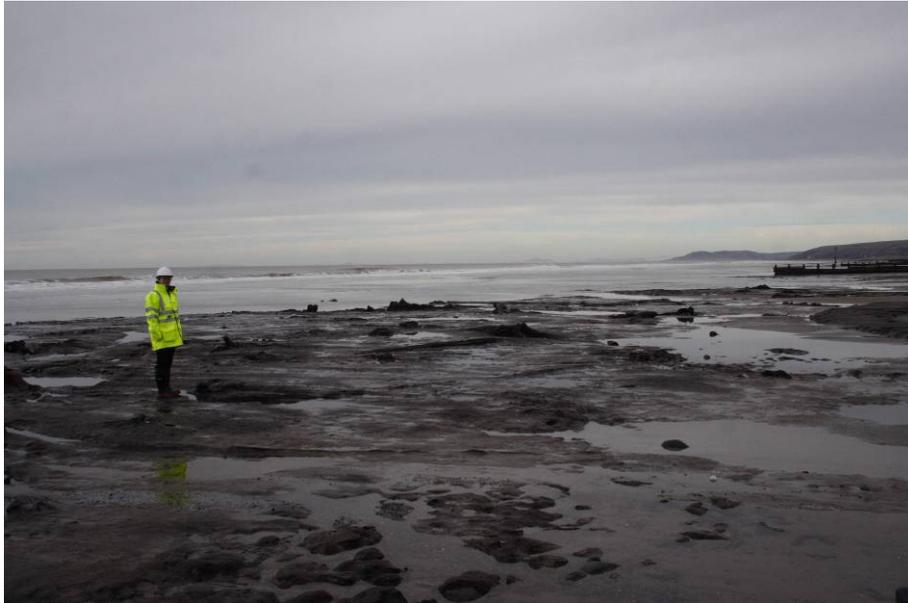
Photo 12: Peat and submerged forest exposures at Borth – 16th February 2011

Borth, Ceredigion – PRN 45106. Although undertaken as part of archaeological monitoring works associated with the construction of the new coastal defences at Borth, it was possible to undertake some wider observation of the exposed peat deposits in the area. Exposures were most notable in early February 2011 in an area close to the southern end of the beach, an exposure which is said to have been the largest for many years by local residents. These peats have subsequently been completely covered by sand again.

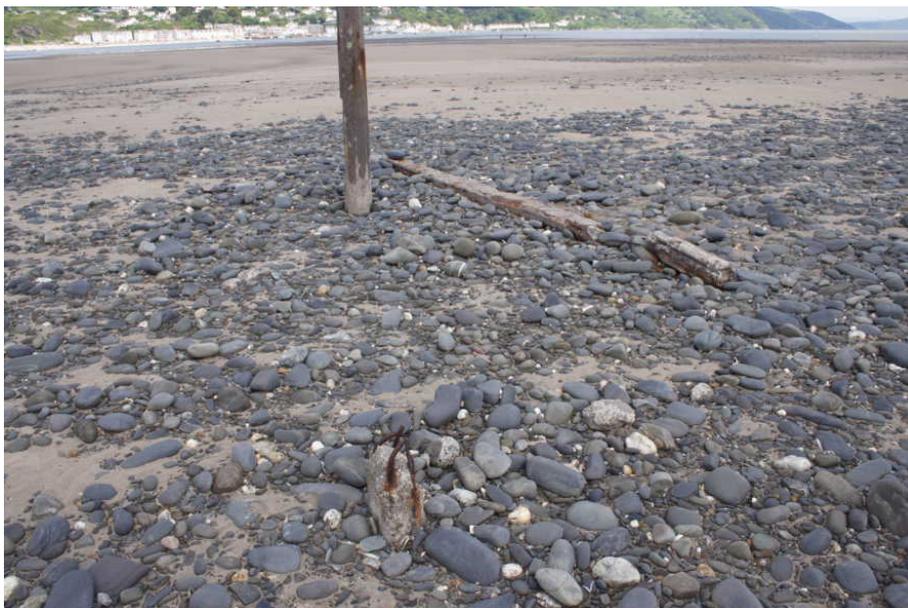
Photo 3: Collapsed navigation marker Ynylas Las Ferry

A medieval ferry crossing is recorded in the vicinity of Ynyslas but its exact location is unknown. A collapsed reinforced concrete pillar was noted on the beach at NGR SN 6088 9509 that had recently been replaced with a further reinforced concrete pillar topped with a diamond shaped panel that may represent a navigation marker. A short distance to the southeast of the possible navigation marker a partially buried timber construction with a cast iron gear wheel and pulley was identified which is considered to form the remains of a possible cable or chain ferry point.

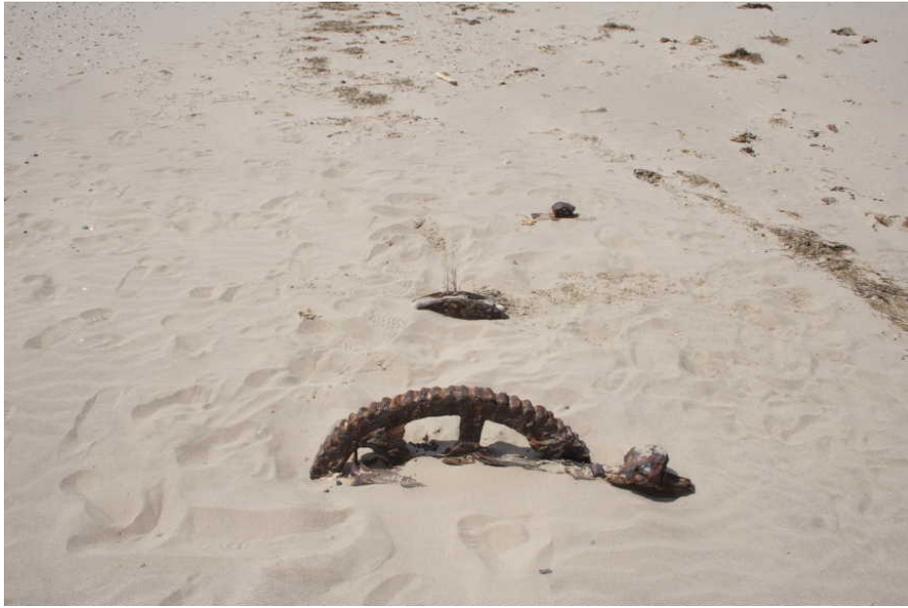
Photo 4: Remains of possible cable ferry point.

Further research has revealed that the ferry was to be replaced by a railway bridge during the 1860s but this never occurred and the ferry was still in operation in 1917 and continued to be marked on Ordnance Survey maps up until the 1960s (Williams, 2010¹).

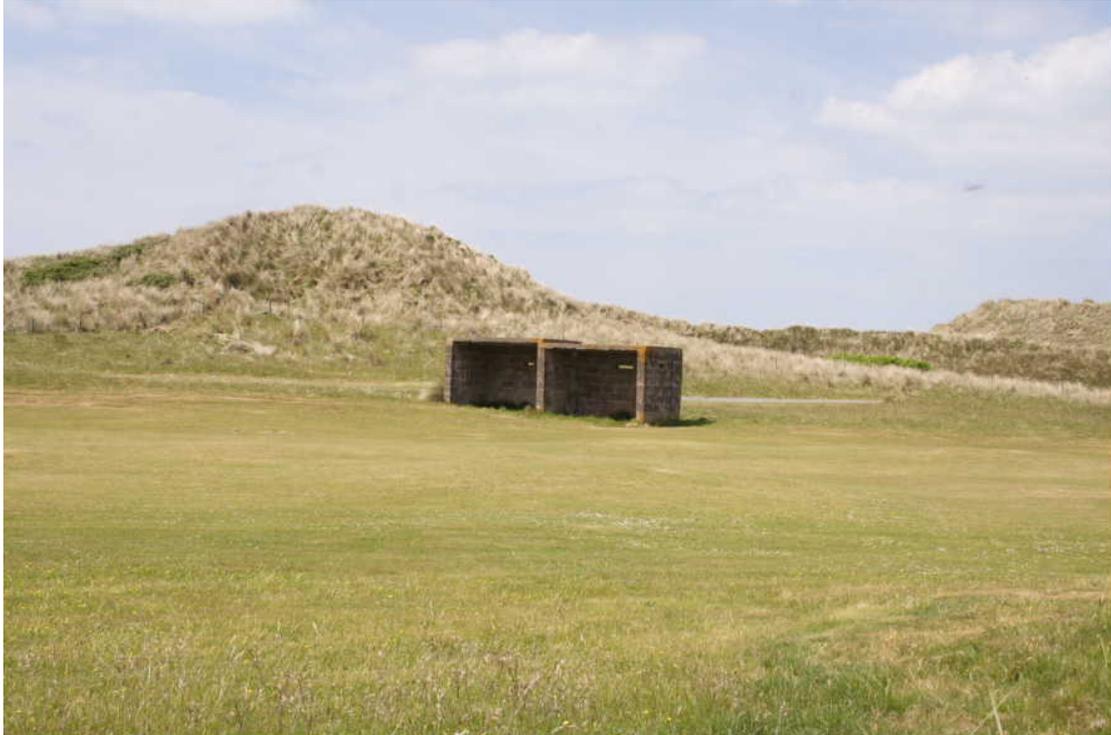
Photo 5: Military structure, Ynylas Golf Course.

The structure appears to be in a good state of repair due to its location on the golf course and is not threatened by erosion.

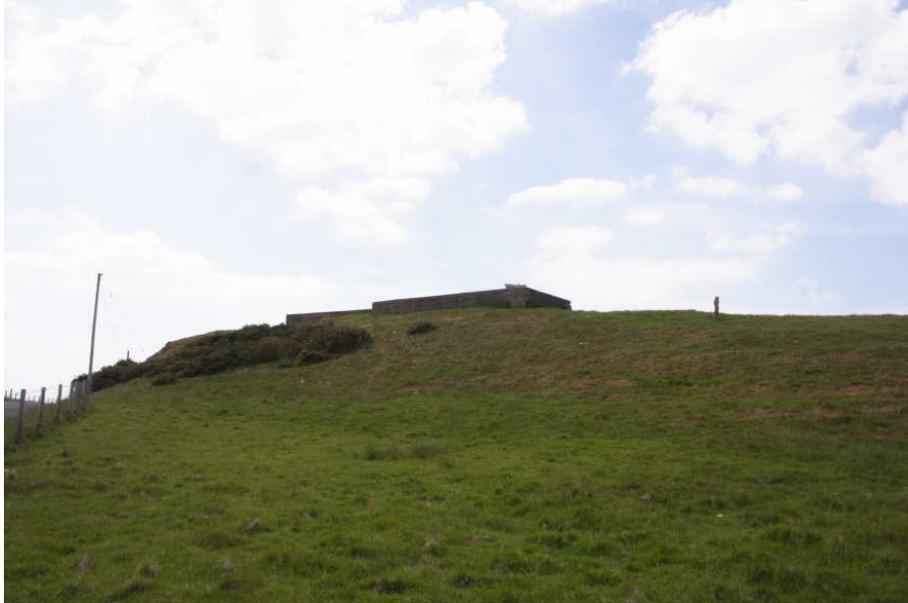
Photo 6: Possible military structure at Plas Ynys.

The structure appears to be in a good state of repair.

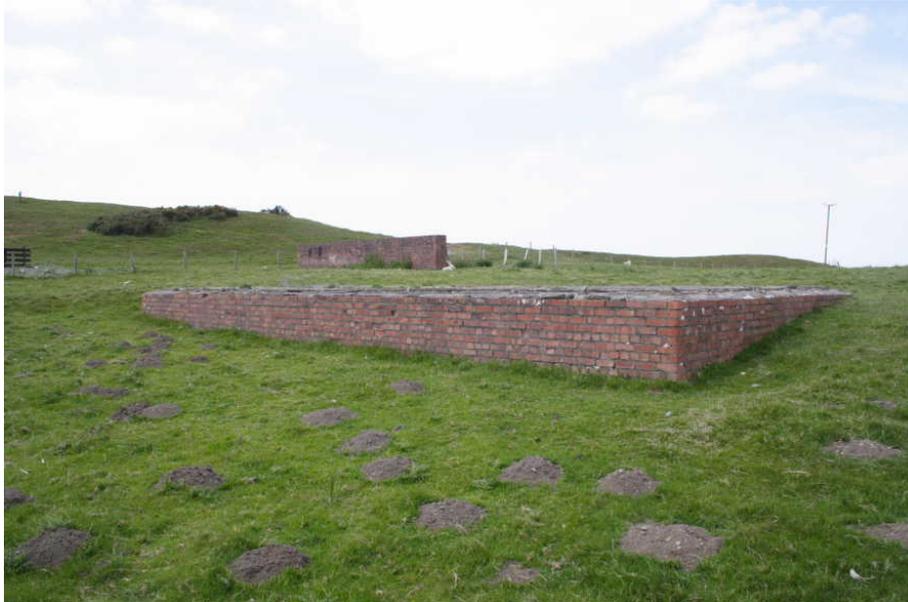
Photo 7: Brick structures at Saxondale.

erosion but animal burrowing noted around the structures may eventually destabilise them.

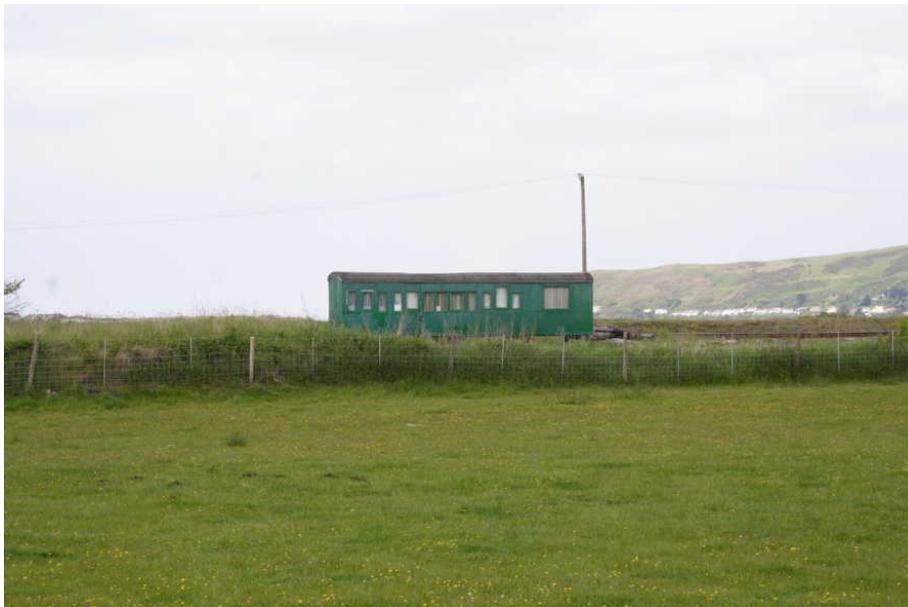
Photo 8: Railway coach utilised as dwelling as site of Ynys Las station.

It was not possible to closely examine the railway coach as it was located on private land immediately adjacent to the railway line. Outwardly the coach appears in relatively good condition but given its location, propped up nature and probable wood construction decay would set in quickly without regular maintenance.

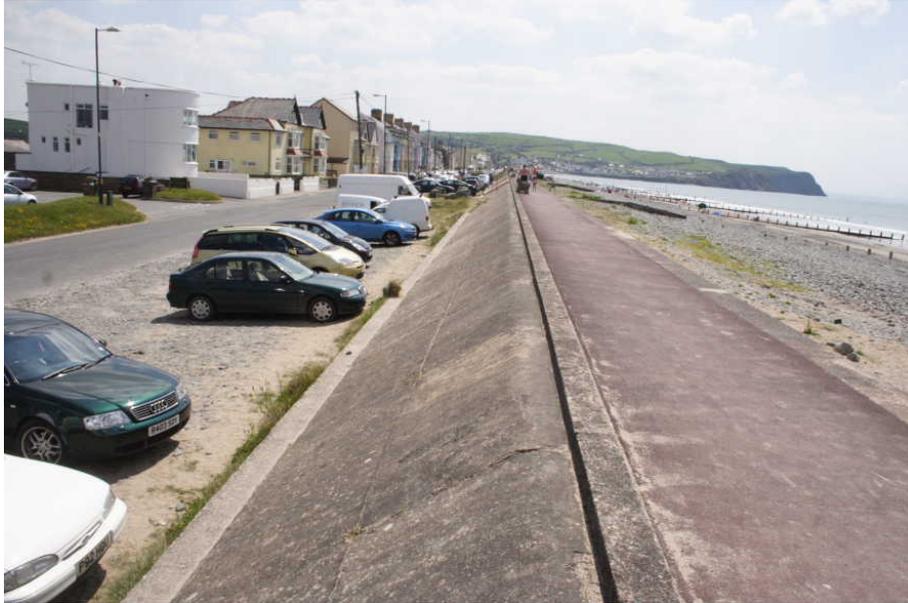
Photo 10: Modern sea defences at Borth sea front.

Directly to the north of the town a massive concrete wall is present, whereas along the sea front through the town a massive timber and metal breastwork creates the defence between the rear of the houses and the beach.

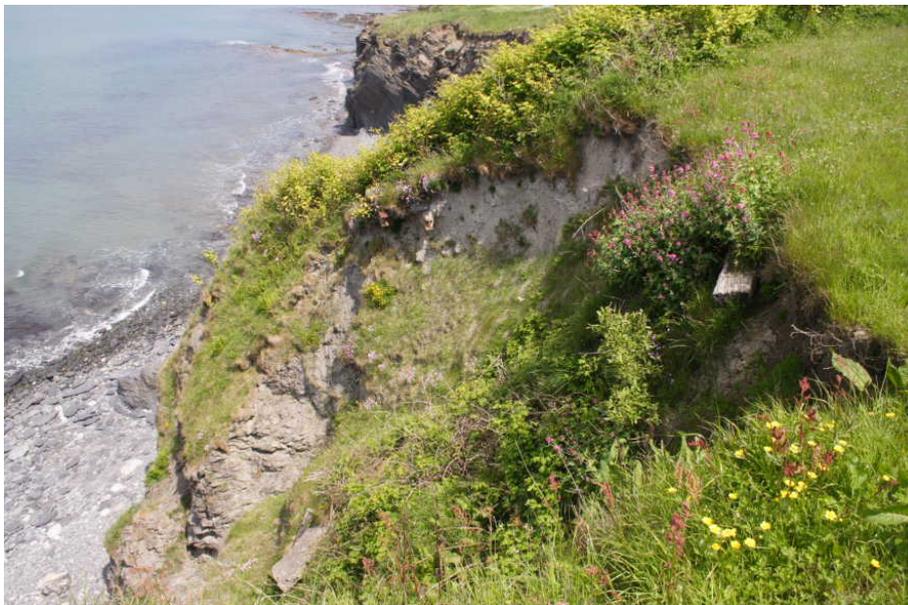
Photo 11: Collapsed cliff to south of Borth village.

At the south end of Borth sea front between NGRs SN 60679 88829 and SN 60327 88720, an area also classed as being at risk of slight coastal erosion, it was possible to view that part of the cliff has collapsed suggesting more serious erosion in this area. The upper area of the collapsed cliff had a timber beam and former railway track protruding from it suggesting haphazard shoring up of the area. It is considered that coastal erosion in this area should be reassessed to a medium category and the area would benefit from additional monitoring.

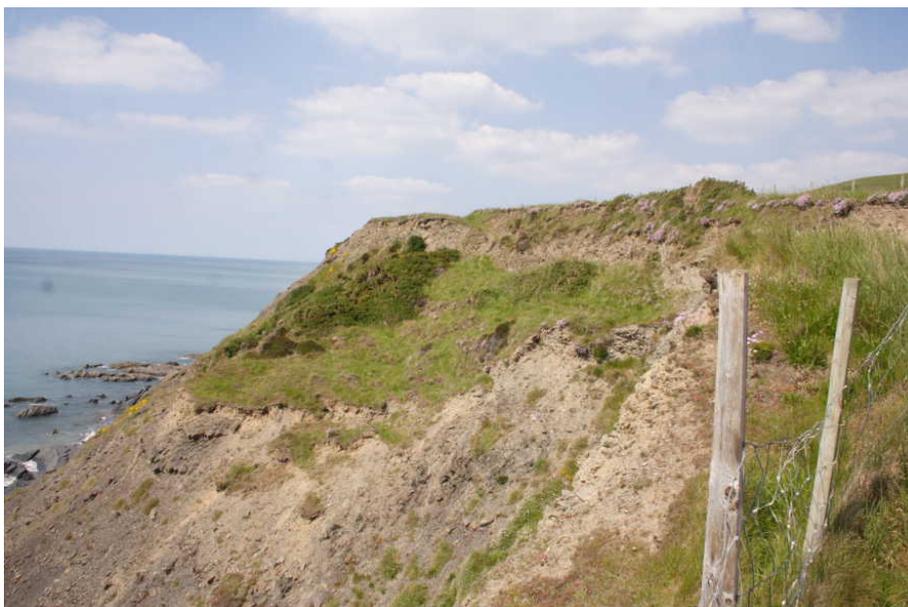
Photo 13: Eroded cliff face to north of Clarach Bay.

Clarach Bay was targeted for a site visit as it is located at the beginning of a long stretch of coastline classed as under medium threat of coastal erosion. The main bay area appears to be relatively stable with very little erosion apparent. However, towards the north the effects of erosion become much more apparent with large areas of cliffs noted as collapsed leaving large areas of overlying soil open to the elements. In addition the area appears to be popular with walkers given that it lies on the Ceredigion Coast Path and in places 'footfall' is starting to erode areas around the path. The area contains a large camping and caravan park popular with visitors. It is considered that the medium coastal erosion classification of the area may need to be reassessed.

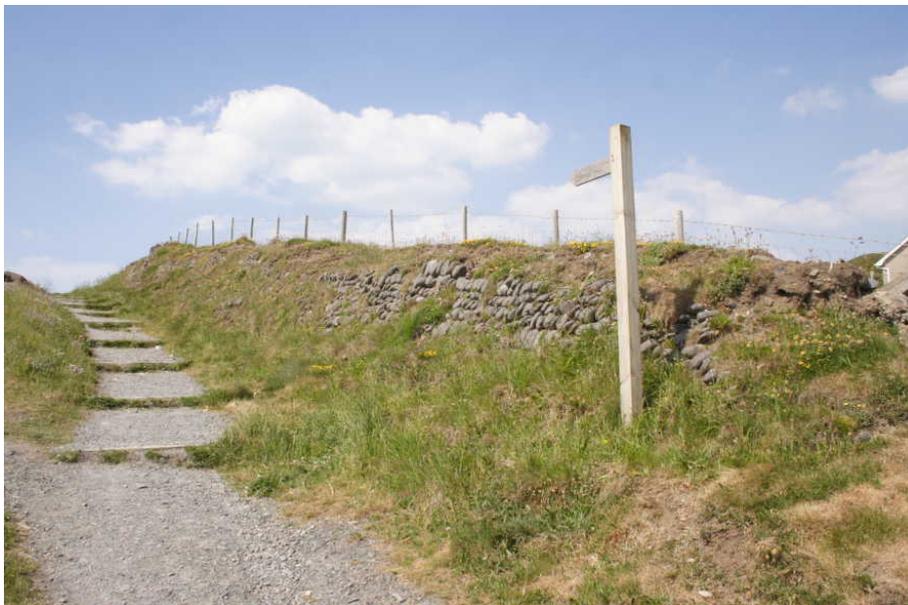
Photo 15: Boundary bank at Clarach Bay.

During the course of the site visit to Clarach Bay a substantial revetted boundary bank was identified immediately to the rear of the entertainment complex of the caravan park. The bank survives a height of over 1m and is in a stable condition, but vegetation is growing through which may suggest root damage. It is considered that the bank is under no immediate threat from coastal erosion but more immediately from human and animal activity. The date for the bank is unknown.

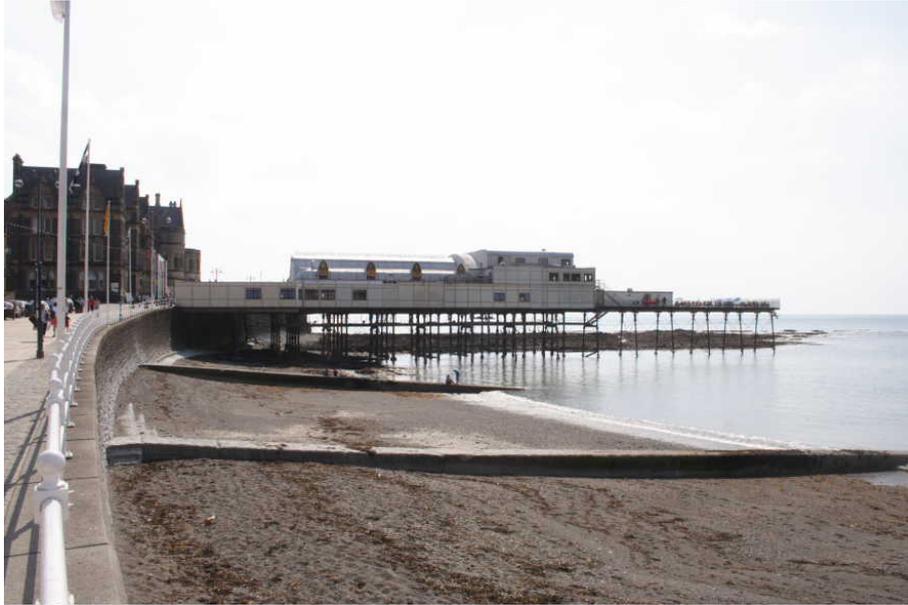
Photo 17: South facing view of Aberystwyth Pier.

Constructed in 1865 Aberystwyth Pier was the first purpose built pleasure pier in Wales. Following rebuilding and extension work the pier attained a length of 800 feet (243m). The length was halved following storm damage in 1938.

The pier is currently occupied by a snooker club, restaurant, bar and amusement arcade, the signage of which is not in keeping with a 19th century structure. The structure itself is supported on cast iron pillars set on concrete bases. The cast iron supports seem to be stable but do appear to be outwardly corroded which may suggest internal corrosion of the iron resulting in structural weakness. Cast iron is a strong building material when under vertical pressure, however, when exposed to lateral pressure it is relatively weak and prone to failure. Similarly concrete also has the potential to degrade and fracture. Given that the pillars and supports of the pier are exposed to the tide and elements it is possible that this may be concern. Cross tie bars visible between the pillars suggest an attempt to address this weakness.

The pier structures appear to be in a good state of repair externally, but some of the sash windows on the south side appear to be decaying and in need of attention.

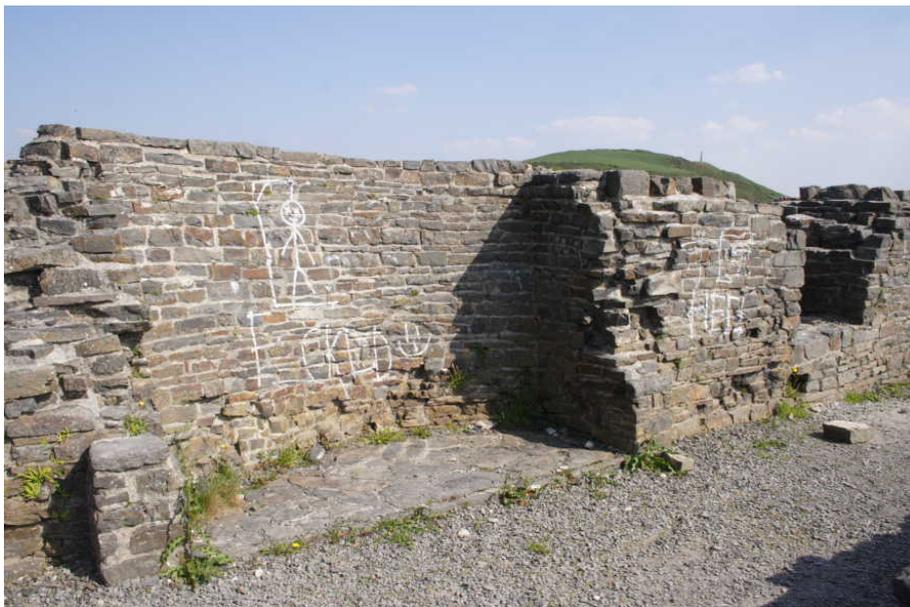
Photo 22: Graffiti on Aberystwyth Castle remains.

Substantial remains of medieval castle overlooking the sea at Aberystwyth. The castle remains and grounds are now utilised as a public park and are not under threat from coastal erosion. However, the use of the castle and its grounds as a public park, which appears to be accessible both night and day, present a different threat of erosion. It was noted that graffiti was present on the remains and it was witnessed that members of the public climb on the masonry remains which has the potential to dislodge stonework. In addition vegetation was also to be seen growing on the remains which left unchecked could potentially weaken the structure through root action.

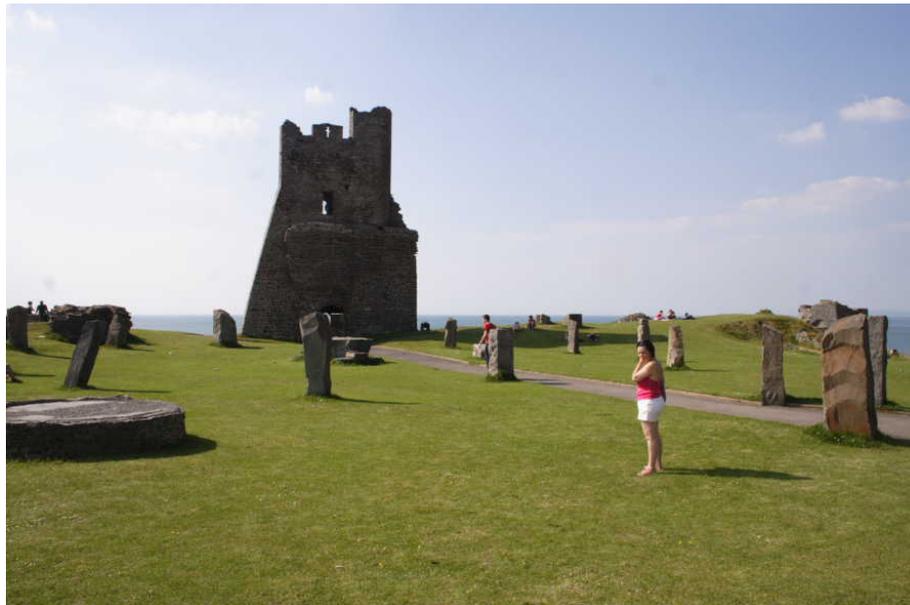
Photo 25: Gorsedd stones at Aberystwyth.

The circle is in good condition and generally appears to be free from erosion. However, graffiti was noted on some of the stones which is considered unsightly and suggests that the stones are open to access both day and night.

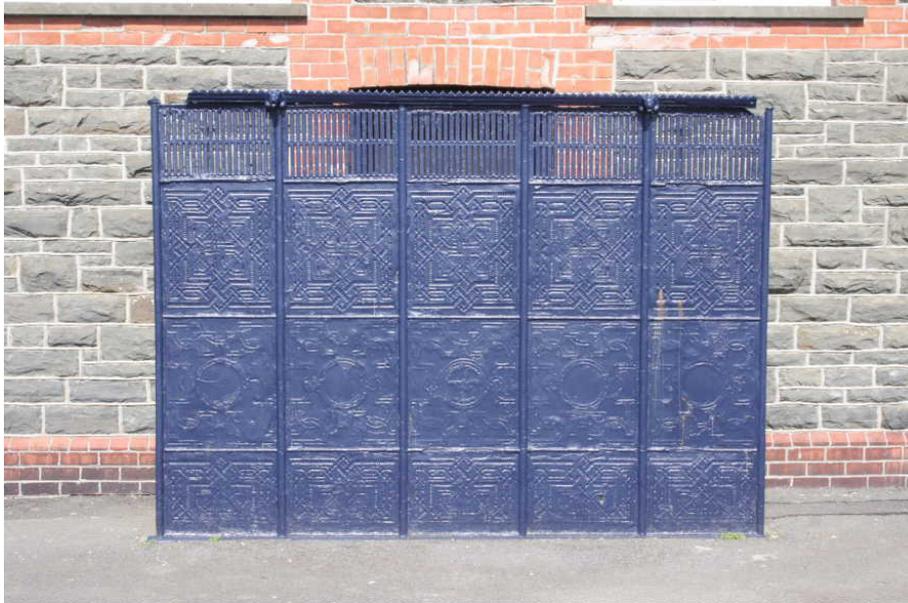
Photo 26: Privacy screens at Castle conveniences Aberystwyth.

The structure and privacy screens appear to be in a good state of repair the only visible problem being small areas of surface rust on the privacy screens which could be easily treated.

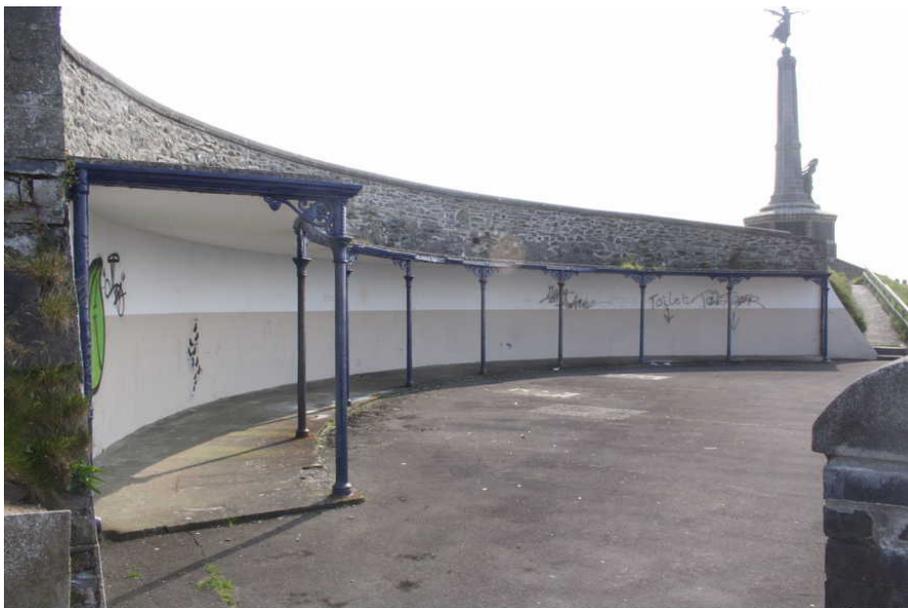
Photo 27: Early 20th century curved shelter adjacent to Aberystwyth Castle.

Early 20th century curved shelter constructed of cast iron columns with decorative scrollwork capitals. The shelter appears to be stable but has been vandalised with graffiti, in addition to graffiti the capital of one of the cast iron columns has been broken and much of the guttering has been damaged, particularly in the mid section of the structure.

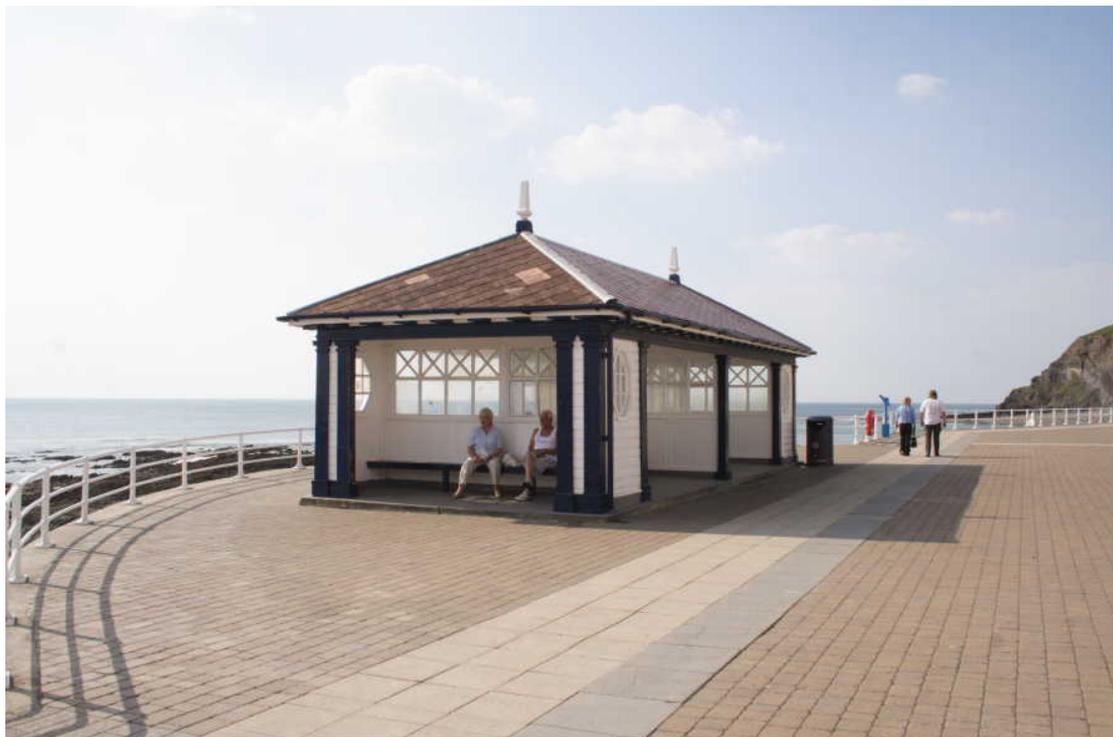
Photo 30: Shelter at seafront, Marine Terrace, Aberystwyth.

The structure is in a very good state of repair and appears to have been recently entirely painted and re-roofed on the east side.

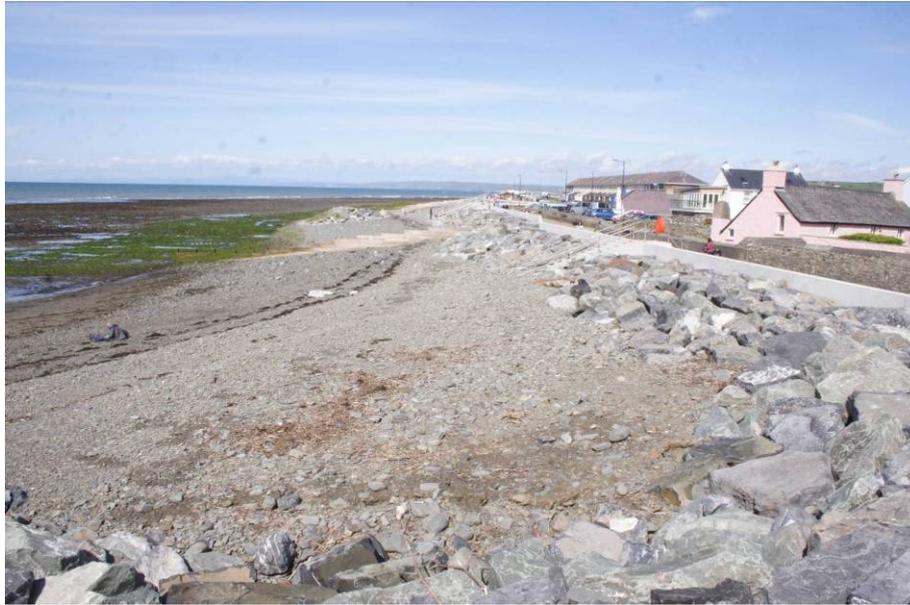
Photo 31: Renewed sea defences north of Aberaeron Harbour.

Aberaeron was targeted for a site visit as it is categorised as being stable but is known to have suffered from heavy flooding and deteriorating sea defences in recent years suggesting that this categorisation may need to be reassessed.

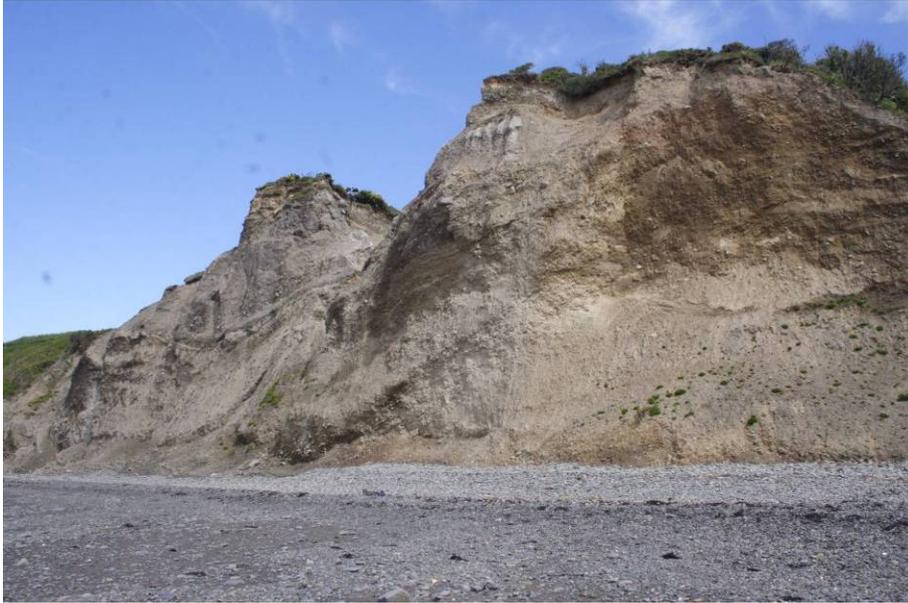
Photo 32: Heavily eroded coastline at Gilfach y Halen.

The coastline at Gilfach y Halen was targeted as it has been previously categorised as an area of major coastal erosion. Heavy erosion was visible in all areas of the coastline at this location with access to the northern end prohibited by road closure due to its dangerous nature. A number of large collapses were noted below an adjacent holiday park suggesting that coastal erosion is a major problem in this area and is considered to be the worst case seen on the Ceredigion coast so far. Access was not permissible to either of the two recorded PRNs at this location.

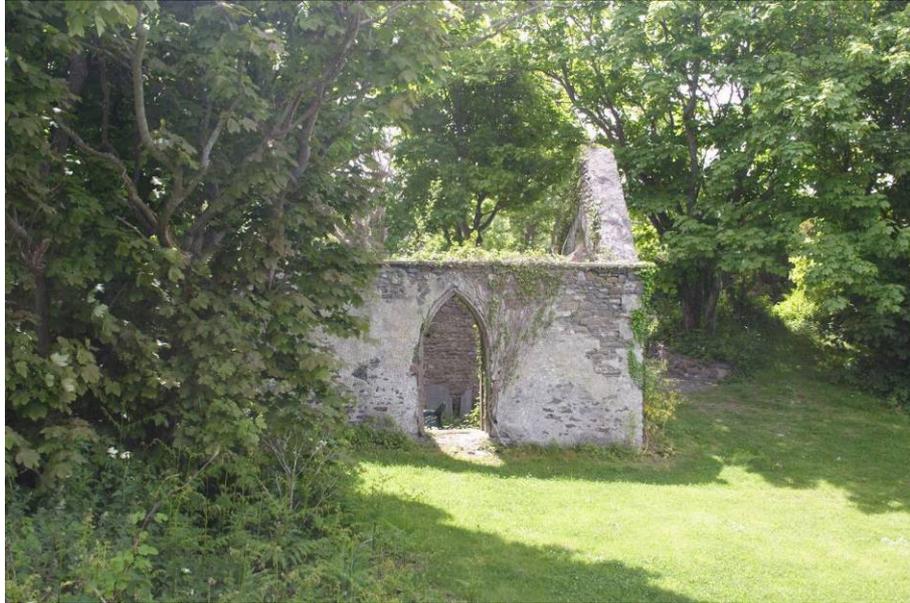
Photo 36: Summer house to north of Plas Llanina.

The summer house appears to be stable but is starting to decay with ivy and other vegetation present on the walls. It is also possible that the mortar bonding the walls may be degrading causing structural weakness, whilst the sealing of the

The structure appears to be slightly mislocated on the regional HER, a more accurate NGR would be SN 40453 59816.

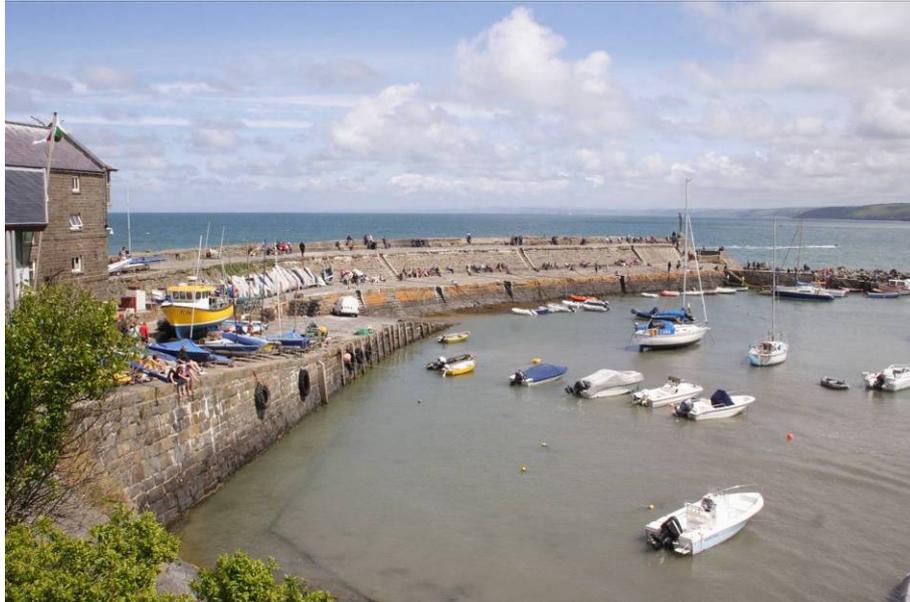
Photo 40: Pier and slipway at New Quay from northwest.

Substantial 19th century pier constructed of rectangular stone block and incorporating a parallel slipway. Both pier and slipway are in a good state of preservation and do not appear to be immediately under threat from erosion. However, as the pier was partially obscured by water it is unclear if erosion is present beneath the water line and further monitoring would be considered beneficial.

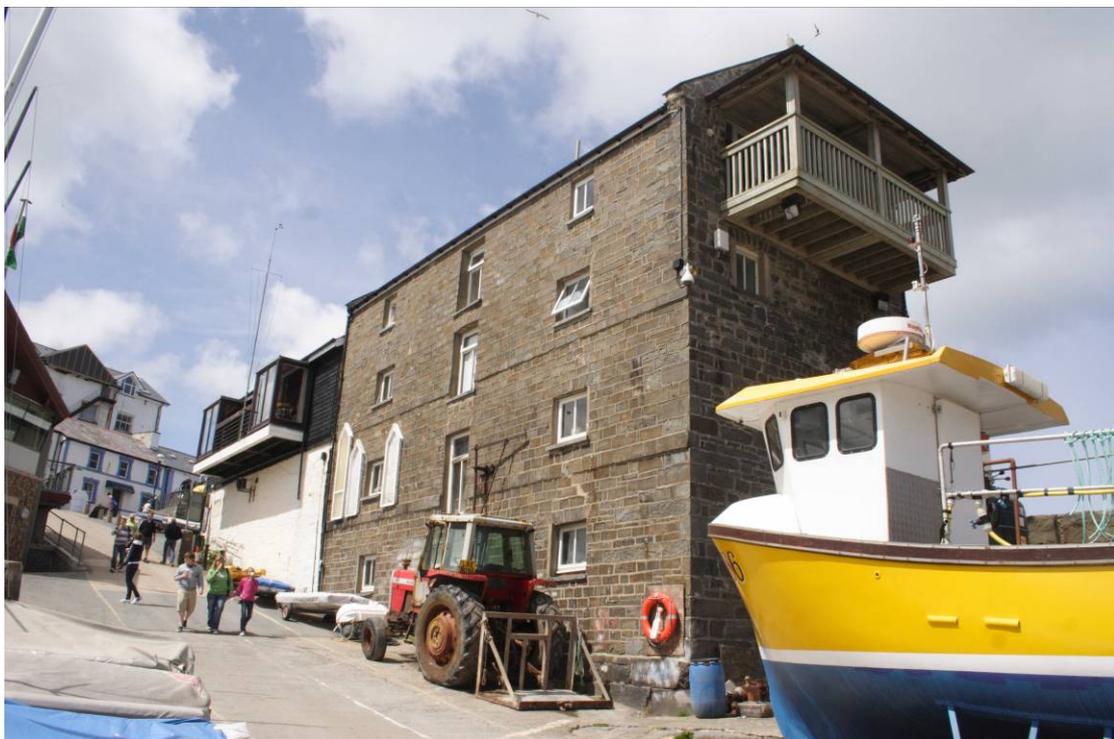
Photo 41: Former warehouse now known as the Pier Building.

Grade II listed 19th century former warehouse now occupied by the New Quay Yacht Club. The structure, constructed of regularly coursed stone blocks and roofed with slate is in a very good state of repair and appears not to be suffering from erosion, however, a possible threat is its location on a steep access road where it is exposed to possible damage from road vehicles towing boats and trailers to and from the pier area.

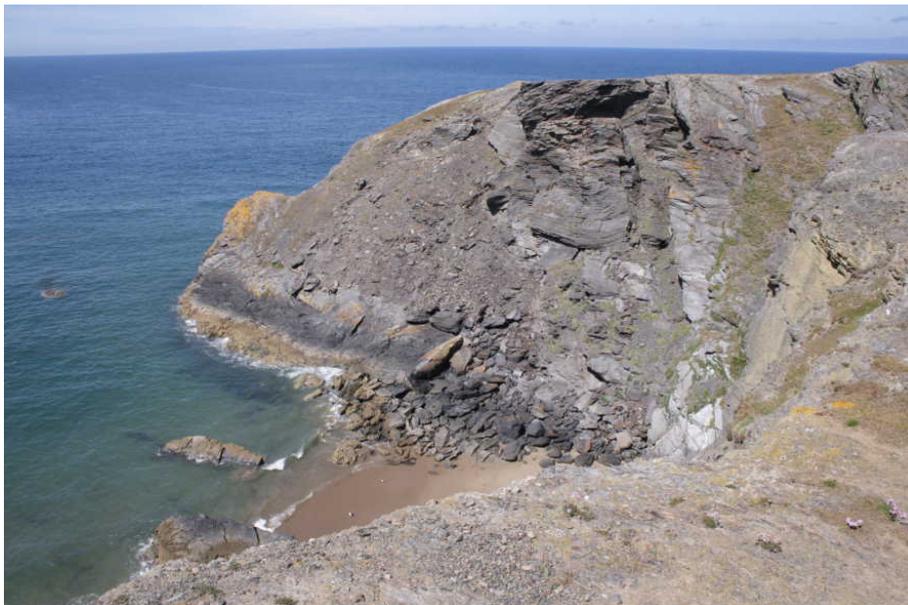
Photo 45: Coastline at Ynys Lochtyn facing north.

However to the north of Llangranog erosion appears to be more of a problem with large areas of eroded cliff noted especially around the area of Ynys Lochtyn.

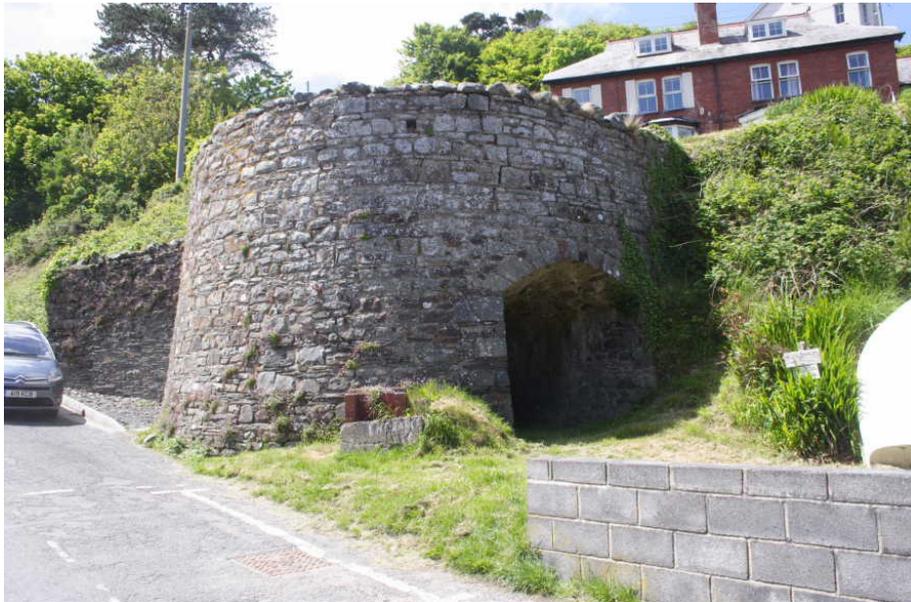
Photo 52: Lime kiln at Llangranog beach from northeast.

bearing the date 1887. The structure appears to be stable with very little evidence for decay.

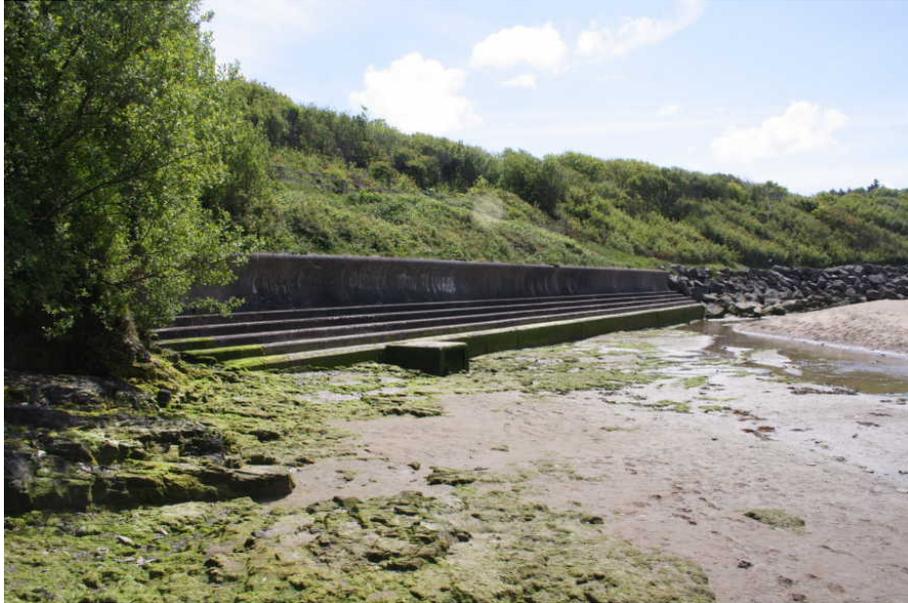
Photo 58: Concrete and stone sea defences at Traeth Dyffryn beach, Aberporth.

The sea defences are free from erosion and decay at present but this is considered likely to change over time.
