**LLANFAIR AR Y BRYN,
LLANDOVERY
CARMARTHENSHIRE
SN 77026 35221**

ARCHAEOLOGICAL RECORDING

March 2011

**RHIF YR ADRODDIAD / REPORT NO. 2011/24
RHIF Y PROSIECT / PROJECT RECORD NO. 100721**

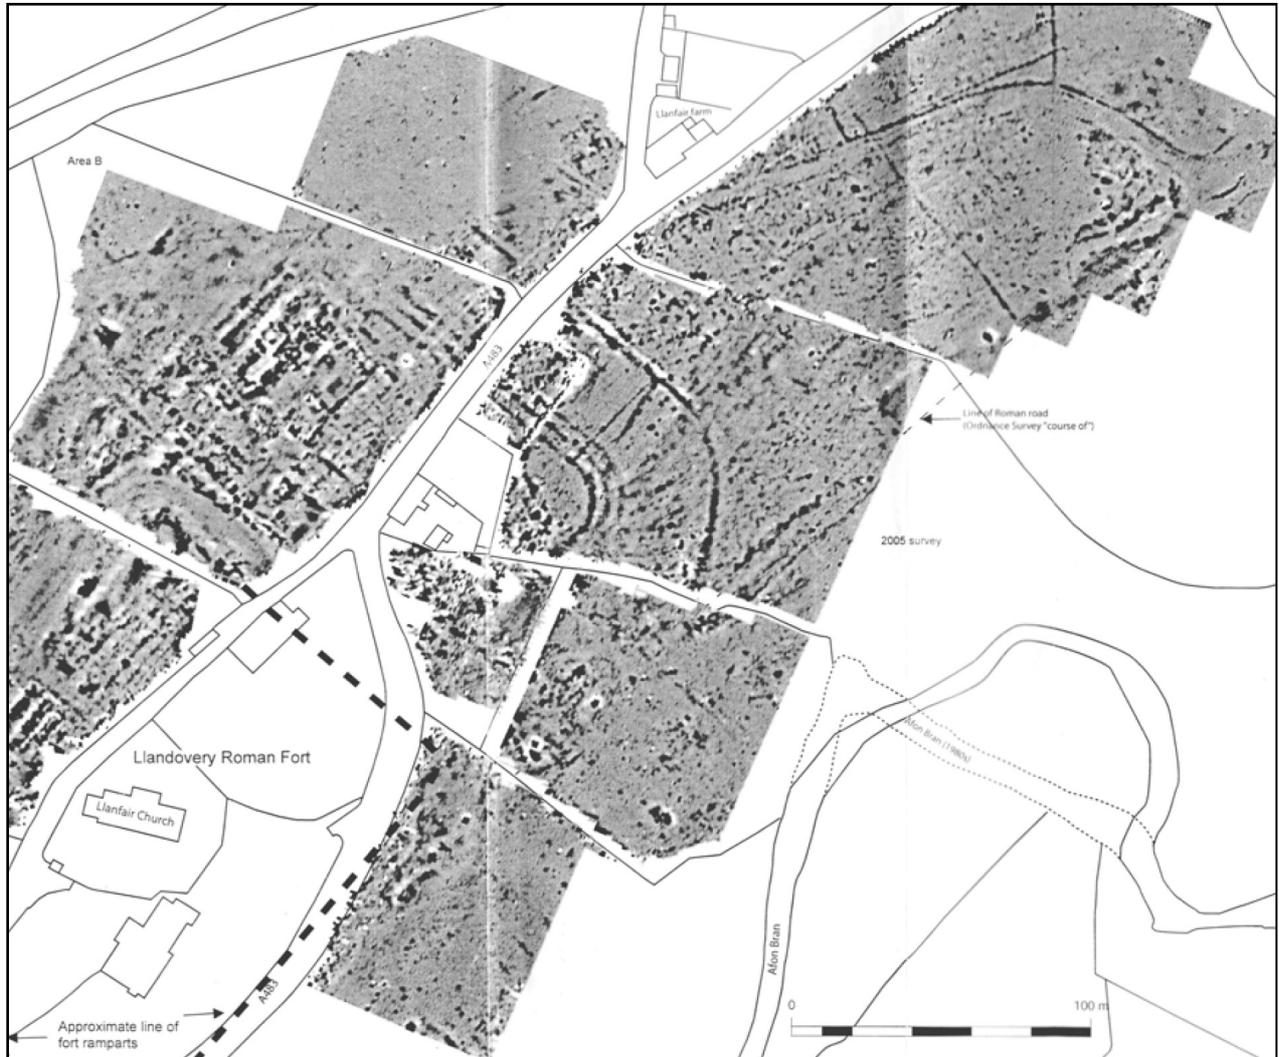
Figure 2: Combined results of the 2004 and 2005 geophysical surveys of the Llandovery Roman Fort

The geophysical survey also gave clear indications of a road leading off the main Via Julia Montana, which ran northwest before turning to run west-southwest and then southwest into the *porta praetoria* (main entrances) of both phases of the fort, part of which is overlain by the current A483 as it approaches Llanfair Ar Y Bryn House from Llanfair Farm (see Figure 2).

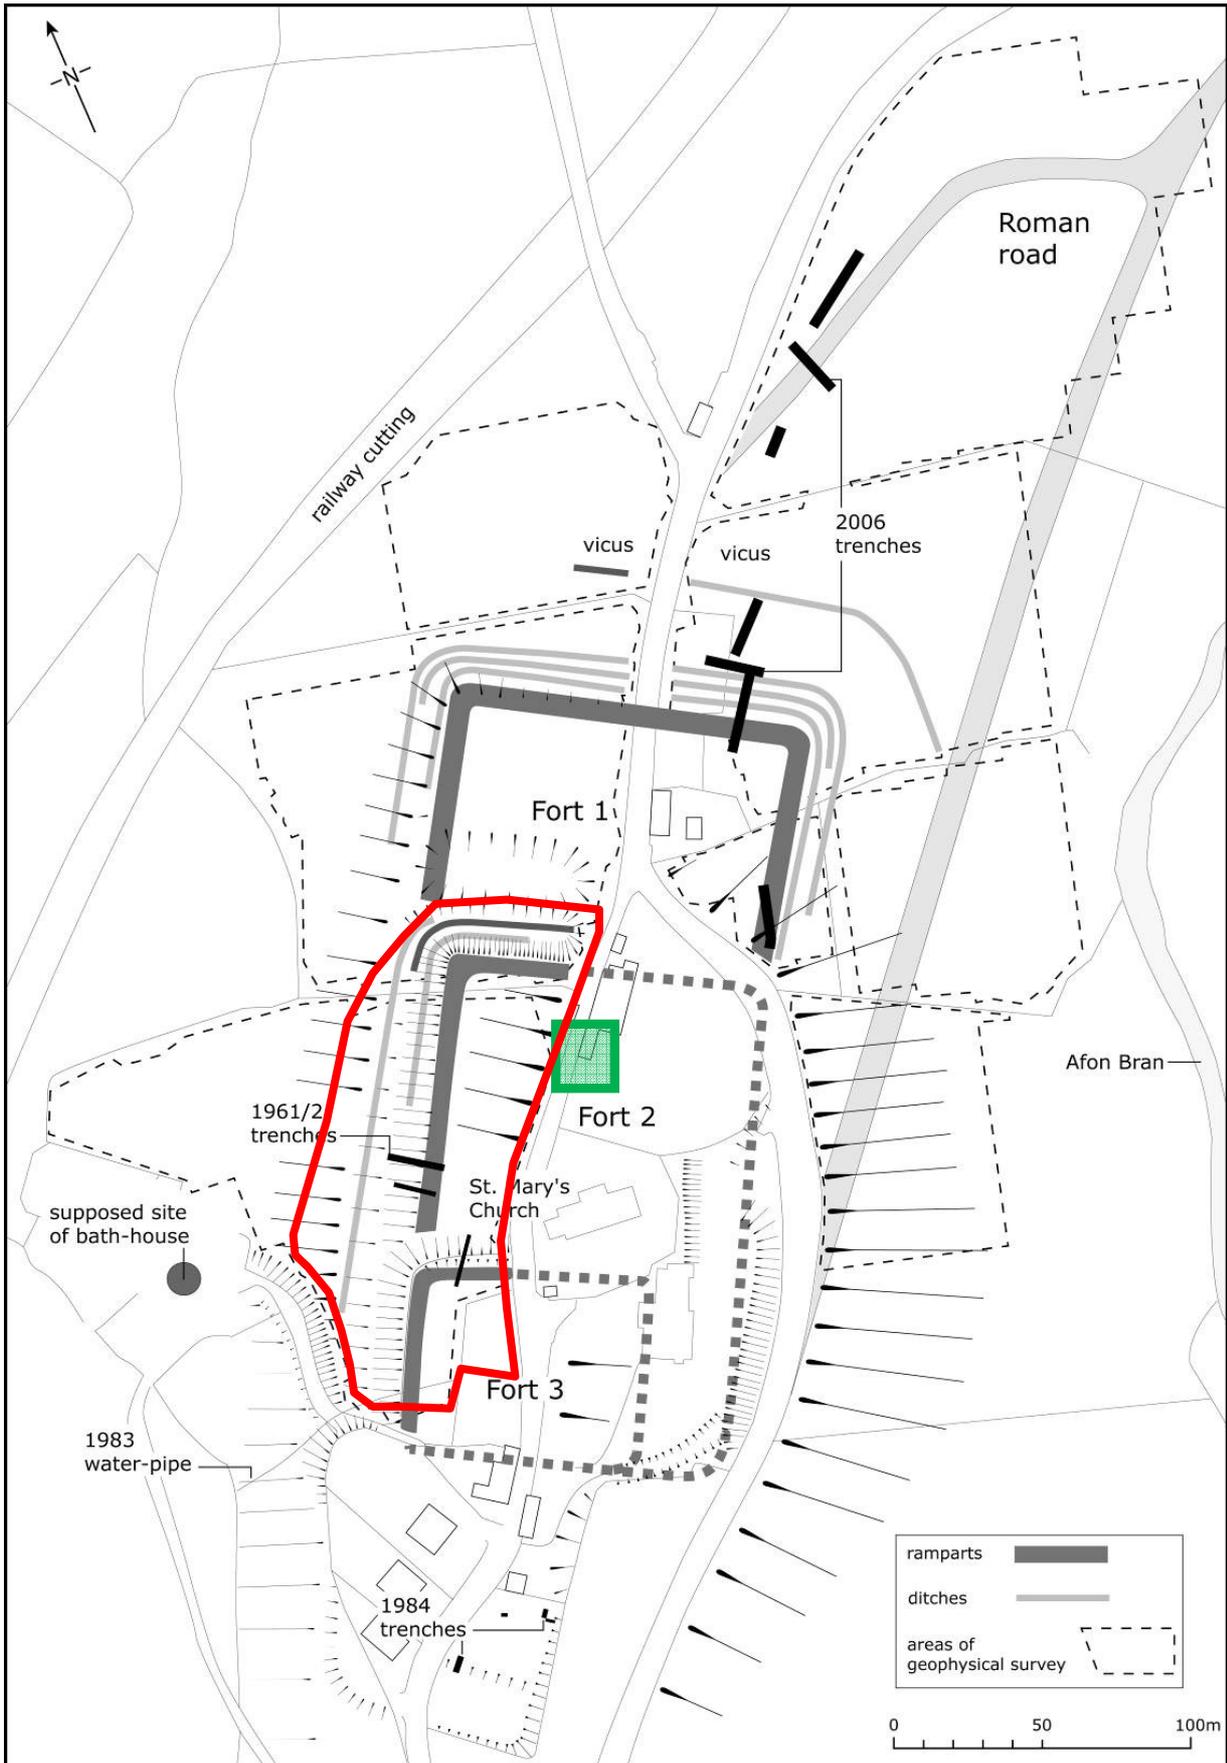
Figure 3: Three fort phases at Llandovery, showing site location (green box) and approximate area of original Scheduled Ancient Monument (red boundary)

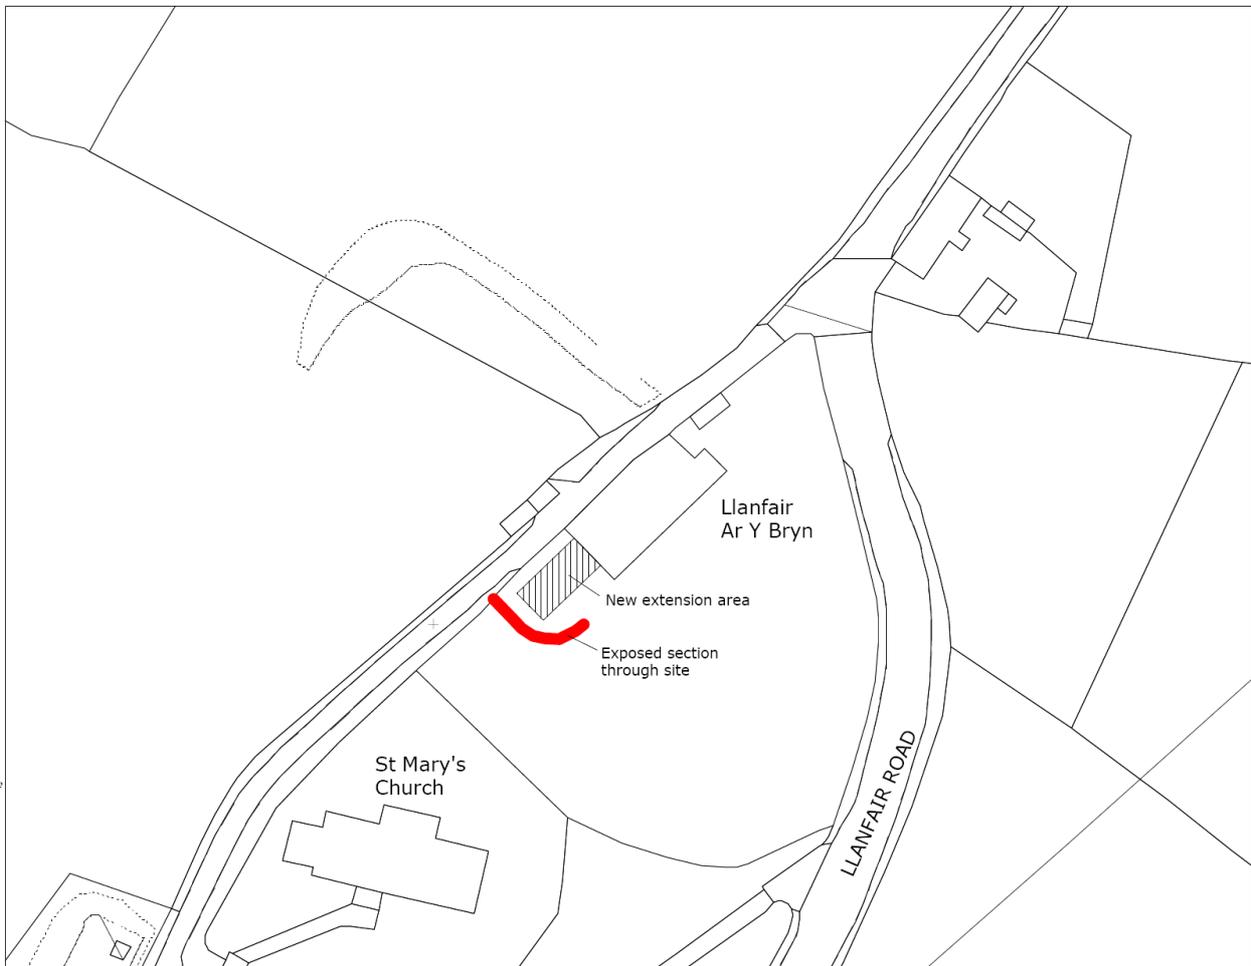
Figure 4: Llanfair Ar Y Bryn showing location of the extension area and approximate location of the exposed section through the site

The exposed section curved around the extension area, from the northeastern end curving to the south, then running in a northwestern direction to the tall property boundary wall (see figure 4). In this area the ground level for Llanfair Ar Y Bryn House and the new extension is lower than the road on the opposite side of the boundary. From the machined out level base of the extension footings the exposed section increased in height from 1.10m at the northeast end, to 1.55m at the northwestern end adjacent to the boundary wall.

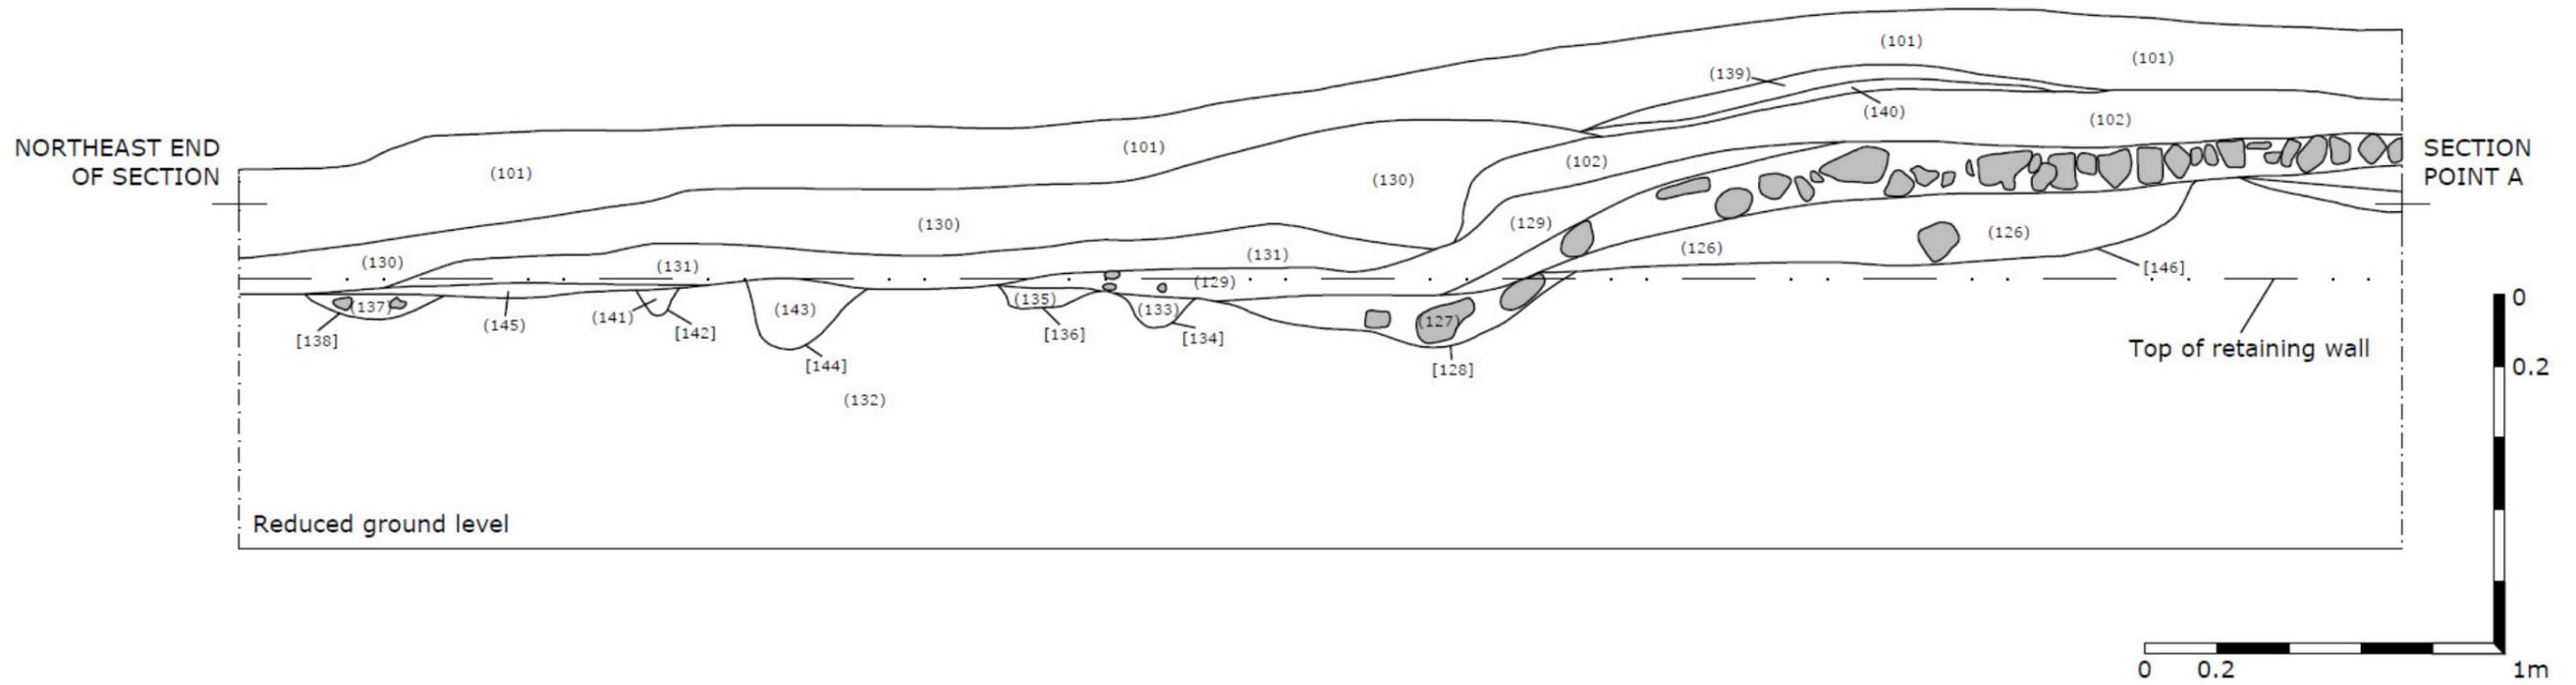
Figure 5: Northeastern end of exposed section through site (0m to 6m) (Photos 6 to 10 / Parts A to E)

Layer (132) sealed two further features, a small U-shaped cut [134] filled by (133) and a shallow scoop, cut [136] filled by (135). Cut [134] measured 0.22m in width and 0.10m in depth. Cut [136] was 0.26m in width and 0.07m in depth.

To the north of these features a further thin layer was present sealing archaeological features below. This layer (145) comprised a very dark soil. It sealed three underlying features, including a U-shaped cut, [144], of 0.34m width and 0.20m depth, containing fill (143). A further small U-shaped cut [142] was also present 0.10m in width and 0.08m in depth, containing a single fill (141). At the northeastern end of the section a shallow scoop was also present sealed by layer (145), cut [133] containing a single stony fill (132). This scoop measured 0.47m in width and 0.08m in depth.

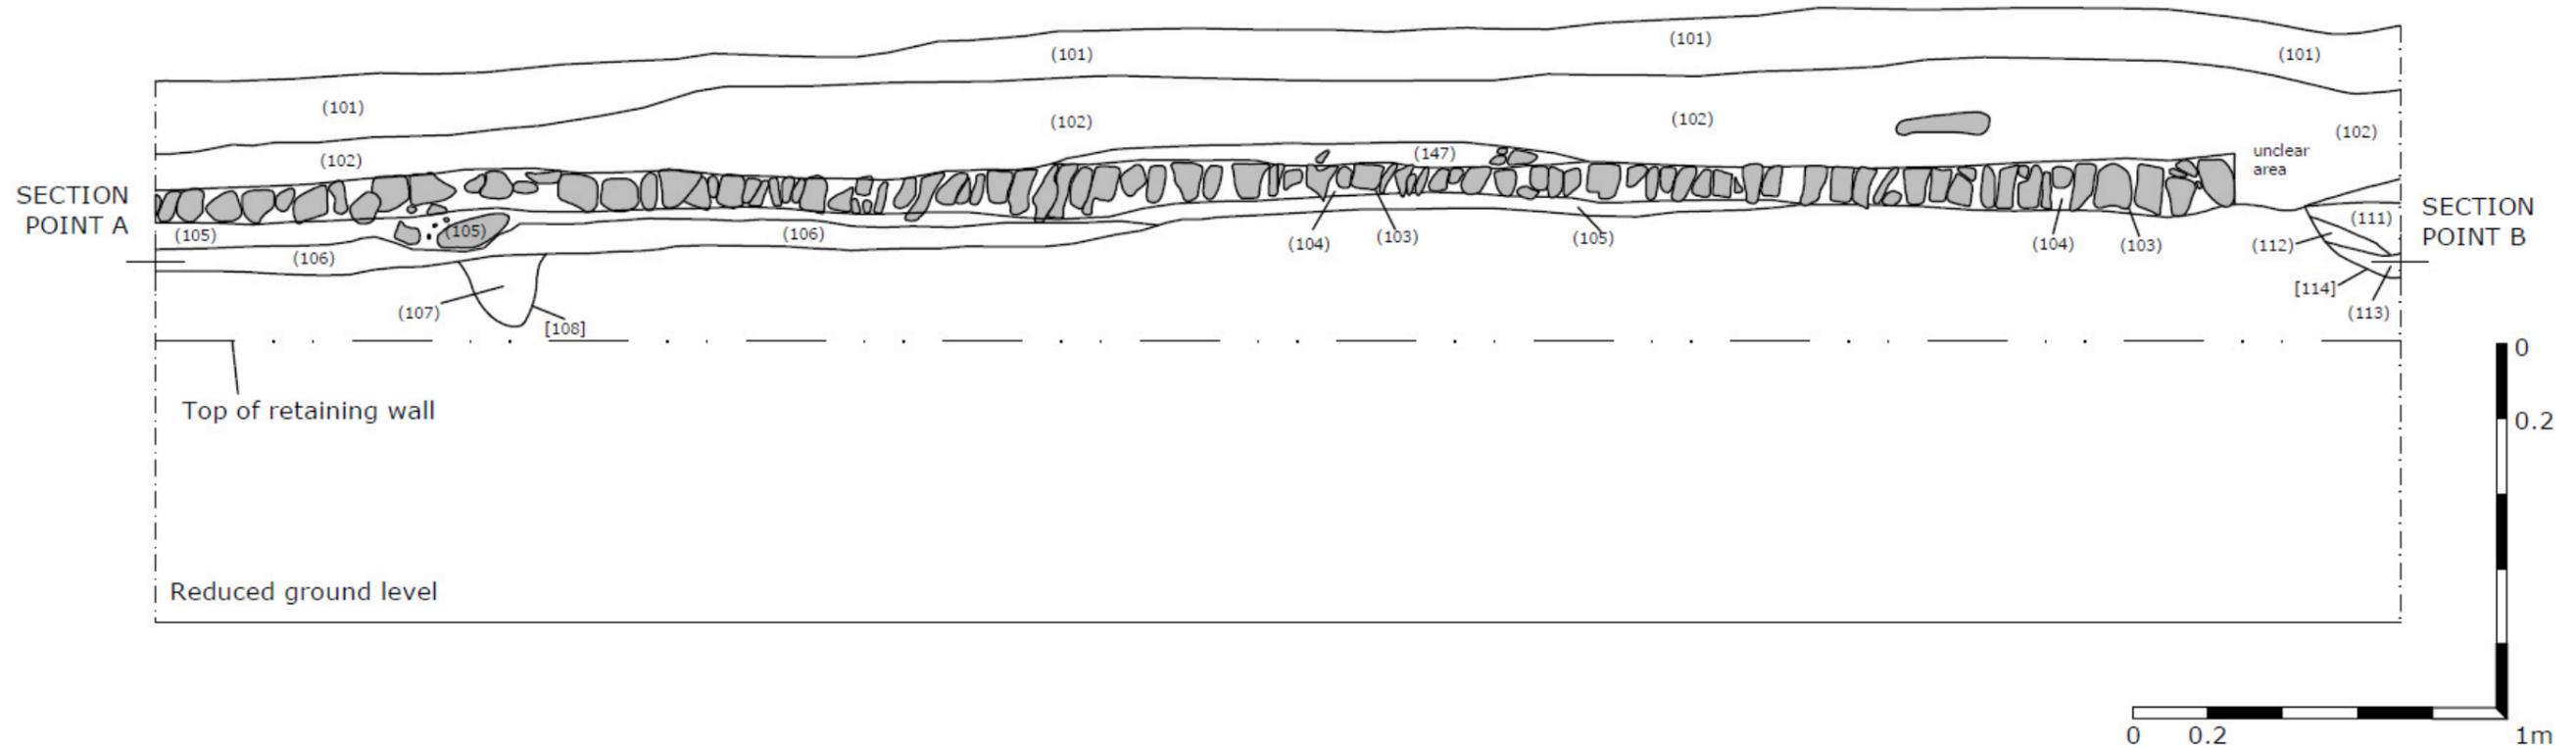
Figure 6: Central part of exposed section through site (6m to 12m) (Photos 11 to 14 / Parts F to I)

Crossing the central part of the exposed section was a pitched cobbled surface which showed up very clearly, comprising cobbles (103) and surrounding loose fill (104). This surface contained a small fragment of eroded brick, but was otherwise mostly made up of water worn pebbles with a few more angular stones also. For the most part the surface was sealed by the subsoil (102), although was stratigraphically below a small layer (147), which was similar in character to layer (110) to the west. An area at the western end of the cobbled surface could not be interpreted with any degree of confidence. The cobbles appeared to stop abruptly, with an area of subsoil (102) then being present, before layer (110) appeared below.

The cobbled surface lay stratigraphically above layer (105), a light silty layer containing a few stones. Layer (105) lay above (106), a slightly darker and less stony context. Layer (106) lay above fill (107) of feature cut [108] a small U-shaped cut, 0.21m in width and 0.24m in depth. A sherd of amphora and a second sherd of possible amphora with part a repair staple adhered to it were recovered from either layer (105) or (106).

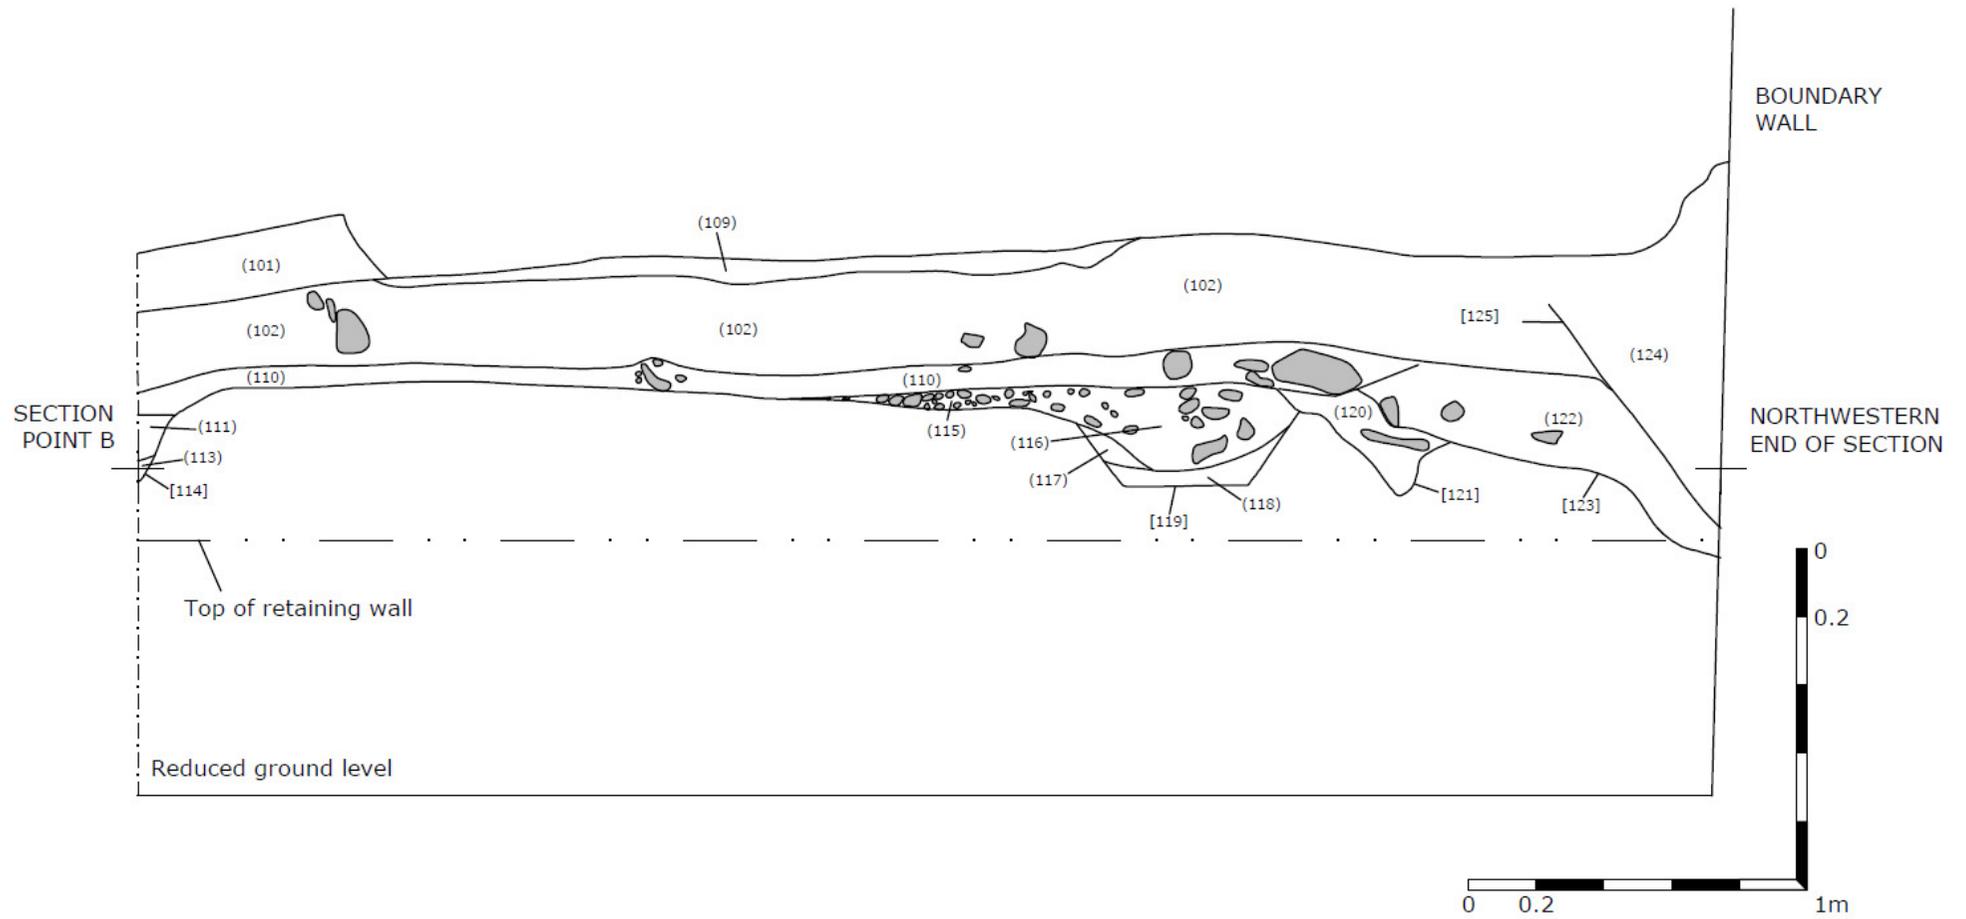
Figure 7: Northwestern end of exposed section through site (12m to 16.68m) (Photos 14 to 16 / Parts I to K)

Cutting through the subsoil on the northwestern end of the section was the foundation trench cut for the large boundary wall, which stood to a total height of some 3.4m from the base of the levelled area. The cut was steep sided [125], filled with loose material similar in character to the subsoil (124). The lower part of the boundary wall foundation cut comprised a minimal removal of natural ground to create a neat bedding trench for the wall. The top of the cut for this wall was not clearly discernible, as the fill and the subsoil appeared to merge into one.

Also below layer (110) at the western end of the section was another cut also truncated by foundation cut [125]. This feature, cut [123], was an irregular based feature with a single fill (122). It measured 1.10m in width and 0.55m maximum depth, with only the eastern side of the feature visible (the western side truncated by the boundary wall). The feature contained a few small stones, but no finds were recovered. The colour of the fill, its texture and similarity to other features recorded in other parts of the section suggested it was of likely Roman date. The relationship of this fill to layer (110) was somewhat uncertain, but (123) is considered earlier.

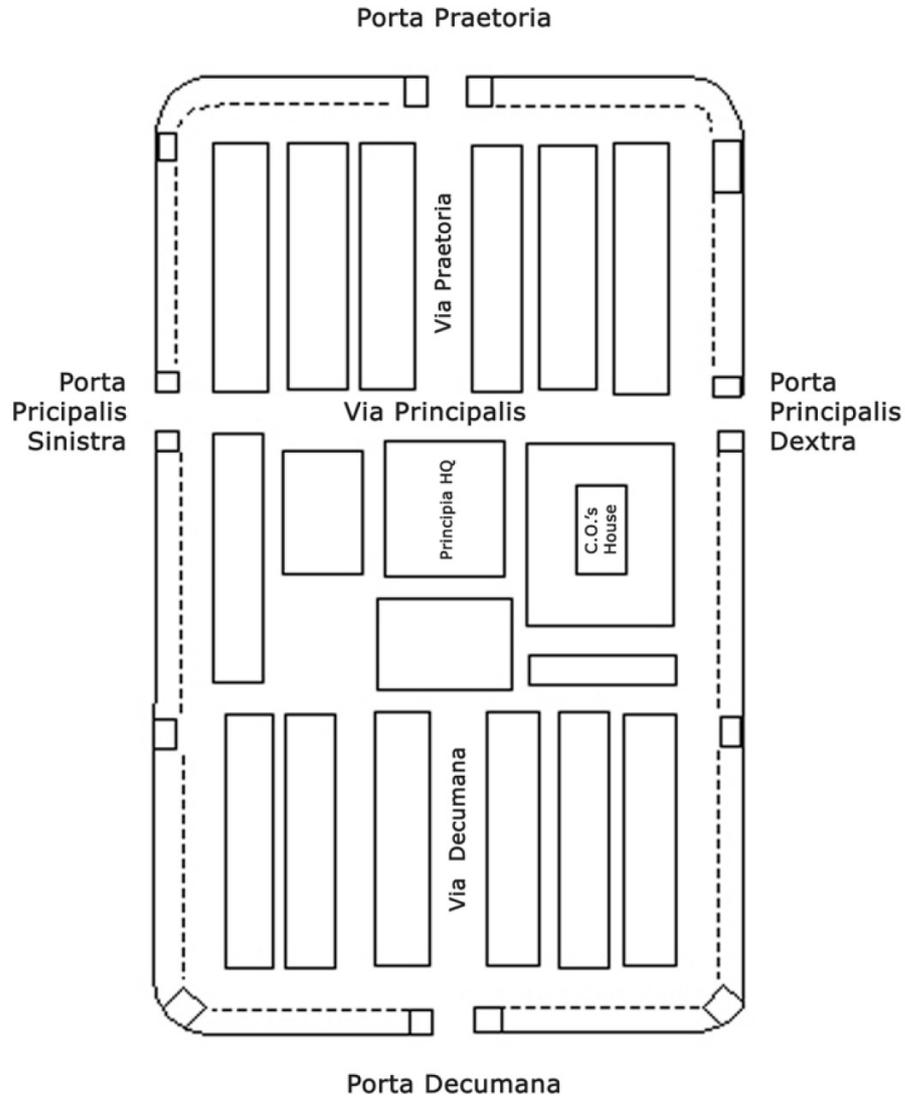
Figure 8: Typical layout of a Roman Auxiliary Fort (after Breeze 2002)

The layout of the fort at Llanfair Ar Y Bryn would have followed the typical lay-out of an auxiliary fort. Roman forts usually faced either the enemy, the line of march, or east (Breeze 2002:7), with the fort at Llanfair facing NE, towards Castell Collen, another auxiliary fort on a line of march. The interior of the fort was divided up by a series of internal roads and the placement of different buildings, with barrack blocks tending to occupy the front third of the fort's interior. Four gates gave entrance through the defences of the fort: the main *Porta Praetoria* at the front of the fort; the *Porta Decumana* at the rear of the fort; and the *Porta Principalis Dextra* and *Sinistra* on the opposite sides. These latter two gates were connected by an internal road, the *Via Principalis*, with an intervallum road, the *Via Sagularis*, running round the whole circuit of the fort inside the rampart.

Within the central range of buildings in the interior of the fort were the *Principia* or headquarters buildings, which usually opened onto the *Via Principalis*. Adjacent to this was the commanding officer's house, the *Praetorium*, with a granary often flanking the *Principia* on its other side. These buildings would have

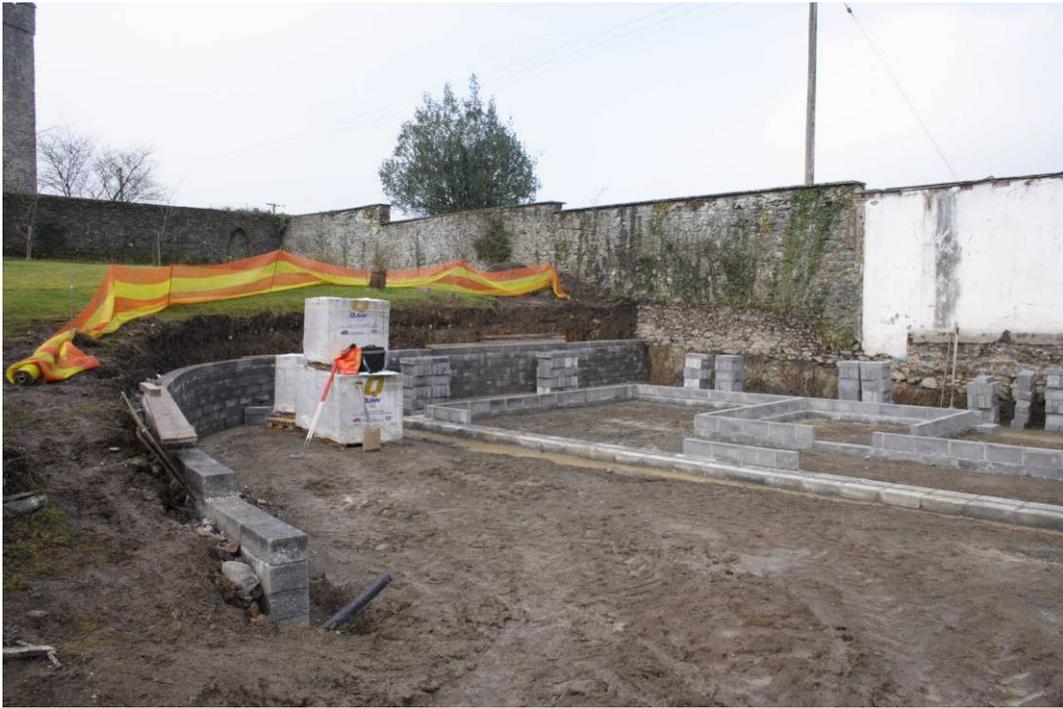
Photo 1: Overview of site with exposed section along left hand side of photograph (viewing southwest)

The new extension is situated on the site of a former glass house constructed many years previously and at which time most of the area in which the new extension was to be constructed was levelled. The groundworks required for the new extension area, which covered a larger footprint than the glass house, had been undertaken prior to the visit to the site by the archaeologist (Photos 1 & 2).

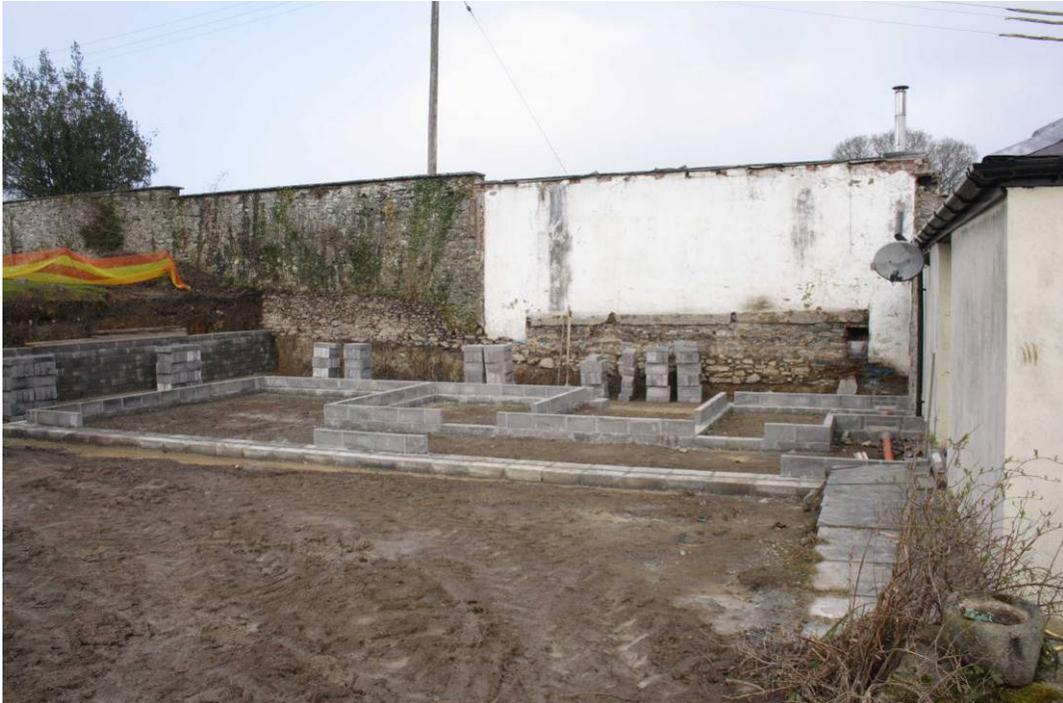
Photo 2: Area of extension, showing ground level and inserted foundations with boundary wall behind (viewing west)

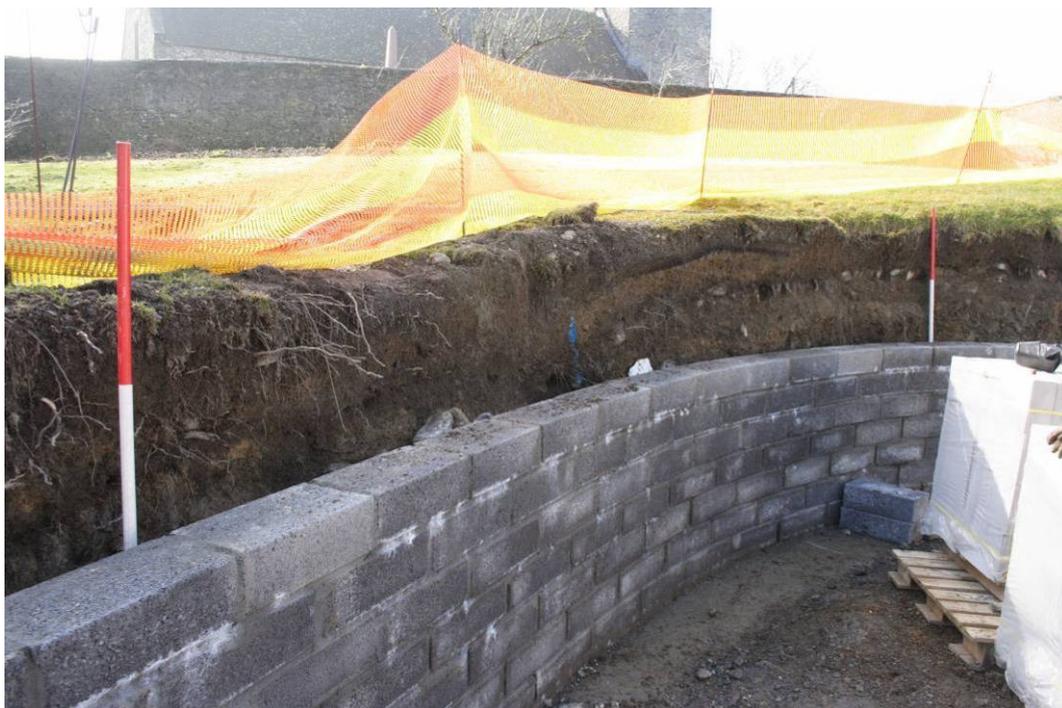
Photo 3: Eastern side of exposed west facing section

The area available for the archaeological investigation comprised the exposed vertical edges around the levelled footprint of the new extension (Photos 3, 4 & 5). A low retaining wall (around 0.75m in height), had been built against some of the exposed sections, but all surviving archaeological levels were still visible behind or above the top of the wall.

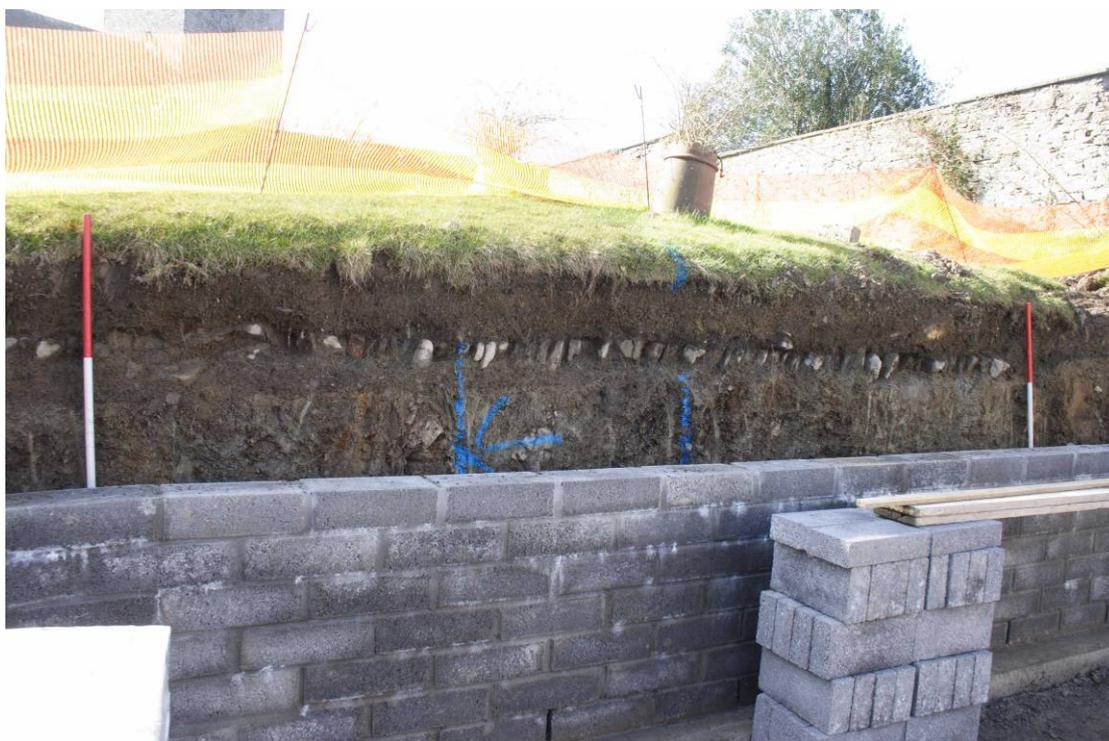
Photo 4: Central part of exposed north facing section

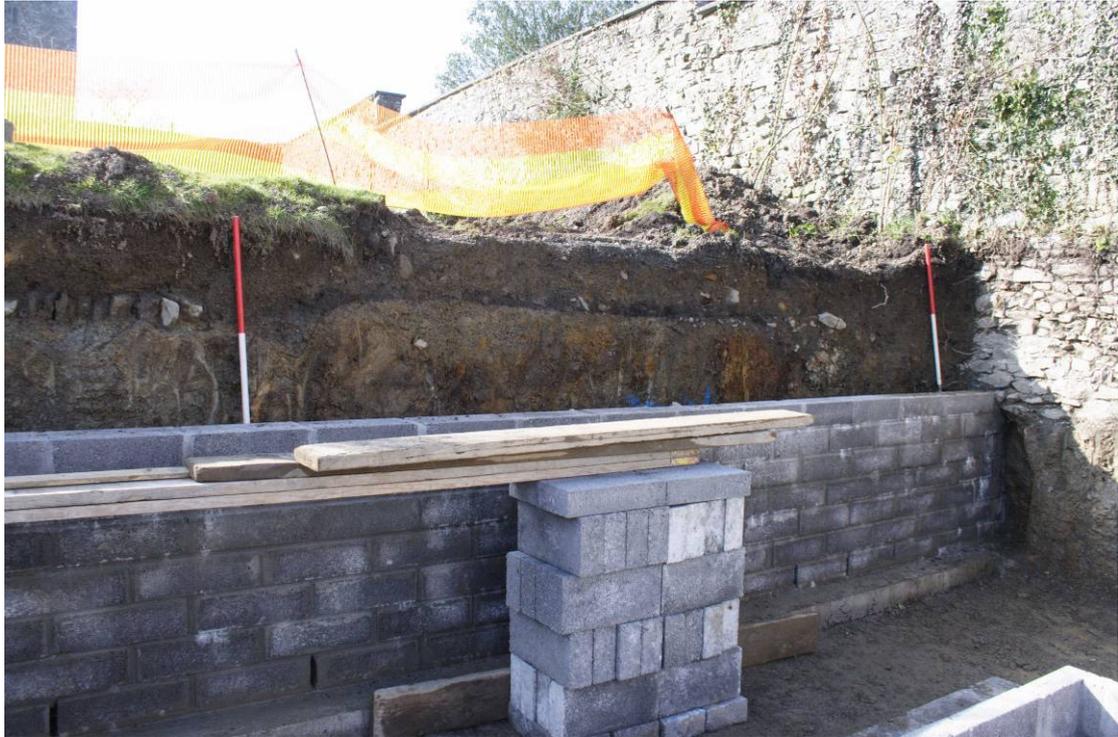
Photo 5: Western side of exposed north facing section

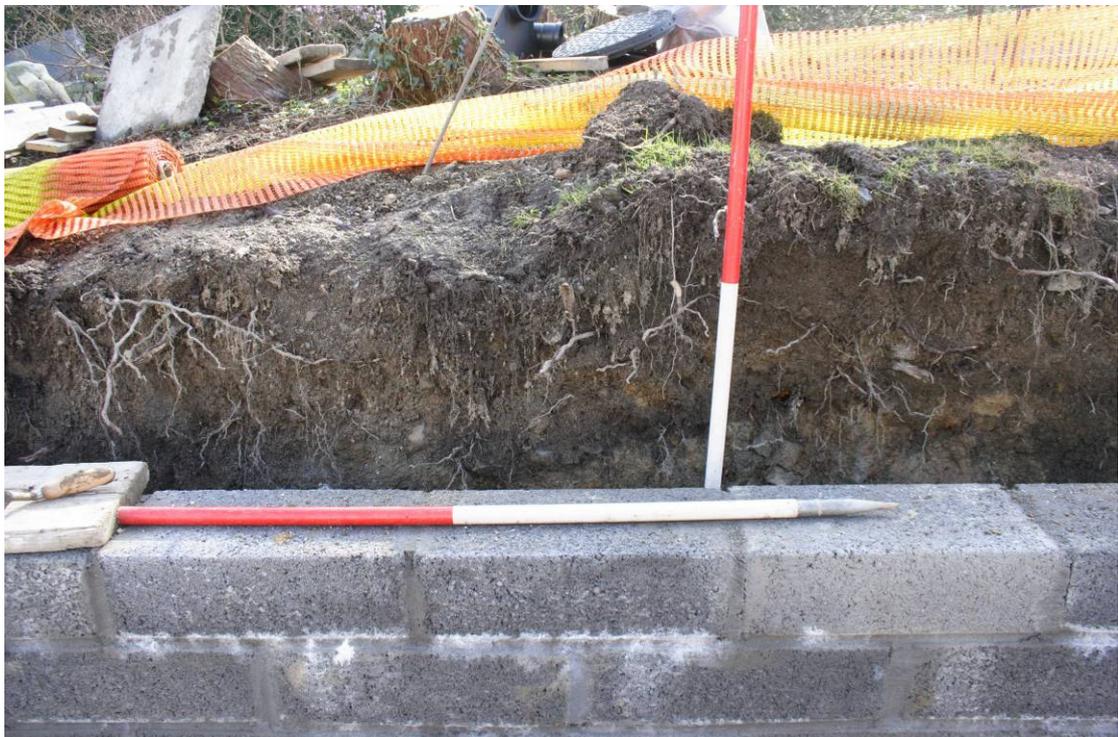
Photo 6: Part A of exposed section from northeast to northwest contexts (101), (130), (131), (145), (137) and [138]

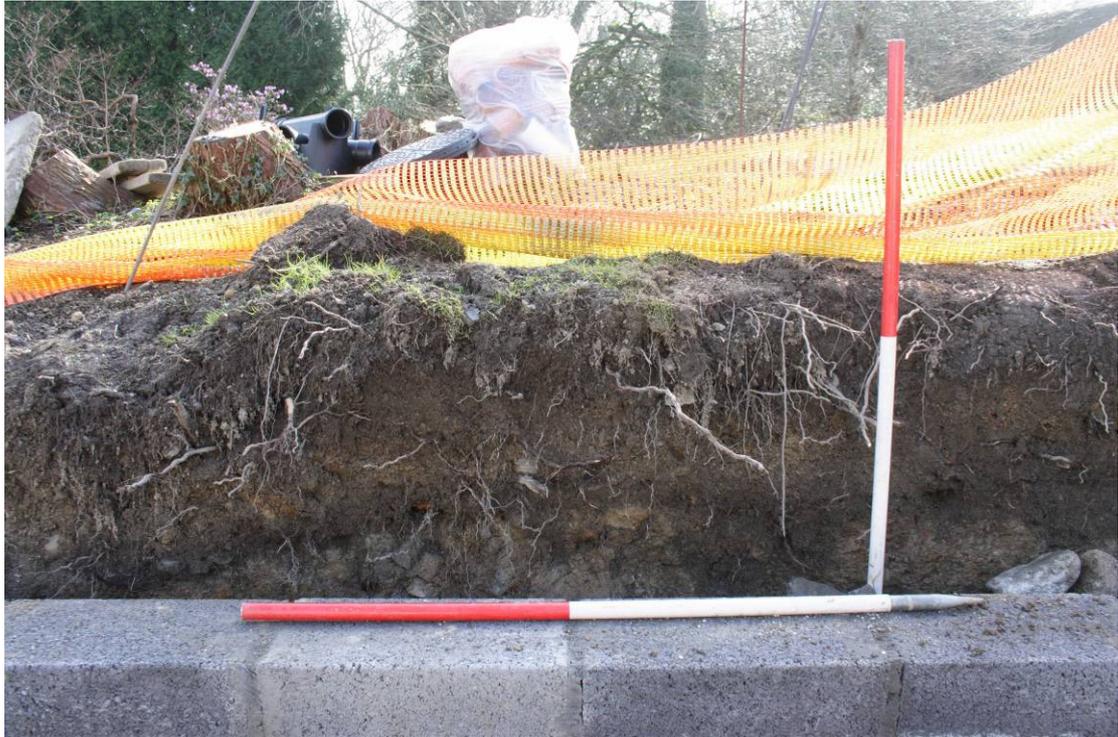
Photo 7: Part B of exposed section from northeast to northwest contexts (101), (130), (131), (145), (141), [142], (143) and [144]

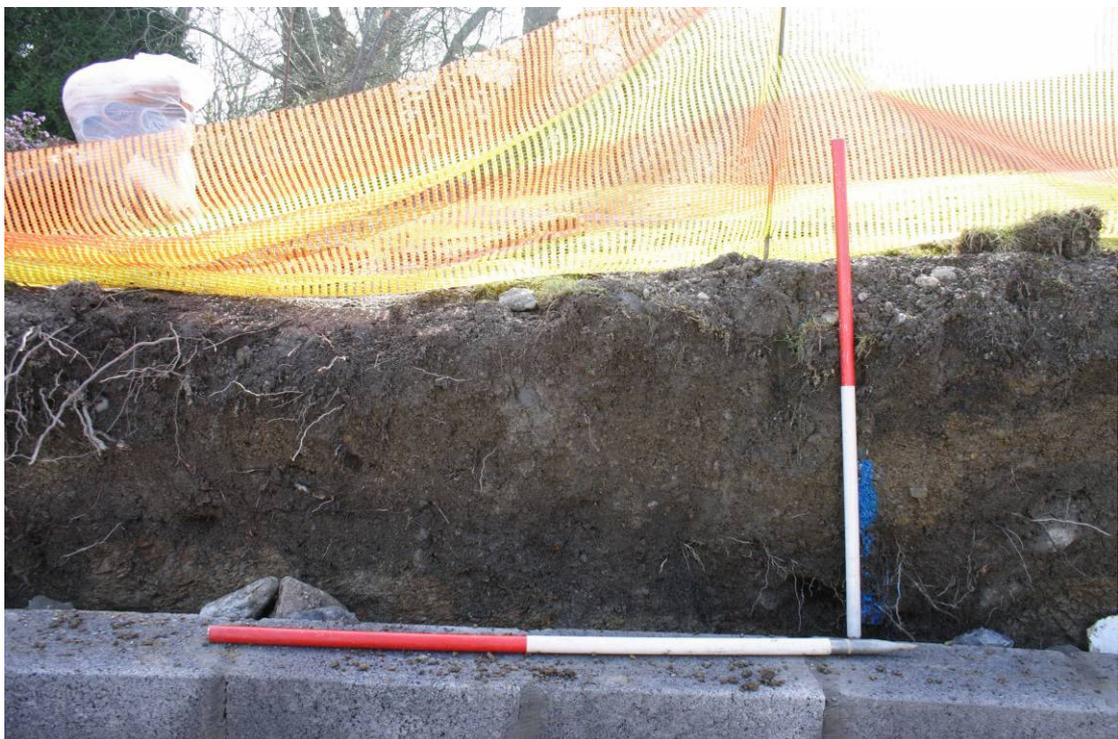
Photo 8: Part C of exposed section from northeast to northwest contexts (101), (130), (131), (135), [136], (133), [134] (127) and [128]

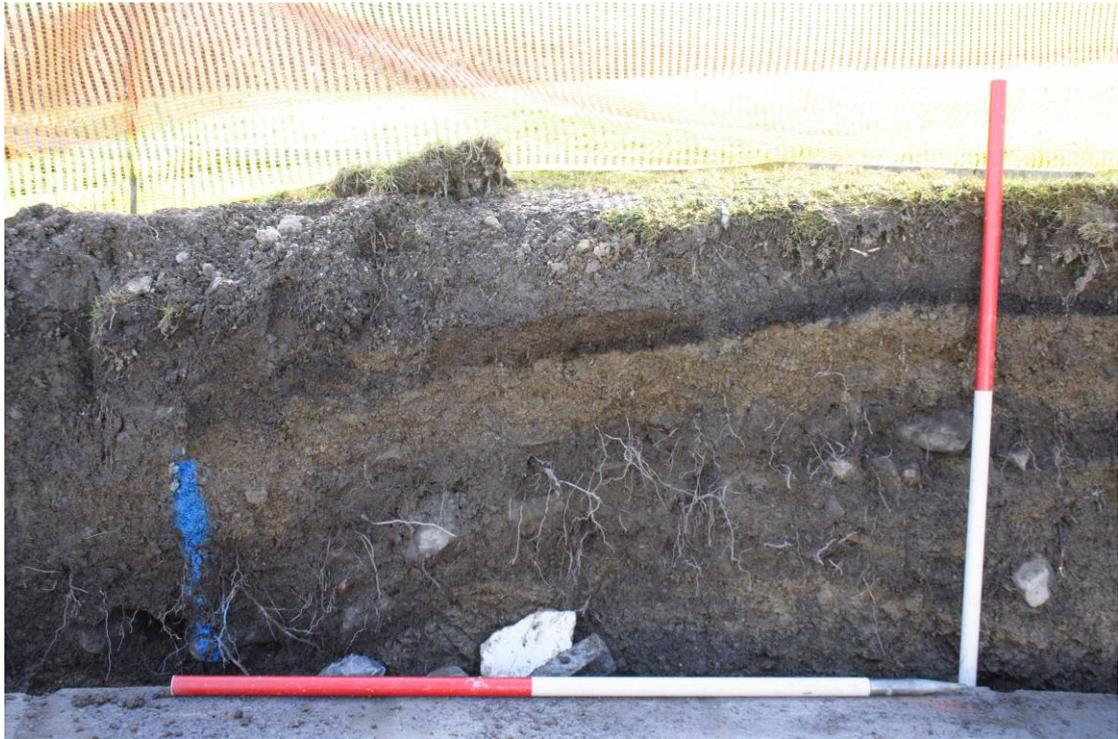
Photo 9: Part D of exposed section from northeast to northwest contexts (101), (139), (140), (102), (103), (104), (129), (127), [128], (126) and [146]

A feature into which cobbled layer (103)/(104) may have slumped, was truncated by the possible terrace cut [146]. The underlying feature, cut [128] was 1.00m in width and survived to a maximum depth of 0.23m. It contained a single fill (127), which was similar in character to the loose fill of the cobbled surface (104), but was more compacted in this area. A number of larger rounded stones or cobbles were present within the fill.

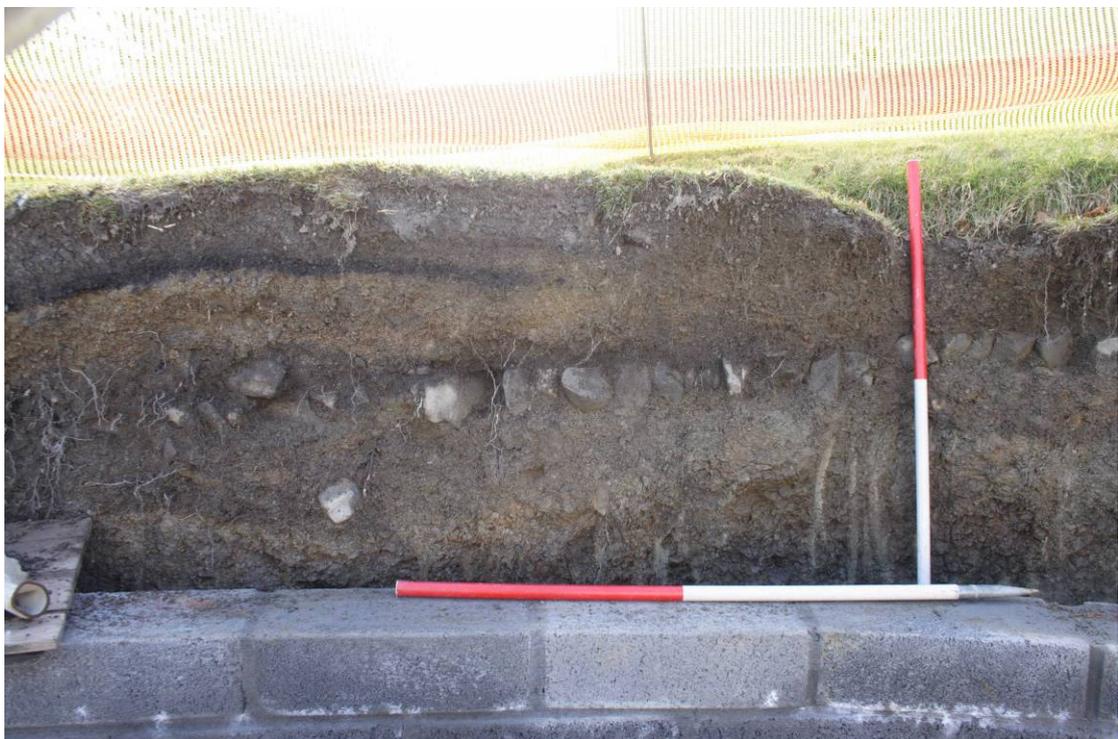
Photo 10: Part E of exposed section from northeast to northwest contexts (101), (139), (140), (102), (103), (104), (126) and [146]

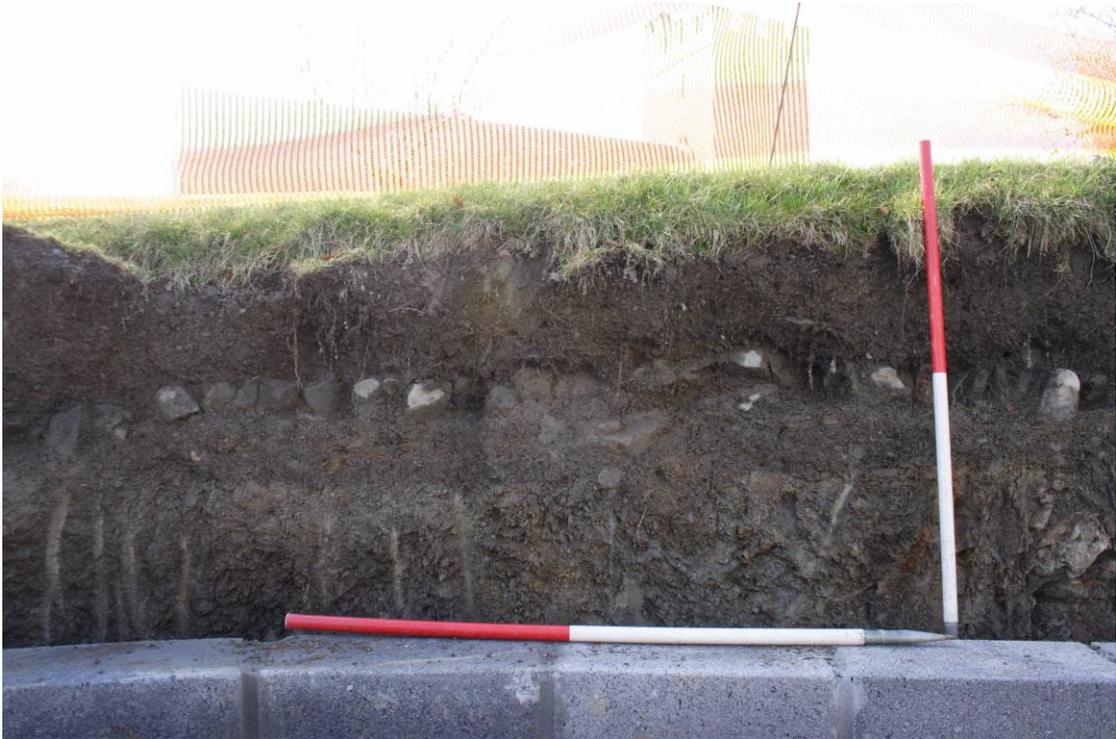
Photo 11: Photo F of exposed section from northeast to northwest contexts (101), (102), (103), (104), (105), (106), (107) and [108]
