**LLANFAIR AR Y BRYN,
LLANDOVERY
CARMARTHENSHIRE
SN 77026 35221**

ARCHAEOLOGICAL RECORDING

March 2011

**RHIF YR ADRODDIAD / REPORT NO. 2011/24
RHIF Y PROSIECT / PROJECT RECORD NO. 100721**

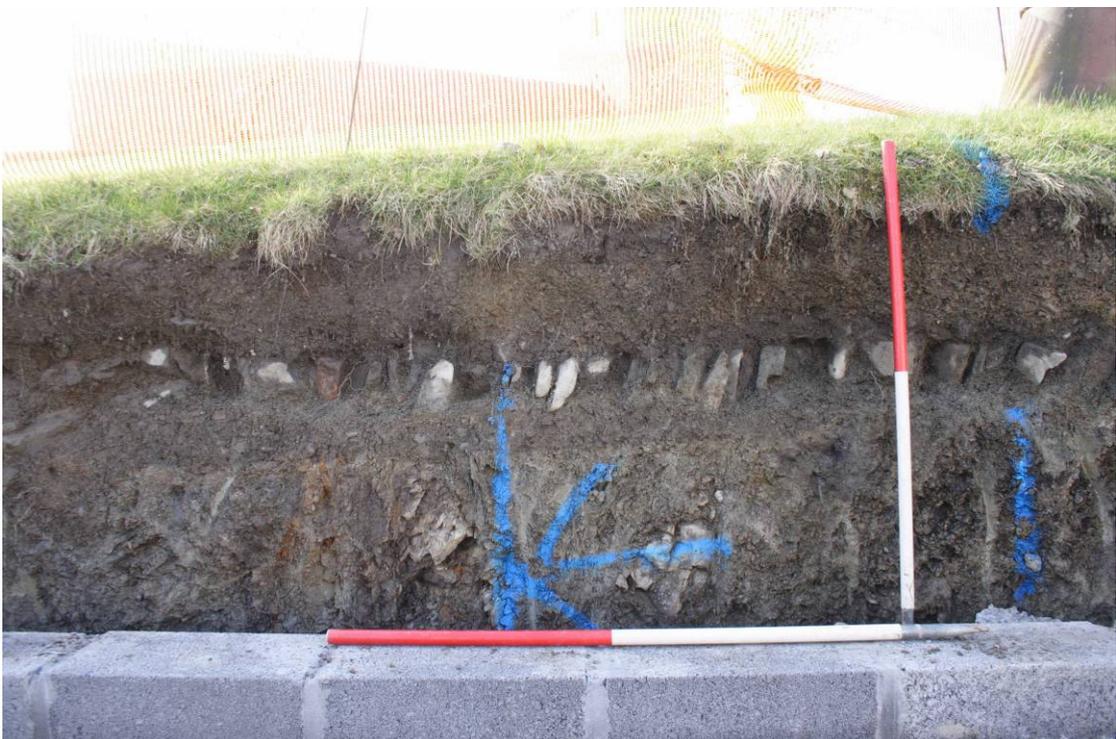
Photo 12: Photo G of exposed section from northeast to northwest contexts (101), (102), (103), (104), (105), (106), (107) and [108]

The cobbled surface lay stratigraphically above layer (105), a light silty layer containing a few stones. Layer (105) lay above (106), a slightly darker and less stony context. Layer (106) lay above fill (107) of feature cut [108] a small U-shaped cut, 0.21m in width and 0.24m in depth. A sherd of amphora and a second sherd of possible amphora with part a repair staple adhered to it were recovered from either layer (105) or (106).

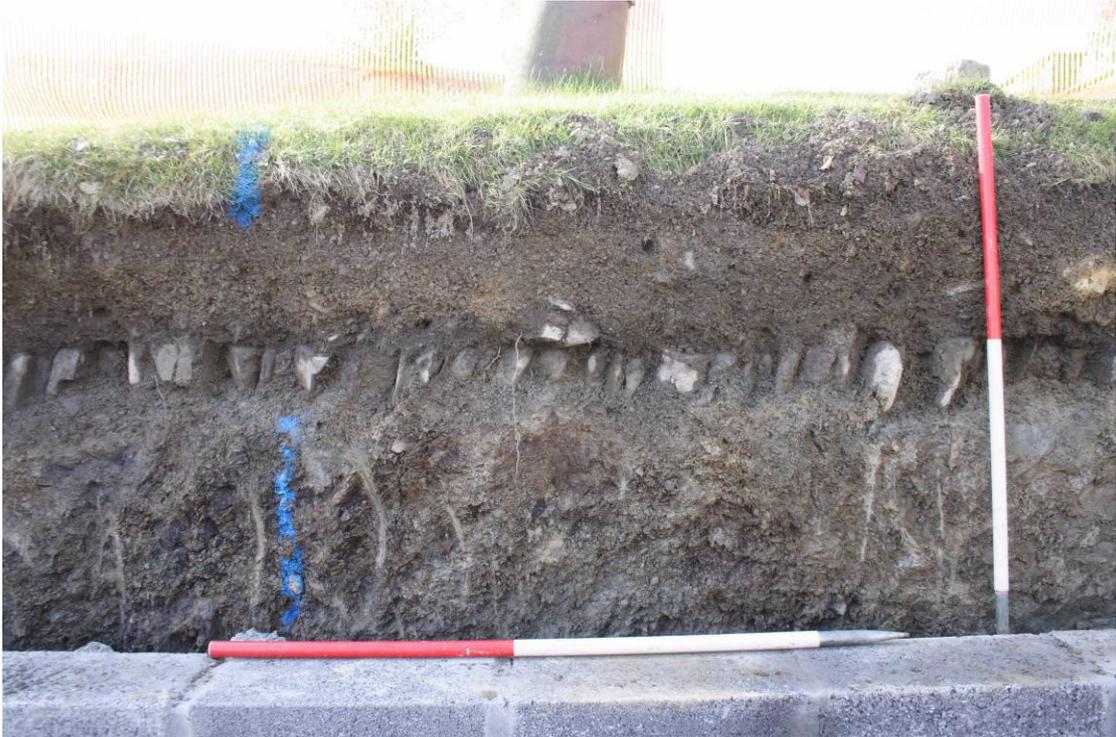
Photo 13: Photo H of exposed section from northeast to northwest contexts (101), (102), (103), (104), (147), (105) and (106)

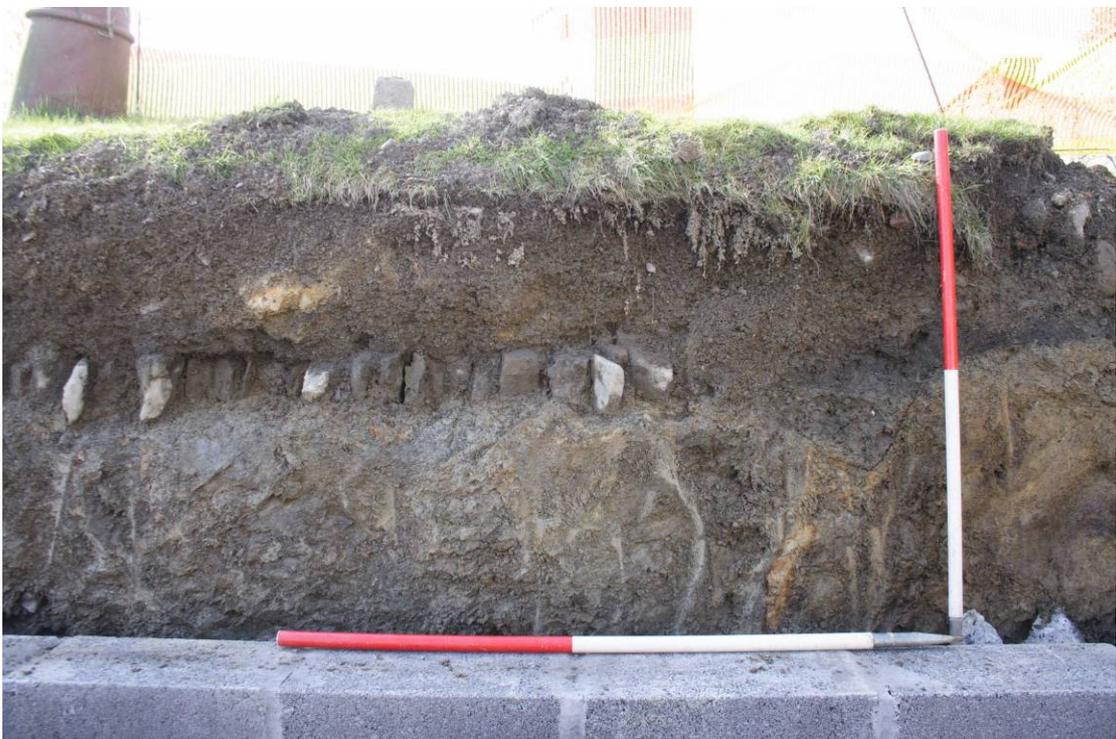
Photo 14: Photo I of exposed section from northeast to northwest contexts (101), (102), (103), (104), (110), (111), (112), (113) and [114]

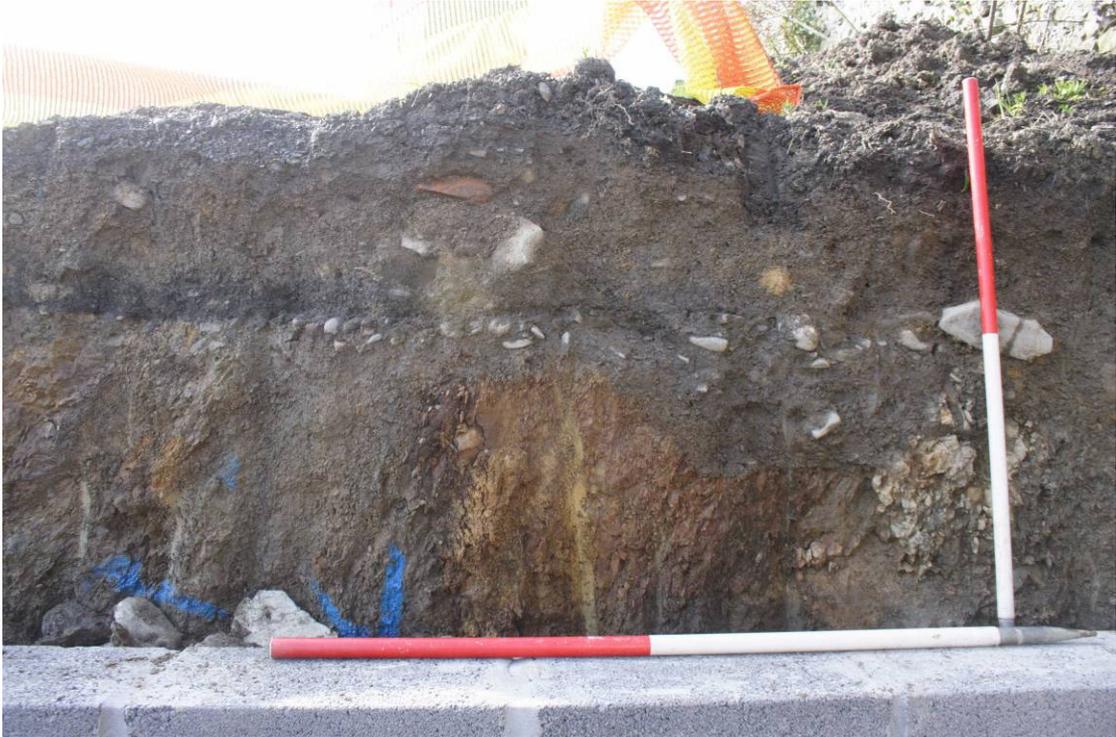
Photo 15: Photo J of exposed section from northeast to northwest contexts (109), (102), (110), (115), (116), (117), (118) and [119]

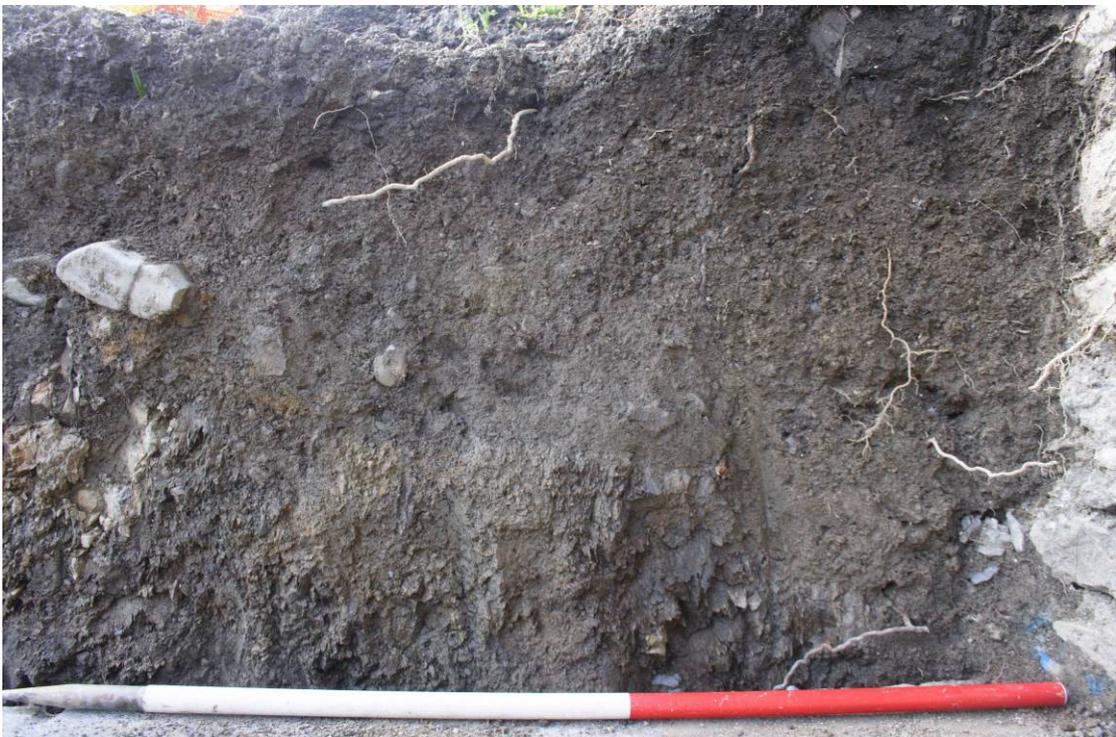
Photo 16: Photo K of exposed section from northeast to northwest contexts (102), (124), [125], (122), [123], (120) and [121]

Cutting through the subsoil on the northwestern end of the section was the foundation trench cut for the large boundary wall, which stood to a total height of some 3.4m from the base of the levelled area. The cut was steep sided [125], filled with loose material similar in character to the subsoil (124). The lower part of the boundary wall foundation cut comprised a minimal removal of natural ground to create a neat bedding trench for the wall. The top of the cut for this wall was not clearly discernible, as the fill and the subsoil appeared to merge into one.

Also below layer (110) at the western end of the section was another cut also truncated by foundation cut [125]. This feature, cut [123], was an irregular based feature with a single fill (122). It measured 1.10m in width and 0.55m maximum depth, with only the eastern side of the feature visible (the western side truncated by the boundary wall). The feature contained a few small stones, but no finds were recovered. The colour of the fill, its texture and similarity to other features recorded in other parts of the section suggested it was of likely Roman date. The relationship of this fill to layer (110) was somewhat uncertain, but (123) is considered earlier.

To the west of the cobbled surface close to the boundary wall of the property lay a further series of possible Roman features including a larger pit or ditch [123], truncated by the post-medieval boundary wall foundation trench [125]. This feature truncated an earlier V-shaped feature [121] which could be the remains
