**Plas Newydd Drainage Trench Inspection 06.01.04**

# Plas Newydd

# Plan Occupied Drainage Trench - 6.1.04

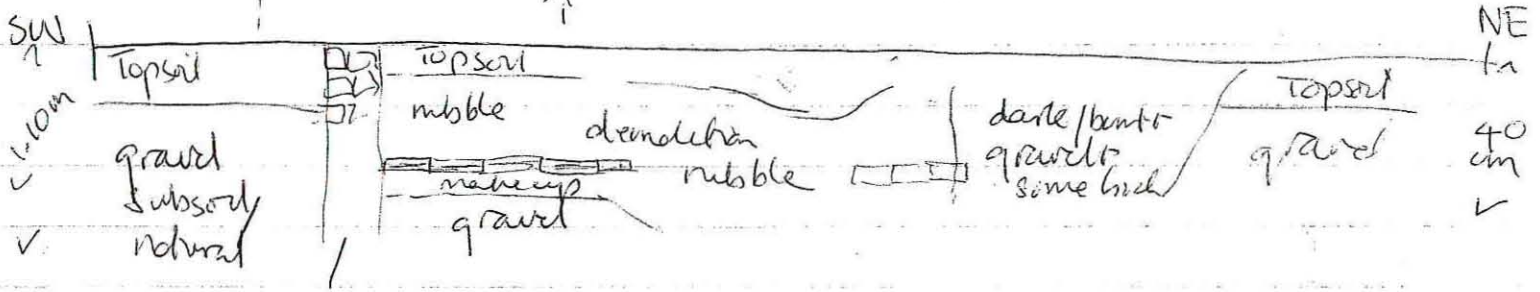
Section Location of gable end of house  
 NW ↑

Natural subsoil - Band of gravel - large stones  
 overlain by smaller stones - all water went in a  
 day/beam brown mix

? wall  
 Structure  
 which is bld  
 by rubble

▬ = quarry tile floor  
 □ = brick

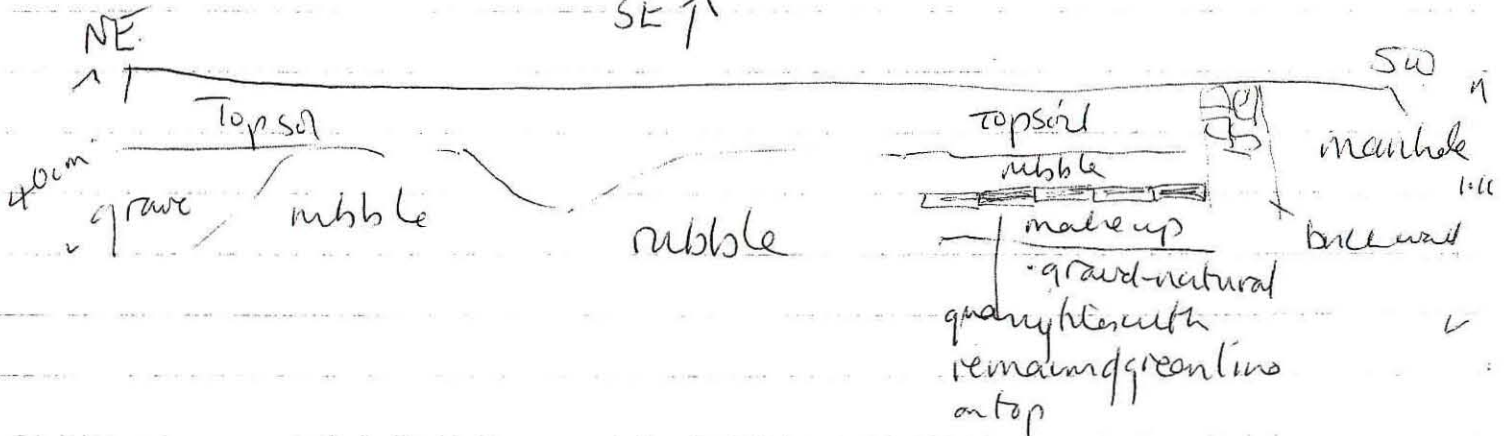
Garden  
 SE ↑

Trench appears to have cut through demolition rubble & floor of 'pre-fab' building constructed in the  
 ? early 20<sup>s</sup> - used by 'Albert Davis' - gardener  
 his home - he left in 1950s - demolished in 1960s
