Proposed extension to Llanrhos cemetery, Conwy

ARCHAEOLOGICAL ASSESSMENT

CPAT Report No 406.1

**N W Jones, R J Silvester,
A and M Roseveare
February 2001**

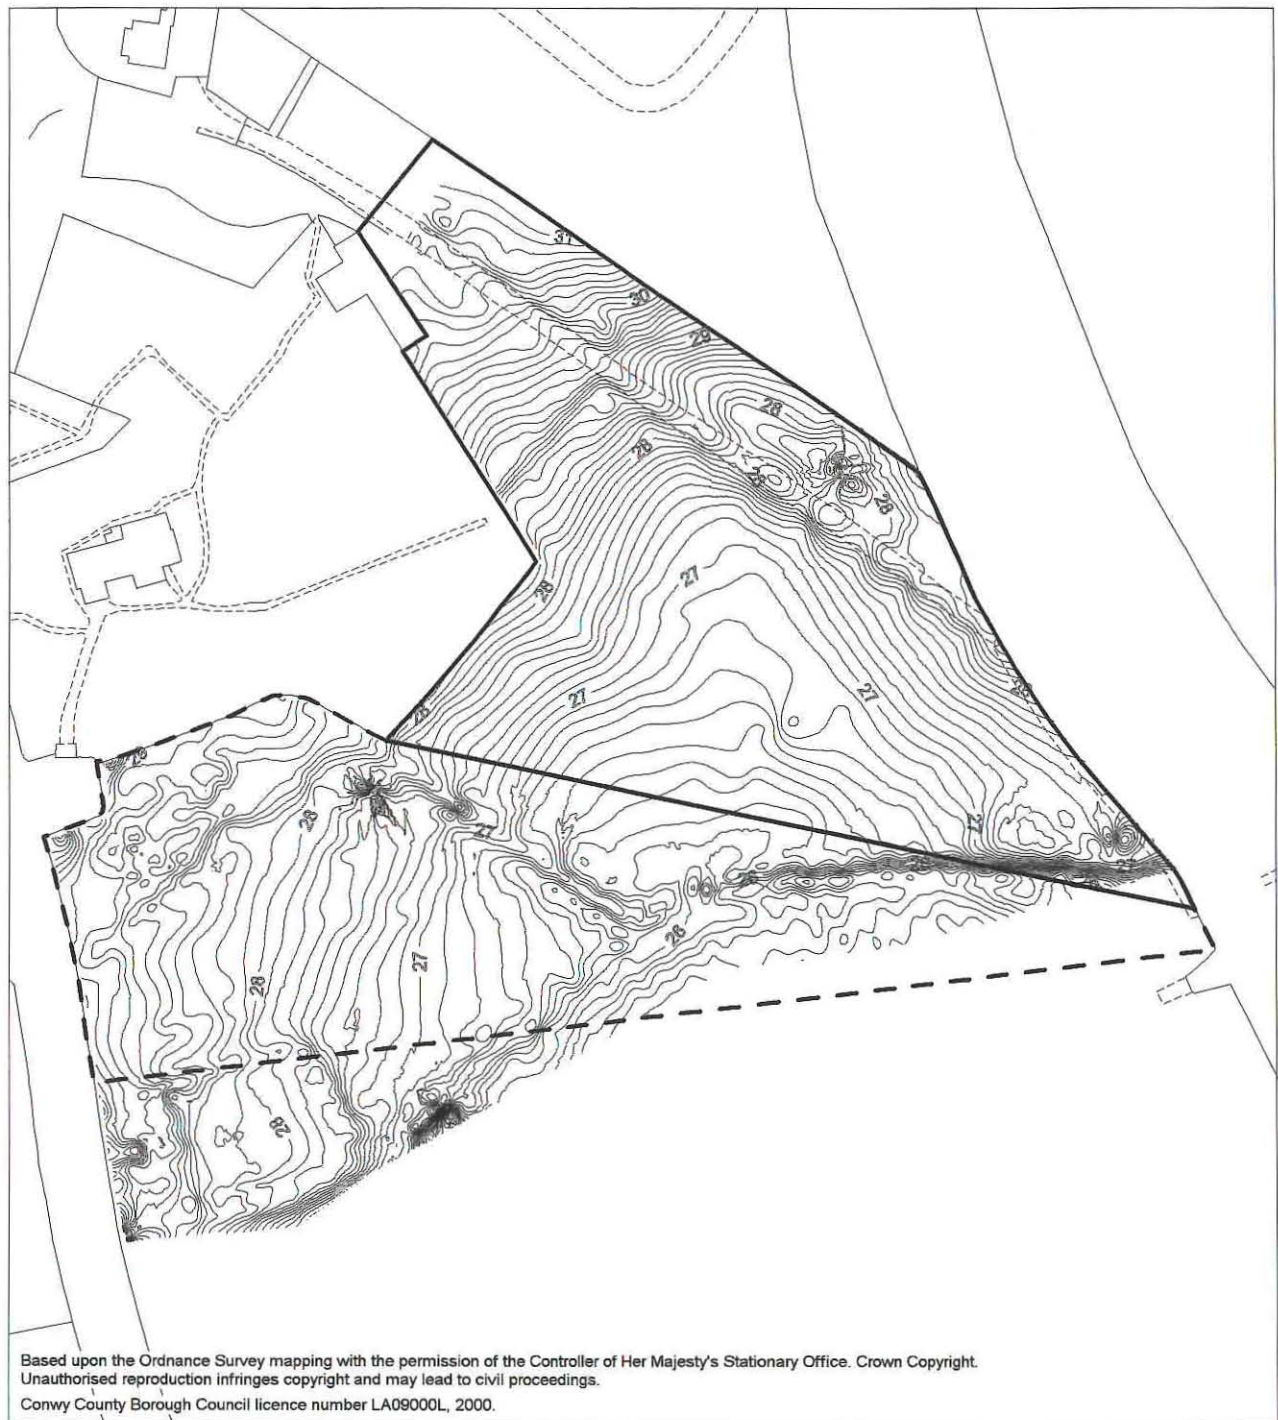
Fig. 7 Contour survey, scale 1:1,500

- 4.2 The results from the survey are presented in two forms: a contour survey (Fig. 7) at 100mm intervals related to Ordnance Datum, and a false relief plot (Fig. 8) which is particularly interesting as it identifies a number of features not evident from the contour plot.

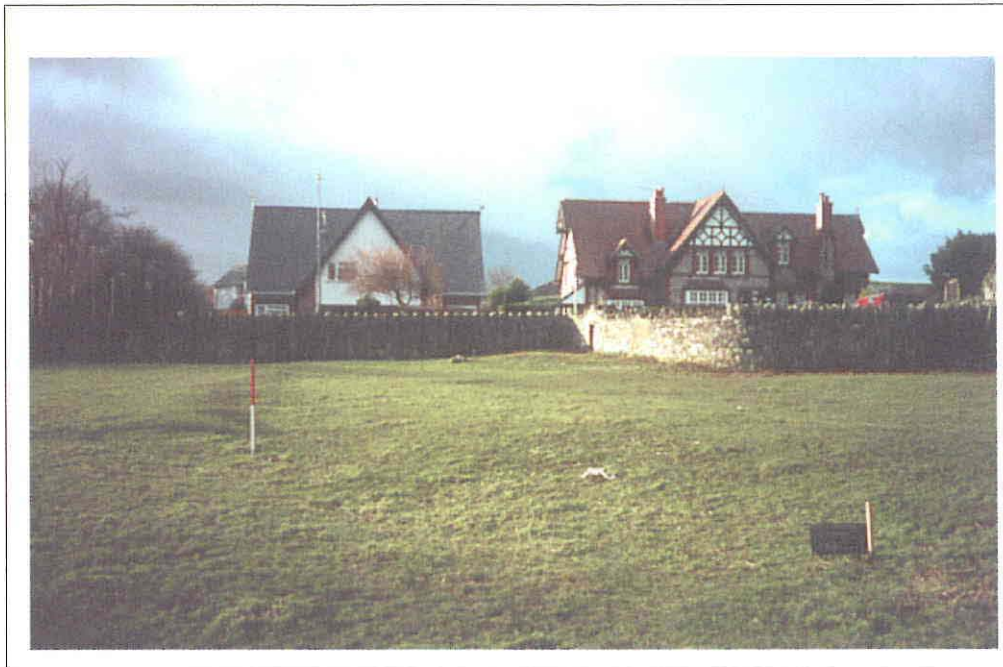
Plate 1 Earthwork remains of Glebe House PRN 12991

- 4.3 A confused set of earthworks mark the site of buildings immediately to the south of the present churchyard, presumably associated with the site of Glebe House and associated structures (see section 3.11), although it is difficult to identify individual buildings. There is, however, a broad platform standing 0.3m to 0.4m above the land to the south and extending as far as the churchyard to the north. Various small earthworks exist on this platform, notably a low (0.15m) and approximately circular mound, and there is also a suggestion that the platform may have been subdivided, as indicated by two broad indentations in the southern edge of the platform. Other small and less well-defined earthworks are assumed to be elements of a number of structures together with boundaries and a track which are depicted on the Tithe Map (Fig. 2). It is possible that the surviving earthworks may also relate in part to earlier settlement predating the Tithe Map, although this cannot be demonstrated.

PRN 12991 **Name:** Glebe House earthworks **NGR:** SH79348028
Type: Platform **Period:** Post medieval? **Form:** Earthwork **Condition:** Damaged
Source: Tithe Map 1840
 Earthwork survey
Dimensions: c. 60m long x 23m wide x 0.4m high
Description: Earthwork remains of Glebe House and associated buildings, consisting of a raised platform with low earthworks suggesting several buildings.
Category: C

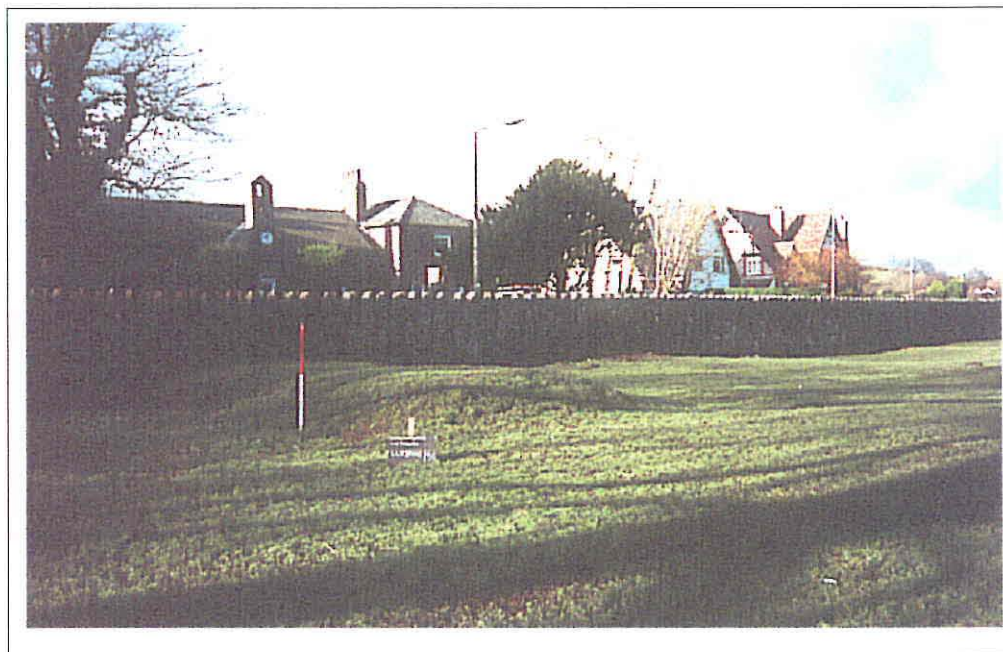
Plate 2 Earthwork remains of Mostyn Arms, PRN 12992

- 4.4 The Tithe Map and Ordnance Survey 1st edition (Figs 2 and 4) show two buildings forming the Mostyn Arms. From the surviving earthworks it is clear that the modern road has encroached on the western side of the site destroying part of the southern building and at least the west wall of the other. There is some exposed masonry concentrated towards the south-east corner of the complex, which seems to be a stub of stone wall, perhaps a jamb or corner. There are also fragments of brick visible in the turf but it is difficult to determine whether these are part of the public house or not as there are some firmly embedded fragments of concrete towards the south-east corner which may indicate that materials from elsewhere have been dumped on the site. The adjoining yard or enclosure to the east is well-defined and although the interior is featureless its appearance suggests that a yard surface may survive below the topsoil. The Ordnance Survey of 1889 (Fig. 4) shows two small structures at the south-east corner of the enclosure, and although these could not be identified as earthworks, some brick and rubble was visible.

PRN 12992 **Name:** Mostyn Arms earthworks **NGR:** SH79338020
Type: Platform **Period:** Post medieval? **Form:** Earthwork **Condition:** Damaged
Source: Tithe Map 1840
 OS 1st edition 1889
 Earthwork survey
Dimensions: c. 31m long x 14m wide x 0.4m high
Description: Earthwork remains of two buildings forming the Mostyn Arms public house, together with adjacent enclosure or yard measuring 34 x 31m, defined by banks 0.4m wide and 0.4m across.
Category: C

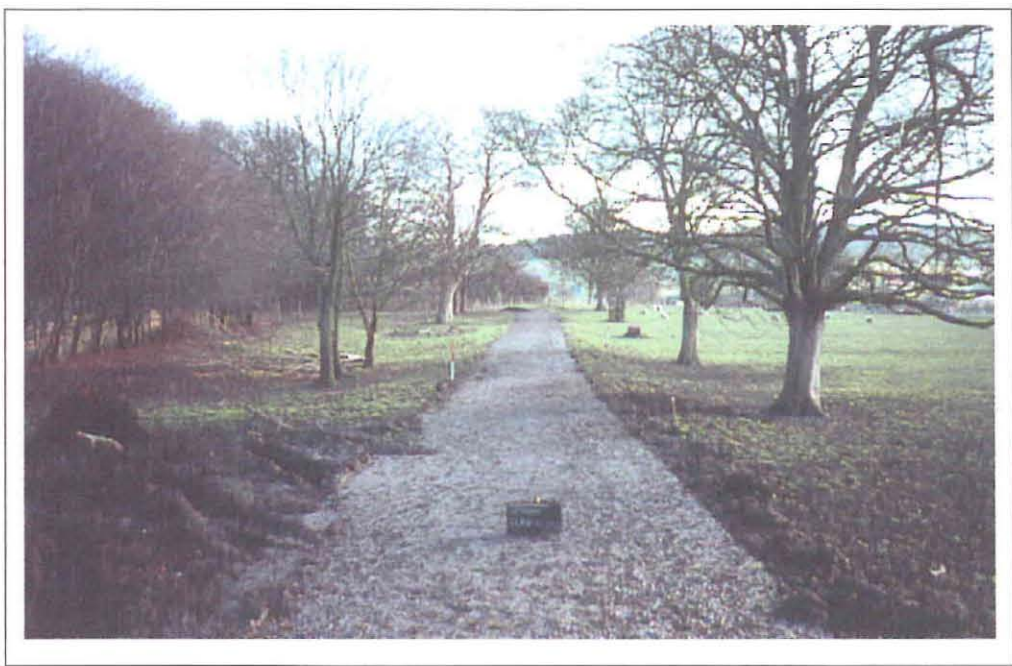
Plate 3 Former Estate Drive, PRN 12993

- 4.5 This feature is known to have been created by Lady Augusta Mostyn during the second half of the 19th century. The drive, which has a tarmac surface a little over 3m wide, was originally flanked by an avenue of trees, many of which are now missing. Aligned north-west to south-east the drive is scarped into the slope by approximately 0.3m at the north-west end but raised on an embankment as the ground falls to the south and east. The embankment profile is asymmetrical with a longer and steeper fall to the south-west, reflecting the topography. Beyond the survey area the drive has been lost beneath the new A470.

PRN 12993 **Name:** Gloddaeth Estate drive **NGR:** SH79458034
Type: Drive **Period:** 19th Century **Form:** Earthwork **Condition:** Damaged
Source: OS 1st edition 1889
 Earthwork survey
Dimensions: c. 3m wide x 0.3m high
Description: Former drive and avenue of trees associated with Gloddaeth Estate.
Category: C

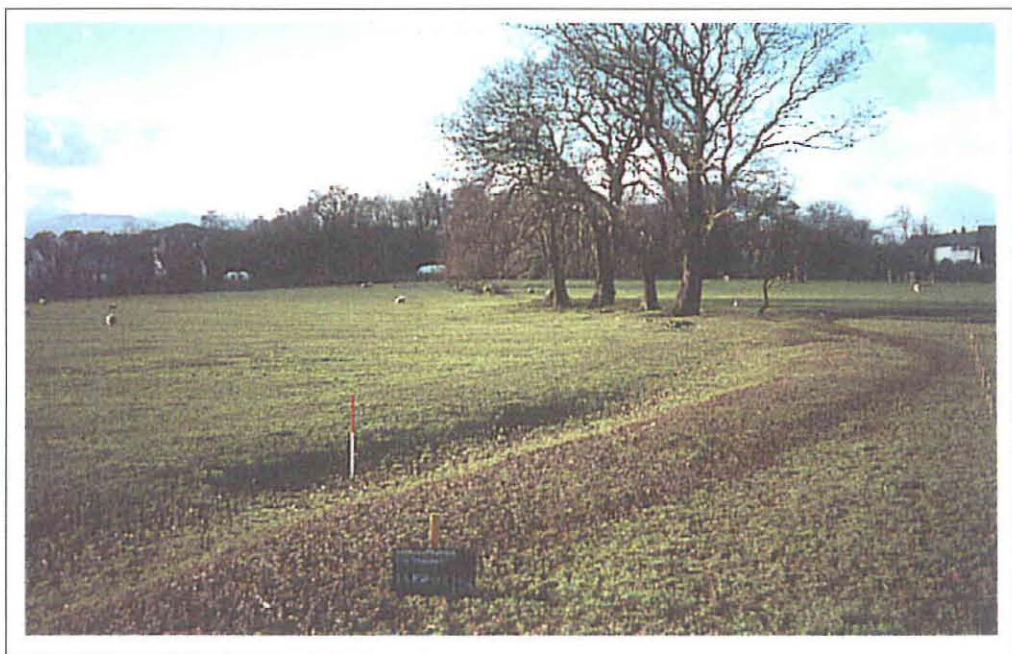
Plate 4 Earthwork remains of former field boundary, PRN 12996

PRN 12996 **Name:** Llanrhos boundary III **NGR:** SH79448025
Type: Field boundary **Period:** Medieval ? **Form:** Earthwork **Condition:** Damaged
Source: Tithe Map 1840
 OS 1st edition 1889
 Earthwork survey
Dimensions: up to 1.3m high
Description: Earthwork lynchet with possible ditch along S side and suggestion of revetment wall along eastern section.
Category: C
