**Evaluation of the Site of the East Garden &  
Associated Features at Powis Castle, Powys, Wales**

**Project PHL20001**

Prepared for the National Trust in Wales  
Copyright ArchaeoPhysica 2002

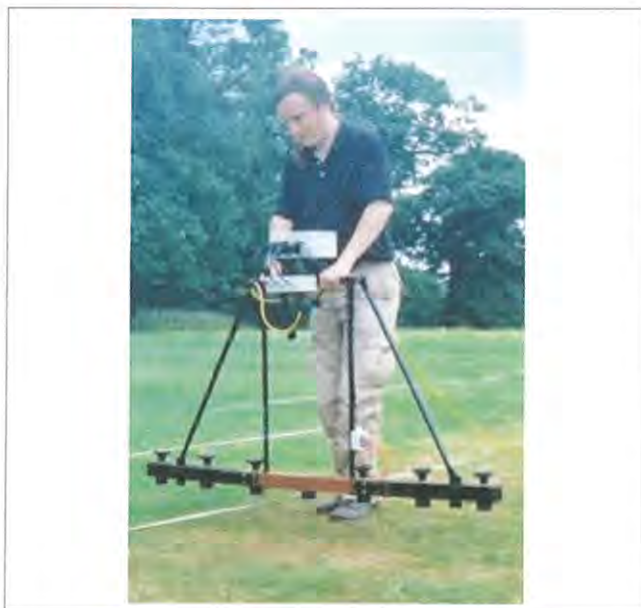
Figure 8 RM15 electrical resistance meter

- Instrument: Geoscan Research RM15 twin probe resistance meter, 0.5m mobile probe spacing, ~3m (variable) remote probe spacing and 1mA current injection
- Sampling: 1m station interval along lines 1m apart, data collected in 30m grids in a zigzag pattern

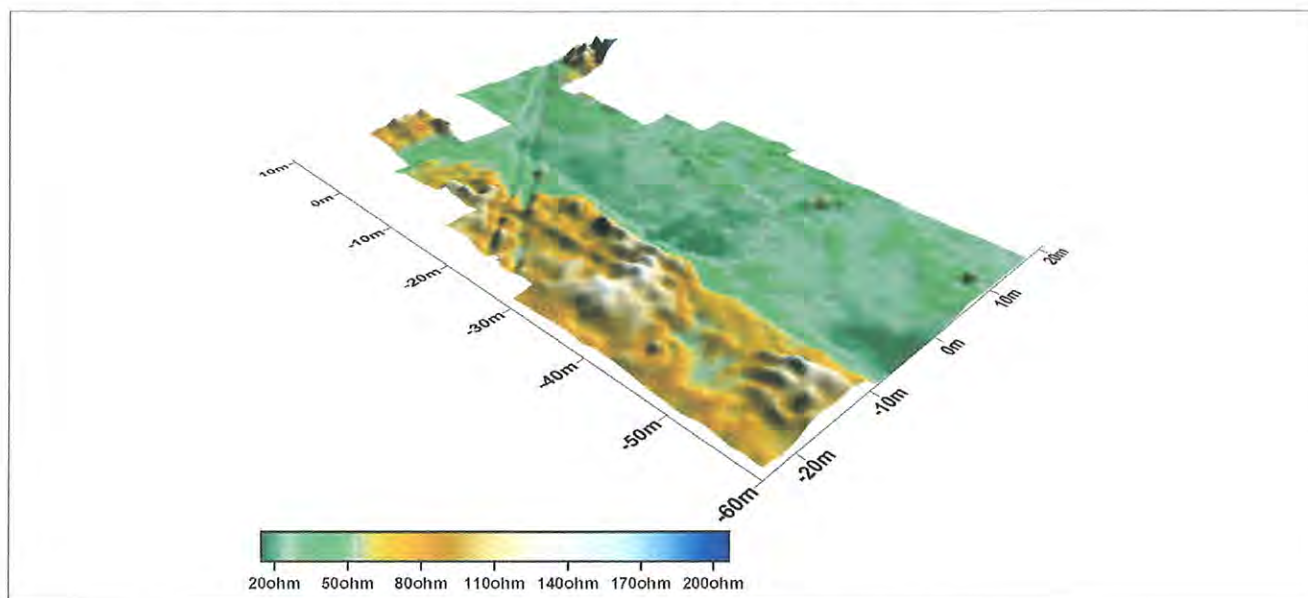
Figure 11 Perspective image of data from park survey

natural variations in the subsurface or are caused by very broad or deep features. In the parkland they seem to be concentrated against the Northeast edge of the high-resistance band running Southeast to Northwest. This may imply that they are related although it is difficult to qualify this from the data alone. This alignment is also shared, however, by the line of the Eastern approach to the castle and therefore this is probably the origin.

The area centred at (-3, -34) has a noticeably straight Northwestern edge which, although coincident with the join between two separate areas of survey, is too large a change in amplitude to be accounted for by this alone. This may therefore be related to the linear mildly resistive anomalies noted immediately to the Northeast in section 4.9.3.3.

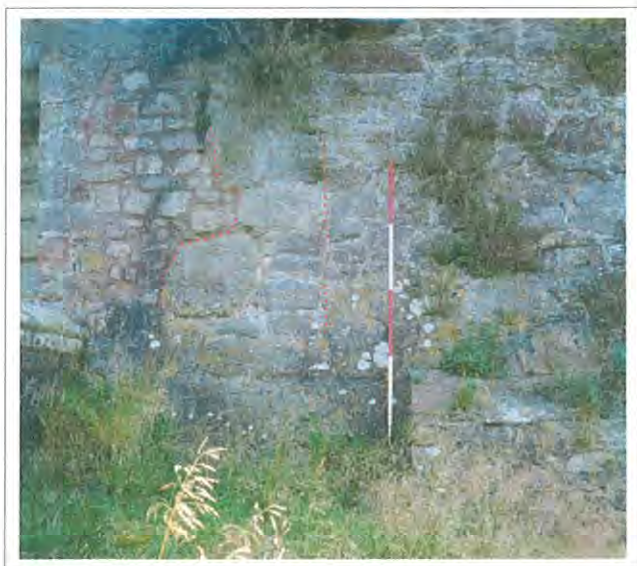
narrow track round the North side of the castle, hence the underpinning. The upper part of the wall is therefore the older part and must have risen from the ground old level previous to the construction of the track. This implies that at the South end where this older masonry extends further down the retaining wall, the old ground level must have been quite a bit lower. This observation does not reveal much about the development of the overall structure but if a medieval gatehouse existed it would have stood at this end and hence there may have been abrupt variations in the former ground level here.

Figure 12 The principal joints in the bowling green wall. Left is the edge of modern disturbance while right is the concealed butt joint

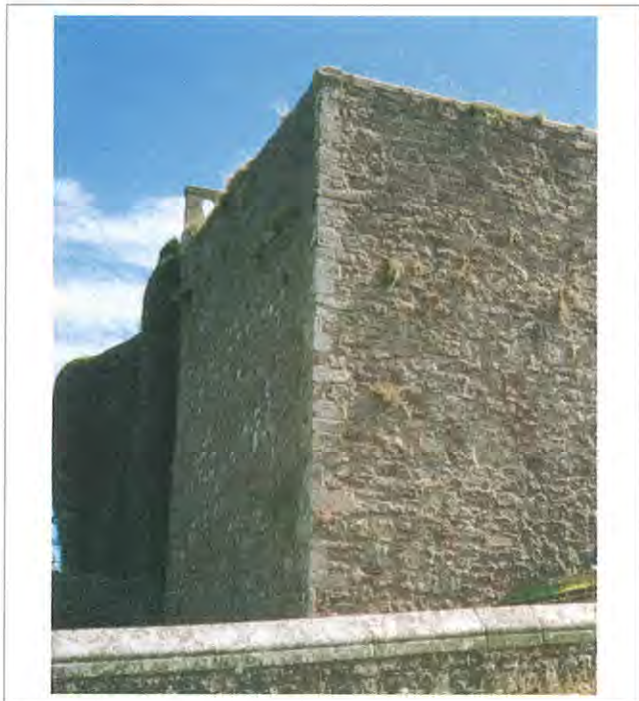
Figure 13 The rubble masonry and quoins of the extended High Terrace

The masonry of the original structure is tidily constructed with fairly large quoin stones at the corner whereas the extension has the appearance of being constructed from recycled masonry as there is a mixture of unsorted faced and non-faced stone of variable sizes, laid as a simple rubble bond. The quoins visible on its Southeastern and Northeastern corners are again of mixed stone, mostly squared rubble but with some fine-grained stone used only for dressings at Powis. These factors suggest that it is built from the rubble of demolished structures. It is tempting to suggest

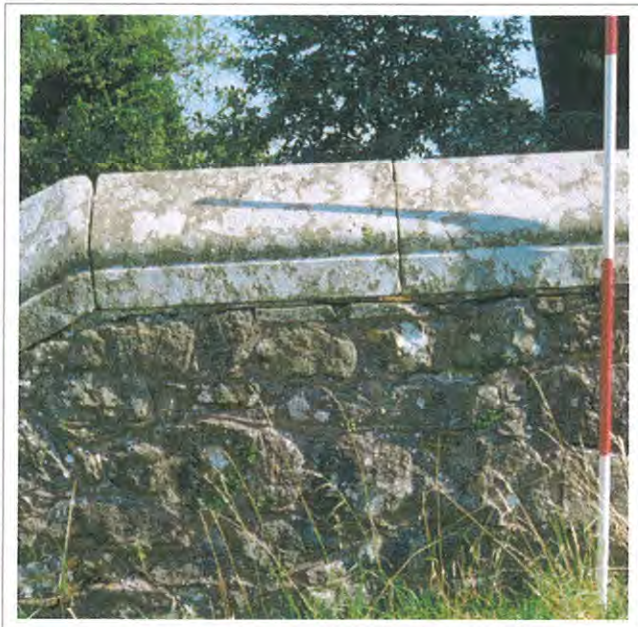
Figure 14 The masonry of the North wall of the stairs.  
Note that the coping has hardly eroded

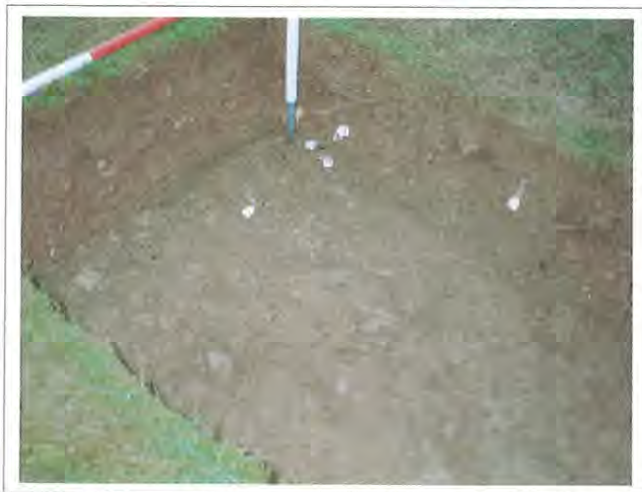
Trench 6 was cleaned down onto a compact horizontal compressed layer of soft shillet-like stone [25] sealed by the grey sandy material [22]. This was clearly an artificial surface so excavation

Figure 15 Surface [25] in trench 6

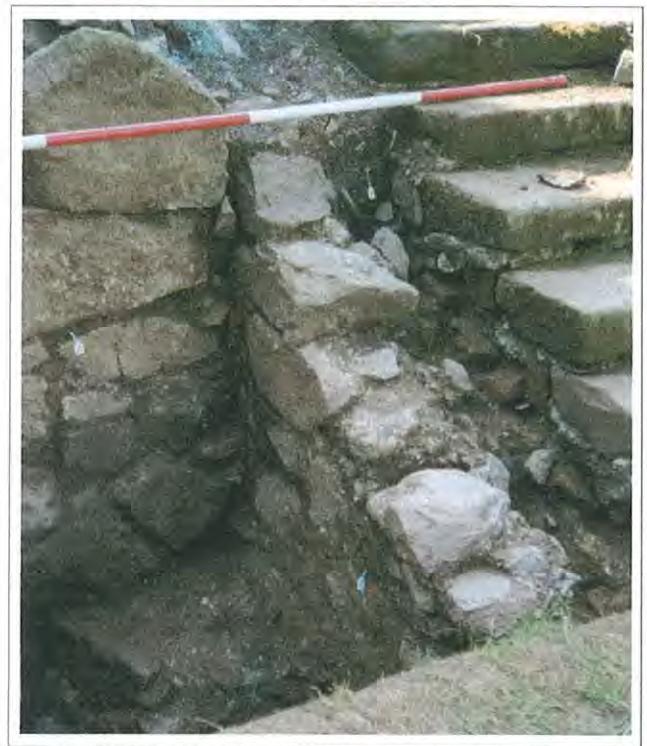
topsoil and turf that had encroached upon the treads of the stair. The large depth of soil seems to be an attempt to smooth the irregularities left by the truncation of the buried structures. Only a short section of the wall [33] projected from the face [32] of the terrace but sufficient remained to see that it had been altered at various stages, the last perhaps linked to the relaying of the treads. These were bedded upon a mixture of lime, soil and broken bricks [36] of the eighteenth century or earlier judging by their shape. Some were bedded in lime mortar that extended onto and into the robbed top of the wall suggesting that they were re-laid after the wall was truncated. Where this wall nears the top of the bottom flight a greenish ashy lime mortar continued from the lower wall [33] up onto the truncated masonry stub projecting from the wall [3] within the terrace. This would suggest that a later wall had stood upon both of these.

Figure 16 Terrace wall [32] butting stair wall [33]

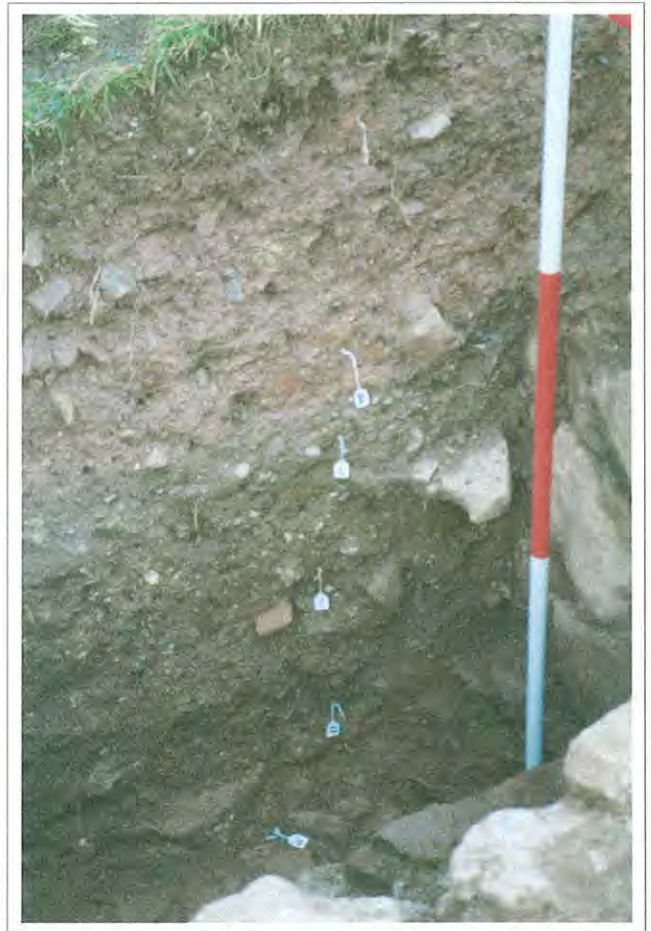
and occasional larger fragments of brick up to 0.1m long. Overall it is a poorly sorted friable material that powders to a dust when dry and is probably a mixture of building rubble and soil. Below this is context [10], a mid pinkish orange silty clay, completely different in colour and texture from deposits above and below it. Like [6] above, [10] contains numerous fragments of bone, pottery, glass, brick, lime, charcoal and shell. This again suggests rubbish dumping and lenses of red silt imply that it accumulated over time as a series of discrete events.

Figure 17 North-facing section of trench 1. Bands of dumped material overlay dark garden soil above the rubble at the bottom of the trench

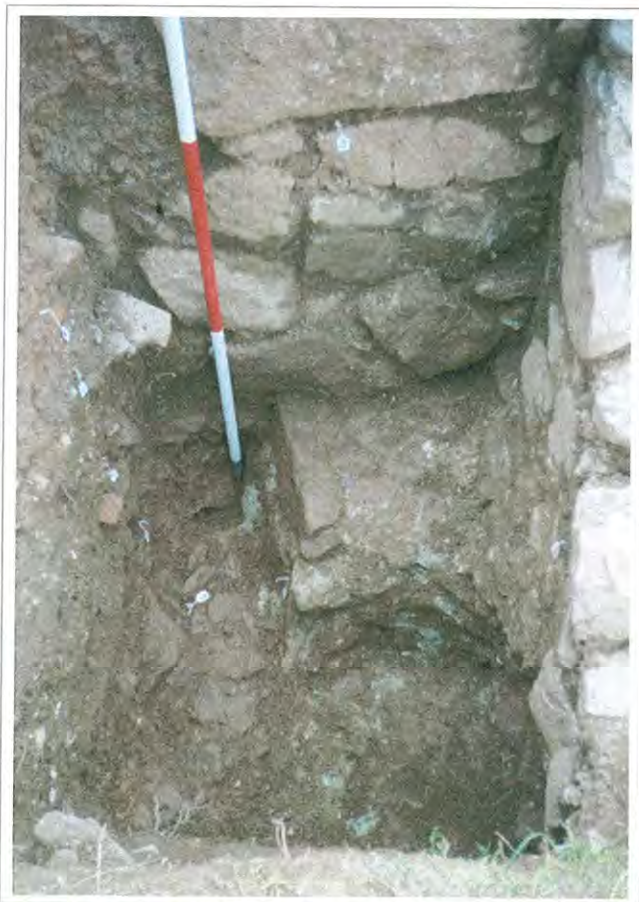
It is possible that masonry [31] is no more than a footing for the wall [33] against the stair because rubble [30] seems to continue beneath the masonry. [31] also appears to be slightly set into the rubble implying that deposit [34] may simply be the fill of a construction cut - it is very similar to the silty matrix of the rubble. The rubble itself lacks pottery which is unusual in this system of deposits and again suggests a different origin or phase of construction.

Figure 18 At the top is terrace wall [32] seated on masonry [31] below wall [33] to the right. Rubble [30] is just appearing in the base of the trench

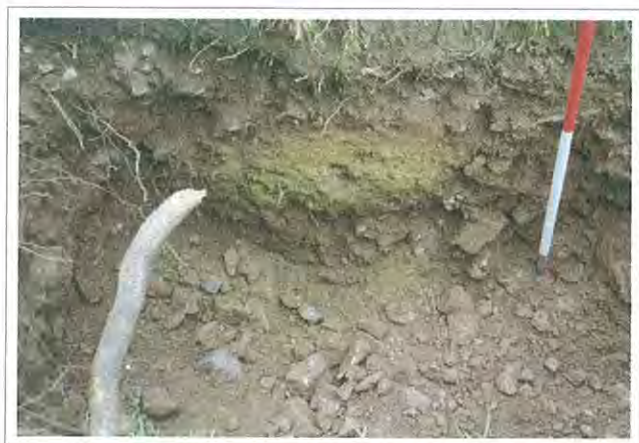
than this. The geophysical survey detected a substantial (over 60m long) very high resistance feature that trench 5 cuts into and this has been interpreted as an early terrace, implying the rubble to be the in-fill of this feature and fitting the geophysical result nicely.

Figure 19 Section through rubble in trench 5 with [39] to the left and [40] to the right in a cut [41] at right end of the yellow clay

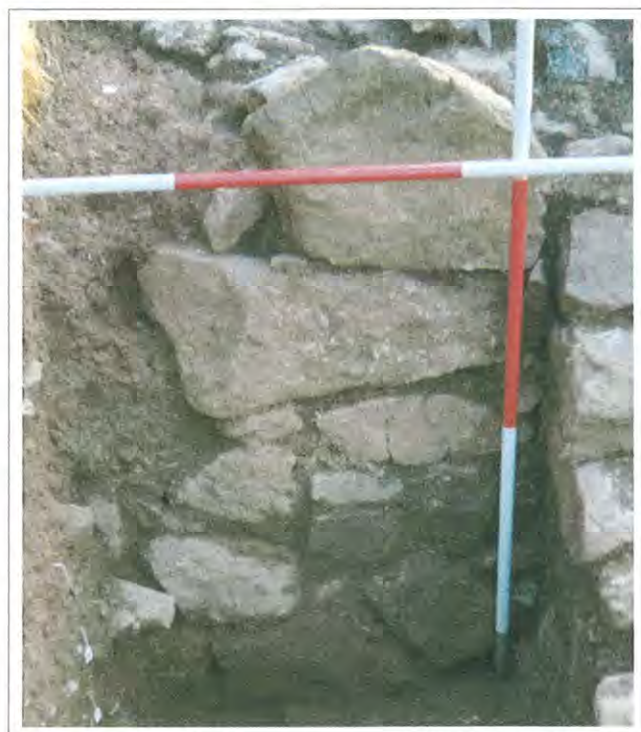
The butt joint between the end of the newer terrace wall [32] (built in front of deposit [8] and wall [3]) and wall [33] demonstrates that the terrace was widened after the wall flanking the stair was built, matching the assumption that the earlier terrace wall [3] is part of [33] at depth. The base of the terrace wall [32] rests on masonry feature [31] and upon the silt and rubble contexts [29], [34] and [30]. Above deposit [29] is a substantial depth of a well-sorted crumbly soil [21] with many small flecks of lime and a substantial accumulation of pottery. This would seem to have been a cultivated soil from its homogeneity and fine crumb structure, probably accumulated against the base of the terrace. The large quantity of pottery sherds is interesting, past gardeners may have used the area for dumping rubbish, perhaps beneath the bushes hinted at on Pritchard's plan of 1771 at the base of this terrace.

Figure 20 The full surviving height of terrace wall [32], showing the coarse masonry, damaged to the left during demolition. The butt joint against the stair wall [33] to the right is clear. The wall was probably only a little higher when built

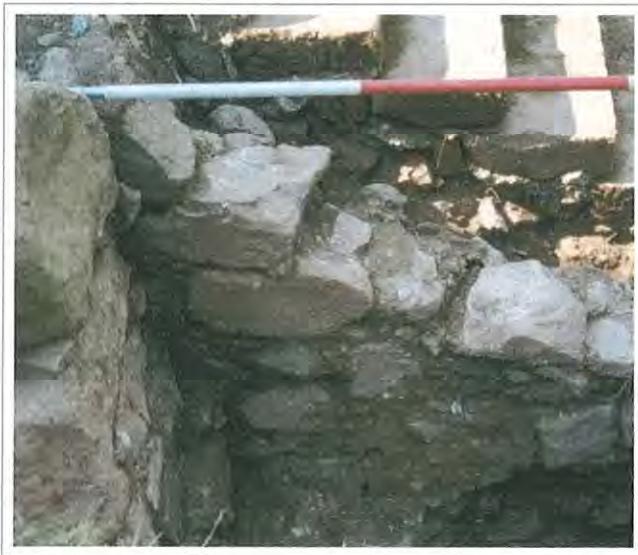
As noted in section 6.5.2, above, wall [33] flanking the South side of the stair seems to have been altered at its East end. This change in the masonry coincides with the cut [38] into the masonry feature [31] below it and deposit [21] seems to also to have been disturbed at this location as there is a looser pocket of material against wall [33]. This places the alteration to the wall after the widening of the terrace because deposit [21] butts against the later terrace wall [32]. It must also have happened before the eventual demolition of the wall because post-demolition deposits, e.g., [27] were not disturbed by the alteration. The anonymous plan of 1752 and Dineley in 1684 suggest that the walls flanking the stair were originally terminated with stone or even brick piers which were not found during excavation. It seems likely that the disturbance relates to the removal of these piers

Figure 21 The stair wall [33] with terrace [32] to left and treads [35] behind. The section to the right has been altered and the cut into its footings is visible at bottom right. In the shadows next to the stairs brick rubble and mortar can be seen under the stone treads
