CPAT Report No. 1434

Powis Castle East Front

Building Survey and Watching Brief

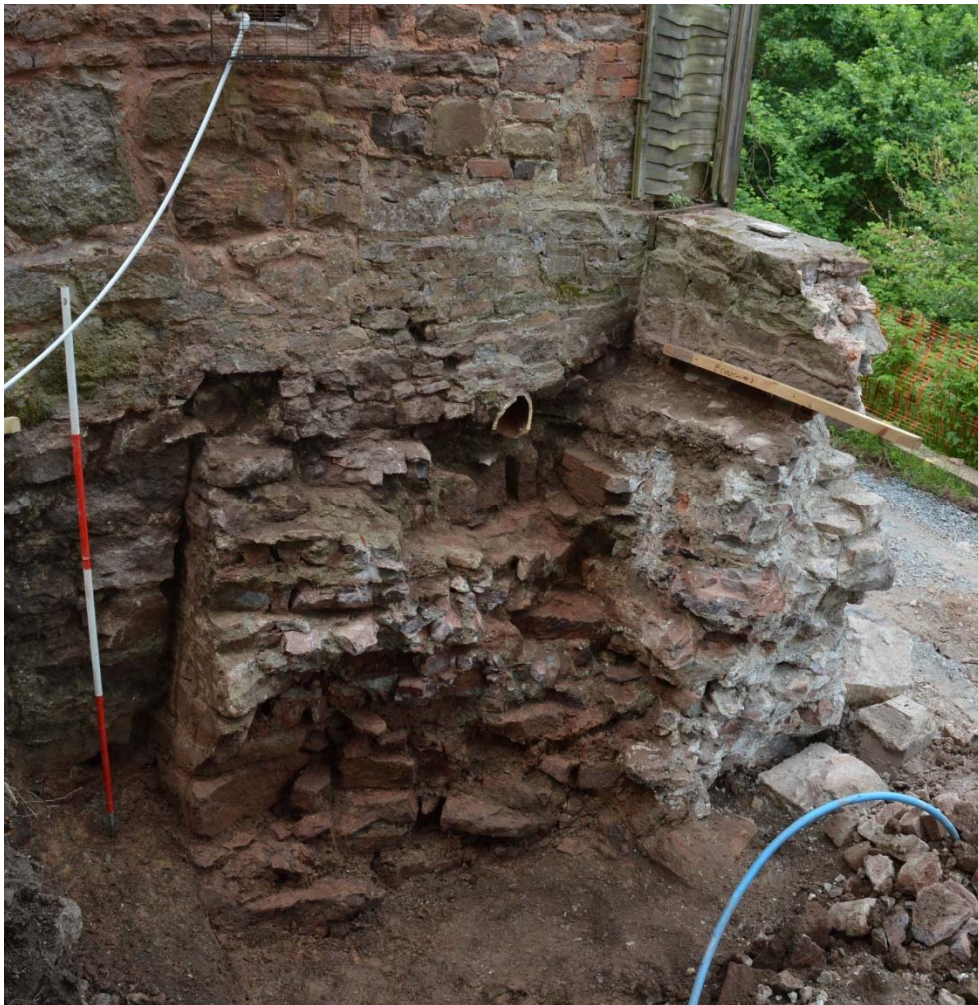
Cover photograph: North-east facing cross section through the curtain wall.

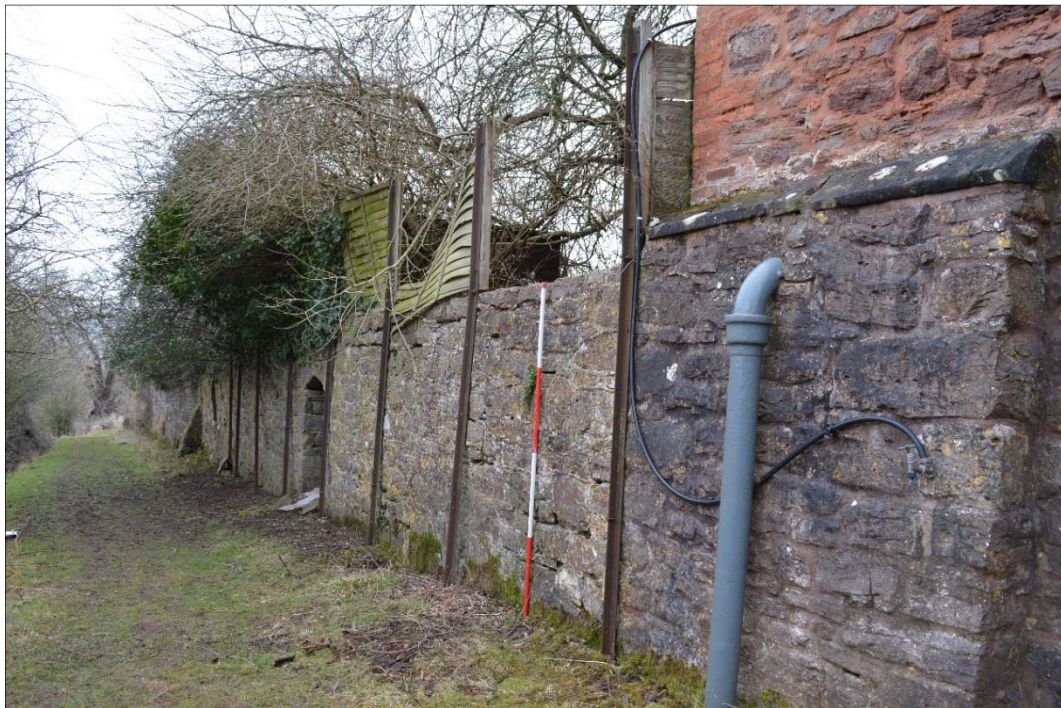
Fig. 3 The section of retaining wall recorded during the building survey.

- 3.1. Prior to the commencement of ground works a detailed drawn and photographic record was completed of the c. 7m-long section of retaining wall to be removed (Fig. 3). The length of wall recorded extended to beyond the recess to the north-east of the new access point.

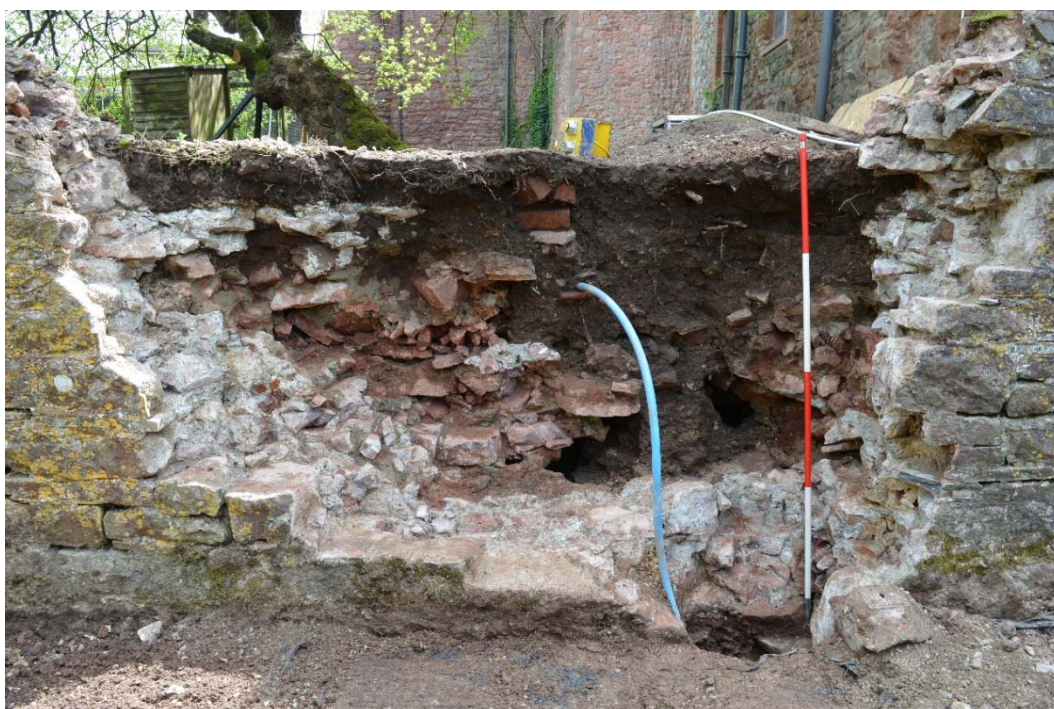
Fig. 4 The red conglomerate corework of the medieval curtain wall was gradually uncovered as the retaining wall was removed

- 4.1. The watching brief was conducted during the removal of a 7.5m-long section of retaining wall along the north-west side of the Old Bowling Green at the point where a new access was to be constructed. The work was undertaken between May 18th and June 7th 2016.
- 4.2. The retaining wall was removed by hand, using power tools, with the work being monitored on an intermittent basis, rather than as a detailed watching brief. At an early stage it became apparent that the remains of an earlier structure lay behind the retaining wall, although it was not possible to determine its significance until the 7.5m-long section of wall had been removed completely.

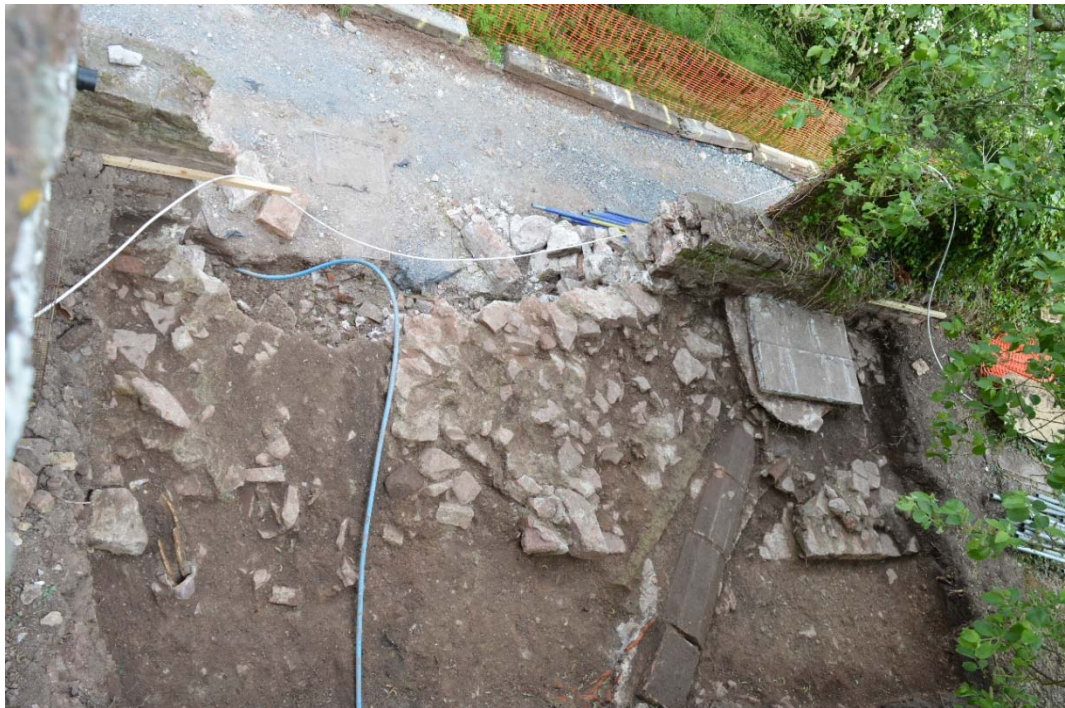
Fig. 5 The upper part of the medieval curtain wall showing recent disturbance by service trenches, viewed from the roof of the adjacent kitchen wing.

- 4.4. Removal of the topsoil (1) revealed the rubble core of the wall (3), the outer face of which had been removed, with the 18th-century retaining wall (4) being bonded directly onto the corework. It was also apparent that the area had seen significant modern disturbance, with the insertion of two substantial service trenches, one of which connected to an alcove in the retaining wall, immediately to the north-east of the section which had been removed.

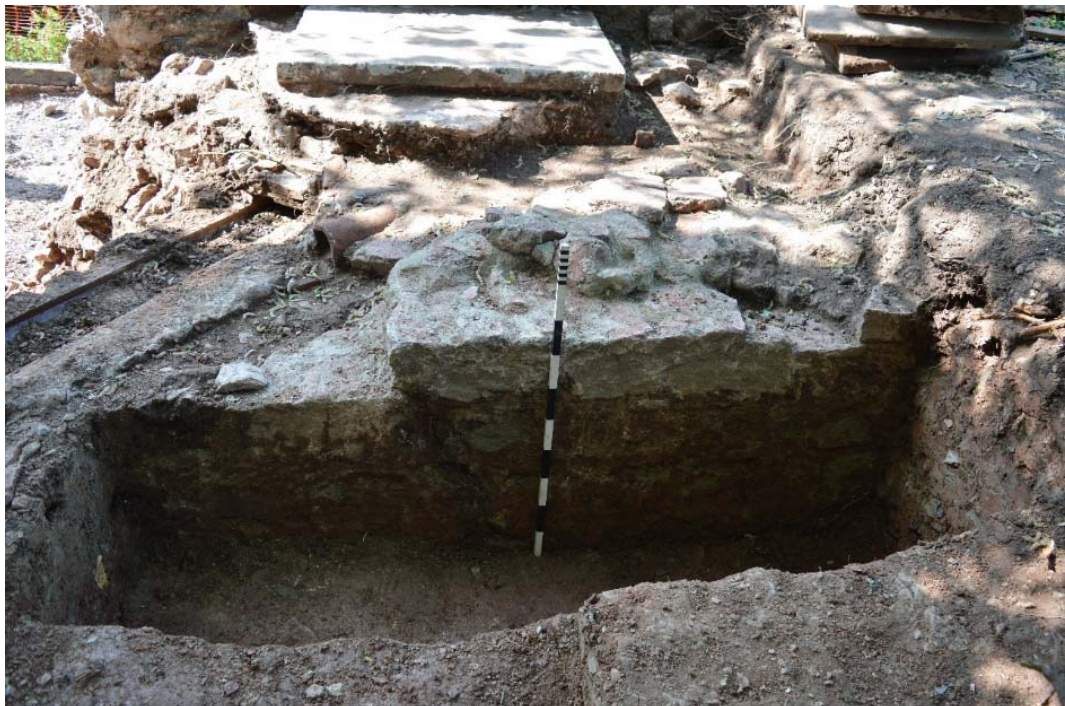
Fig. 6 View from the south-east showing the upper part of the internal facing of the medieval curtain wall

- 4.8. The internal face was relatively well preserved and was built from dressed, close-bonded conglomerate blocks laid in rough courses, with a slight batter of around 0.2m between the top and bottom of the wall, surviving to a height of approximately 1.8m. The corework consisted of lime-mortared conglomerate rubble.

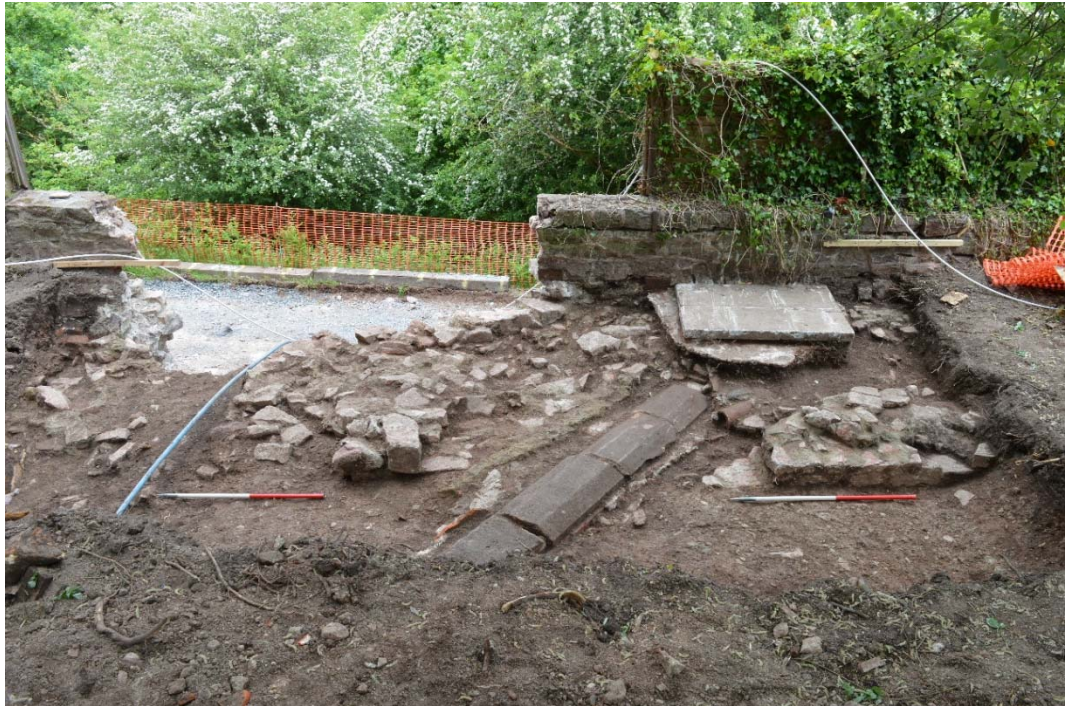
Fig. 7 The top of the medieval curtain wall, viewed from the south-east

- 4.7. The medieval wall survived to a width of up to 1.95m, having been truncated by the later retaining wall. However, assuming that the external face would have been in approximately the same position as the retaining wall the original width would have been around 3.0m.

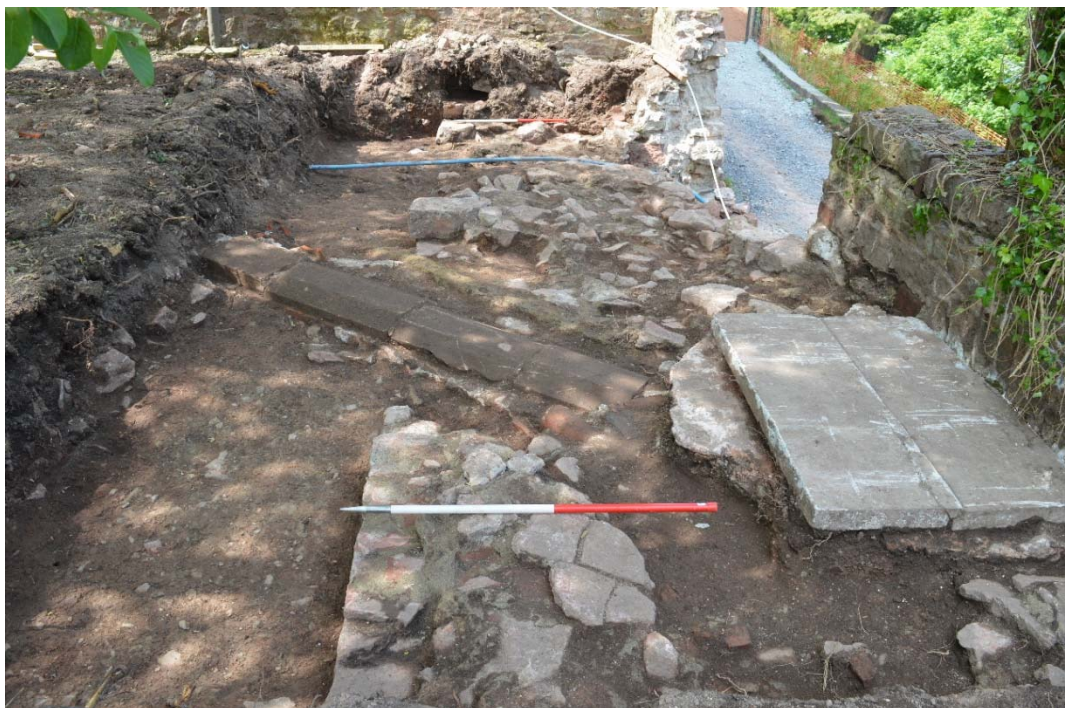
Fig. 8 The top of the medieval curtain wall, viewed from the north-east

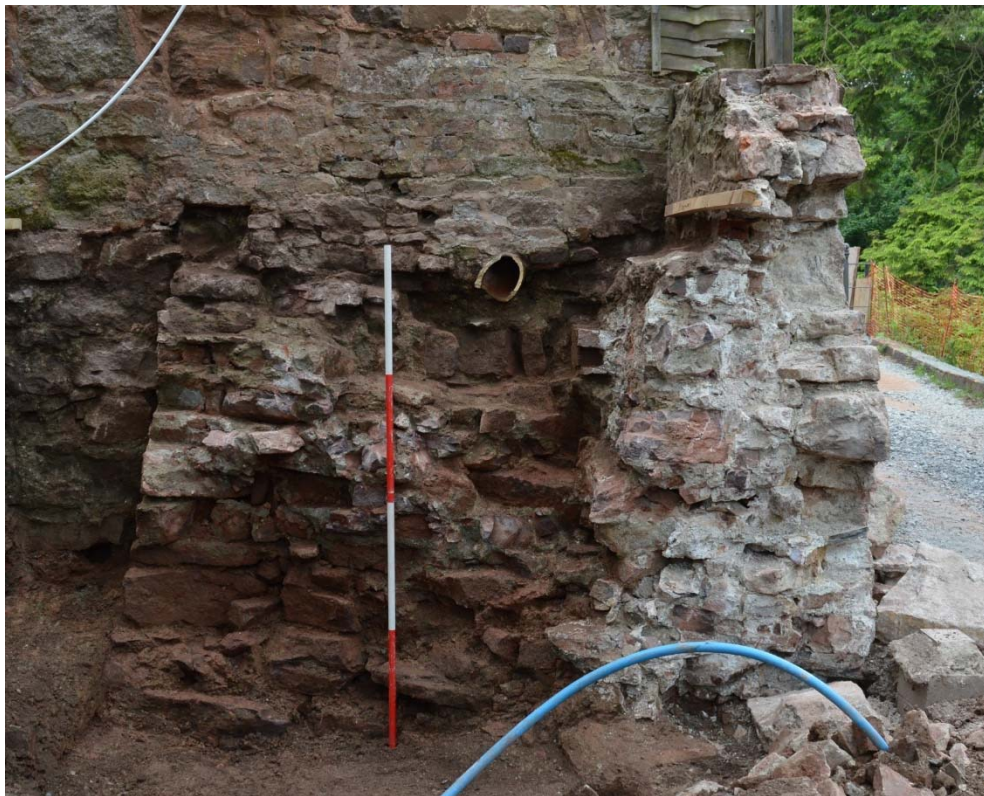
Fig. 9 North-east facing section through the medieval curtain wall

- 4.10. Natural soils were revealed at a depth of approximately 2m below the level of the internal ground surface, although the interface between the natural deposition and the landscaping deposit (15) was quite diffuse and not clearly delineated. There was no obvious evidence for a medieval ground surface which would have been contemporary with the wall.

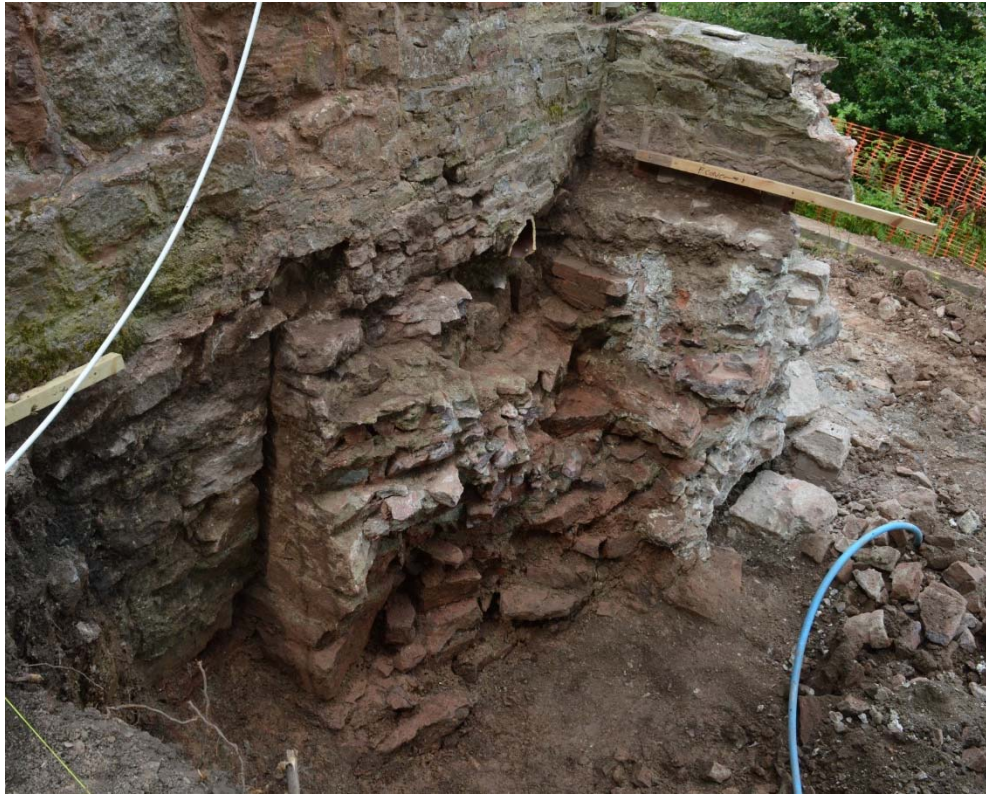
Fig. 10 The medieval curtain wall, showing the butt-joint with the 18th-century kitchen wing

- 4.9. It was evident that the curtain wall continued beneath the 18th-century kitchen wing, the foundations of which were butted against the inner face of the wall (Fig. 10).

- 5.5. The medieval wall continued beneath the 18th-century kitchen wing of the castle, the foundations of which had been butted against it, and extended further to the north-east, presumably continuing around the circuit of the former bailey.

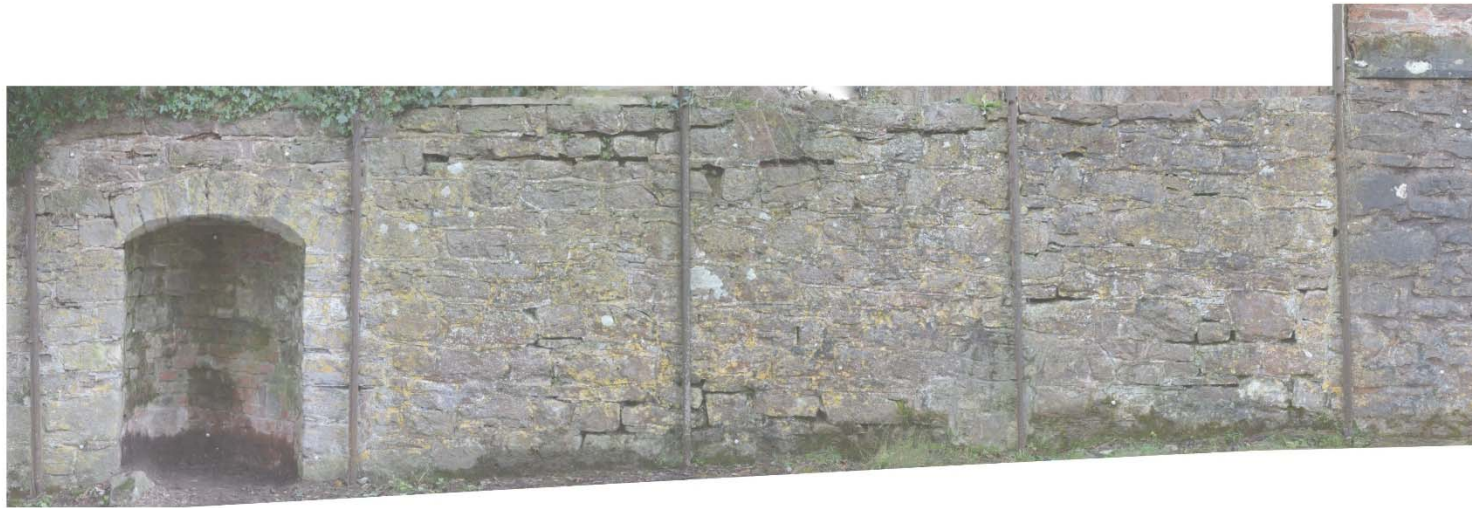
Fig. 11 Rectified photograph and stone-for-stone survey of the section of retaining wall on the north-western side of the Old Bowling Green

- a stone-for-stone elevation drawing of the section in question.
- 3.3. The survey was conducted using a combination of total station surveying and rectified photography to produce the stone-for-stone elevation (Fig. 11). Although not affected by the current works, the survey also included the small alcove which is immediately adjacent to the section of wall removed during the watching brief.
