*Survey Commissioned
by
The National Trust Wales Archaeologist
Office*

*Surveyed
by
I.P. Brooks
Engineering Archaeological Services Ltd*

*The Brecon Beacons Survey
2011 Interim Report*

EAS Client Report 2011/01

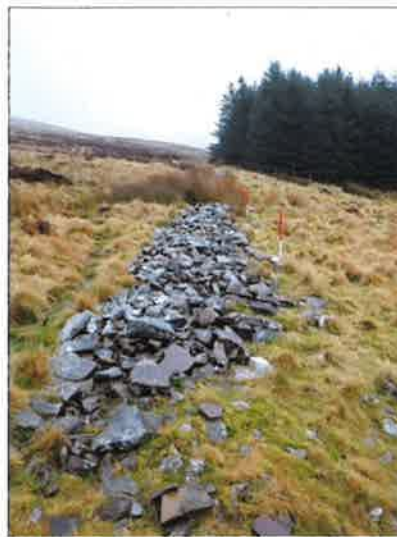
Summary: Collapsed dry stone wall

Description: A collapsed dry stone wall running north west to south east on the lower slopes of Y Gyrn. Consisting largely of a linear spread of stones 1.3 m wide and up to 0.3 m high. Constructed of relatively small slabs of local stone in the size range 150 - 350 mm. The wall is better preserved to the NE with several courses surviving, standing to a height of 0.5 m. Possibly part of the field system associated with the Storey Arms.

Recommendations: Maintain in current condition

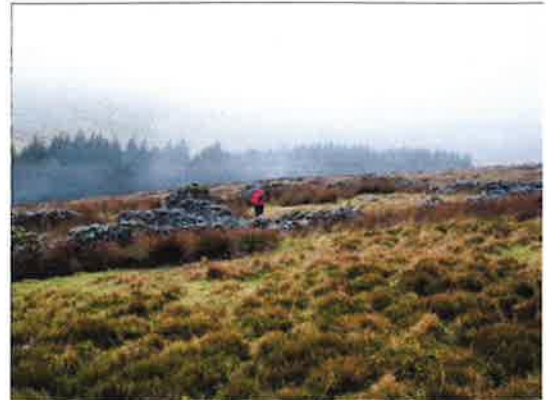
Description: A large rectangular sheepfold divided into two main enclosures with two small pens between the two and a possible third pen in the NW corner of one of the main enclosures. Constructed of dry stone walling up to 1.4 m high and 1.10 m wide. The north west enclosure is approx. 10 x 12 m in size, the central pens 2.4 m wide and the SE enclosure 20 x 12 m. There is also a guide wall leading to the central opening.

Condition: fair

Stability: slow deterioration

Recommendations: Maintain in current condition. There are two modern hearths within the enclosures, discourage the construction of new hearths

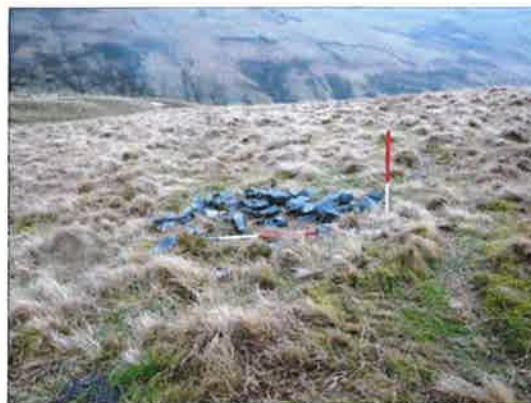
Description: A low, roughly circular pile of stones covering an area 2.3 x 1.8 m in size and reaching a height of 0.3 m. Some of the stones appear to be earth fast.

Condition: fair

Recommendations: Maintain in current condition.

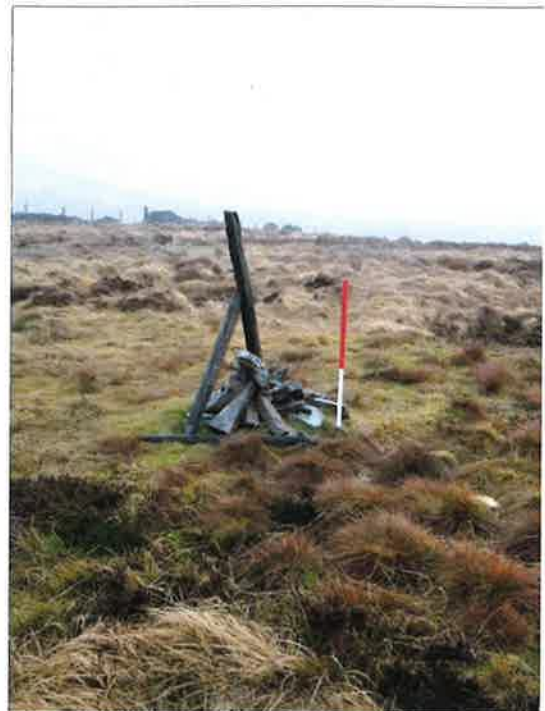
Description: An old fence post re-set in a small pile of stones. Possibly a modern way marker. Located on the northern end of the Y Gyrn Plateau.

Condition: good

Recommendations: Maintain in current condition

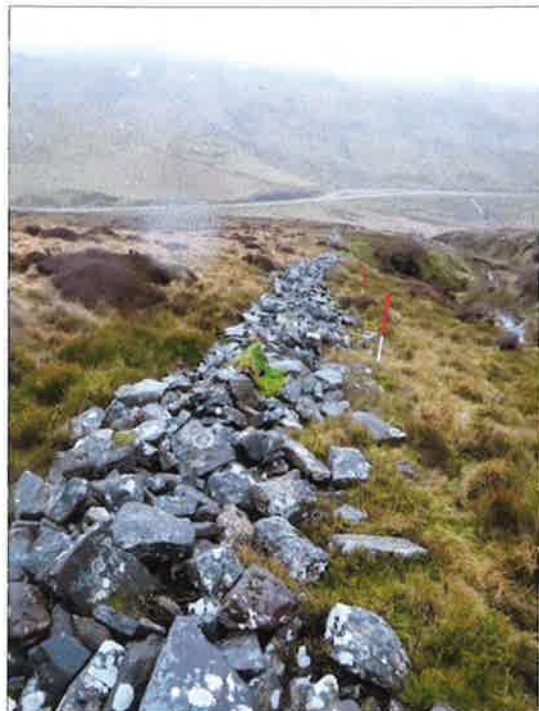
Description: A tumbled dry stone wall with a spread of 1.5 m, surviving to a height of up to 0.5 m. Constructed of local stone blocks it runs approximately E - W between Wall 860226 and the SW boundary of the property. It roughly follows the line of a stream with a series of right angle bends that have previously been interpreted as evidence for an enclosure, although no evidence of linking walls survive.

Condition: poor

Recommendations: Maintain in current condition

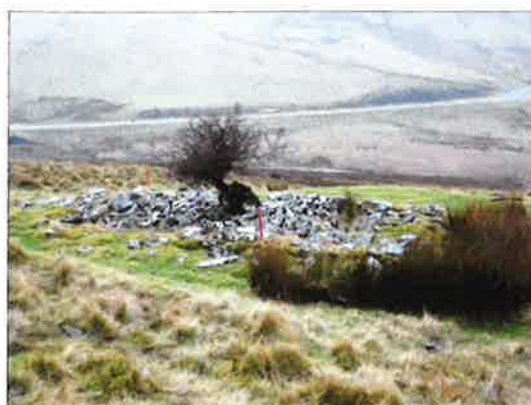
Description: Small, two roomed hut surviving as very low, tumbled, dry stone walls defining an area of approximately 7 x 6 m. The distribution of tumbled stone suggest the building had stone gables with a possible chimney on the SE gable. Walls 0.80 m thick; surviving to a height of 0.5 m in places. The presence of squared stone blocks suggest these were used as lintels. Some post-medieval pottery noted in local mole-hills.

Condition: fair

Recommendations: Maintain in current condition

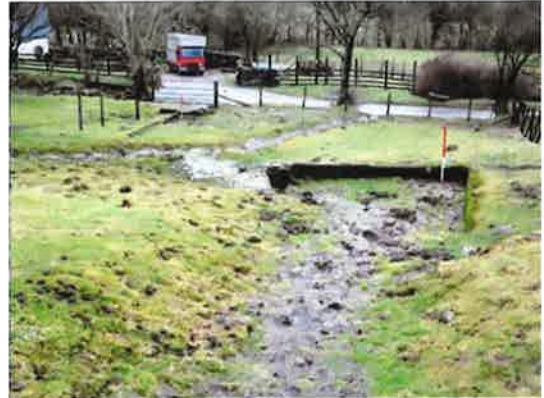
Description: Remains of a square concrete tank 2.6 x 3.2 m in size with a leat running towards Blaen Glyn Farm. The leat is partly line with a concrete pipe and partly an iron trough. The leat leads to a dry stone walled structure with a concrete slab top, 3 x 2 m in size and 0.7 m high, which may be another tank. A circular tank at the top of the field probably relates to this feature

Condition: poor

Threats to Site: Water erosion, potential for stock damage and collapse of dry stone structure

Recommendations: Monitor condition

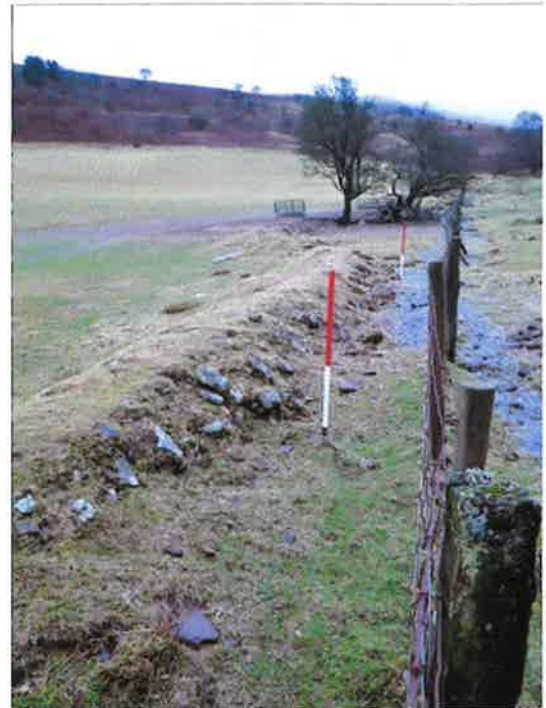
Description: A low stony bank, 1.5 m wide and 0.5 m high with a sinuous plan roughly running SE to NW. At its SE end it turns to the NE roughly following the modern field boundary. Although it clearly contains a core of stone the bank is largely turf covered. It probably originally had a hedge on top of the bank, but no longer serves as a field boundary, having been replaced with a post and wire fence. The upper section of the bank probably also served to channel water away from the field.

Condition: poor

Threats to Site: Feeding station close to bank resulting in some stock damage

Recommendations: Move feeding station away from bank, maintain in current condition

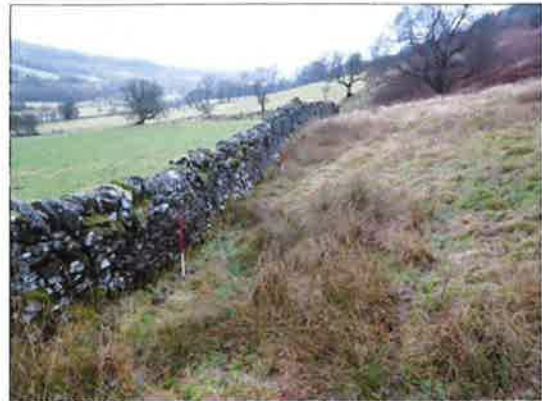
Description: Dry stone wall constructed from local sandstone slabs with larger boulders at foundation level. Survives to its full height of 1.7 m with intact coping for much of its length. Serves as a boundary today.

Condition: good

Recommendations: Maintain in current condition

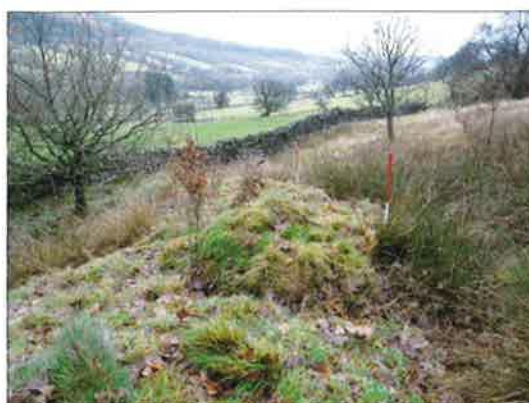
Description: An arching earth and stone bank forming a roughly triangular enclosure in the SW corner of the field above wall 860234. The bank is 3 m wide and stands to a height of 0.3 - 0.4 m with a slight ditch on its eastern side. Truncated by a farm track at its south end. Function unknown.

Condition: fair

Recommendations: Maintain in current condition

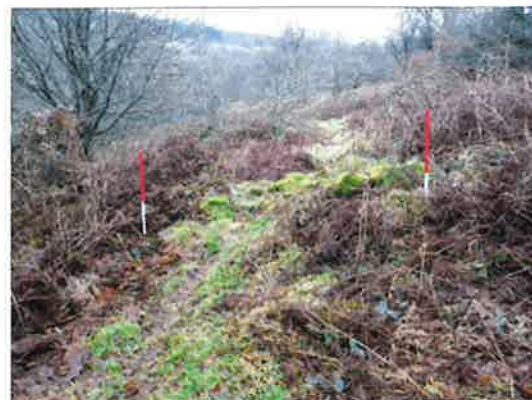
Summary: Tumbled dry stone wall

Description: The tumbled remains of a dry stone wall running E - W between the fields of Blaen Glyn Farm and Carno Wood Quarry. 0.8 m wide and surviving up to 0.4 m high in places. The wall was constructed of local sandstone slabs now much tumbled, moss covered and hidden in dense scrub.

Condition: poor

Recommendations: Maintain in current condition

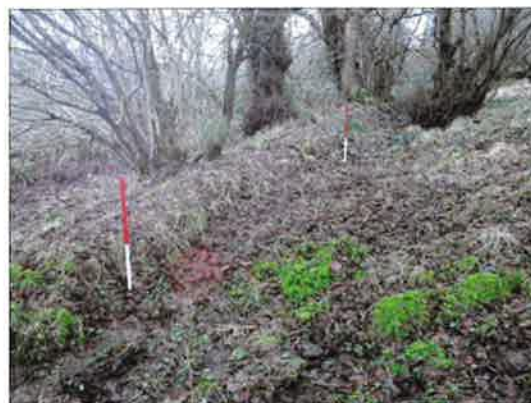
Summary: Small enclosure bounded by an earth and stone bank.

Description: A small enclosure approximately 62 x 32 m in size formed by a low curving bank and ditch in NW corner of a field adjacent to Carno Wood. The bank is 1.5 m wide and up to 0.6 m high with a slight ditch on its up hill side. Mature trees growing on top of bank.

Recommendations: Maintain in current condition

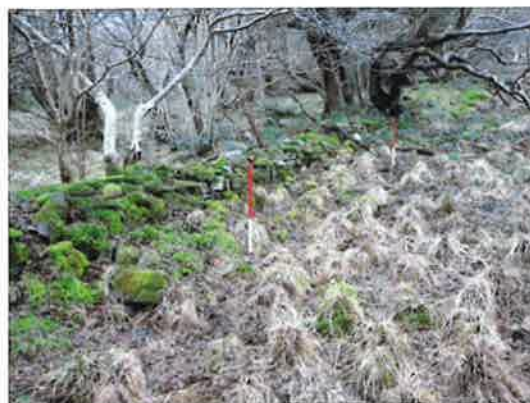
Summary: Dry stone wall

Description: A dry stone wall forming the southern boundary of Carno Wood, 1 m wide, surviving to 0.4 m high, collapsed in places. Constructed from local sandstone slabs.

Recommendations: Maintain in current condition

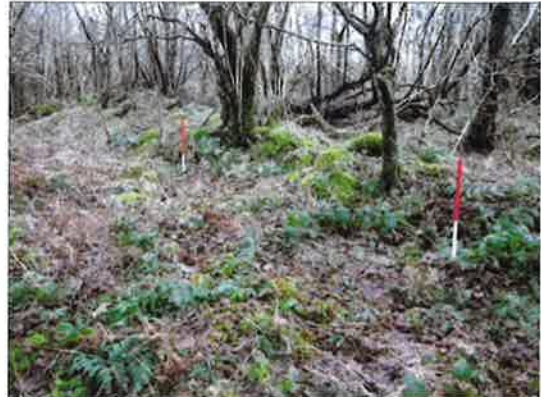
Description: A stony bank running SE - NW through Carno Wood, in places appearing as wall like. 1.4 m wide and up to 1 m high in places, but very collapsed in places and moss covered. No longer functioning as a boundary.

Condition: poor

Recommendations: Maintain in current condition

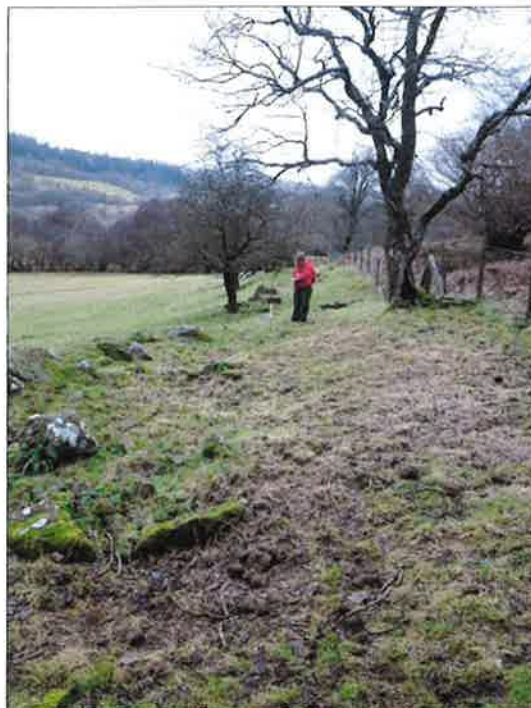
Description: Earth and stone bank running NNE - SSW along the eastern edge of the improved fields immediately south of Carno Wood. The bank generally has sloping sides with a rounded top, but incorporates some notably large, positioned, upright slabs. Mature trees grow on top of the bank. The bank is 1.5 m wide and between 0.3 and 0.4 m high. Stone slabs have an average size of 1.3 x 0.6 x 0.4 m. Towards the SW end the bank tends to be more of a revetted stone bank.

Condition: fair

Threats to Site: Potential for stock damage, also damage from falling trees.

Recommendations: Maintain in current condition

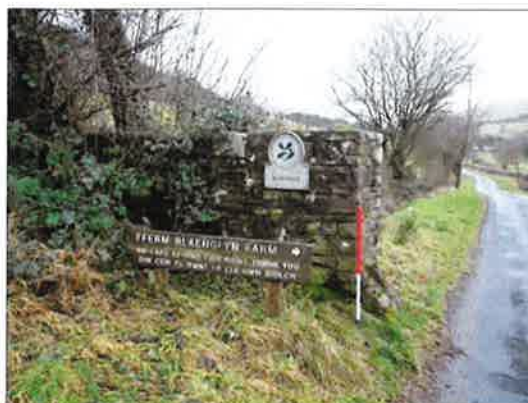
Description: A short length of mortared stone wall adjacent to the access road to Blaen Glyn Farm, carrying the Blaen Gwyn NT sign. 0.6 m wide and up to 1.6 m high the wall is on the same alignment as 860238. A modern rebuild adjacent to the road.

Condition: good

Recommendations: Maintain in current condition

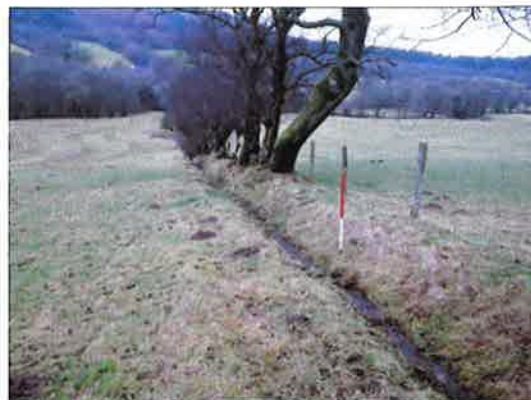
Summary: Earth bank

Description: An earthen bank, 1.2m wide and 0.4 m high along the northern boundary of Blaen Glyn Farm. The bank has sloping sides and a rounded top. Mature trees grow on top of the bank which still acts as a boundary, having a post and wire fence along the top. There is a slight ditch along the south side.

Recommendations: Maintain in current condition

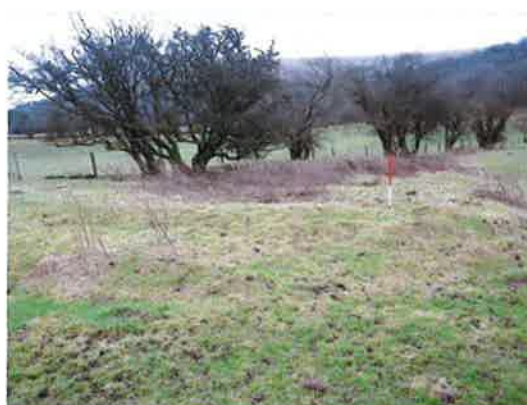
Description: A 6 m square platform sitting on a large raised triangular, platform 20 x 24 m in size. The structure platform is defined by a very low bank to the east and west and a slight scarp to the north. There is also a turf covered bank 12 m long, 2 m wide and up to 0.6 m high to the NE of there structure platform.

Condition: fair

Recommendations: Exclude from any ploughing in the field

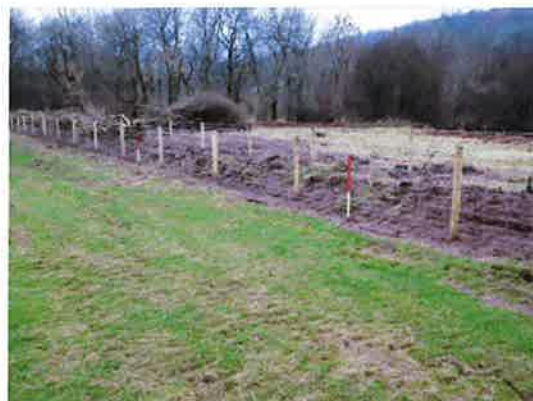
Summary: Earth and stone bank

Description: An earth and stone bank, 1.6 m wide and up to 0.7 m high acting as a field boundary. The bank has been recently remodelled and a hedge on to re-instated. A large pile of recently excavated stones close to a gate suggests that the existing gateway has been widened.

Recommendations: Maintain in current condition

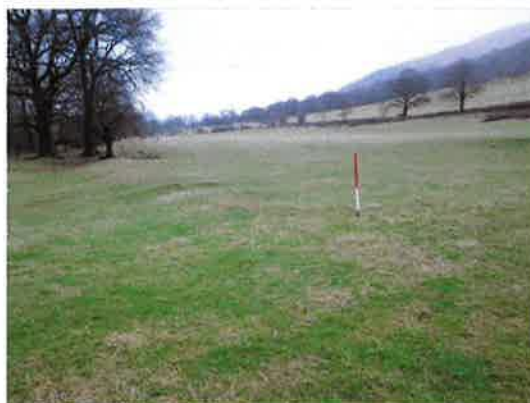
Summary: Low earthen bank

Description: A low bank defining the original SW corner of one of the improved fields now divided by a post and wire fence. The bank is low and spread through land improvement, but nevertheless is visible. 2.9 m wide with a max height of 0.3m. A continuation of 860244.

Condition: poor

Recommendations: Avoid ploughing if possible

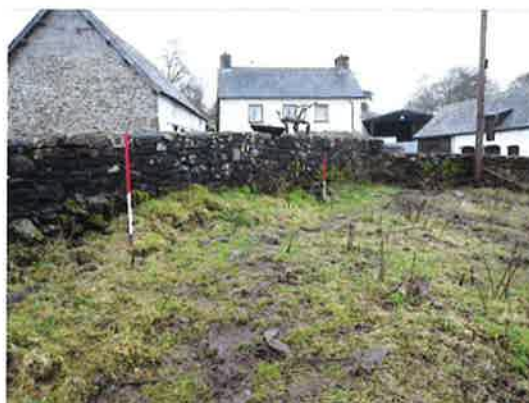
Summary: Mortared stone wall

Description: A modern, mortared stone wall, 0.5 m thick and 1.6 m height on the eastern side of the Blaen Glyn farmyard. Probably sitting on the remains of an earlier wall. Cement capped in places, stone coping elsewhere.

Recommendations: Maintain in current condition

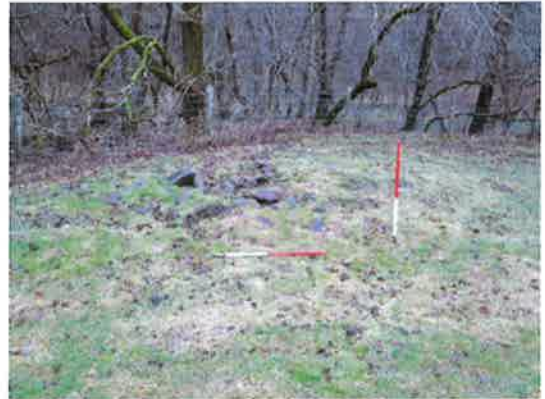
Description: A low, roughly circular, unstructured pile of stones, partly turfed over. 4 x 3 m in size and up to 0.4 m high.

Condition: fair

Recommendations: Maintain in current condition

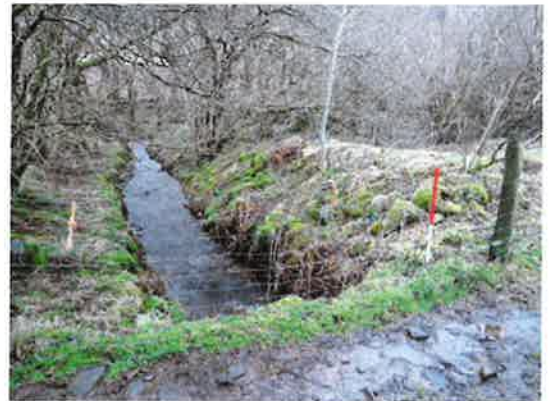
Summary: A leat joining Blaen Glyn farmyard to the Glyn Tarrel

Description: A cut channel running from the farmyard to the Glyn Tarrel. 1.2 m wide and approximately 1 m deep with a noticeably square profile. There is a substantial bank, 4 m wide and up to 1.5 m high along its northern edge presumably created from the digging of the leat. The precise function is unknown.

Condition: good

Recommendations: Maintain in current condition

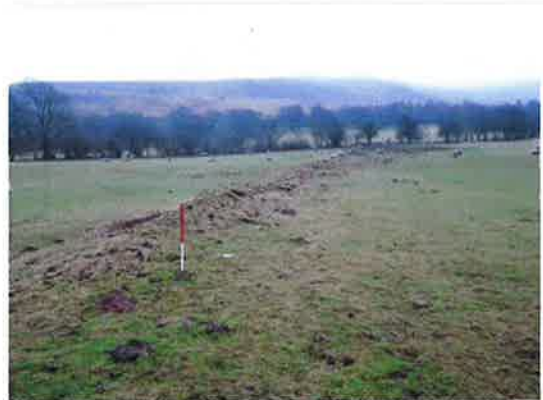
Description: An earth and stone bank, no longer acting as a field boundary, but running roughly up the middle of a large field, running approximately NW - SE. 2.5 m wide and up to 0.7 m high. At its eastern end the bank turns south and forms the boundary bank between the fields and the track 860250.

Condition: poor

Threats to Site: Areas of erosion through stock damage, both historic and active. This is particularly noticeable where there is a modern feeding station.

Recommendations: Maintain in current condition, move the feeding station away from the bank

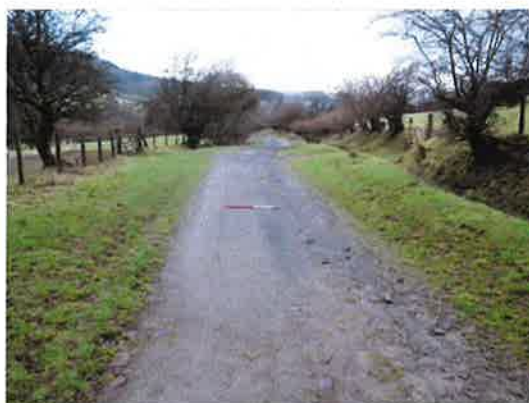
Description: A 8 m wide track/road with a ditch along its eastern side forming a routeway along the base of Glyn Tarrel. Formed of a tarmac road from Carno to Blaen Glyn farm and then a rough track with rammed stone surface leading to Storey Arms. Known as the Coach Road it probably was the major route through the valley before the current A470 was built. Now part of the Taff Trail. There are a number of modern stone built culverts with concrete pipes under the track and three bridges supporting the track.

Condition: good

Recommendations: Maintain in current condition

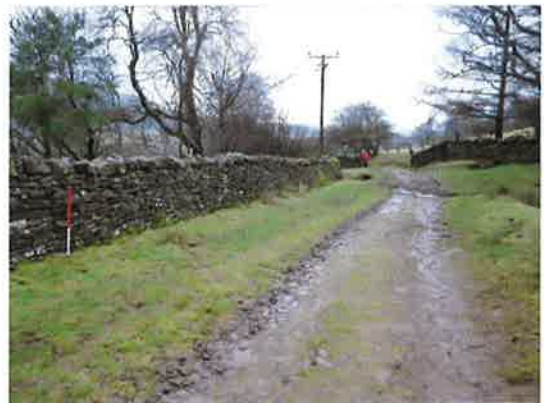
Description: Dry stone wall 0.8 m wide and up to 1.4 m high running alongside the routeway 860250. Surviving to full height with stone coping. Constructed from local sandstone blocks

Condition: good

Recommendations: Maintain in current condition

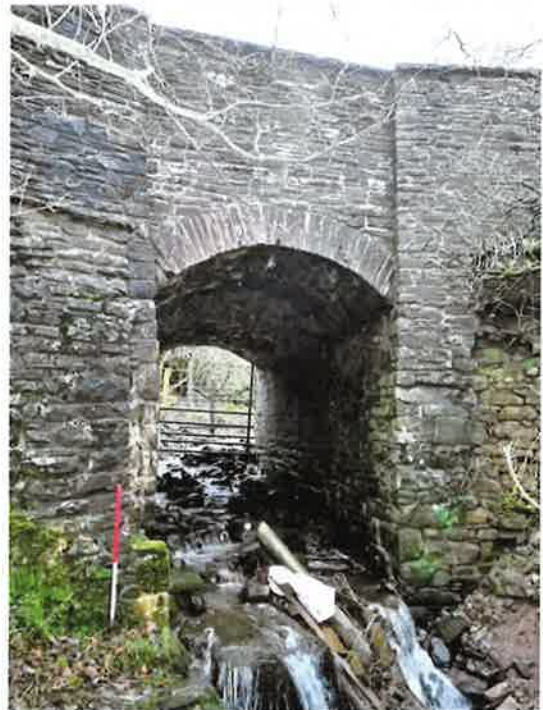
Description: A single span bridge carrying the routeway 860250 across a stream. The outer skin of mortared masonry appear to encase an earlier structure. Segmented arch, slightly depressed, random mortared stonework with squared quoins and stone voussoirs.

Condition: fair

Recommendations: Maintain in current condition

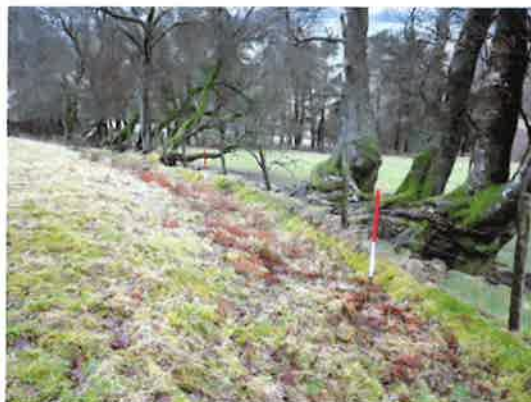
Description: An earth and stone bank marking the boundary between a field and the routeway 860250. Still acting as a boundary with a post and wire fence running along the top of the bank. The bank is 3 m wide and up to 0.4 m high on the eastern side with sloping sides, a rounded top and mature trees growing along the bank.

Condition: fair

Recommendations: Maintain in current condition

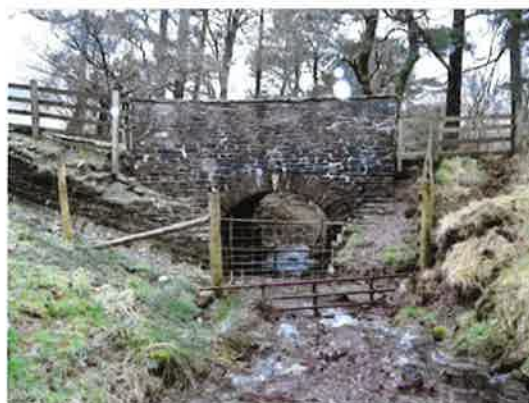
Description: A stone built bridge of very similar character to 860252, also carrying the routeway 860250. Some minor differences in construction as the arch includes a keystone. The bridge appears to sit on earlier foundations up to the point where the arch springs and is a modern build above this point.

Condition: good

Threats to Site: Water damage from stream

Recommendations: Maintain in current condition

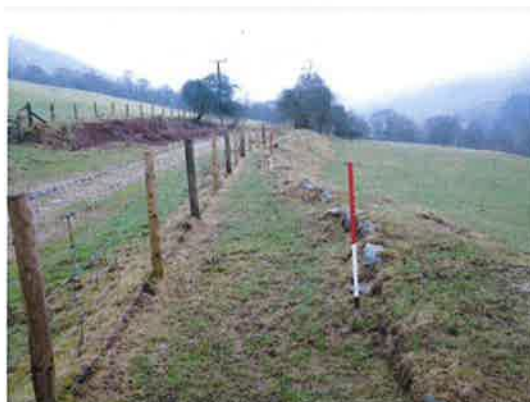
Summary: Earth and stone bank

Description: A short length of earth and stone field boundary bank dividing a field from the routeway 860250. The bank is 2.2 m wide and up to 0.3 m high on its eastern side and 1 m high on its western side.

Condition: poor

Recommendations: Maintain in current condition

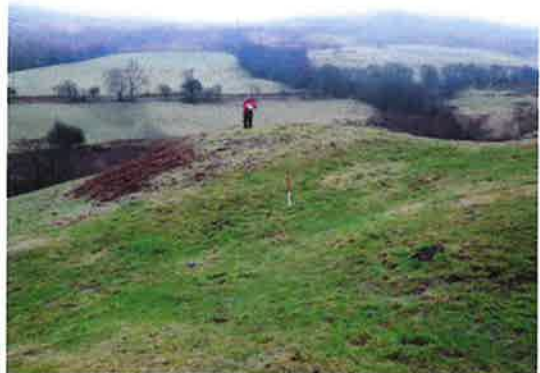
Description: 15m diameter large circular cairn of stones, now largely turf covered and standing to a height of c. 1.5 m. There is the remains of a rectangular trench on the summit, 3.6 x 1.2 m in size. The top of the cairn is slightly oval in shape and 6 x 4 m in size.

Condition: fair

Recommendations: Keep bracken under control, maintain in current condition

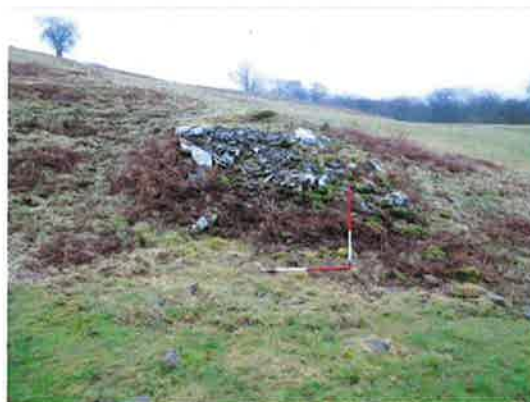
Description: A rough pile of stones placed against the slope below Blaen Glyn Round Cairn (860256). Loosely piled mixture of stones. 3.5 x 3 m in size.

Condition: fair

Recommendations: Maintain in current condition

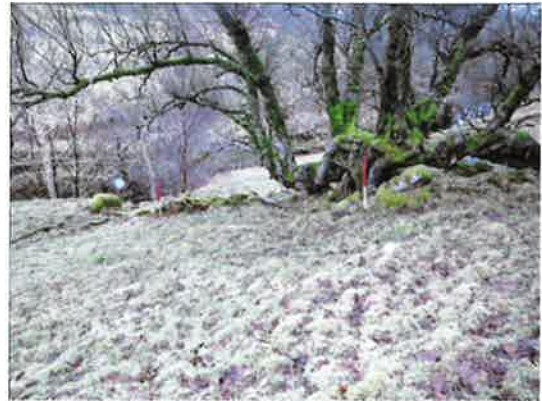
Description: A short stretch of boundary wall 0.8 m wide and up to 0.3 m high, much tumbled and with mature trees growing out of it. Possibly associated with 860259.

Condition: poor

Recommendations: Maintain in current condition

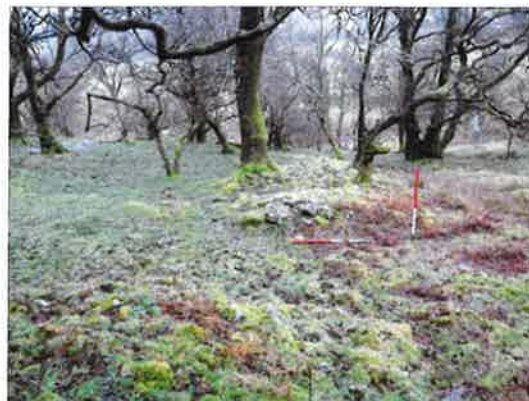
Description: A sub-rectangular flattened area defined by low stony banks. Banks are mainly small stones and are moss covered. Apparent entrances to NE and SW and are possibly of later date. No apparent internal features. Banks 2.5 m wide and up to 0.4 m high. There is possibly an outer, less pronounced bank to the east. An intriguing site which might be of prehistoric date. The enclosure is approximately 31 x 21 m in size

Condition: fair

Recommendations: Maintain in current condition

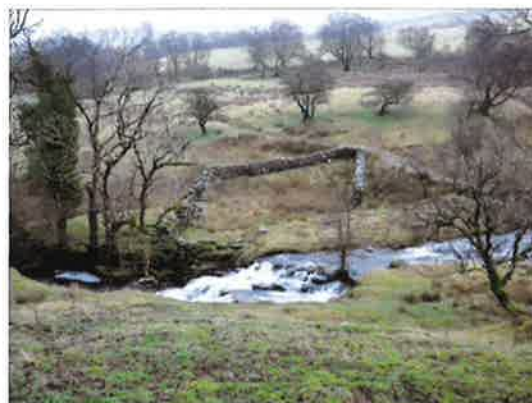
Summary: Rectangular sheepfold

Description: Rectangular, dry stone walled enclosure adjacent to the river. Wall directly adjacent to the river has collapsed, but surviving walls are 0.6 m wide and stand to a height of 1.4 m. Entrances to the north and south and a gutter in the north wall. Sheepfold 13 x 15 m in size.

Recommendations: Maintain in current condition

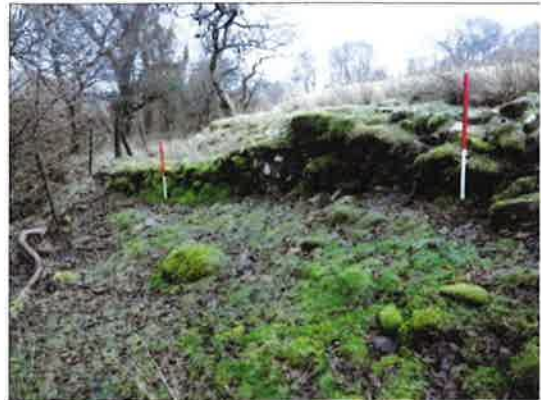
Summary: Dry stone wall

Description: A dry stone wall revetting the river bank.
0.6 m wide and up to 0.7 m high.

Condition: good

Recommendations: Maintain in current condition

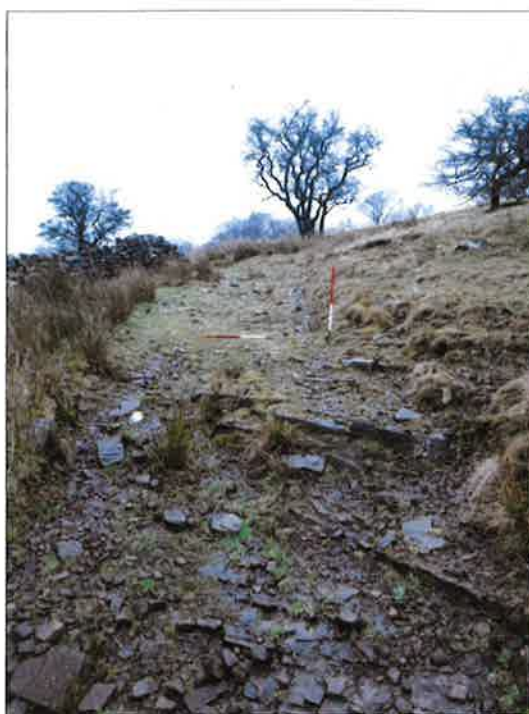
Summary: Track fording the Afon Tarell

Description: A track running from the routeway 860250, across the Afon Tarell. 3 m wide and slightly scarped into the hillside.

Condition: fair

Recommendations: Maintain in current condition

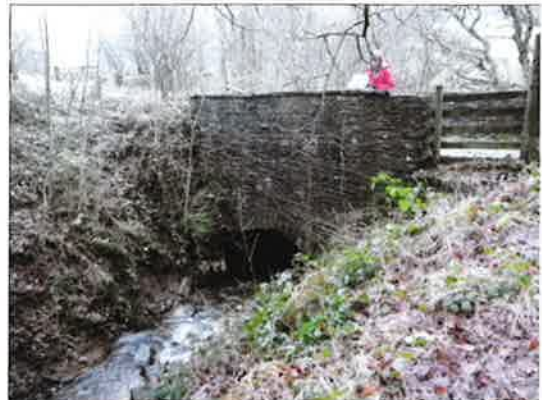
Summary: Stone built single span bridge

Description: Single span stone bridge of a similar design to 860252 and 860254. Carries routeway 860250 over a stream.

Condition: good

Recommendations: Maintain in current condition

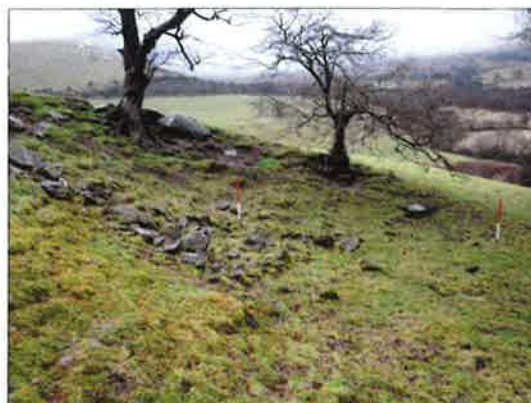
Description: A small stone quarry, 9 x 12 m in size cut into the hillside. There are loose stones against the quarry face (now grassed over) and banks of spoil on the western edge.

Condition: good

Recommendations: Maintain in current condition

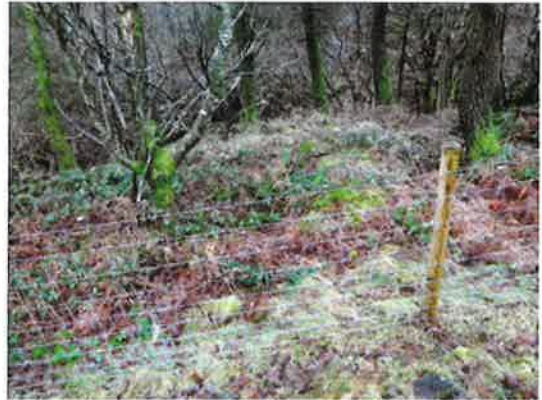
Description: A small structure, 3.8 m x 7 m in size surviving as grassed over footings located on the edge of a steep sided gully with a stream in its base. Possibly associated with the quarry 860264. Footings 0.6 m wide and up to 0.3 m high. A pile of stones at the south end is probably the result of field clearance.

Condition: poor

Recommendations: If possible remove the trees

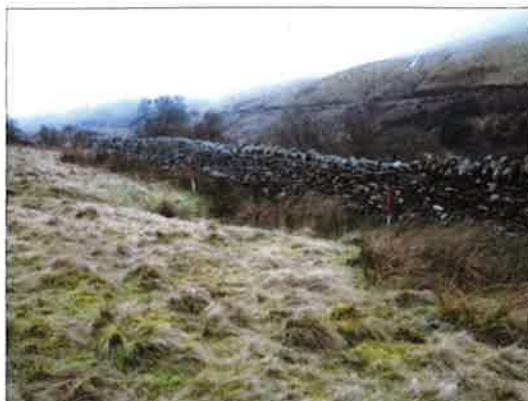
Summary: Dry stone wall

Description: 0.7 m wide and 1.4 m high this dry stone wall runs along the eastern boundary between the improved fields and the open land. Surviving for most part to its full height, although there are some areas of collapse. A post and wire fence runs alongside the wall.

Recommendations: Maintain in current condition

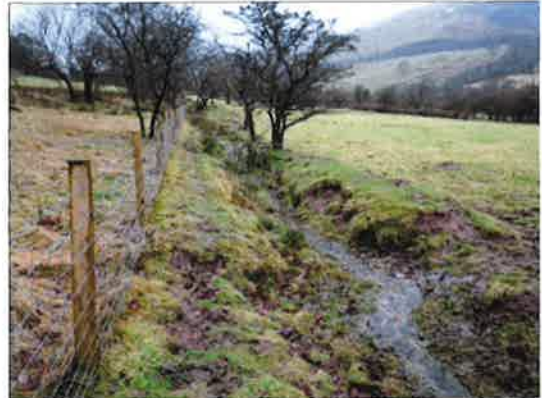
Summary: Earth and stone bank

Description: An earth and stone bank defining two sides of a field to the SE of the farm. The bank is 2 m wide and up to 0.5 m high with sloping sides and a flat top. Mature Trees are growing on top of the bank. There is a ditch on the up slope side to the east.

Recommendations: Maintain in current condition

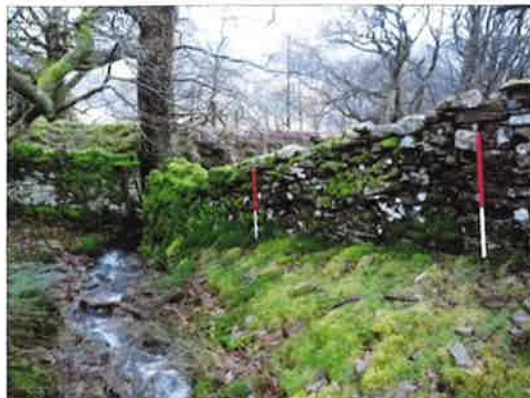
Description: A dry stone wall, 0.50 m thick with a maximum height of 1.4 m alongside a stream on the eastern limit of Blaen Glyn Farm land. Now largely collapsed. The wall no longer functions as a boundary, replaced by a post and wire fence.

Condition: poor

Recommendations: Maintain in current condition

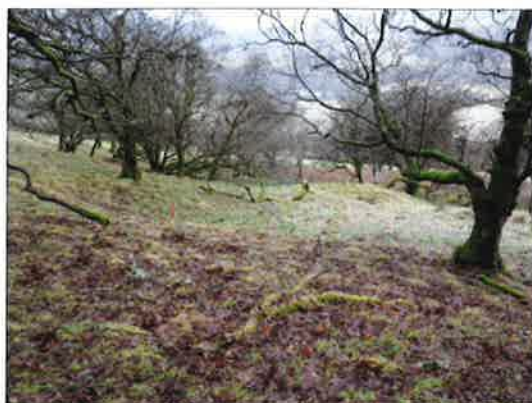
Description: A possible platform, 16 x 6 m in size cut into the slope by 1.2m. Oriented SE - NW there is some doubt whether this feature is anthropogenic or natural in origins. No structural elements observed. Adjacent to trackway 860270.

Condition: fair

Recommendations: Maintain in current condition

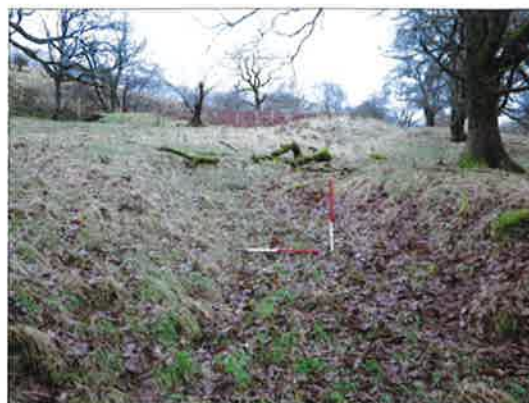
Description: A short length of sunken track running from the improved land towards the open land adjacent to a possible platform 860270. 2 m wide and cut into the hill slope by up to 0.5m.

Condition: good

Recommendations: Maintain in current condition

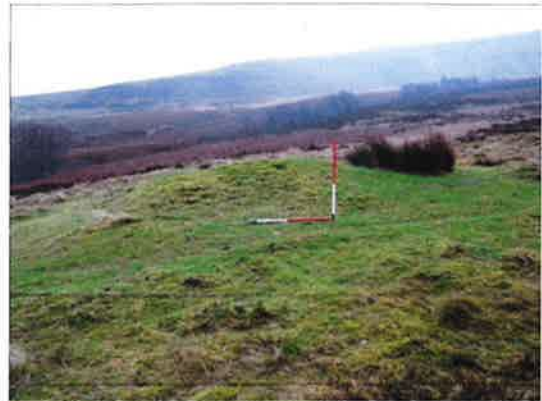
Summary: Circular mound

Description: A turf covered mound 5 x 6 m in size and up to 0.8 m high. No evidence for any other structure.

Recommendations: Maintain in current condition

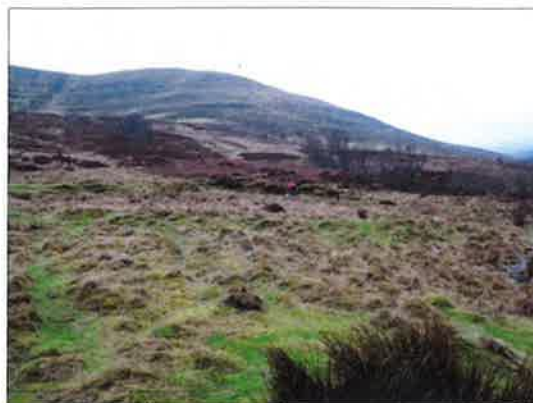
Description: A rectangular platform, 11 x 5 m in size which is built up by approximately 0.8 m on its northern side with a sub-circular enclosure attached on its northern side. The enclosure is approximately 22 x 30 m in size and is defined by an earthen and stone bank 2 m wide and up to 0.4m high. There is a single entrance on the western side which is 3 m wide. There is a small area of erosion on the NW corner of the platform which reveals some evidence for stonework.

Condition: good

Threats to Site: Slight erosion on one corner of the platform, probabale stock damage

Recommendations: Monitor condition and maintain in current condition

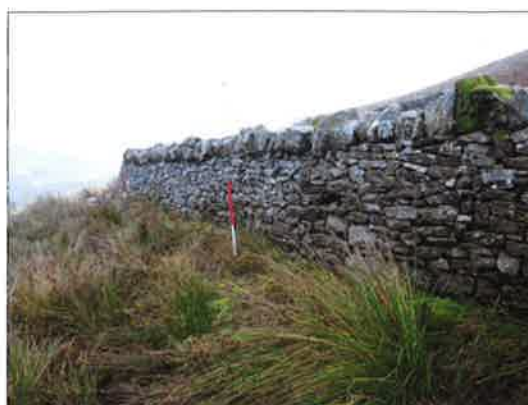
Summary: Dry stone wall

Description: Dry stone wall, 0.6 m wide and 1.3 m high bounding the eastern side of the trackway 860250 between the southern end of Blaen Glyn Farm and Storey Arms. Modern post and wire fence along the east side of the wall. Survives to its full height with stone coping for much of its length, probably re-built. Some areas of collapse also present.

Condition: good

Recommendations: Maintain in current condition

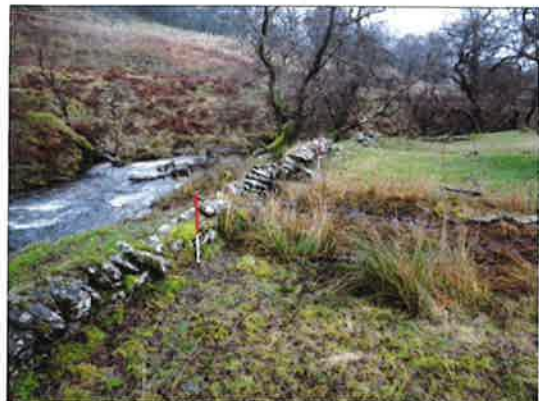
Summary: Dry stone wall

Description: A dry stone wall revetting the eastern bank of the Afon Tyrell. 0.6 m wide, 1 m high on its western side and 0.6 m on its eastern side. Possibly equivalent to 860261.

Condition: fair

Recommendations: Maintain in current condition

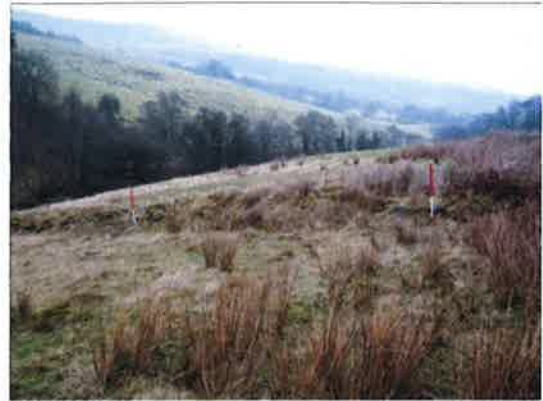
Description: A old field boundary bank which is no longer functioning as a boundary. Earth and stone bank 1.2 m wide and up to 0.7 m high on its south side and 0.3 m on the northern side. Occasional mature tree on the bank, which is rather denuded in places which appears to be the result of historic damage.

Recommendations: Maintain in current condition

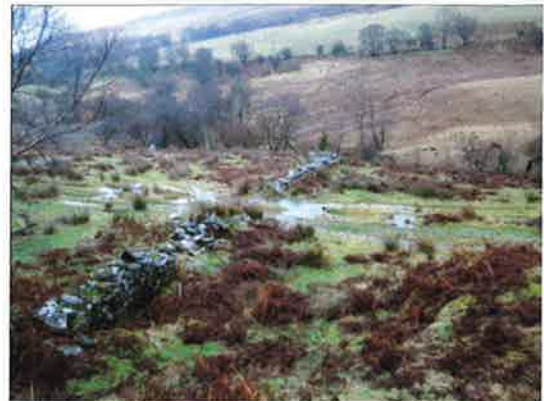
Description: A tumbled dry stone wall defining an irregular shaped field at the southern end of Blaen Glyn Farm. An original entrance into the enclosure at the SW end is flanked by upright stone slabs and is 1.5 m wide. The upright stones are now slightly out of position. The wall is 1 m wide and up to 1.2 m high. The wall is much tumbled and moss covered in places. A modern entrance goes through the feature to the south. The wall appears to contain some hints of terracing

Condition: poor

Recommendations: If possible remove trees, Restrict vehicles to trackway

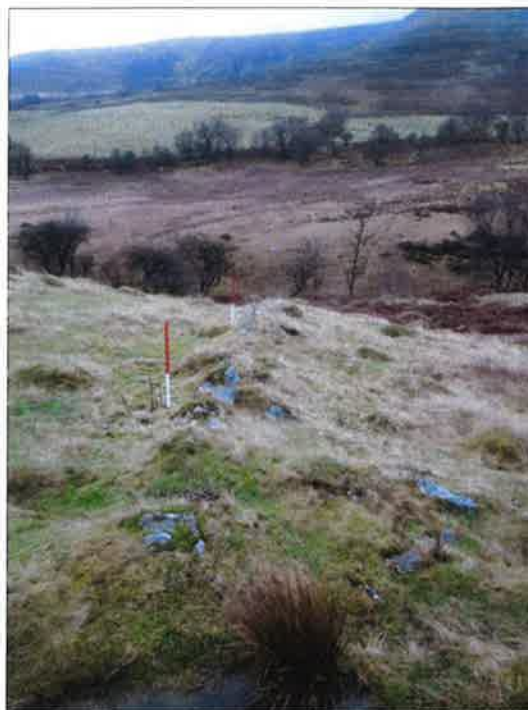
Summary: Earth and stone bank

Description: A stoney bank defining the limits of an old field to the south of Blaen Glyn Farm. No longer serving as a boundary. Bank 1.10 m wide and up to 0.4 m high.

Condition: fair

Recommendations: Maintain in current condition

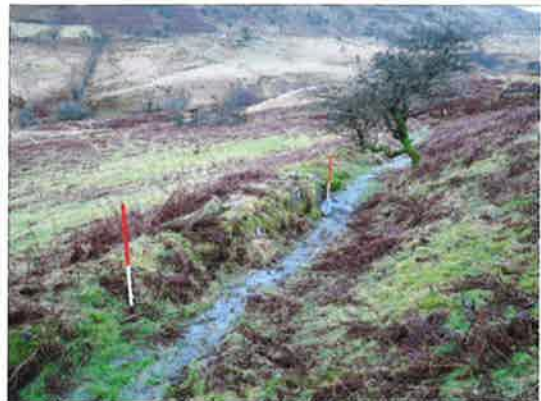
Summary: Earth and stone bank

Description: A stoney bank associated with 860277. The bank incorporates some large stones and is 1.7 m wide and up to 0.6 m high. Part of an old field system south of Blaen Glyn Farm.

Condition: fair

Recommendations: Maintain in current condition

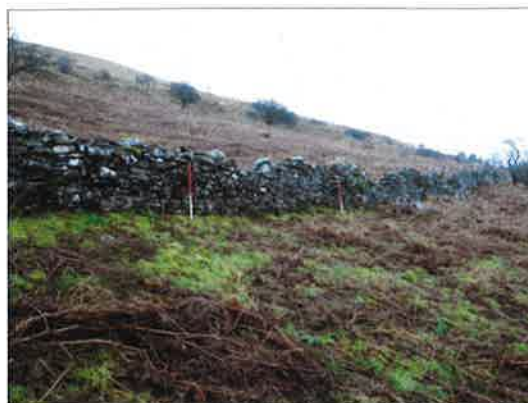
Description: A dry stone wall defining the western edge of the farm land at the southern end of Blaen Glyn Farm. 0.65 m wide and up to 1.4 m high, although the wall is collapsing in places and has been replaced by post and wire fencing along the western end.

Condition: fair

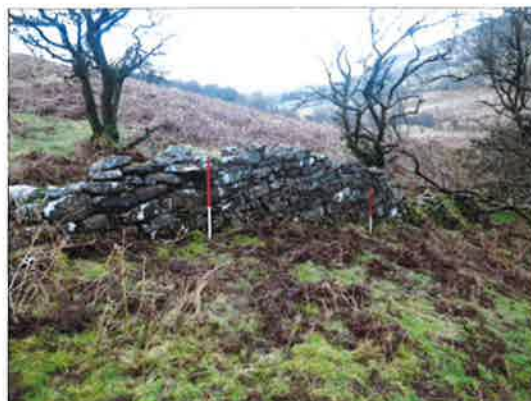
Summary: Dry stone wall

Description: Remains of a dry stone wall forming the southern boundary of a triangular enclosure, part of an old field system to the south of Blaen Glyn Farm. Wall 0.7 m wide and up to 1.4 m high although completely collapsed in places.

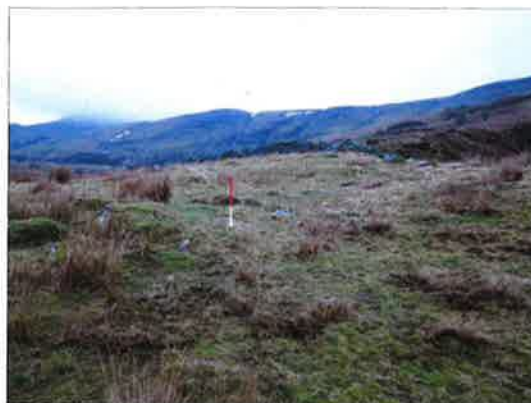
Description: The remains of a rectangular structure defined by low stony banks. The structure is 11 x 7 m in size and is aligned N-S. It was located immediately adjacent to a stream and was defined by low banks, 1.6 m wide and up to 0.4 m high. The bank is missing at the northern end. The function of this feature is uncertain, but may be a small building.

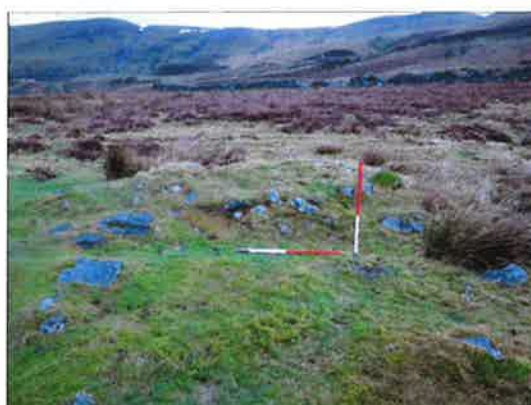
Summary: Small circular pile of stones

Description: A small, roughly circular pile of small stones, 5 x 3 m in size reaching a maximum height of 0.8 m. Partly turfed over.

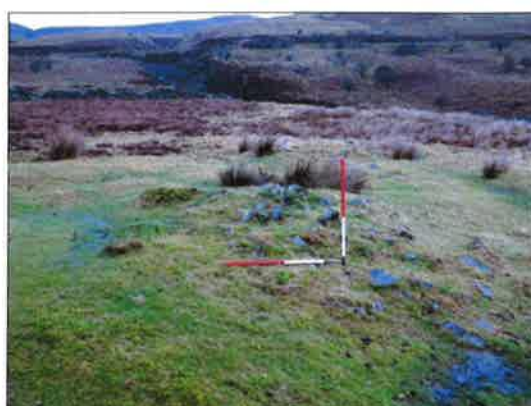
Summary: Small oval pile of stones

Description: A small oval pile of stones, 4 x 2 m in size reaching a height of 0.5 m. Partly turf covered.

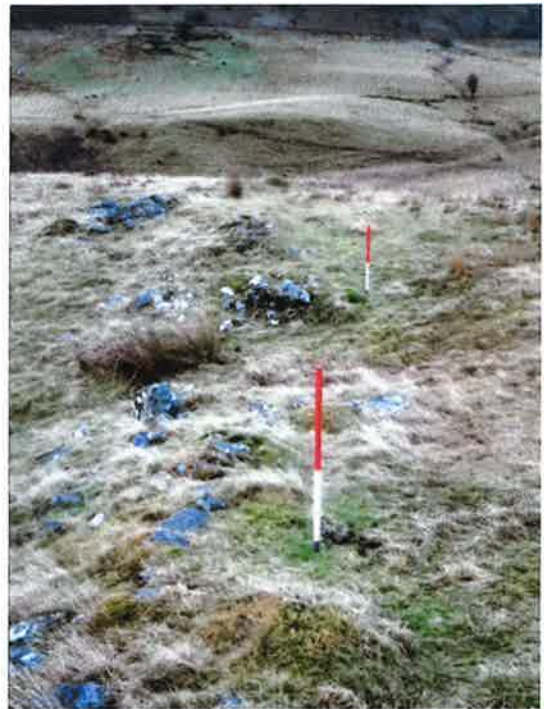
Summary: Stony bank

Description: A stony bank, 1 m wide and up to 0.4 m high with a somewhat sinuous character.

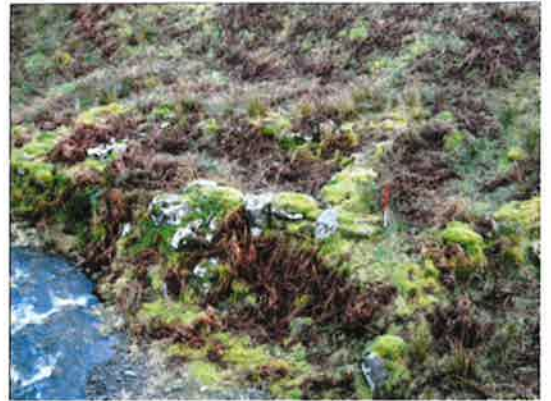
Summary: Rectangular sheepfold

Description: A well built rectangular sheepfold with one large (6 x 3 m) and one small (1.3 x 3 m) compartment. The walls are 0.8 m wide and stand to a height of 0.5 m. The fold sits on a well built platform directly adjacent to a stream. The platform is approximately 1.2 m above the level of the stream

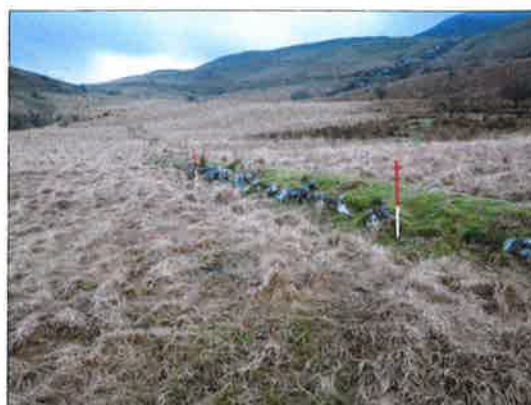
Summary: Dry stone wall

Description: The tumbled and moss covered remains of a dry stone wall, 0.8 m wide and up to 0.7 m high. The southern end of this wall is little more than a stony bank at its southern end.

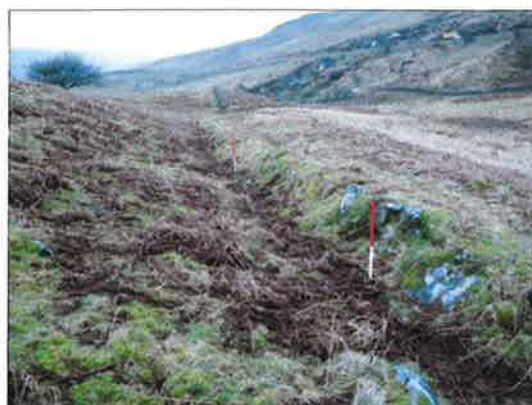
Summary: Earth and stone bank field system

Description: A series of earth and stone banks forming a field system of at least three fields at the southern end of the land farmed by Blaen Glyn farm. Each of the banks are approximately 1.4 m wide and up to 0.5 m high with sloping sides and flattish tops. They appear to be possibly associated with building complex 860288.

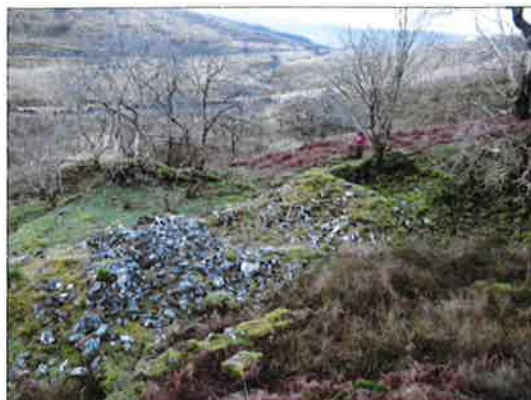
Description: A complex of ruined buildings and a possible small paddock adjacent to a stream. The main building is a three unit stone built building aligned SE – NW and is 19 x 6 m in size. A second smaller structure is situated to the NW 2.6 m x 2.4 m in size with a possible stone platform to the rear. There is also a short length of dry stone wall in the stream bed which presumably acted as a dam. Possibly a farmstead although there appear to be an element of water control system associated with the smaller of the buildings. The buildings and the paddock sit on a large platform built above the stream

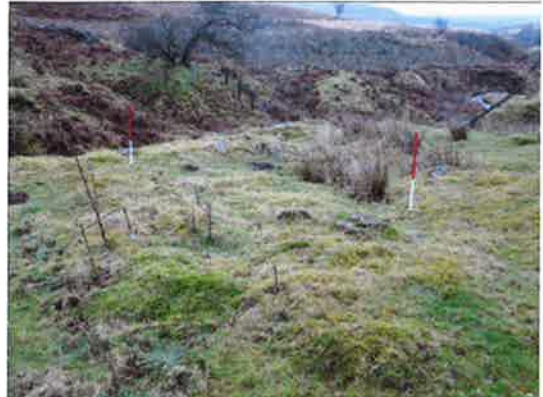
Summary: Small rectangular structure

Description: A small rectangular structure, 3 x 4 m in size surviving at footing level only. Walls are 0.8 m wide and stand to a maximum height of 0.4 m. Situated close to structure complex 860288 on the opposite bank of a stream.

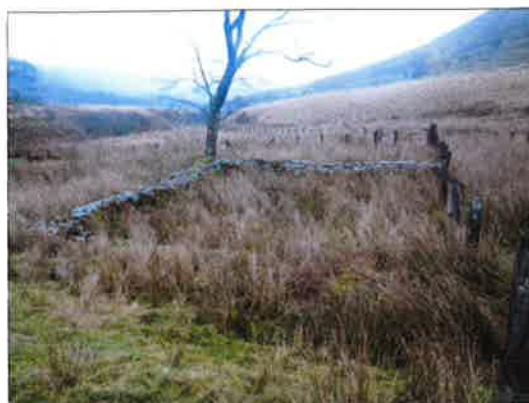
Description: A rectangular sheepfold, 7 x 8 m in size with a length of a wall linking this feature to the property boundary wall. The walls are 0.70 m wide and stand to a height of up to 0.8 m. Only two of the walls stand to any height with a third side replaced by a post and wire fence. The site has been re-used for corralling using post and wire fences of which only the posts survive.

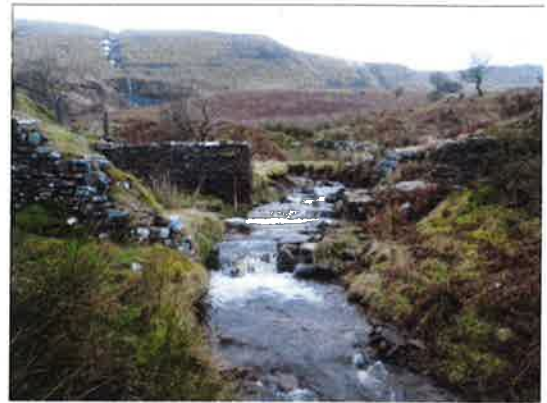
Description: A sluice across a river assumed to be part of a washing area for animals. A stone wall across the valley with a brick lined sluice gate where the stream flows. The bricks are hand made bricks without frogs of probable 19th century type. A groove in the brickwork suggest that the stream was blocked using a series of boards to regulate the level of the stream behind the dam. Now partly collapses on its northern side the dam wall is 0.6 m wide and up to 1.7 m high.

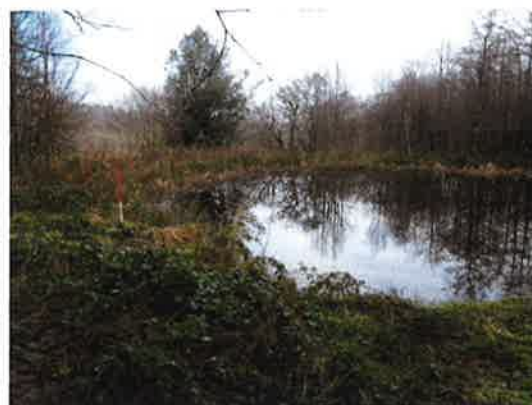
Summary: Man made pond

Description: A man made pond with a bund(dam) along its north, west and eastern sides. The bund is an earth and stone bank approximately 3 m wide and up to 1 m high.
