*Survey Commissioned
by
The National Trust Wales Archaeologist
Office*

*Surveyed
by
I.P. Brooks
Engineering Archaeological Services Ltd*

*The Brecon Beacons Survey
2011 Interim Report*

EAS Client Report 2011/01

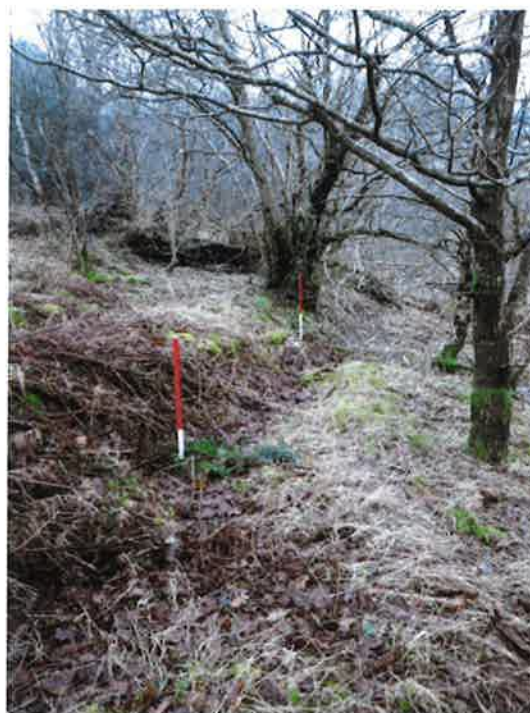
Description: An earth and stone bank, 2 m wide and up to 0.8 m high within Carno Wood. The boundary no longer acts as a boundary. It consists of bank with sloping sides and a flattish top, although there are limited areas with dry stone facing. Trees growing on top of the bank.

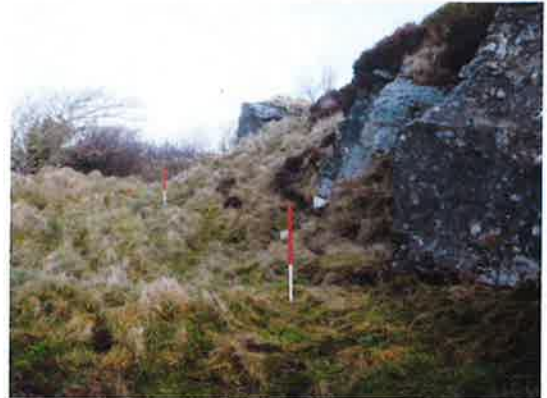
Description: A series of inter-cutting quarried areas running SW - NE for a distance of approximately 75 m along the break of slope south of Carno Wood. The quarry face is a maximum of 5 m high. The material being exploited would appear to be fairly blocky in nature and the spoil would appear to have been tipped over the steep slope to the NW. Wall 860268 runs along the upper limit of the quarried area.

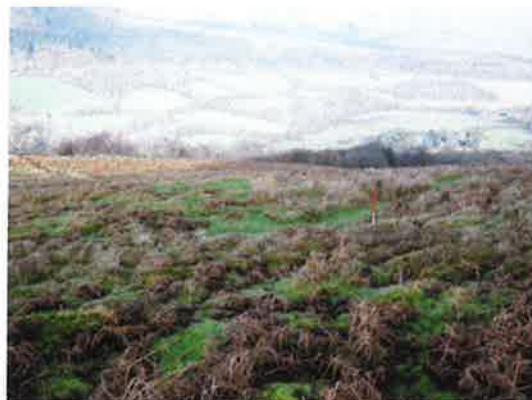
Description: A platform 11 x 3 m in size, cut into the hillside by about 0.8 m at its SE end. The NW end is built up by a similar height.. Orientated down the slope (SE - NW). May be associated with boundary bank 860296.

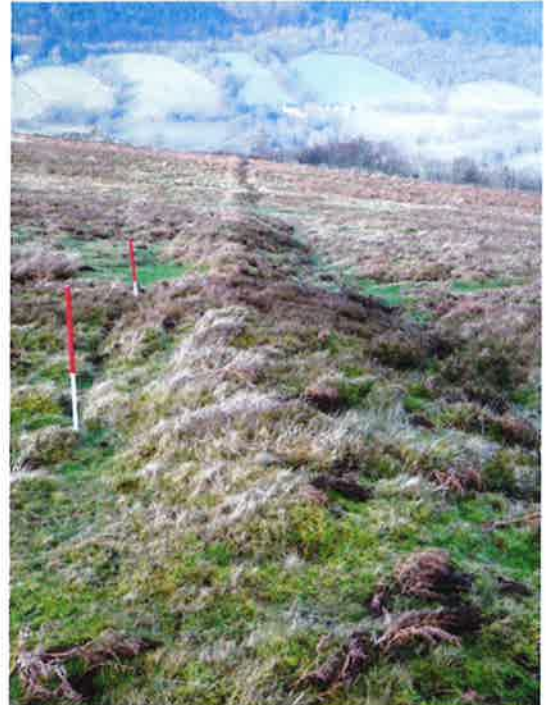
Summary: Earth and stone bank

Description: A bank, approximately 2 m wide and up to 0.4 m high with a rounded profile and a slight ditch on one side. Although it is situated on open land near to Hut Platform 860295 it may also be associated with the quarrying activity 860299.

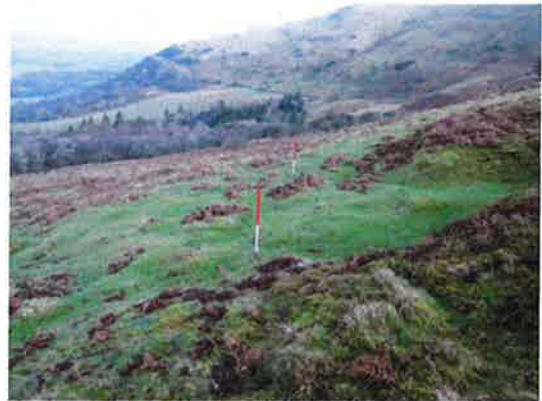
Description: A 7 m diameter circular platform cut into the hillslope by up to 1 m to the south. Built up by up to 1 m to the north.

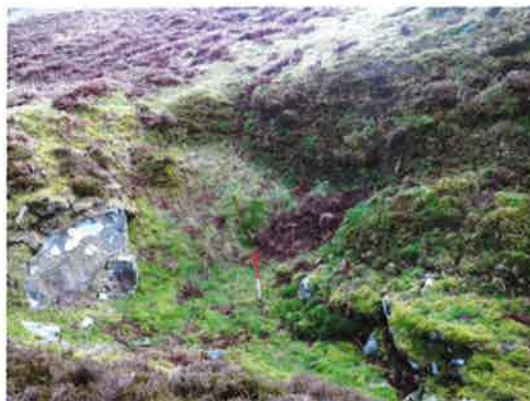
Description: A quarry scoop, 15 x 20 m in size with spoil mounds to the NE, a second smaller quarry scoop exists to the south. Depth of main scoop is at least 5 m. The quarries were designed to extract slabby material.

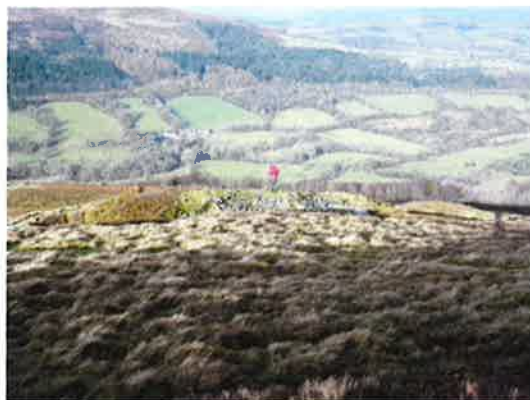
Summary: Series of intercutting quarry scoops

Description: A series of intercutting quarry scoops stretching for about 200 m along the break of slope of the northern end of Y Gyrn. The spoil from the quarries was dumped on the downhill side and was revetted in places to prevent it spreading into the working area. The quarries are relatively shallow with only a 2 m high working face. Slabby material being exploited.

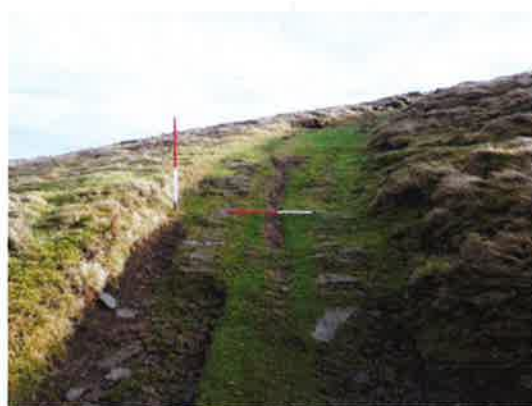
Description: A trackway, 2 m wide and cut into the hill slope by up to 0.5 m where it crosses the steepest part of the hill slope. In places the track surface has been re-enforced with pitched stones. The track runs through the quarried area 860299, so presumably pre-dated the quarrying activity. It extends into the landscape in both directions so not necessarily associated with the quarrying.

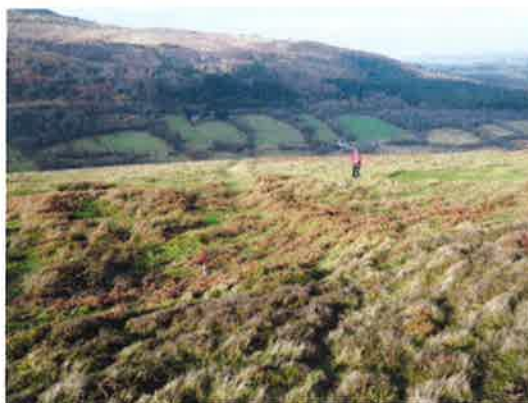
Description: Two directly adjacent structure platforms, one 17 x 5 m and the other 12 x 5 m in size. The platforms are aligned down slope, roughly E-W. Each are cut into the hill slope by approximately 0.5m and are built up at their western end by 0.5 m. Slightly raised banks along the north and south edges. Track 860300 curves around the front face of these huts, appears to respect them.

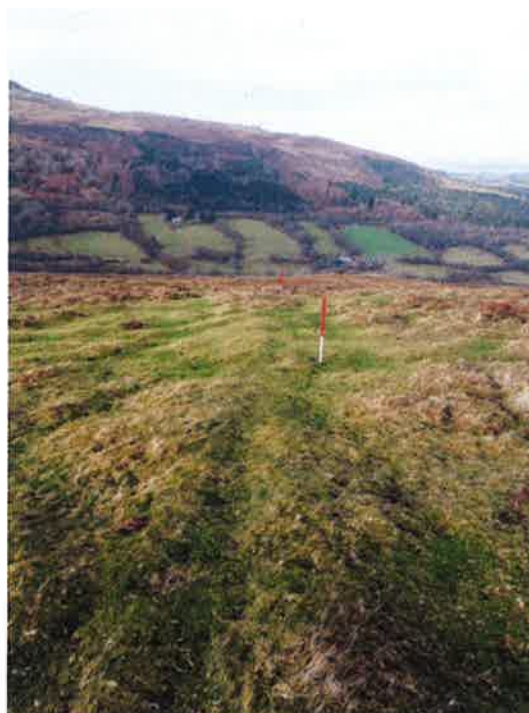
Summary: Short length of earth bank

Description: A short length of earthen bank close to the hut platforms 860301. c. 30 m in length, 1.8 m wide and up to 0.3 m high with a rounded profile.

Condition: poor

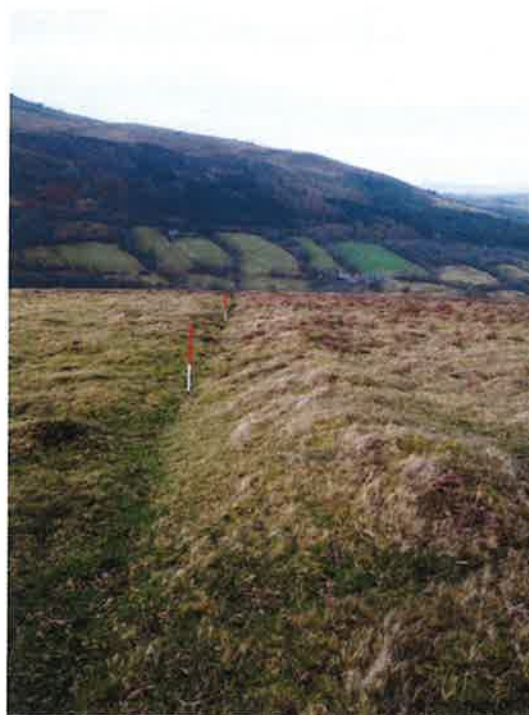
Summary: Earthen bank

Description: A linear earthen bank with a ditch on its SW side. The bank appears to run through between the two long huts 860301, perhaps associated with drainage and probably post-dating the houses. Bank is 2.2 m wide and up to 0.4 m high. The ditch is a maximum of 1m wide and up to 0.2 m deep.

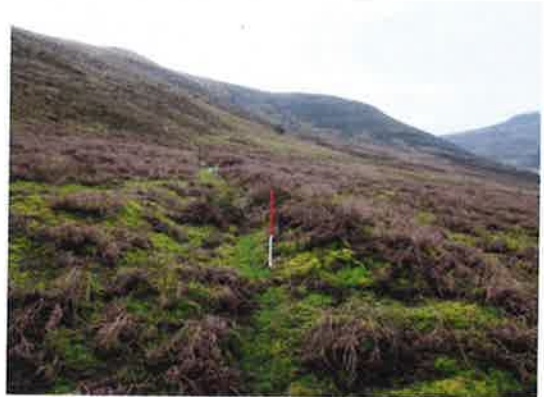
Summary: Earthen bank

Description: An earthen bank with a slight ditch along its eastern side. The bank is 2.3 m wide and up to 0.4 m high with a rounded profile. Ditch is 1.3 m wide and up to 0.3 m deep.

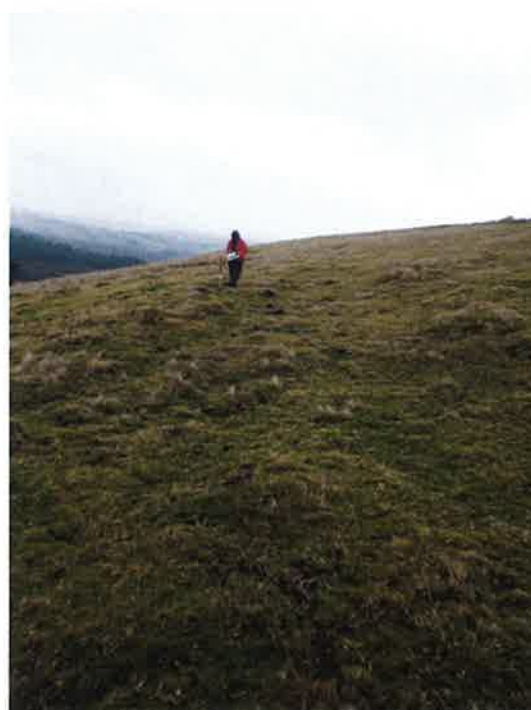
Summary: Hut platform Group with three possible long-houses

Description: A group of three possible hut (Long-house) platforms running across the hill side. One platform is 10 x 5 m in size and is cut into the hillside by 0.5 m at its eastern end and built up by 0.5 m at its western end. The second platform is 12x 7 m and is similarly cut into the hillside at its eastern end and built up at its western end. The third platform is 5 x 5 m in size and is cut into the hillside by 0.4 m, although does not appear to be built up

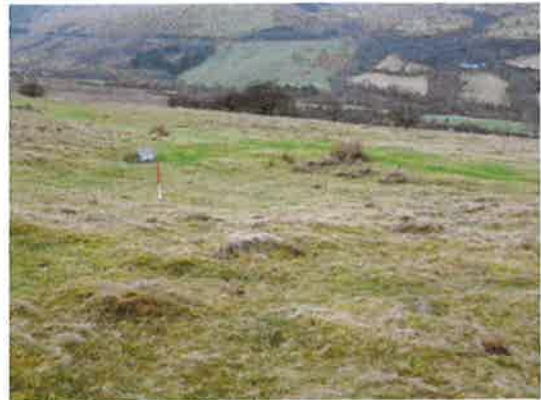
Summary: Two possible hut platforms in close association

Description: Two indistinct possible platforms. One is 12 x 11 m in size and is cut into the hillside by 1 m and is built up by 0.8 m to the W. Upright stones on the southern side. This platform is crossed by track 860300. The second platform is to the SW and is aligned across the slope (N-S). It is 21 x 4 m in size. This platform may be an effect of the local drainage pattern.

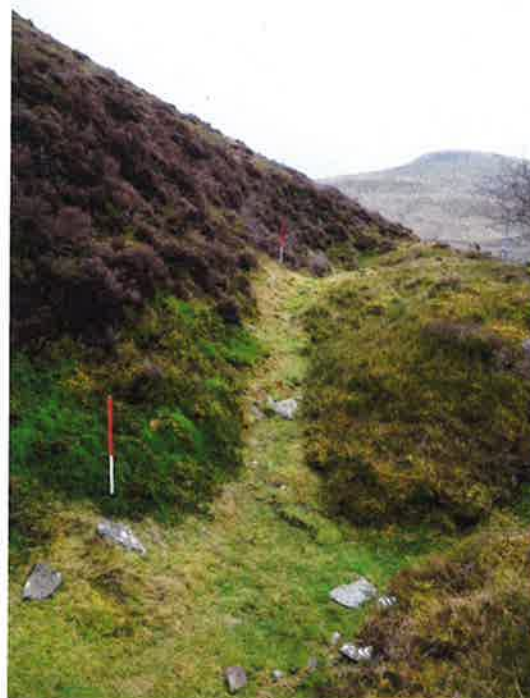
Summary: Series of intercutting quarry scoops

Description: A series of intercutting small quarries forming an irregular trench across the hill slope. Spoil heaps are all on the down hill side with areas of stone revetting on the up-hill side of the spoil heaps to keep the spoil away from the working face. One small divorced quarry at the SW end. Max width 6 m, maximum height 5 m.

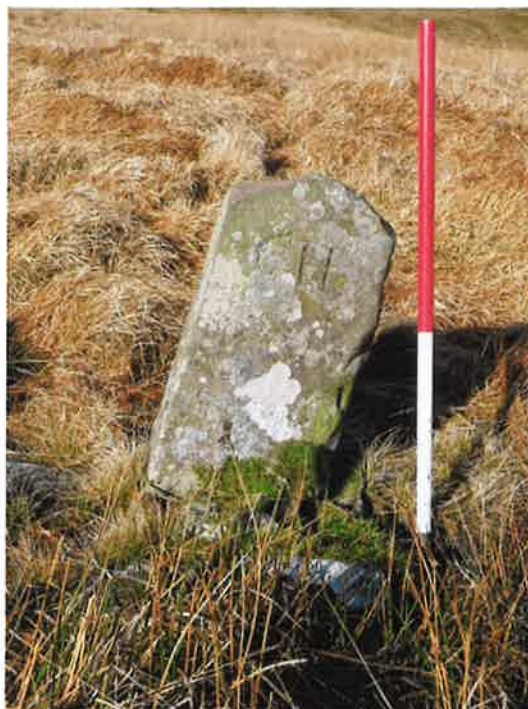
Summary: Upright stone block inscribed CH

Description: Probable boundary marker consisting of a small upright stone, 0.3 x 0.16 x 0.6 m in size which is engraved with the letters "CH" on its eastern face. There are a series of smaller stones packing the area around the base of the stone covering the area of 0.8 x 0.8 m.

Condition: good

Recommendations: Maintain in current condition

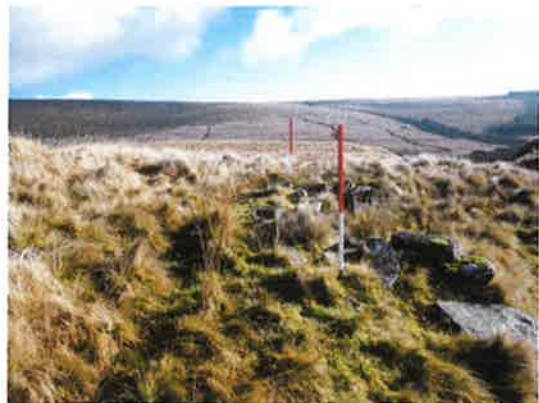
Summary: Small stone built sheep pen

Description: A small stone built sheep pen located on a stream bank. Dry stone walls up to 0.5 m wide surviving to a height of 0.3 m form a structure with an internal area of 2 x 4 m. The stream side edge has been completely destroyed. Located outside the NT property boundary.

Condition: poor

Recommendations: Maintain in current condition

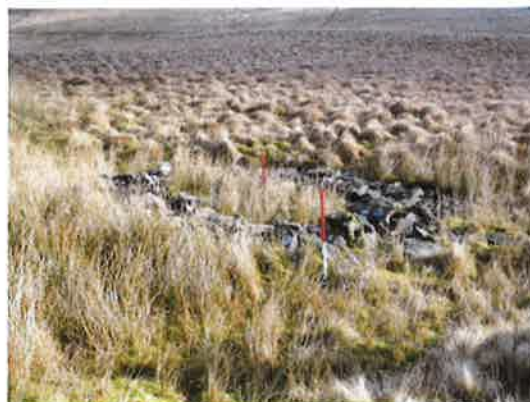
Summary: Ring Cairn

Description: A near circular emplacement of stones consisting of loose stones placed around the circle. 4 x 5 m in size with the width of the stone ring being 1.1 m . The basal stones are earth fast and include some pitched stones. It is possible that this feature may have been re-used as a rough sheep pen. Located outside the NT property boundary.

Condition: good

Recommendations: Maintain in current condition

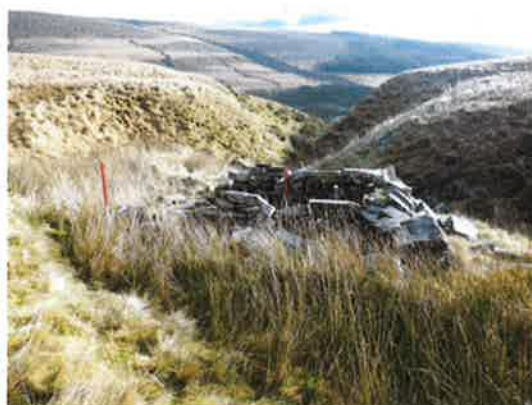
Summary: Rectangular stone built sheep pen

Description: A rectangular stone built sheep pen situated adjacent to a stream. Dry stone walling 0.7 m wide and up to 0.8 m high surround a pen 1.6 x 3.6 m in size. The wall at the north end has collapsed. Located outside the NT property boundary.

Recommendations: Maintain in current condition

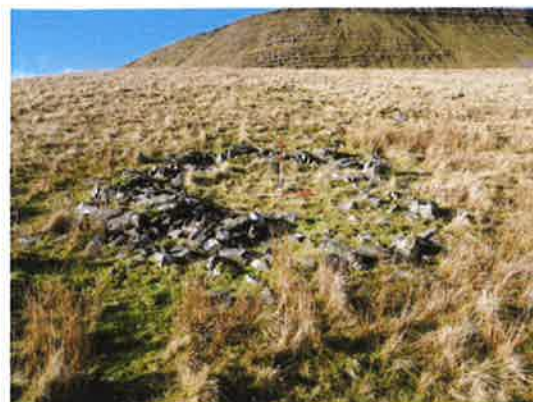
Summary: Ring Cairn

Description: A 6 m diameter, roughly circular stone
emplacement rather curiously sited on a
slight slope. The ring of stones is 1.4 m
wide with the stones being partly earth fast
and includes some pitched stones.

Condition: fair

Recommendations: Maintain in current condition

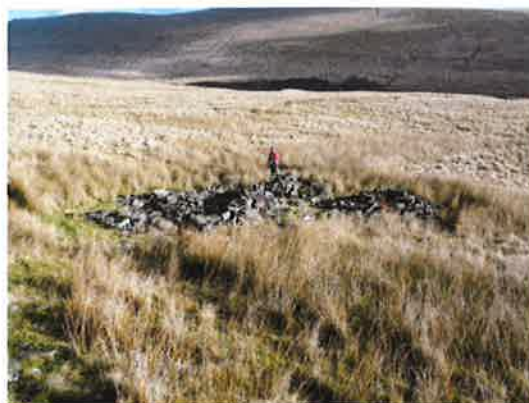
Summary: Irregularly shaped sheep fold

Description: Sheep fold consisting of a a single cell approximately 4 m square with an attached pen 1.8 x 1.6 m in size and an entrance passageway. One of the passage way walls is 4 m long and the other 6 m long. The pen is separated from the main cell by an upright slab. There is also a detached collapsed pen to the south. Walls 0.7 m wide and up to 0.7 m high

Condition: poor

Recommendations: Maintain in current condition

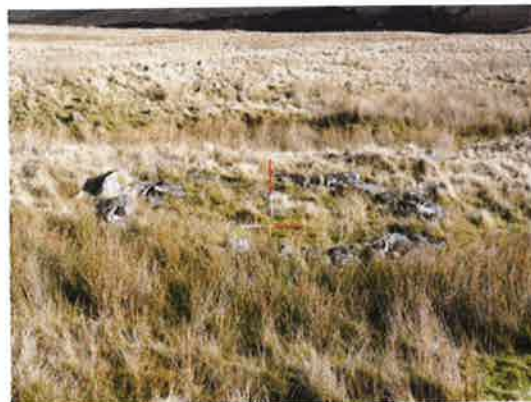
Summary: Ring Cairn

Description: 5 m in diameter this ring of stones is 1 m wide. The majority of stones are earth fast and include some pitched stones.

Condition: good

Recommendations: Maintain in current condition

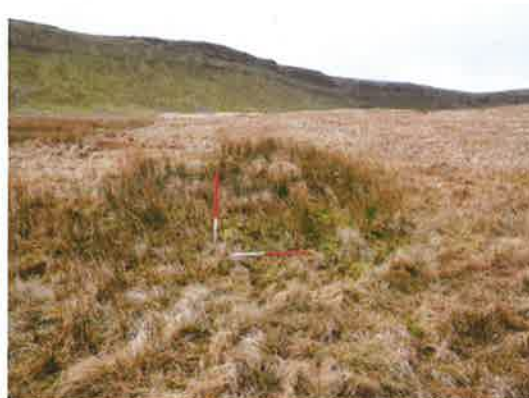
Summary: Oval earth mound

Description: Oval earth mound 5 x 3 m in size, reaching a maximum height of 1 m. This mound is isolated in the NW end of Gwaun Taf.

Condition: good

Recommendations: Maintain in current condition

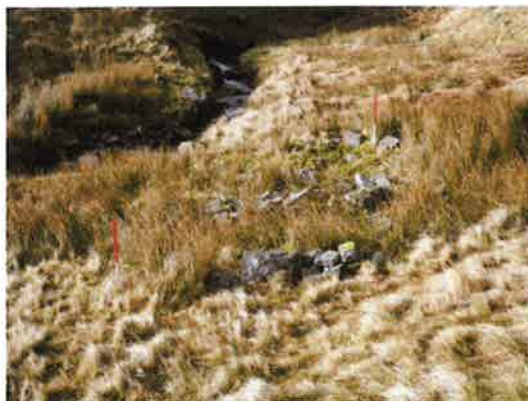
Summary: Sub-rectangular sheepfold

Description: A sub-rectangular sheepfold 7 x 5 m in size with a small, later, pen 2.4 x 2.2 m in the centre. The walls are 0.3 m wide and up to 0.4 m high. The structure only survives at footing level with some of the stones being re-used to create a sheep pen in the centre. The sheepfold is directly adjacent to the stream, with the stream side wall having been lost to erosion.

Threats to Site: Potential for further damage from stream

Recommendations: Maintain in current condition

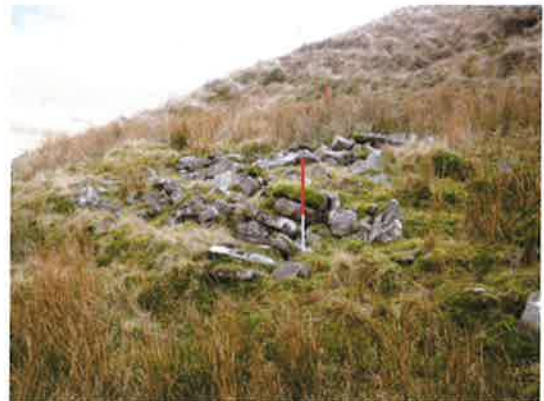
Summary: Sub-rectangular structure

Description: A sub-rectangular stone built structure,
completely collapsed and difficult to define.
Wall have a maximum height of 0.6 m.
Located directly adjacent to the stream.

Condition: poor

Recommendations: Maintain in current condition

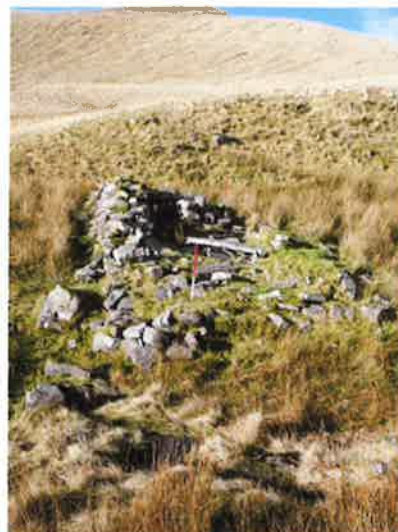
Summary: Rectangular sheepfold

Description: A rectangular sheepfold located directly adjacent to a stream. The structure incorporated a pen 1.3 x 0.7 m in size at the northern end of the main pen which is 5 x 8 m in size. Constructed of dry stone walling 0.7 m wide and up to 1 m high. The southern end is completely lost. The structure sits on a stone built platform which is up to 0.8 m above the stream bed. This could be part of an earlier structure.

Condition: fair

Threats to Site: Potential for further damage from stream

Recommendations: Maintain in current condition

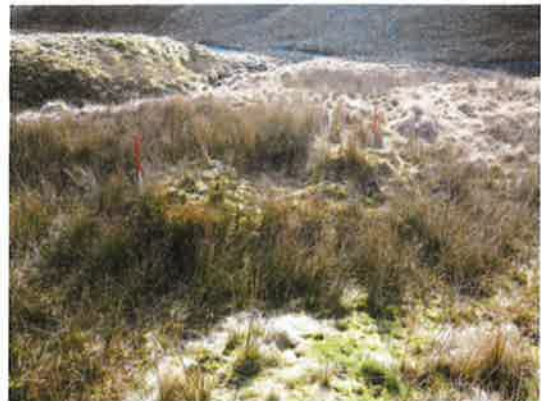
Summary: Small stone built sheep pen

Description: A small stone built sheep pen, 4 x 3 m in size, surviving as very tumbled wall only. Situated adjacent to a stream, close to sheepfold 860319.

Condition: poor

Threats to Site: Potential for further damage from stream

Recommendations: Maintain in current condition

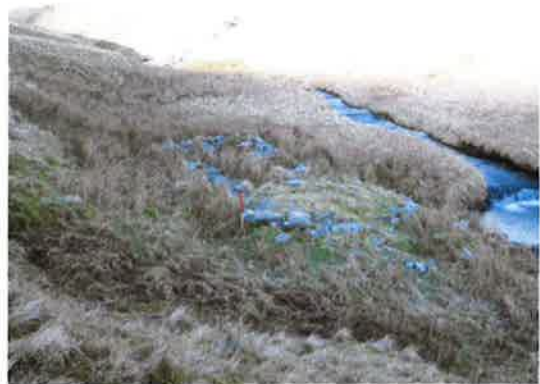
Summary: Rectangular sheepfold

Description: A rectangular sheepfold, 10 x 5 m in size with a large cell and a pen 1.9 x 1.4 m in size at one end. The sheepfold is constructed of denuded dry stone walls, 0.6 m wide and 0.7 m high. There is a short guide wall at the northern end. The structure sits on a platform which may be the remains of an earlier structure. Located adjacent to a natural pool suggest this may be a sheep washing station.

Condition: fair

Recommendations: Maintain in current condition

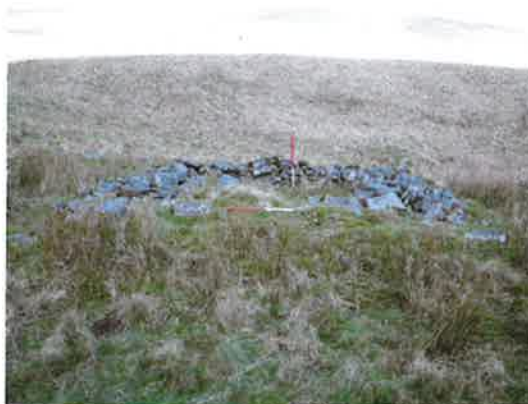
Summary: Small stone built sheep pen

Description: A small, rectangular, stone built sheep pen
2.4 x 1.8 m in size with dry stone walling
0.7 m wide and up to 0.5 m high, but
largely collapsed. Adjacent to 860323.

Condition: fair

Recommendations: Maintain in current condition

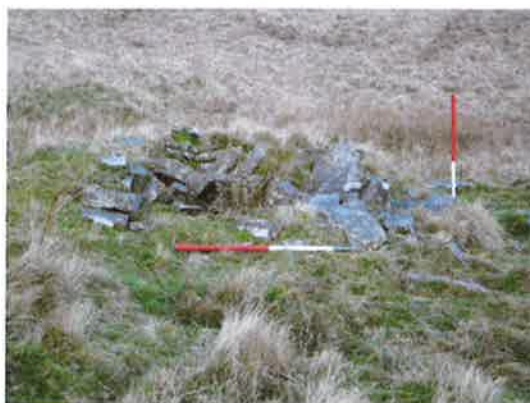
Summary: Small stone built sheep pen

Description: A small stone built sheep pen, 1.7 x 2.2 m in size, defined by a wall/bank 0.5 m wide and up to 0.4 m high. The pen sits on the corner of a larger and earlier platform 860324.

Condition: fair

Recommendations: Maintain in current condition

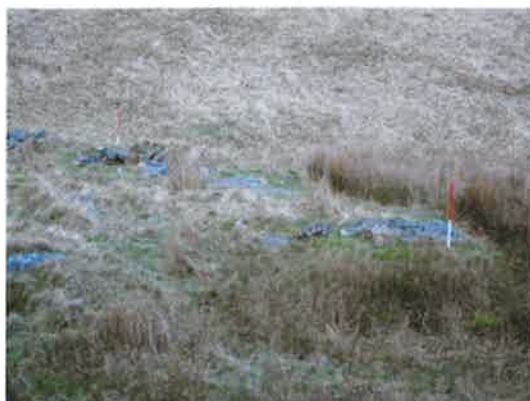
Summary: Large rectangular platform

Description: A large rectangular platform, 10 x 6 m in size edged by large stones, although it was not possible to define any remains of walls. Located adjacent to a stream. A post-medieval sheep pen (860323) is built on one corner

Recommendations: Maintain in current condition

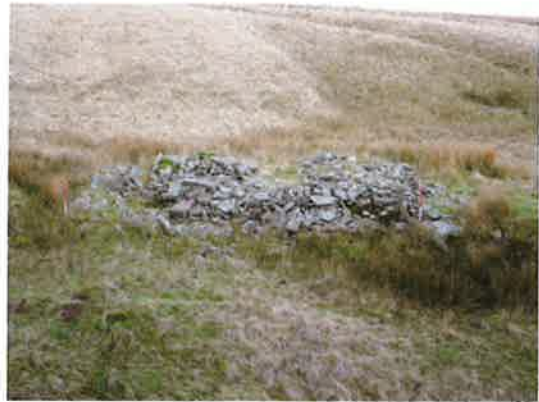
Summary: Rectangular sheepfold

Description: A rectangular sheepfold 7 x 4 m in size with a side pen 3 x 4 m in size at the SE side and a separated pen 3 x 2 m in size also to the east. The main pen sits on an earlier platform which is 1.5 m longer than the pen. The walls are 0.5 m thick and up to 0.8 m high.

Condition: poor

Recommendations: Maintain in current condition

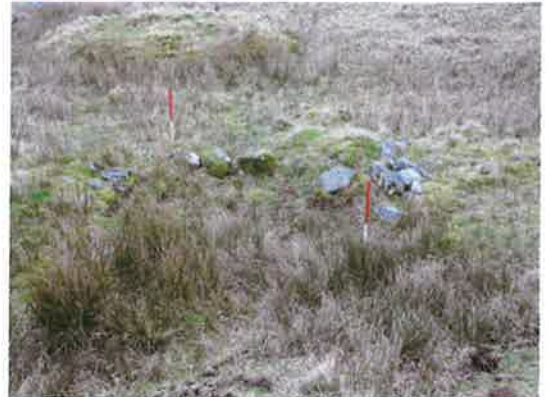
Summary: Small sub-rectangular sheep pen

Description: A small, sub-rectangular sheep pen utilising the natural hill slope to the east as one side. Covering an area 3 x 3 m in size the remaining sides are defined by very rough dry stone walls 0.5 m wide and up to 0.5 m high. Very tumbled.

Condition: poor

Recommendations: Maintain in current condition

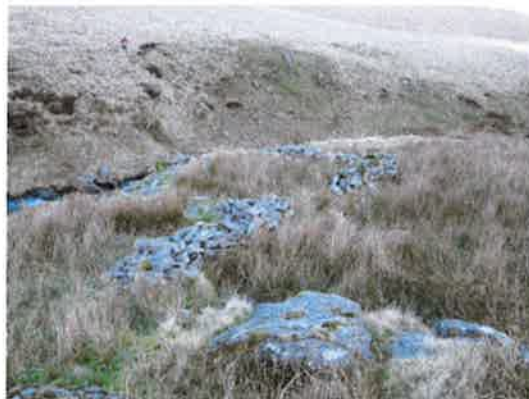
Summary: Sub-rectangular stone built sheepfold

Description: A sub-rectangular stone built sheepfold 6 x 5.5 m in size defined by dry stone walls 0.6 m wide and 1.1 m high. There is a 5 m length of guide wall of the northern side. The eastern wall, adjacent to the stream has collapsed.

Condition: poor

Recommendations: Maintain in current condition

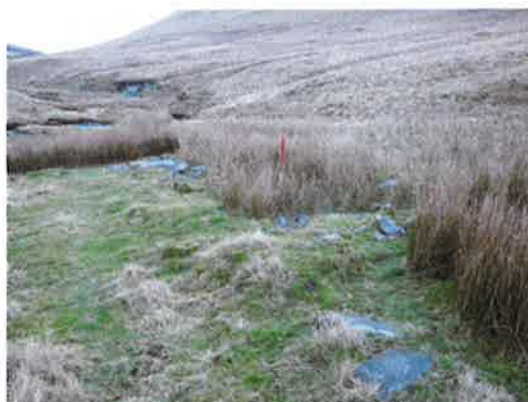
Summary: Rectangular structure

Description: A rectangular structure 6 x 4 m in size surviving as earth fast footings only, 0.8 m thick.

Condition: poor

Recommendations: Maintain in current condition

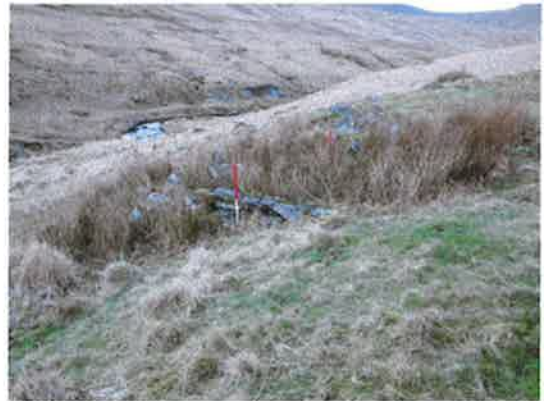
Summary: Small roughly constructed sheep pen

Description: A small roughly constructed sheep pen,
constructed partly against natural boulders,
now much collapsed. Dry stone walls 0.7 m
wide and 0.5 m high. Structure 3 x 4 m in
size.

Condition: fair

Recommendations: Maintain in current condition

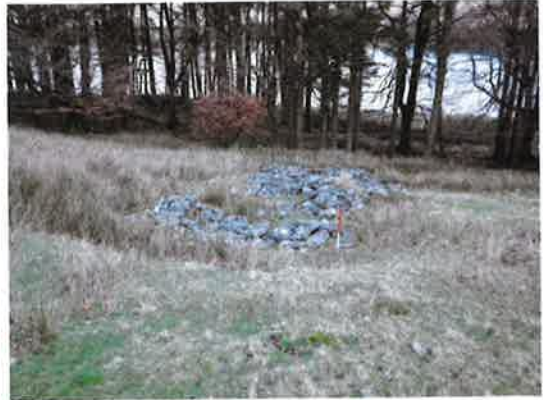
Summary: Elongated rectangular sheepfold with two cells

Description: An elongated rectangular sheepfold with two cells, one 6 x 5 m in size and the other 5 x 5 m. defined by dry stone walls 0.6 m thick and up to 0.5 m high. Much tumbled. The sheepfold appears to sit on a slight platform cut into the hill slope. Located just outside the NT property boundary.

Recommendations: Maintain in current condition

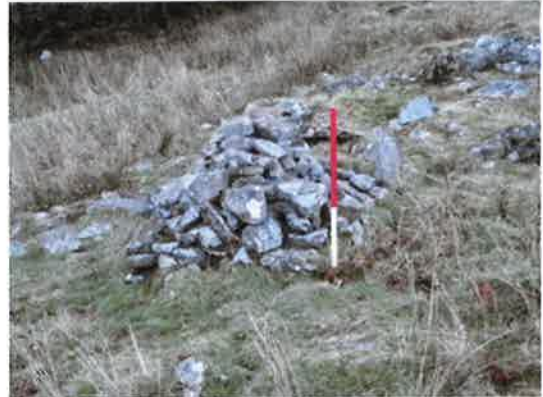
Summary: Small pile of stones

Description: A modern walker's cairn approximately
1.5 m in diameter and 0.7 m high sitting on
the NE corner of a sheep pen 860332. Located
just outside the NT property boundary

Condition: good

Recommendations: Maintain in current condition

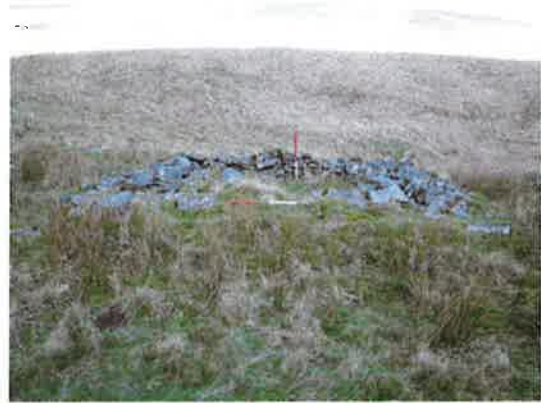
Summary: Rectangular sheep pen

Description: A rectangular sheep pen, 4 x 2 m in size, cut into the slope slightly to the west. Defined by tumbled dry stone walls 0.6 m thick and up to 0.8 m high. Located just outside the NT property boundary

Condition: poor

Recommendations: Maintain in current condition

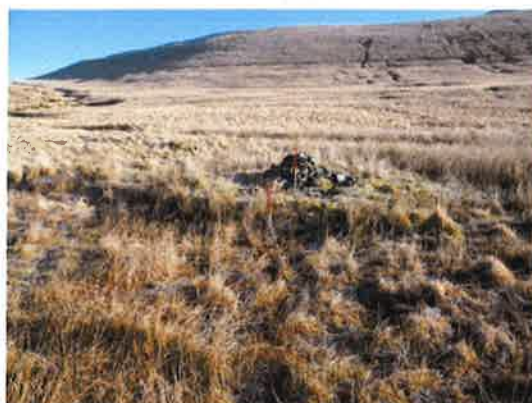
Summary: Low circular cairn

Description: Near circular low, stone cairn 6 x 5 m in size and 0.6 m high, now largely turf covered. The centre of the mound has been disturbed by the construction of a modern walker's cairn which is 2 m in diameter and 0.7 m high.

Condition: fair

Threats to Site: Potential for further damage from the walker's cairn

Recommendations: Discourage extension of walker's cairn

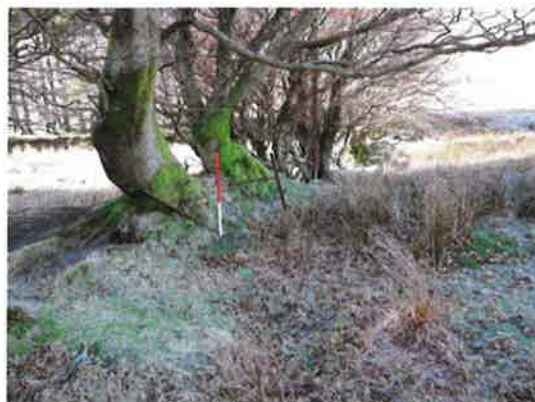
Summary: Earthen boundary bank

Description: An earth bank along the property boundary south of Gwaun Perfedd. The bank is 1.1 m wide and up to 0.3 m high with trees planted along the top of the bank. Some of these had been cut and laid to form a hedge which has now grown out. The profile is very uneven because of the level of erosion in places.

Condition: poor

Threats to Site: Along the boundary, potential for damage from fence maintainance

Recommendations: Maintain in current condition

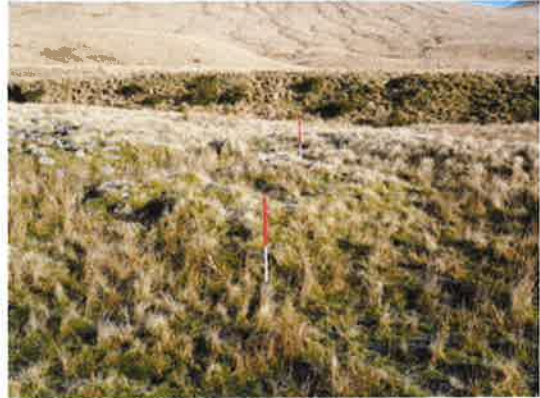
Summary: Small square structure

Description: A small square structure 3 x 3 m in size defined by a low, turf covered stony bank 0.8 m wide. The structure is aligned with 860336 to which it may be related. There are also other similar structure in the immediate area on the stream bank.

Condition: poor

Recommendations: Maintain in current condition

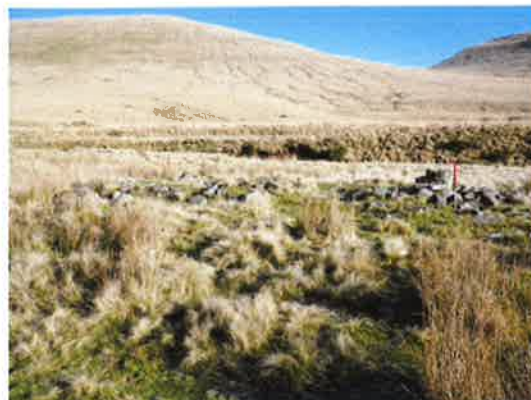
Summary: Rectangular structure

Description: A rectangular structure, 10 x 3 m in size with two equal sized cells. Turfed stone banks, 0.8 m wide and up to 0.3 m high include some stones set on end. Aligned with 860335. Located with a group of similar structures on the stream bank.

Condition: fair

Recommendations: Maintain in current condition

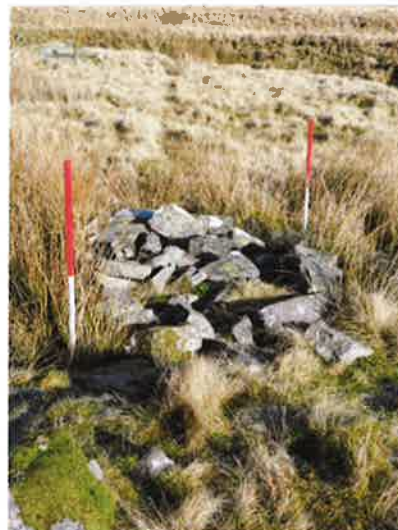
Summary: Rectangular structure

Description: A rectangular structure 9 x 5 m in size with no internal divisions. Defined by turfed stone walls 0.7 m wide and up to 0.4 m high. Collapsed stone feature suggest walls were higher. Located with a group of similar structures on the stream bank.

Condition: fair

Recommendations: Maintain in current condition

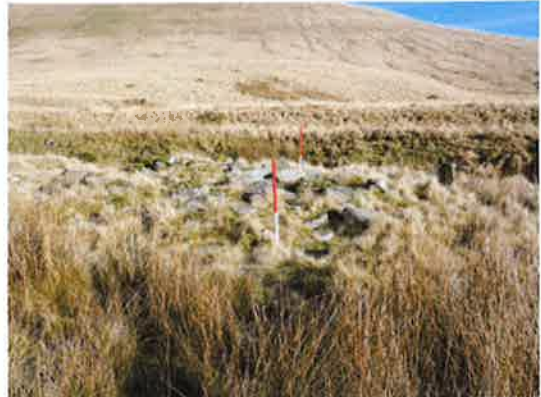
Summary: Small stone pen

Description: Small stone pen built directly adjacent to structure 860337. 2 x 1.3 m in size it is defined by collapsed dry stone walls 0.3 m thick and 0.2 m high.

Condition: fair

Recommendations: Maintain in current condition

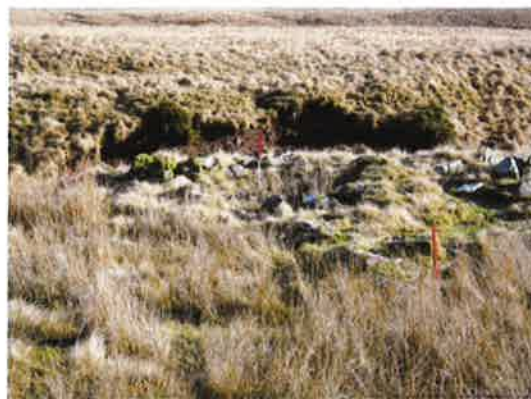
Summary: Small rectangular structure

Description: Small rectangular structure, 3 x 2.5 m in size directly adjacent to structure 860340. Not possible to define the walls which have completely collapsed into the centre of the feature.

Condition: poor

Recommendations: Maintain in current condition

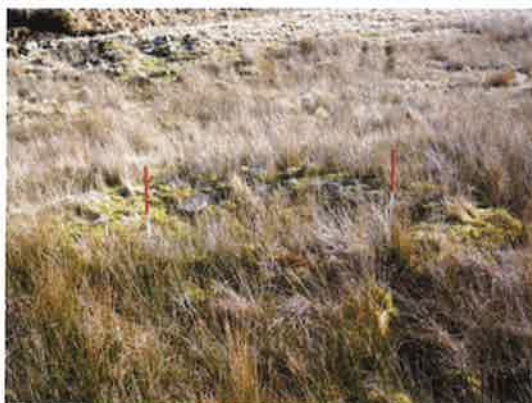
Summary: Sub-rectangular sheepfold

Description: A sub-rectangular sheepfold 2 x 4 m in size with a short length of guide wall to the west extending for 5 m. The guide wall is 1 m wide and 0.25 m high. The stoney bank defining the fold is 1 m wide and 0.5 m high.

Condition: poor

Recommendations: Maintain in current condition

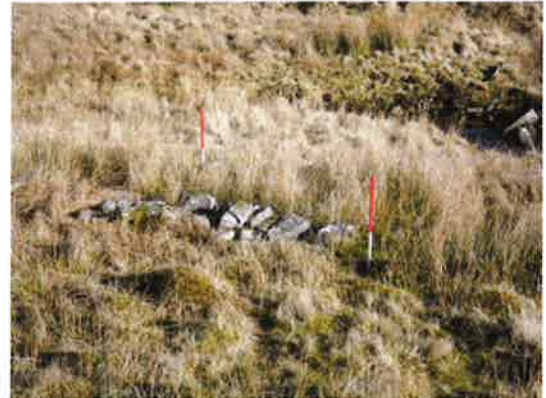
Summary: Sub-square structure

Description: Sub-square structure with a possible entrance to the north. 3 x 3 m in size. Stone banks, turf covered 0.9 m thick and 0.3 m high.

Condition: fair

Recommendations: Maintain in current condition

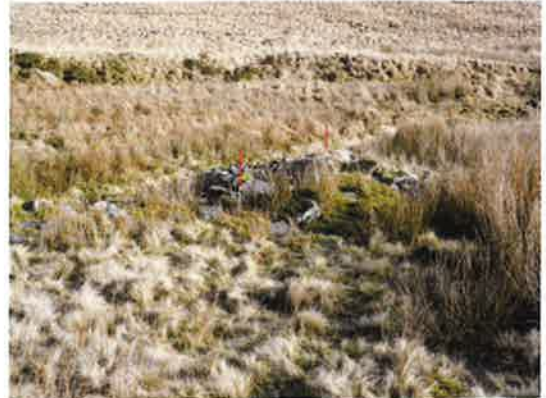
Summary: Rectangular stone built sheep pen

Description: A rectangular stone built pen 4 x 3 m in size surrounded by dry stone walls 0.7 thick and 0.3 m high. The walls are very tumbled. Located on a stream bank.

Condition: poor

Recommendations: Maintain in current condition

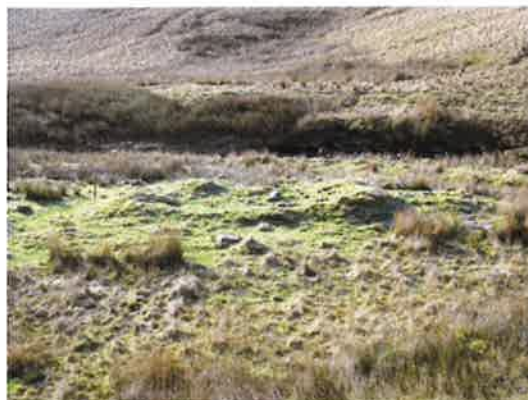
Summary: Rectangular stone built sheep pen

Description: A rectangular sheep pen with an internal measurement of 4 x 1.3 m with collapsed walls 0.6 m thick and up to 0.6 m high. The eastern edge, adjacent to a stream has collapsed into the adjacent stream.

Recommendations: Maintain in current condition

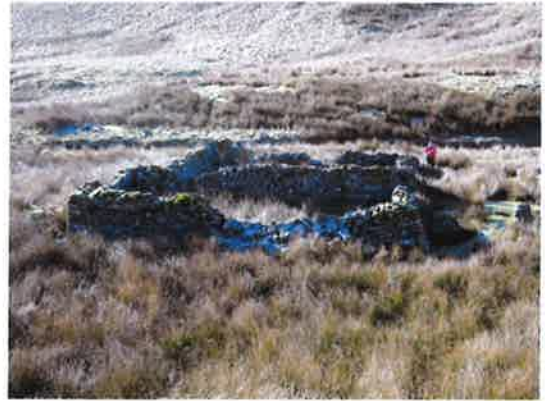
Summary: Large two celled sheepfold

Description: A large two celled sheepfold with an eastern cell 6 x 11.5 m in size and a western cell 8 x 10 m in size. There is a guide wall extending from the western end leading towards the stream by 6 m. The walls for the most part were 0.9 m thick and 1.6 m high. The most easterly wall has some collapse.

Condition: fair

Recommendations: Discourage the lighting of fires

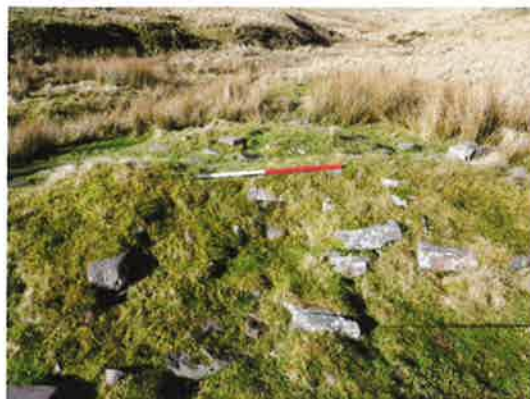
Summary: Rectangular structure with possible fireplace

Description: A rectangular structure 8 x 5 m in size with the hint of a fireplace at its northern end. The turf covered walls are 0.8 m wide along the lateral wall and either 1.2 or 1.4 m thick at the gable ends. They reach a height of 1.3 m. Areas of tumbled stone to the west and north. This building may have been used as a source of stone for the adjacent sheepfold 860344.

Condition: poor

Recommendations: Maintain in current condition

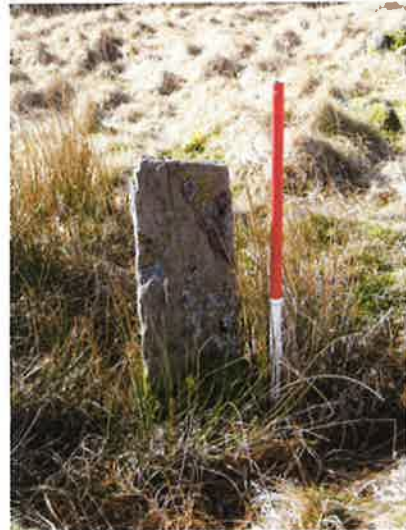
Summary: Small standing stone.

Description: A standing stone 0.25 x 0.13 x 0.7 m in size. Possibly a boundary marker.

Condition: fair

Recommendations: Maintain in current condition

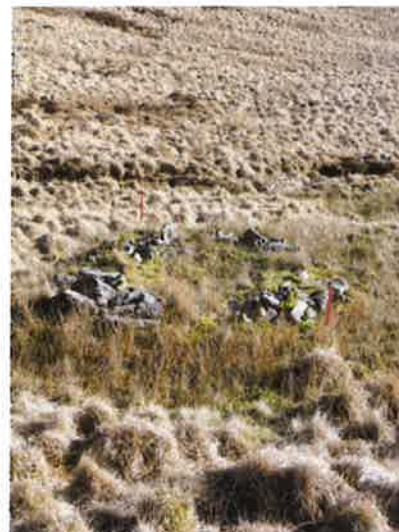
Summary: Sub-rectangular structure

Description: Turf covered walls/banks defining an area 4 x 2 m in size. The walls are 1.2 m wide and 0.5 m high. The entrance is defined by an upright slab. Located close to a stream in a group of similar structures.

Recommendations: Maintain in current condition

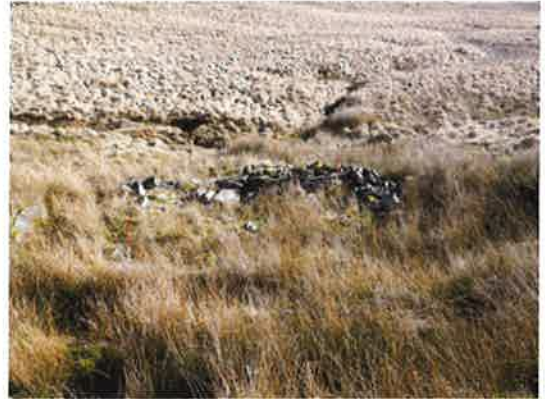
Summary: Rectangular structure

Description: A rectangular structure 6 x 4.5 m in size with the hint of a fireplace at the south end and an entrance to the east. The walls are 0.8 m thick and stand to a height of 0.6 m.

Condition: fair

Recommendations: Maintain in current condition

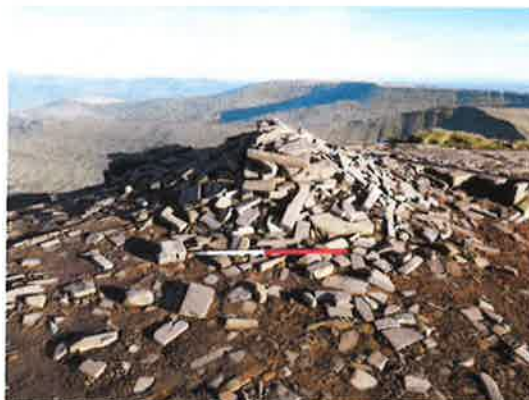
Summary: Walker's cairn

Description: A conical pile of stones 2 m in diameter and up to 0.7 m high. Constructed from small stones. Sitting on bare rock.

Condition: good

Recommendations: Maintain in current condition

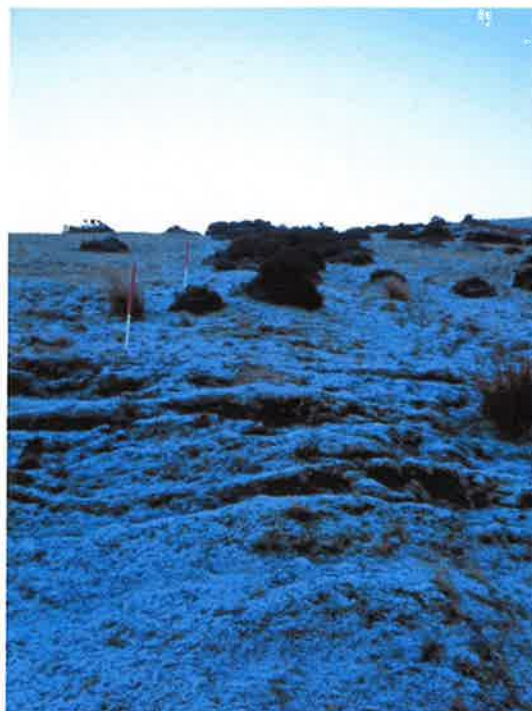
Summary: Low earthen bank

Description: A low earthen bank cutting off the northern spur of Bryn Teg. Bank 2.5 m wide and up to 0.4 high with a rather spread out, disrupted profile.

Condition: poor

Stability: rapid deterioration

Recommendations: Maintain in current condition

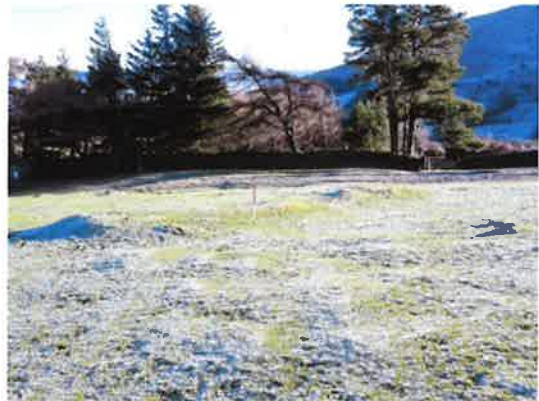
Summary: Low earthen bank

Description: A short length of notably wide bank, up to 4 m wide and 0.3 m high, this bank is aligned E-W across the very southern tip of the northern spur of Bryn Teg. The function of this bank is uncertain. It could be traced for only 15 m and has a slightly curved plan.

Recommendations: Maintain in current condition

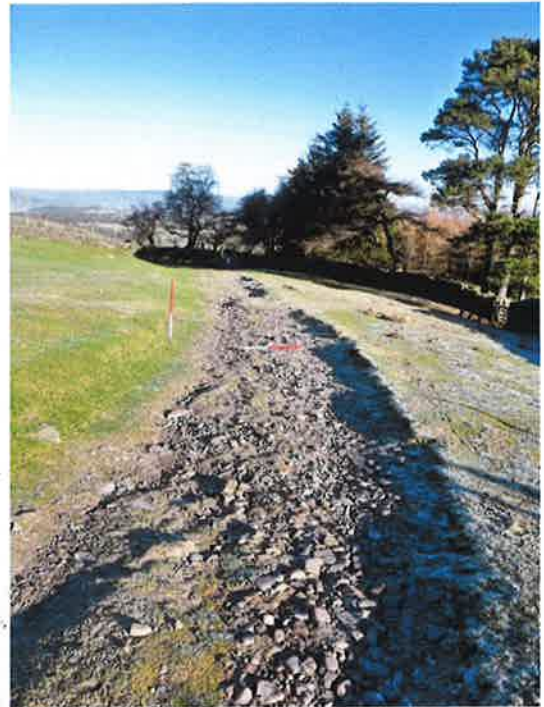
Summary: Major track

Description: A 3 m wide track cut into the hillside by up to 0.5 m in places. This is a significant trackway running along the western side of Cwm Cynwyn, crossing over Craig Cwm Cynwyn and continuing south beyond the NT property boundary. Still in use.

Condition: fair

Threats to Site: Some vehicle damage

Recommendations: Maintain

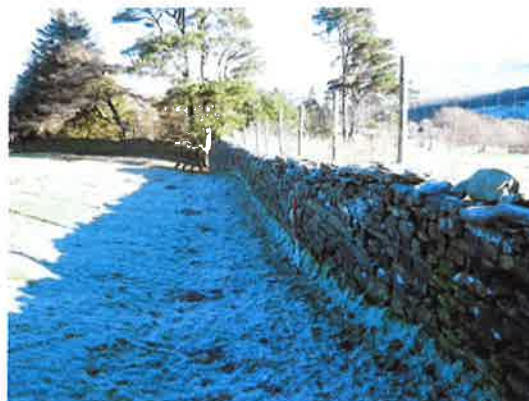
Summary: Dry stone wall

Description: A dry stone wall running alongside the track 860352 at its northerly limit. Still functioning as a boundary this wall is 0.6 m wide and typically 1.10 m high, although it reaches a height of 1.8 m in places. The condition of the wall deteriorates as it runs south, with a fence surviving as the boundary.

Condition: fair

Recommendations: Maintain in current condition

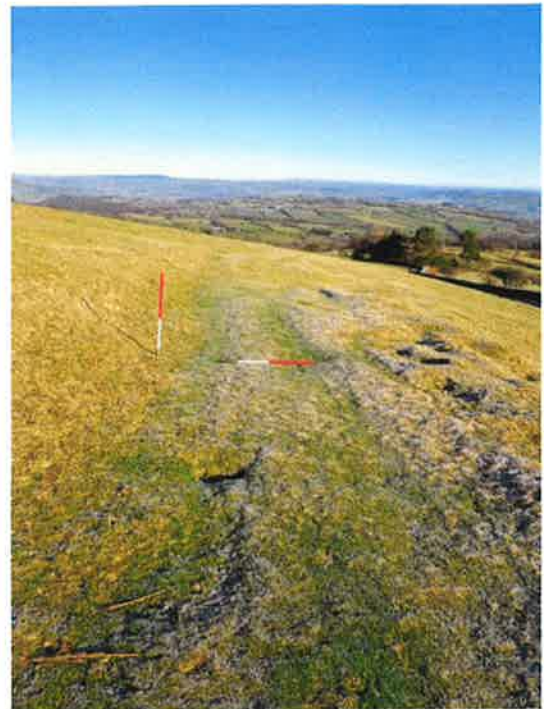
Summary: Track branching off 860352

Description: A length of track branching off track 860352. Running roughly NS along the northern spur of Bryn Teg. Up to 5 m wide and cut into the slope by up to 1 m along its western edge.

Recommendations: Maintain in current condition

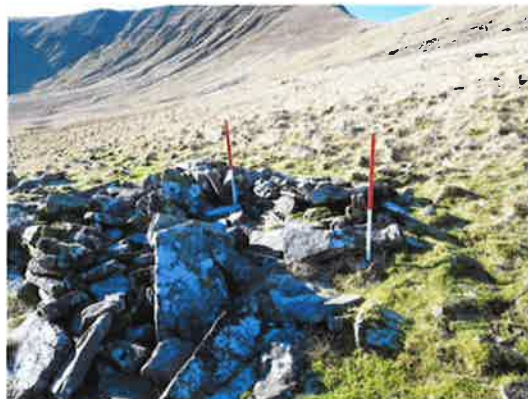
Summary: Small, near square pen

Description: A small pen, 1.4 x 1.6 m in size internally defined by collapsed dry stone walls surviving to a height of 0.5 m and 0.4 m thick. The pen was constructed amongst a pile of natural scree.

Condition: fair

Recommendations: Maintain in current condition

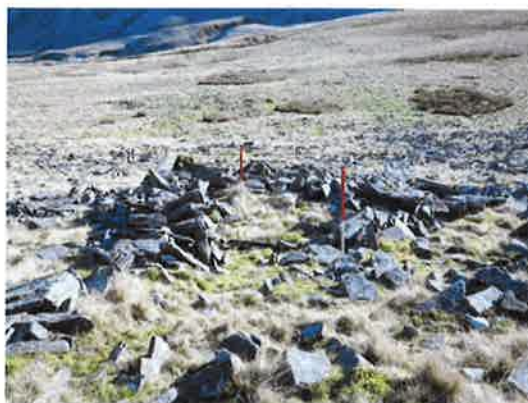
Summary: Irregularly shaped pen

Description: An irregularly shaped pen 2.3 x 2.9 m in size with dry stone walls 0.6 m wide surviving to a height of 0.8 m. Located high on the western slopes of Cwm Cynwyn in a pile of natural scree.

Condition: fair

Recommendations: Maintain in current condition

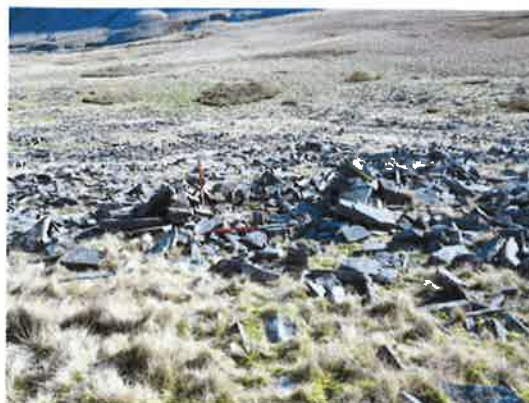
Summary: Small roughly constructed pen

Description: A small roughly constructed pen 1.9 x 1.8 m in size, internally, defined by dry stone walls 0.5 m wide and up to 0.8 m high created by clearing of stones in the natural scree into piles around the structure.

Condition: poor

Recommendations: Maintain in current condition

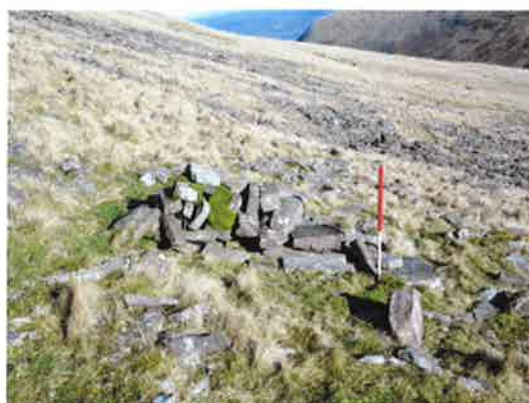
Summary: A group of twelve small piles of stone.

Description: A group of twelve small piles of stone situated on an area of natural scree on the south west flanks of Cwm Cynwyn. These appear to be collections of useful sized slabs in preparation for carting away for use elsewhere. The piles tend to be roughly rectangular in plan and are typically 2 m long, 1 m wide and 0.5 m high.

Condition: fair

Recommendations: Maintain in current condition

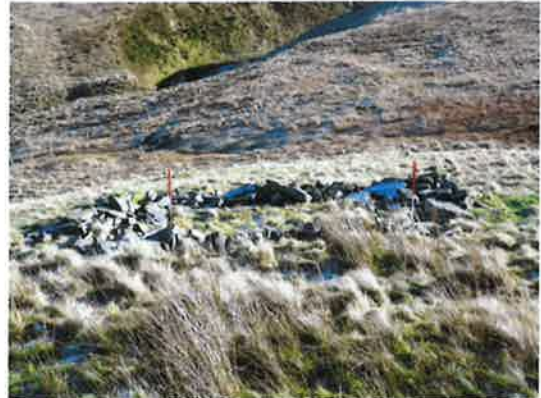
Summary: Small rectangular structure

Description: A small rectangular structure, 5 x 2.5 m in size with dry stone walls 0.5 m wide and surviving up to 0.3 m high. Rather roughly constructed, now very tumbled, probably a sheepfold.

Condition: fair

Recommendations: Maintain in current condition

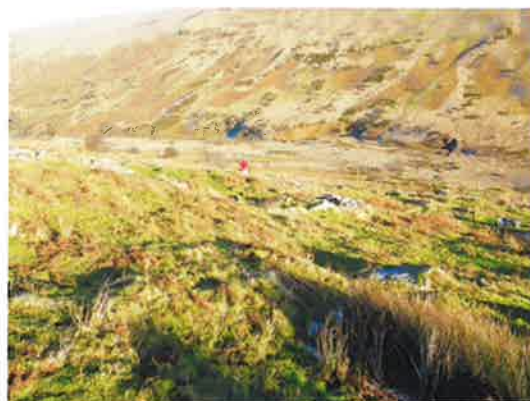
Significance: Regional Importance Condition: fair
Vulnerability: medium Survival: moderate Stability: slow deterioration
Threats to Site: Sheep runs cross the site
Recommendations: Monitor, consider a more detailed survey
County HER No: 3174, 80260, 80261 and 80262 County Name: Cwm Cywyn Hafod I
NMR Number: 142670 Other ref:
Photos: Beacons_860360 Monitor date: 20/01/2011
