*Survey Commissioned
by
The National Trust Wales Archaeologist
Office*

*Surveyed
by
I.P. Brooks
Engineering Archaeological Services Ltd*

*The Brecon Beacons Survey
2011 Interim Report*

EAS Client Report 2011/01

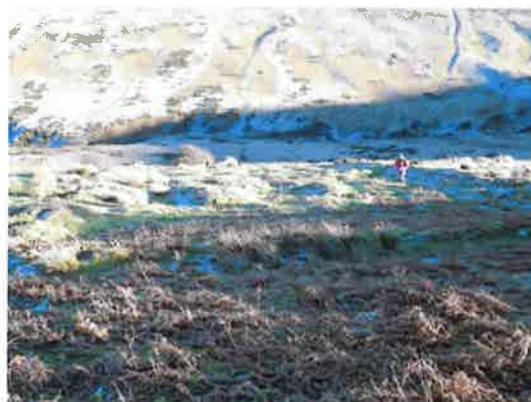
Summary: Platform with associated sub-rectangular enclosure

Description: A large sub-rectangular enclosure approximately 40 x 20 m in size divided into two fields. In the western field there is a platform 5 x 2.5 m in size running across the hill slope. The banks for the enclosure are 2 m wide and up to 0.5 m high. The platform is defined by a low turf covered banks 1.2 m wide and up to 0.5 m high. At the northern end this bank becomes 2.8 m wide. To the NE is a third, less clearly defined enclosure.

Condition: fair

Recommendations: Monitor, consider a more detailed survey

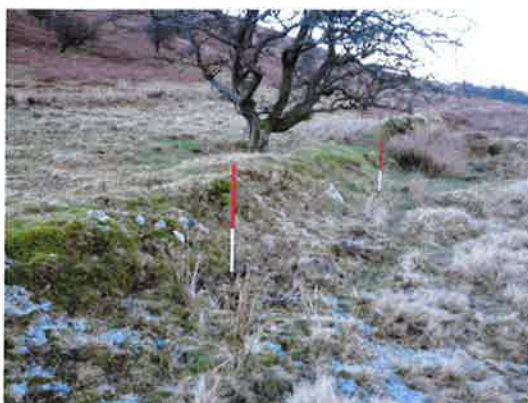
Summary: Earth and stone bank

Description: A substantial earth and stone bank, 1.7 m wide and up to 0.5 m high with sloping sides and flattish top. The bank forms a steam side enclosure adjacent to the western side of the stream in the base of Cwm Cynwyd. Associated with 860363.

Condition: fair

Recommendations: Maintain in current condition

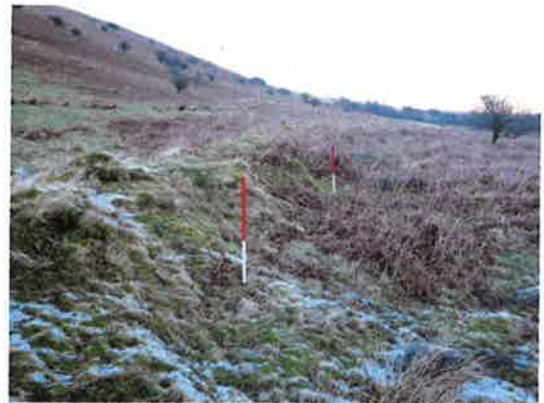
Summary: Earth and stone bank

Description: A substantial stone and earth bank similar to 860363 in character. 2.5 m wide and up to 1 m high. The bank loops around at its northern end to create an enclosure against the stream in the base of Cwm Cynwyn.

Condition: fair

Recommendations: Maintain in current condition

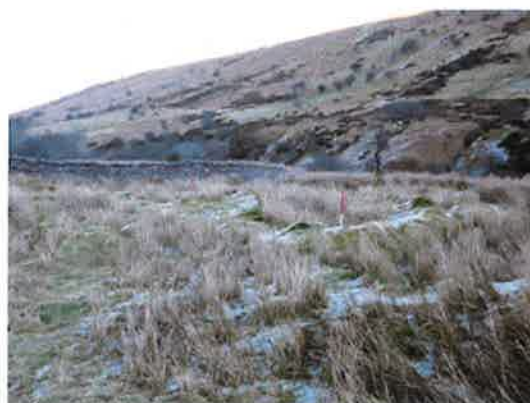
Summary: Two celled structure platform with associated field system

Description: A two celled rectangular platform 13 x 3 m in size with low earth and stone banks defining two cells, one 6 m long and the other 7 m long. The area around the platform has a range of earthen banks defining part of a field system which is an extension of the fields defined by 860363 and 860364.

Condition: poor

Recommendations: Maintain in current condition

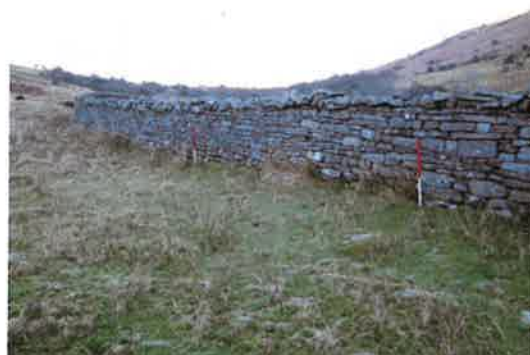
Summary: Dry stone wall

Description: A dry stone wall marking the eastern property boundary in the base of Cwm Cynwyd. 0.7 m wide and 1.4 m high.

Condition: good

Recommendations: Maintain in current condition

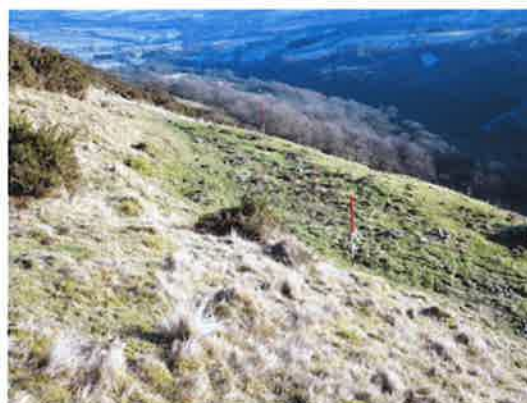
Summary: Sub-rectangular platform

Description: An elongated, sub-rectangular platform 15 x 5 m in size aligned NE-SW along the slope of the hill. Cut into the slope to the west by about 1 m and built up to the east by a similar amount.

Condition: fair

Recommendations: Maintain in current condition

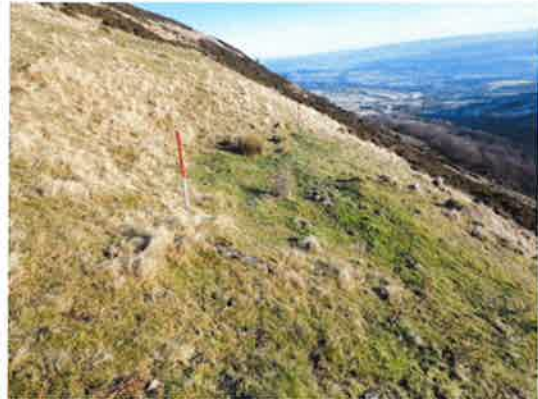
Summary: Sub-rectangular platform

Description: A sub-rectangular platform 10 x 4 m in size aligned NE - SW along the hill slope. The platform is cut into the slope by 1.2 m at its western end.

Recommendations: Maintain in current condition

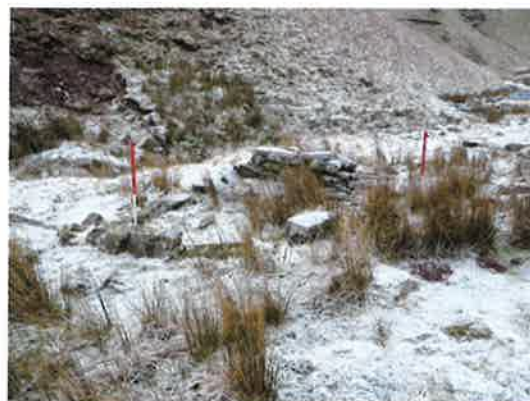
Summary: Small rectangular pen

Description: A small rectangular pen, 2.1 x 1.6 m in size, internally defined by dry stone walls 0.5 m thick and surviving up to a height of 0.6 m at the southern end of the structure. Elsewhere the walls have collapsed. Situated in the base of the stream gully at the southern end of Cwm Sere.

Condition: fair

Recommendations: Maintain in current condition

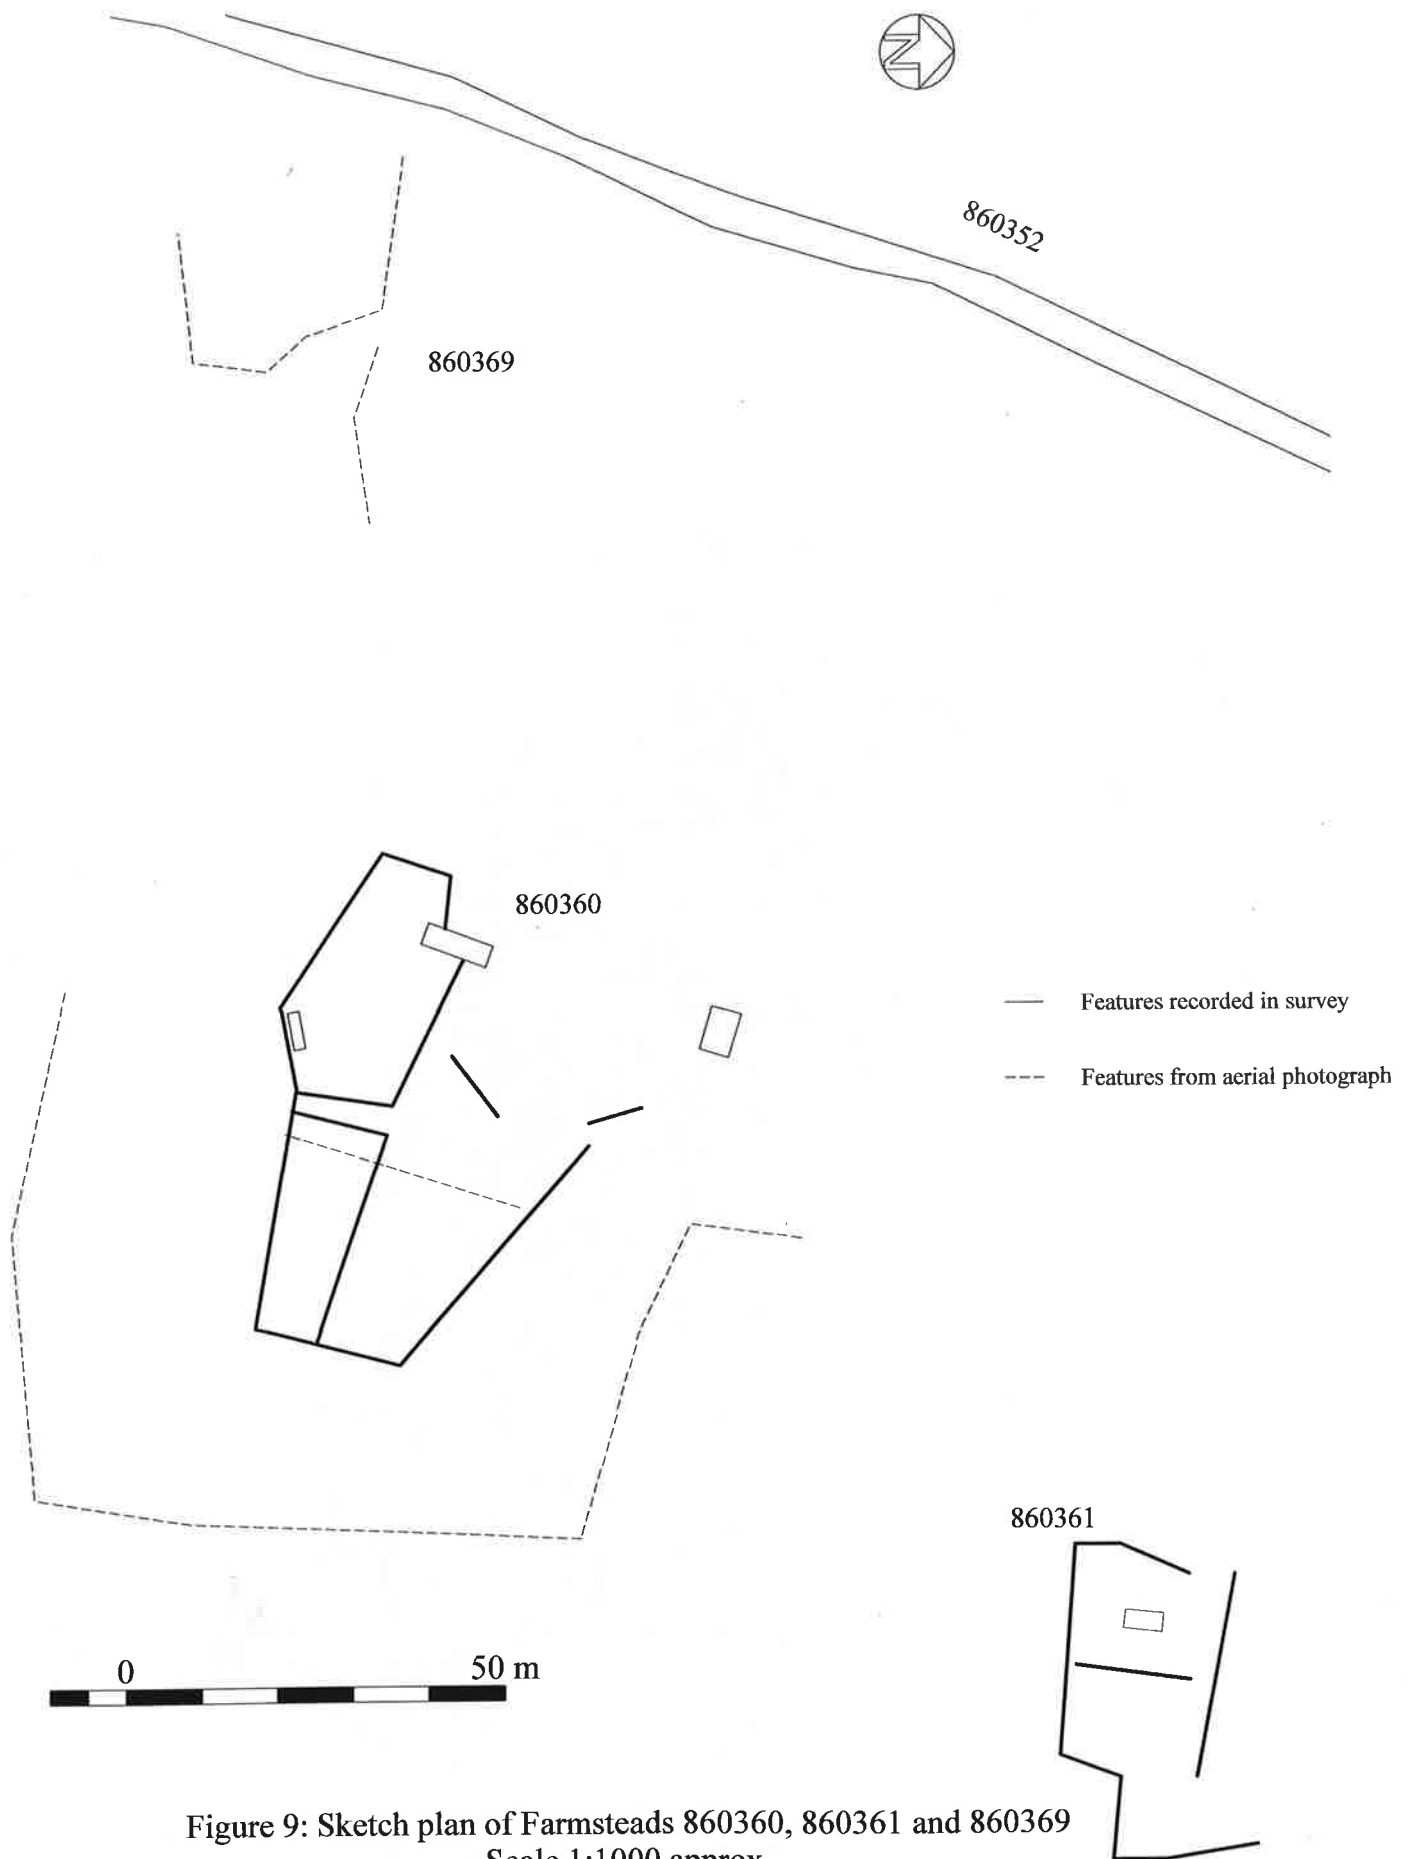
Figure 9: Sketch plan of Farmsteads 860360, 860361 and 860369
Scale 1:1000 approx.

Within Cwm Cynwyd, in the eastern survey area there are two farmsteads which are probably of medieval date (860360 and 860361, Figure 9). The largest of these (860360), contains three rectangular building platforms and an associated field system. The platforms range in size from 6 x 4 m to 9 x 3 m in size, two of which appear to be incorporated into the field system, defined by stone and earth banks, and the third sits just outside. The field system covers an area of approximately 65 x 50 m and includes the remains of at least three fields.

The field systems associated with 860360 and 860361 have already been discussed; however, the aerial photograph of this area shown on Google Earth (<http://maps.google.co.uk/maps?ll=51.887444,-3.4058237&z=16&t=h&hl=en-GB>) suggests that there may be a larger field system shown as crop mark only (Figure 9).

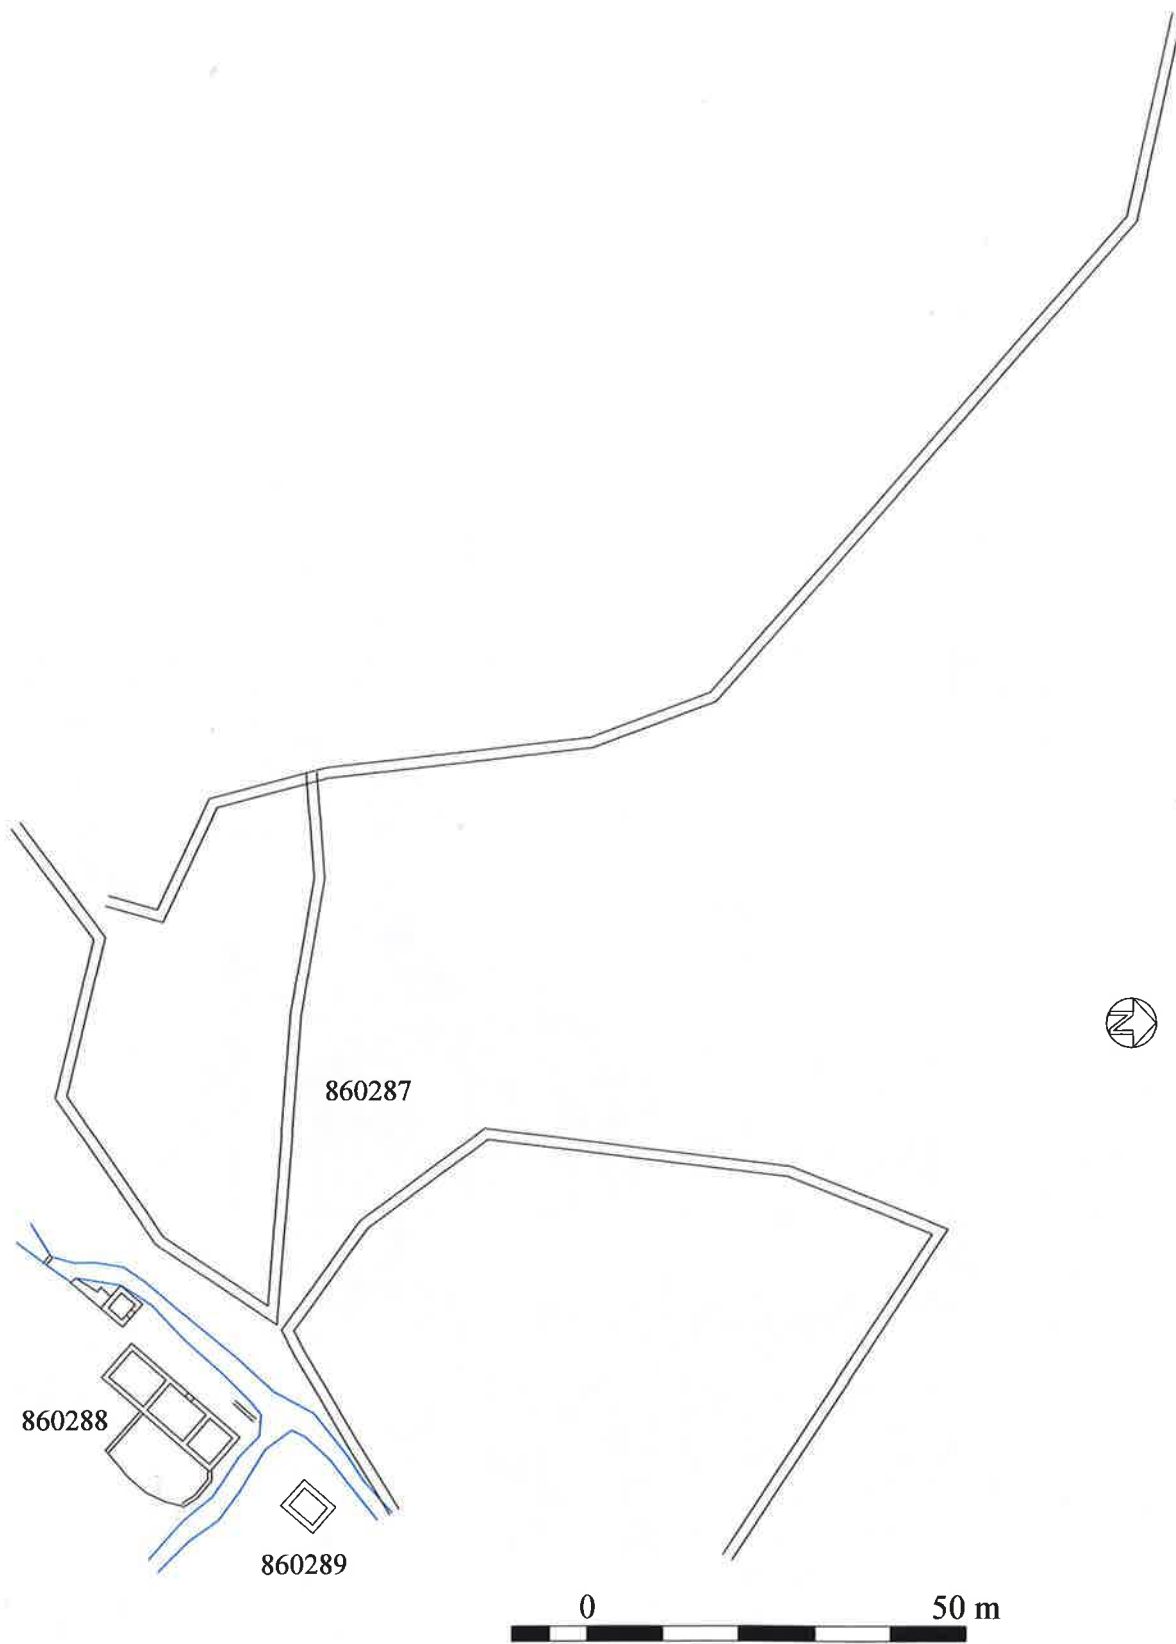
Figure 10: Sketch plan of Buildings 860288 and 860289
and Field System 860287
Scale 1:1000 approx.

At the southern end of the land farmed by Blaen Glyn Farm 860288 was a complex of structures including a three celled building 19 x 6 m in size (Figure 10). Slightly to the north west are the remains of a second building 3 x 4 m in size with a stone platform to its north west. This platform appears to be at a similar level to a short length of dry stone walling blocking the adjacent stream. It is possible that the platform is a leat support and that the second structure housed either a water wheel or a tank which was fed from the stream. The structure complex would also appear to be related to a field system on the

The second field system is represented by a range of earth and stone banks in the southern end of the land farmed by Blaen Glyn Farm, to the west of the Afon Tarell (Figure 10). This is most developed at its southern end (860287) where it is associated with a range of buildings (860288 and 860289) alongside one of the streams. Other fragments of this field system survive to the north (860274, 860276, 860277, 860278, 860280, 860284 and 860286). 8602274 is of particular note as it includes an original gateway marked by upright stone slabs defining a 1.5 m gap in this dry stone wall.

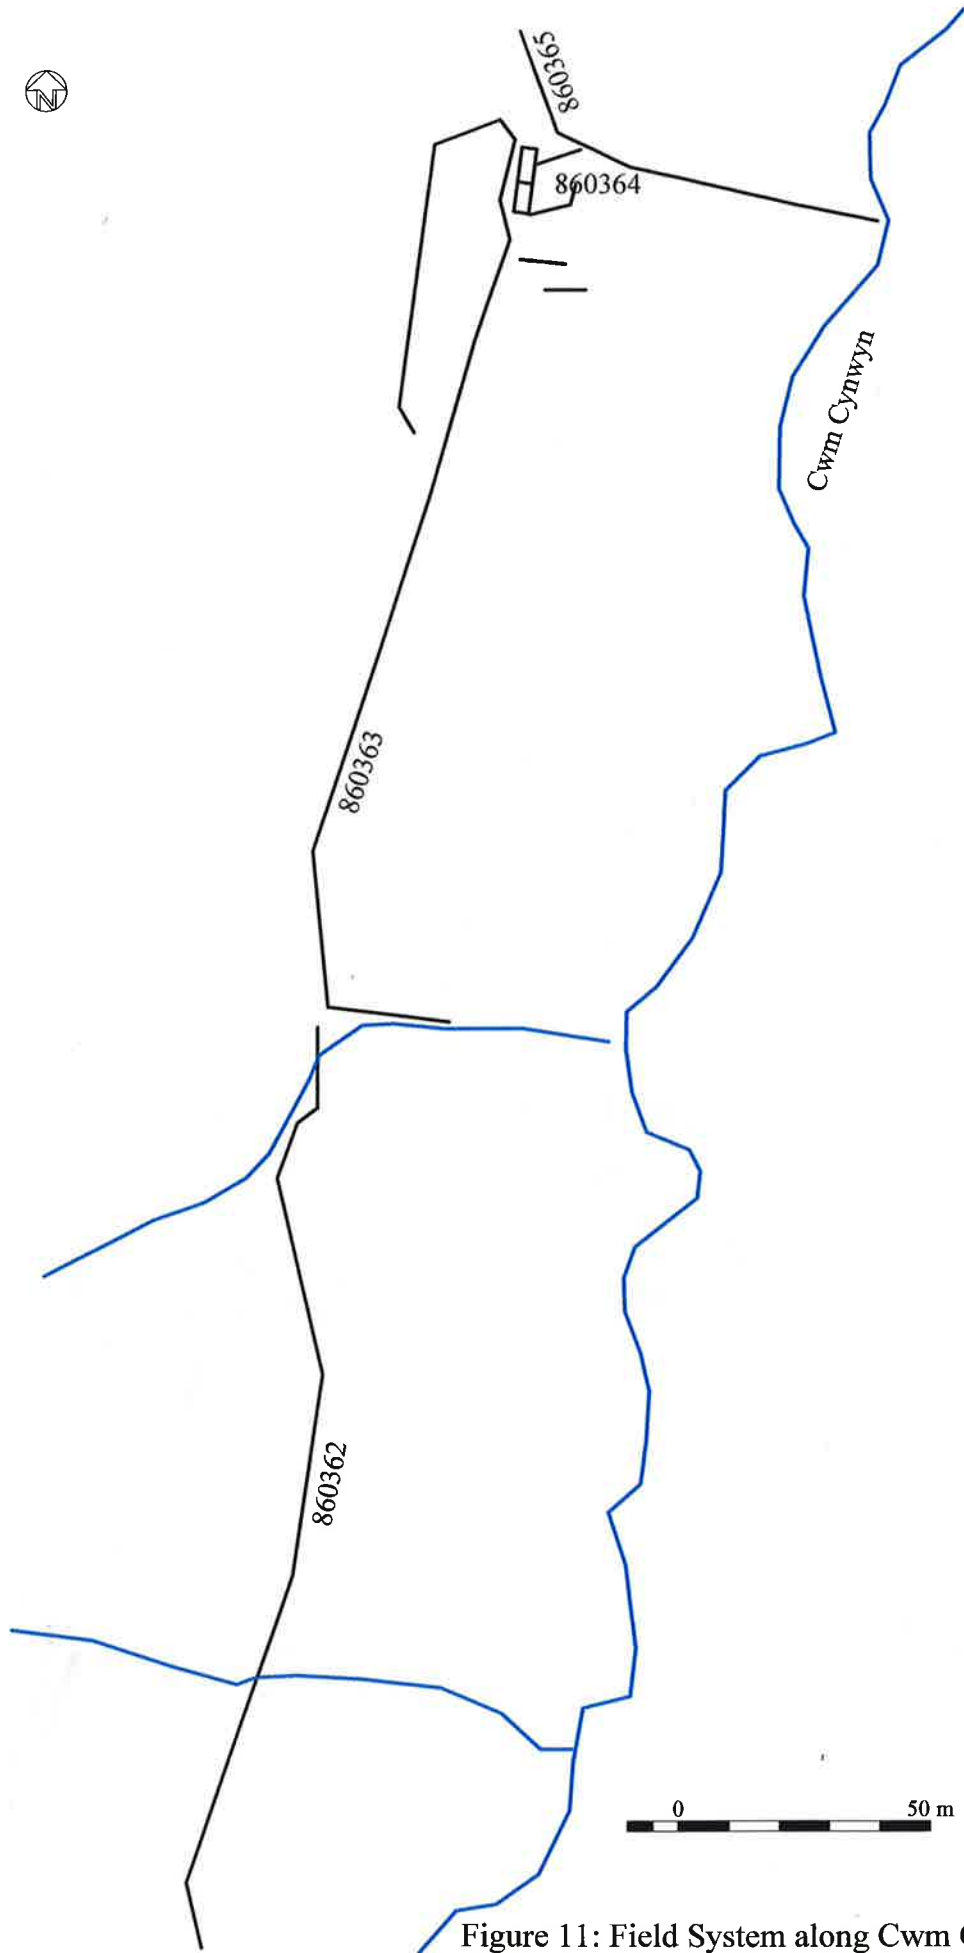
Figure 11: Field System along Cwm Cynwyn
Scale 1:1500 approx.

The larger structure (860364) is 13 x 3 m in size and is divided into two cells (Figure 11). It also sits within a field system defined by the earthen banks 860362, 860363 and 860364 along the western banks of Nant Cynwyn

Along the western bank of Nant Cynwyn a series of earthen banks (860362 and 860363) form a series of fields along the stream (Figure 11). This system also has a single platform 860364 and small paddocks at its northern end.
