THE CLWYD-POWYS ARCHAEOLOGICAL TRUST

*Nantclwyd House, Castle Street
Rhuthun, Clwyd*

SUMMARY REPORT

Nantclwyd House, Castle Street, Rhuthun (SJ 1235 5818)

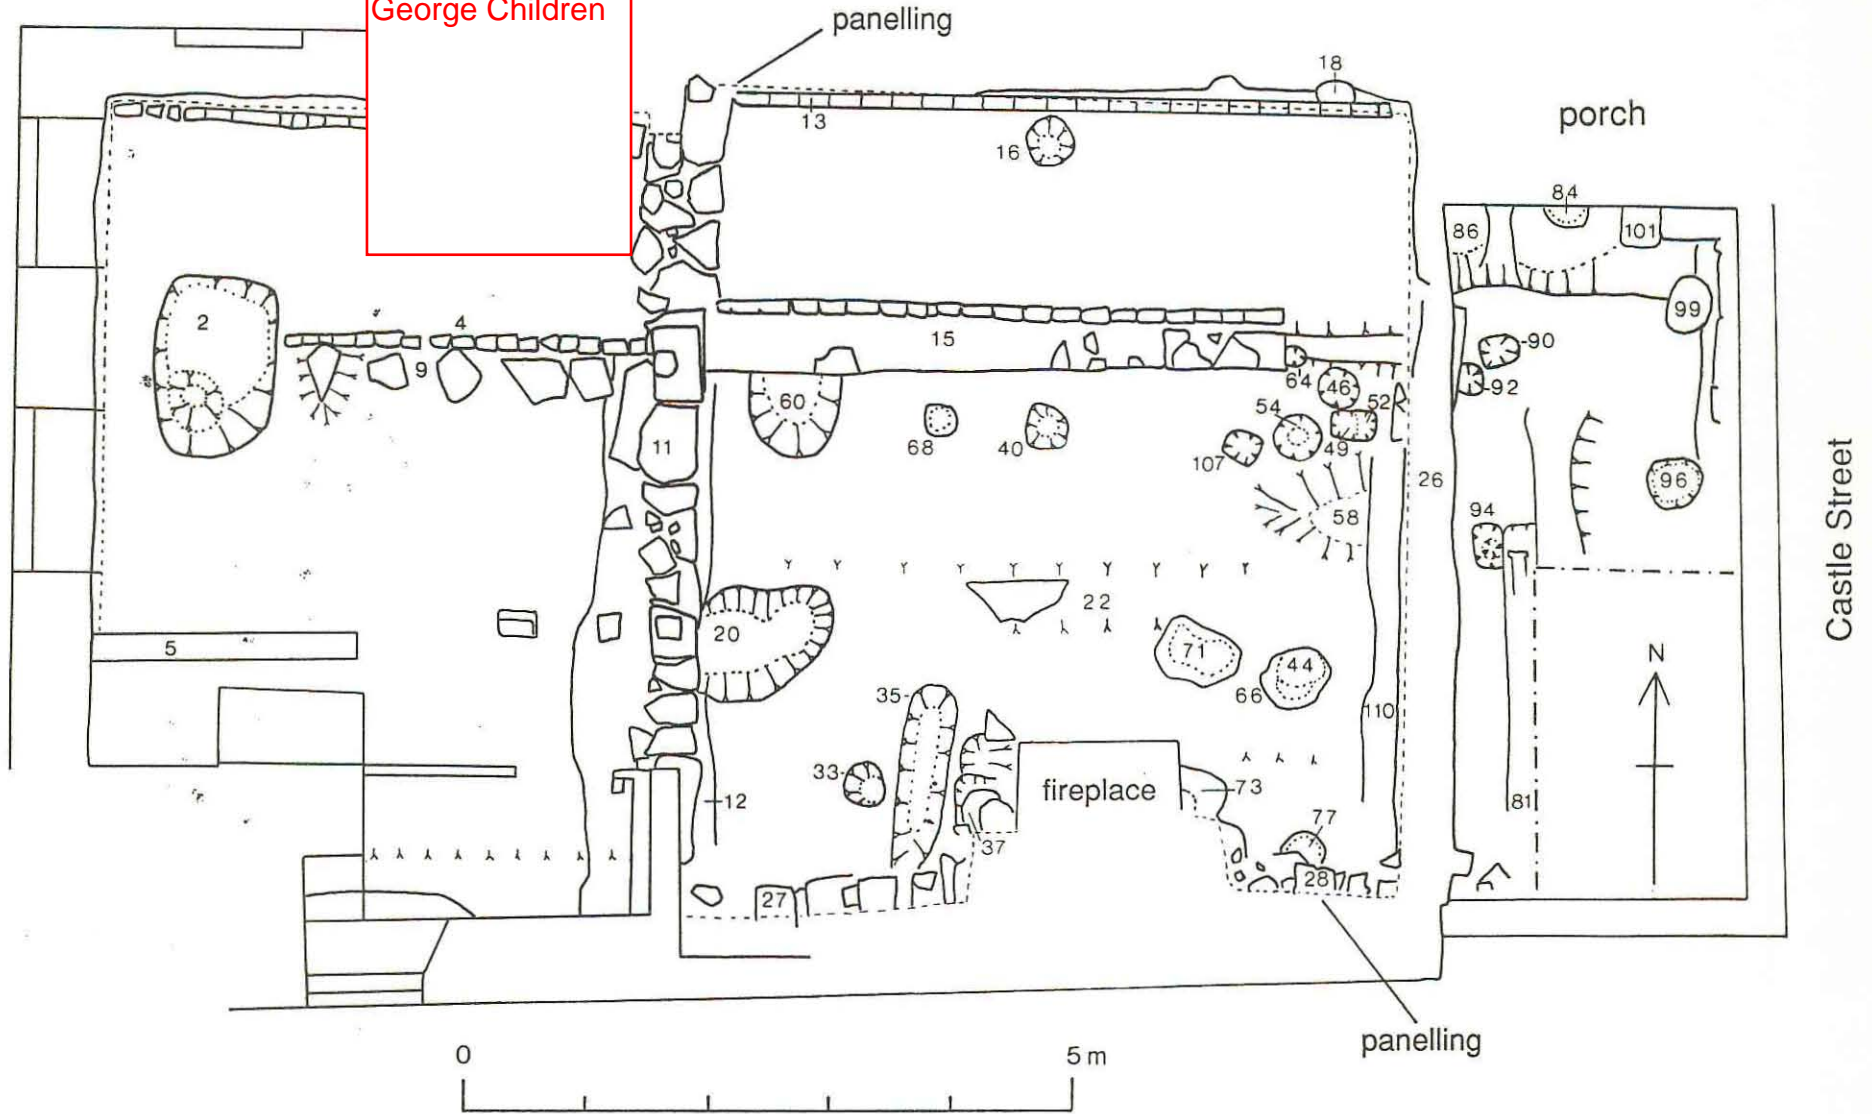
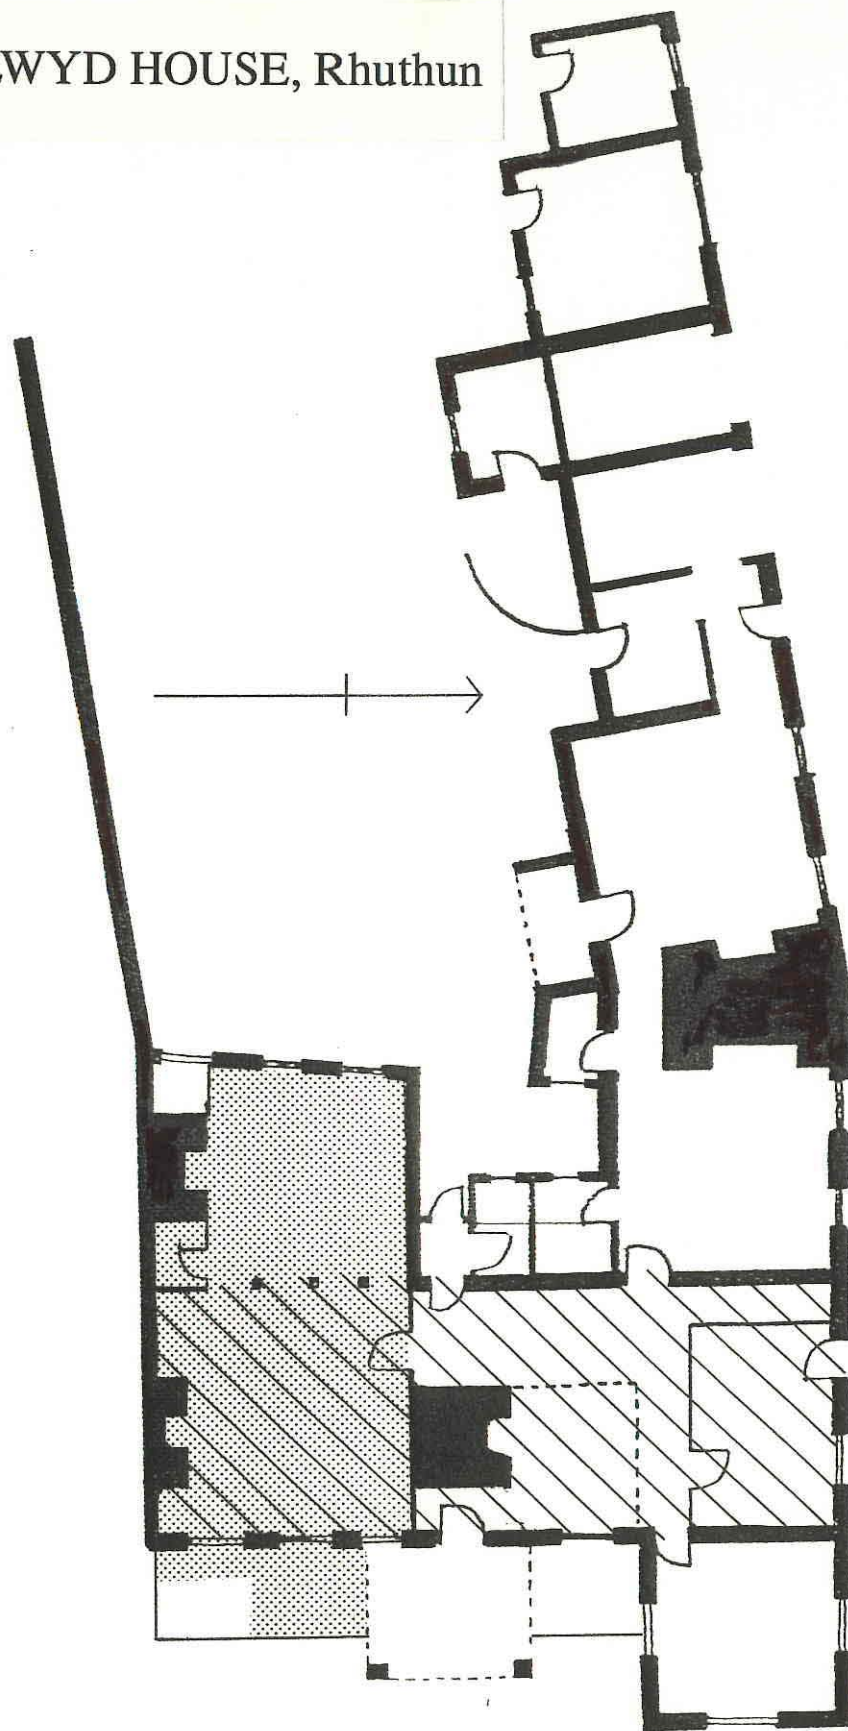
NANTCLWYD HOUSE: plan of excavations

cruck-framed hall-house

area of excavation

As part of the restoration process the Clwyd-Powys Archaeological Trust were invited by Clwyd County Council to excavate and record the area beneath the floor in the south parlour, together with a small area at the front of the house. It was hoped that the excavations would reveal earlier floor layers and internal wall divisions which might help to elucidate the earlier building phases of the house and any earlier phases of activity. The excavations were carried out over a two week period during March 1991.

Excavations at the front of the house consisted of a trench 0.70m wide against the exterior of the east wall, and an adjoining area about 3 x 1.75m to the south of the porch. Part of the area had been disturbed by a modern drain, context 81. Removal of about 15 cm of overburden revealed a layer of roofing shale (context 79) which extended beneath the wall footings of the east wall. At the south end, the footings lay above soil layer 80, which contained daub and charcoal, with no evidence for a construction trench along the length of the wall examined. A number of features were recorded, some of which cut through context 79, but none being necessarily early in date.
