Axton Water Mains Refurbishment

ARCHAEOLOGICAL CONTRACTED WATCHING BRIEF

CPAT Report No 261

Report for Dwr Cymru:Welsh Water (North East Division) Ltd.

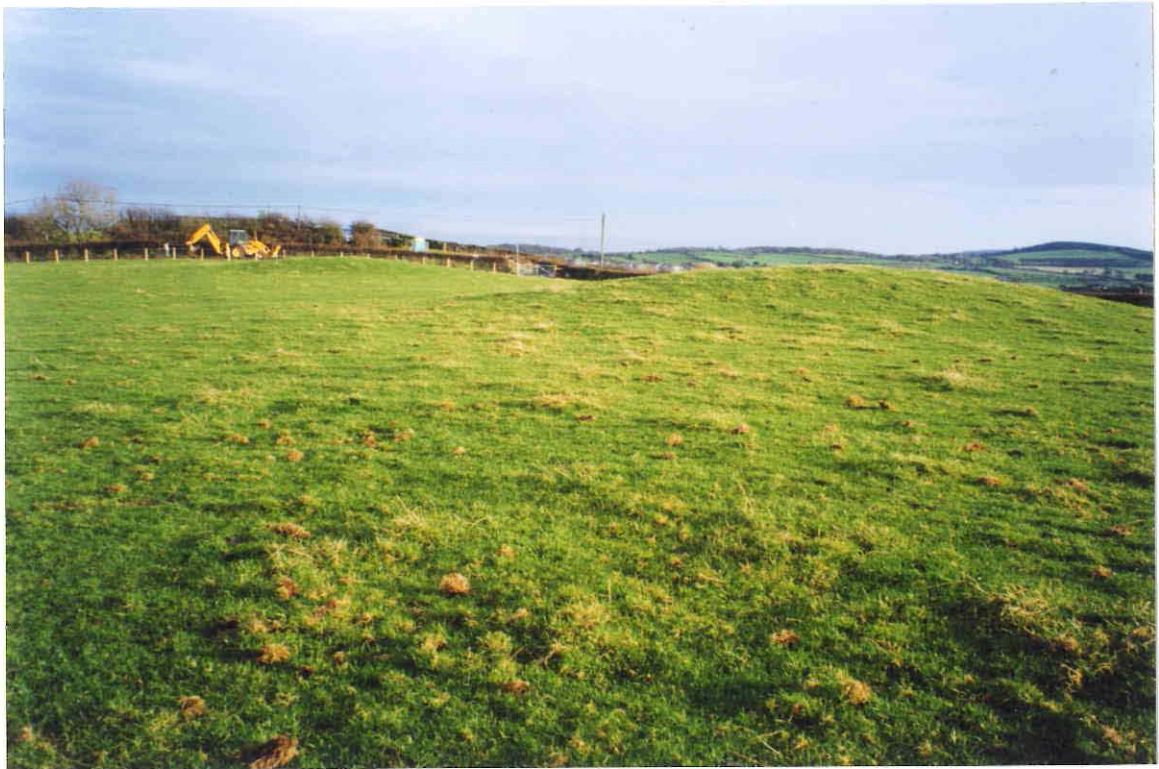
PLATE 1 Axton Barrow sites PRNs 102466 (foreground) and 102467 (background).
View from west, towards pipeline corridor.

| | Turf covered mound in field of improved pasture, measuring c.20m diameter and rising to 1.8m max. height above the level of the field on the south side. Best preserved of Axton barrow group. | |
| | Turf covered mound in field of improved pasture, measuring 18.3m diameter and rising to 1.5m max. height above the level of the field on the north side. | |

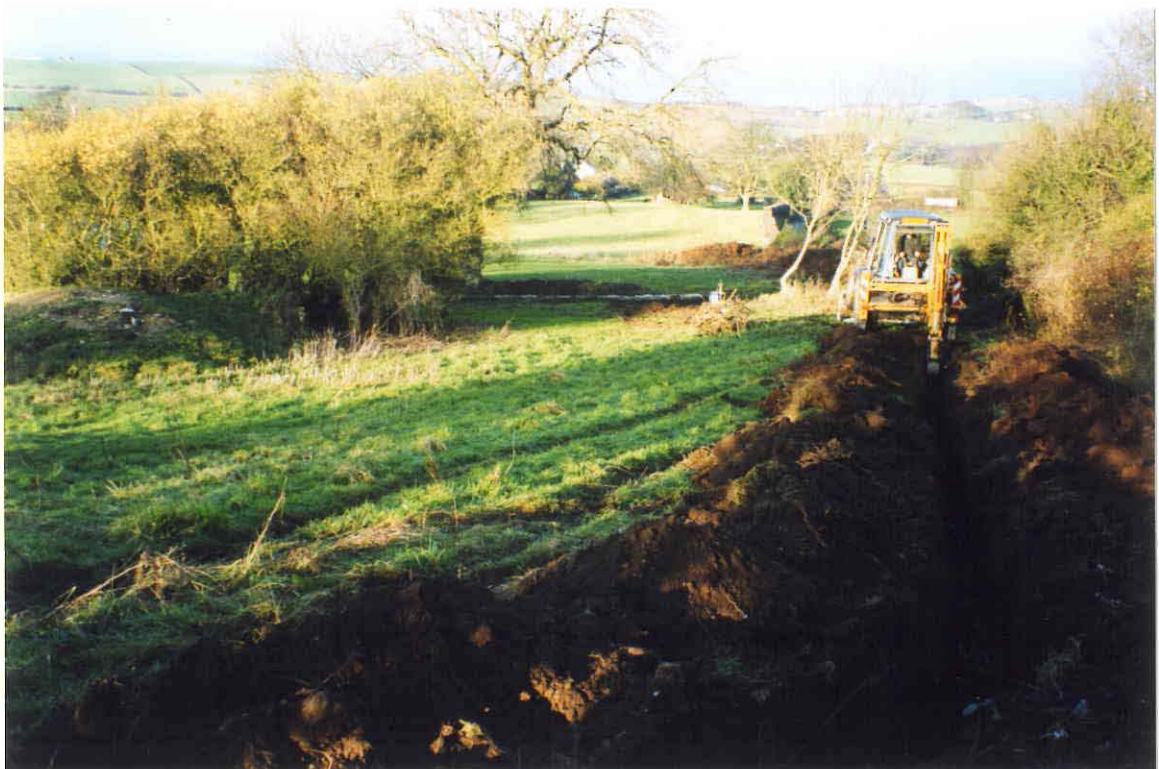
PLATE 2 Site 1. Ash Cottage Shaft, South and pipeline excavation trench.
View from south.

| | Shaft and grassed-over spoil mound located south-west of Ash Cottage. Westernmost shaft on the parallel joint, south of the Axton main vein. Part of Mynydd Axton mineworkings (Site 4). | |

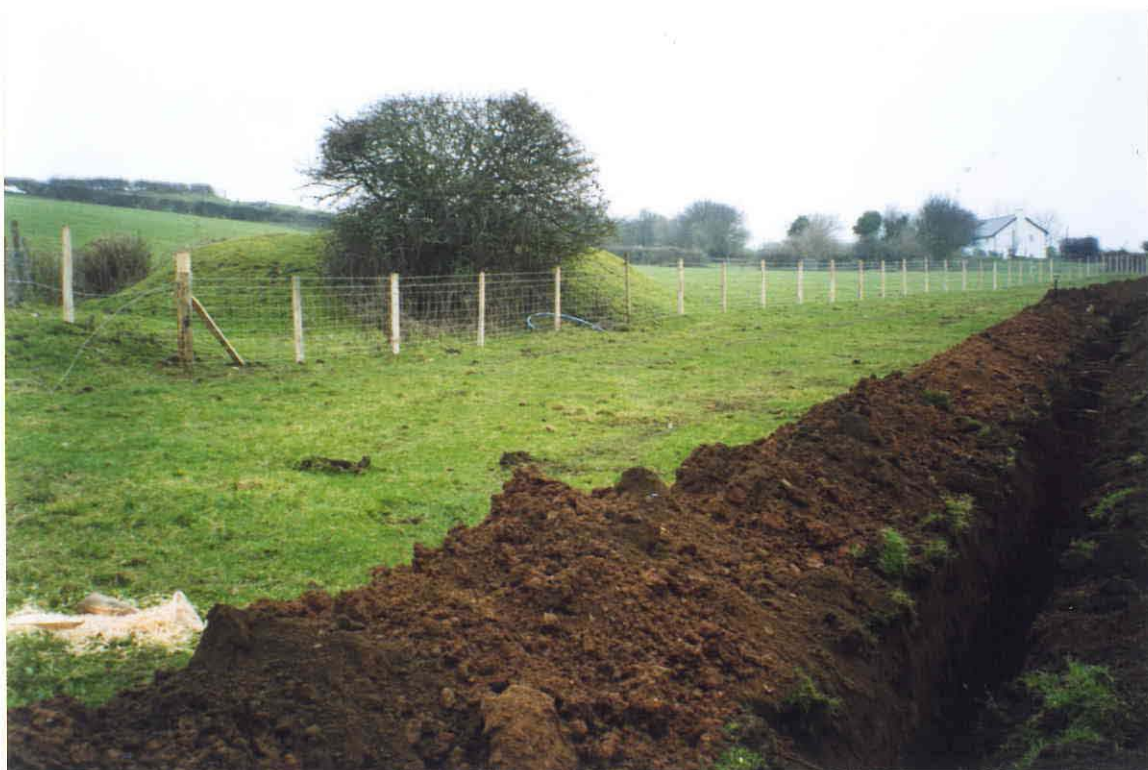
PLATE 3 Site 2. Ash Cottage Shaft, North and pipeline excavation trench.
View from west.

- 4.8 In the trench cut near Ash Cottage shaft north (Site 2; SJ 1042 8043), a small spur was cut to facilitate connection to a stop pipe, which was sited in the north side of the spoil mound. In excavating this small trench, the topsoil removed was a darker brown in colour and the fill was redeposited darker brown sandy soil, a slightly dirtier version than the undisturbed layers beneath the ploughsoil. Several lumps of calcite were recovered, a mineral associated with lead veins.

| | Shaft and spoil mound located immediately north-west of Ash Cottage. One of the shafts on the Axton Vein, worked by Axton Mine (PRN 103308). | |

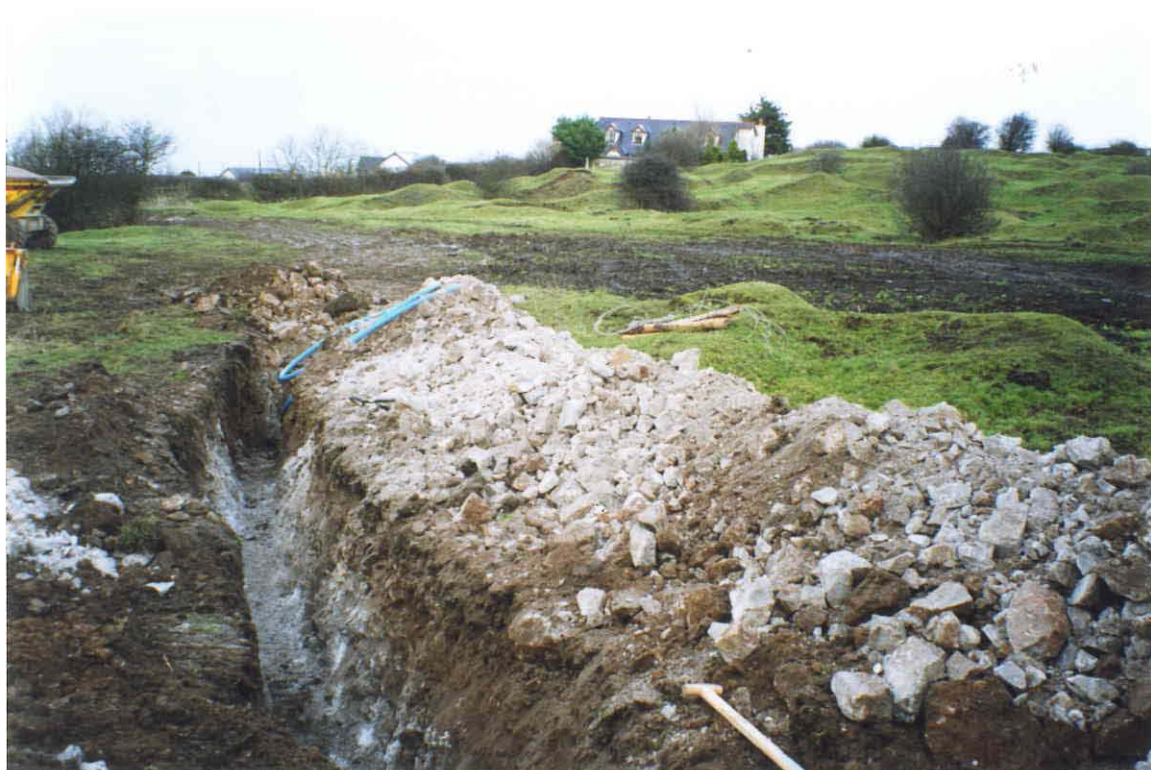
PLATE 4 Site 5. Area of early quarrying. Pipeline excavation trench encountering the natural
Carboniferous Limestone of Axton ridge. View from south.

- 4.5 The sides of the trenches failed to reveal any new archaeological features, but confirmed the geological surveys and mapping of the area (Rudeforth *et al* 1984; Smith 1921; Webb 1923). Across the ridge, the bedrock of the Carboniferous Limestone lay directly below c.0.2 - 0.3m of ploughsoil. Elsewhere, on the north side of the ridge, c.0.3m max. of the brown humic stone free ploughsoil overlay c.0.45m of light brown sandy soil with very little stone. A clean reddish/brown sticky boulder clay was located beneath the sandy layer to the base of the trench. The limestone in the sandy layer increased and became more compacted towards the ridge.

| | Area of former mining and quarrying activity occupying Plot 1926, as surveyed on the 1964 OS map (Flintshire Sheet SJ 1080). Quarrying appears to post-date the earlier exploration for lead on the west end of the Axton vein. Includes one U-shaped quarry, recorded as "Old Quarry" by the OS in 1870. | |
