*Llansantffraid Sewage Treatment Works*  
ARCHAEOLOGICAL ASSESSMENT

CPAT Report No 219

**R. Hankinson**  
March 1997

Report for Severn Trent Water Ltd.

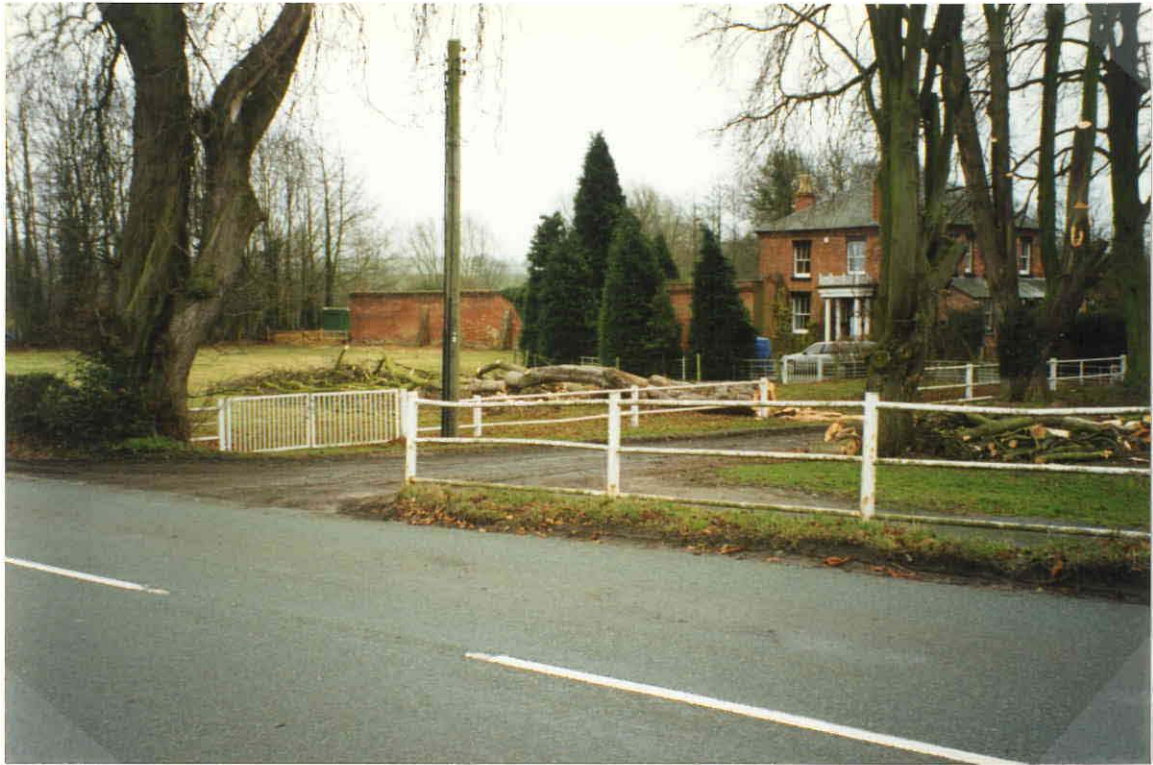
**Site No 1 from North**

The majority of the buildings relating to the Mill complex are located outside the defined "Area of interest"; the extant buildings include the mill itself, a substantial brick built house, and a range of

outbuildings. All the buildings are built of brick and would appear to date to the late 18th, or perhaps early 19th, century; the mill complex is first depicted on the Ordnance Surveyors drawing of 1829-30. The only building which falls within the area of the assessment is an L-shaped block of outbuildings. The outbuildings are depicted as a square block on the Tithe map, and the footings of the south-eastern end of the block are of mortared stone, which suggests that the building depicted on the Tithe map was built of mortared stone and was rebuilt prior to 1886 when the First edition Ordnance Survey 1:2,500 map was published. This may have implications for the age of the mill site as a whole.

**Importance C**

6.2.1 The extant buildings relating to this former mill appear to be in private ownership, and it seems unlikely that they will be disturbed by the implementation of the scheme. Examination of the relevant cartographic sources suggests that any former buildings which may have been related to the mill are unlikely to be found to the south-east of the present buildings.

6.2.2 It seems unlikely that any disturbance of the site will be considered. However, if this is not the case, further examination of the area including rapid recording of any standing buildings, and perhaps excavation to determine whether there were any previous buildings on the site, may need to be considered.

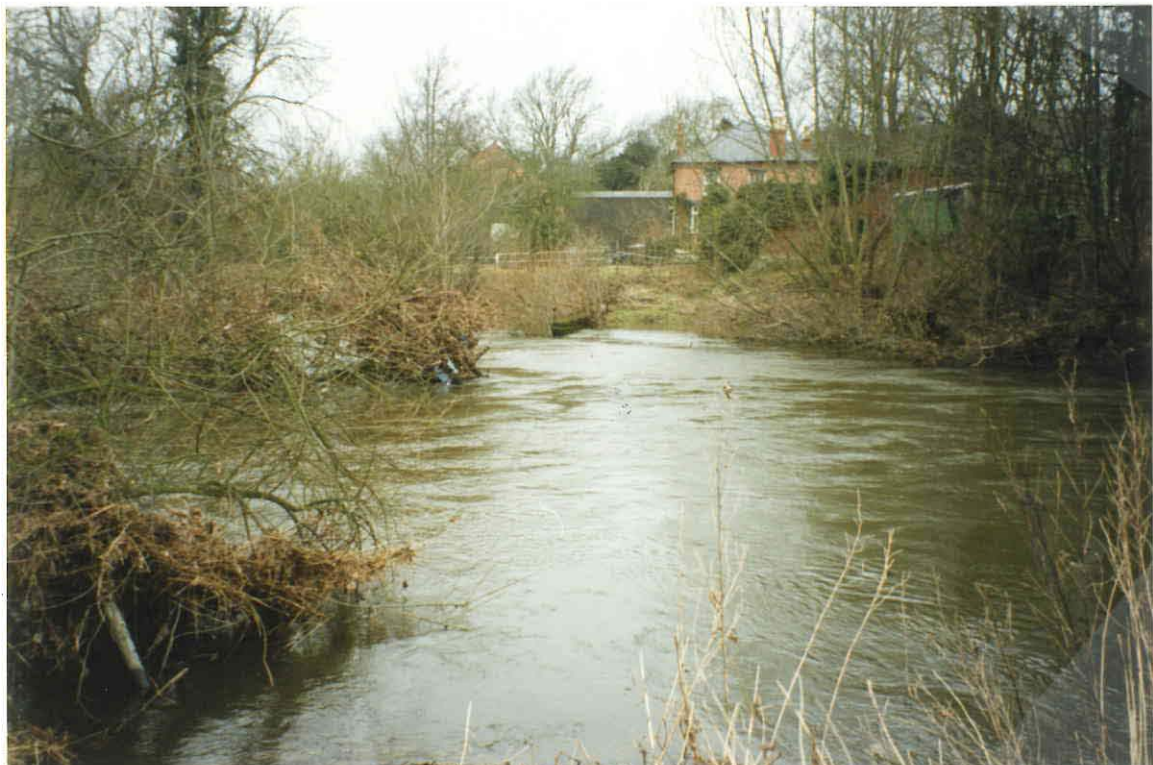
**Site No 2 from South-East**

The first definite depiction of the mill weir is on the 1886 Ordnance Survey map, although the Ordnance Surveyors drawing of 1829-30 has a faint line crossing the river which may represent a weir. The present weir is built of concrete and appears to date to the later 19th century, although it could not be examined closely due to high water levels. The north-western end of the weir nearest the mill survives for a length of c.15m, but the central section is missing, and it appears ruinous on an aerial photograph taken in 1947. The south-eastern end of the weir appears to be covered by river alluvium. The leat leading from the River Vyrnwy to the mill is evident on the Tithe map of 1840, but the method of abstracting water from the river is unclear.

**Importance D**

6.3.1 It is almost inevitable that the line of the weir will be crossed by elements of the proposed works. The late date of the weir, combined with its survival on the north-west and south-east banks of the River Vyrnwy make it unlikely that any specific recording prior to the start of groundworks will be necessary. However, in view of the potential for there being an earlier weir on the site, it may be worthwhile for a watching brief to be carried out during any potential construction work on the line of the weir. It would be preferable that any works crossing the line of the weir do so through its missing central section.

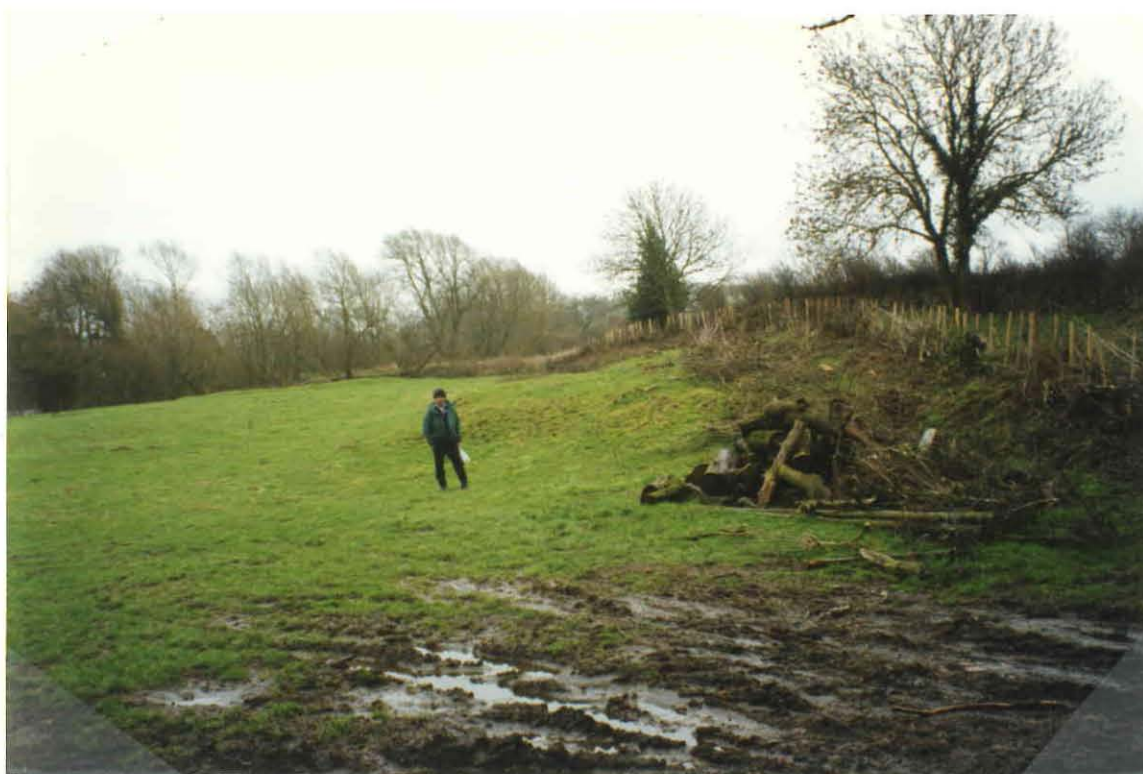
**Site No 3 from North-West**

The presence of a brick kiln in the field to the south-east of the present sewage treatment works is suggested by the 1798 enclosure map which names the field as "Brick kill field" and "At the Brick Kiln". Examination of the field during the fieldwalk survey revealed a possible site for the kiln which is given above. The kiln appears to have been built into the side of a bank which defines the north-eastern side of Lletty Lane. The likely remains of the kiln are represented by a semi-circular earthwork which protrudes into the field measuring 27m north-west/south-east, with a semi-circular earthwork of 10m diameter added onto its north-east side. The earthworks are embanked to a height of 1.4m above the level of the field. The upper part of the smaller earthwork has an approximately central hollow which may be the site of the kiln.

**Importance B**

6.4.1 This probable former brick kiln appears to be located entirely to the north-west of Lletty Lane. Accordingly, if the site works are restricted to Lletty Lane itself, it seems unlikely that the site will be disturbed. If any site works are planned for the area of the brick kiln a programme of EDM survey and excavation should be considered.

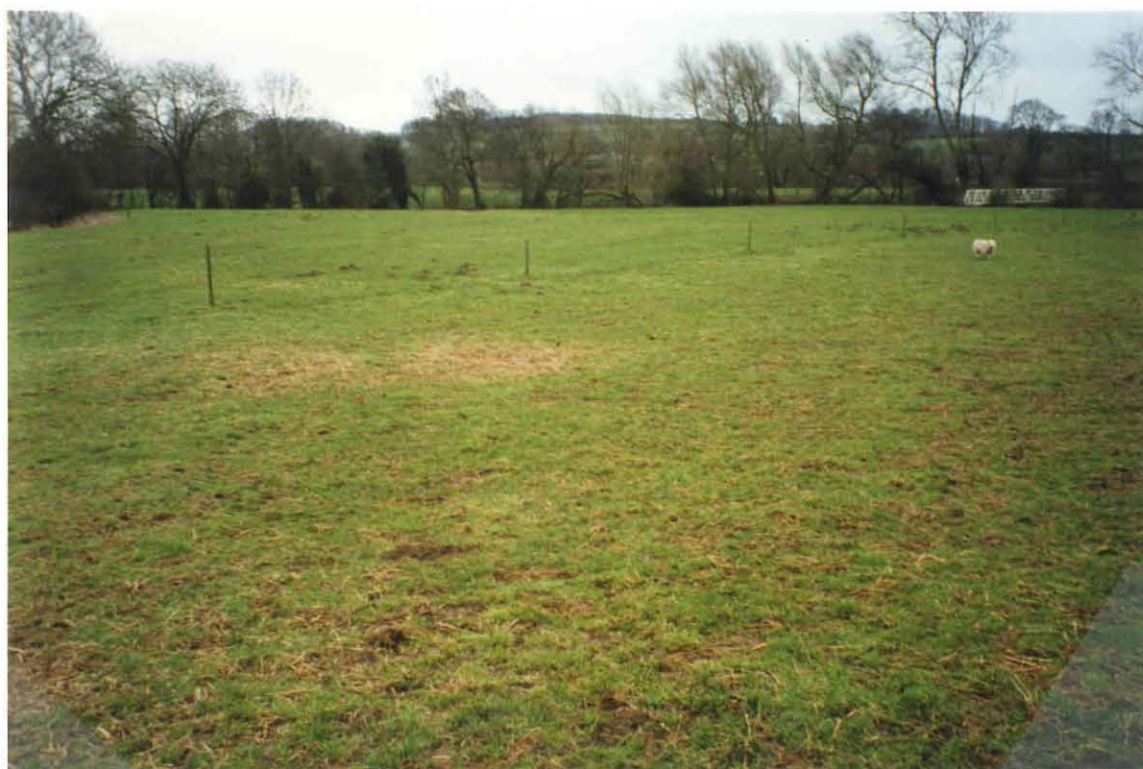
**Site No 4 from North-West**

An area of ridge and furrow cultivation aligned approximately west-north-west/east-south-east. The separation of the ridges is approximately 7m, with the ridges approximately 0.1m high. The ridges are now generally in poor condition, perhaps due to later agricultural activity.

**Importance D**

6.5.1 This area of ridge and furrow cultivation is in generally poor condition. If the proposed site works follow Lletty Lane the remaining traces of cultivation should not be disturbed. The poor condition of the site would probably render EDM survey impracticable if disturbance was considered.

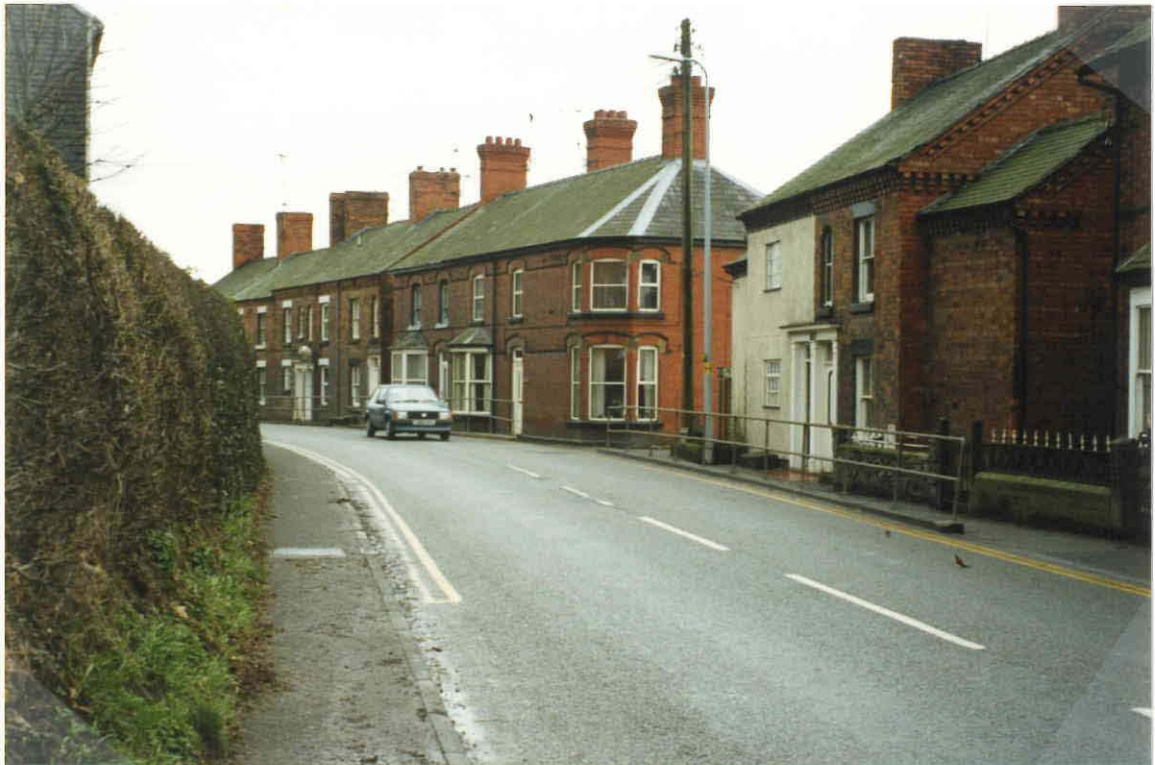
**Site No 8 from West**

The brick built terraces fronting onto the A495 through Llansantffraid on its south side, to the east and west of its junction with Lletty Lane, fall within the assessment area. It is assumed that none of these inhabited dwellings will be disturbed by the proposed construction works; none of the dwellings within the assessment area appear to be earlier than the later 19th century. It may be significant that the cottages immediately to the north of Lletty Lane are called "Cambrian Cottages", this is most likely a reference to the railway (Site No 7), which infers that they were not built before 1864 when the Cambrian Railway Co took over the running of the line. None of the buildings depicted running along the south side of the A495 on maps predating the 1886 Ordnance Survey map fall within the assessment area.

**Importance C****Sources**

6.9.1 These groups of inhabited cottages, at the junction between Lletty Lane and the main A495 through Llansantffraid, are of relatively modern date. It seems most unlikely that any disturbance to these structures will be considered. No evidence of earlier dwellings within this part of the assessment area has yet been found, a watching brief during any site works at the junction may confirm this.

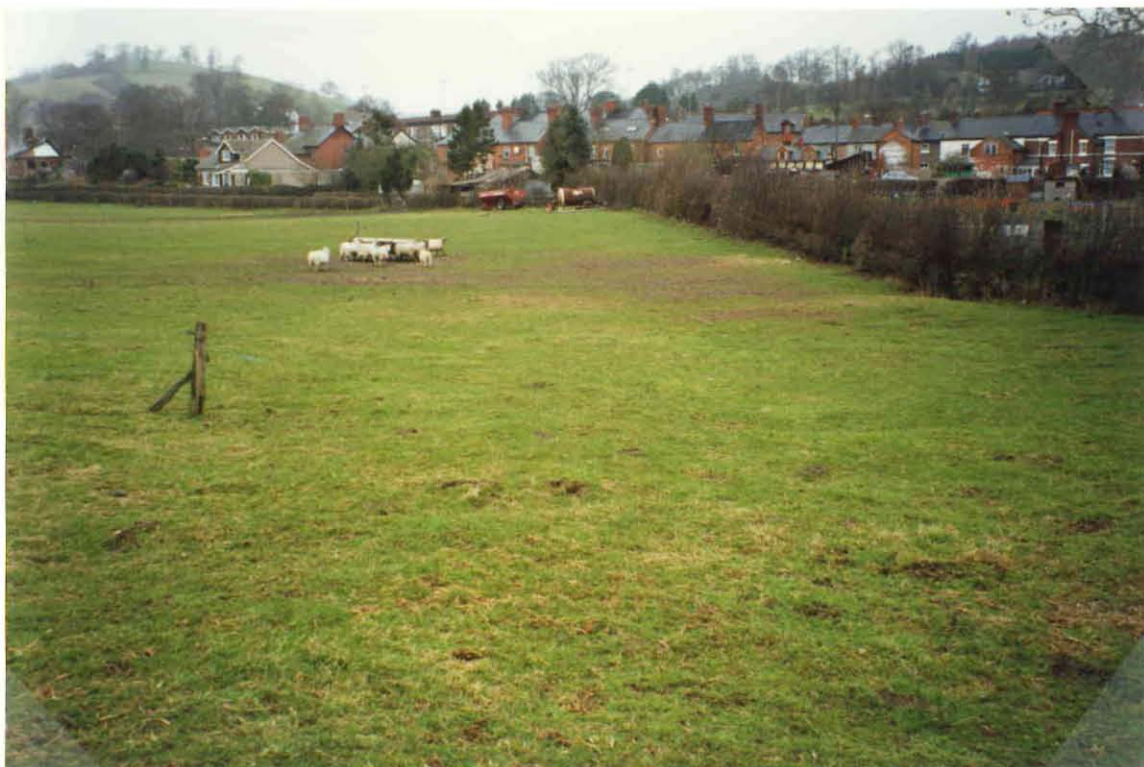
**Site No 5 from South-East**

An area of ridge and furrow cultivation aligned approximately north-west/south-east, although there is evidence of superimposed ridge and furrow aligned north-east/south-west. The separation of the ridges is approximately 5m, with the ridges up to 0.2m high. The ridges are now generally in poor condition, perhaps due to later agricultural activity.

**Importance      D**

6.6.1 This area of ridge and furrow cultivation is in generally poor condition. If the proposed site works follow Lletty Lane the remaining traces of cultivation should not be disturbed. The poor condition of the site would probably render EDM survey impracticable if disturbance was considered.

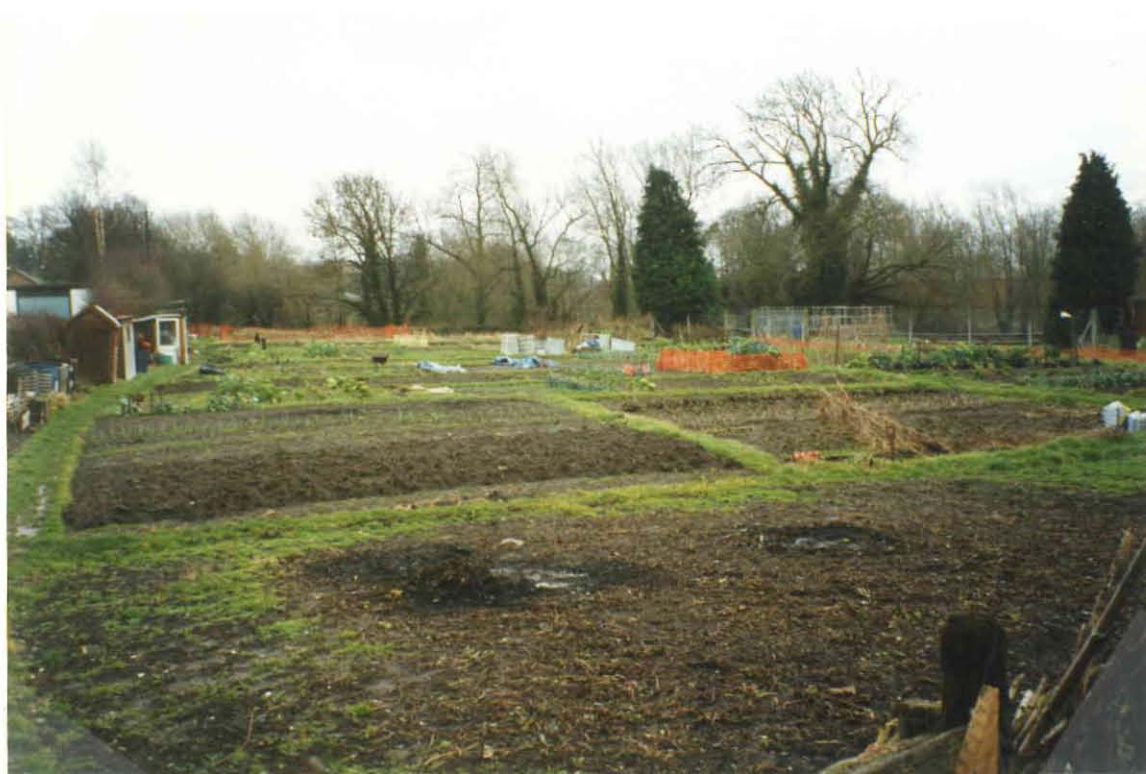
**Site No 6 from West**

This field name is recorded in the Tithe apportionment of 1838; it suggests that the field was used for open arable agriculture. The apportionment records it as being glebe (ie church) land which explains the Llan element. The field is the site of the present sewage treatment works and village allotments; no surface evidence relating to its previous use is readily apparent.

**Importance      F**

6.7.1 No surface evidence relating to this placename is evident. A watching brief in this area may provide further information, but owing to the disturbance caused by the working of the village allotments, it seems unlikely that any sub-surface traces of previous agriculture will survive.
