Caersws to Machynlleth Gas Pipeline (Phase 2 Talerddig to Machynlleth)

ARCHAEOLOGICAL EVALUATION

R.Hankinson June 2000

Report for RSK Environment Ltd on behalf of British Gas Transco

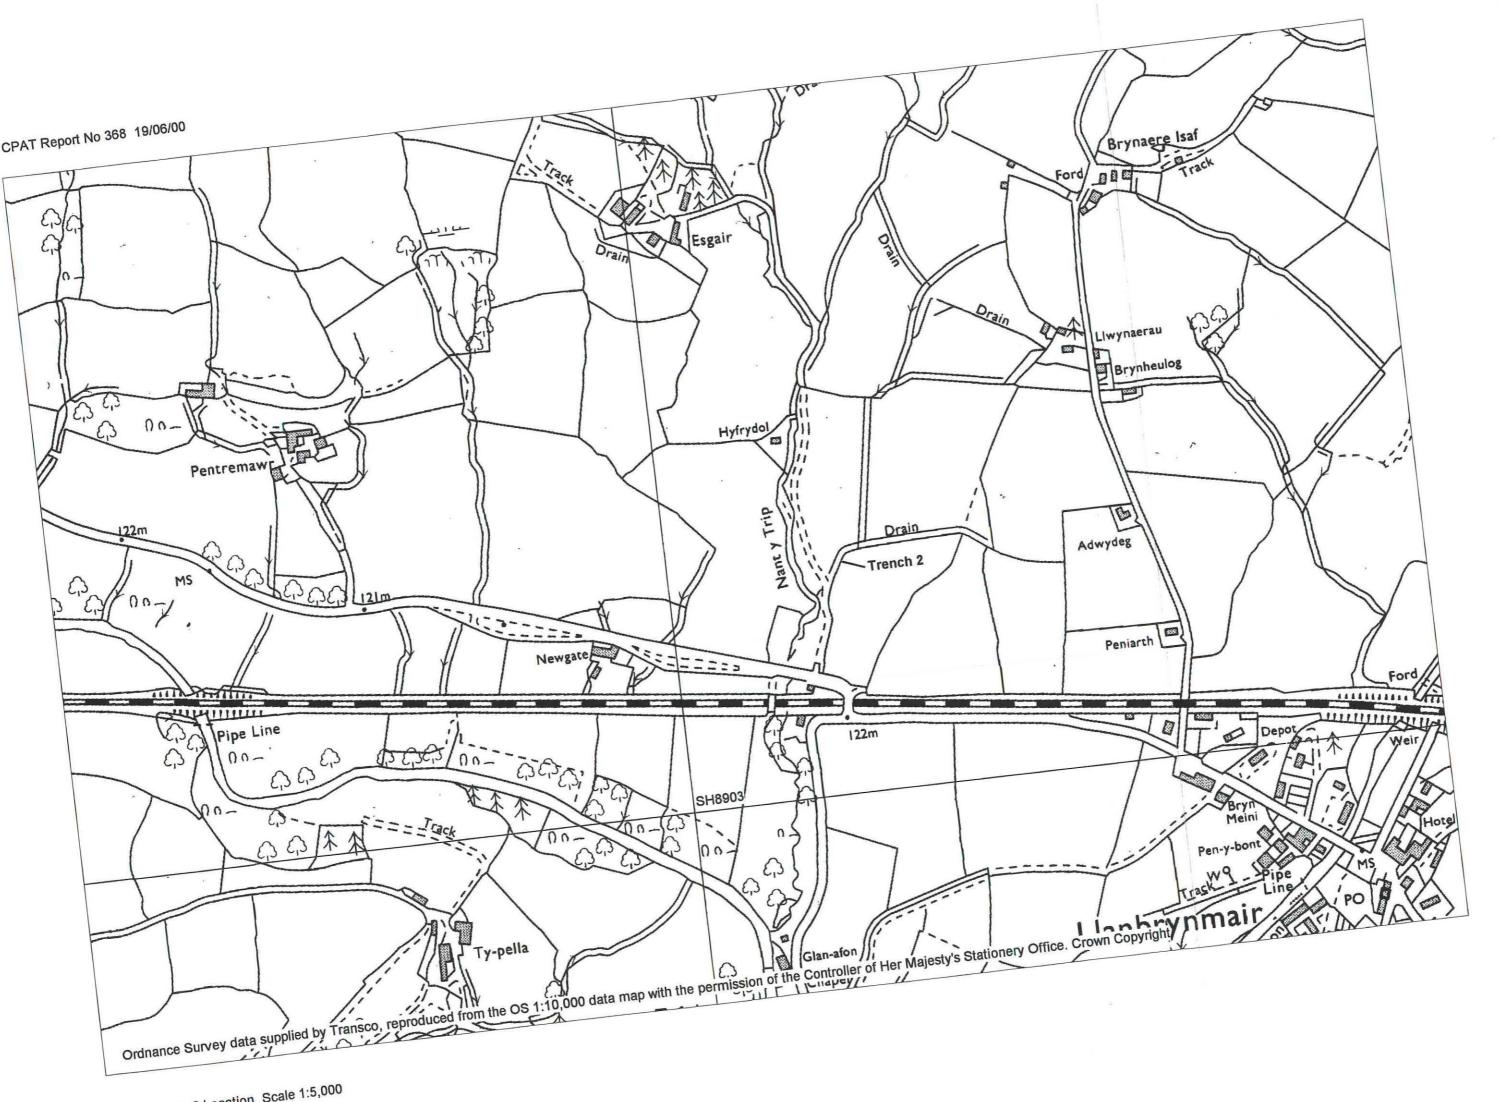
The trench described in this paragraph, measuring 27.8m x 1.7m, was entirely excavated by machine, though the sides and base were cleaned by hand to reveal the features present. The uppermost layer, 0.1m-0.3m thick, consisted of light buff-brown clay silt topsoil (1). Underlying the topsoil in the south-west part of the trench were a series of peat layers (2), (3) and (4), up to approximately 0.7m in depth; the layers included some silty material and a

reasonable quantity of wood, mostly oak, none of which was found to have been worked. The peat layers were seen to overlie a layer of light buff-brown clay silt (5), though this faded out 10m from the south-west end of the trench. A layer of deep brown sticky peat (6), immediately beneath layer (5), rested on a layer of grey silty gravel (7), which was considered to be the base of the peat deposits. The central section of the trench flooded rapidly and it proved to be difficult to relate the features in the south-west part of the trench with those in the north-east part. The peat layer (3) did continue into the north-east part of the trench, but lensed out within a layer of mottled blue-grey and buff silt (8). Underlying the silt layer at the north-east end of the trench was a slightly darker silt layer (9). The base of the north-east part of the trench was believed to be formed of a continuation of the silty gravel layer (7) encountered in the south-west part of the trench. A total of four land drainage features (10), (12), (14) and (16) were revealed in the base of the trench; these features cut all other layers except the topsoil and are considered to be of modern date.

- Trench 1 (PRN 80293: SH 8208 0526) (Figs 1 & 3; Plates 1 & 2)

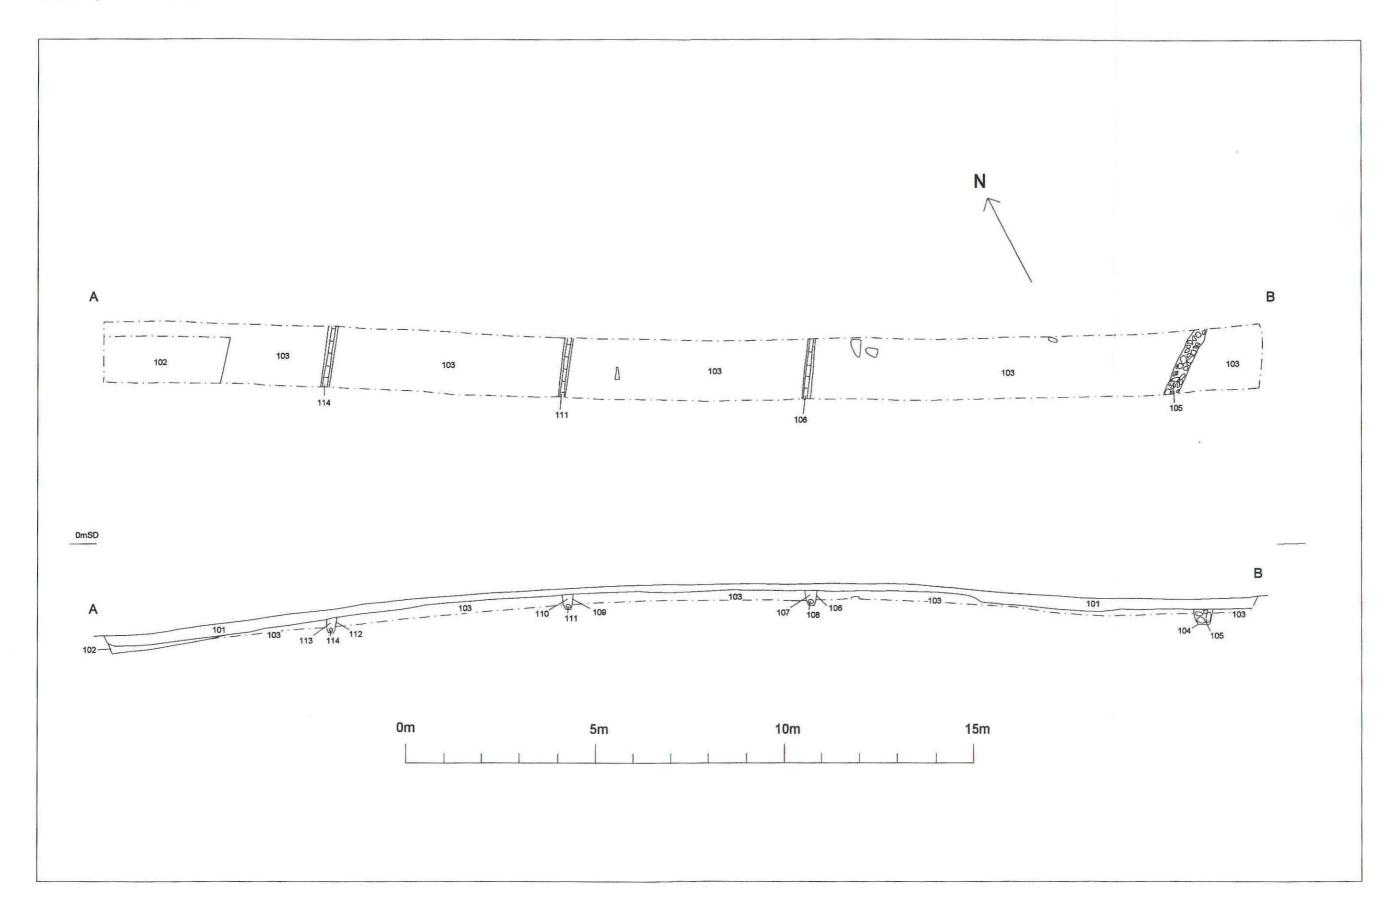
Fig 4 Trench 2, Plan and Section. Scale 1:100

The trench described in this paragraph, measuring 30.5m x 1.7m, was largely excavated by machine, with the sides and base being cleaned by hand to reveal the features present. The uppermost layer, 0.2m-0.35m thick, consisted of light grey-brown loamy topsoil (101), containing a small number of sherds of 18th to 19th-century glazed pottery. At the extreme north-west end of the trench the topsoil overlay a layer of orange-brown loamy soil (102), excavated by hand to a maximum depth of 0.2m, which thinned to the south-east before ending 3m from the north-west end of the trench. A layer of clean yellow-grey clay (103), with orange mottling and containing stones up to 0.5m across, was found beneath both of the layers described above and undoubtedly represents a natural subsoil deposit. The level of the subsoil was approximately 1m higher in the centre of the trench, and it would seem that PRN 80283 is therefore the result of a natural process which has resulted in the formation of a linear bank of subsoil. A total of four land drainage features (104), (106), (109) and (112) were found to be cut into the natural subsoil; presumably to improve its restricted drainage. Features (106), (109) and (112) are recent in date and contain segmental pipes, but (104) consists of a trench, 0.4m deep, with a cobbled stone fill (105) and apparently represents an earlier attempt to drain the gully to the south-east of PRN 80283.

3.4 Trench 2 (PRN 80283: SH 8926 0341) (Figs 2 & 4; Plates 3 & 4:)

- 4.2 The results of the excavation of Trench 2 demonstrate that the recorded feature (PRN 80283) consists of a natural, perhaps glacial, deposit of clay and stones, giving the appearance of a bank. There appeared to be some build up of a secondary natural subsoil deposit on the north-west side of the bank.

- 4.3 Both trenches revealed that drainage works had been carried out, in an attempt to improve ground conditions for agricultural use. The drainage works in Trenches 1 and 2 appeared to be largely of recent date, though an earlier stone-lined drainage gully was present in Trench 2. However, no significant archaeological features or deposits were identified in either trench.
