Caersws to Machynlleth Gas Pipeline (Phase 2 Talerddig to Machynlleth)

ARCHAEOLOGICAL WATCHING BRIEF AND EXCAVATION

R.Hankinson
January 2001

Report for RSK Environment Ltd and British Gas Transco

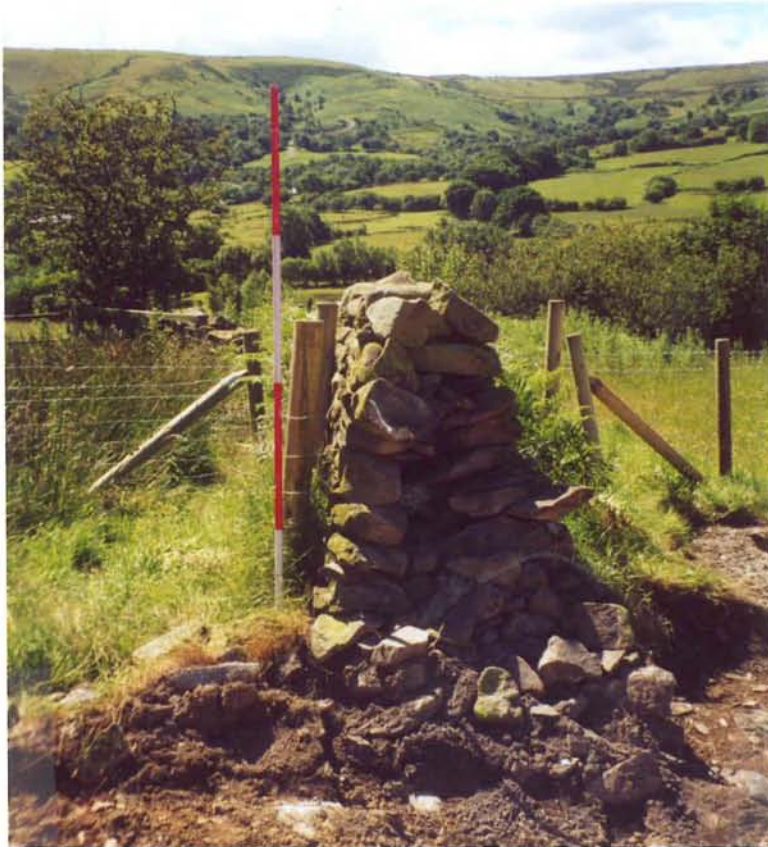
Plate 1. PRN 80816 from NNE

PRN 80816. Wall (Plate 1: SH 9324 9934). The wall was cut during the topsoil stripping, revealing a section through it. The wall was seen to be constructed of facing stones with a loose rubble core; its appearance suggests it is of relatively modern construction.

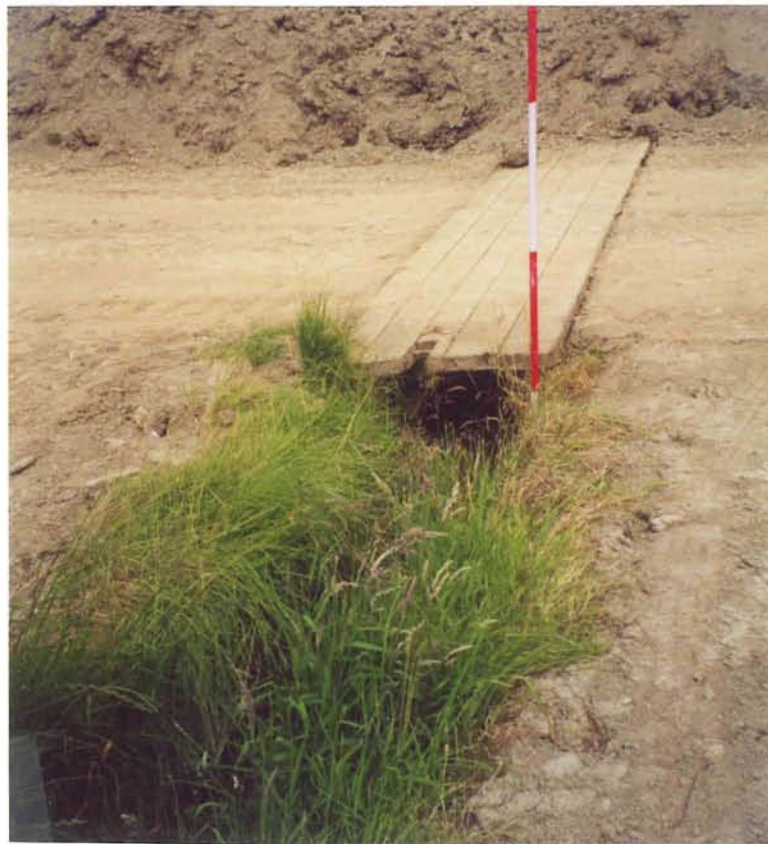
Plate 2. PRN 80094 from SSW

PRN 80094. Leat (Plate 2: SH 9009 0309). The leat was crossed by the wayleave, but was flumed (pipe installed to retain flow) and covered by protective timbers during topsoiling. No evidence relating to its age or morphology was evident.

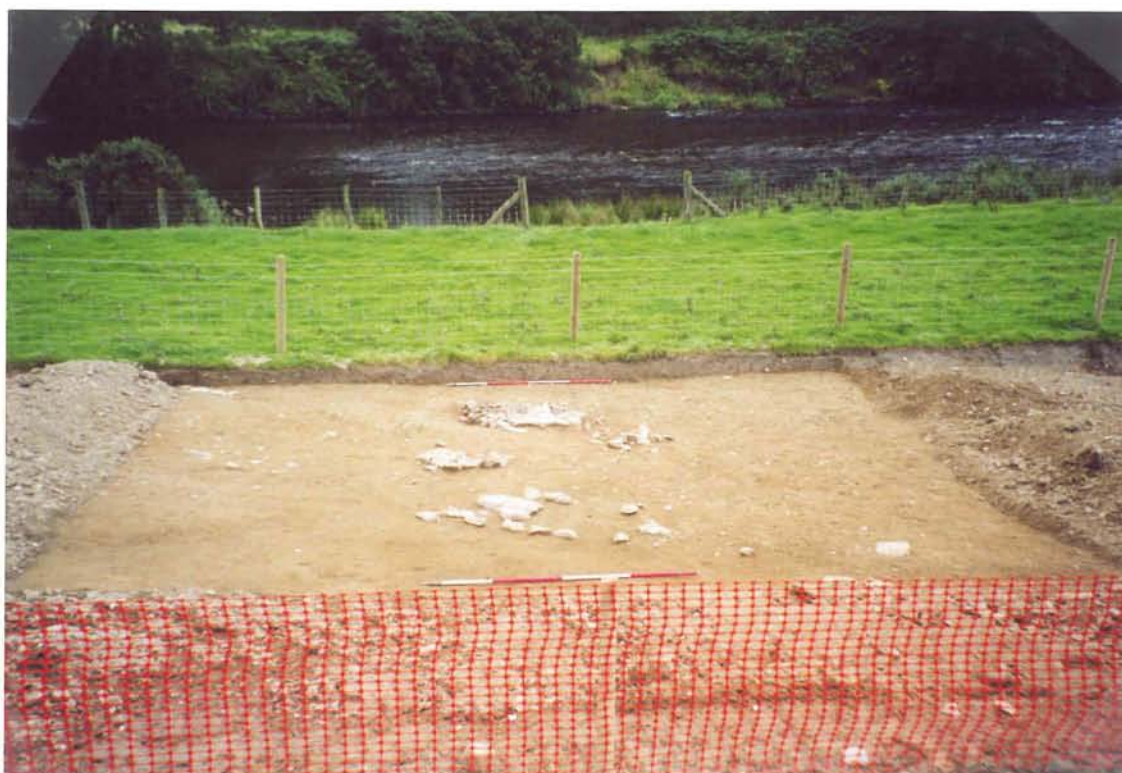
Plate 3. PRN 77899, excavated area after cleaning from NW

PRN 77899. Cottage (Plates 3-8: SH 8201 0513). The site of this former dwelling was revealed by topsoil stripping during the watching brief. One main hearth and two smaller features were revealed, one of which apparently post-dated the main hearth. These probable hearths were in varying conditions but would appear to have been constructed of tightly packed stones set into clay, which was reddened by heat where it came into close proximity with the stones. Finds including pottery and iron nails were recovered. The most likely interpretation of the site is that it was a timber framed dwelling occupied in the 16th to 18th centuries (see excavation report, below).

- 4.5 Cleaning of the site area revealed three main stratigraphical layers. Layer 4 occupied the north-western side of the cleaned area and consisted of clean and largely stoneless grey and orange-brown gritty silt. Layer 7 occupied the south-eastern side of the excavation and consisted of mottled grey and light brown, slightly gritty silt containing some stone, flecks of charcoal, two fragments of calcined bone and iron nails. The intervening area between layers 4 and 7 formed a curve with its apex to the north and was occupied by a layer (5), of mixed

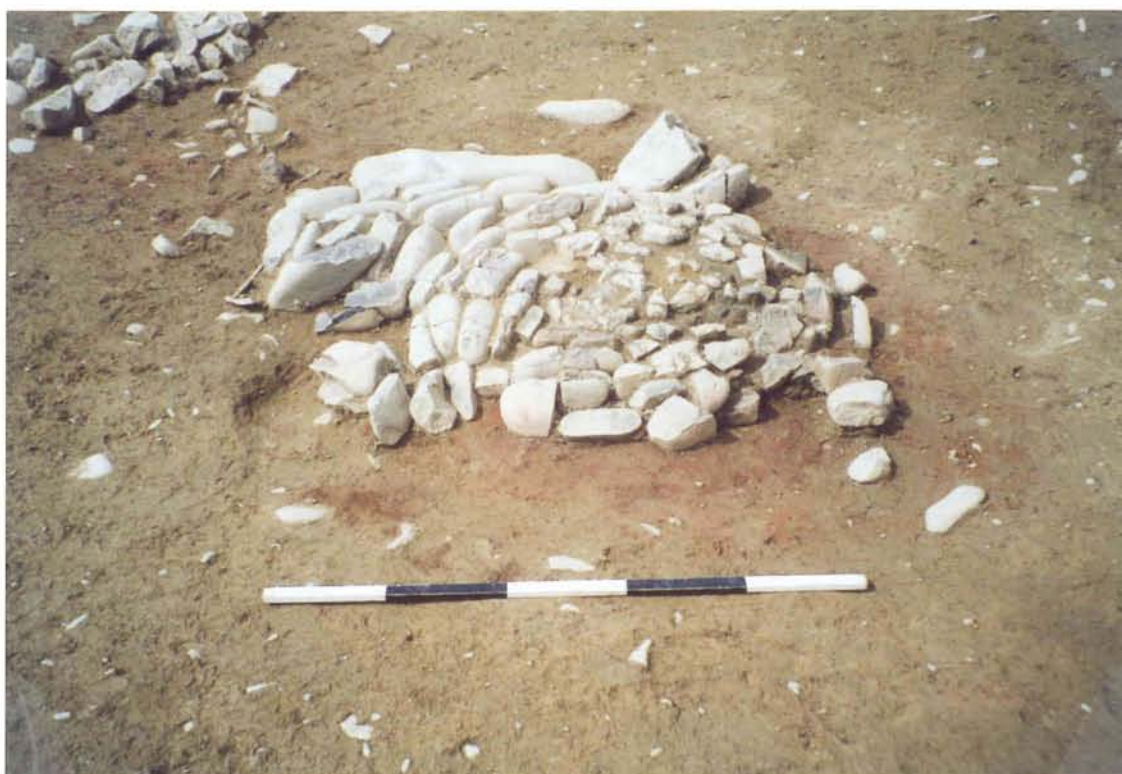
Plate 4. PRN 77899, main hearth (11) from SE

- 4.6 Three stone features (9), (10) and (11), interpreted as hearths, were exposed during the process of cleaning the site, all of which had apparently been cut into layer 7. Each hearth consisted of tightly packed stone cobbles which, with a single exception, were of no more than 0.2m in size, and probably collected from the river bed only a few metres away. Care had obviously been taken in constructing the hearths, and around the stones in each case was a reddened corona of clay which could be readily distinguished from layer 7. The main hearth (11) was sub-rectangular in shape with an east-north-east/west-south-west alignment; some stones had been lost, but it would probably have measured 1.7m by 1.2m. A second, smaller hearth (10) was sub-circular, approximately 1.1m in diameter, and may have formed a subsidiary feature associated with, but post-dating, the main hearth on its west side. A section through both (Fig 3) revealed the upper layers of 10 had cut through those of 11, indicating its secondary origin. Both hearths comprised a hollow, excavated into layer 7, filled with brown sticky clay (14 and 17), the upper 0.2m of which (13 and 16) had been reddened by heat. Closely packed stones (12 and 15) had then been set into the top of the clay, and the upper surfaces of some of these were found to have been fractured by excessive direct heat; a single iron object was found within the stones forming layer 12.

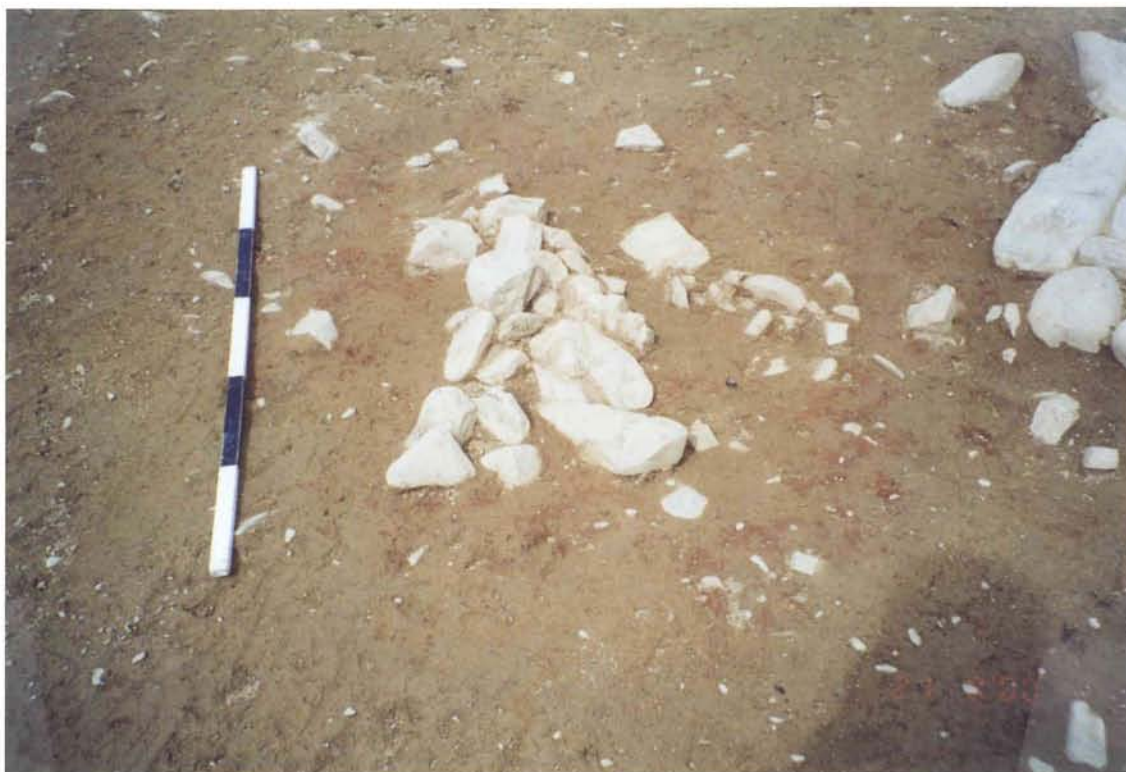
Plate 5. PRN 77899, probable subsidiary (10) to main hearth from S

- 4.12 The function of the site also remains obscure, though we can perhaps indulge in some speculation. The most curious feature is the presence of no less than three hearths. Certainly hearth 10 was later than the main hearth, 11, but this does not mean that it supplanted it - it could simply have been subsidiary. The appearance of three hearths, all with traces of burning on their stones, indicative of use, suggests specialist activity, rather than a simple dwelling which would surely have necessitated only a single hearth. Whether that activity can be associated with the nearby river - such as catching and smoking fish - is not something that can be ascertained. The river is well known for its fishing to the present day, which would in a historic sense imply that the fishing would be well protected by its owners, and this could have led to the founding of small riverside settlements for use by water bailiffs.

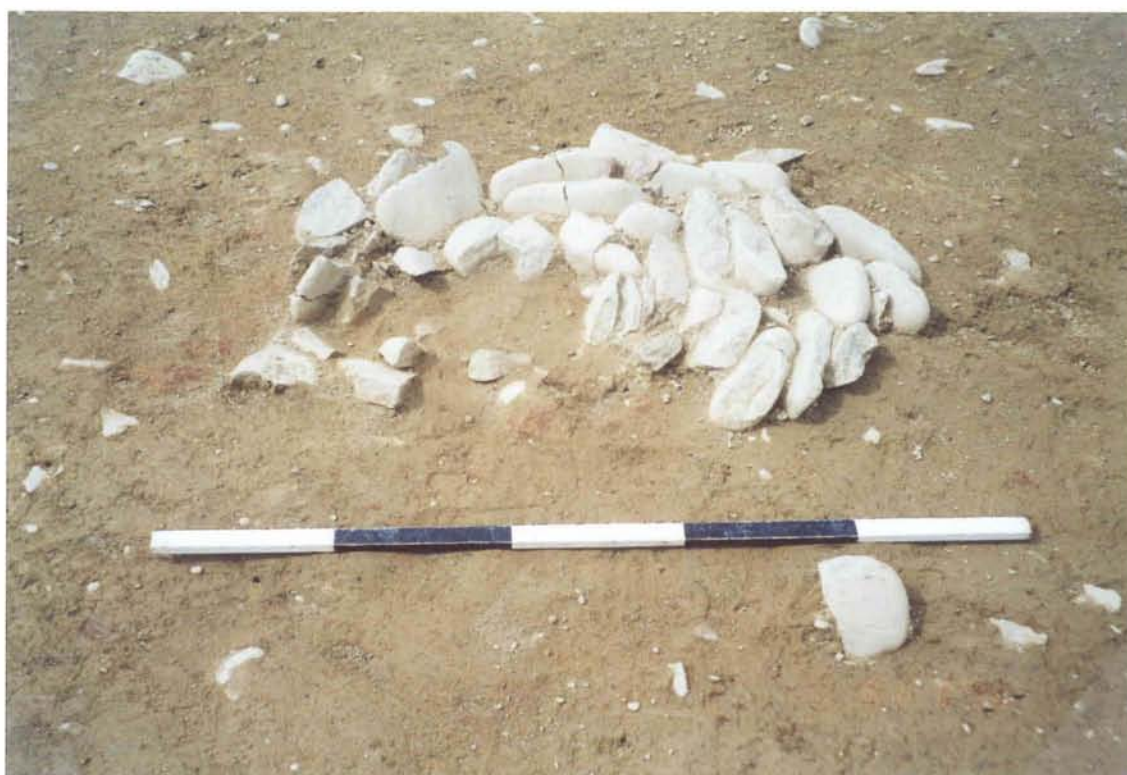
Plate 6. PRN 77899, probable secondary ?hearth (9) from SE

- 4.7 The remaining hearth (9) appeared to be morphologically similar to the other hearths, with its remaining surface stone covering an oval area measuring approximately 1.0m x 0.6m. Such were the similarities in surface appearance to both 10 and 11 that it was not sectioned.

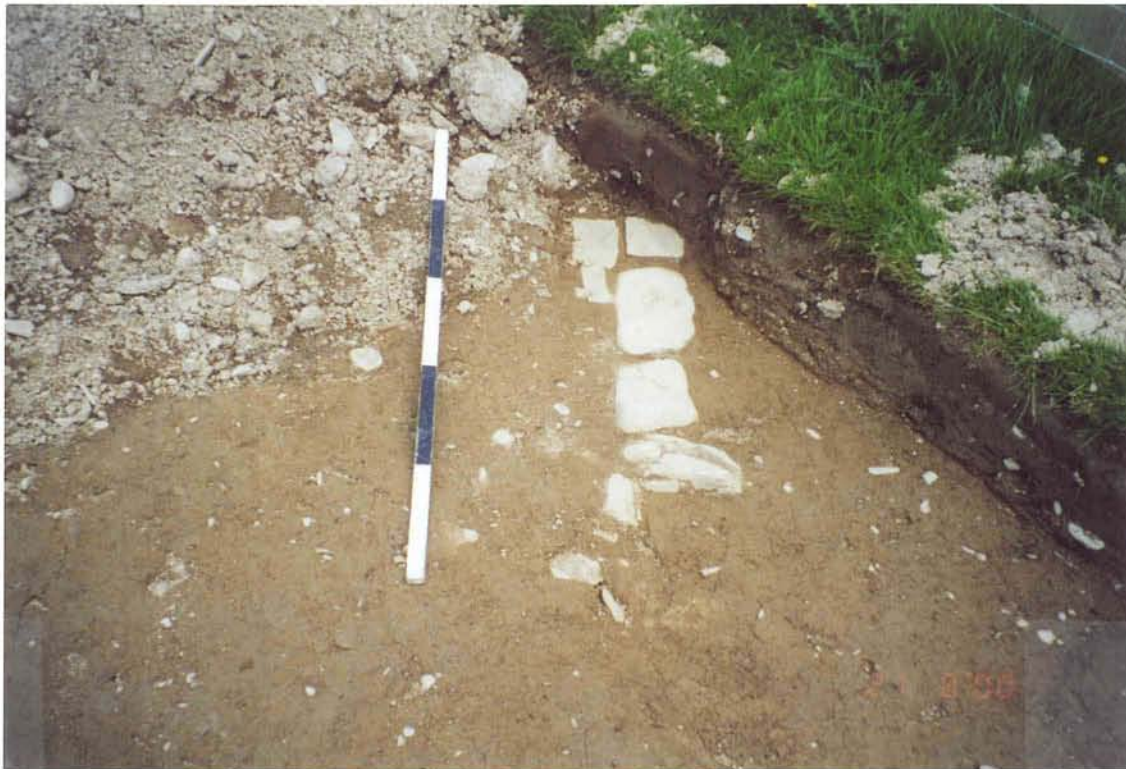
Plate 7. PRN 77899, possible foundation wall (8) from W

- 4.8 The only visible feature in addition to those described above was a 1.0m length of laid stones (8). The feature ran from its west end into the extreme eastern corner of the excavated area and could not be completely investigated as a result, though there was a suggestion of facing on its north side.
