# Llanwyddelan Churchyard Wall, Powys

## ARCHAEOLOGICAL WATCHING BRIEF

**CPAT Report No 498**

Report for St Gwyddelan's Parochial Church Council

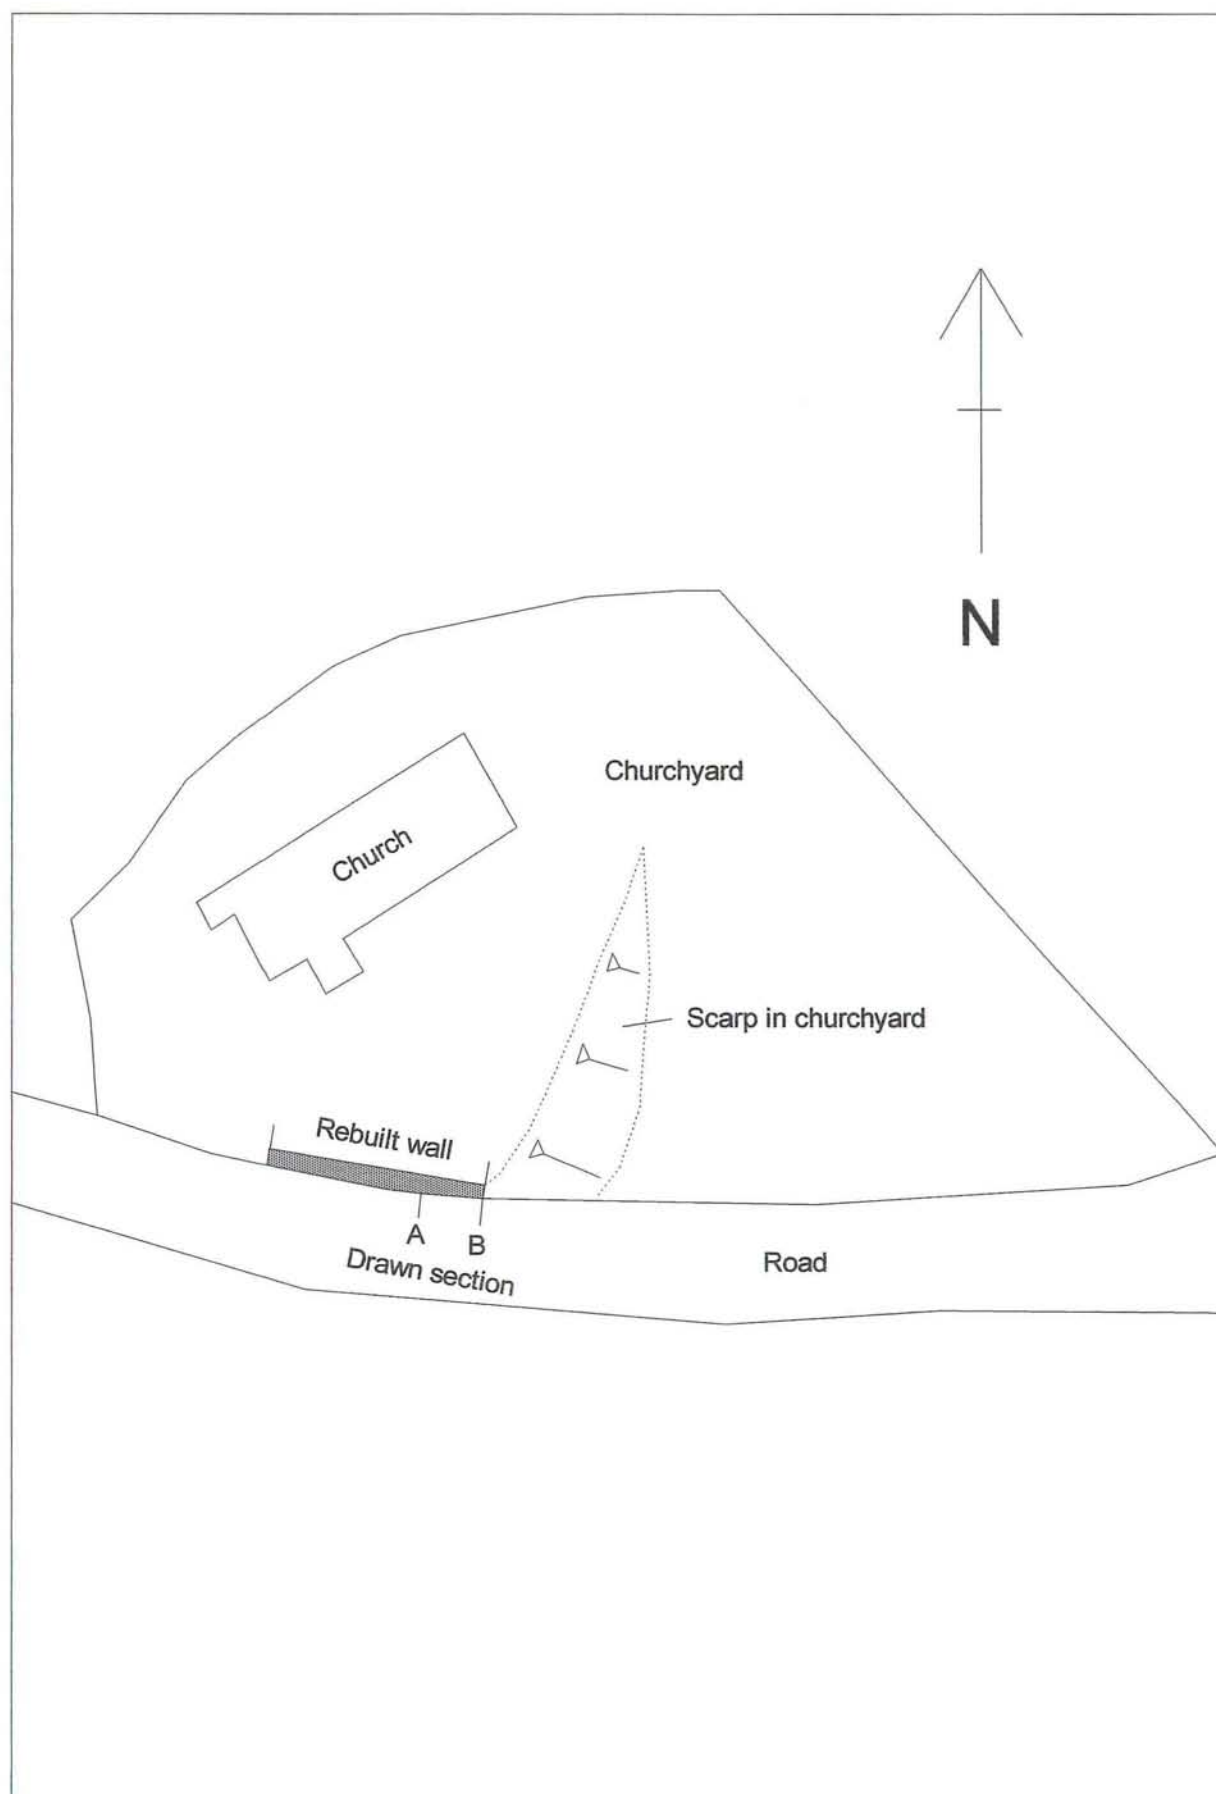
Fig 2 Location of rebuilt wall and drawn section. Scale 1:500

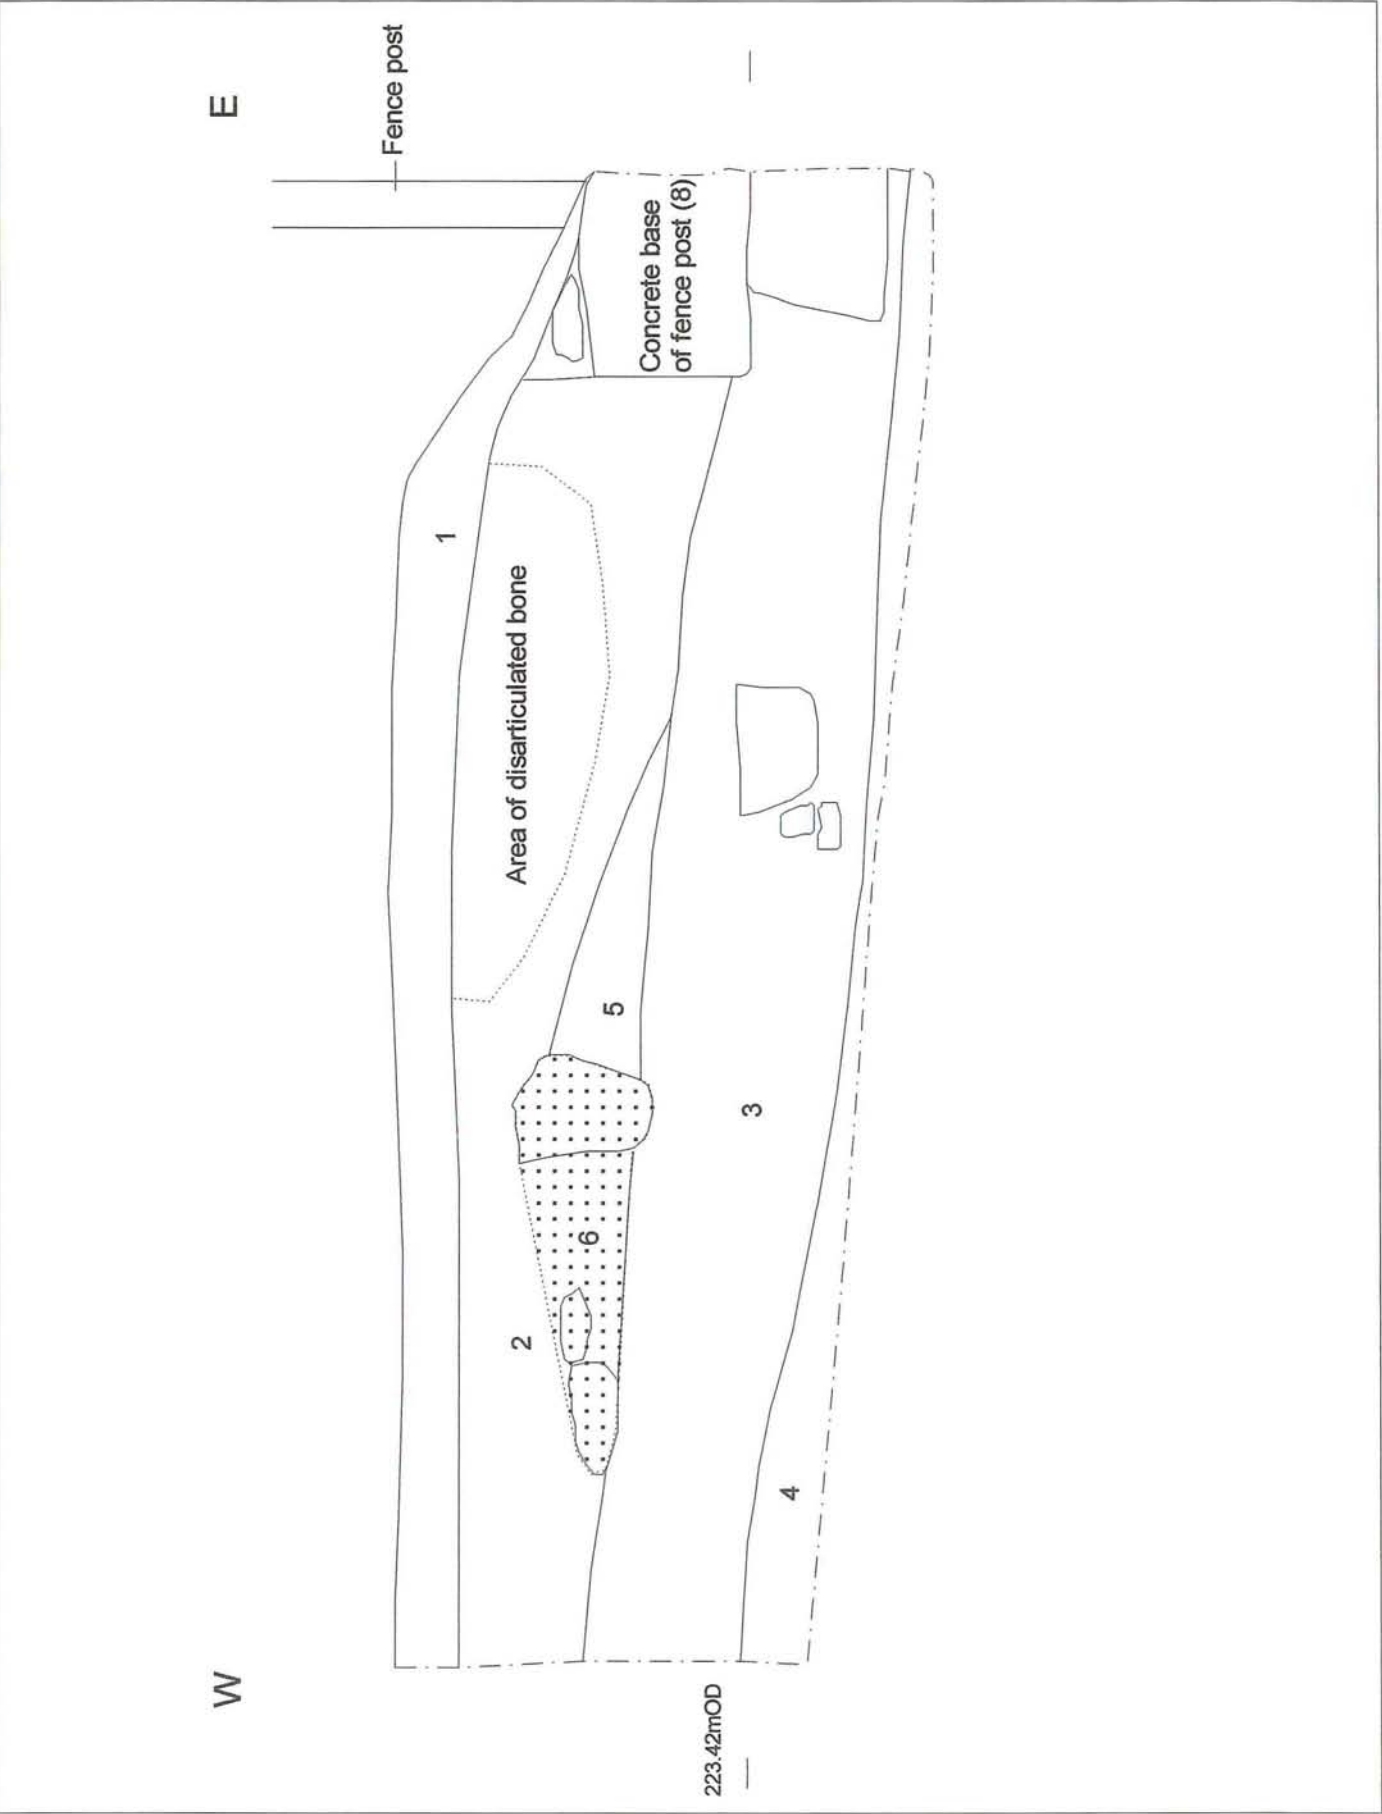
- 4.4 Examination of the section which resulted from the machining revealed an upper layer of dark grey-brown gritty loam topsoil (1), which varied in thickness from 0.1m at the west end of the demolished wall section, up to a maximum of 0.2m at the east end. Beneath the topsoil was a layer of grey-brown sticky clay silt (2) which varied from 0.2m in thickness at the west end of the section up to 0.6m in thickness at 0.8m from the east end of the section, where it coincided with the scarp which is believed to define the line of the former churchyard boundary. It was evident from the section that the line of the scarp had been cut prior to the construction of the wall, probably during an earlier widening of the road to the south of the churchyard. At this time, the south side of the churchyard would have been cut back to its present position and the wall built to prevent erosion of the exposed face.

- 4.5 Cleaning of the 3.9m-long section at the east end of the demolished wall revealed three features of interest, some of which may relate to previous churchyard boundaries. The uppermost of these consisted of a 1.4m-length of the section within layer 2, which contained a random collection of disarticulated bone and a small amount of 19th-century pottery, running west from a position directly beneath the top of the scarp (see Fig. 3). To the west of the area of disarticulated bone, three stones were exposed in the section at a lower level. These could possibly be the foundation of a former churchyard boundary wall (6), 1.1m wide and 0.35m high, which appeared to be set into the top of the underlying subsoil (3). A mortar and plaster-rich lens of material (5), within layer 2, was found immediately to the east of the possible wall. This was initially 0.25m thick, but faded out to the east after 1.0m.

- 4.6 Beneath layer 2, there were two layers of natural subsoil. The uppermost consisted of an orange sticky clay silt (3), which was 0.2m thick at the west end of the demolished wall section, thickening to a maximum of 0.55m at its east end. The underlying deposit of grey clay (4) was at least 2.0m in thickness and contained more angular stone towards its base.

Fig 3 Section A-B after removal of revetment wall. Scale 1:20

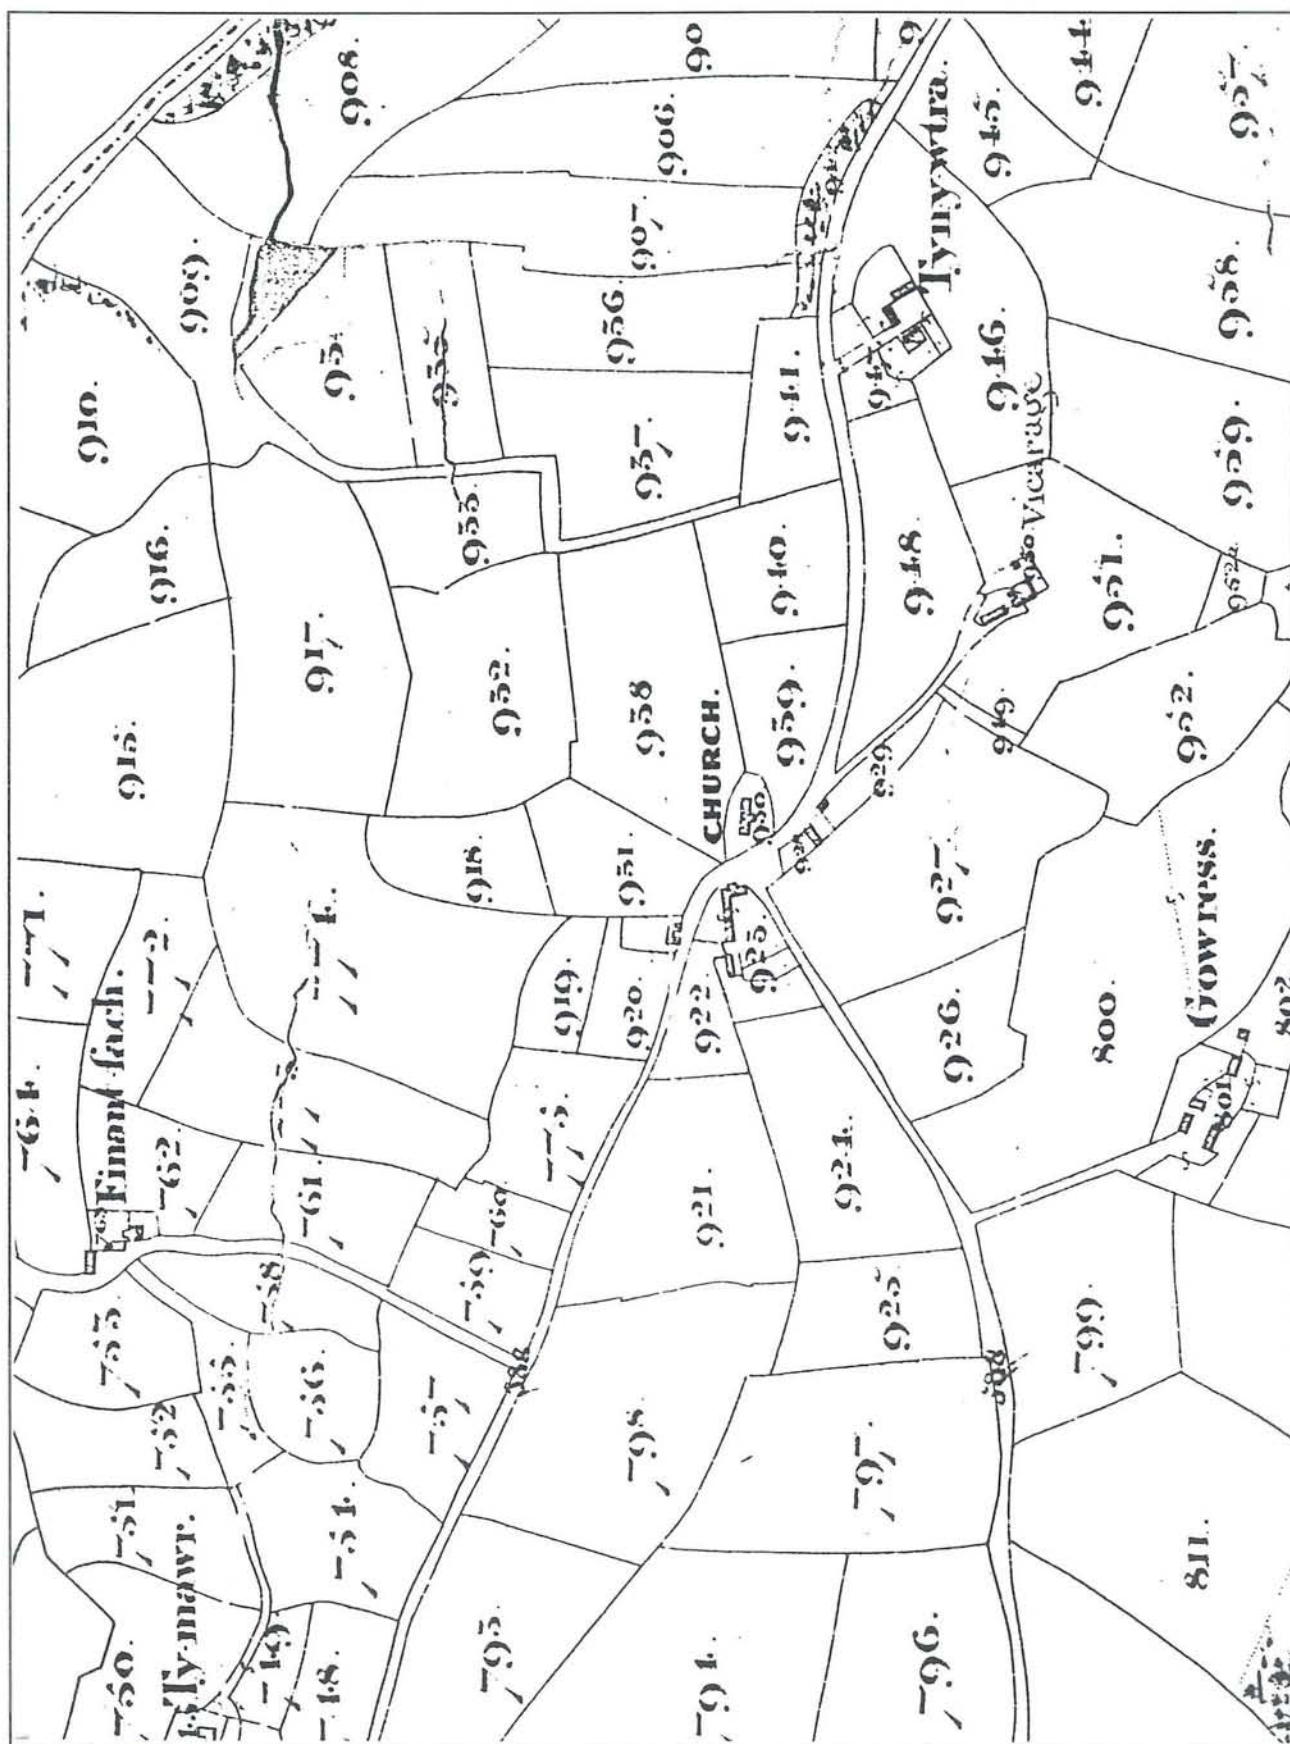
- 3.3 The churchyard appears to have originally been oval in shape (see Fig 4), forming a raised area surrounding the church. The south-east part of the previous boundary is still visible within the churchyard, which gained its present appearance when it was extended to the south-east in 1938 (Silvester and Frost, 1999).

Fig. 4 1843 Llanwyddelan Tithe map.

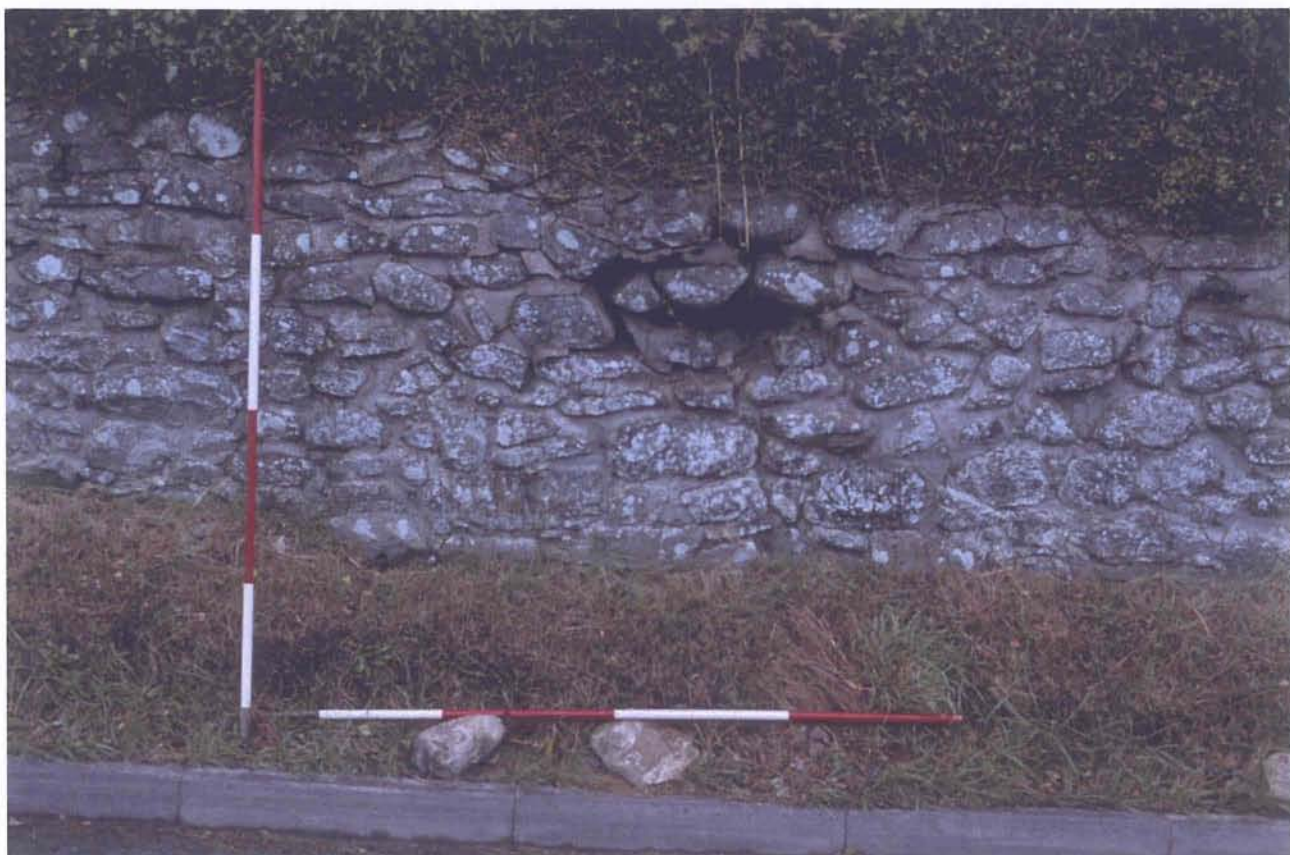
- 4.2 The demolition of the wall by machine was largely completed when the works were visited, but it was apparent that the wall comprised a mortared stone revetment. The soil behind the wall was then cut back to the specified position by machine and the section which was revealed was examined. A 3.9m-long section at its east end was cleaned by hand, photographed and drawn. Context record forms were completed which described all of the visible features and layers that were revealed.

Plate 2 Section of revetment wall prior to rebuilding, from S. Photo CPAT CS02/40/16.

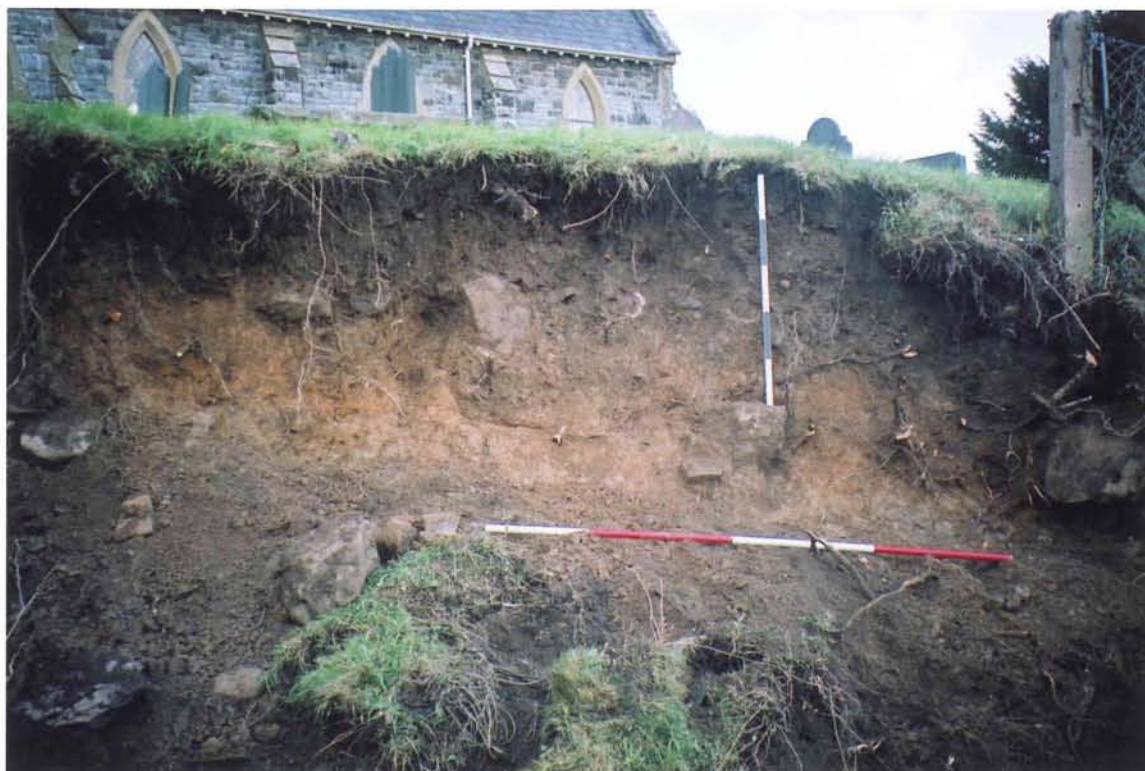
- 4.7 The disarticulated bone which was revealed by the excavations could not be related to a specific burial or burials. It appeared most likely that the bone was derived from burials that had been disturbed, probably during a phase of church rebuilding, or possibly when the road to the south of the churchyard was widened. All bone which was seen during the archaeological works was retained on site in order that it could be re-deposited in consecrated ground when the new wall was completed.

Plate 3 Section A-B after removal of revetment wall. Photo CPAT 1259.02

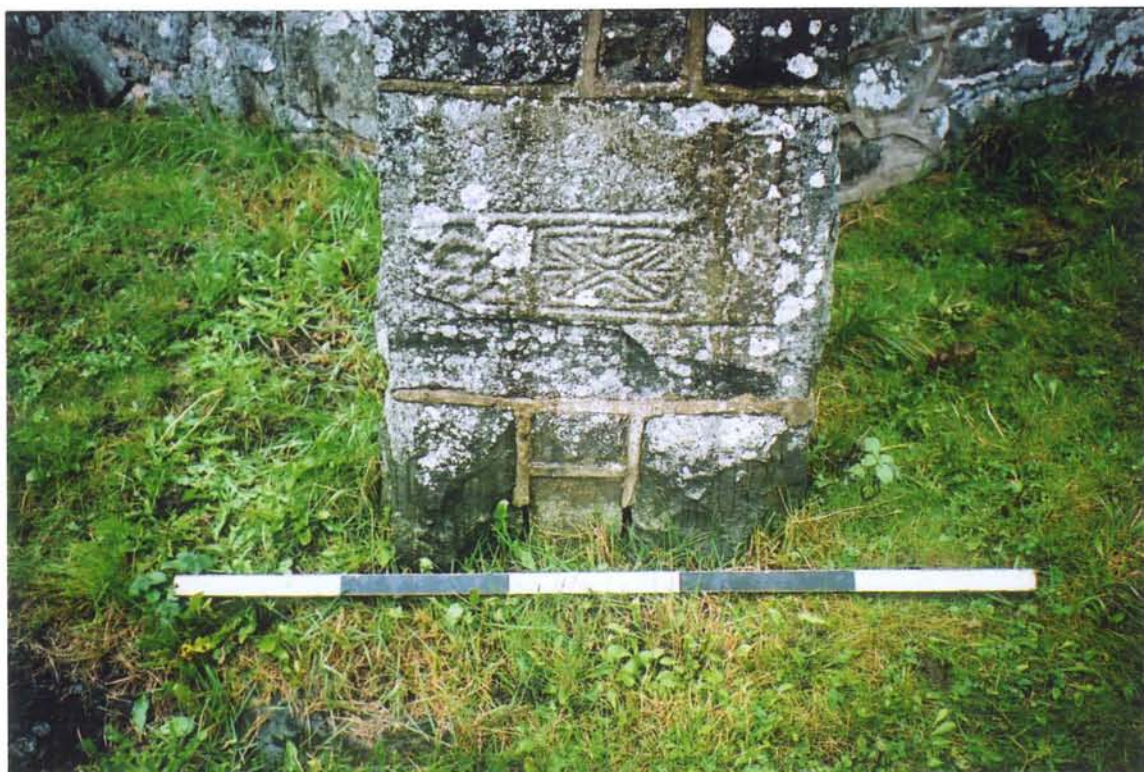
- 3.1 The church of St Gwyddelan is believed to have an early medieval origin. This is largely as a result of the dedication and the form and appearance of the churchyard, but corroborative evidence is provided by a carved early medieval stone which has been incorporated in the buttress at the east corner of the present church (plate 4).

Plate 4 Early medieval stone in east buttress of St Gwyddelan's church. Photo CPAT 1259.08
