**Extension to the Cae Rhys sand and  
gravel quarry, Pen-y-cefn, near  
Caerwys, Denbighshire**

**ARCHAEOLOGICAL EXCAVATION**

**CPAT Report No 563**

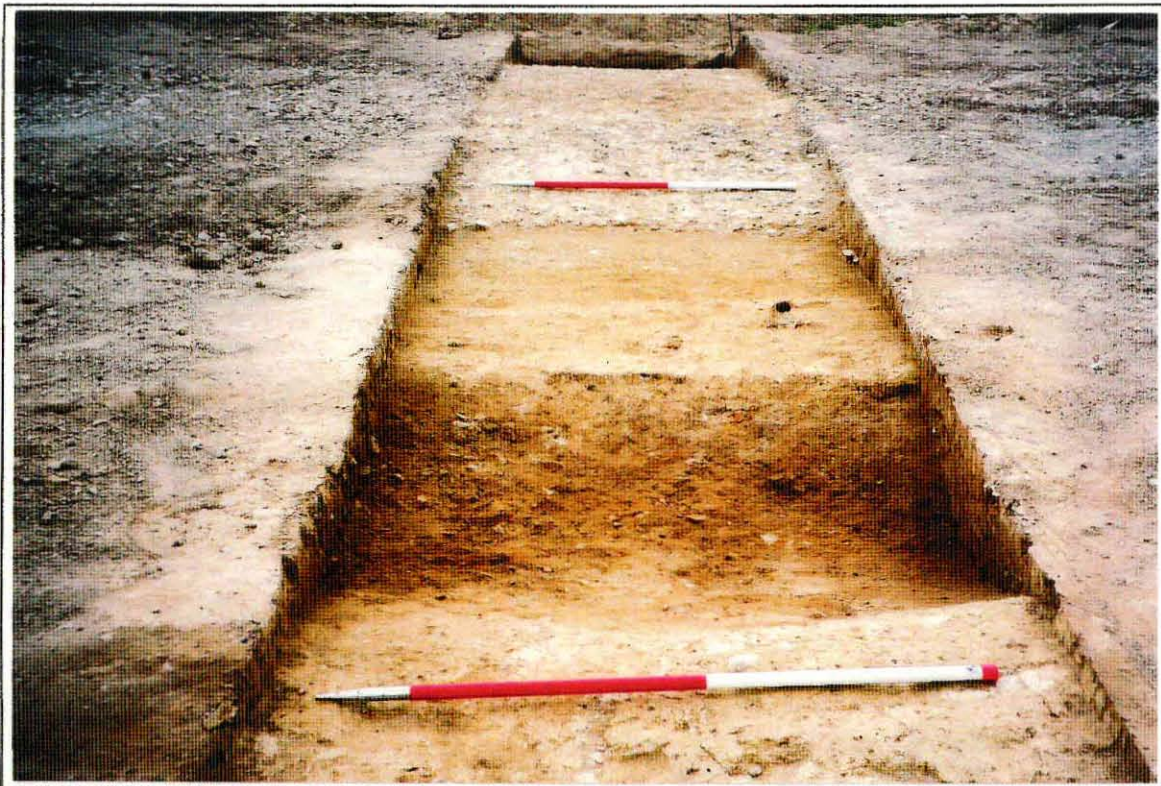
Plate 1 Upper surface of road surface (12) and fill of earlier ditch (16) after excavation of later ditch (9).  
Photo CPAT 1418.07

- 4.9 The succeeding road surface was represented by a markedly cambered layer of stones set in variegated orange and grey-brown silt (12), up to 0.15m thick. It was evident that this layer represented an undisturbed road surface, approximately 4.5m in overall width, which had been built up to prevent the accumulation of surface water. On its south side was a shallow ditch (16), 0.9m wide and 0.17m deep, filled with a pale yellow smooth silt (6), and presumably a drainage feature. Ditch 16 was situated immediately to the north of a second ditch (9) and was clearly earlier as its fill had been partially removed when 9 was cut. Ditch 16 certainly represented a ditch flanking the south side of the road phase represented by layer 12, but it may also have functioned at an earlier date in conjunction with at least some of the earlier road surfaces. A bank of disturbed material (25), 0.1m high, on the south side of ditch 16, may represent spoil excavated from the ditch. On the north side of this phase of the road, a lens of pale yellowish-grey gritty silt (7) was identified which appeared to represent a progressive accumulation of material washed from the road surfaces.

- 4.10 The uppermost layers of the road consisted of, in the centre, a layer of loose rounded gravel (2), 0.06m thick, flanked on its north side by a contemporary layer of compact yellowish stony silt (3), 0.04m thick, and on its south side by a contemporary layer of pale yellow gritty silt (4), up to 0.08m thick. On the south side of layer 4 was a ditch or drainage channel (9), 0.8m wide and 0.25m deep, with a fill (10) of yellow-flecked light grey-brown silt. This ditch cut a bank of pale yellow silt (5) on its south side, the latter evidently of artificial origin for it post-dated the original construction phase of the road, represented by layer 13, although its precise origin and function is unclear. Ditch 9 may also have partially cut the bank of disturbed material (25), noted above.

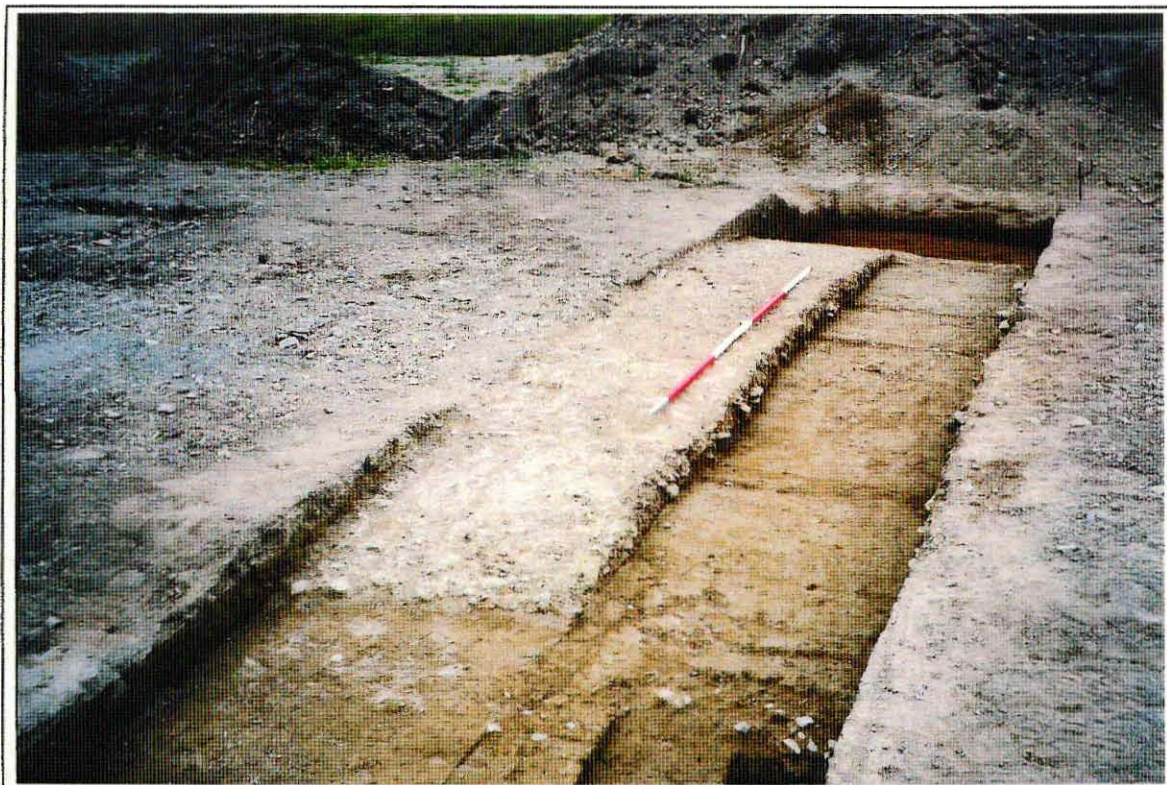
Plate 2 Road surface (15) showing possible wheel-ruts. Photo CPAT 1418.10

- 4.8 The overlying road surface was composed of compacted pale grey stony silt (15), 0.04m thick. It represented a road approximately 5.2m wide and contained three possible wheel-ruts (19, 20 and 21), running east-west in its upper surface. The wheel-ruts averaged 0.1m wide by 0.02m deep, and some leaching resulting from water accumulation in them was recognised in the layers beneath. This layer was sealed beneath a lens of gritty orange sand (11), 0.03m thick.

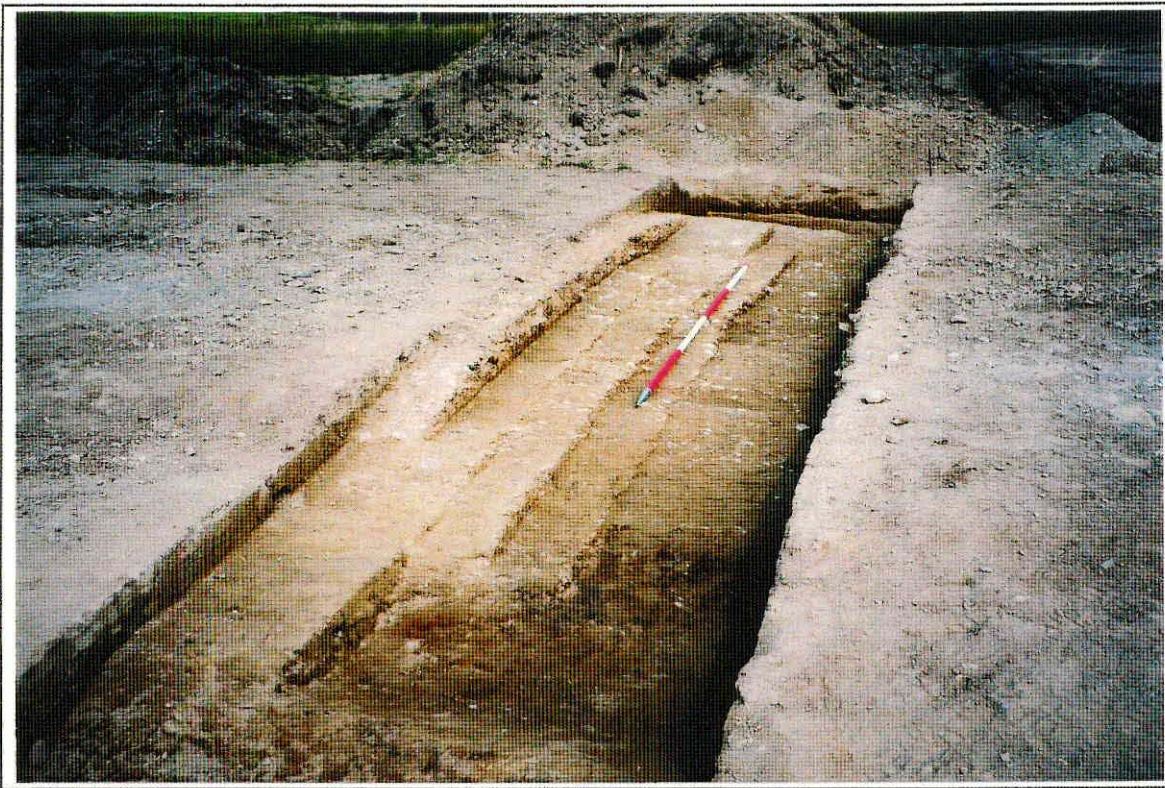
Plate 3 Earliest road surface (22) also showing intermediate surfaces and section of earlier ditch (16).  
Photo CPAT 1418.13

- 4.5 The earliest road surface was composed of small stones compacted into a pale, pinkish-grey silt (22), 0.1m thick. This road was approximately 5.75m in width and the material in the base of its makeup included some red boulder clay which is comparable with the natural subsoil where the Roman road was excavated in 1989 at Waen Gate, Rhualt (see para 3.2).

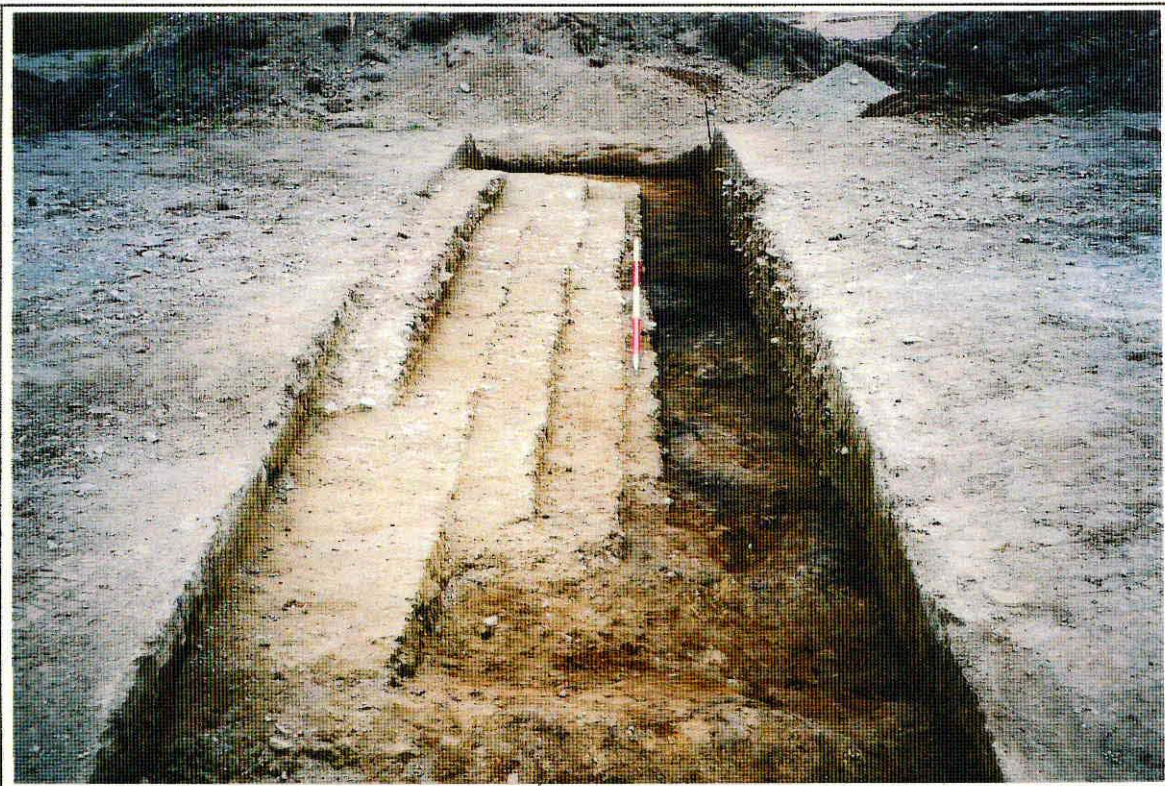
Plate 4 Upper surface of disturbed layer (13) denoting construction phase of road. Photo CPAT 1418.14

- 4.4 The natural subsoil within the trench consisted of loose orange silt (8), containing many angular stones, overlying which, but only beneath the line of the later road, was a lens of pale grey stony silt (24), 4.9m wide and up to 0.06m thick, probably a leached subsoil horizon. Above this, and overlying the subsoil beyond the limits of the later road, was a loose rich brown silt (23), up to 0.1m thick, which is likely to represent a buried soil deposit, and it in turn was covered by a mixed dark-grey, brownish and orange silt (13), 0.05m thick, which extended to a width of 7.85m and appeared to represent disturbed or trampled material, probably combined with vegetation clearance. A small fragment of mortar was recovered from the upper surface of layer 23, which is likely to have been deposited during this phase.

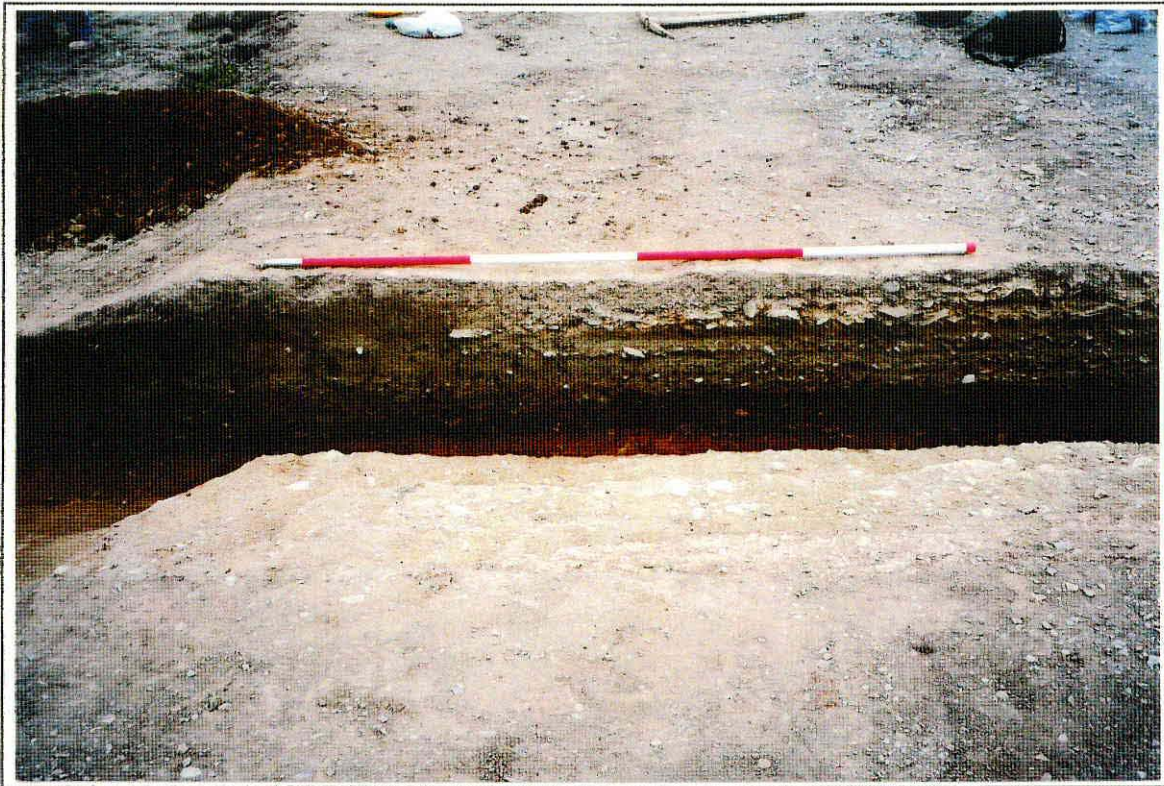
Plate 5 North part of section after excavation. Photo CPAT 1418.21

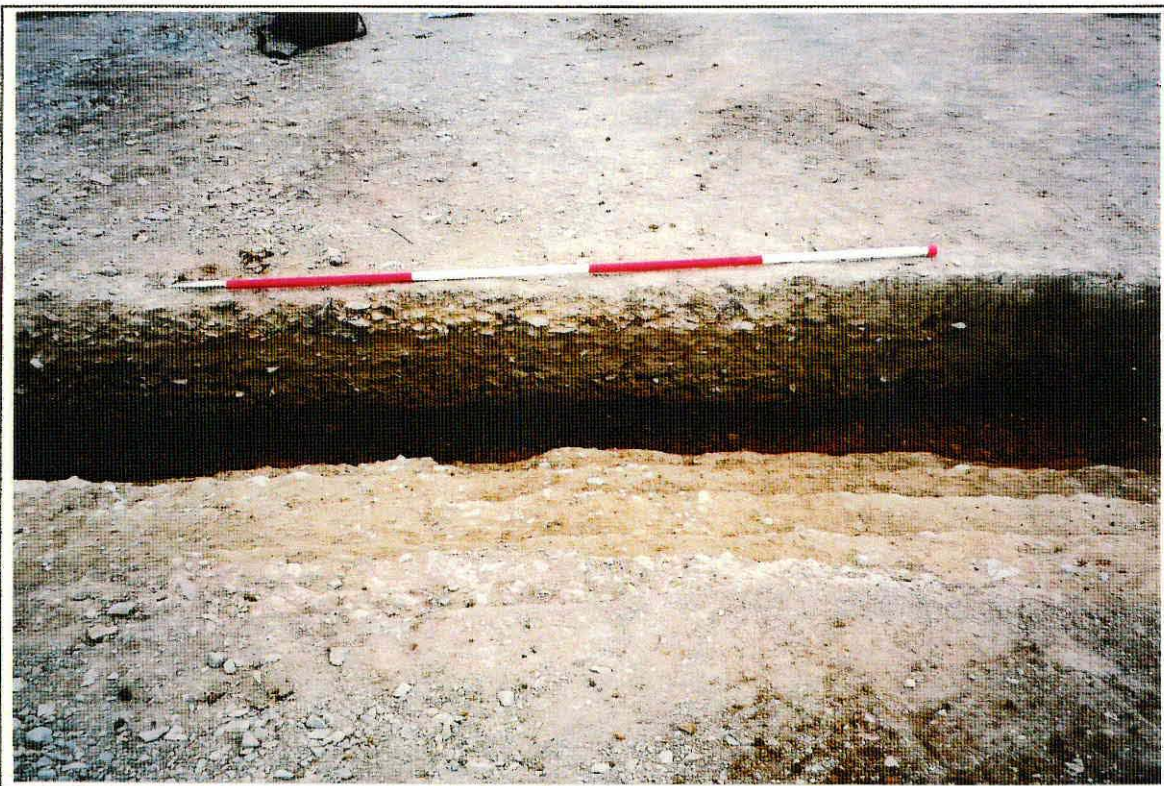
Plate 6 Central part of section after excavation. Photo CPAT 1418. 22

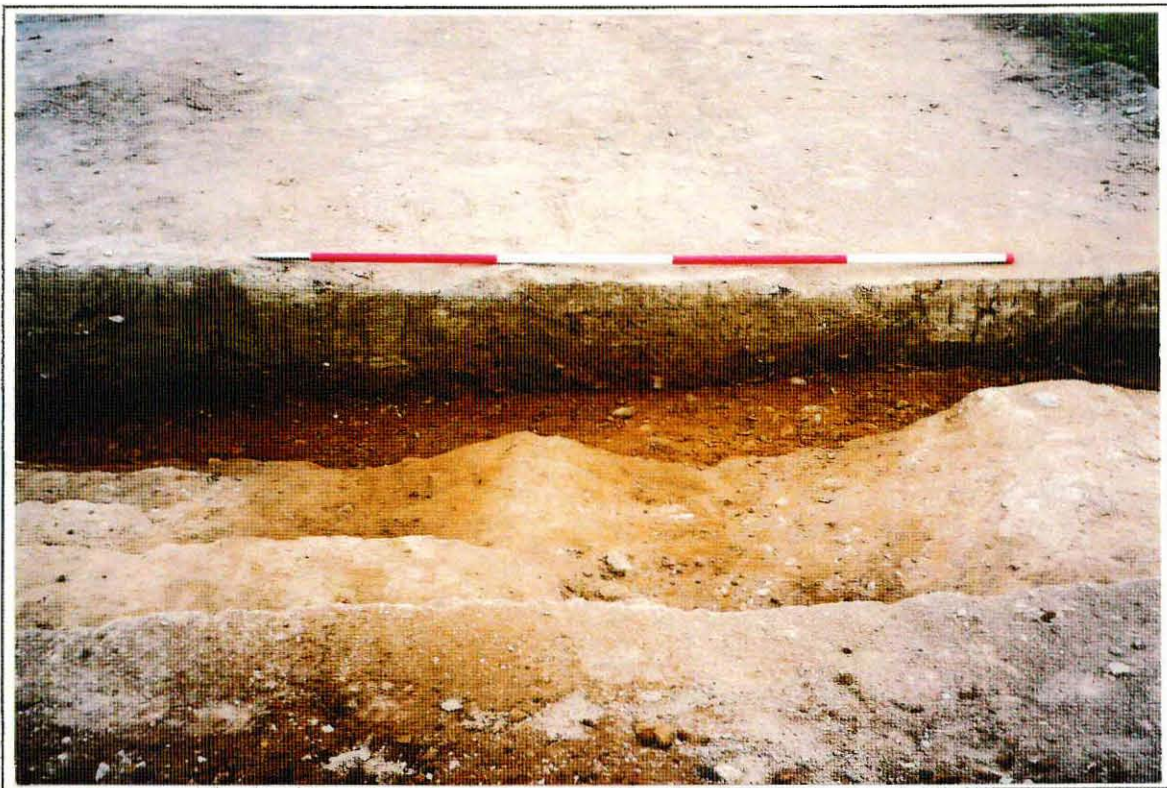
Plate 7 South part of section after excavation. Photo CPAT 1418.23
