# Llanidloes Link Road, Powys

## ARCHAEOLOGICAL ASSESSMENT

**CPAT Report No 583**

**R Hankinson**  
October 2003

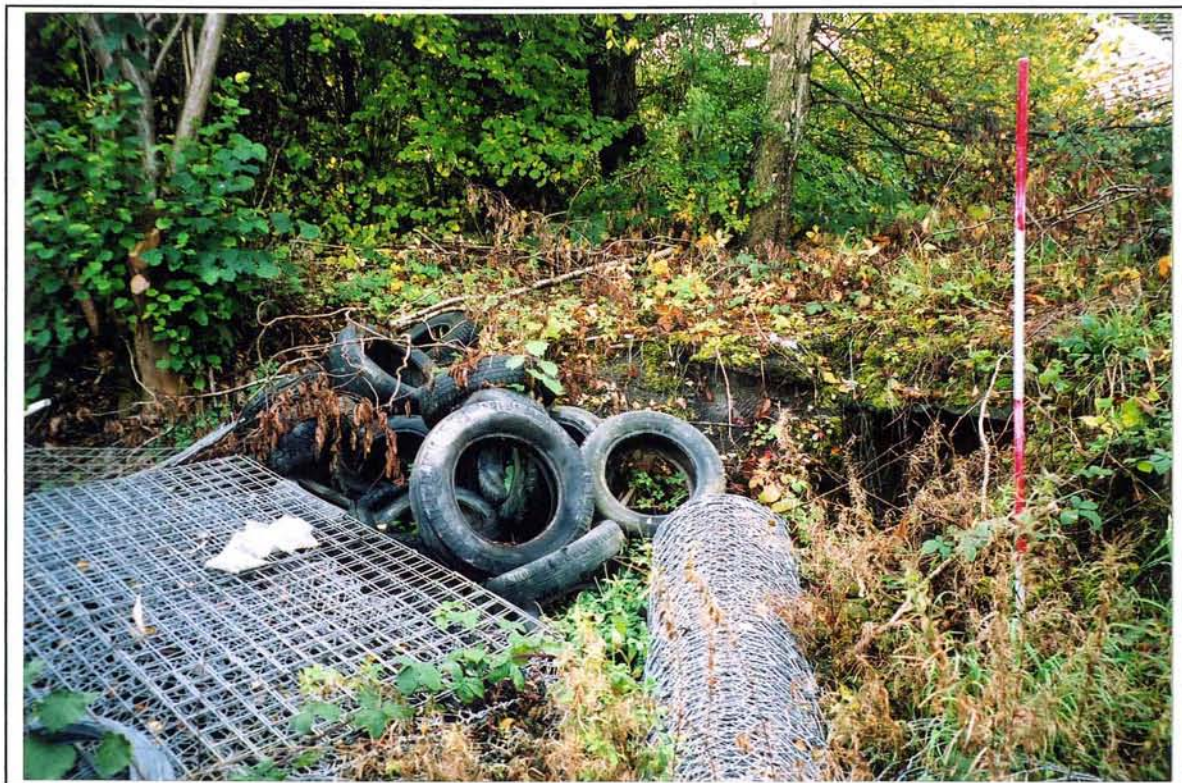
Plate 1 Traces of a building at the south-west end of the railway sidings (Site 1). Photo CPAT 1543.01

The remaining features of this site are likely to be destroyed by construction work, but currently are largely hidden beneath later activity and vegetation. A watching brief should be carried out during site clearance to determine whether any significant structures survive and if so, then preservation of them by record should be considered.

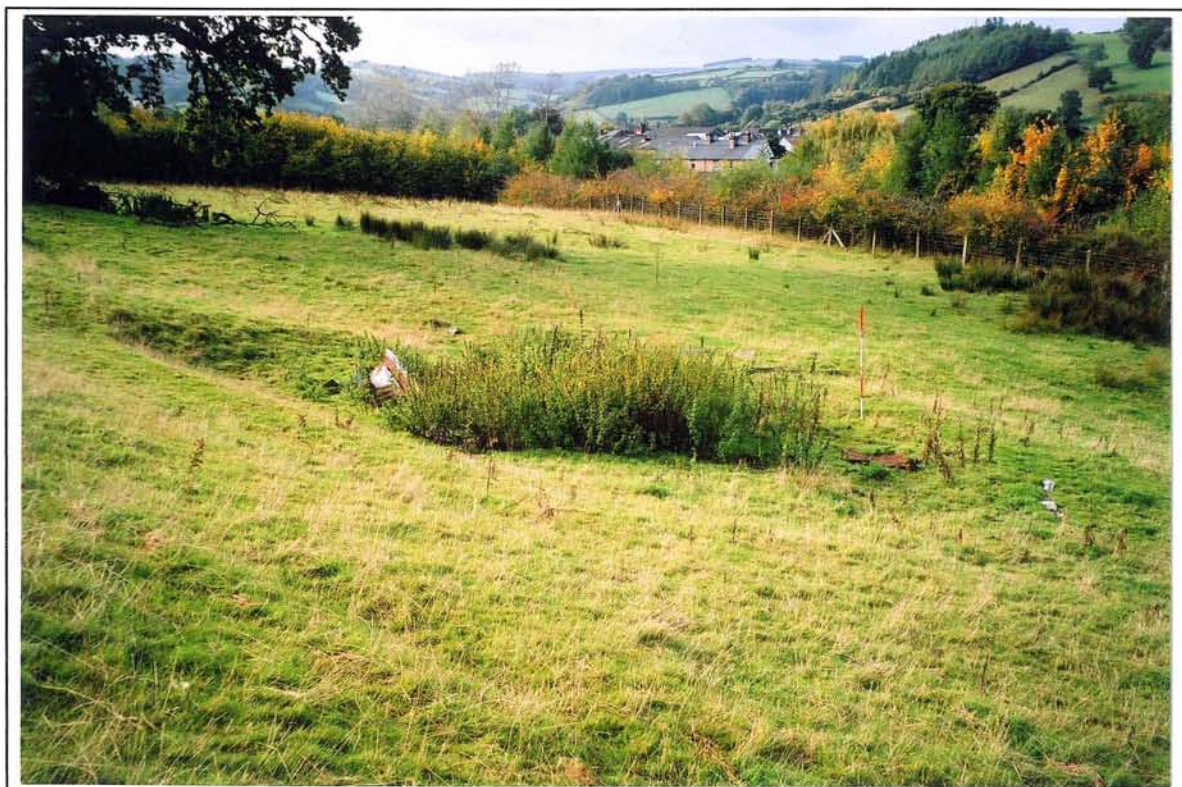
Plate 2 Platform on site of Lower Green barn I (Site 3). Photo CPAT 1543.03

Although this site appears to be of relatively recent origin and is largely destroyed, its siting on a levelled platform might suggest an earlier structure on the same site. In order to allow for the recording of any features which would confirm or deny the above hypothesis, a watching brief should be carried out during site clearance/topsoil removal.

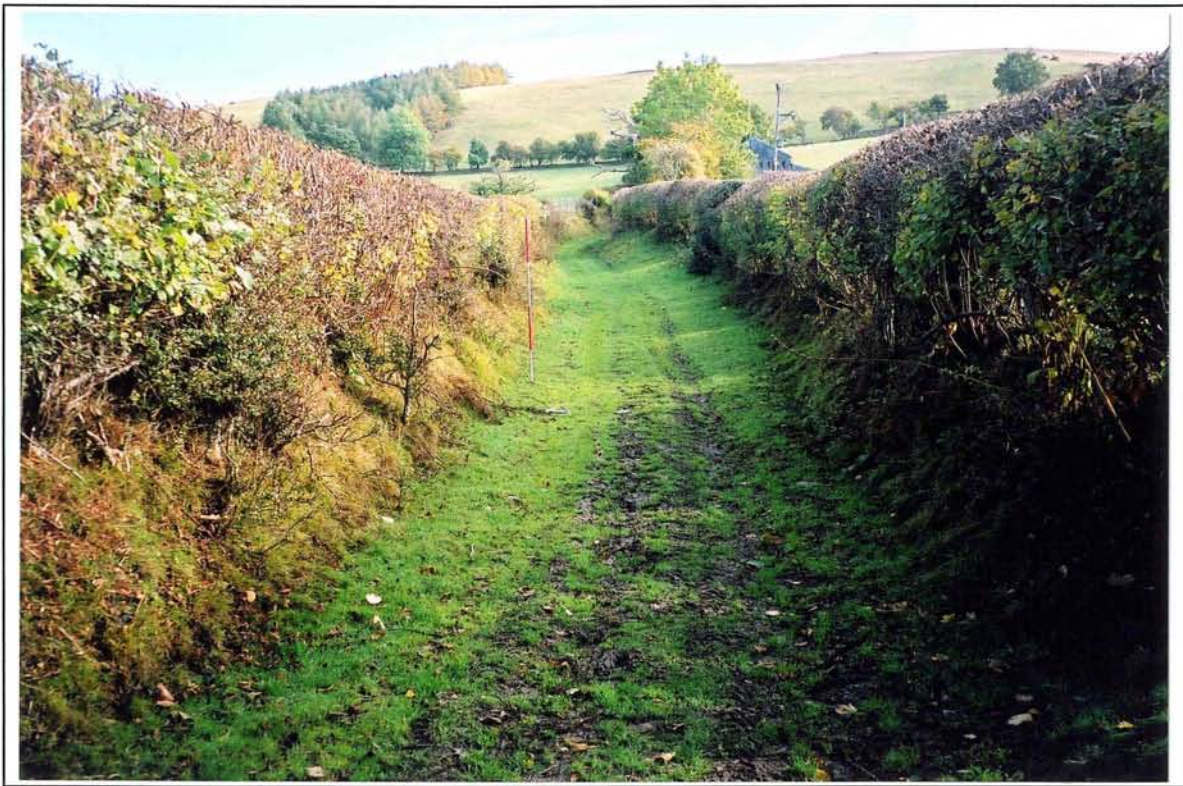
Plate 3 Eastern part of Wtra Bron-y-bedd holloway (Site 4). Photo CPAT 1543.04

The holloway is believed to be of importance owing to its connection with early post-medieval activity in Llanidloes. Preservation in-situ is unlikely to be practicable, and the most appropriate mitigation would seem to be a measured survey of the surviving earthworks which represent the original line of the sunken lane.

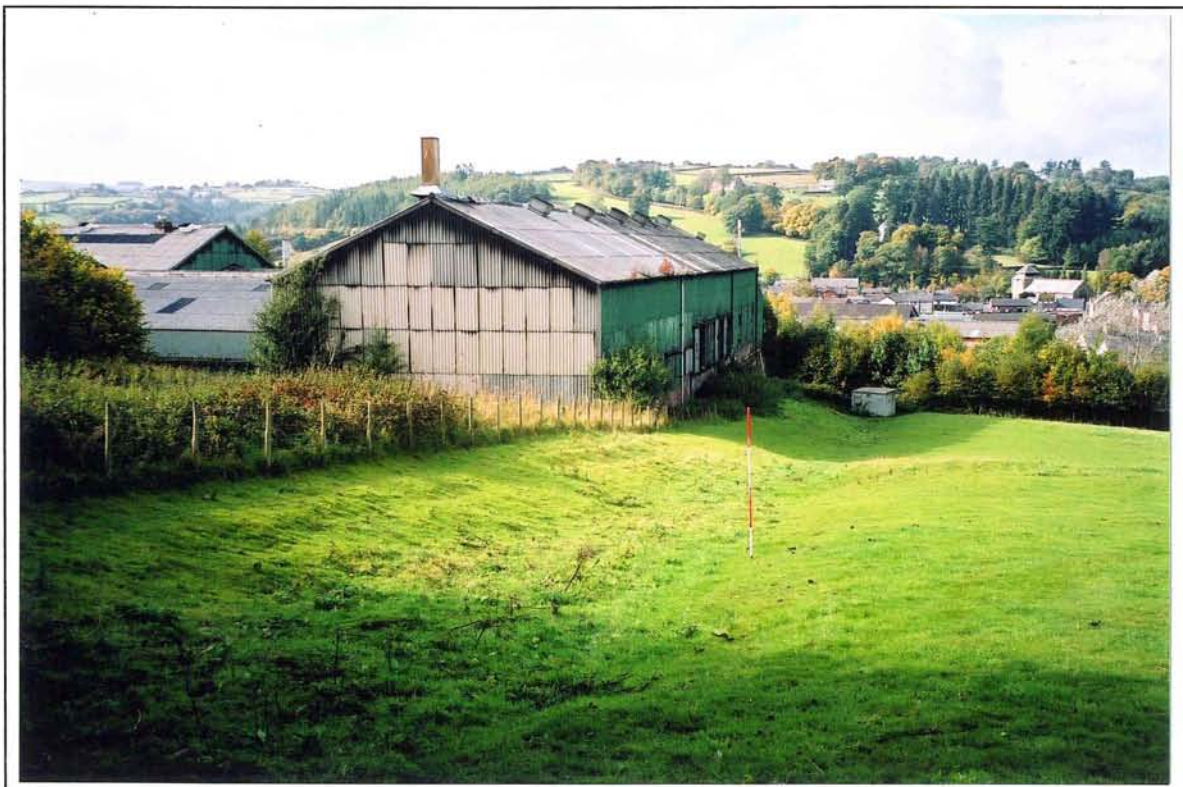
Plate 4 Llanidloes Foundry (Site 6) and western part of Wtra Bron-y-bedd holloway (Site 4).  
Photo CPAT 1543.08

Although the foundry is of relatively recent origin, there are believed to be a number of original features which still survive within the existing buildings. Furthermore one of the buildings may have originally been constructed to provide power for functions related to the railway and an earlier foundry. In order to provide a record of any significant surviving features, a photographic survey should be carried out prior to the commencement of any site clearance.

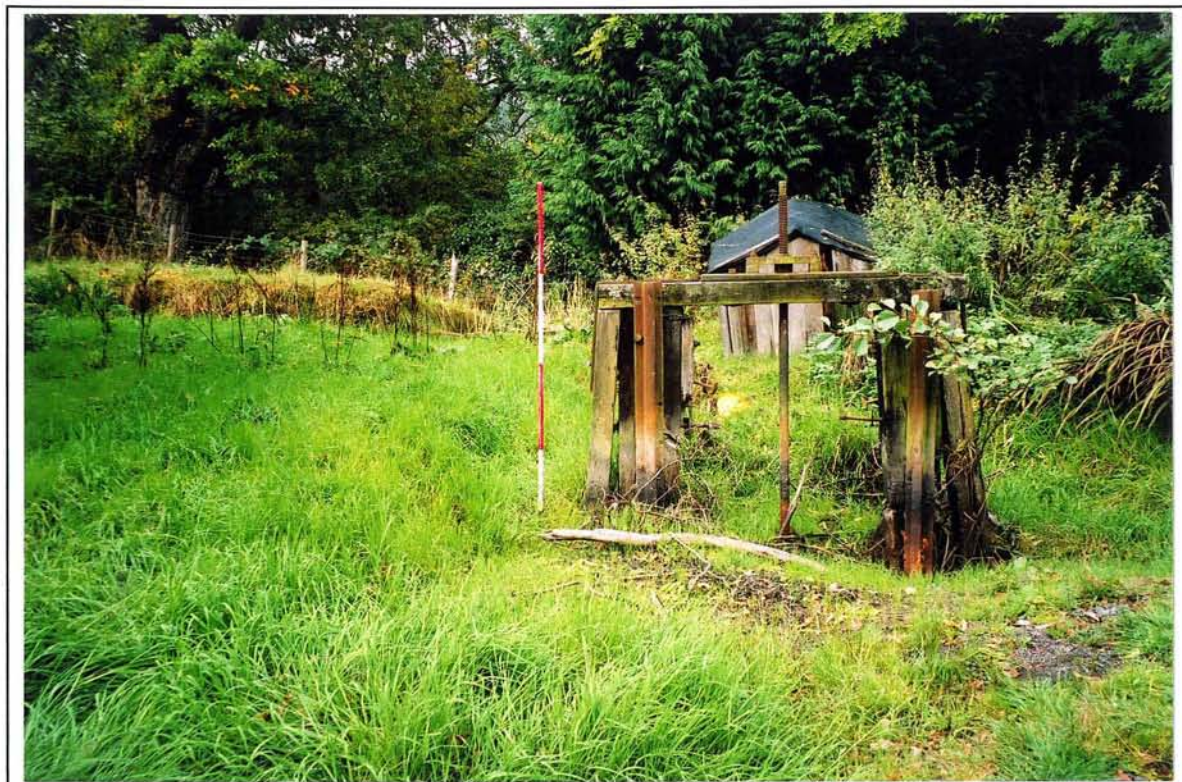
Although the reservoir is choked by flood debris from the stream, the main structures (dam wall and spillway, sluice mechanism etc) are still in relatively good condition. The site is an important element in understanding the method by which the railway engineers utilised the natural resources of the locality and the structures should accordingly be preserved in-situ, if this is at all possible. If disturbance to the structural remains is inevitable, then preservation by record should be attempted, although the potential difficulties inherent in providing an adequate record, given the fact that most of the surviving structures are partially masked by debris, may render the results less than satisfactory.

Plate 5 Lletty Cochnant reservoir (Site 5). Photo CPAT 1543.07

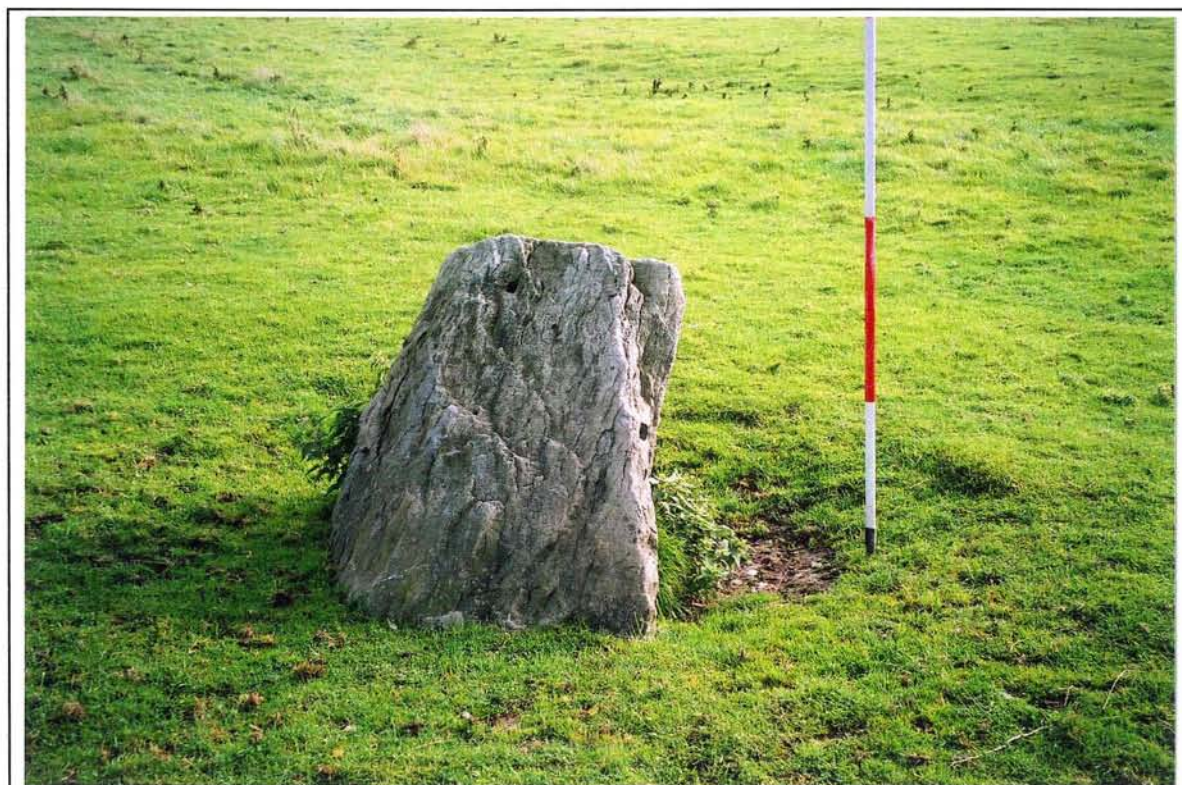
Plate 6 Llanidloes Foundry stone (Site 7). Photo CPAT 1543.09

Although the stone may be of 19th-century origin, the possibility that it may be earlier in date cannot be ruled out. The site should be evaluated to ensure that it is not of prehistoric origin.

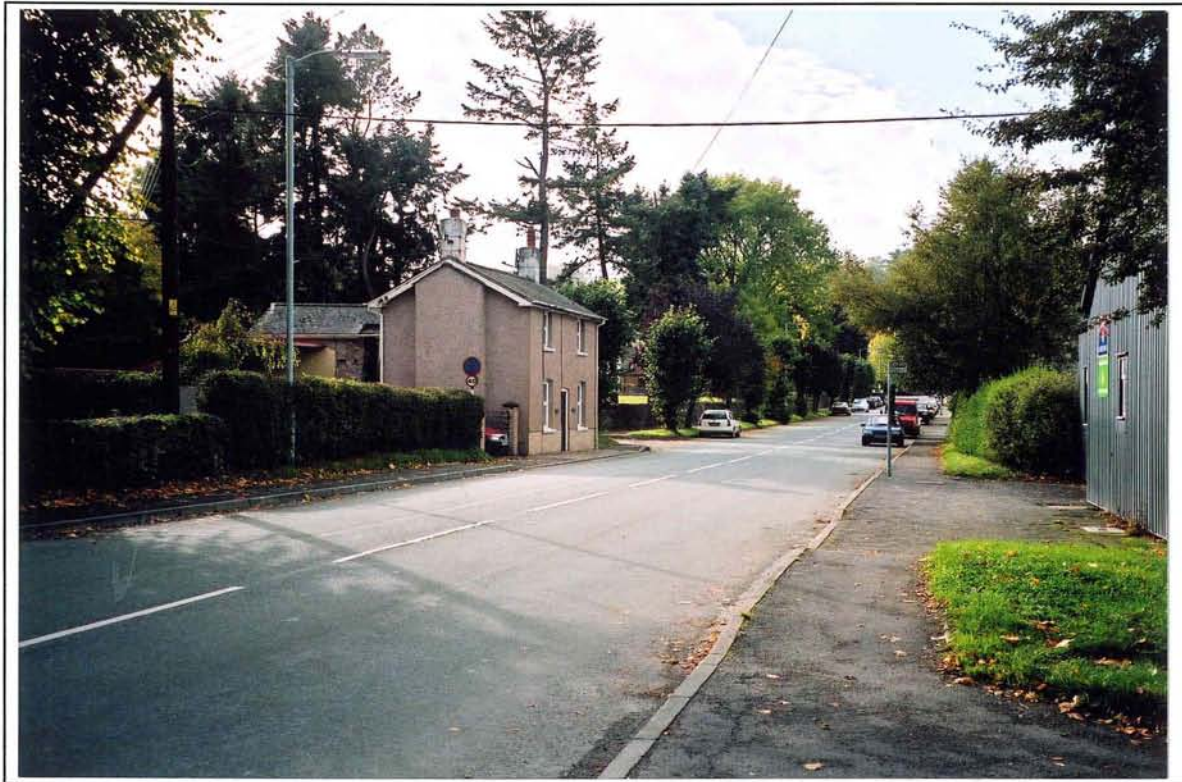
Plate 7 Old Tollgate Cottage (Site 9) and the eastern end of Victoria Avenue. Photo CPAT 1543.12

The building appears to be substantially intact, despite some more recent cosmetic alterations. It should be preserved in-situ, if at all possible.

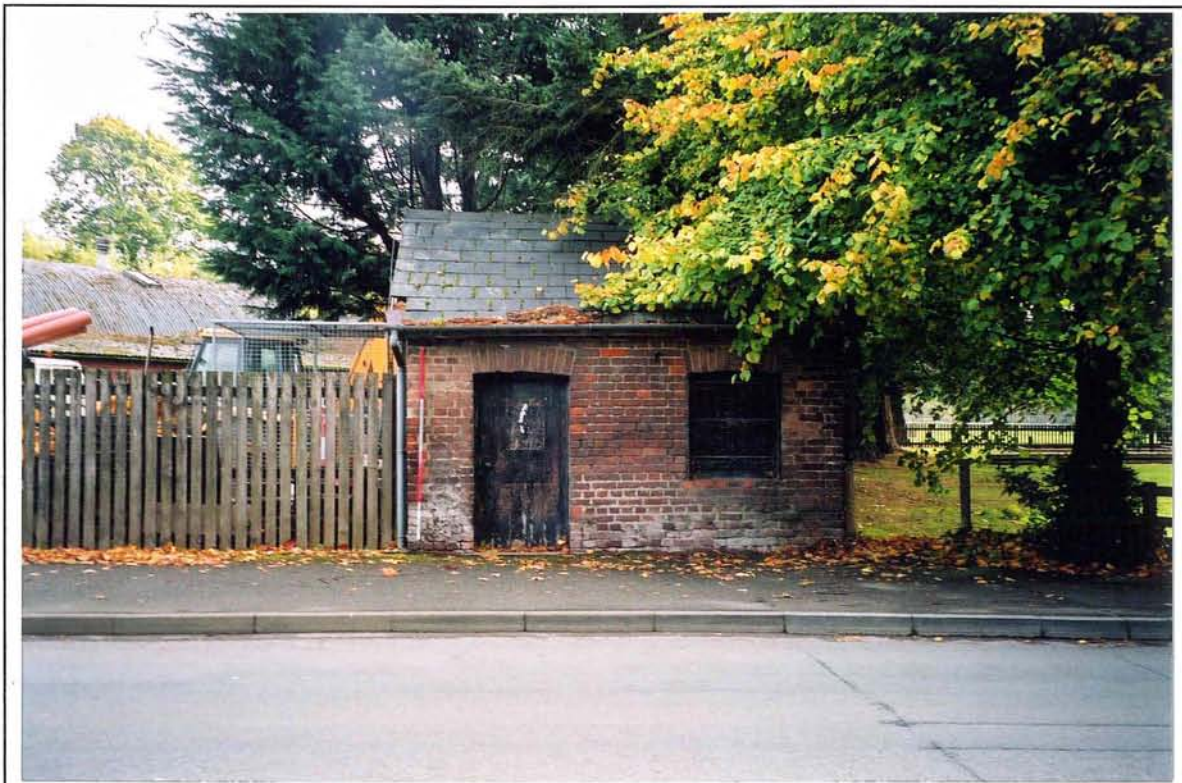
Plate 8 Victoria Avenue weighing machine (Site 10). Photo CPAT 1543.13

Owing to construction constraints, it is unlikely that the surviving building can be preserved in-situ. In view of the uncertainty regarding the nature of the site it should be evaluated prior to the commencement of construction work. This should include the examination and recording by measured survey and photography of the interior and exterior of the building. An updated written record should also be compiled once access can be gained to the interior.
