A470 Cardiff - Glan Conwy Trunk Road, Improvements South of Builth Wells, Powys

ARCHAEOLOGICAL ASSESSMENT
FINAL REPORT

CPAT Report No 429.1

R Hankinson and N W Jones
September 2002

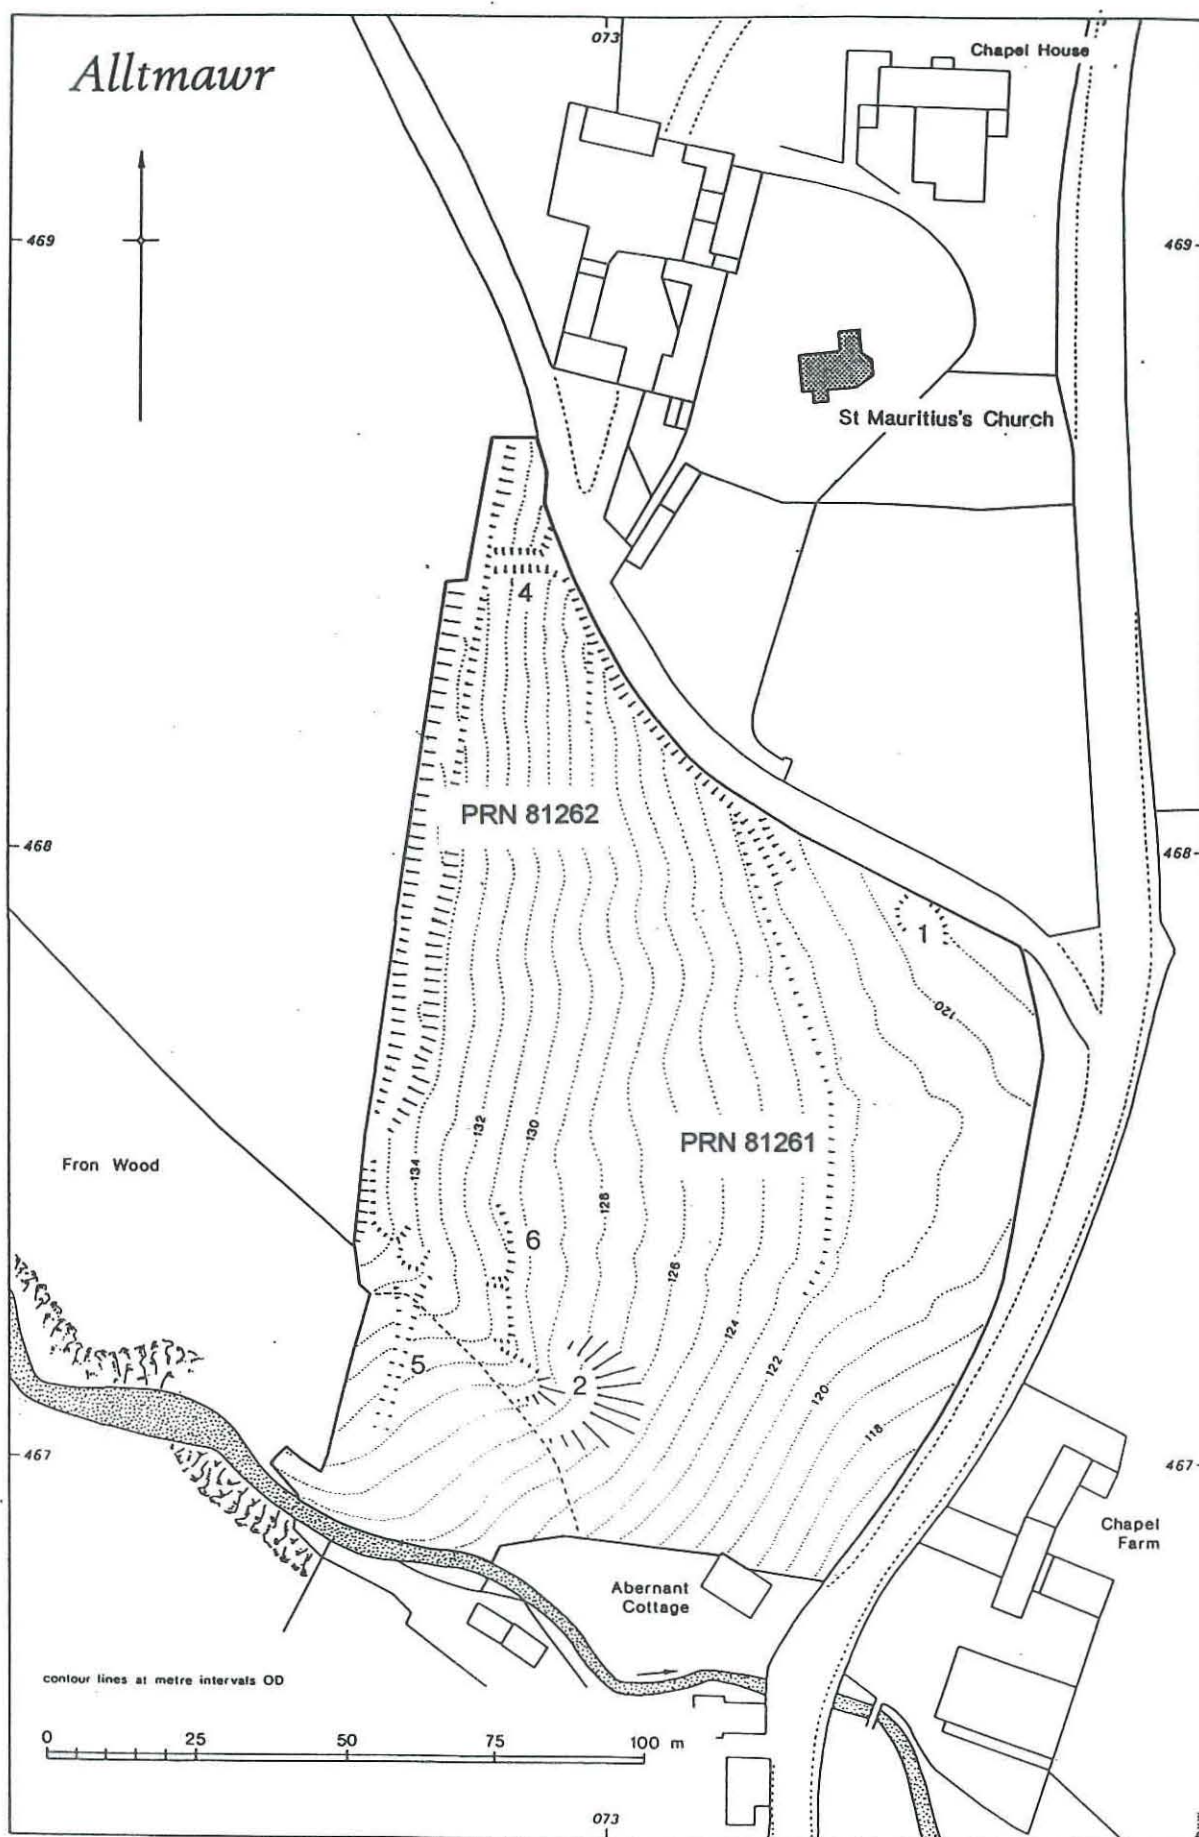
Fig. 2 Survey of settlement earthworks at Alltmawr (Jones 1993)

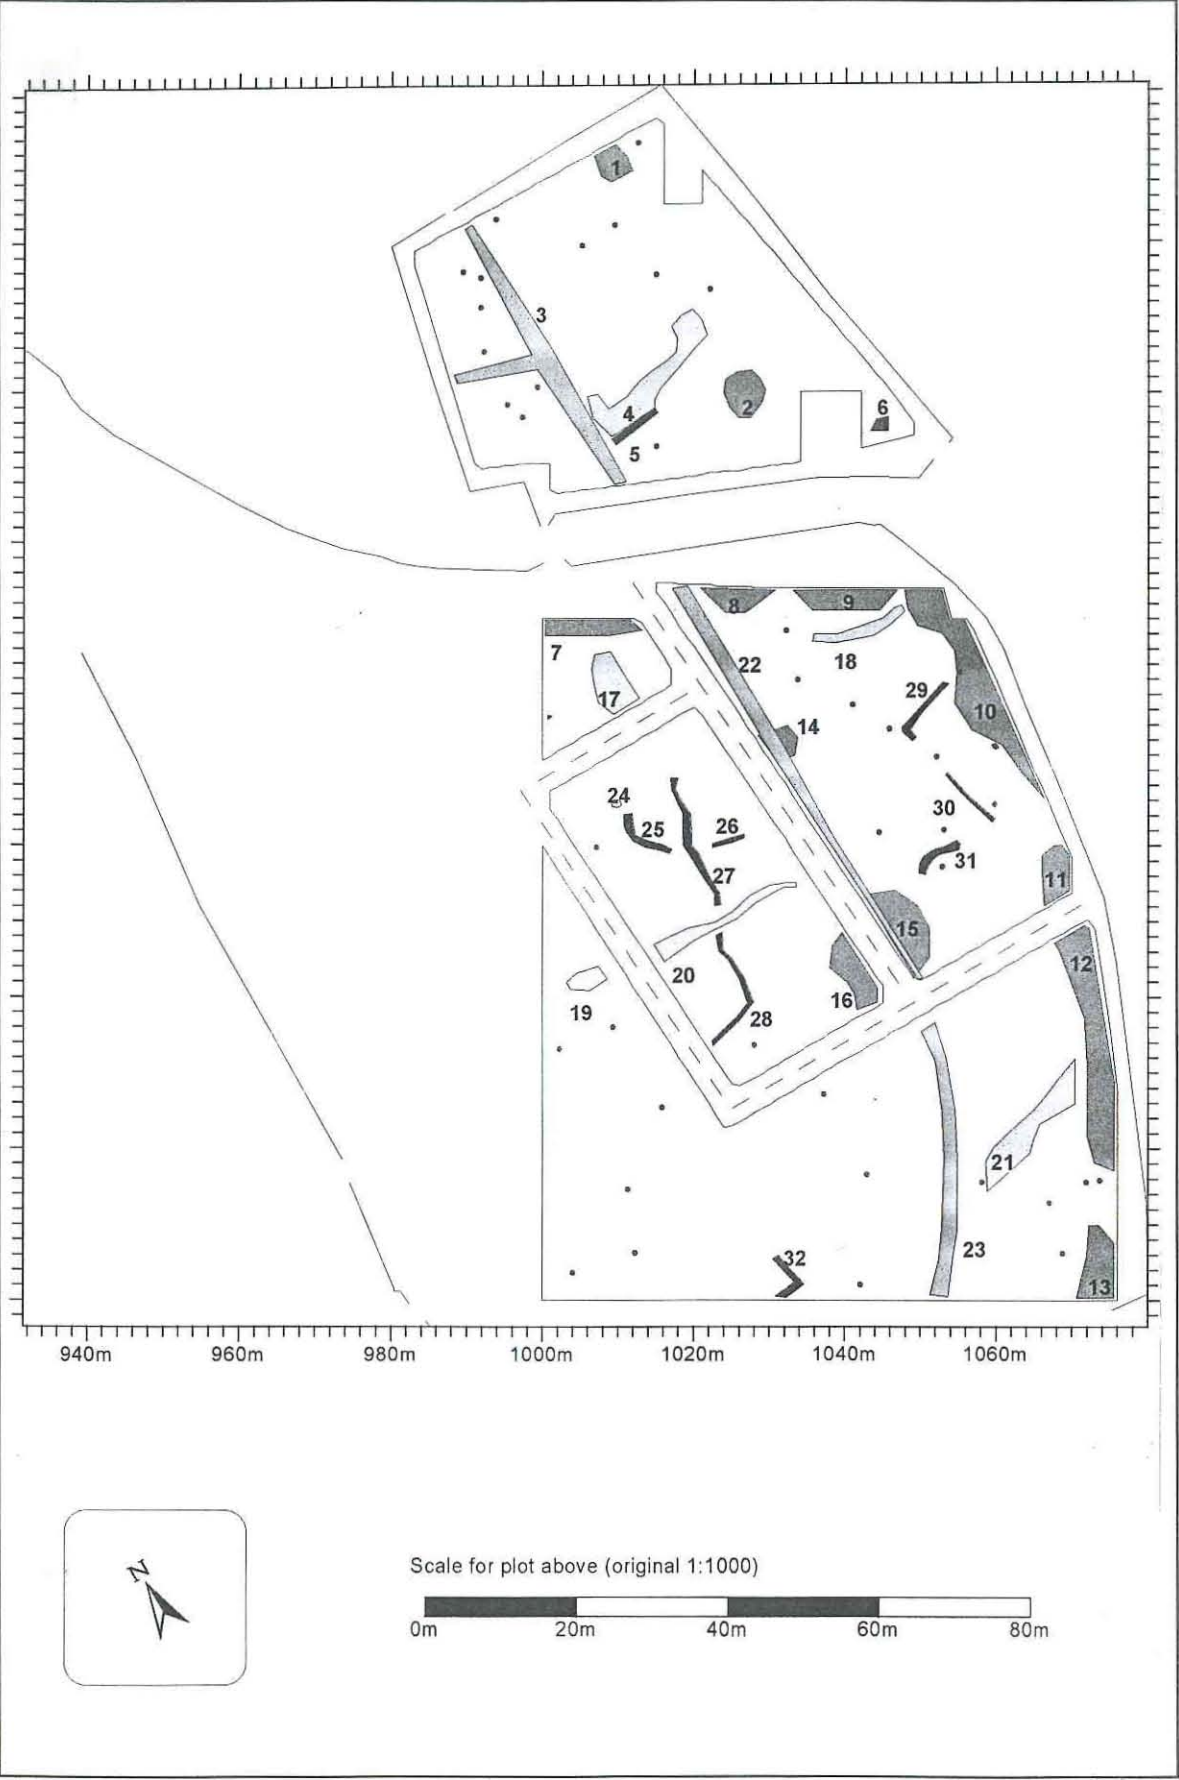
Fig. 16 Geophysical survey results

- 3.4 The geophysical survey was undertaken by ArchaeoPhysica (of Shrewsbury, Shropshire), on behalf of CPAT, during June 2002, and employed a caesium vapour magnetic gradient survey at 1m line separation within the area defined in the curatorial brief. Full technical details and explanations can be found in the separate report submitted by ArchaeoPhysica to CPAT but are not included in this report for reasons of conciseness.

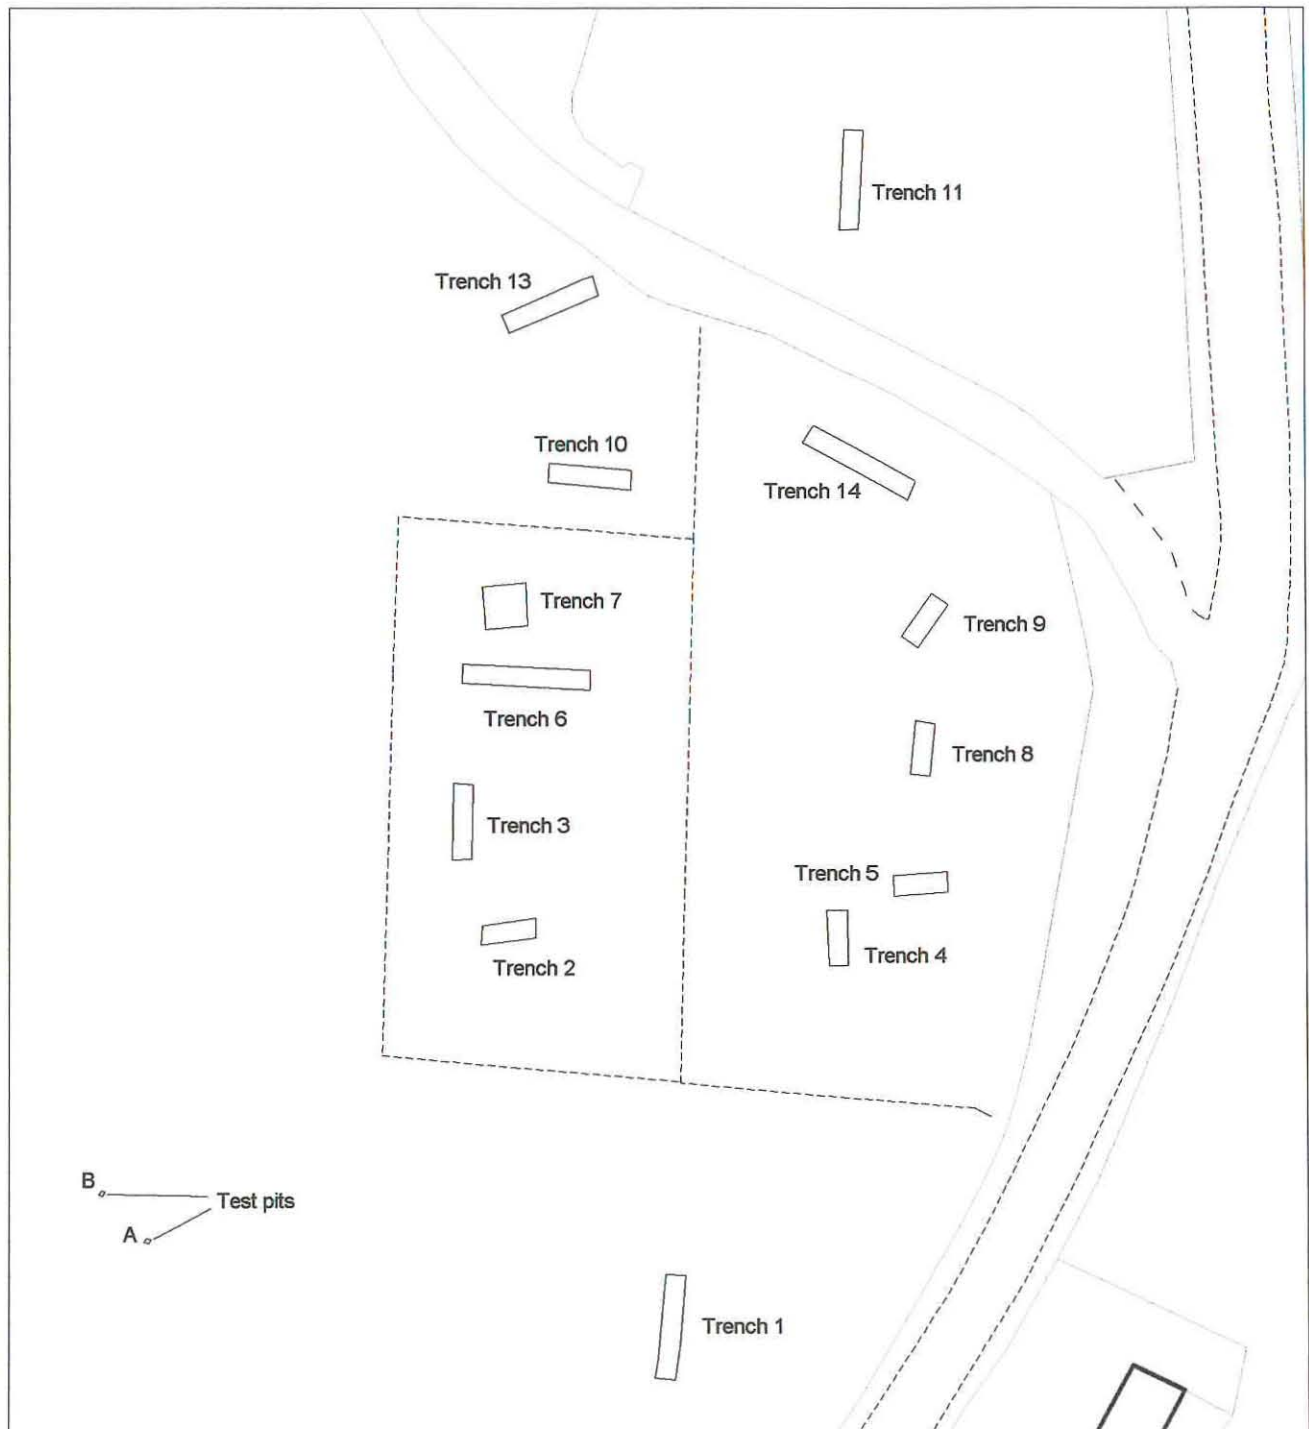
Fig. 17 Plan of excavation trenches, scale 1:7,000

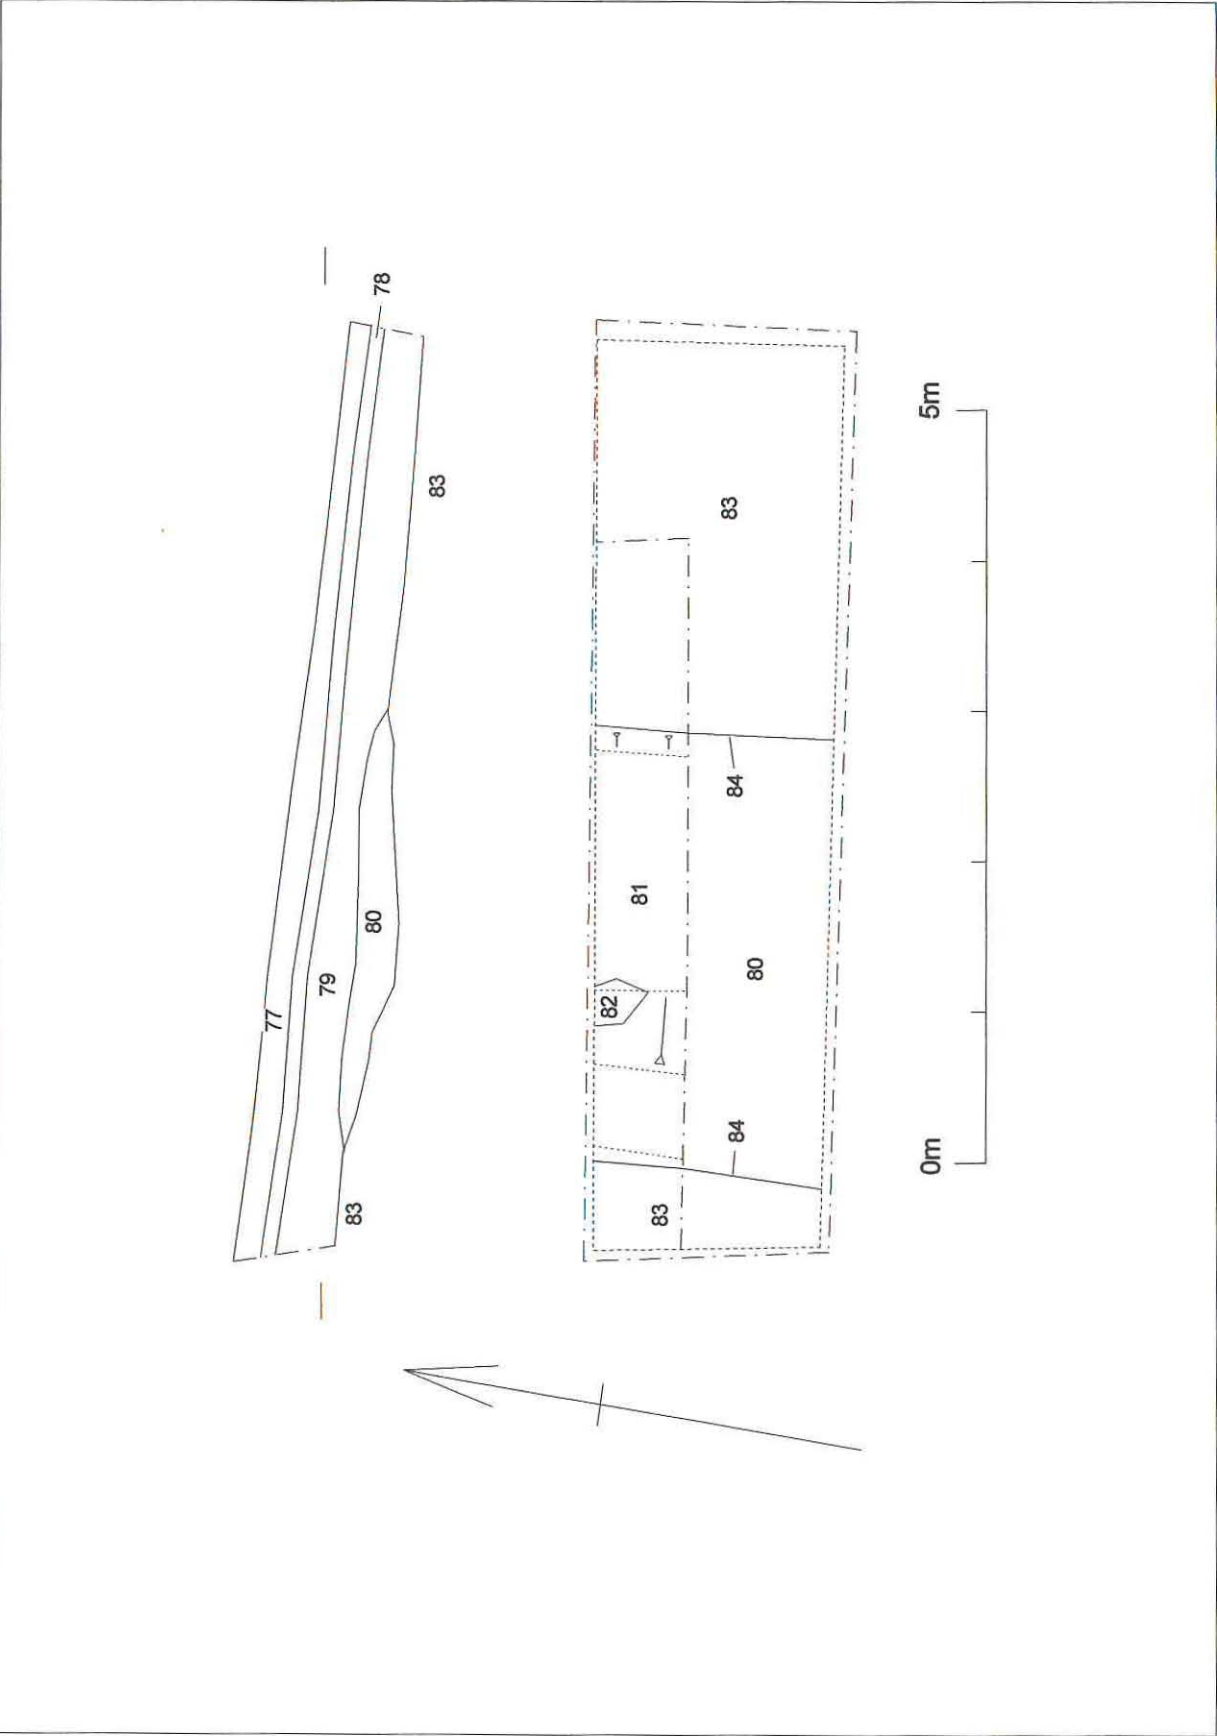
Fig. 18 Trench 2 plan and section, scale 1:50

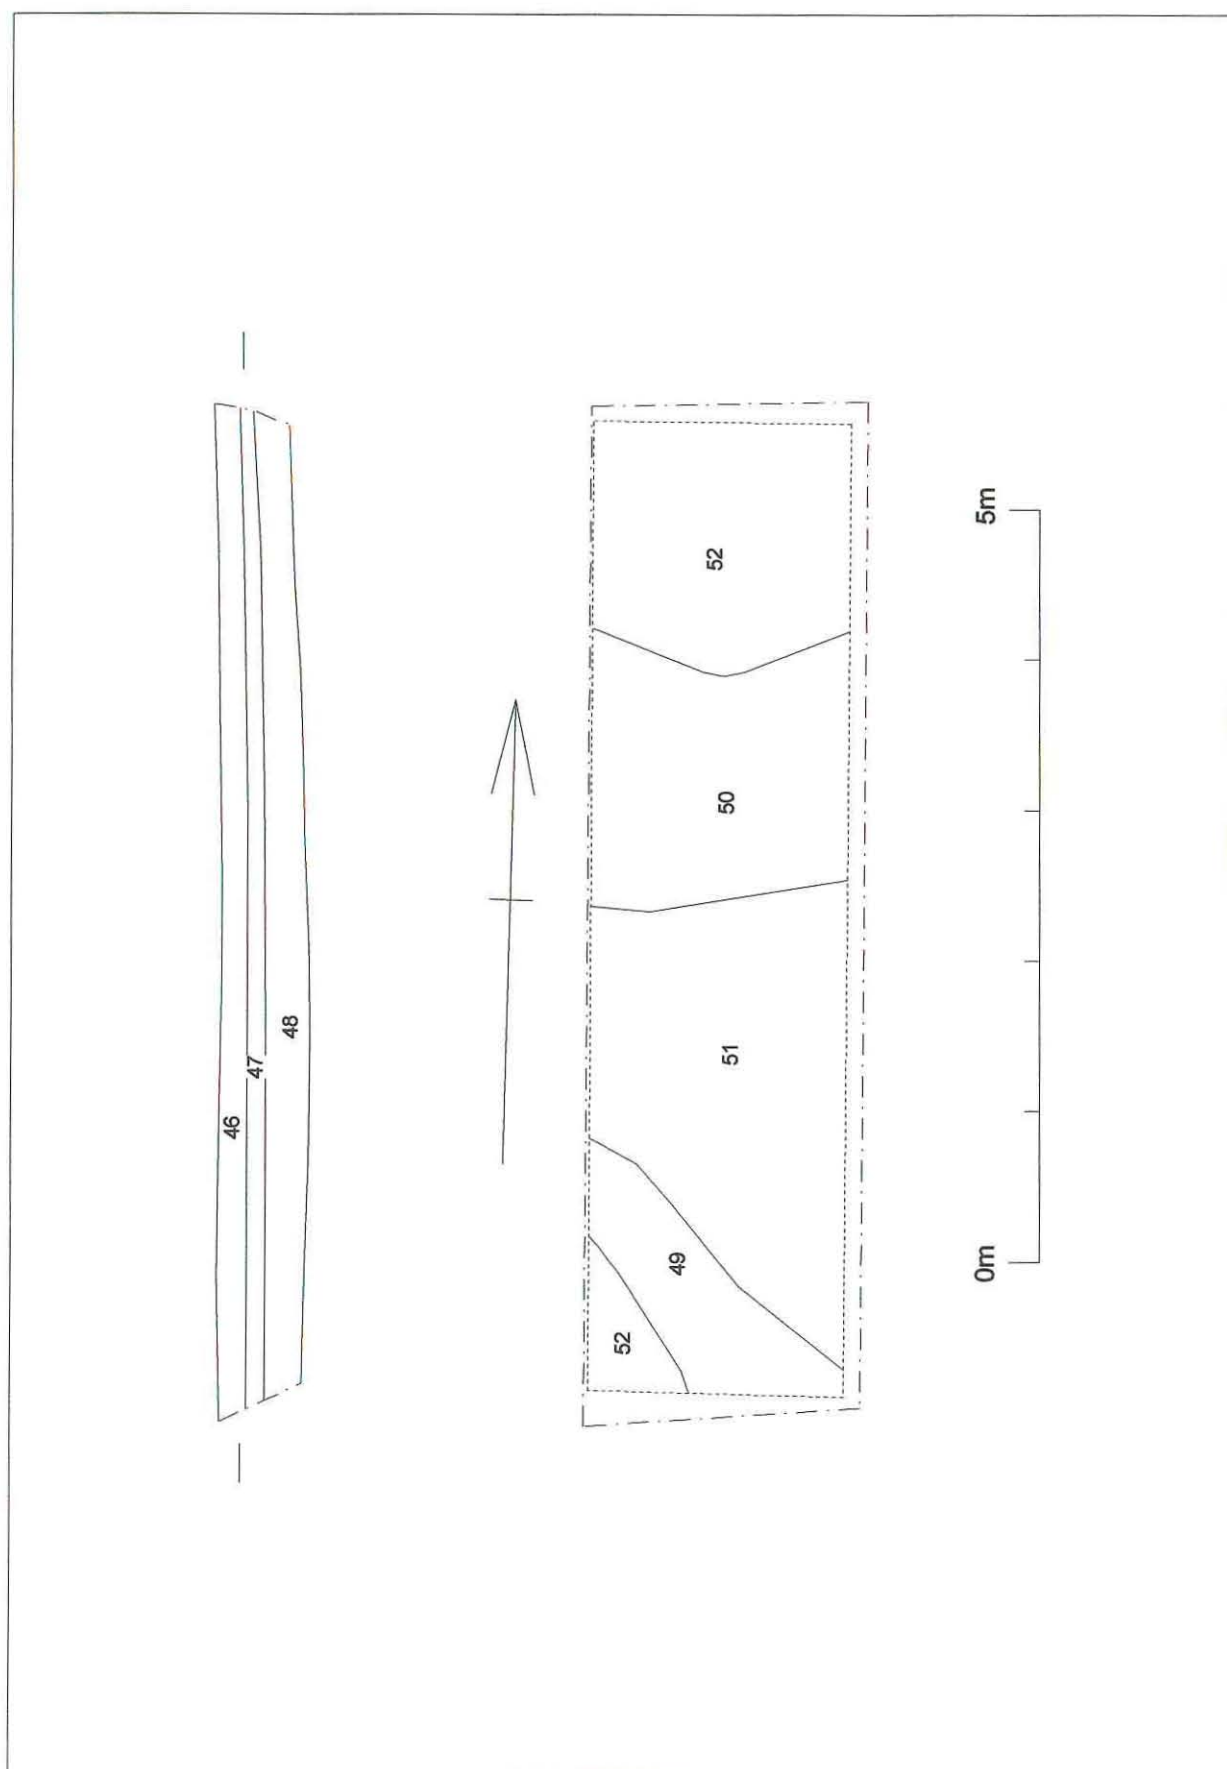
Fig. 19 Trench 3 plan and section, scale 1:50

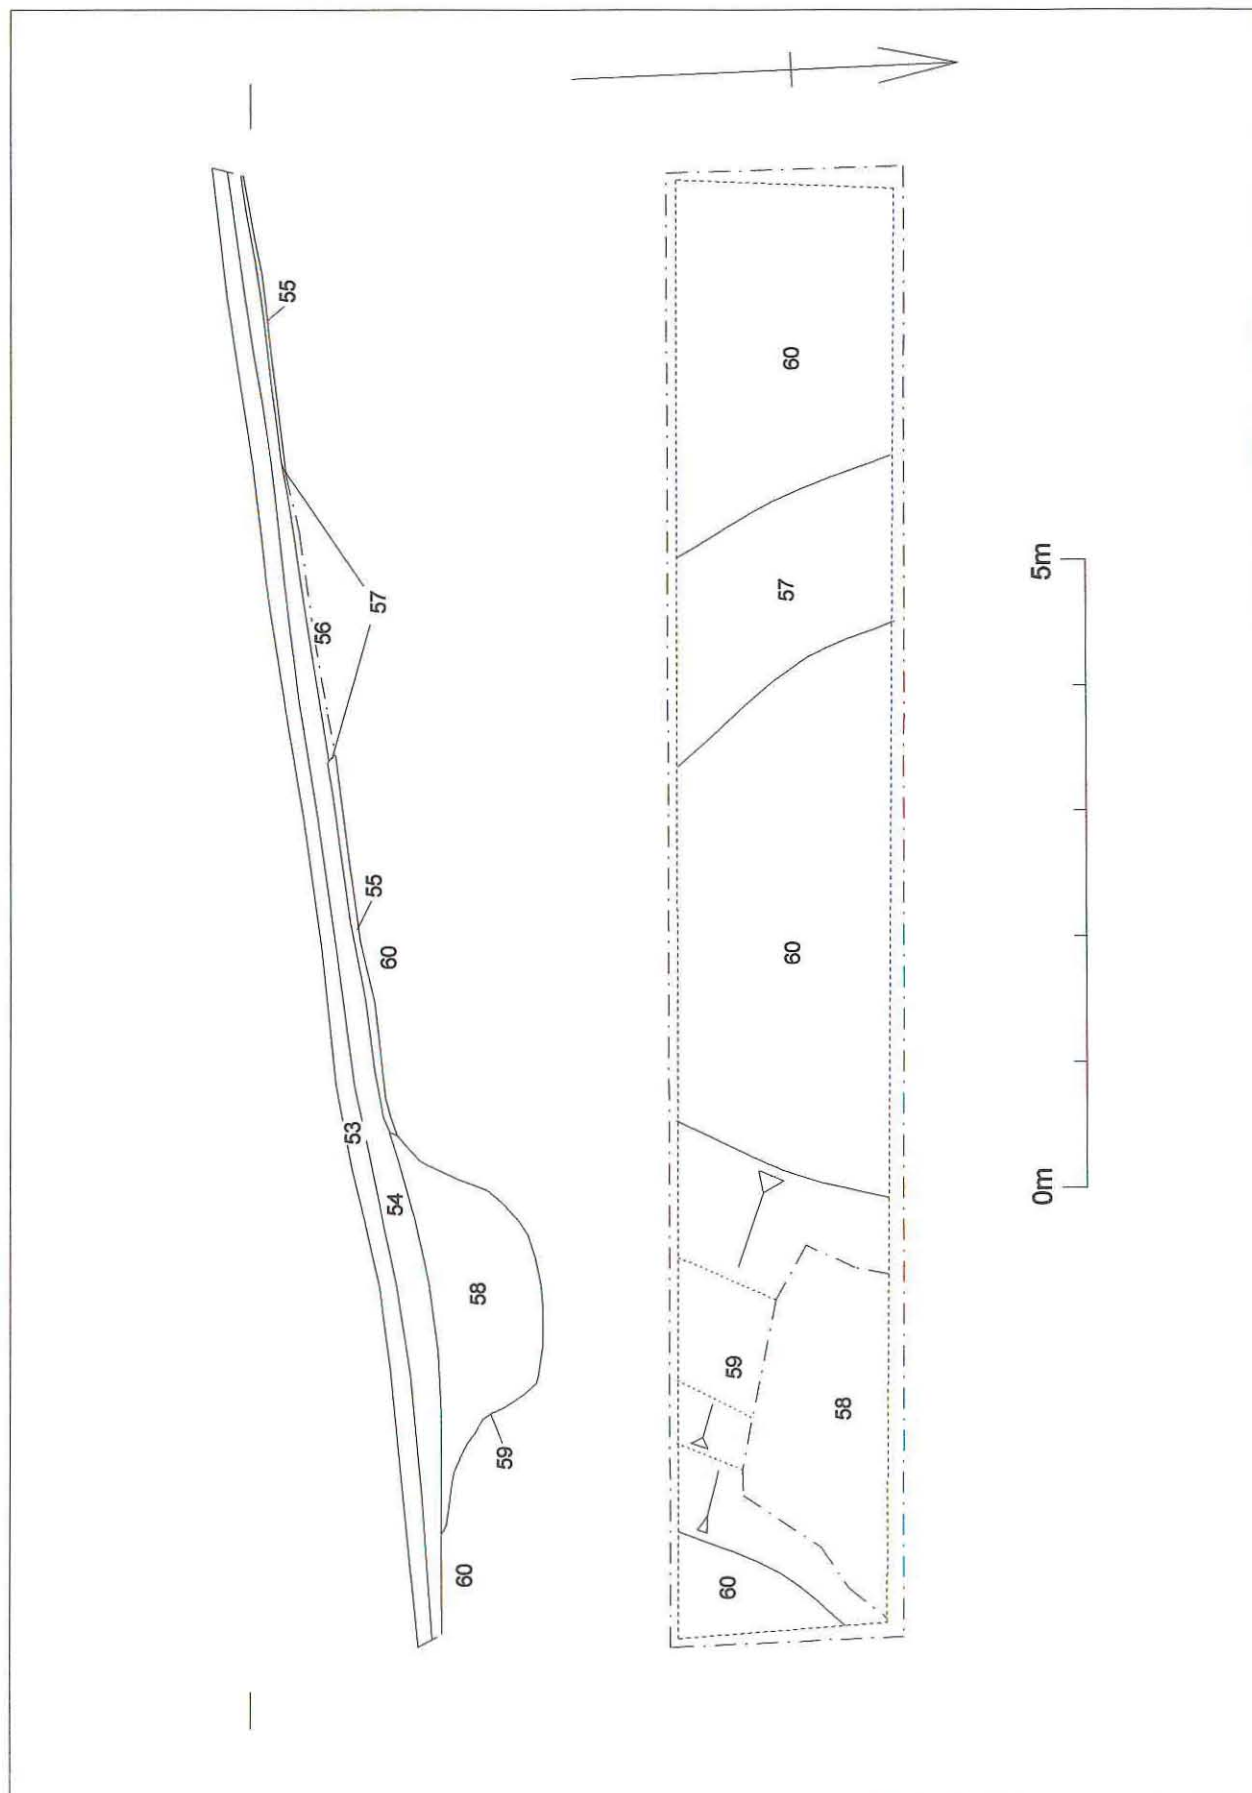
Fig. 20 Trench 6 plan and section, scale 1:60

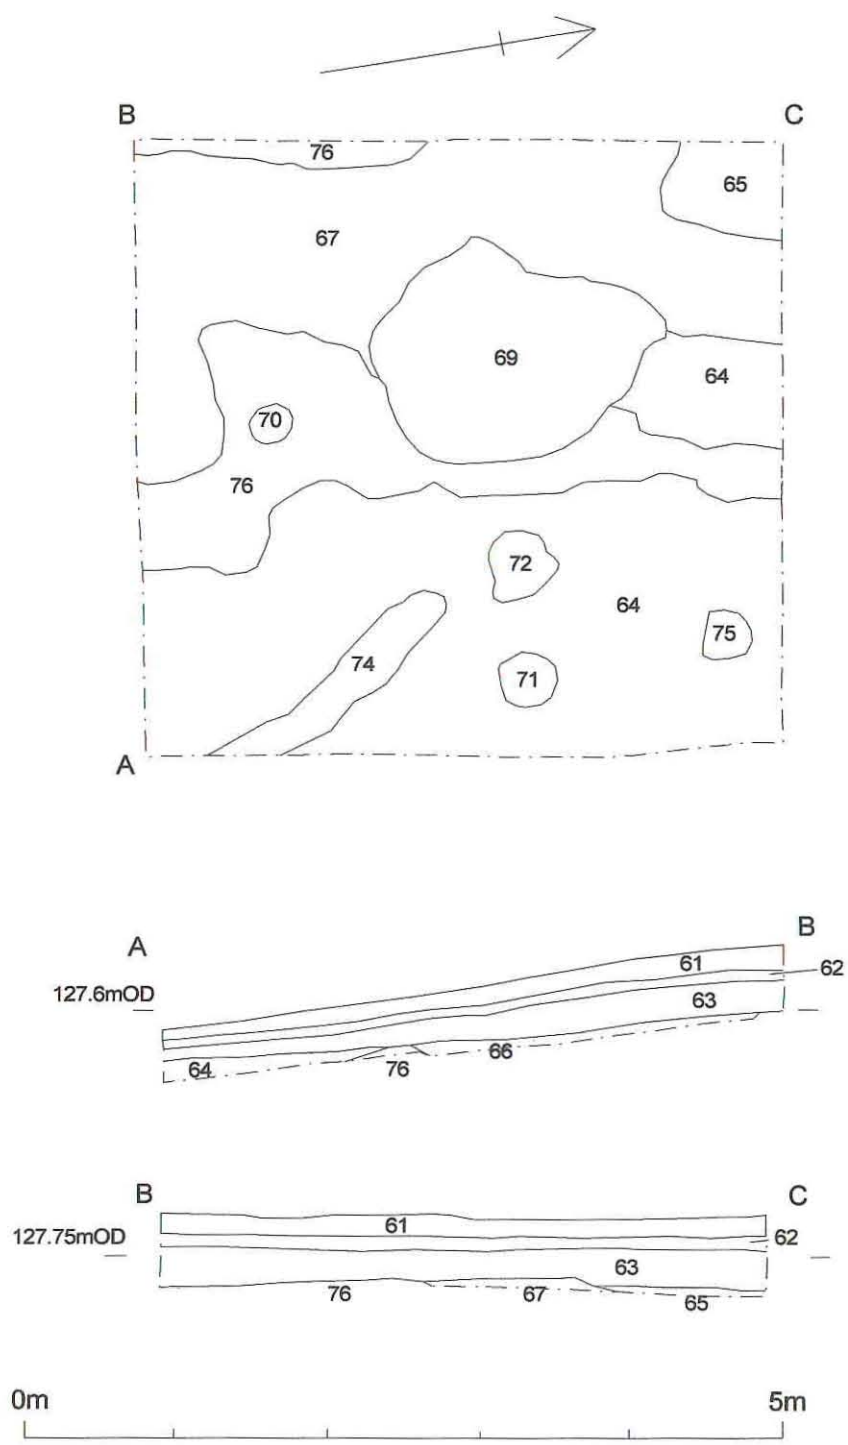
Fig 21 Trench 7 plan and sections, scale 1:50

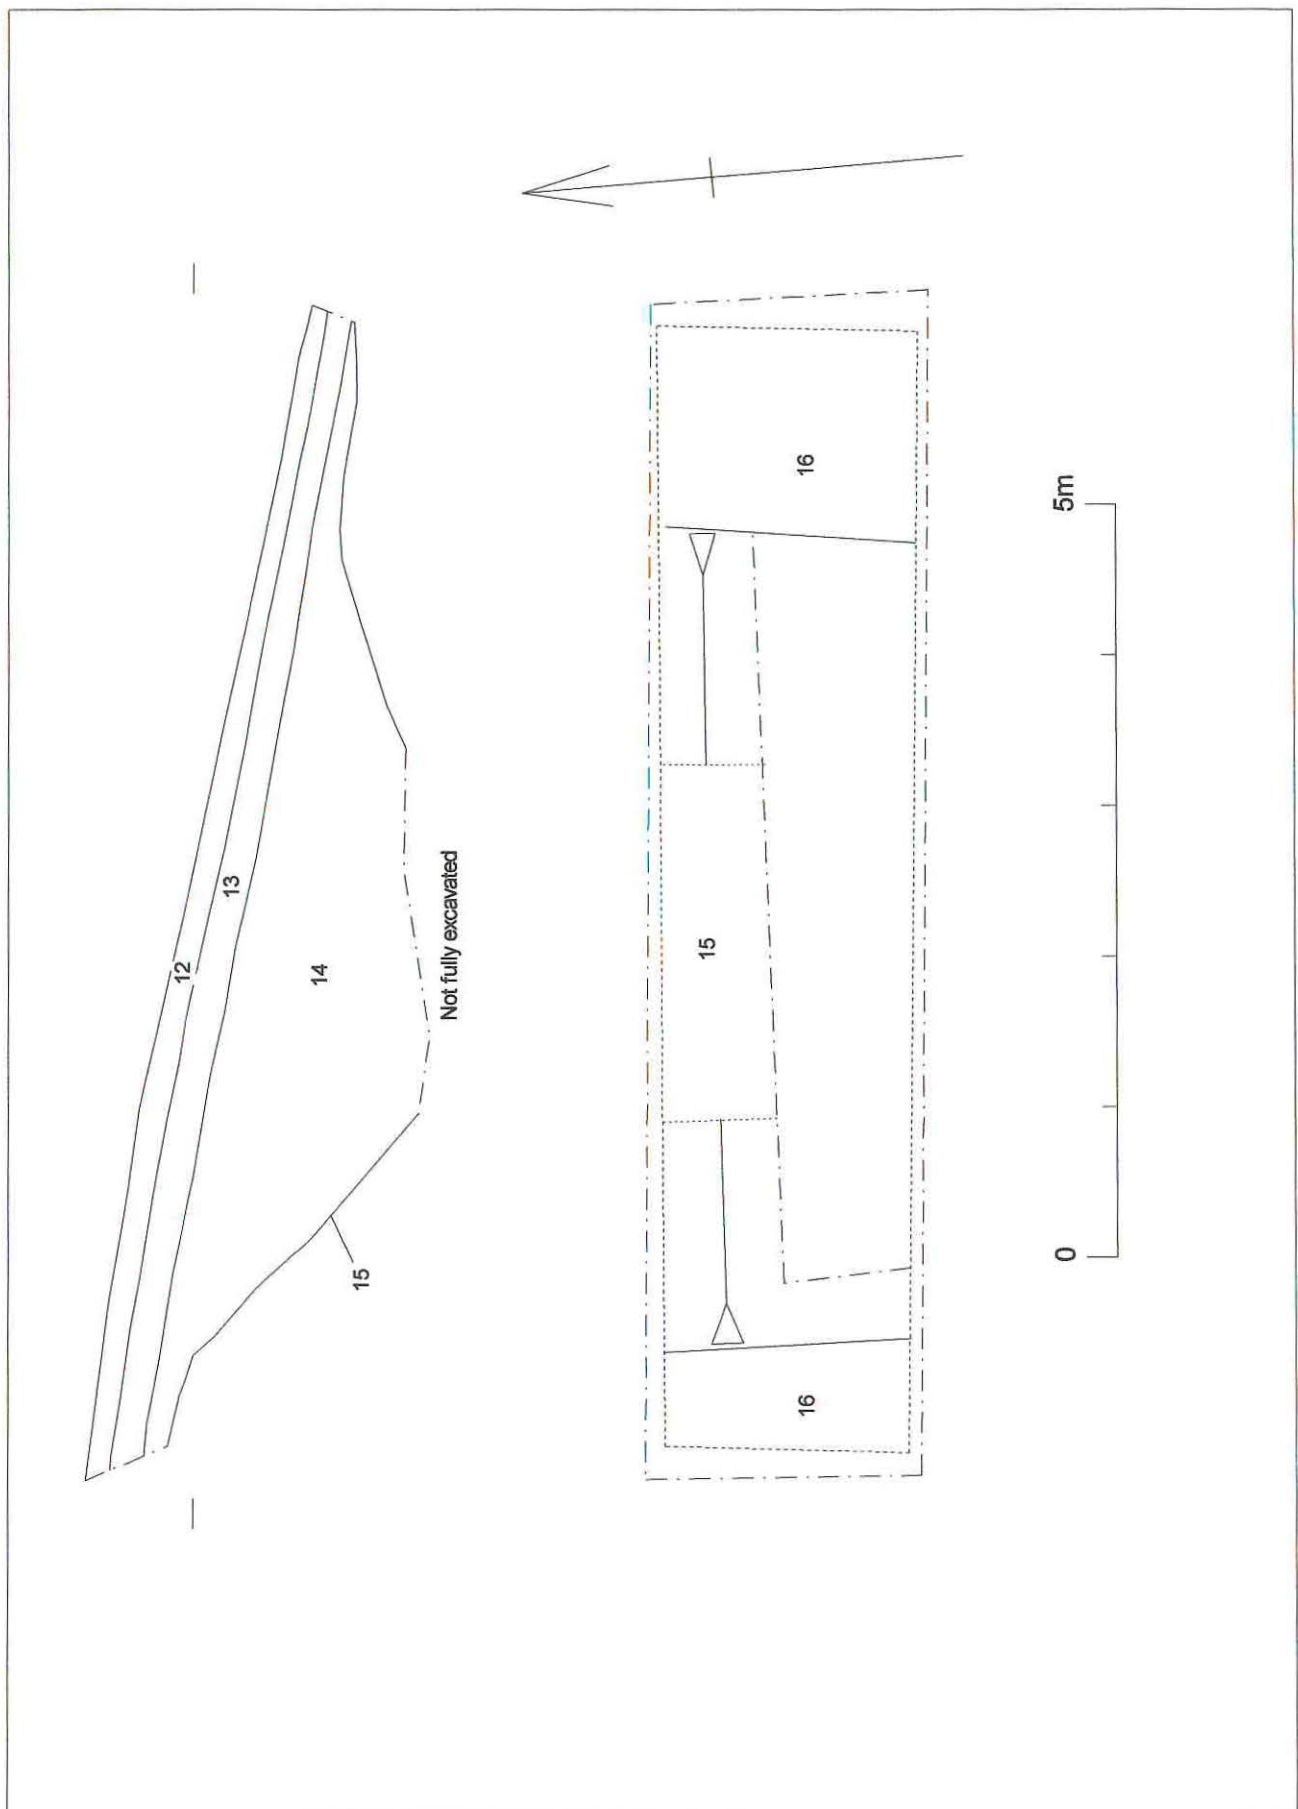
Fig. 22 Trench 10 plan and section, scale 1:50

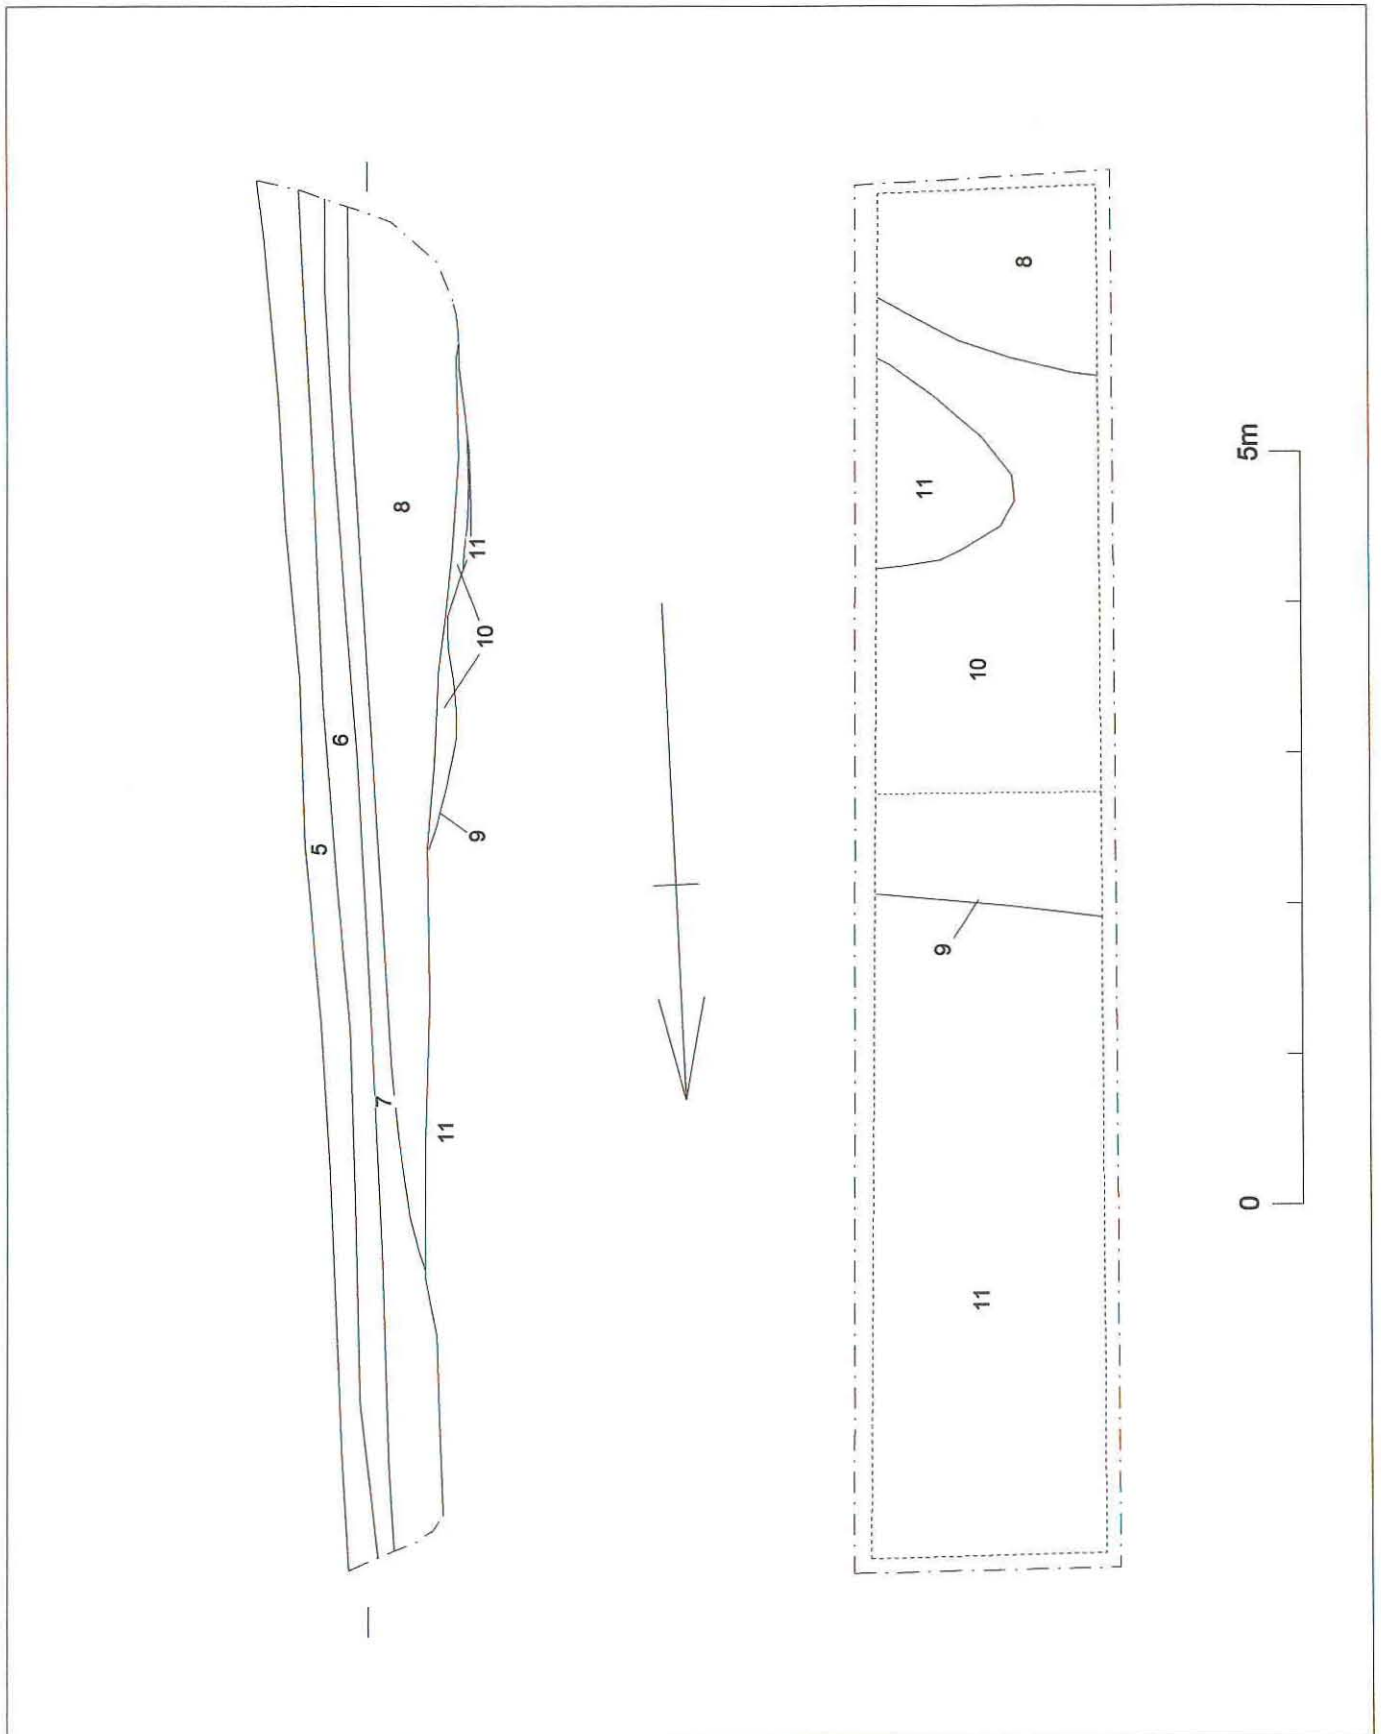
Fig. 23 Trench 11 plan and section, scale 1:50

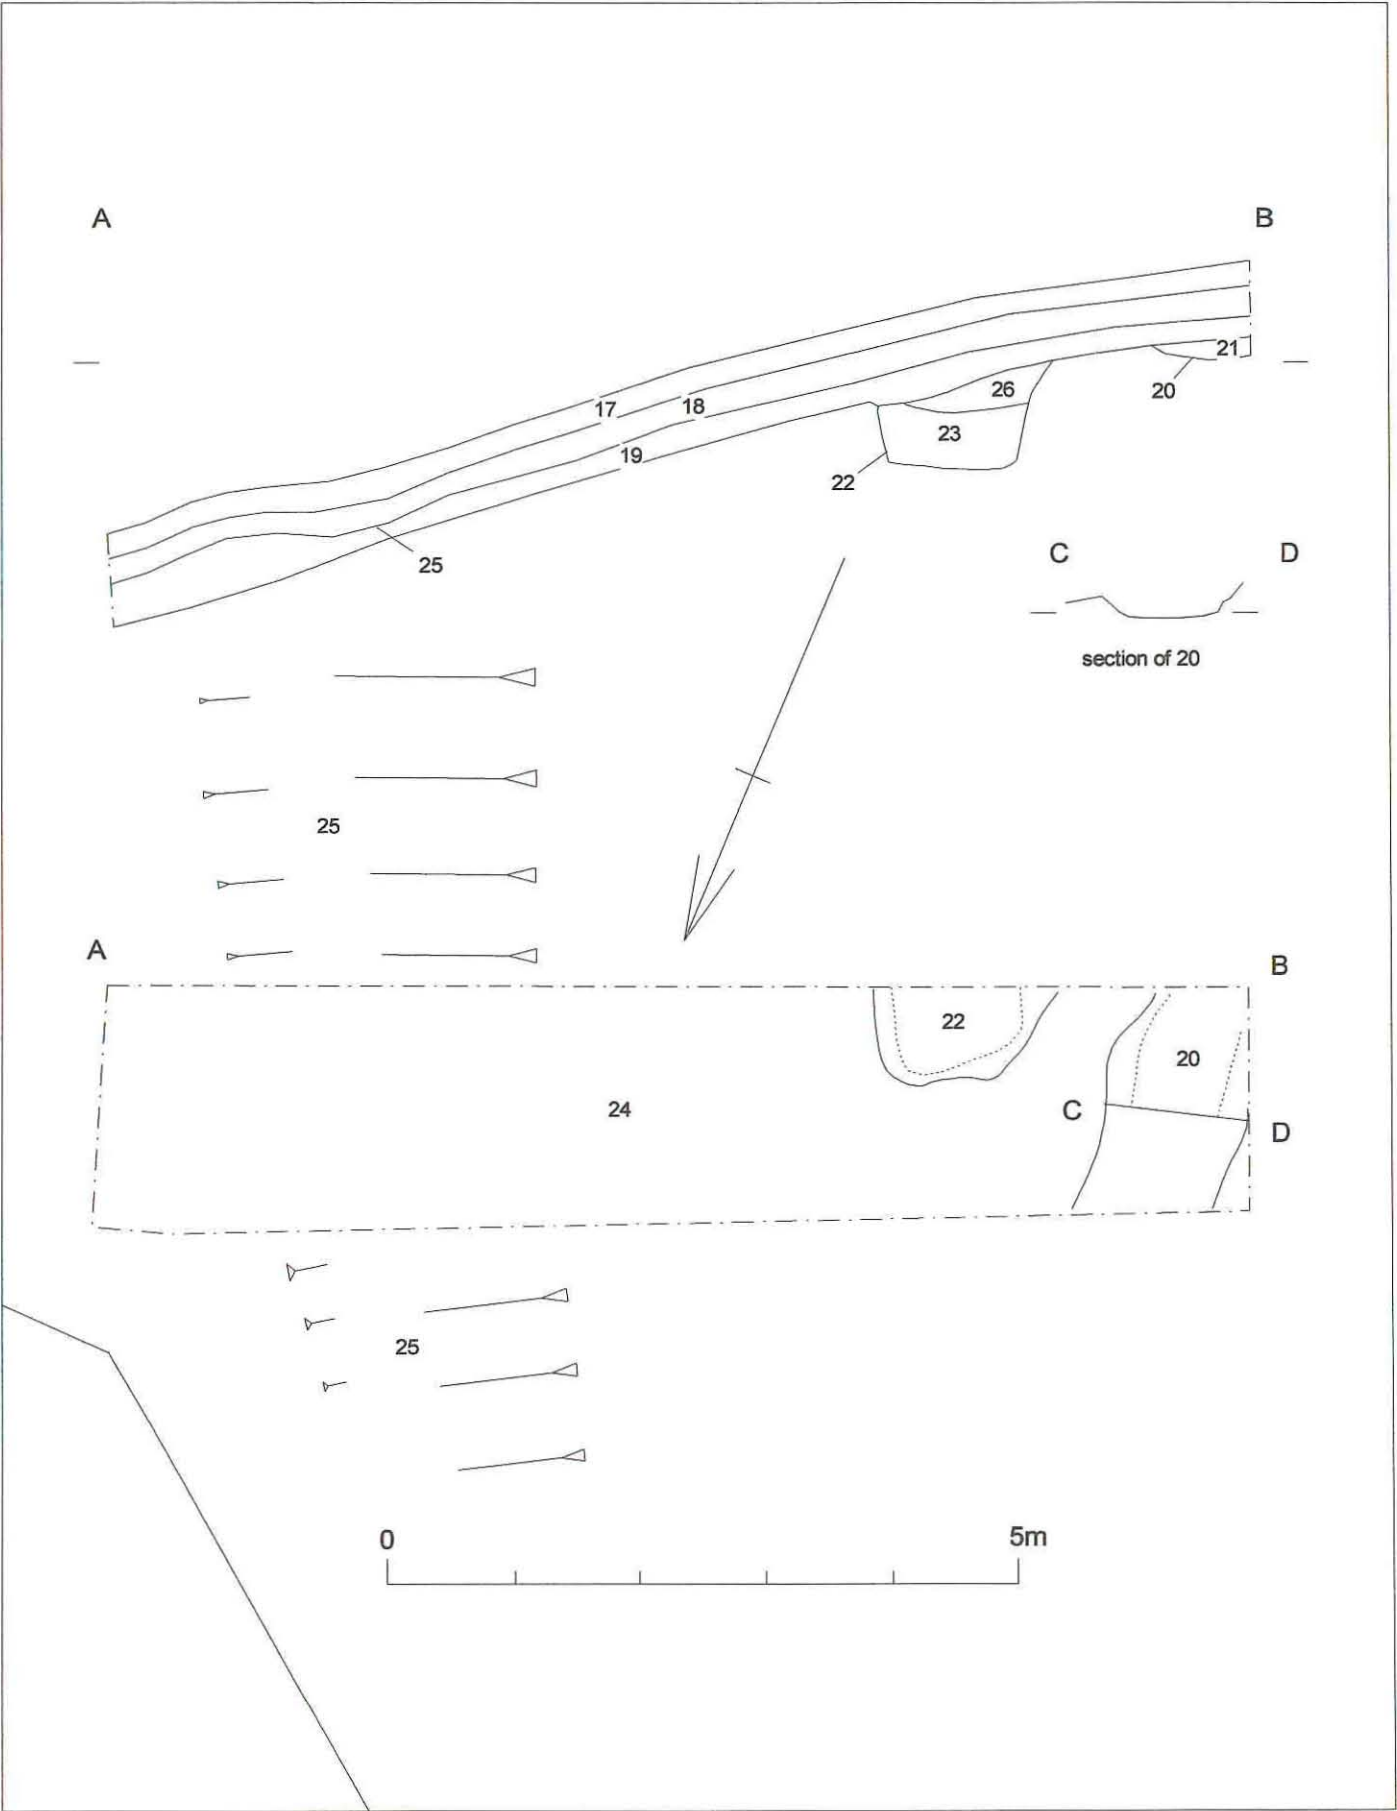
Fig. 24 Trench 13 plan and section, scale 1:60

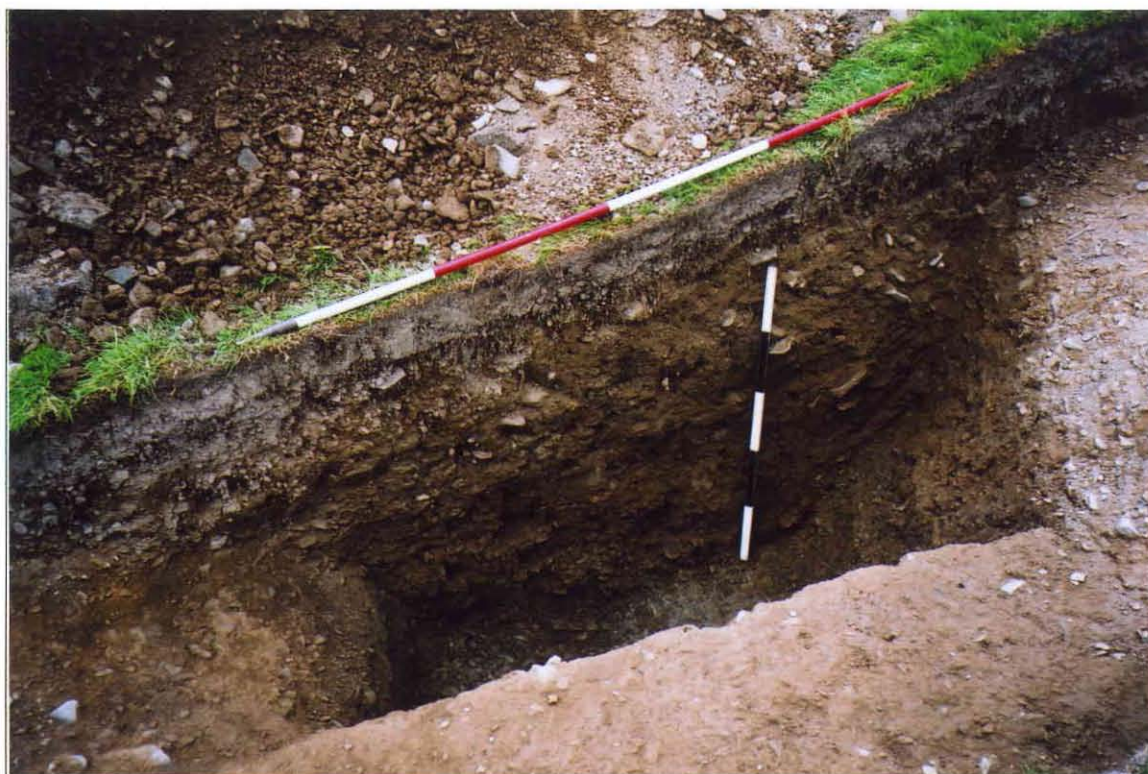
Plate 15 Gully 59 in Trench 6. Photo CPAT 1226.16

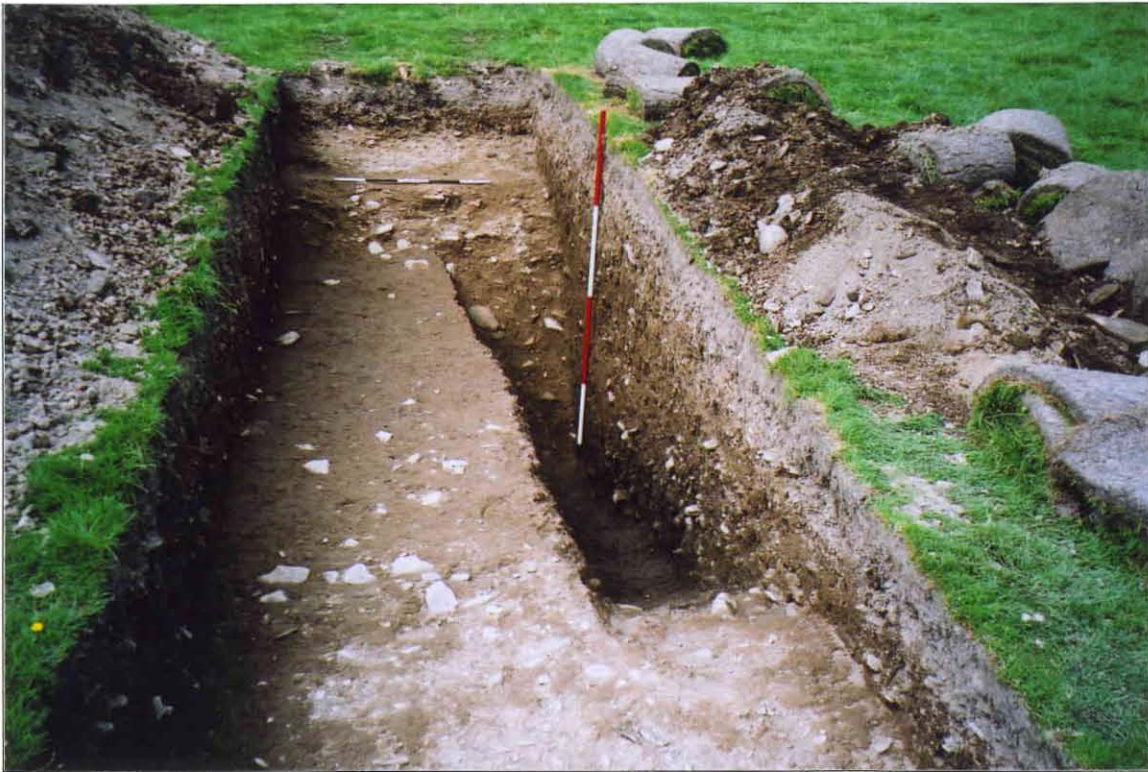
Plate 17 Gully 15 in Trench 10. Photo CPAT 1225.15
