A470 Cardiff - Glan Conwy Trunk Road, Improvements South of Builth Wells, Powys

ARCHAEOLOGICAL ASSESSMENT
FINAL REPORT

CPAT Report No 429.1

R Hankinson and N W Jones
September 2002

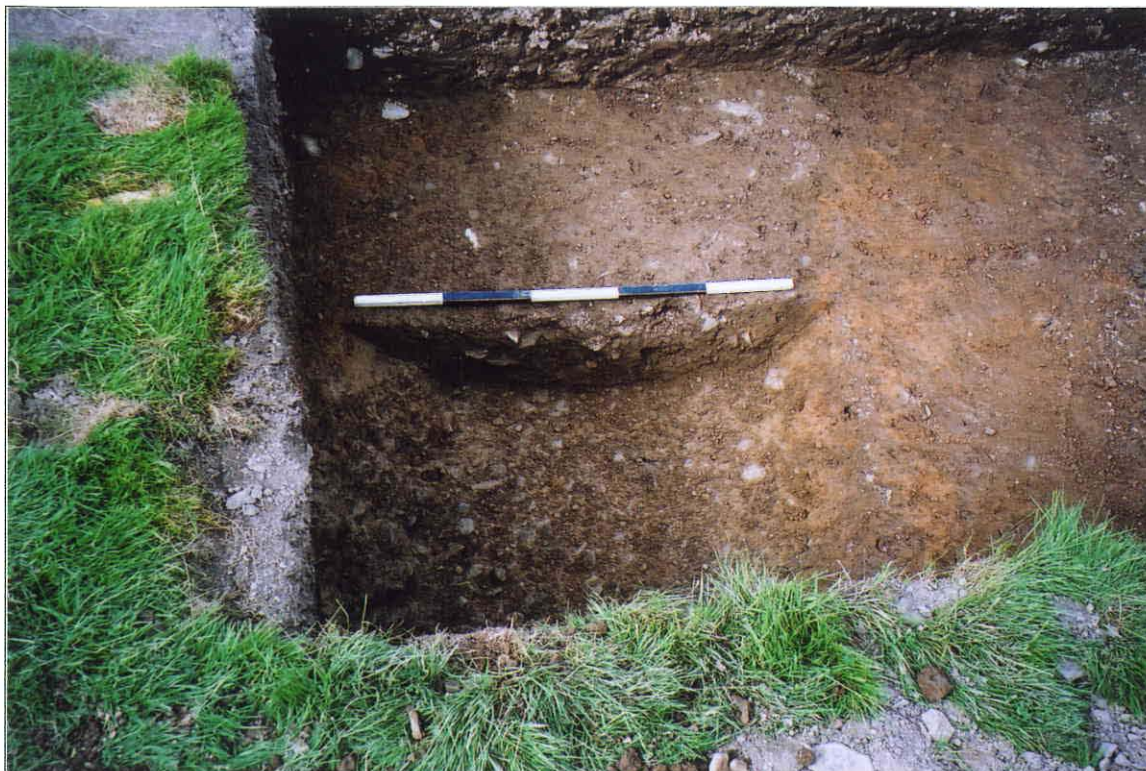
Plate 19 Gully 20 in Trench 13. Photo CPAT 1225.14

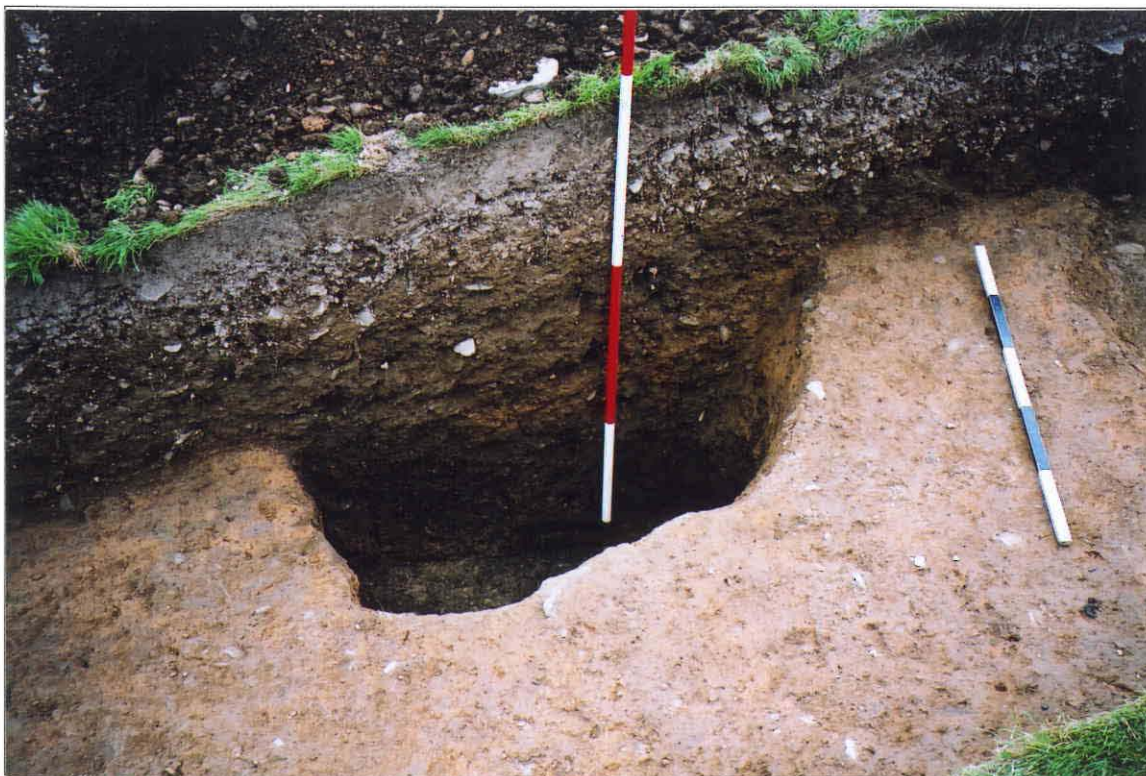
Plate 20 Pit 22 in Trench 13. Photo CPAT 1225.16
