**Llangollen to Llansilin Overhead / Underground  
Powerline  
ARCHAEOLOGICAL ASSESSMENT**

**CPAT Report No 547**

**By F Johnson  
September 2003**

**Report for West Coast Energy Ltd.**

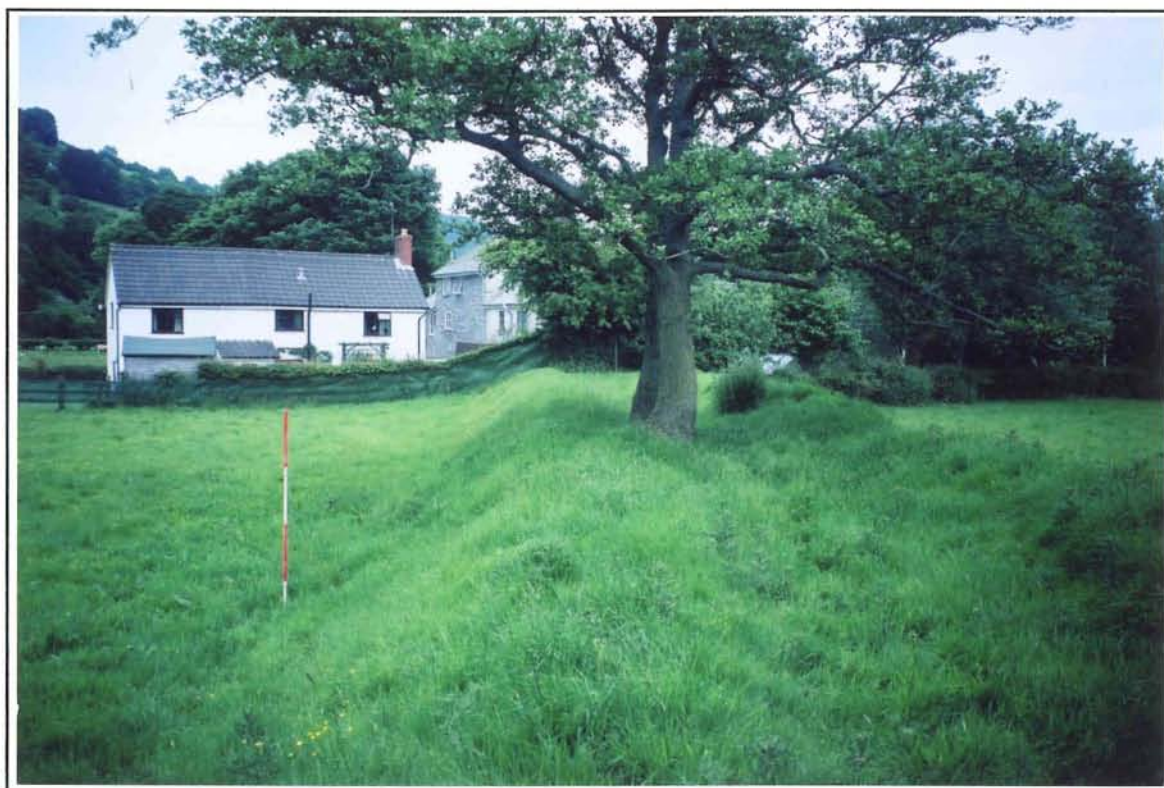
The leat feeds Ty Gwyn mill (PRN 38680) from the west, where it is sluiced from the Ceiriog. The leat has been partly destroyed by the Sewage Works although the western end survives.

Plate 1 Felin Newydd Leat, PRN 86046, viewed from the south-east. Photo CPAT 1361.19

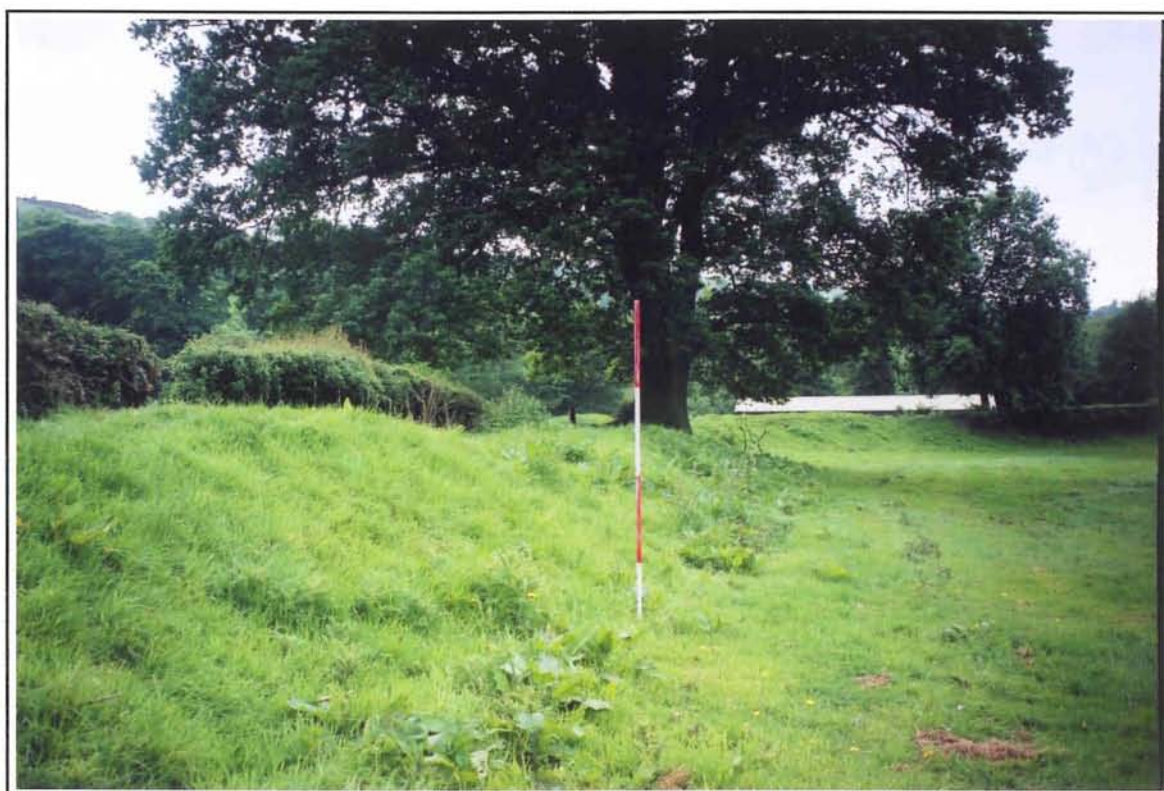
A relatively wide and high bank curving across the flood meadows of the River Ceiriog, shown as a possible trackway on the first edition Ordnance Survey maps. The bank stands up to 1.5m high, and is c. 6m wide at the base. It runs north-west to south-east, then turns north-west towards the farm at Ty Isaf. Its function is unknown, but it is very substantial for a simple field boundary, and may possibly have functioned as a flood defence, or as a routeway through the marshy flood meadows.

Plate 2 Ty Isaf Bank, PRN 86062, viewed from the north-east. Photo CPAT 1361.15

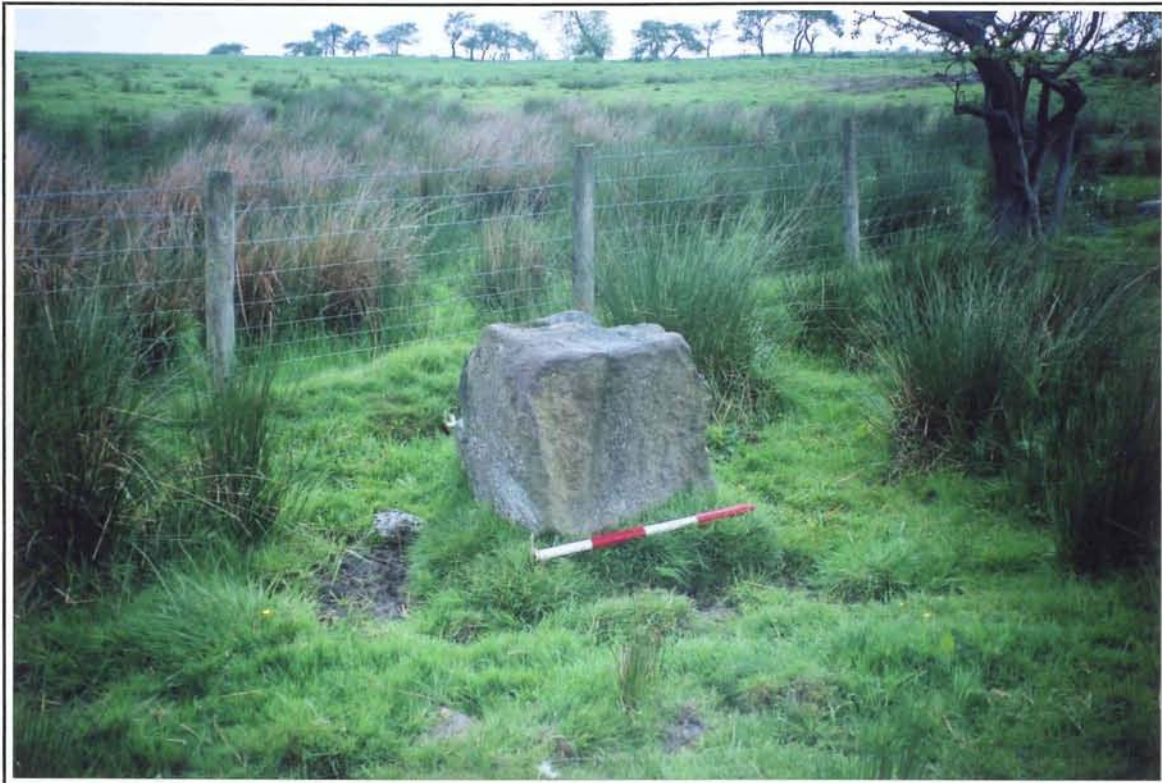
Two stones positioned on the south-facing slopes of Pen y Gwely. The western stone is a regular block immediately adjacent to the field boundary, measuring 1.25m x 1m and 1m high. Its position adjacent to the boundary suggests it may have functioned as a boundary marker. The second stone (at SJ21363328) measures 1 x 0.5m and 0.6m high. There is slight suggestion of a low ridge running north-east from the stone to the boundary hedgeline, 35m away, suggesting a possible former enclosure.

Plate 3 Pen y Gwely Stones (western stone), PRN 86056, viewed from the south-east. Photo CPAT 1361.12

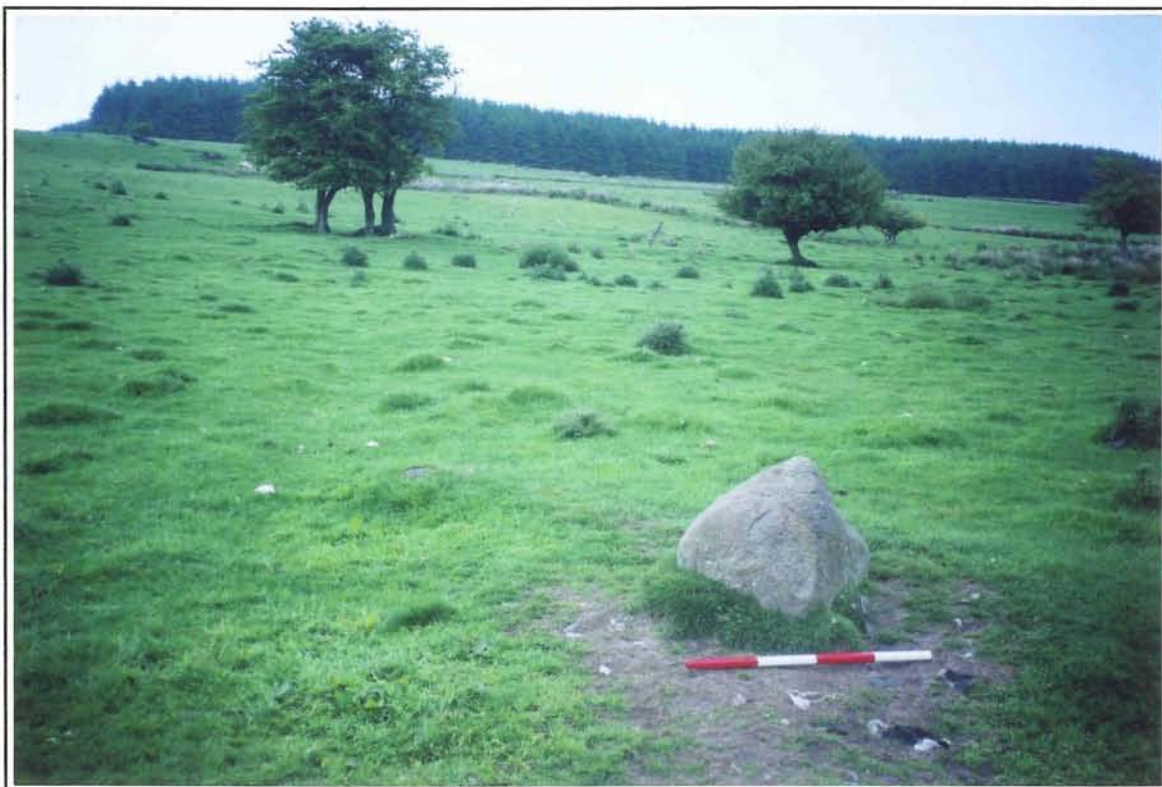
Plate 4 Pen y Gwely Stones (eastern stone), PRN 86056, viewed from the south. Photo CPAT 1361.11

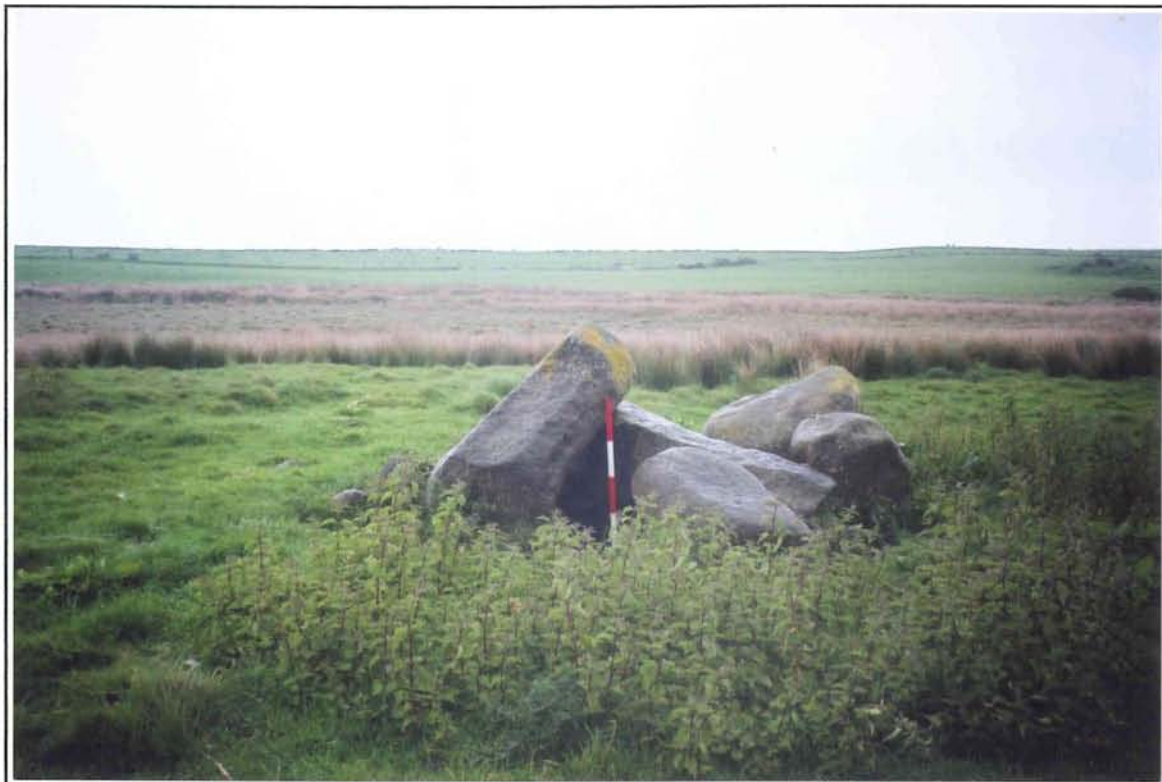
A cairn of six large boulders, the largest being 2 x 1 x 1.5m, lying atop a low rise surrounded by boggy ground, to the west of Pen y Gwely. The stones appear to have been placed to form a hollow at the western end. There is a slight suggestion of a low bank surrounding the cairn, but this may have been created by sheep erosion around the stones. The cairn may be the result of field clearance but could be on the site of a prehistoric cairn.

Plate 5 Pen y Gwely Cairn, PRN , viewed from the south-east. Photo CPAT 1361.13

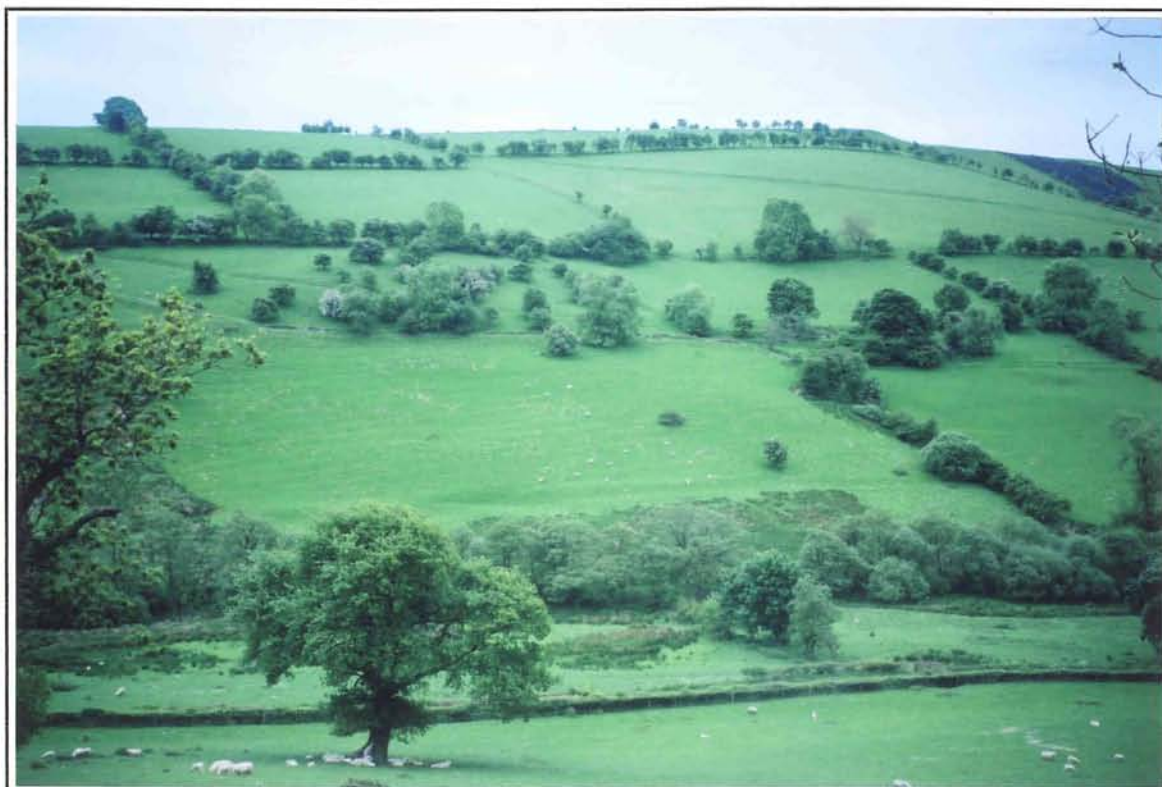
Faint traces of regular ridging, identified from a 1971 aerial photograph, are only just apparent on the ground. From the opposite hillslope the ridging is clearly visible and actually runs very slightly downslope to the north-east. Further ridging running slightly straighter along the contour is also visible in the field immediately adjacent to the north-east.

Plate 6 Mynydd Lledrod Ridging, PRN 86038, viewed from the north-east. Photo CPAT 1361.8

PRN	Name	Type	Condition	Category	Impact	Mitigation
86038	Mynydd Lledrog ridging	Ridge and furrow	Damaged	C	Partial loss	Avoidance/ Preservation by record
86040	Mynydd Lledrod Trackway	Trackway	Damaged	C	Partial loss	Avoidance/ Preservation by record
86045	Coed Hafod-Gynfawr slate quarry	Quarry	Damaged	C	Partial loss	Avoidance/ Preservation by record
86046	Felin-newydd leat	Leat		C	Partial loss	Avoidance/ Preservation by record
86047	Bryn Ellyll building	Building	Near destroyed	C	Partial loss	Avoidance/ Preservation in situ / Demarcation
86054	Hafodig Uchaf Trackway	Trackway	Near intact	C	Partial loss	Avoidance/ Preservation by record
86055	Hafodig Trackway	Trackway	Near intact	C	Partial loss	Avoidance/ Preservation by record
86056	Pen y Gwely Stones	Boundary stone	Intact	C	Partial loss	Avoidance/ Preservation in situ / Demarcation
86060	Groes Lwyd Quarry	Quarry	Damaged	C	Partial loss	Avoidance/ Preservation by record

7.6 For all sites identified as requiring mitigation, avoidance of these features, both by the powerline infrastructure and any associated works and access, would be the preferred option wherever possible. Two sites have been identified where preservation in situ should be ensured (PRNs 86047 and 86056) and it is recommended that they are clearly marked out with a buffer of at least 25m prior to works commencing to ensure avoidance.

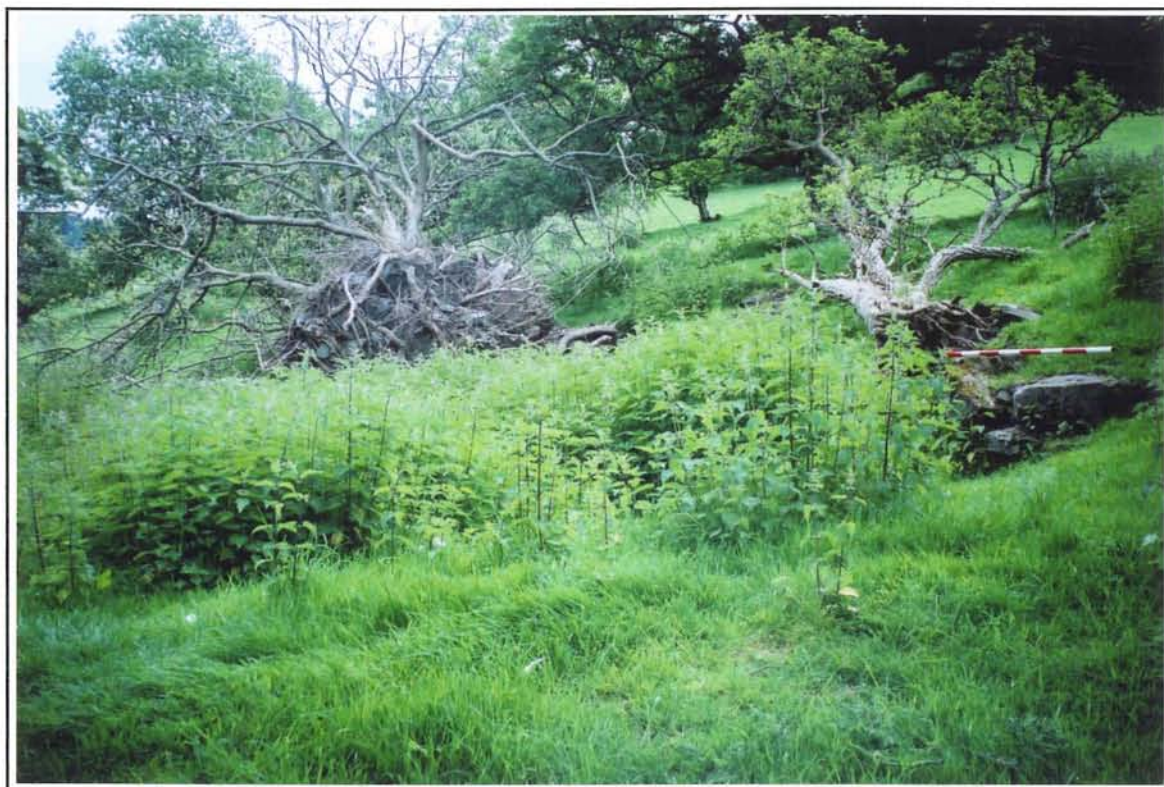
The now-ruinous farm was still in use in the later 19<sup>th</sup> century when it was called Hafodig-uchaf. The visible remains comprise a very ruined building with associated enclosures and possible outbuildings. The walls of the building are completely tumbled and exist only as footings or low turf-covered banks. The building appears to be rectangular, measuring c. 15.0 x 6.5m and set on a terrace in the hillslope, with the rear, southern wall set into the slope. A yard or enclosure wall lies to the north, with a possible outbuilding suggested by the presence of mortared stone. The outbuilding to the east appears to consist of walling set against the open rock face to the rear. The site was originally accessed by a green trackway entering from the east (PRN 86054).

Plate 7 Hafodig-uchaf, PRN 86039, viewed from north-west. Photo CPAT 1361.4

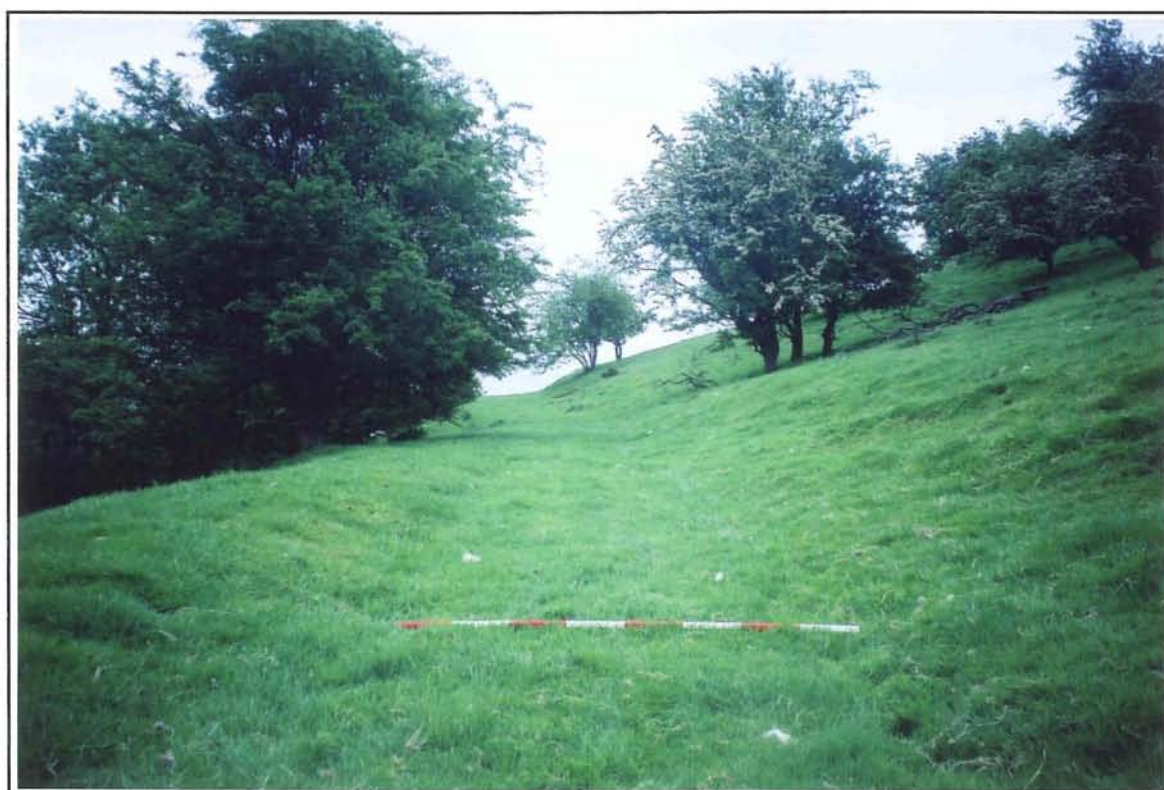
A terraced trackway running approximately east-west obliquely across the contours of the hillslope, giving access to Hafodig-Uchaf and associated enclosures. The trackway is c. 2m wide, and is bounded downslope with a low bank and cut into the hillslope on the northern side.

Plate 8 Hafodig-uchaf Trackway, PRN 86054, viewed from the north-west. Photo CPAT 1361.5

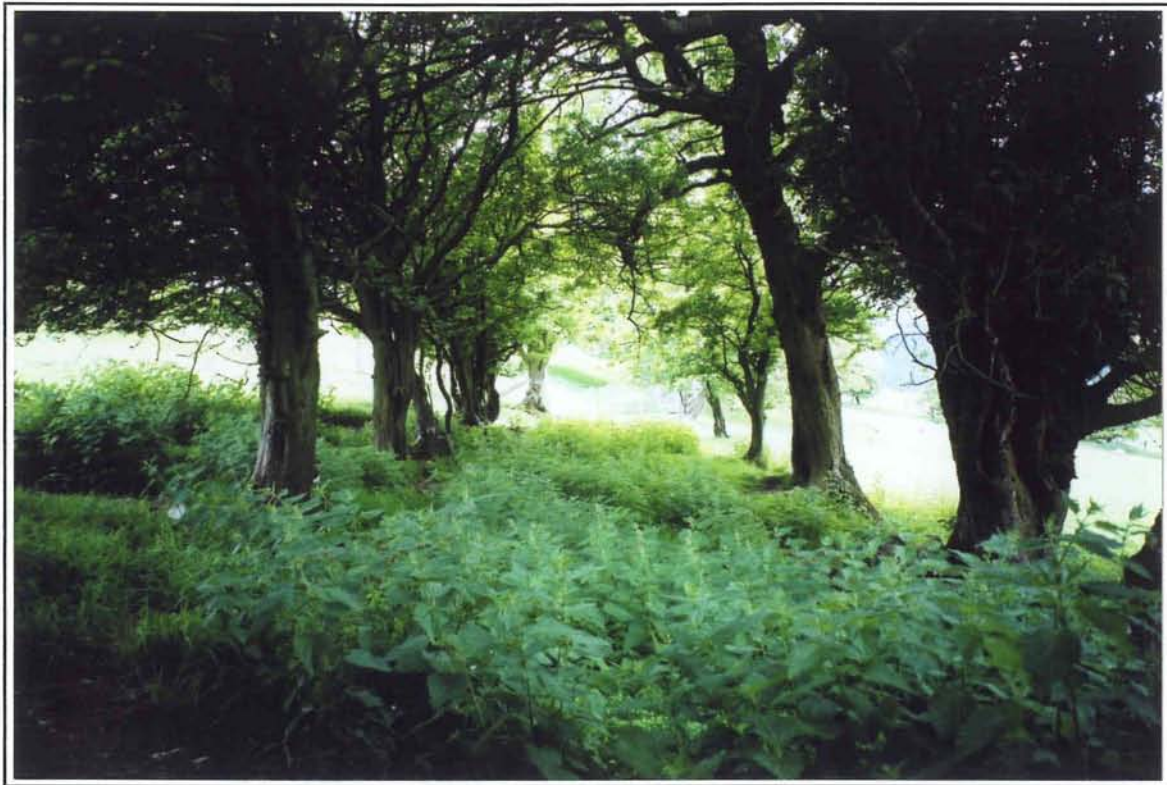
The trackway runs north-east to south-west along the contour of the hillslope and forms the boundary for fields above and below. The trackway is bounded for much of its length by mature, former hedged, trees, and filled by nettles. It is c. 4m wide and terraced into the slope.

Plate 9 Hafodig Trackway, PRN 86055, viewed from the east. Photo CPAT 1361.7

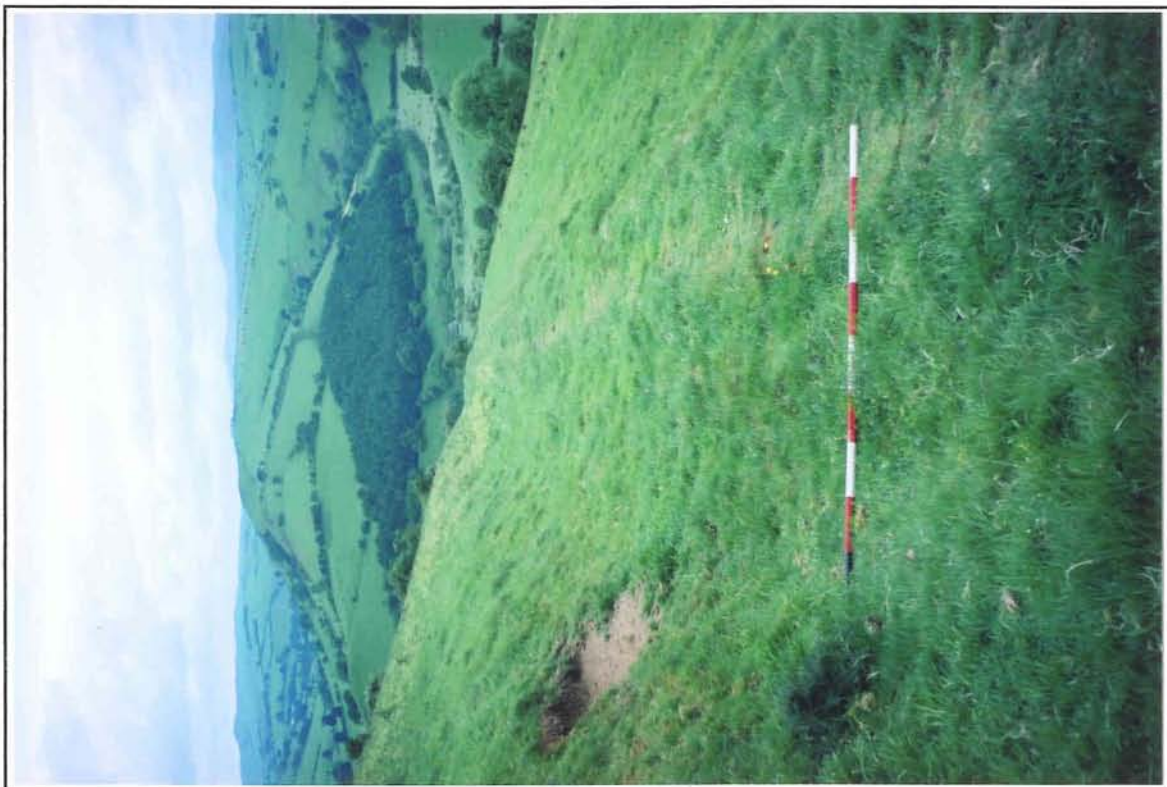
A terraced trackway running approximately east-west, obliquely across the contours. At the southern end the trackway continues south-east along the fenceline for some distance. At the north-west end it turns northwards to link with trackway PRN 86055. The trackway is approximately 1.75m wide, and cut into the slope on the southern side to a depth of up to 1.5m. There is a slight bank on the downslope, northern side, with a steep drop of c. 1m to the natural hillslope.

Plate 10 Mynydd Lledrod Trackway, PRN 86040, viewed from the south-east. Photo CPAT 1361.6
