*Porth Mawr boundary wall,
Crickhowell, Powys*
ARCHAEOLOGICAL SURVEY

CPAT Report No 53

by N W Jones
March 1993

Report prepared for Welsh Office Highways Directorate

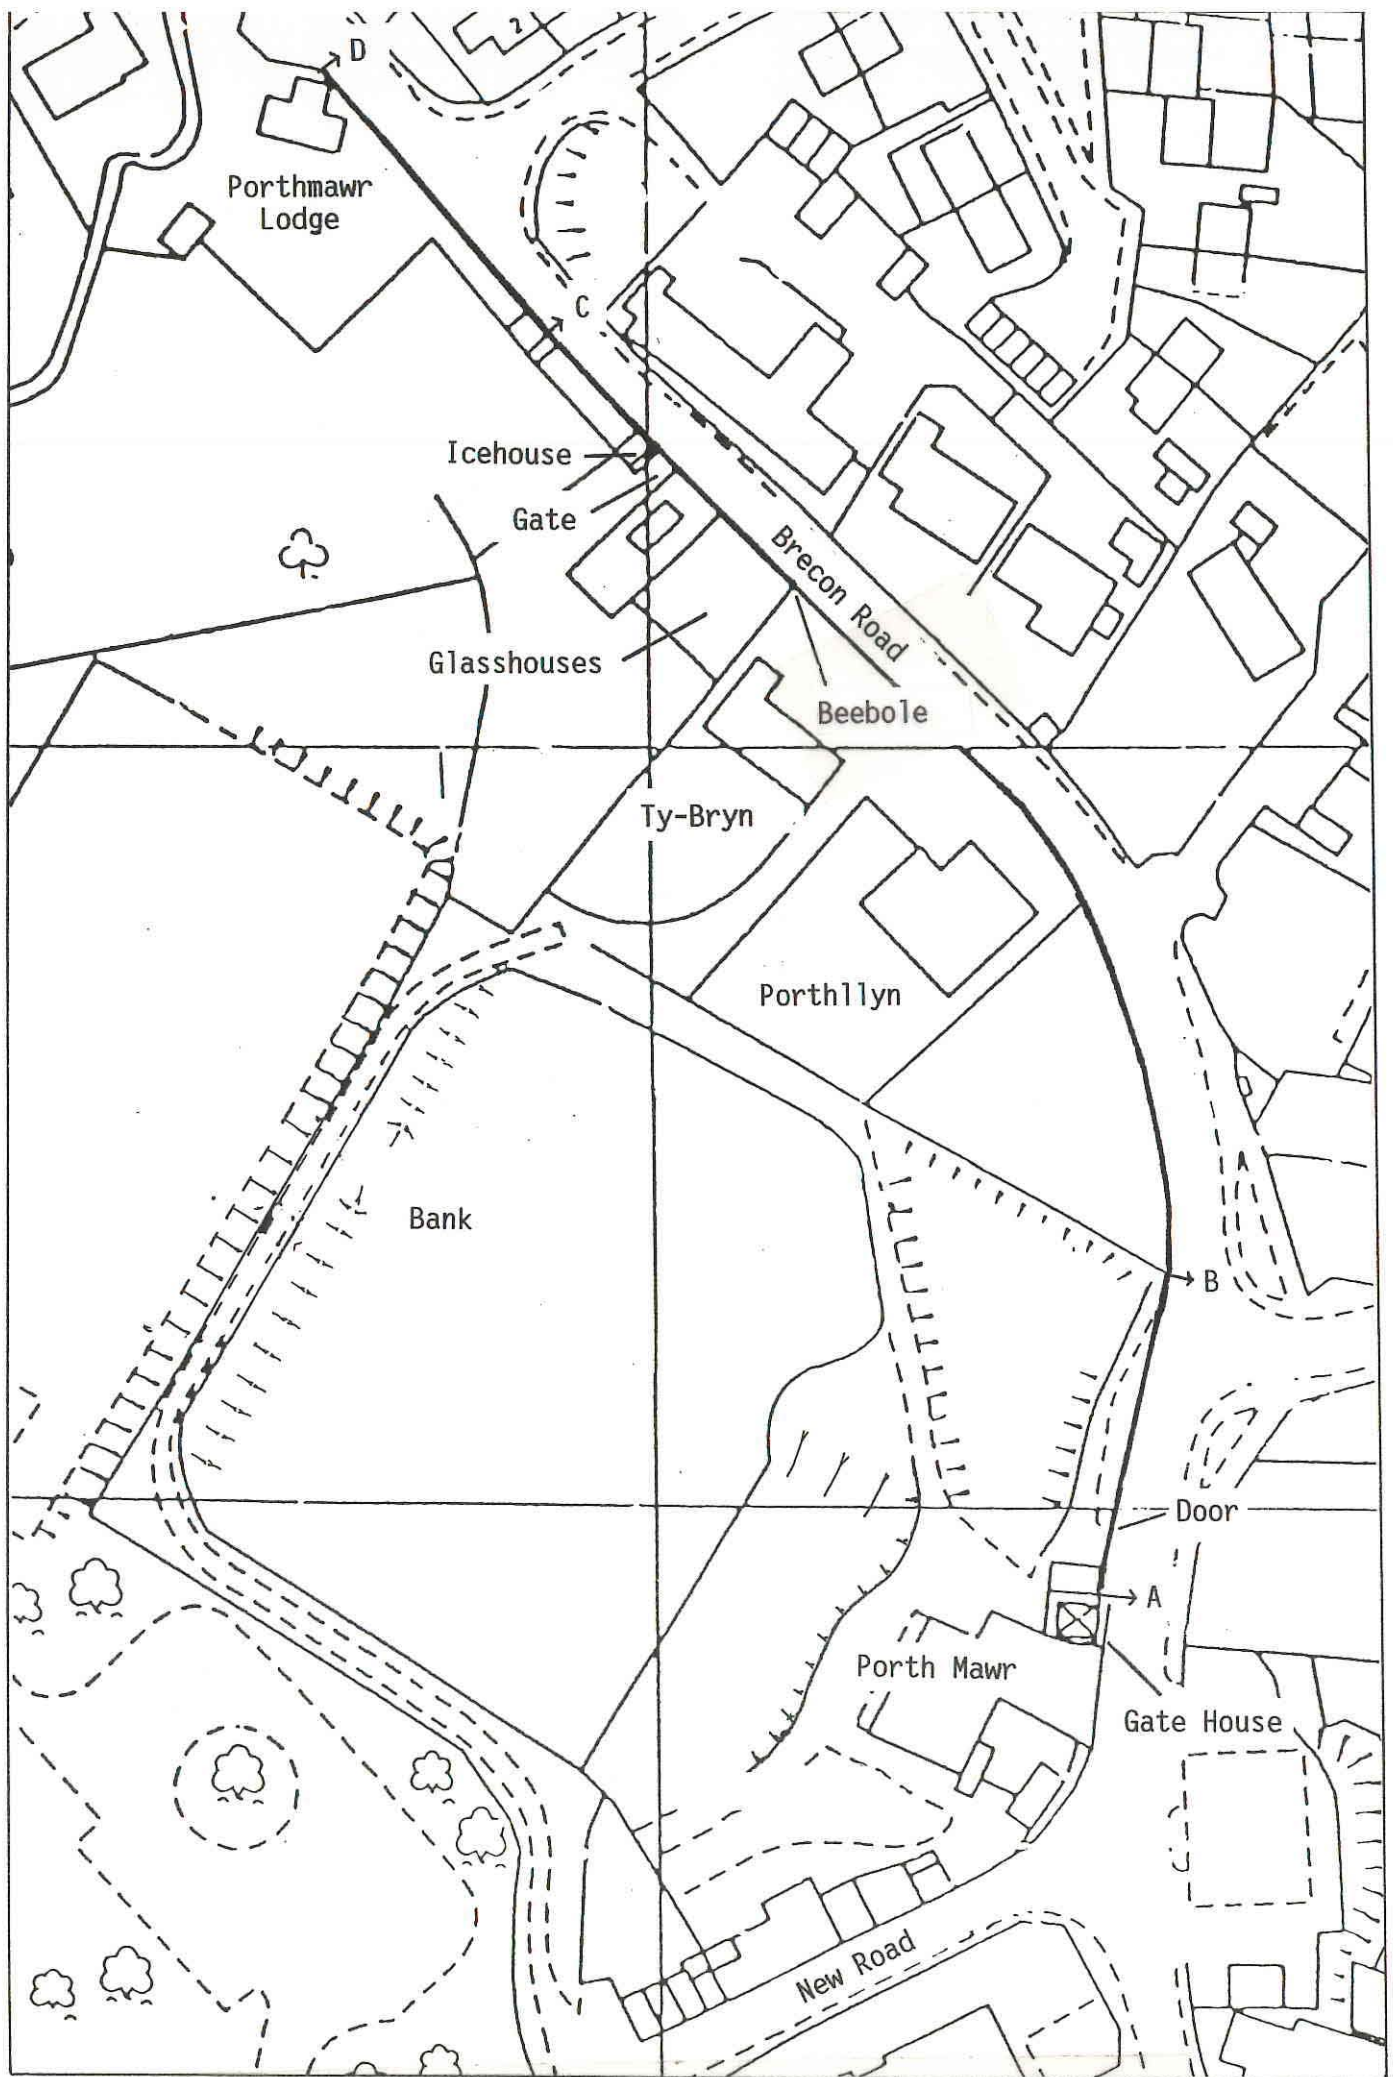
Fig 2: Porth Mawr boundary wall. Scale 1:1000

- 4.1 Following an inspection of the boundary wall, its length has been divided into three main sections (labelled in Fig 1), according to differences in construction.

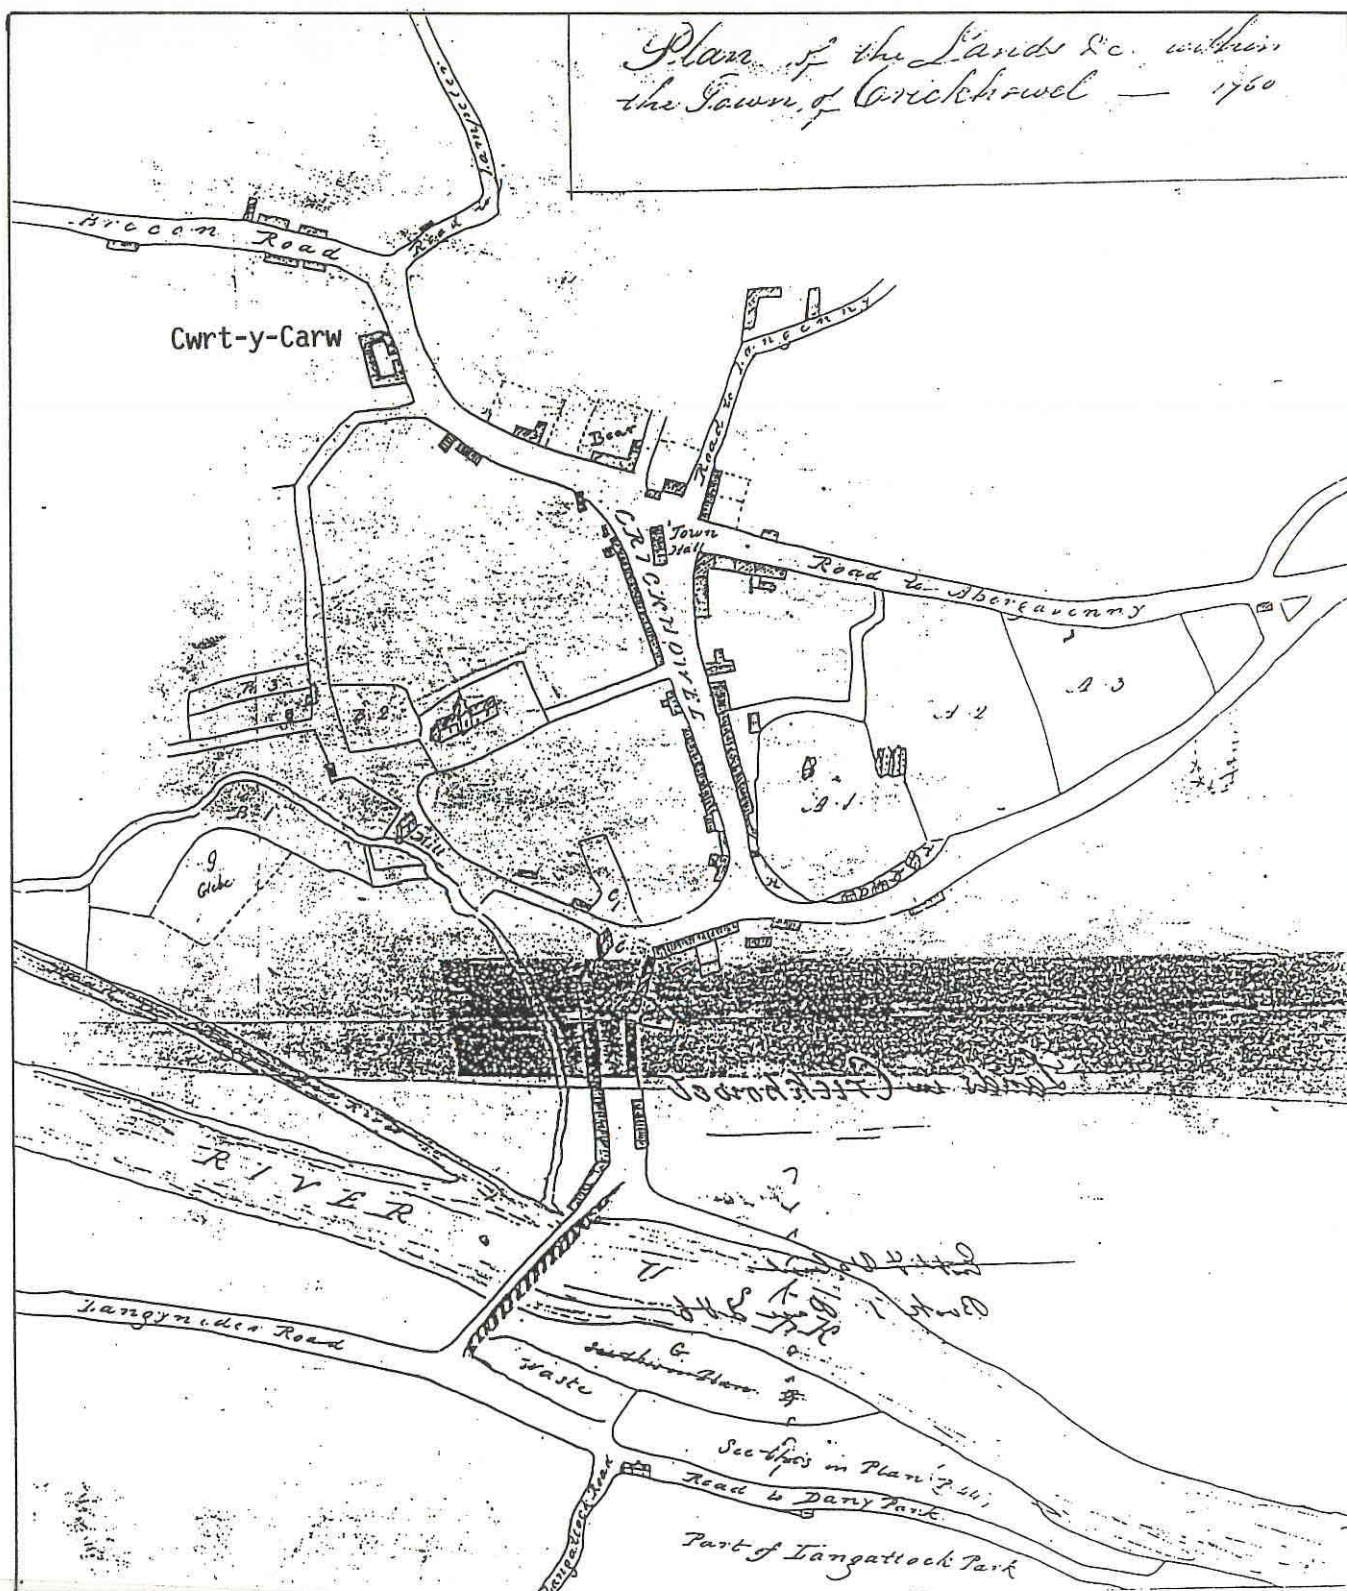
Fig 3: 1760 Plan of Crickhowell showing Cwrt-y-Carw

- 3.3 An unprovenanced map of 1760 (Fig 3), a copy of which was obtained from Mr Louis Hurley of the Crickhowell Civic Society, depicts what one must assume to be Cwrt-y-Carw as a courtyard manor similar to Tretower. Although the accuracy of the map has to be questioned, it appears to show the Gatehouse set centrally within a range of buildings fronting Brecon Road and forming the east side of the courtyard. The whole would appear to measure c.30 x 18m overall,

enclosing a courtyard of c.18 x 7m. It is of course possible that not all of the range of buildings shown on the map belong to the original 15th century construction.

However, since the doorway appears to be an original feature, it poses the question of where did it lead. One possibility is that it lead into a room in the east wing of the 15th-century courtyard house, as depicted on the plan of 1760. The other is that it led onto a wall walk, which would have required the wall to be of considerably greater thickness than its present appearance. As noted above, the interior may have been refaced, and therefore possibly also narrowed.

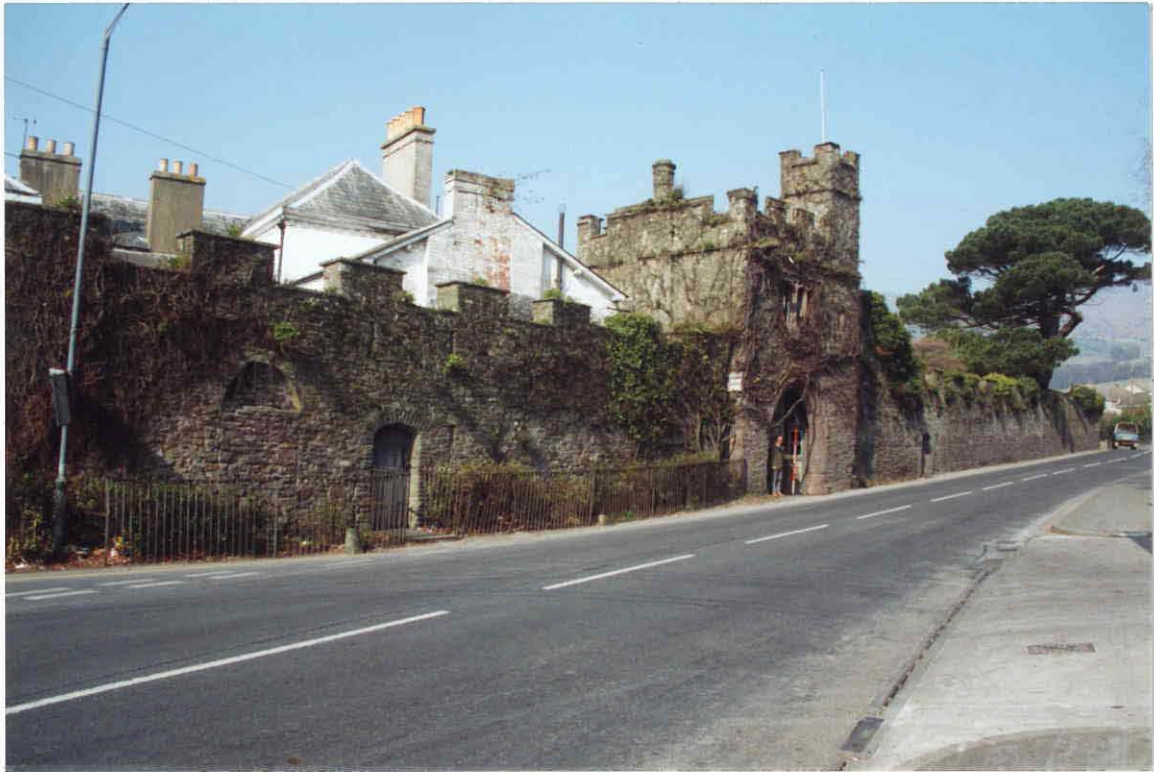
Plate 1: View of Porth Mawr Gatehouse and boundary wall from the south east

- 2.1 Porth Mawr lies on the northern side of Crickhowell (Fig 1), with the Gatehouse fronting onto Brecon Road just to the north of the junction with New Road (Fig 2, SJ 2175 1857). The boundary wall extends to the north and north-west of the Gatehouse for a distance of c.230m (Plate 1).

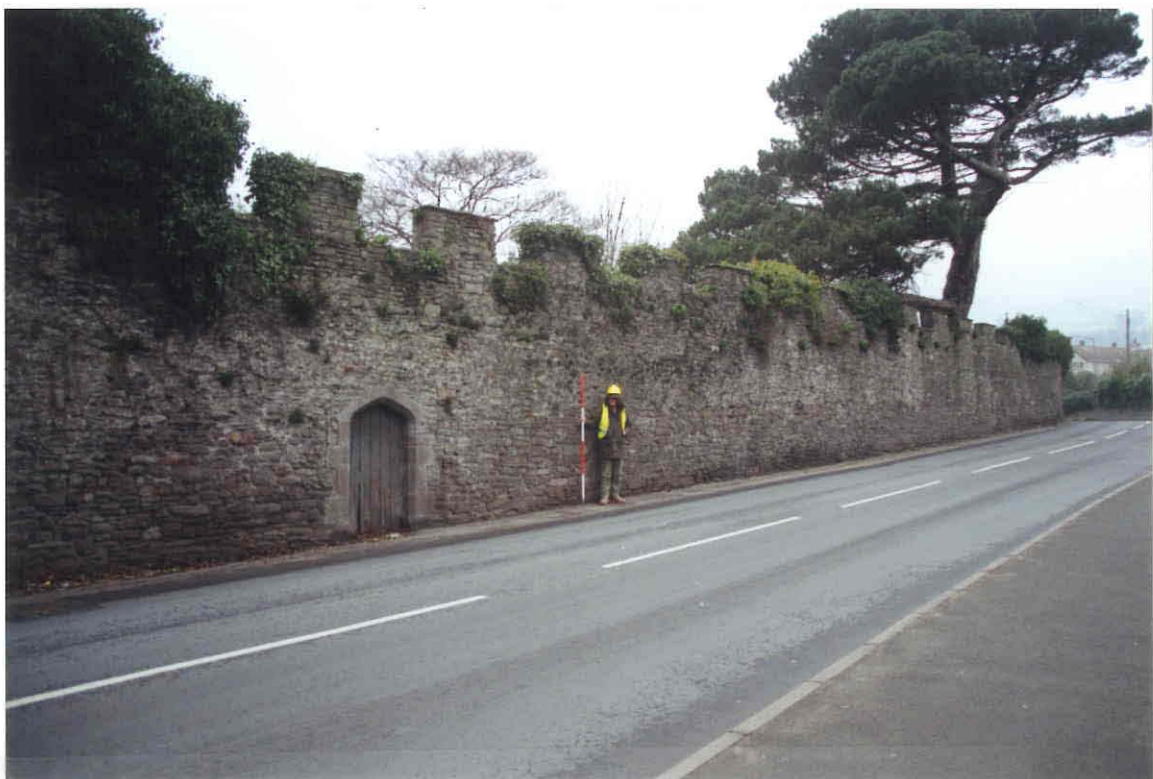
Plate 2: Boundary wall Section A-B from the south east

- 4.2.1 Section A-B adjoins the Gatehouse at its southern end and extends for c.43m to the north (Plate 2). The overall height of the wall decreases from 4.20m to 3.85m at B due to the rise in ground level. Immediately adjacent to the Gatehouse the wall is at least 1.75m higher, the upper part belonging to a 19th-century gazebo which butts onto the lower part of the wall on the interior. The construction is generally of mortared random rubble up to a height of c.2.30m. At this level a course of thin angular limestone marks a change in build, the upper part constituting a presumed 19th-century addition comprising the plain crenellated capping.

- 5.1 The section of wall between A and B, adjoining the Gatehouse to the north, is the only part which is of possible late medieval origins. Although the interior has probably been refaced and the upper crenellated section is certainly recent, it is possible that the lower exterior portion of the wall is original. Certainly it must predate the construction of the present house, and the drawing of the early 19th century shows part of this section which may be that surviving today. As noted above, it is difficult to tell whether the doorway is an original feature: although the style is contemporary, it could have been reused. One argument against this, however, is that the plan of 1760 shows that part of the building fronting Brecon Road as only extending c.12m to the north of the Gatehouse, and there is no evidence of a change in build at this point, which could therefore suggest that the entire section has at some point been rebuilt.

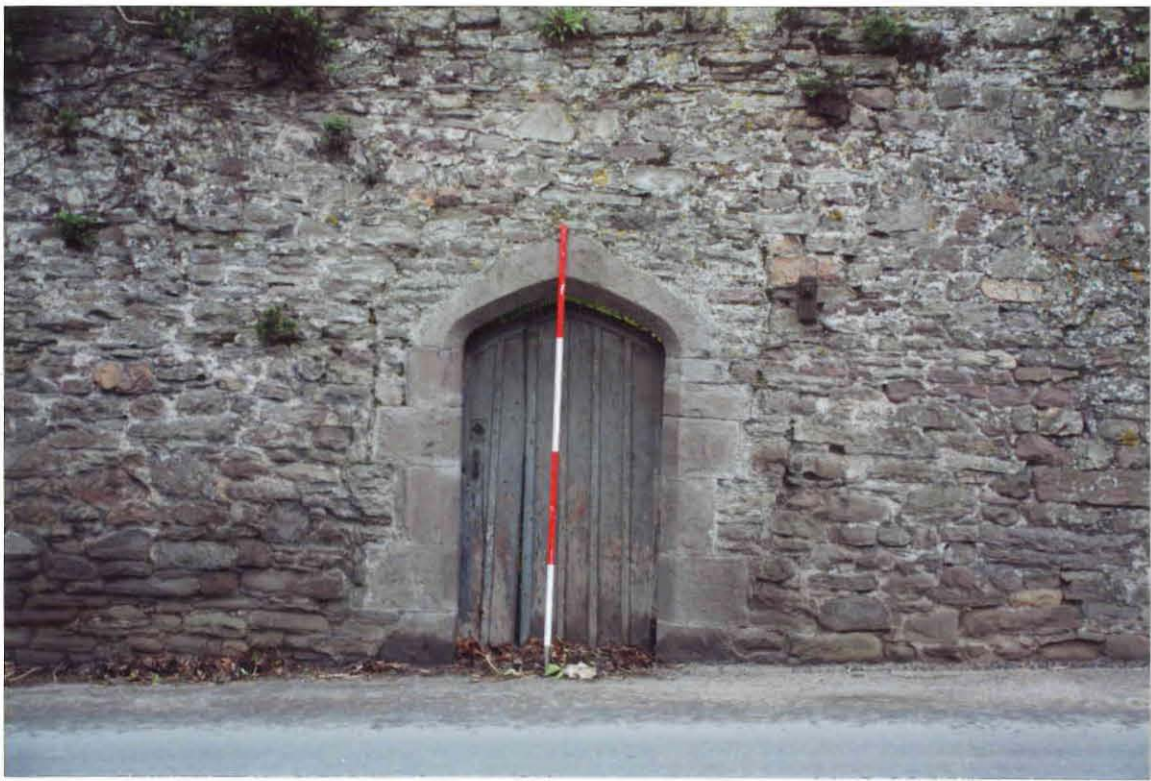
Plate 3: Doorway in Section A-B from the exterior

- 4.2.2 The wall contains a doorway 7.83m north of the Gatehouse, with a dressed stone arch 1.69m high and 0.91m wide (Plates 3). Although the dressed masonry is probably of late medieval date, presumably associated with the original construction, its position within this wall is not necessarily in situ. The internal elevation reveals a larger opening 2.13m high and 1.10m wide (Plate 4), the appearance of which suggests that the interior has been either rebuilt, or that the dressed stonework has been reused and possibly the whole length of wall is a reconstruction.

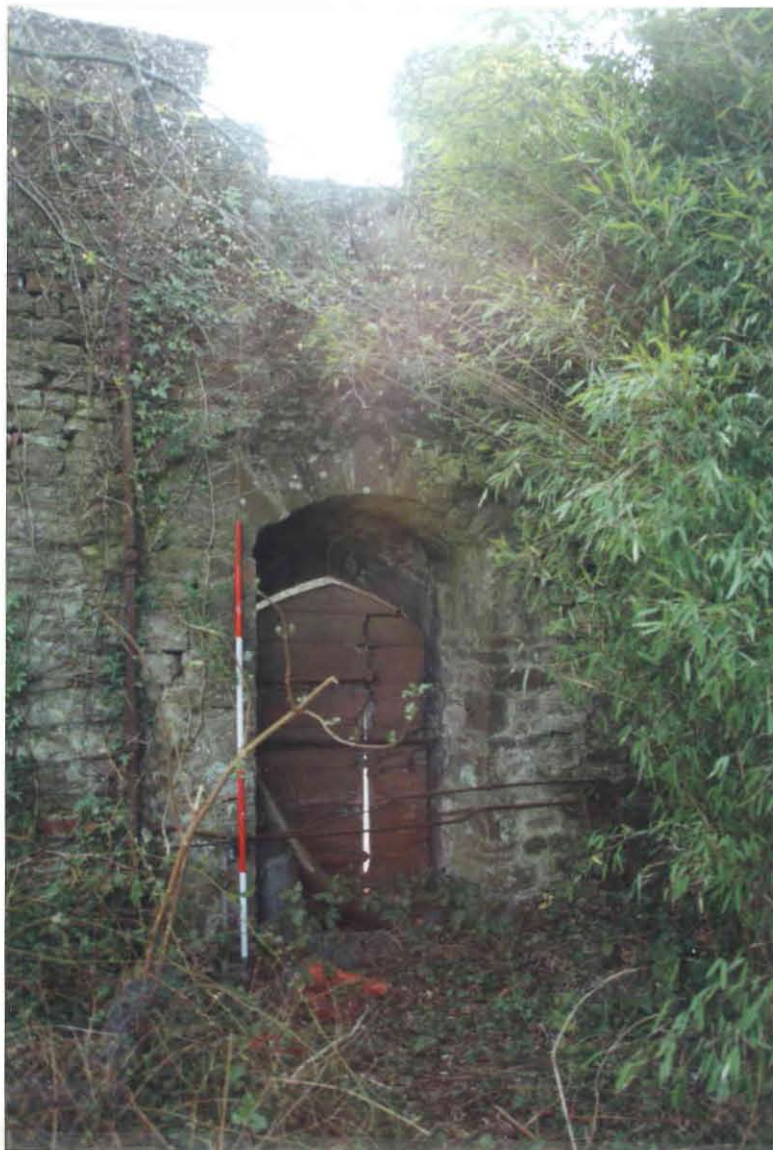
Plate 4: Doorway in Section A-B from the interior. Note wider opening.

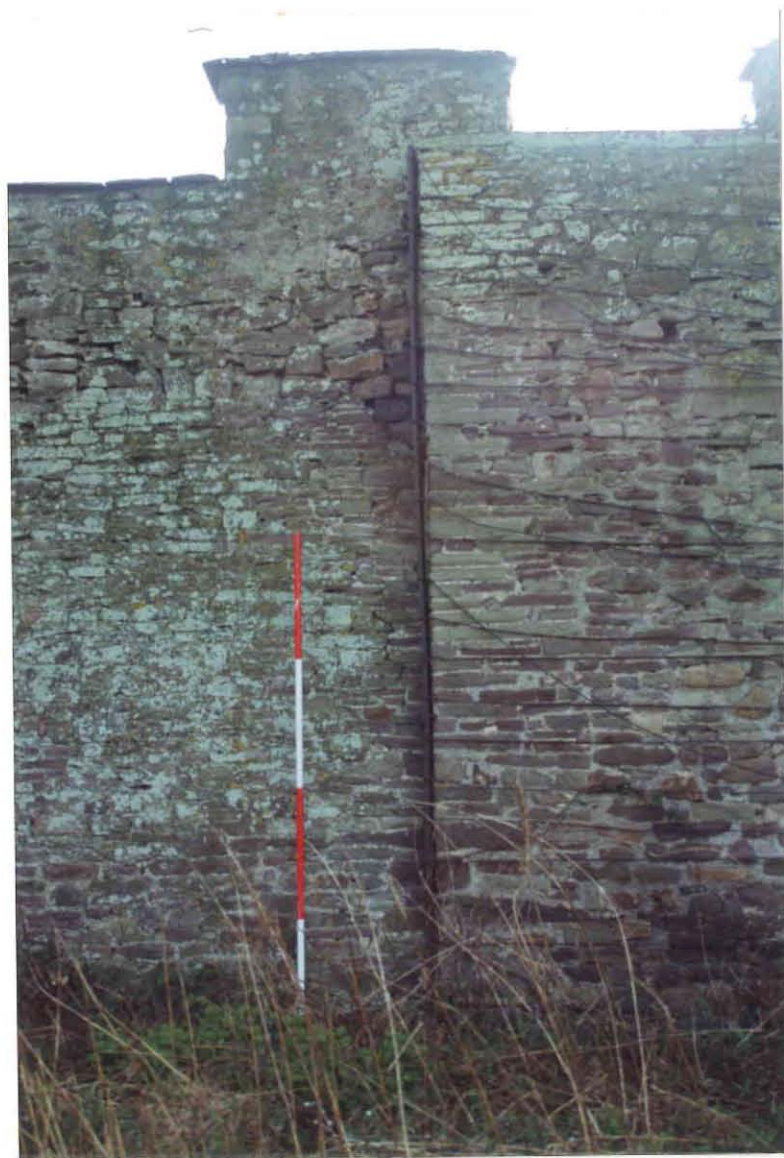
- 4.2.3 The majority of the interior appears to have been refaced, or at least repointed at some date and has numerous fragments of brick included within it. This continues for 32.35m to the north of the Gatehouse at which point the facing ends and the wall steps inward, narrowing by some 0.15m. This is further marked by a change in the character of the wall-facing. Beyond this point the wall is well faced with fairly regular, mortared pink limestone up to a height of c.1.95m. Above this, the construction is again of rubble and corresponds to the previously noted change on the exterior face, consistent with the later addition of the crenellations (Plate 5).

Plate 5: Section A-B interior showing refacing on the right and later addition of crenellations.

- 6.1 The possibility of small scale trial excavation against the interior of the wall in section A-B to identify the exis-

tence of any earlier foundations relating to the previous width of the wall, or possibly associated with the 15th-century occupation.

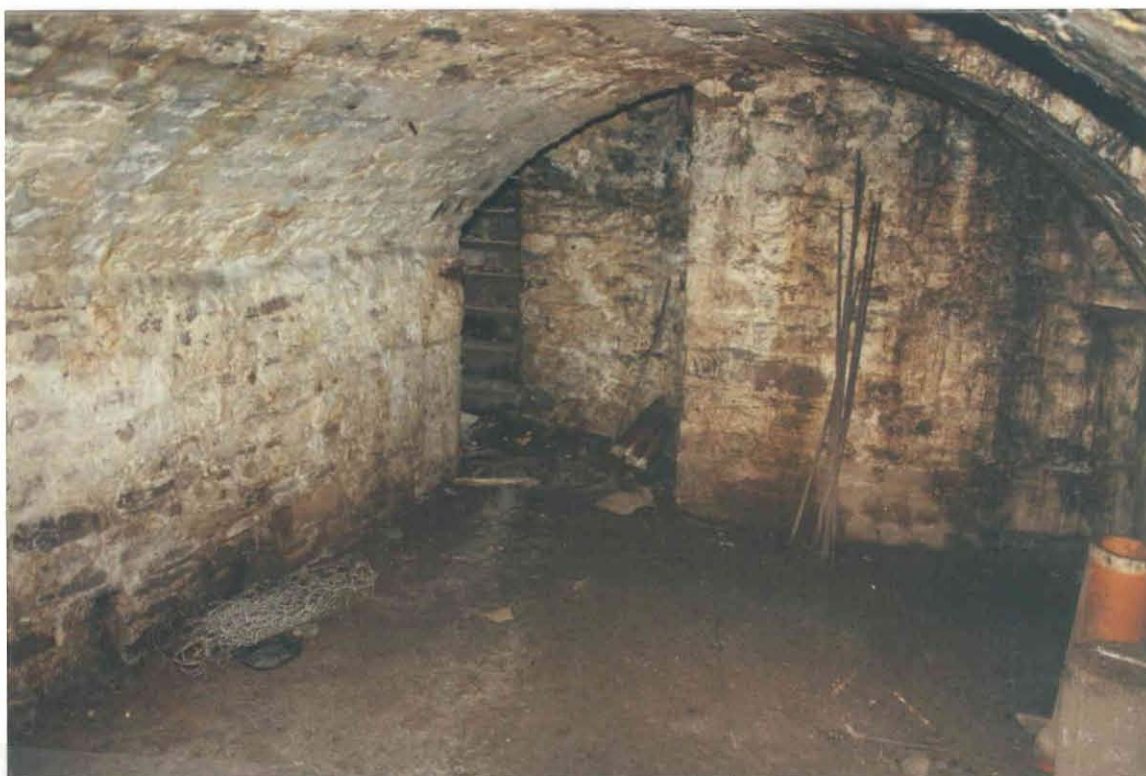
Plate 6: The icehouse.

- 4.3.5 Immediately to the north of the gateway, a doorway in a lean-to building leads down a flight of steps into a subterranean chamber (Plate 6), the floor level of which is c.1.70m beneath ground level. A detailed survey was prevented due to a lack of lighting, but it was possible to

record the basic layout. The chamber at the base of the stairs was 3.93m long, widening from 1.90m to 3.00m. The ceiling was constructed of arched brick. At 1.68m along the south western wall a narrow opening c.0.90m wide led upwards, possibly linking to a manhole visible on the surface. Beyond the first chamber a narrow passage led for 3.50m to a dwarf wall c.0.50m high and 0.50m wide. Beyond this the floor level dropped a further 0.90m into a second chamber measuring 3.45 x 2.45m. A roughly square blocking, possibly for a chute, was visible in the end wall c.1.75m above floor level. It is presumed that this was constructed during the 19th century as an icehouse, although there are apparently stories of its use for hanging venison in the days when Porth Mawr had a deer park.

- 5.2 It would appear that the majority of the boundary wall, the section between B and D, is of 19th-century construction. Presumably, this is contemporary with the construction of Porth Mawr which was completed in 1825, and formed the boundary wall to the kitchen gardens and orchards. Although of relatively recent origin, the wall still possesses considerable historical value, particularly in association with Porth Mawr House and Gatehouse. On the interior of the wall, the presumed beebole and the icehouse are of particular note and are worthy of further investigation and recording.

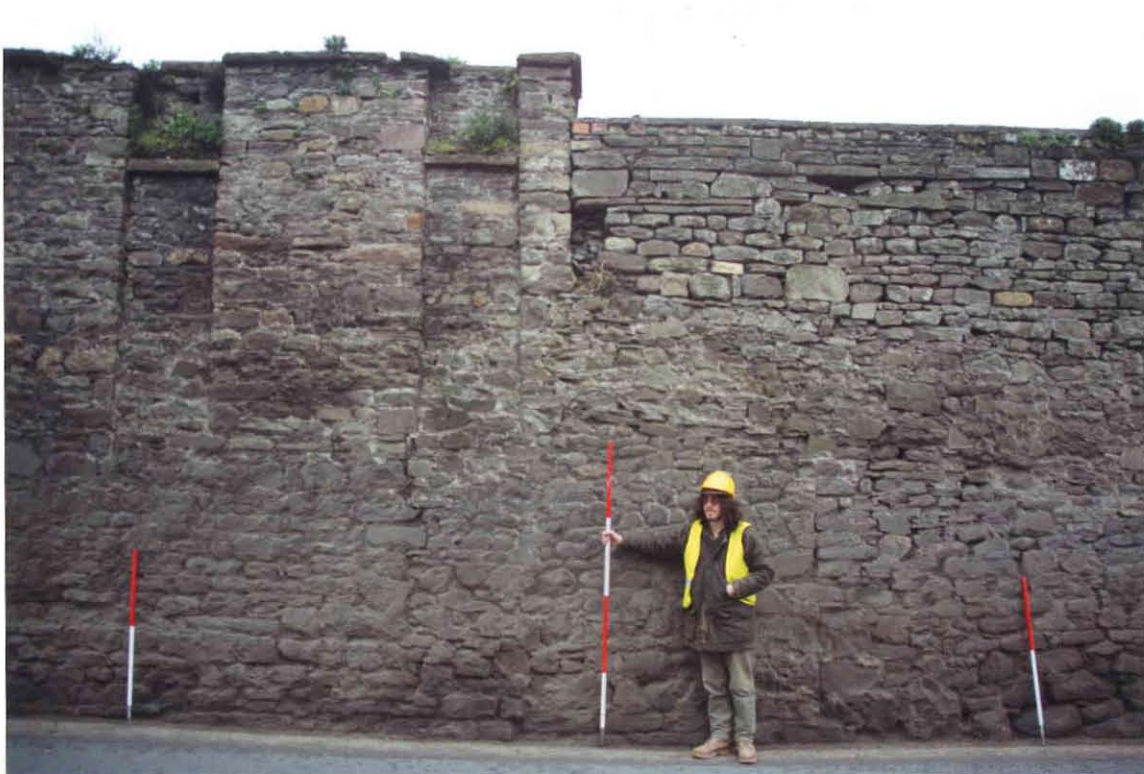
- 4.3.1 Continuing north and then north-west from B the wall is of a single phase of construction, consisting of a mortared rubble exterior set on a low plinth up to 0.55m high. The total height is c.4.10m, the upper part being crenellated with plain cappings, now largely removed, and feathered aprons to the crenels (Plate 7).

- 4.4.1 The final section of wall is marked by a change in construction and height from C to the Lodge at D. The south eastern end of this section begins with a blocked opening 2.73m wide and 2.96m high (Plate 7). This also coincides with the end of the crenellations, and the wall beyond is only c.3.00m high, of rubble construction with no plinth. Above the blocking, and continuing for 6.60m to the north west, the upper part of the wall has been rebuilt to a height of 4.28m as part of a further lean-to building on the interior.

Plate 7: Change in construction at C: Note blocked entrance and upper section rebuild at south eastern end of Section C-D.

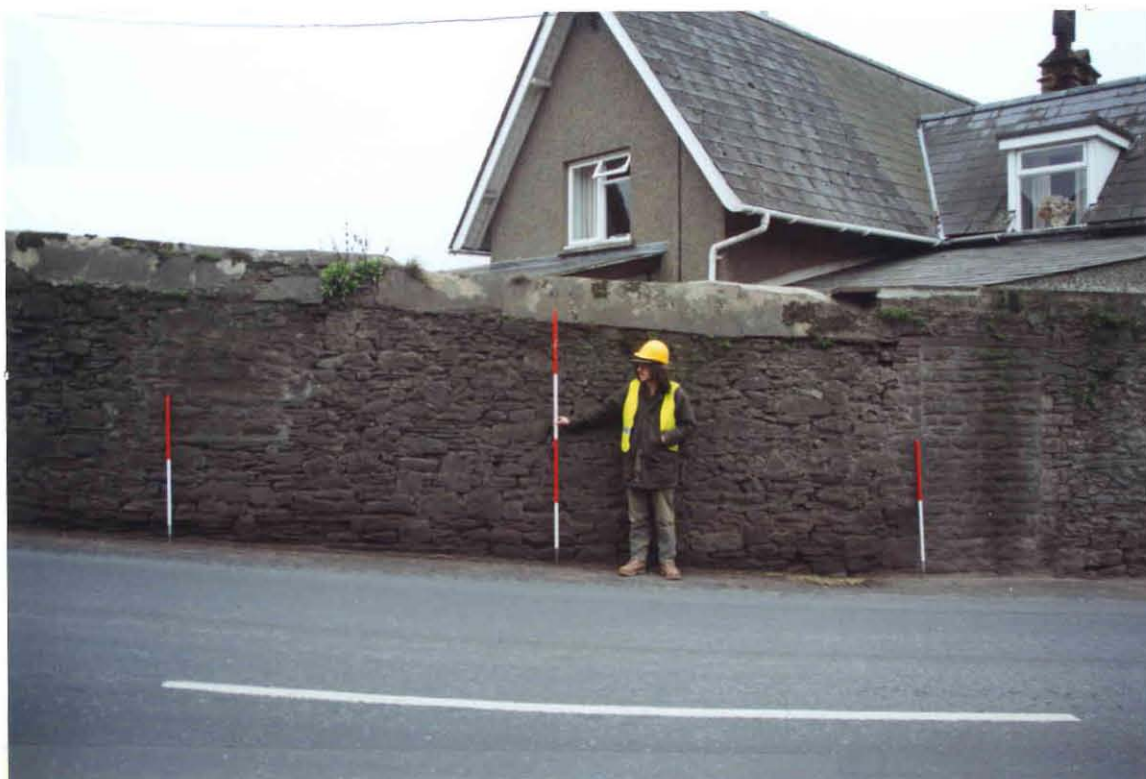
Plate 8: Blocked door and window in Section C-D.

- 4.4.2 Two blocked features were visible in the exterior face of the wall (Plate 8). A blocked doorway 2.04m high and 1.10m wide was identified 5.45m south-east of the end of the wall at D. A further 5.10m to the south-east was a blocked window 0.8m above the road, 1.70m high and 1.20m wide.
