*Brynkinallt Colliery, Chirk*

ARCHAEOLOGICAL WATCHING BRIEF

CPAT Report No 171

Report prepared for Richards, Moorhead and Laing

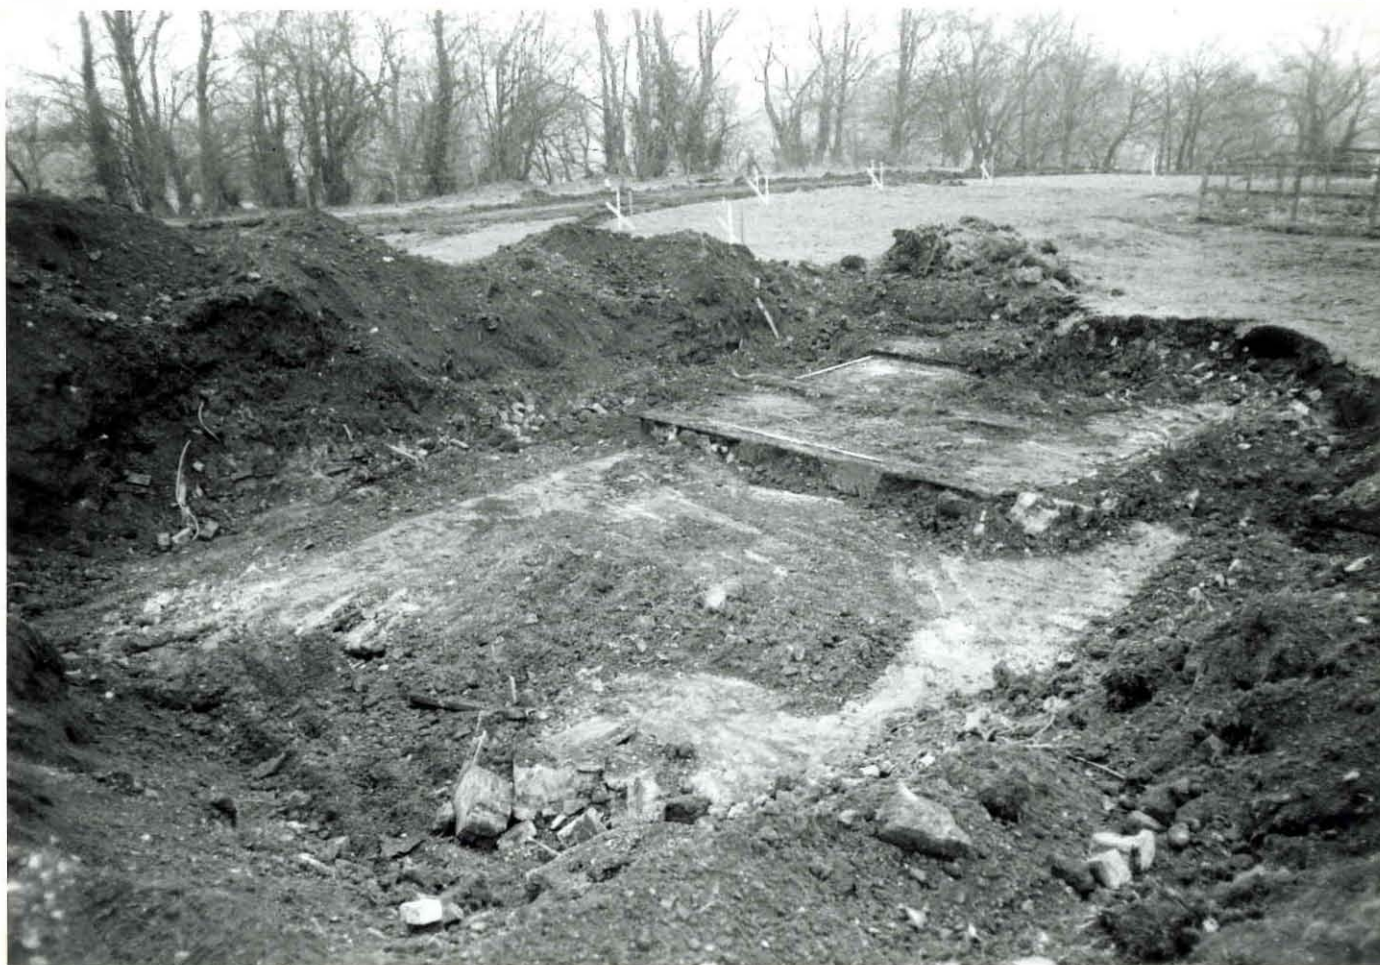
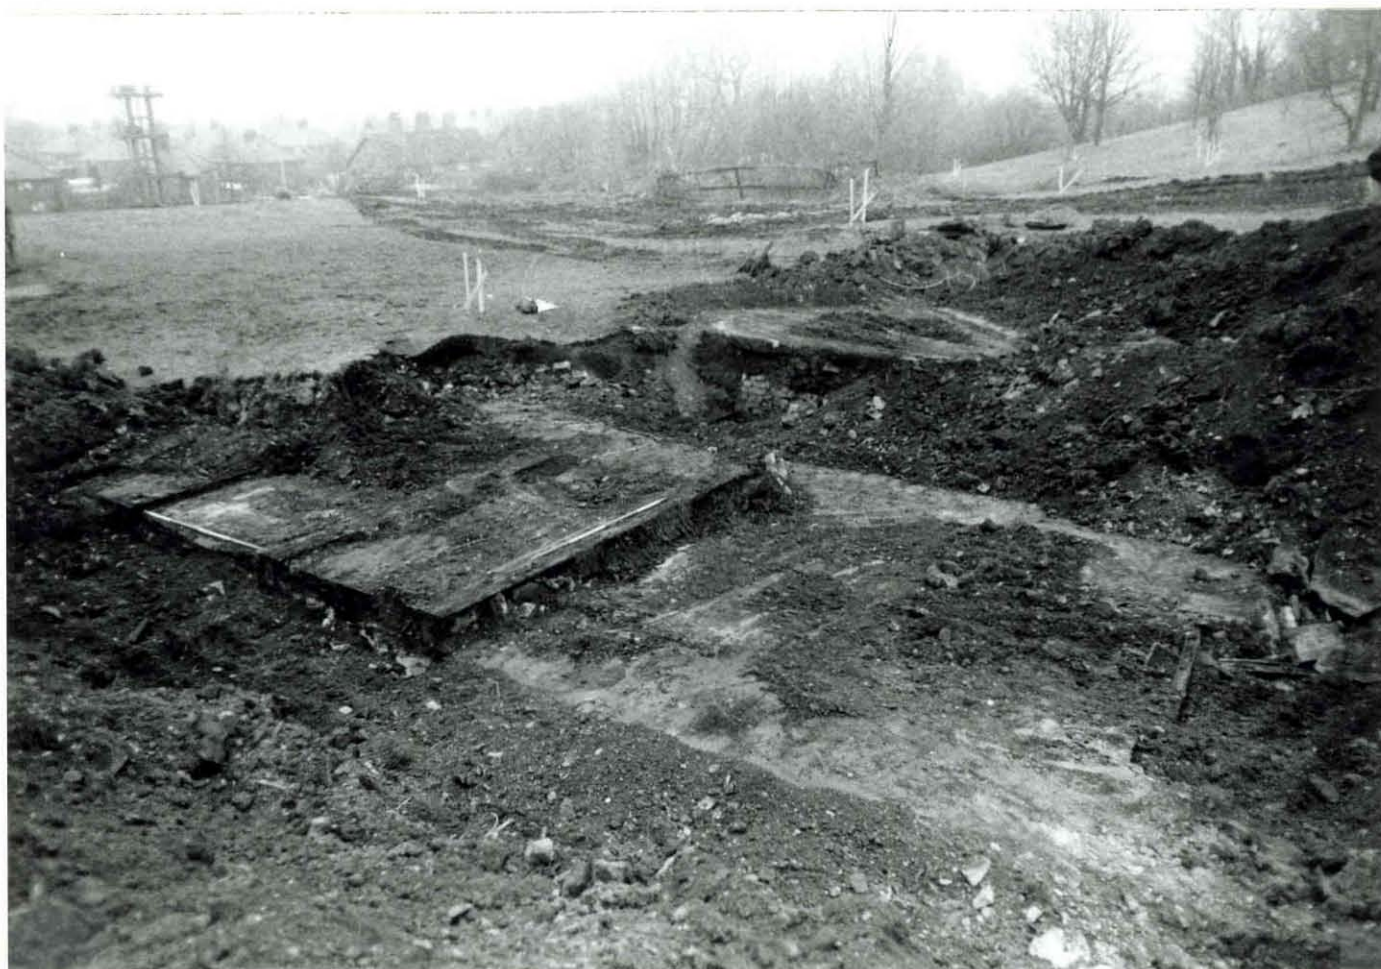
- 3.6 The machine was used to remove up to 2.20m of colliery waste covering the structure, which was then clean and recorded in detail using EDM Total Station survey equipment. A full photographic record was maintained throughout (Plates 1-2).

Plate 1. Winding House from NE. Photo CPAT 443.11

Plate 2. Winding House from SE. Photo CPAT 443.14

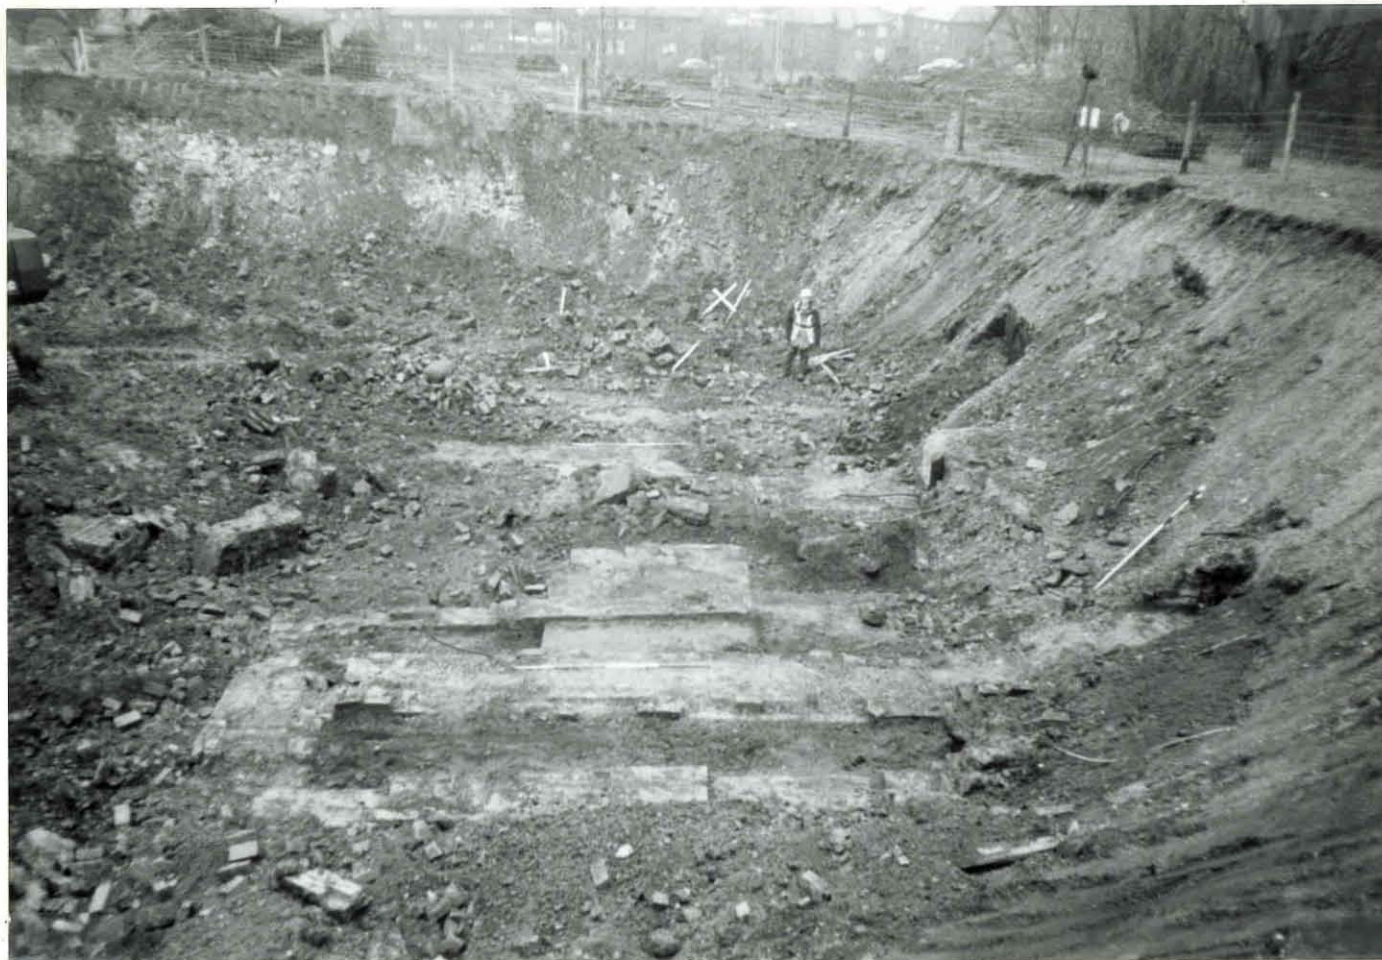
- 3.12 An arrangement with the contractors enabled a brief period of recording once the initial excavation had been completed. At this stage up to 4m had been removed revealing the foundations and some internal detail. The building was rapidly cleaned and recorded using EDM Total Station equipment, to produce a detailed plan of the features visible (fig. 10 and Plates 3-4).

Plate 3. Fan House from E. Photo CPAT 444.33

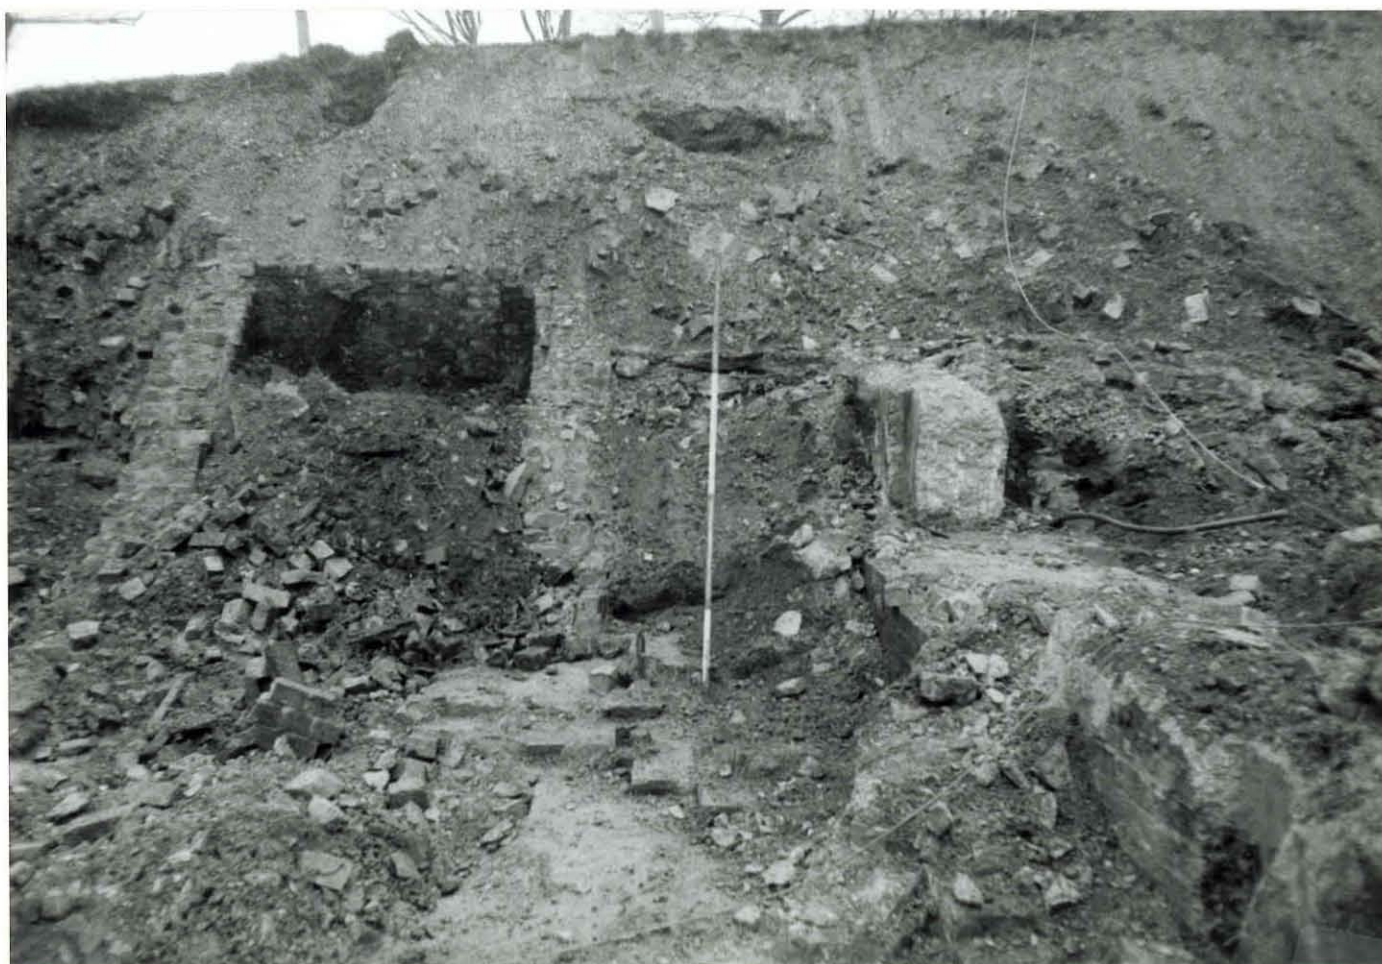
- 3.16 The western side was generally at a lower level and contained a series of brick walls, some of which may have been support for machinery. At the south-west corner two parallel walls 1.18m apart extended beyond the investigated area to the south. At the north-west corner a yellow brick structure was visible at a higher level in the excavation face, having the appearance of a flue. Adjoining this to the east was a rectangular red brick feature measuring 1.8 x 2.5m (Plate 4).

Plate 4. Fan House from S. Photo CPAT 445.9

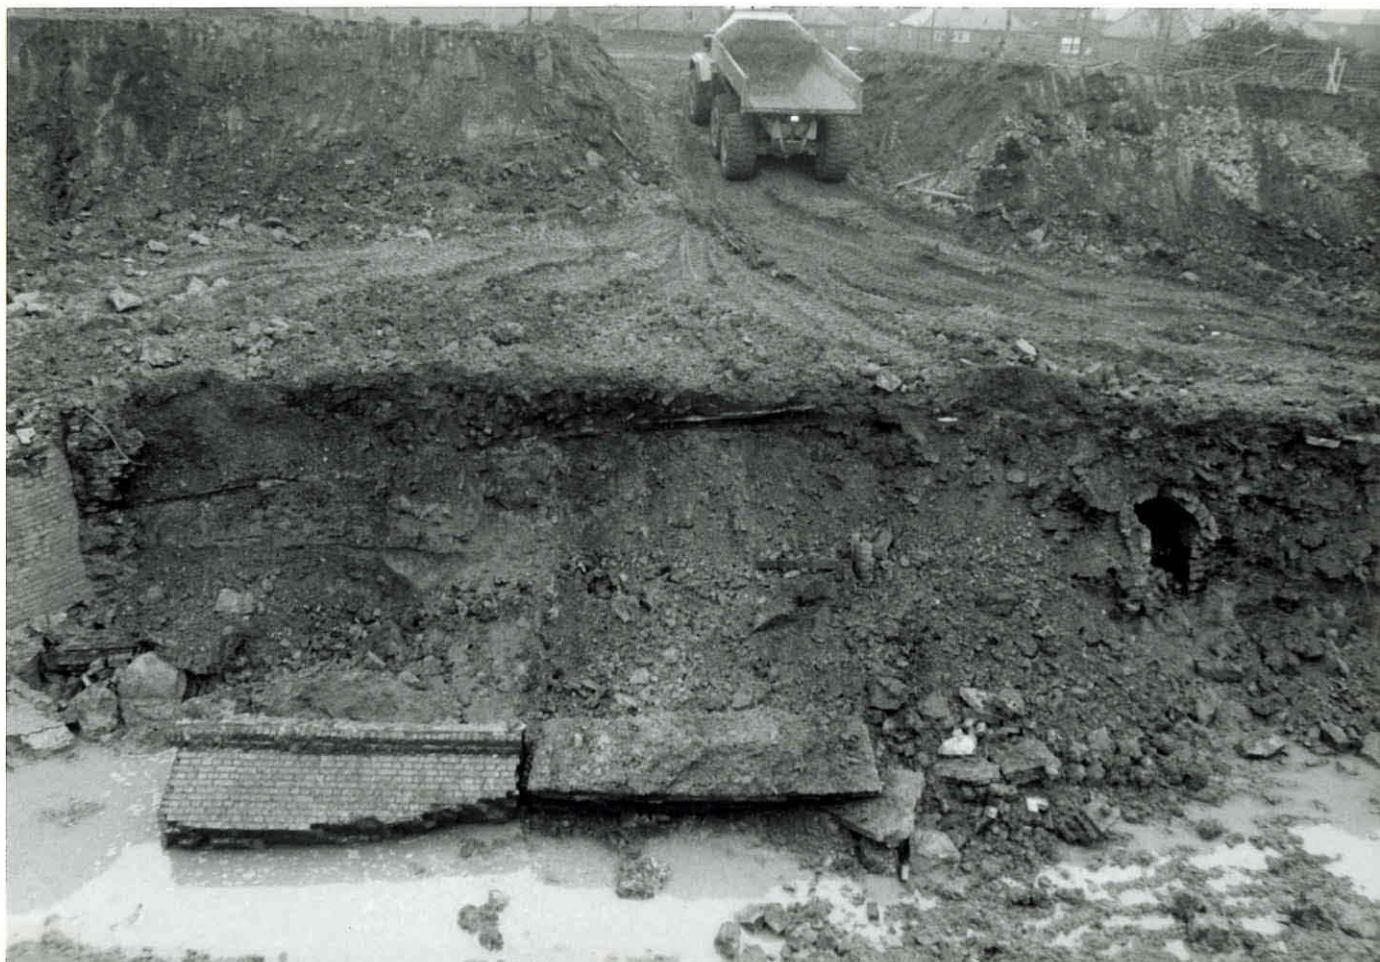
- 3.19 The watching brief during the excavations in the area of the shaft revealed that the shafthead was formed by substantial steel girders and concrete blocks, overlying the original yellow brick shaft lining. A brick-lined tunnel, Tunnel 3 (Plate 5), was seen joining the shaft on the northern side, but there was now opportunity to record it. This presumably provided access to the shaft.

- 3.25 A brick-lined, arched tunnel or culvert was identified during the watching brief midway between the two shafts, running east-west (Plate 5). This was visible in the exposed eastern face following the initial phase of excavation, and its function is unknown.

Plate 5. Shaft No1 with Tunnel 2 (collapsed) and Tunnel 3. Photo CPAT 445.17

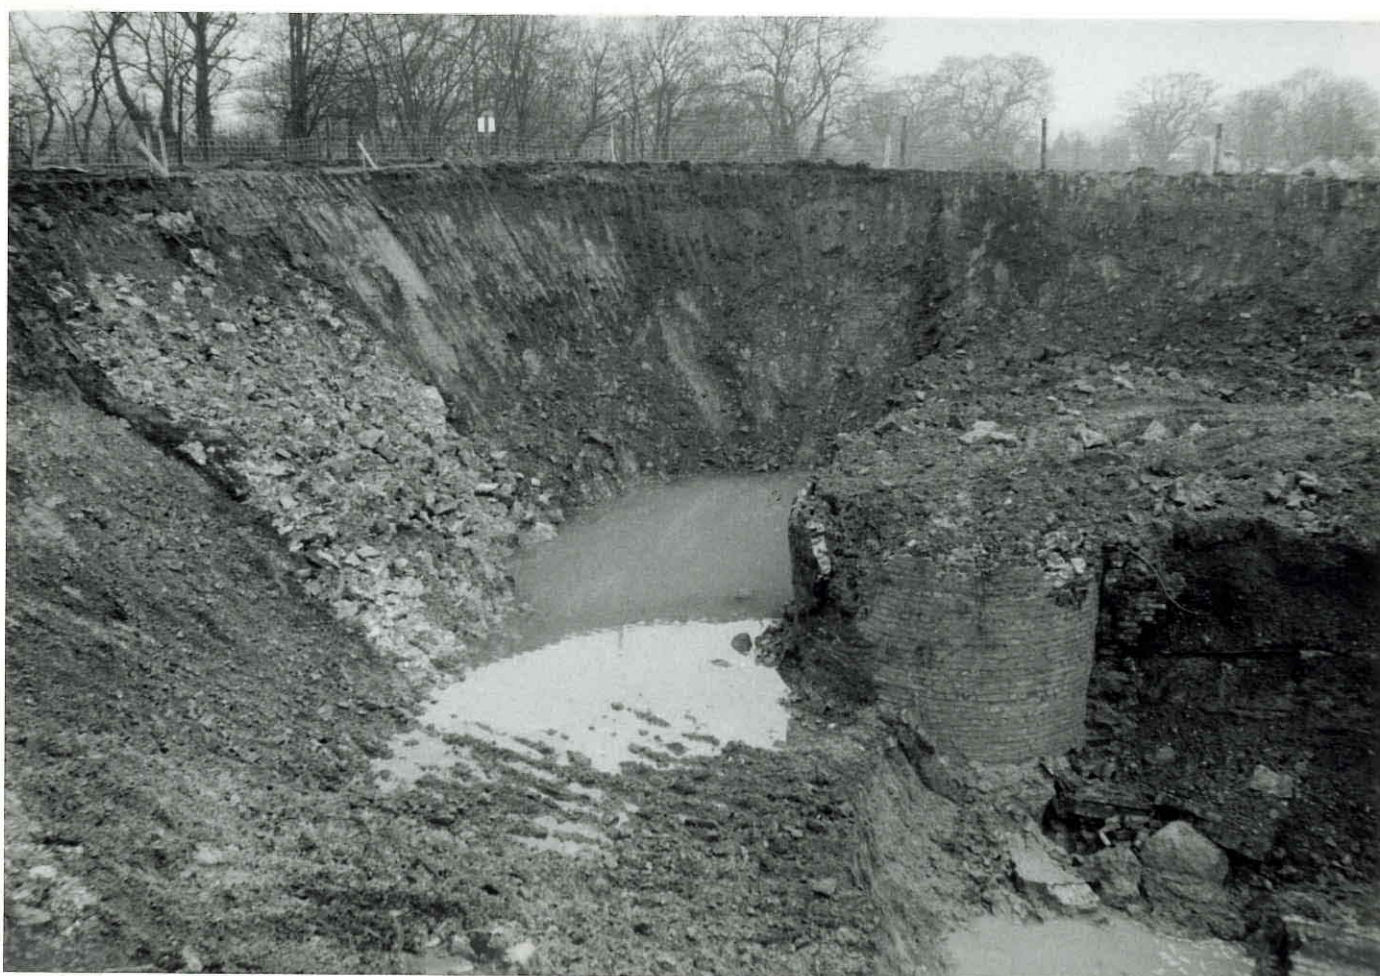
- 3.22 During the excavations surrounding No 1 Shaft the remains of a substantial building were observed immediately to the south, extending beyond the excavated area. The building was of sandstone construction and coincided with the structure shown on the early Ordnance Survey maps (figs 3-4),

which indicated a plan measuring 8 x 5m. There was no opportunity for measured recording although a photographic record was maintained (Plate 6).

- 3.23 The substantial construction of the building, together its position close to the shaft, is typical of a late 19th century pumping engine house. However, there is no evidence to suggest that such a structure existed at Brynkinallt. The building is shown in two photographs dated 1912 (Kelly 1990, nos 6 and 10), although these give no clues as to its function.

Plate 6. Shaft No 1 and Building 1 from E. Photo CPAT 445.12
