# Small Enclosures in North-east Wales PROJECT REPORT

N.W.Jones February 1999

Report for Cadw: Welsh Historic Monuments

The Clwyd-Powys Archaeological Trust 7a Church Street, Welshpool, Powys, SY21 7DL

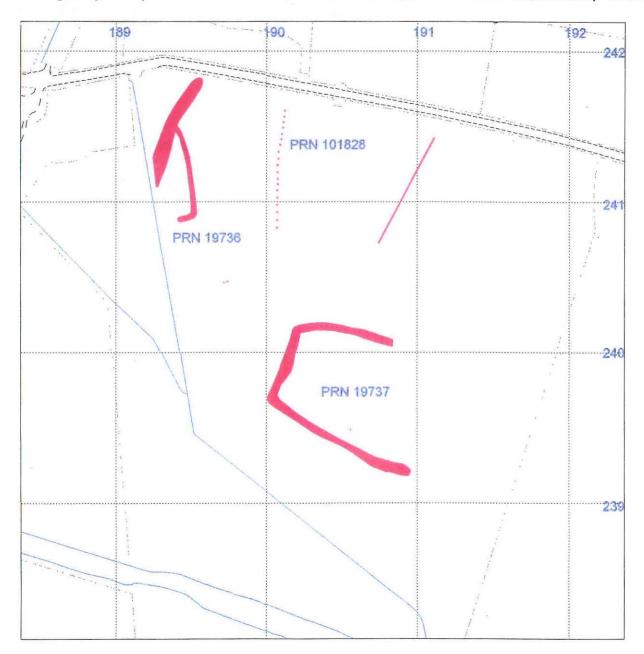
Llangedwyn Cropmark Enclosures A, B PRNs 19737, 19736. Scale 1:2,500. Map SJ12SE

Poorly defined cropmark enclosure consisting of a N-S ditch c. 3.5m wide forming E side, with SE corner and part of S side also visible. Broad cropmark to NW may not be associated. Pit alignment PRN 101828 lies c. 55m to E.

Not visible at time of visit 20/5/98

Substantial single ditched enclosure, sub-rectangular with slightly rounded corners. c. 75m NE-SW by at least 110m NW-SE. Ditch up to 5m wide. E side not visible. Internal area c. 0.62ha.

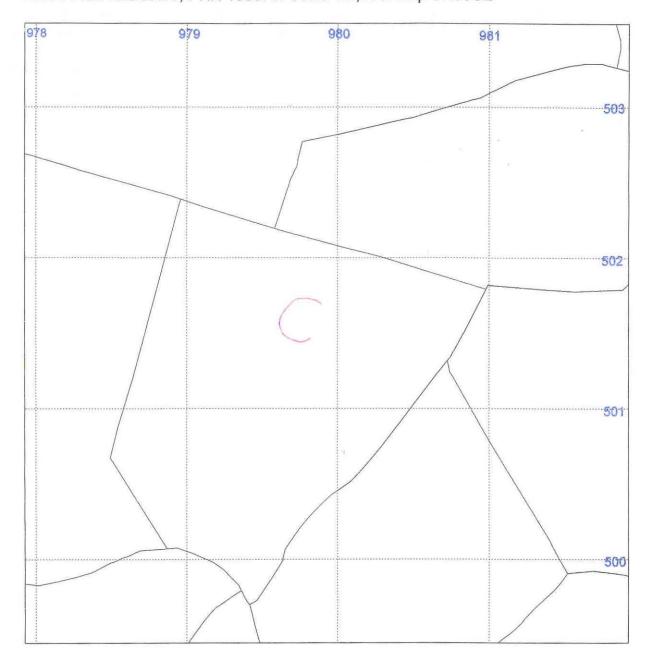
Hafod Wen Enclosure, PRN 100678. Scale 1:2,500. Map SH95SE

The remains of a curvilinear enclosure marked by a ditch 4m wide and 0.2m deep with no trace of a bank. It is 36-42m in diameter. Davies notes that a prominant bank did once exist. U0985;

Site visit 30/10/98. The enclosure survives as described above and is best preserved to the SW. Possible slight counterscarp, but no sign of an inner bank. The full circuit is not visible, with the E side missing.

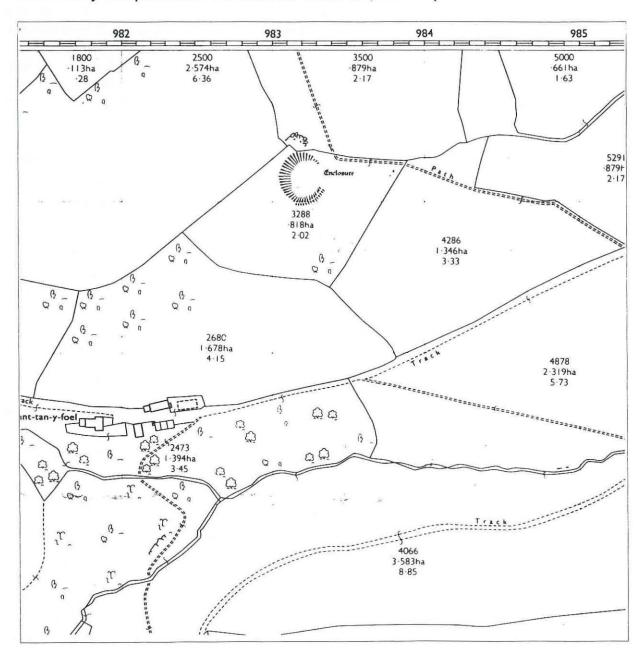
Nant Tan-y-foel platform. PRN 100700. Scale 1:2,500. Map SH94NE

A sub-circular platform scooped out of the hillside on the N and W, elsewhere surrounded by a bank 0.3m high and 5m wide. No trace of an entrance. Probably a hut platform c. 30m in diameter. U0985

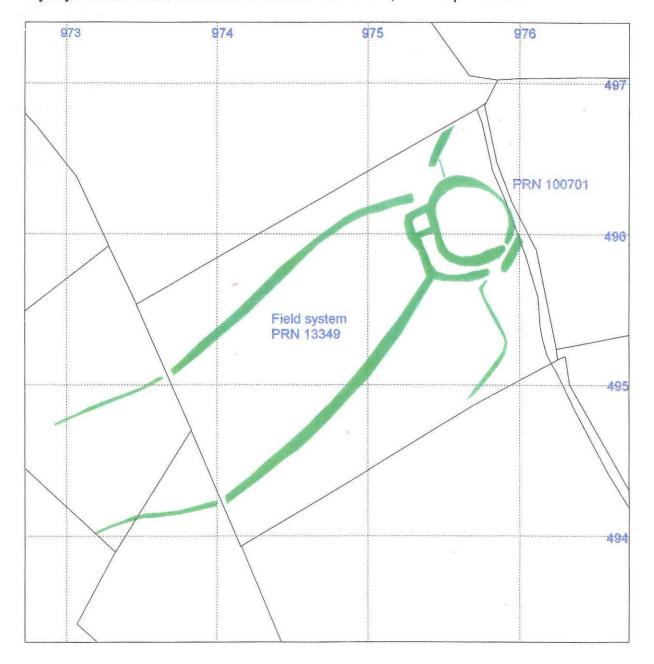
# Tyddyn Tudor Enclosure A PRN 100701. Scale 1:2,500. Map SH94NE

Circular enclosure roughly 50m in diameter. Bank 0.3m high. Possible entrance to E. Curvilinear platform appends to W. Sited on level ground. Note CAR 655 to NW. U0985;

Sub-circular enclosure c. 50m diameter with probable entrance to SE. Internal area c. 0.21ha. Outer bank to S and W with S entrance, c. 12m from main encosure. The outer bank terminates at the NW with a sub-square enclosed area c. 15m x 15m. The E side is damaged by a track. Associated field system PRN 13349 most obvious to W, but also extending to S and N.

Field system consists of linear banks radiating from enclosure PRN 100701, two roughly parallel to the W, one to the N and one to the S. Continuation of field banks in adjacent field to W.

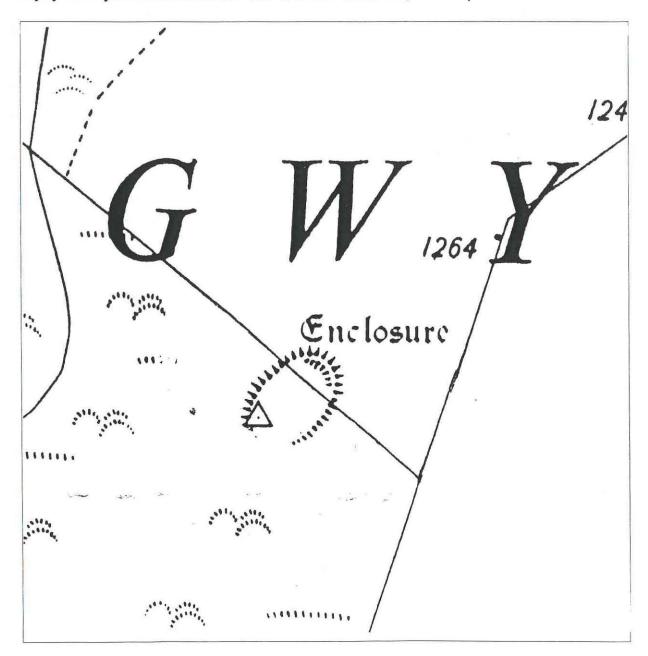
Mynydd Rhyd Ddu enclosure. PRN 100789. Scale 1:2,500. Map SJ04NE

An oval enclosure on the level summit of Mynydd Rhyd Ddu. The surrounding bank is 0.8m high at most. Made up largely of stone. In poor condition to SW of field wall. Possible entrance to N not noted in 1983. U0885;

Oval enclosure as depicted by OS. Bank roughly 0.75m to 1.0m wide and 0.5m high. Interior is higher than perimeter. LB 19/5/98

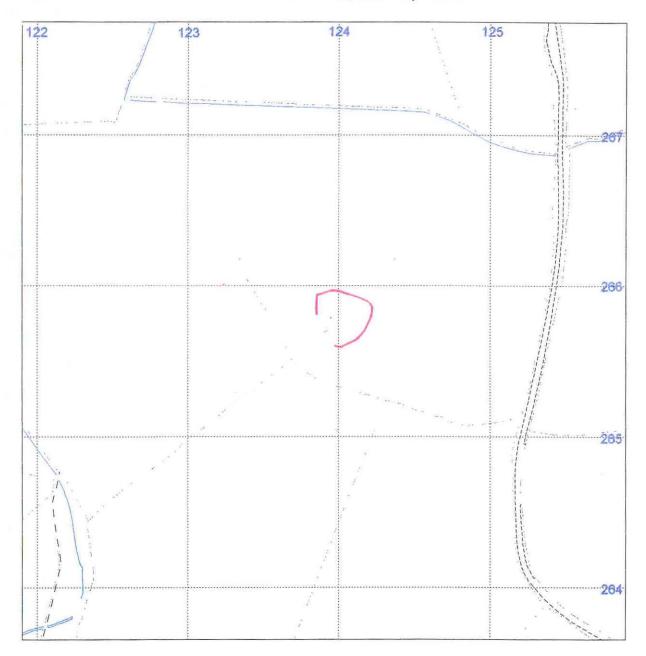
Hen Fache Enclosure PRN 101049. Scale 1:2,500. Map SJ12NW

Cropmark of small oval enclosure marked by single line. St. Joseph suggests Iron Age date. Situated on flat ground with good views to S and W. U0885;

AP plot as part of project 509 1998. Single narrow ditch defines sub-circular enclosure c. 36m diameter, with an internal area of c. 0.1ha. SW corner not clearly visible, but may include the entrance.

Not visible at time of visit 20/5/98.

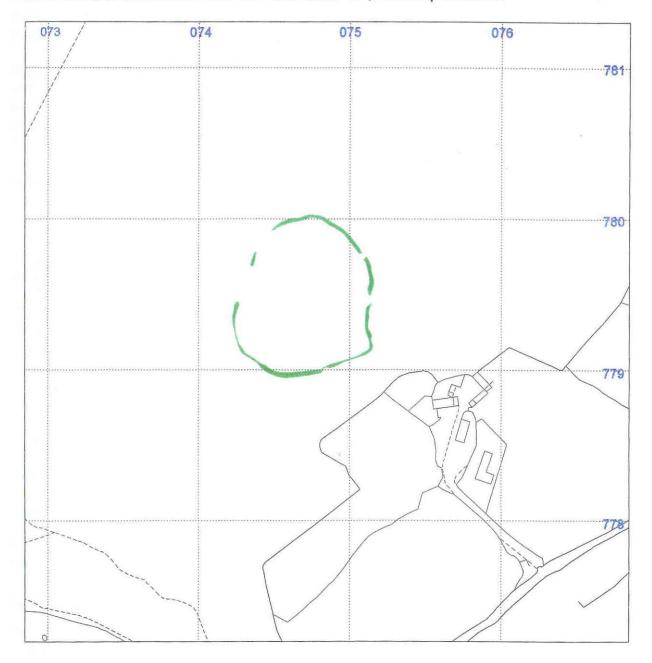
Marian Ffrith enclosure. PRN 101730. Scale 1:2,500. Map SJ07NE

Ground survey August 1998. Site measures 105m N-S x 88m E-W, enclosing an area of c. 0.72ha defined by a low bank best preserved to the S where it follows the crest of a limestone ridge. Numerous limestone outcrops within general area, running roughly E-W. The site is currently being used as a course for trail bikes which is leading to some damage to the turf cover.

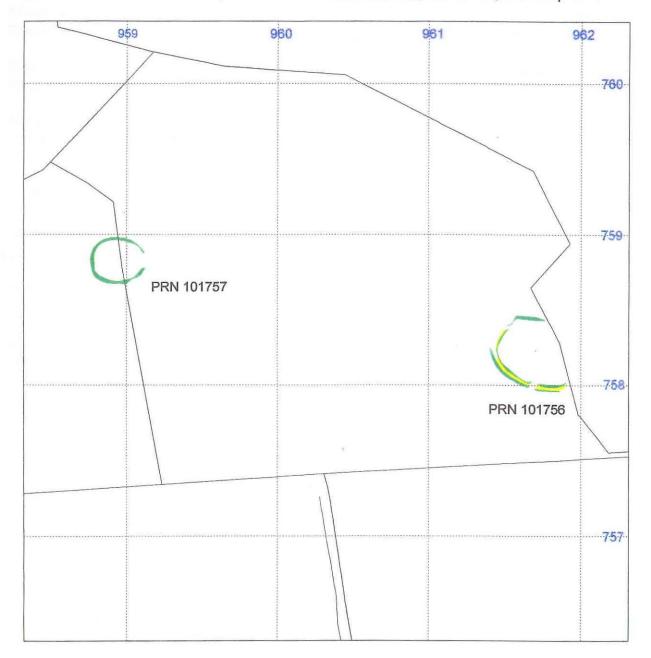
Warren enclosures A and B, PRNs 101756 and 101757. Scale 1:2,500. Map SH97NE

Site visit 17/5/98 - Prominent earthwork embankent c. 0.15-0.3m high at E end of field. Enclosure c. 50m diam. with internal area of c. 0.18ha. Embankment diminishes to S, possibly the entrance, and with possible quarry damage. Highest point is to NNW, interior domed with several depressions visible. Features to W may be associated trackways/field boundaries. The SE side has been damaged by small-scale quarrying, mostly along the S side.

Ground survey August 1998. Small oval enclosure 35m E-W x 30m N-S, bank up to 0.3m high and 1m wide. Possible entrance to E. Crossed by N-S fence and damaged by quarrying on W side. See also PRN 101756;

Access for farm vehicles along the western side of the fence has led to some damage of the bank and interior. CPAT site visit 1998.

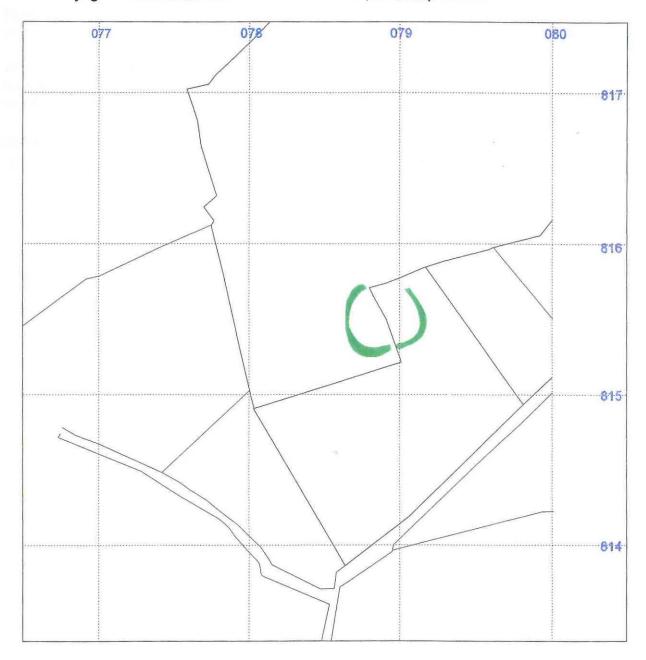
Gwaenysgor Enclosure. PRN 101773. Scale 1:2,500. Map SJ08SE

Ploughed down earthwork enclosure noted on 1984 AP (Musson). Oval in shape with no visible entrance. Bisected by hedgeline. Bank to SE is 0.6m high and 1.5m wide. No trace of ditch or entrance. N0884;

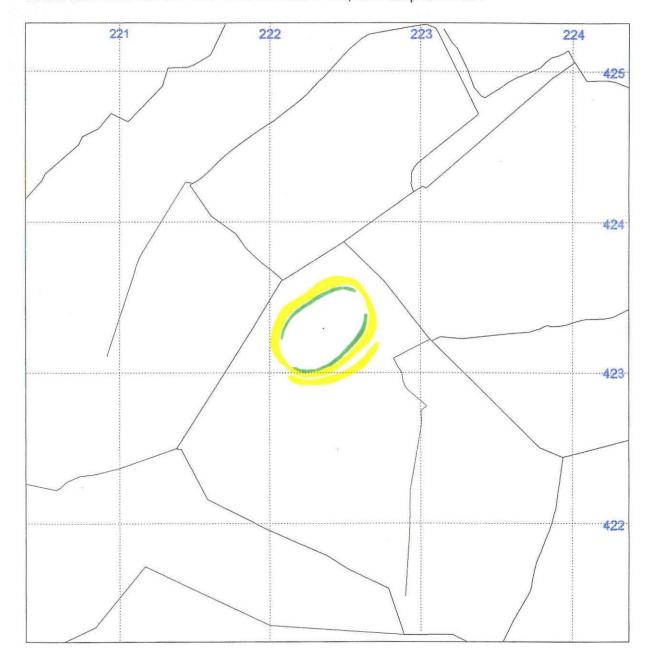
Wern Isaf Enclosure. PRN 101807. Scale 1:2,500. Map SJ24SW

Earthwork enclosure first noted on CPAT AP sited on summit of small hillock with good views all around. Oval in shape. Multivallate on SE side. N1184;

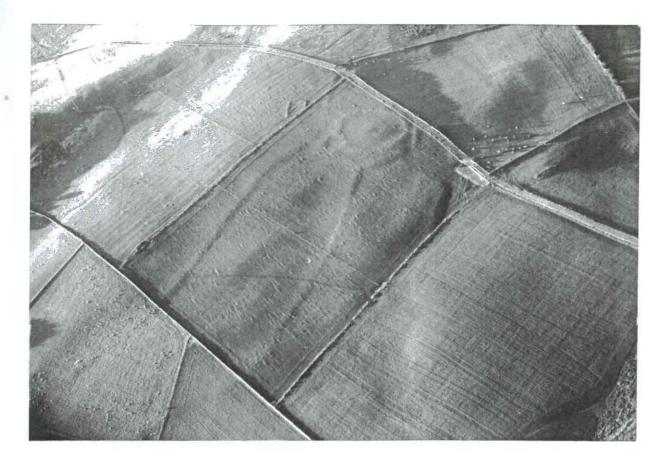
Plate 1: Tyddyn Tudor enclosure A PRN 100701 and field system from S. Photo CPAT 87-MB-1012

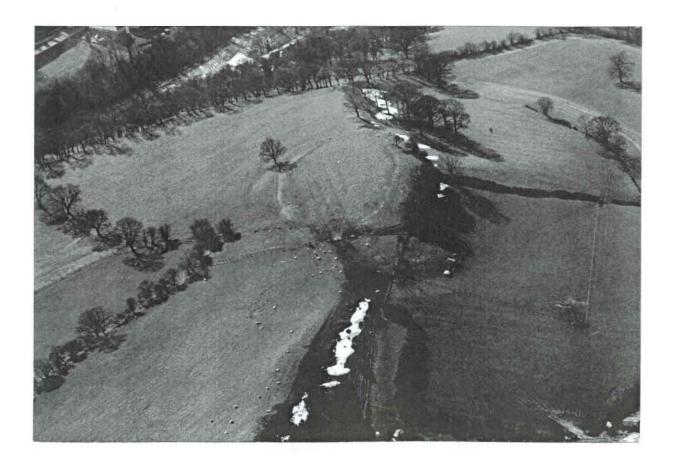
Plate 2: Wern Isaf enclosure PRN 101807 from NE. Photo CPAT 85-6-29

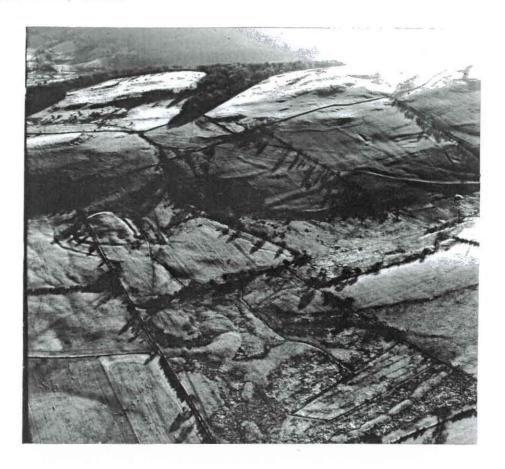
Plate 3: Caer Drewyn enclosures PRN 101807 and 101810 with field system from N. Photo CUCAP AWP39

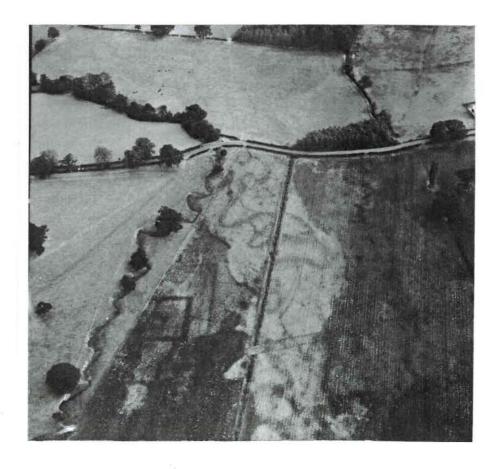
Plate 4: Plasnewydd cropmark PRN 102653 from N. CUCAP CBE 91

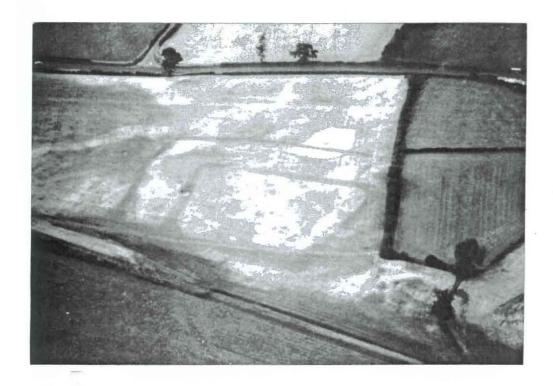
Plate 5: Pentrefelin enclosure PRN 101482 from S. Photo CPAT 79-59-33

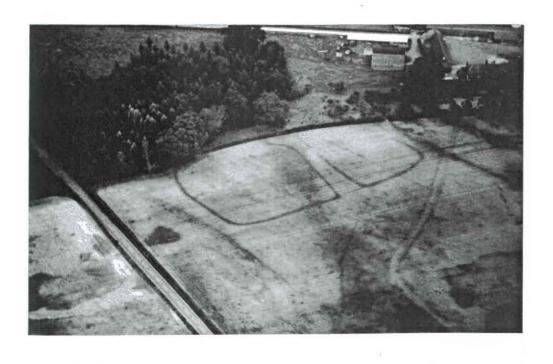
Plate 6: Royton enclosures A and B PRNs 102658-9 from NW. Photo CPAT 79-60-8

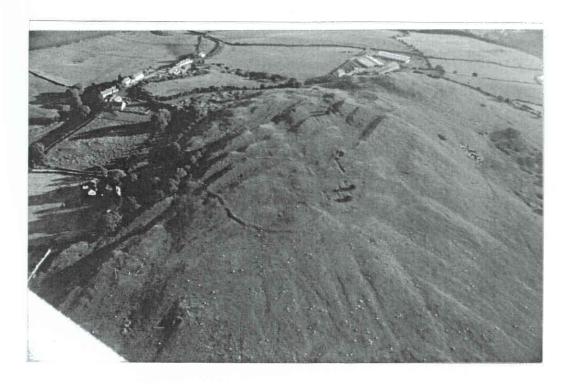
Plate 7 Marian Ffrith enclosure PRN 101730 from E. Photo CPAT 84-51-15

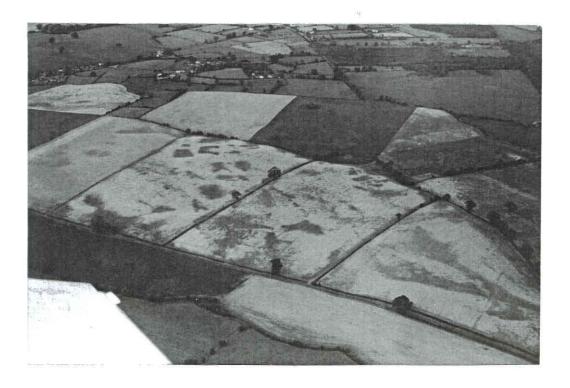
Plate 8 Blackhurst enclosures B and C PRNs 101714-5 from SW. Photo CPAT 79-22-3

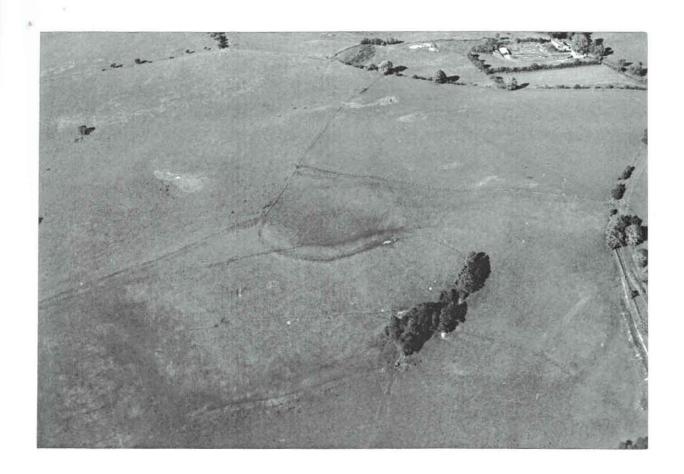
Plate 9 Pen-y-Mynydd enclosure PRN 102156 from SW. Photo CPAT 89-MB-550
