*St Elidan's Church, Llanelidan,  
Denbighshire*  
ARCHAEOLOGICAL WATCHING BRIEF

**CPAT Report No 289**

**N.W.Jones**  
August 1998

Report for Cadw: Welsh Historic Monuments

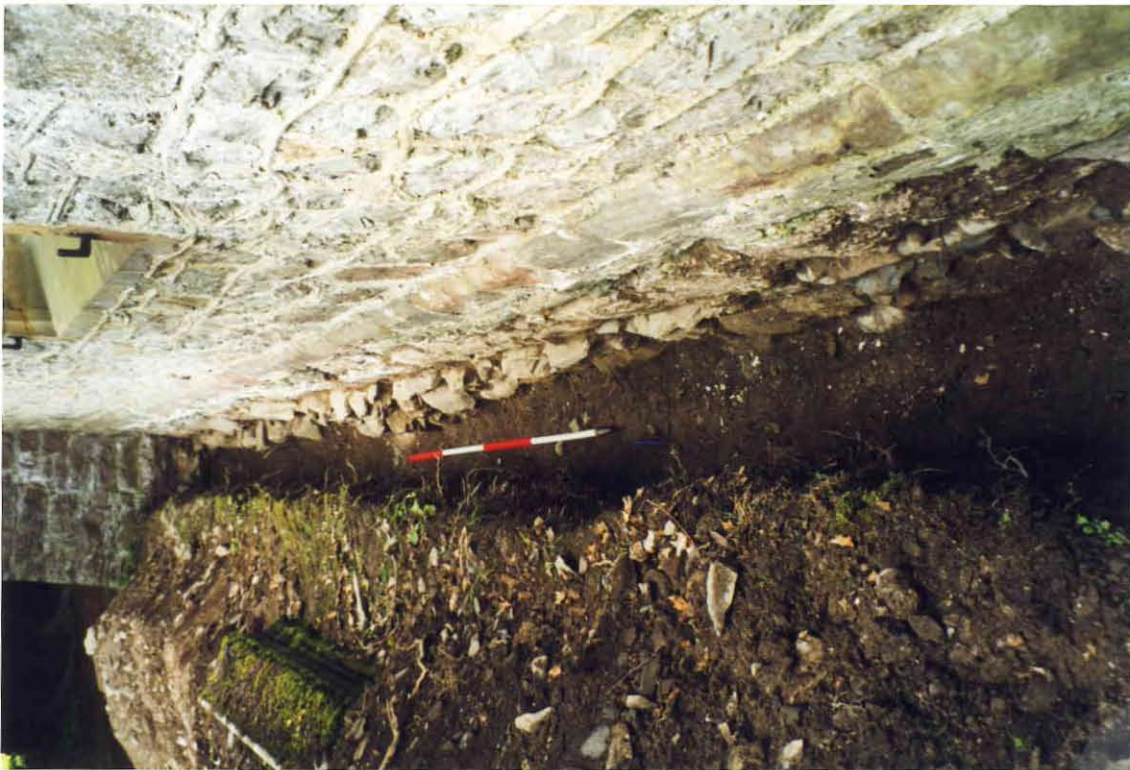
Plate 1: North wall drain from W. Photo CPAT 736.11

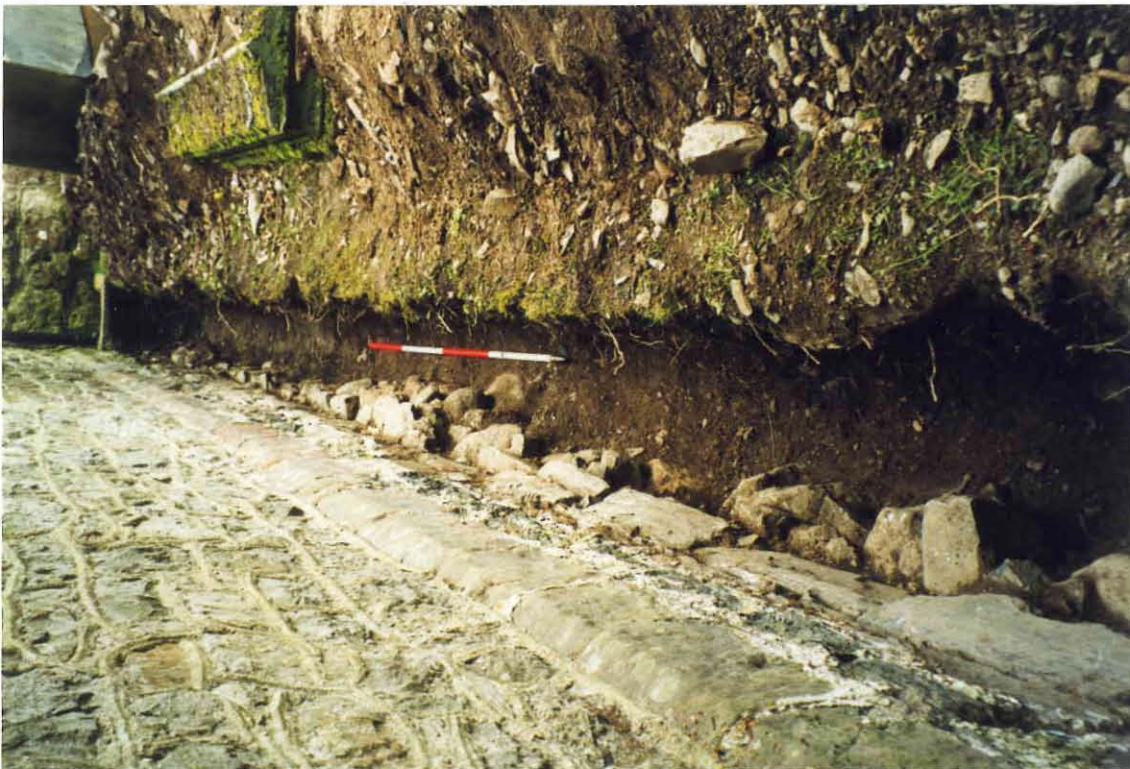
Plate 2: North wall drain from E. Photo CPAT 736.13

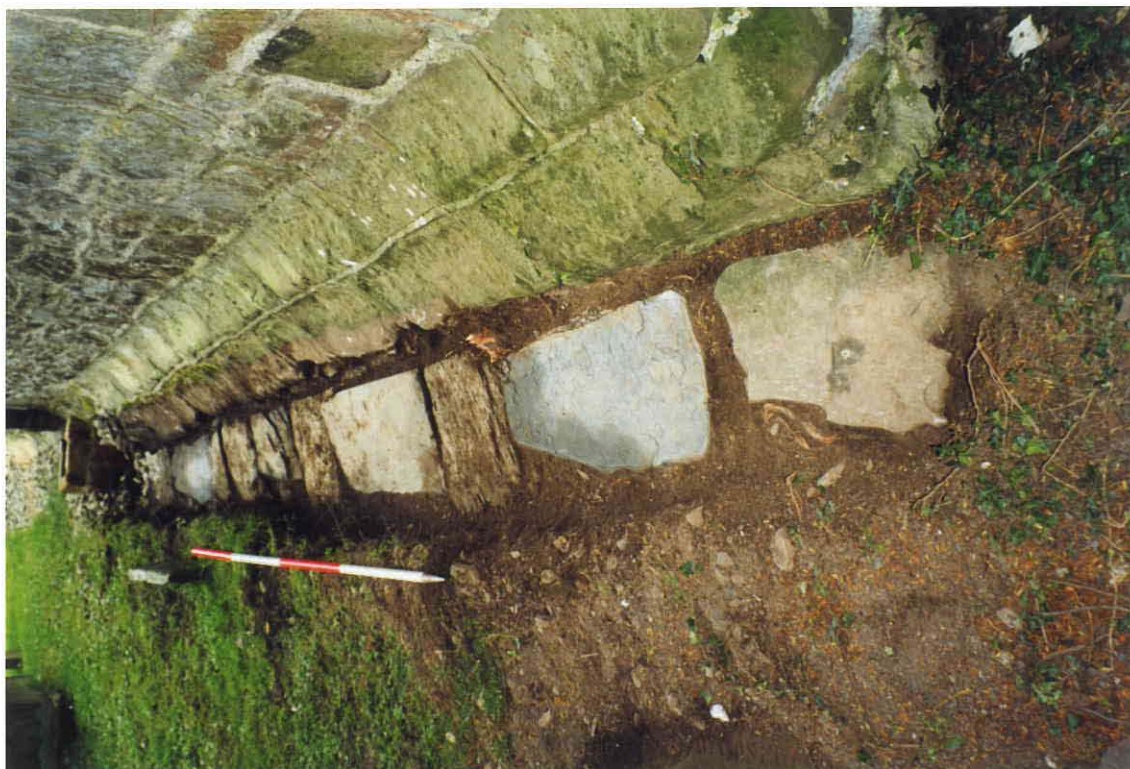
Plate 3: East wall drain showing context 16 from N. Photo CPAT 736.24

- 5.5 The topsoil (15) was removed along the whole length to reveal a layer of flat stones (16) sloping away from the wall at an angle of roughly 25°. The stones, which measured up to 0.8 x 0.4m, were mostly of poor quality slate, laid in a single course and bedded on a layer of lime mortar (17) up to 0.12m thick. It may be presumed that the stones were intended to divert water away from the east wall of the church, and indicate the ground level at the time of construction, which has a *terminus post quem* of 1696 (see 5.6 below).

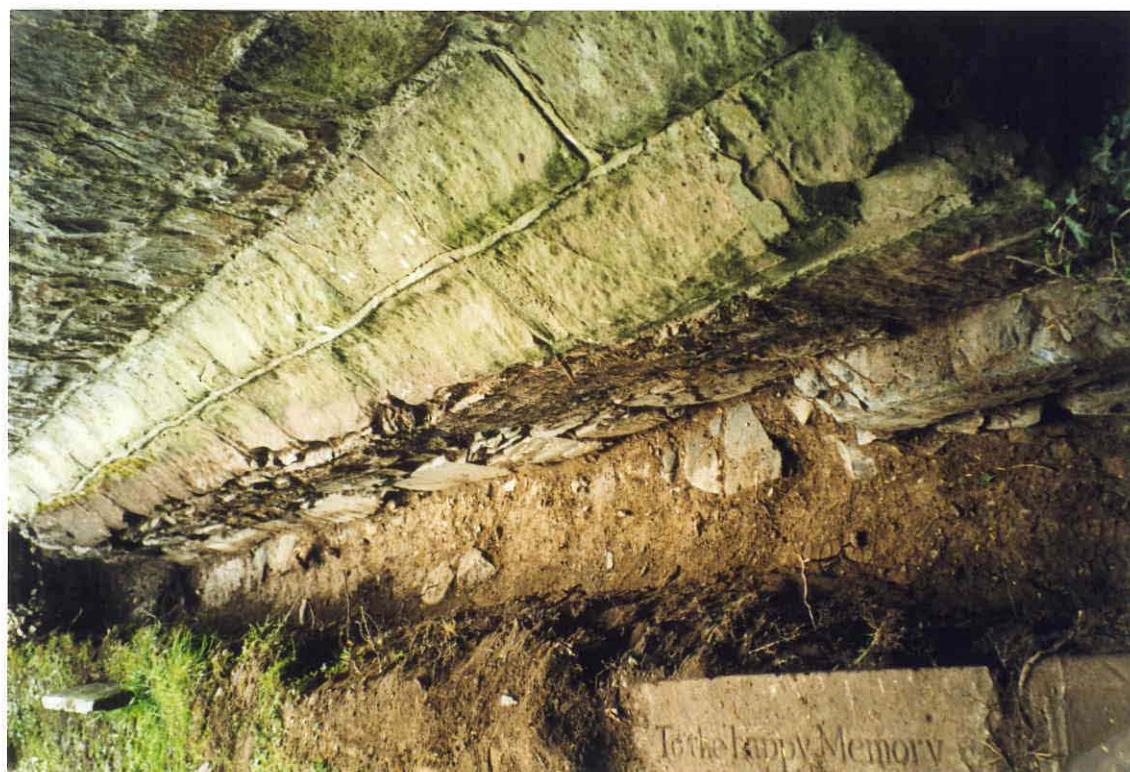
Plate 4: East wall drain from N. Photo CPAT 736.33
