Breiddin Hillfort, Powys
ARCHAEOLOGICAL SURVEY AND ASSESSMENT

CPAT Report No 464

N W Jones
February 2002

Report for Cadw: Welsh Historic Monuments

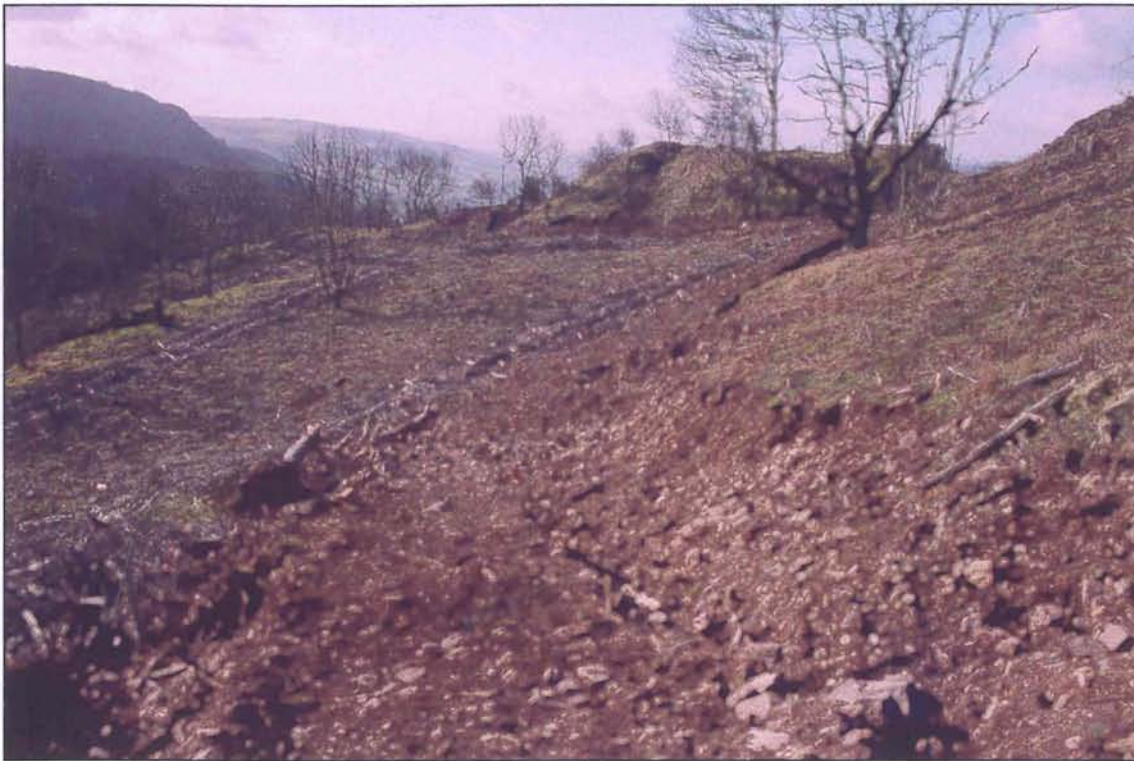
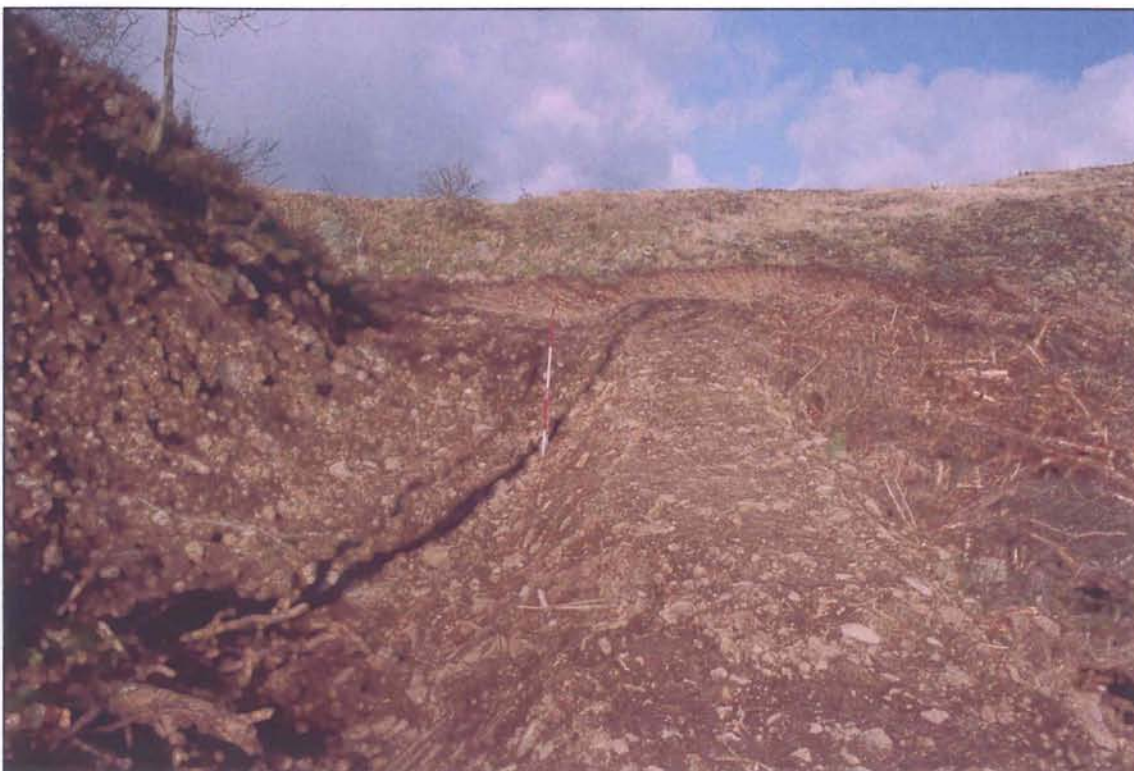
- 3.5 The main element of the disturbance relates to the construction of a substantial earthwork bund (367m in length and averaging c. 0.8m high and between 4m and 6.5m wide), which follows the base of a steep slope (pl 3-4), running generally from north to south largely within an area which was carefully clear-felled by Forest Enterprise during 2001. For the majority of its length the bund has been constructed from material excavated from an area along its western side, between 3m and 8m in width. In general it would seem that mechanical scraping of this area has disturbed or removed at least 0.3m of material below the former ground surface. The bund itself appears to have been constructed by dumping the excavated material directly onto the existing ground surface. The southern 114m of the bund appears to have been constructed from material imported onto the site from outside the scheduled area. Additional disturbance has been caused by the construction of an access track to the east of the winch house.

Plate 3 View south-west from just south of Area A. Photo CPAT cs02/04/25

Plate 4 View north towards Area C. Photo CPAT cs02/04/31

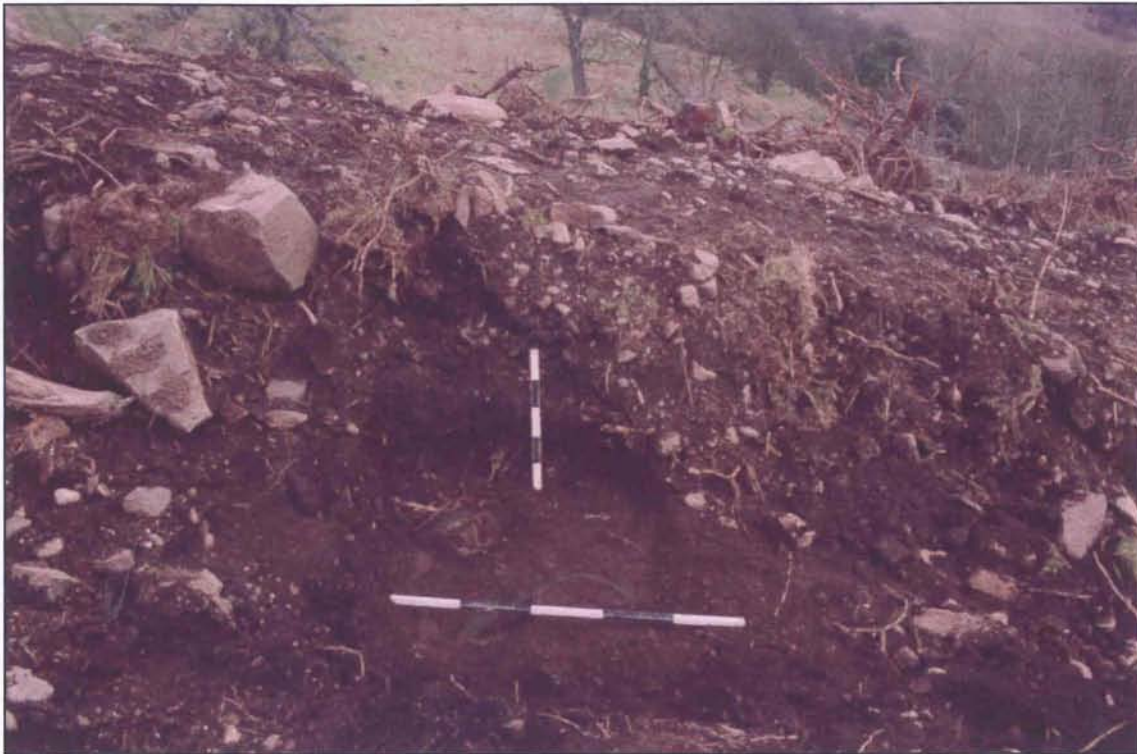
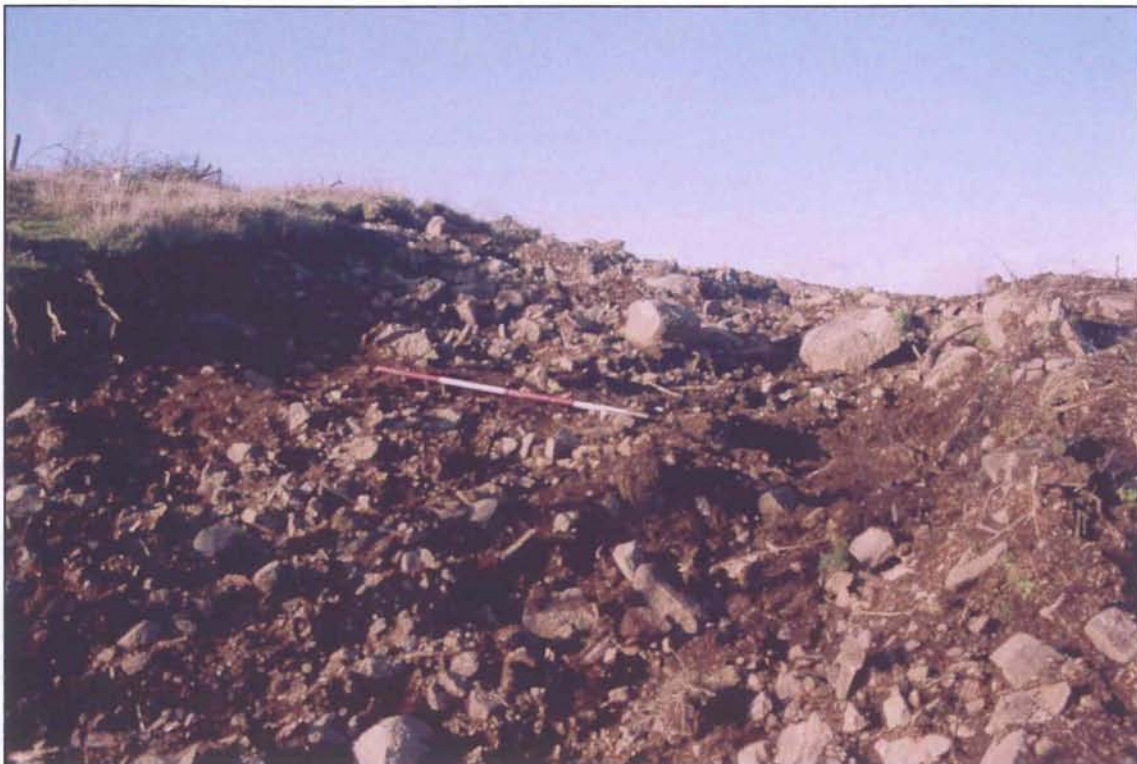
- 3.8 Area A (pl 5-6) was located near the northern end of the disturbance. The bund at this point was 5.9m wide at the base and 0.7m high above the former ground surface. To the west of the bund an area 5.6m wide had been mechanically stripped, the western edge cutting up to 0.45m below the turf, while against the bund the disturbance was up to 0.2m deep.

Plate 5 Area A from west. Photo CPAT cs02/04/08

Plate 6 Area A from south. Photo CPAT cs02/04/11

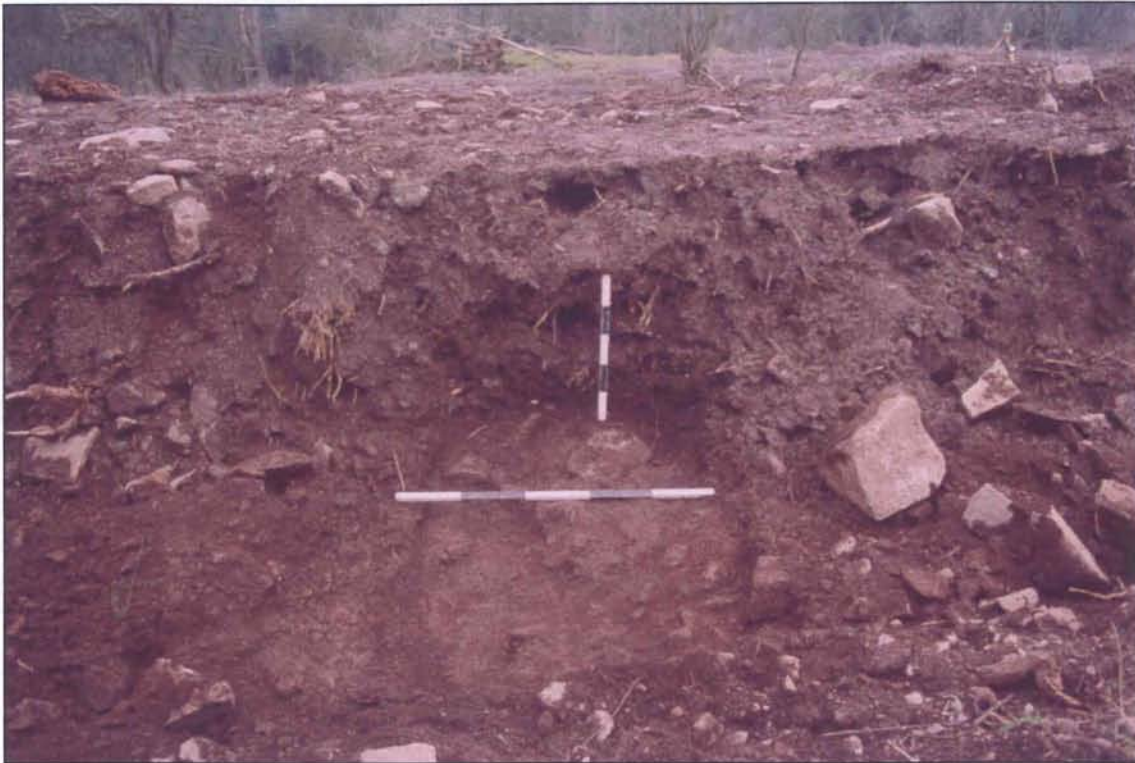
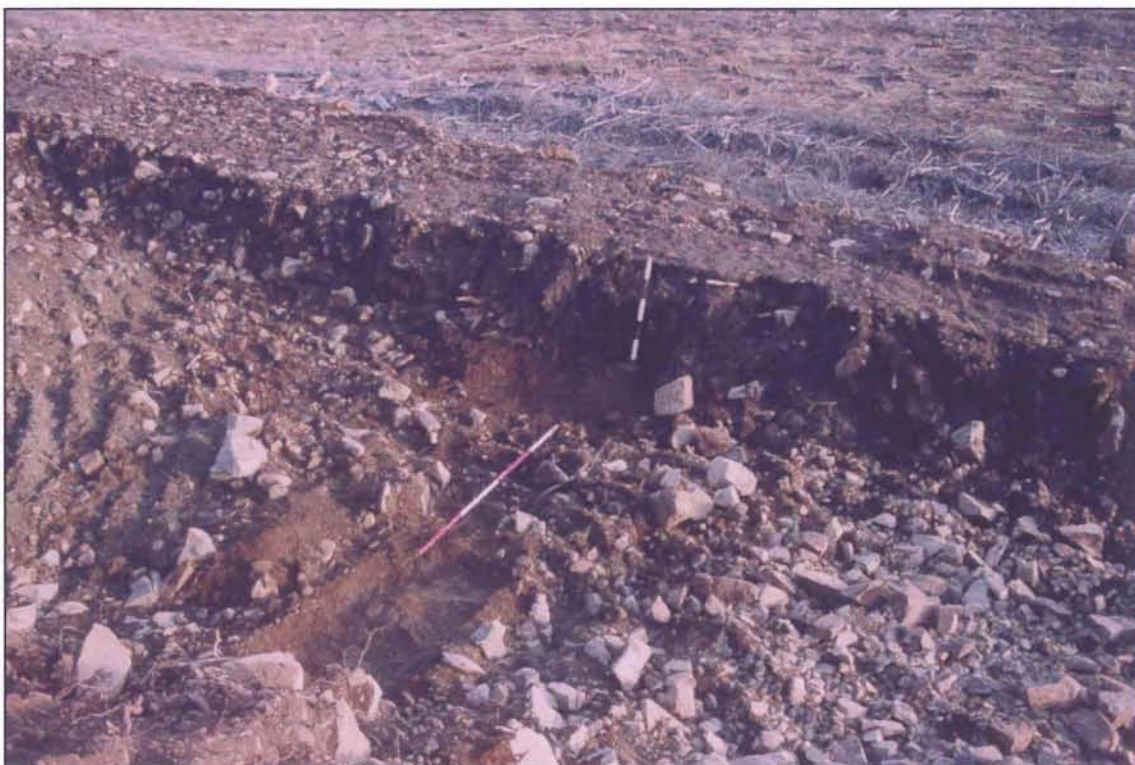
- 3.9 Area B (pl 7-8) was located at the base of a steep natural slope. The bund at this point was 5.4m wide at the base and 0.65m high above the former ground surface. To the west of the bund an area 7.2m wide had been mechanically stripped, the western edge of which cut into the bedrock, while against the bund the disturbance was up to 0.2m below the ground surface.

Plate 7 Area B from north. Photo CPAT cs02/04/10

Plate 8 Area B from north-west. Photo CPAT cs02/04/14

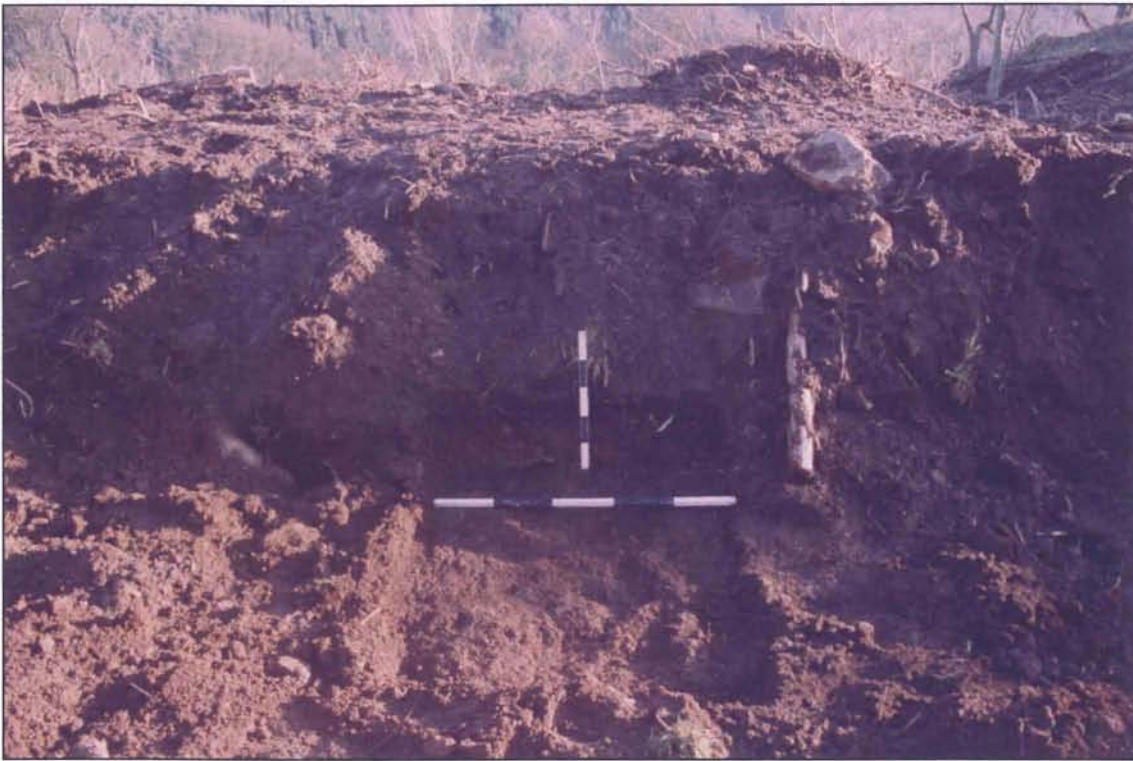
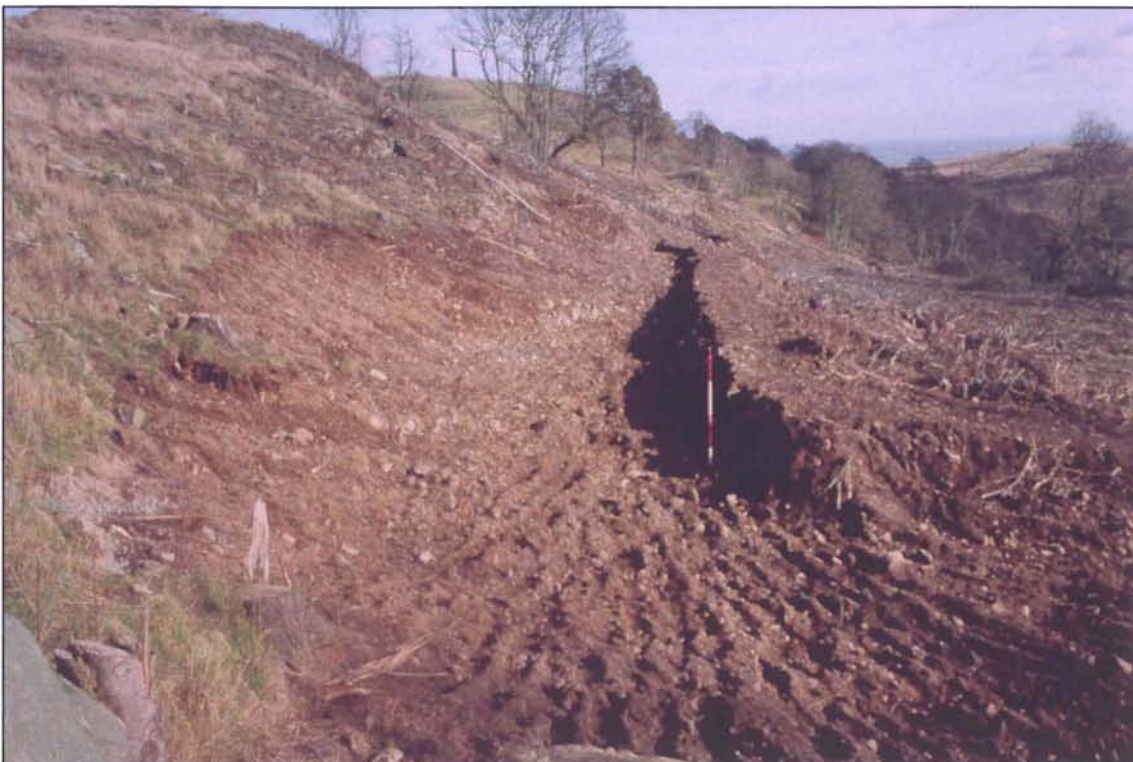
- 3.10 Area C (pl 9-10) was located towards the western edge of a natural terrace. The bund at this point was 3.7m wide at the base and 0.85m high above the former ground surface. To the west of the bund an area 8.6m wide had been mechanically stripped, the western edge cutting into the bedrock, while against the bund the disturbance was up to 0.25m deep.

Plate 9 Area C from north. Photo CPAT cs02/04/17

Plate 10 Area C from west. Photo CPAT cs02/04/29

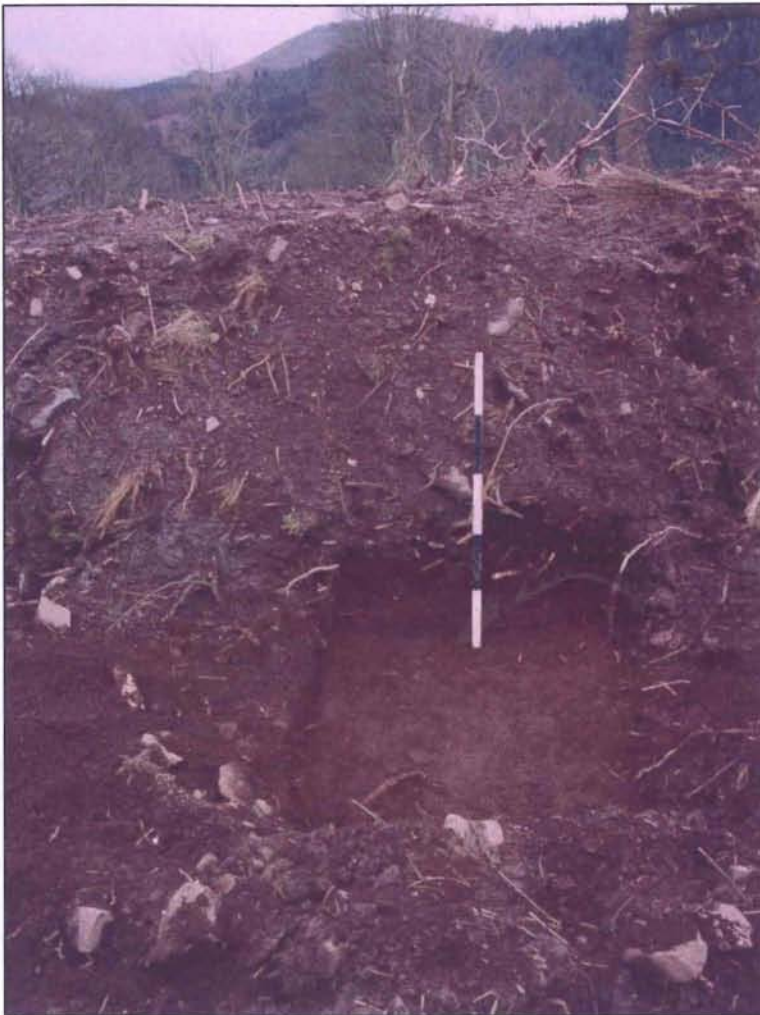
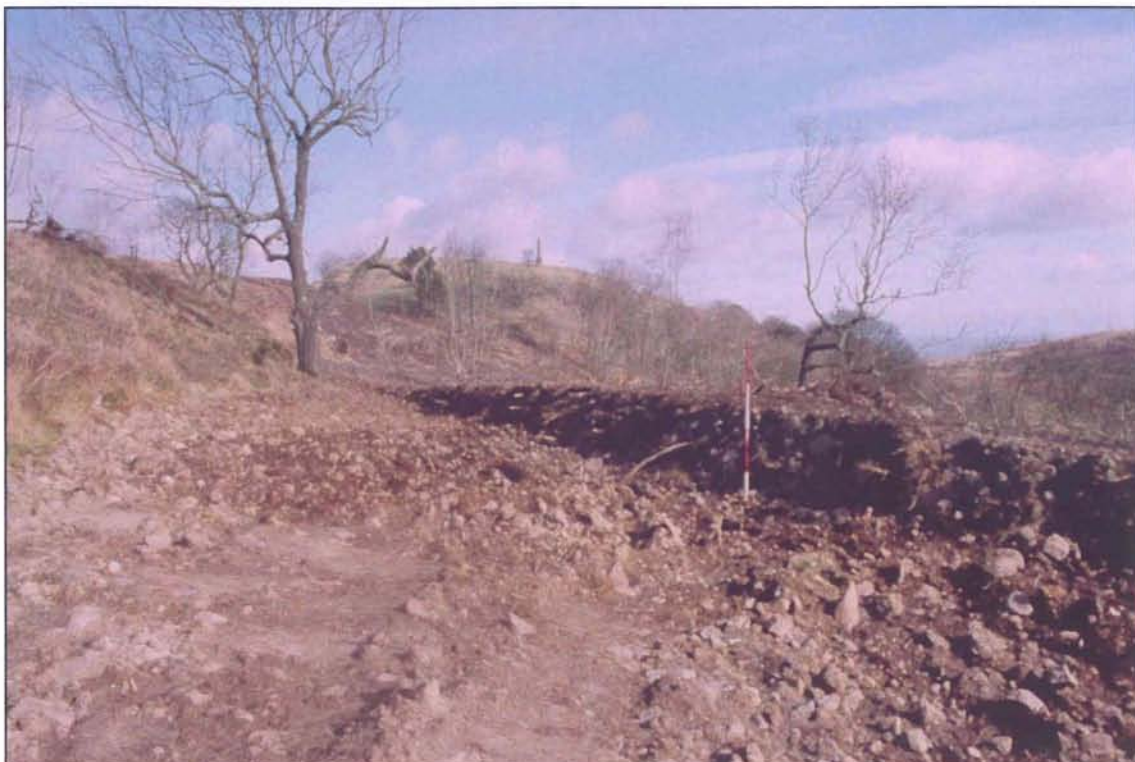
- 3.11 Area D (pl 11-12) was located along a natural terrace to the east of the excavated Area B3-4-5. The bund at this point was 4.6m wide at the base and 1.0m high above the former ground surface. To the west of the bund an area 5.0m wide had been mechanically stripped, the western edge cutting

gradually cutting below the ground surface to a maximum depth of 0.3m against the north-west side of the bund.

Plate 11 Area D from north-west. Photo CPAT cs02/04/21

Plate 12 Area D from south-west. Photo CPAT cs02/04/33

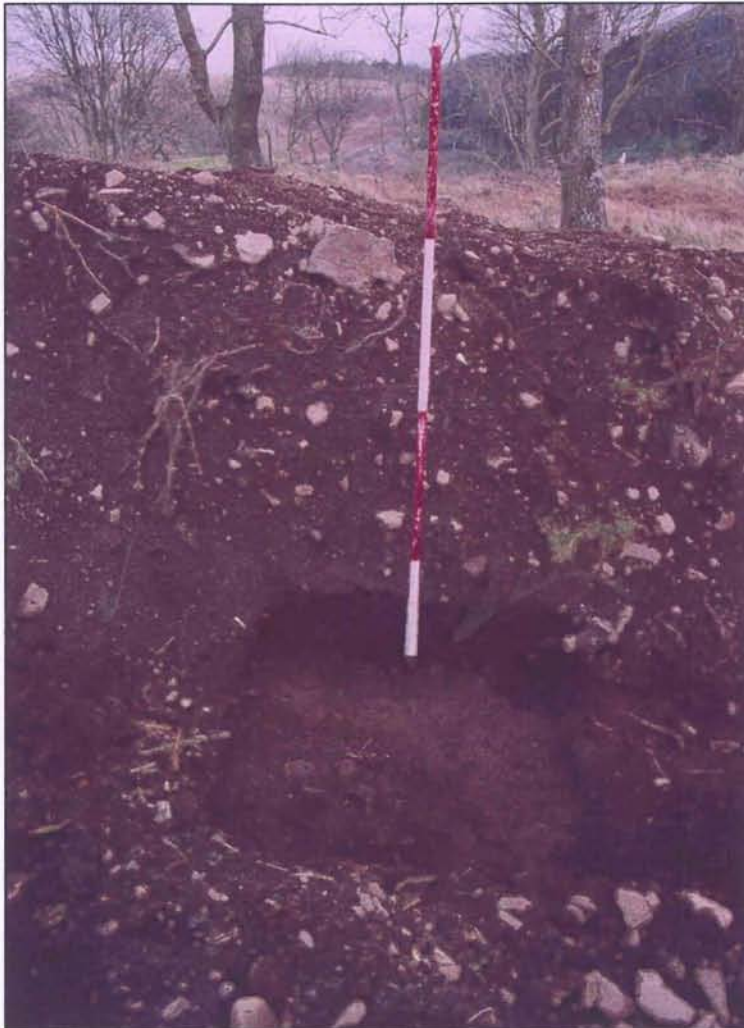
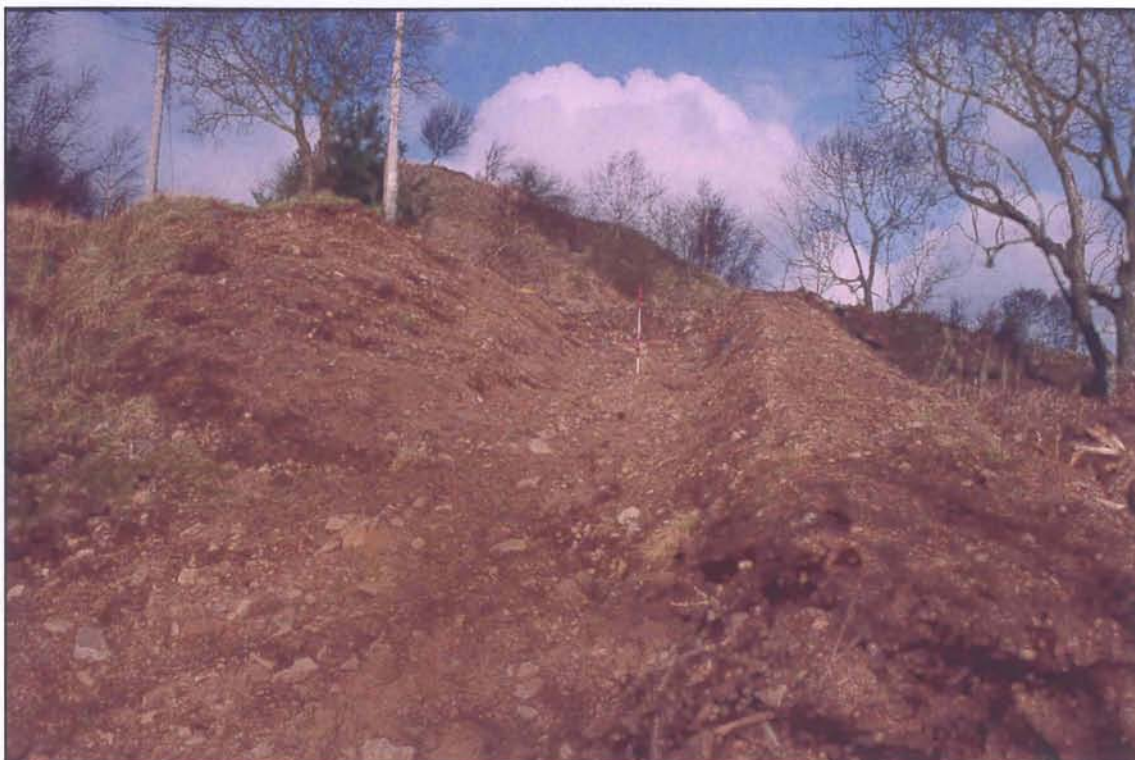
- 3.12 Area E (pl 13-14) was located towards the western edge of a natural terrace. The bund at this point had been constructed from imported material and was 5.8m wide at the base and 0.85m high above the former ground surface. To the west of the bund an area 6.5m wide had been mechanically stripped, the western edge cutting into a mound of quarry spoil at the base of which the turf had been scraped but not disturbed, suggesting that no significant ground disturbance had occurred at this point.

Plate 13 Area E from west. Photo CPAT cs02/04/23

Plate 14 Area E from south. Photo CPAT cs02/04/34
