# **Nantclwyd House gardens, Ruthin, Denbighshire**

**ARCHAEOLOGICAL SURVEY**

**CPAT Report No 567**

**By N W Jones**  
August 2003

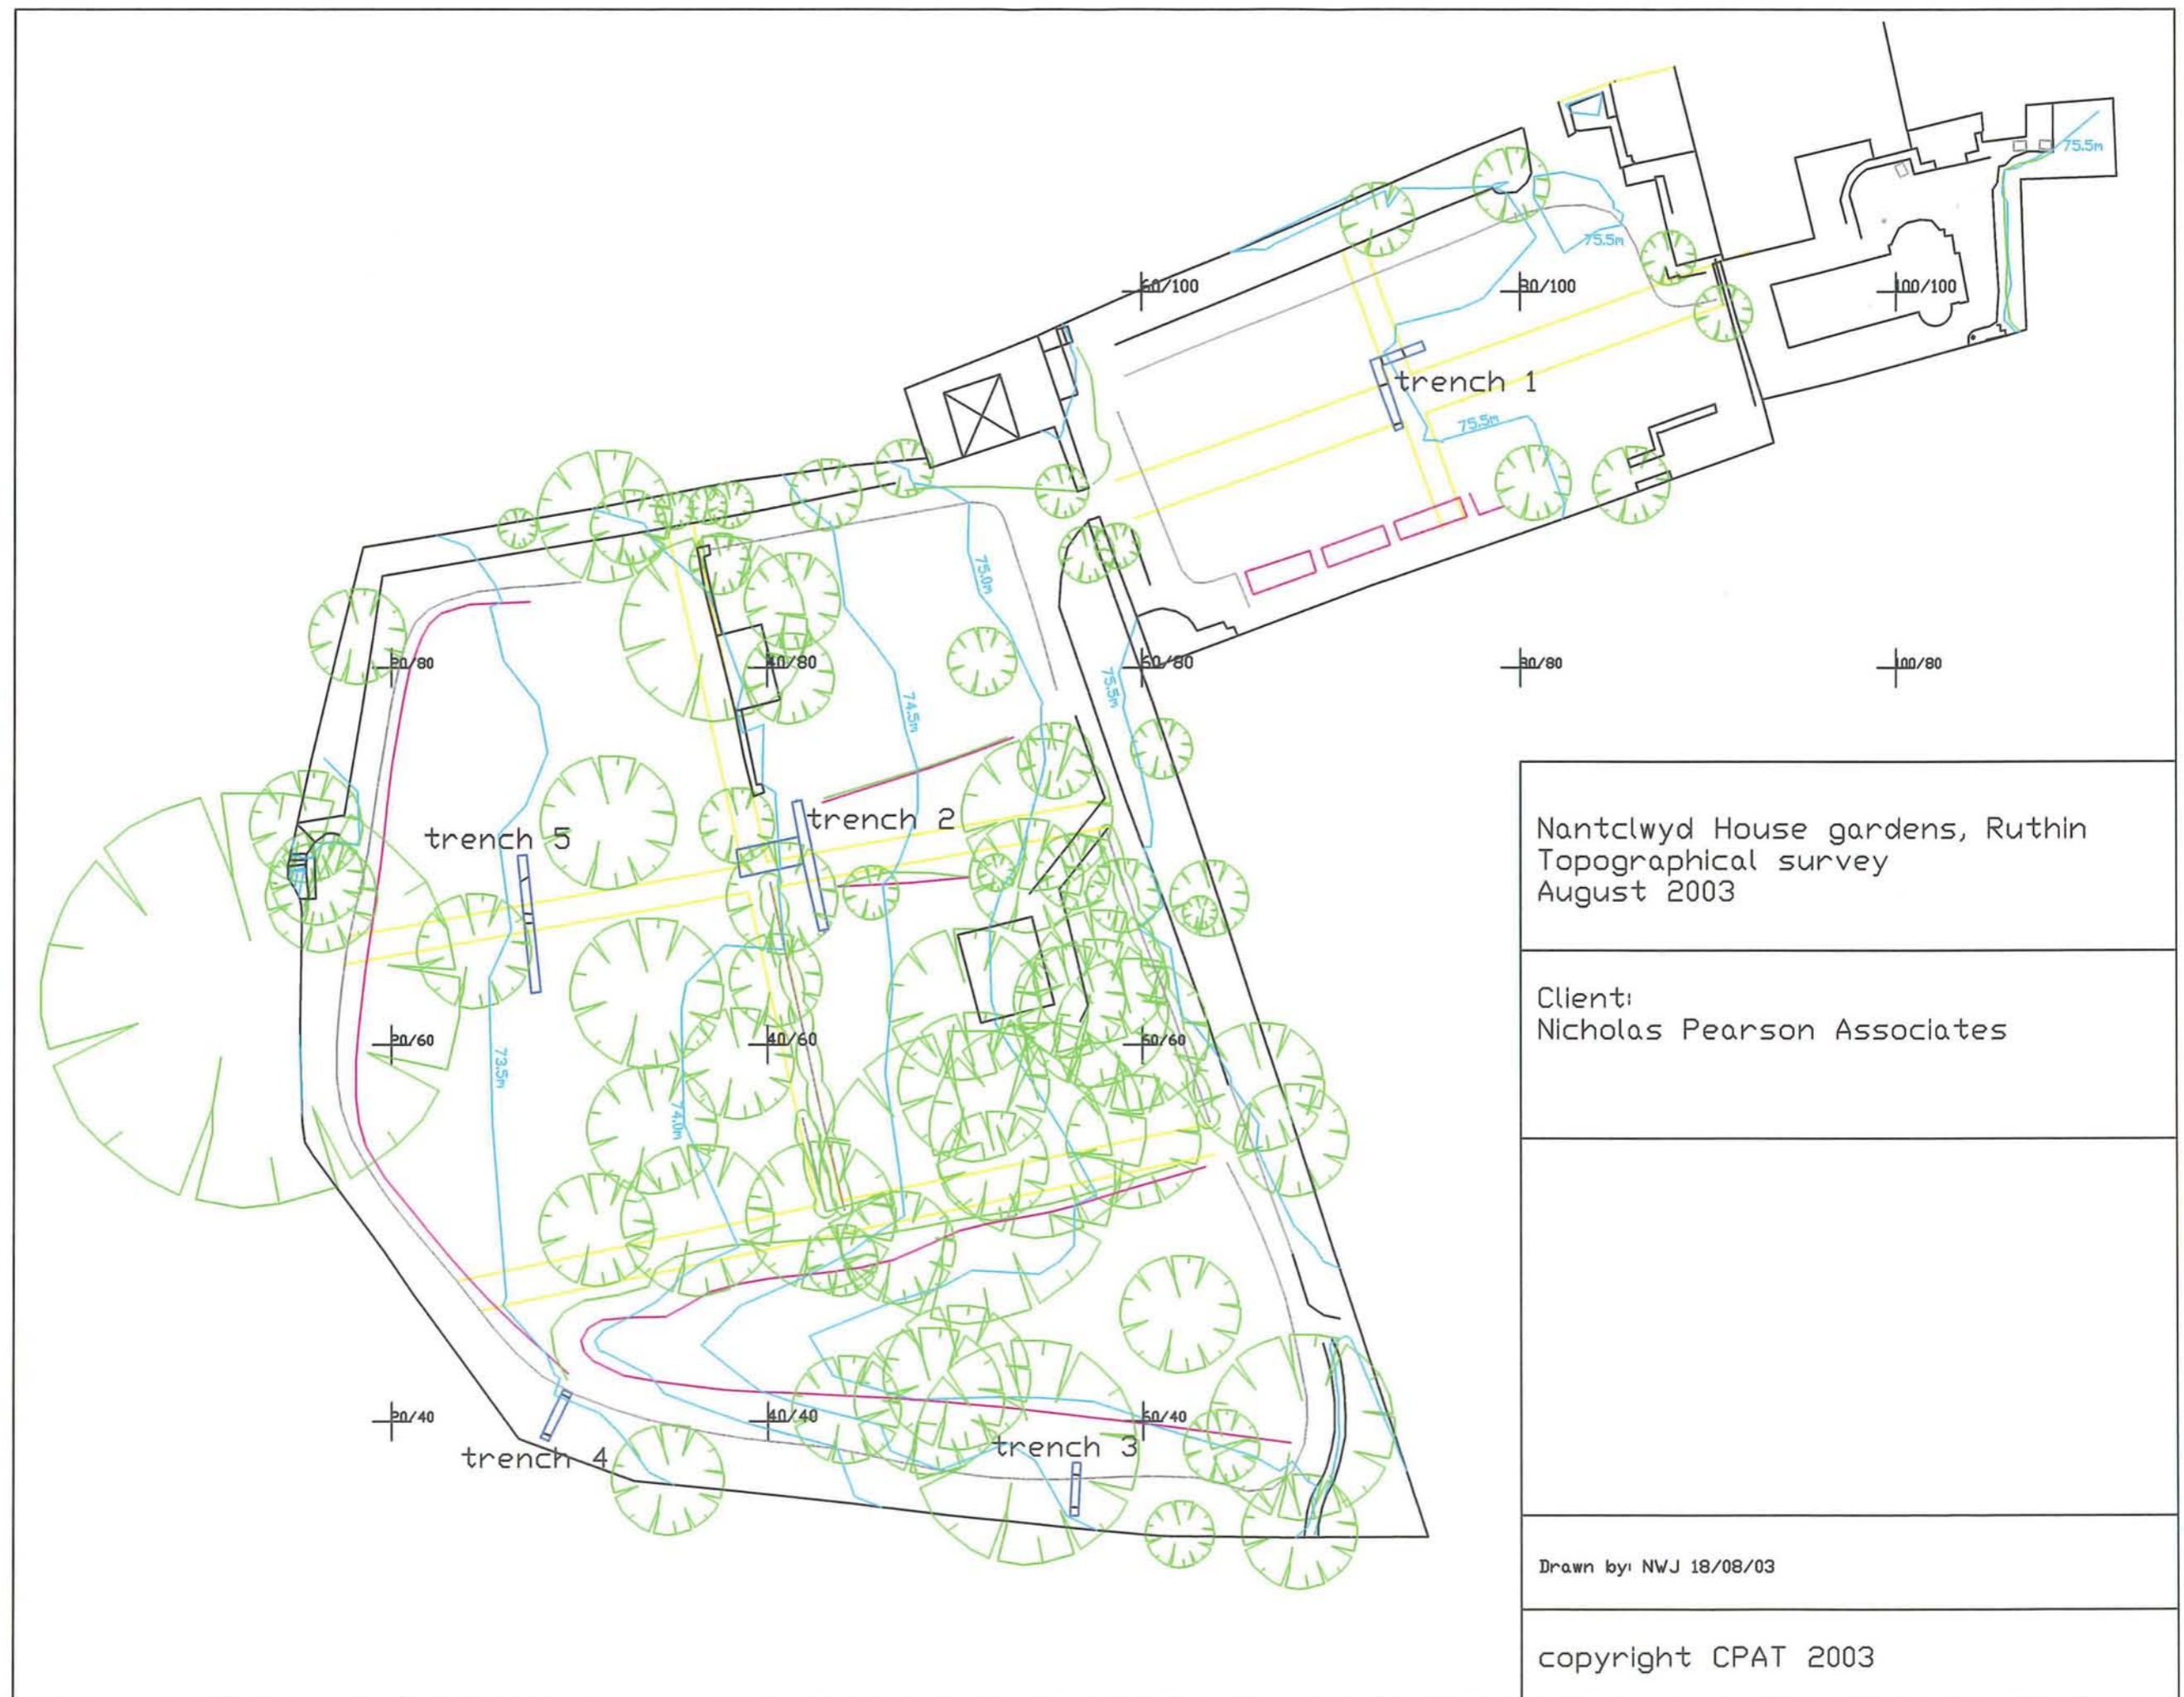
#### **4 TOPOGRAPHICAL SURVEY (fig. 1)**

- 4.1 A Total Station survey was conducted of the whole area of the gardens using a Wild TC500 EDM in conjunction with Penmap survey software. The survey included paths, boundary walls, all identifiable garden features, the top and bottom of all breaks of slope, trees, and sufficient levels to produce a detailed Digital Terrain Model (DTM). Levels were related to Ordnance Datum.

- 4.2 Post-survey processing employed AutoCADR13 to produce the illustration in this report. A copy of the digital data has been supplied with the report and details of the data content is provided in the Site Archive, Appendix 1.

### **Courtyard**

- 4.3 The courtyard area is largely occupied by an infilled swimming pool surrounded by a paved area. An area immediately adjacent to the foundations for the south parlour was excavated in the 1980s and remains at a level lower than the rest of the courtyard. Two dwarf walls to the east of the passage entrance formerly supported the first-floor balcony, now removed. The only other structural element is the remains of a low curving wall to the west of the passage.

- 4.4 The inner garden is largely occupied by a lawned area, formerly a tennis court, with an overgrown herbaceous border along the northern boundary wall. In the south-east corner is a slightly raised masonry structure with paved capping, surrounding the stump of a lime tree, while the sunken outline of more recent flower beds are visible along the southern side. A path leads from the courtyard in front of the herbaceous border towards the gazebo and then to the gateway into the outer garden and on to the south-west corner where there are the remains of a raised, curving platform, originally approached by a flight of steps which have now largely been lost. The area between the gateway to the outer garden and the gazebo is occupied by a spread of stone rubble. Immature hazel and sycamore trees have established themselves in the east end of the garden, while a yew tree stands on the south side of the gateway to the outer garden.

- 4.5 The outer garden, which slopes gently to the west, is largely overgrown with a significant number of immature trees, largely hazel and sycamore, populating the area, particularly around the boundary.

- 4.6 The present structure of the garden is largely 20th-century in origin, with a perimeter path broadly following the 18th-century design. The eastern and northern boundaries are edged by garden borders, with concrete edging to the adjacent paths. Both borders contain a number of apple and pear trees. The raised stone base for a 20th-century summerhouse survives at the northern end of the garden, with projecting walls to the north and south, forming the eastern edge of a former central path. The line of this path continues to the south where the box edging still survives in part. Towards the eastern side are the collapsed remains of a greenhouse with an access path from the east.

- 4.7 The southern end of the garden is occupied by a substantial, irregular mound, around 35m east-west by up to 14m north-south and up to 1.2m high. It seems that at one point the mound was at least partly revetted in stone and a rubble spread just south of the entrance from the inner garden may have derived from this source. As discussed above, the mound may be partly composed of 20th-century spoil but is likely to be at least 18th-century in origin and the western part could have been a garden viewing platform.

- 4.8 The perimeter path along the western wall is at a lower level than the rest of the garden, probably due to landscaping in the 1980s. A gateway in the western wall survives with a flight of steps leading down to it. In the south-eastern corner is a raised area retained by a curving stone wall with two steps leading up at the northern end. A gravestone is clearly visible, marking the area of a pet cemetery.

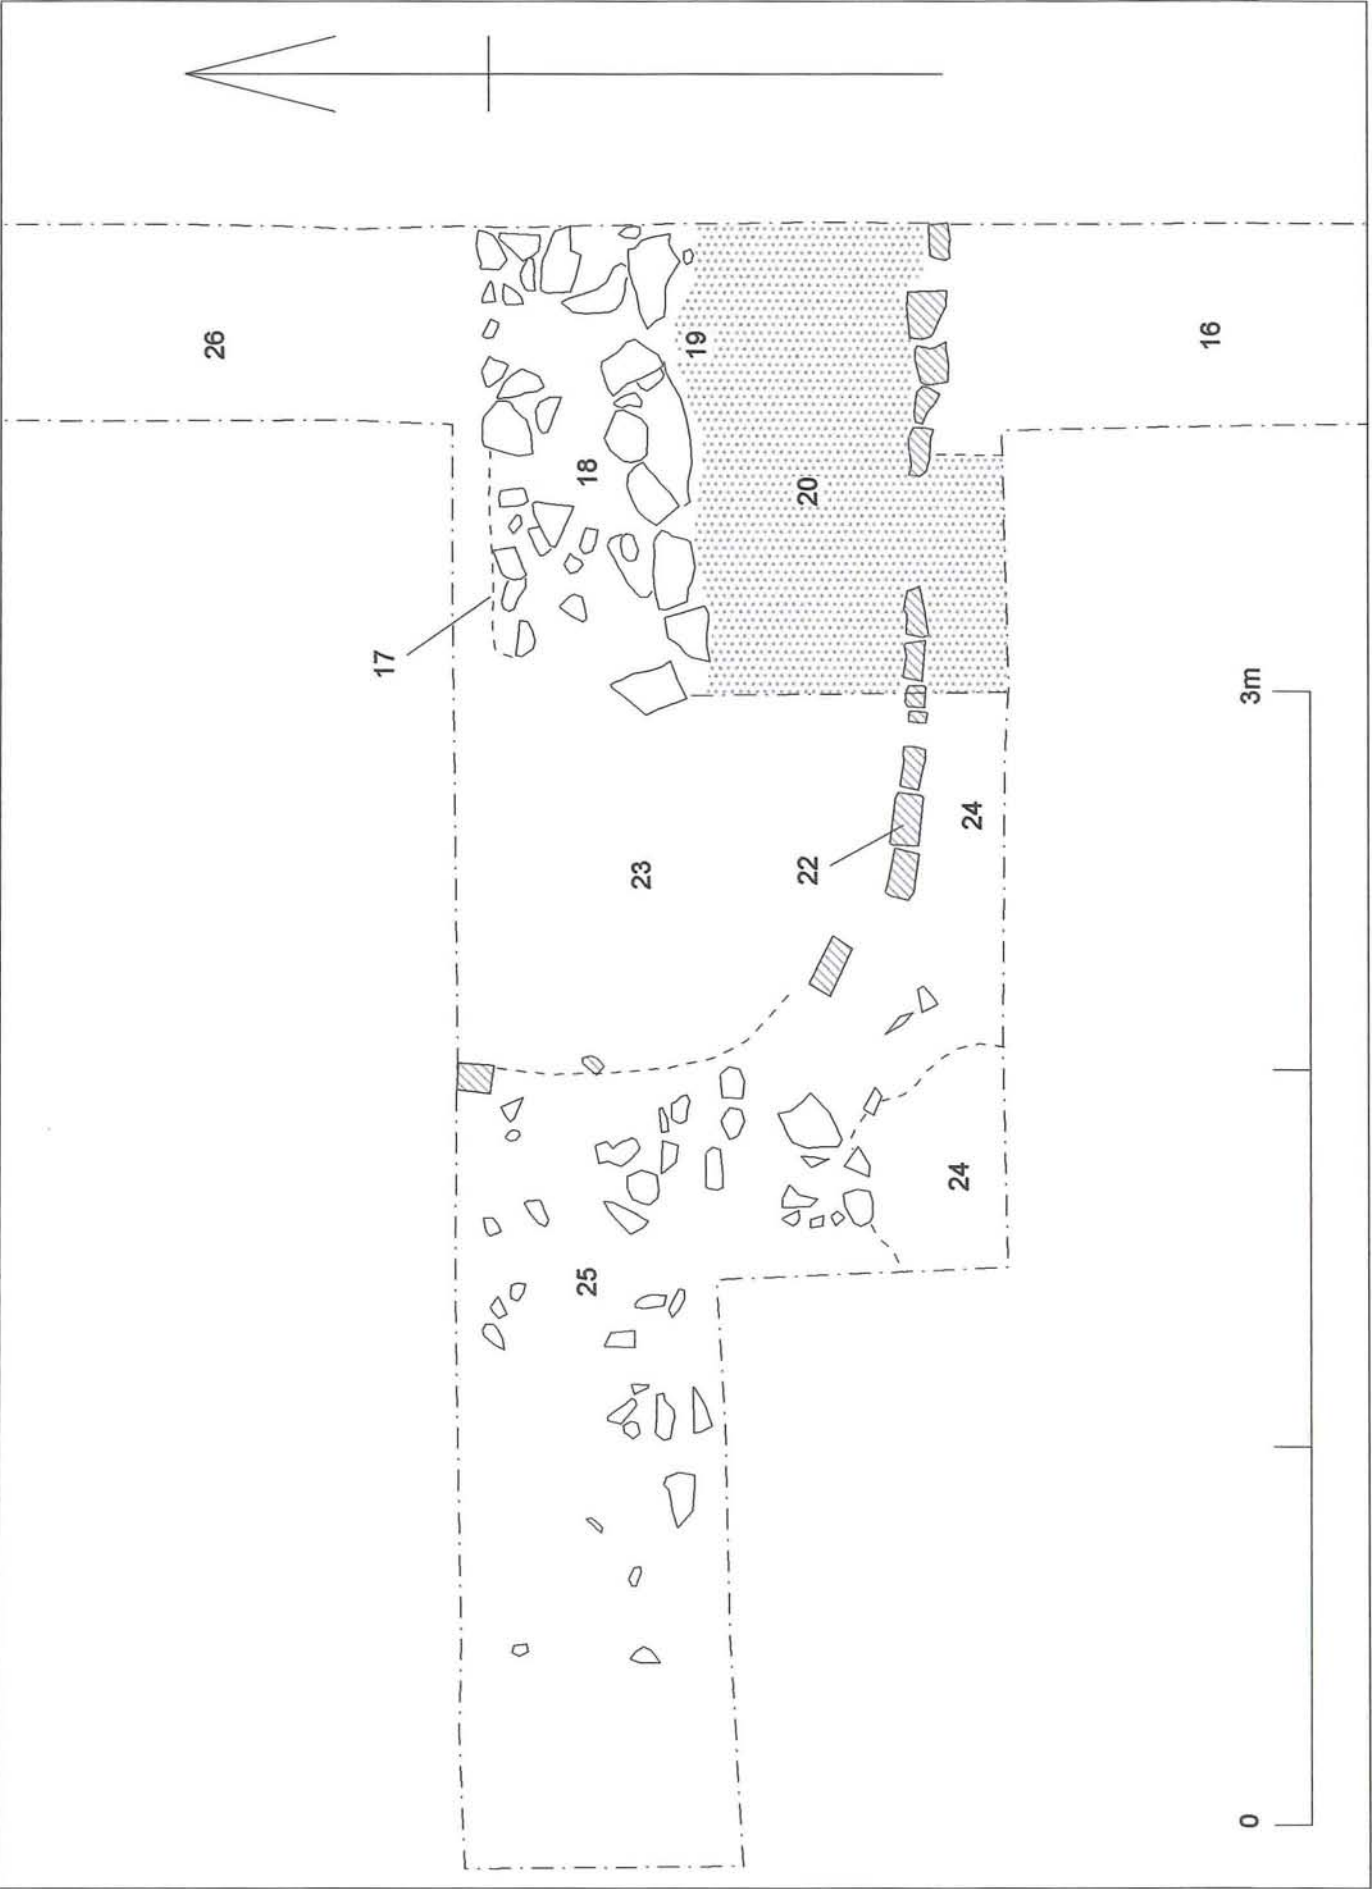
Fig. 2 Trench 2, scale 1:20

- 5.5 The topsoil (16) was removed to reveal a series of path surfaces and edging of different periods. The earliest feature consisted of a line of small edge-set, hand-made bricks (22), running east-west and forming the northern edge of a garden path. Although discontinuous, the edging appeared to curve to the north, indicating the junction between an east-east path and a north-south path. The path itself was composed of compacted soil, ash and cinders (24) which merged with another path surface (25) comprising compacted soil, small stone, ash and shell fragments. It was not possible within the trench to determine the western edge of the north-south path due to root disturbance.

- 5.6 The brick-edged paths had been replaced by a surface of small limestone chippings (20) which overlay the earlier path and the brick edging. Possibly contemporary with this surface was a collapsed dwarf wall (19), aligned east-west and composed of angular limestone with a cement capping. The wall had collapsed to the south and appeared to have been constructed on a stone foundation (18) set within what may have been a foundation trench (17). The later path surface (20) was itself overlain by a line of loose stones (21), including a fragment from a malting kiln floor tile, which was aligned north-south, continuing the line of the adjacent box edging which formed the eastern side of the north-south path.

**Trench 2 (fig. 2; plates 3-4)**

- 5.4 An L-shaped trench, measuring 6.9 x 0.5m north-south and 3.5 x 1.5m east-west, was excavated in the centre of the outer garden, with the intention of identifying two paths known to have bisected the garden.

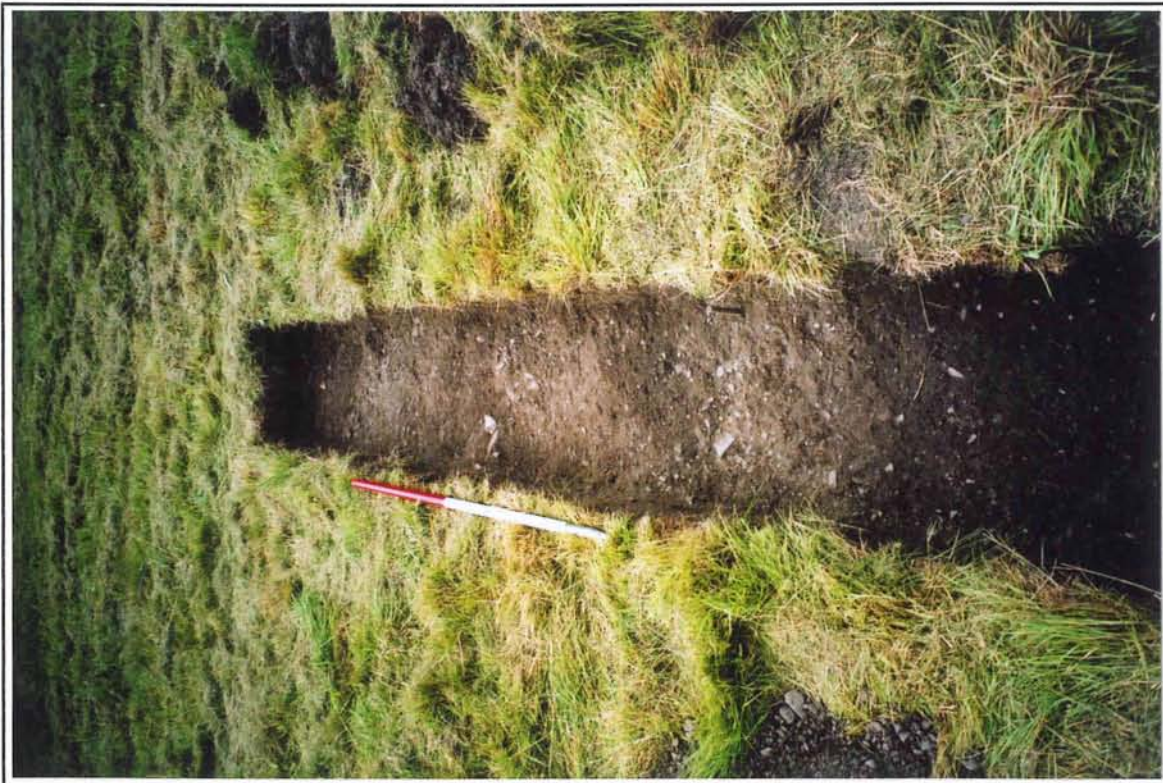
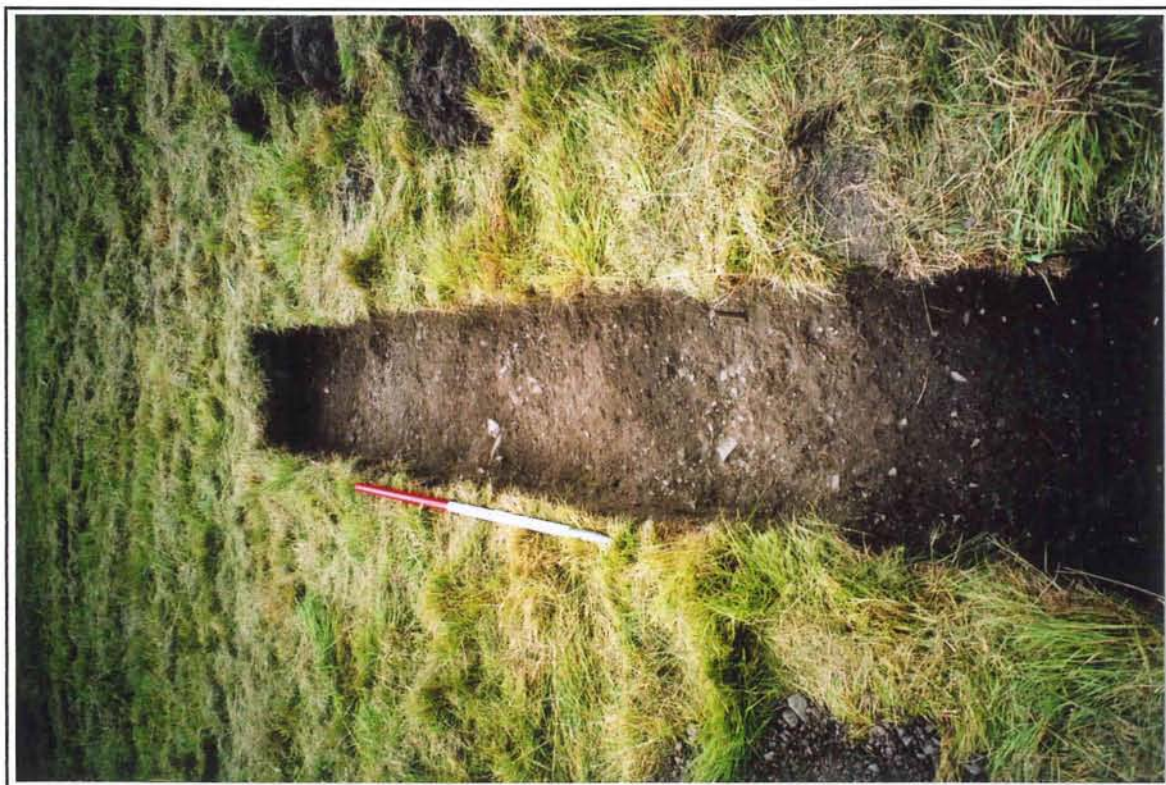
Plate 1 Trench 1 from the north showing east-west path. Photo CPAT 1479.2

- 5.2 An L-shaped trench, measuring 4.0 x 2.9m and 0.5m wide, was excavated in the centre of the inner garden, to the rear of the house, with the intention of identifying two paths known to have bisected the garden.
- 5.3 The topsoil (1) was removed to reveal two areas of compacted gravel, one in each arm of the trench, representing the remains of the paths aligned north-south and east-west. The east-west path (2) was up to 2.1m wide and had a slight camber, being 0.1m below the ground surface in the centre and around 0.18m deep on either side. The north-south path (3) was up to 1.4m wide and also had a slight camber, being 0.1m below the ground surface in the centre and around 0.15m deep on either side. A slight scarp is visible on the surface either side of the trench, which coincides with the eastern side of the path.

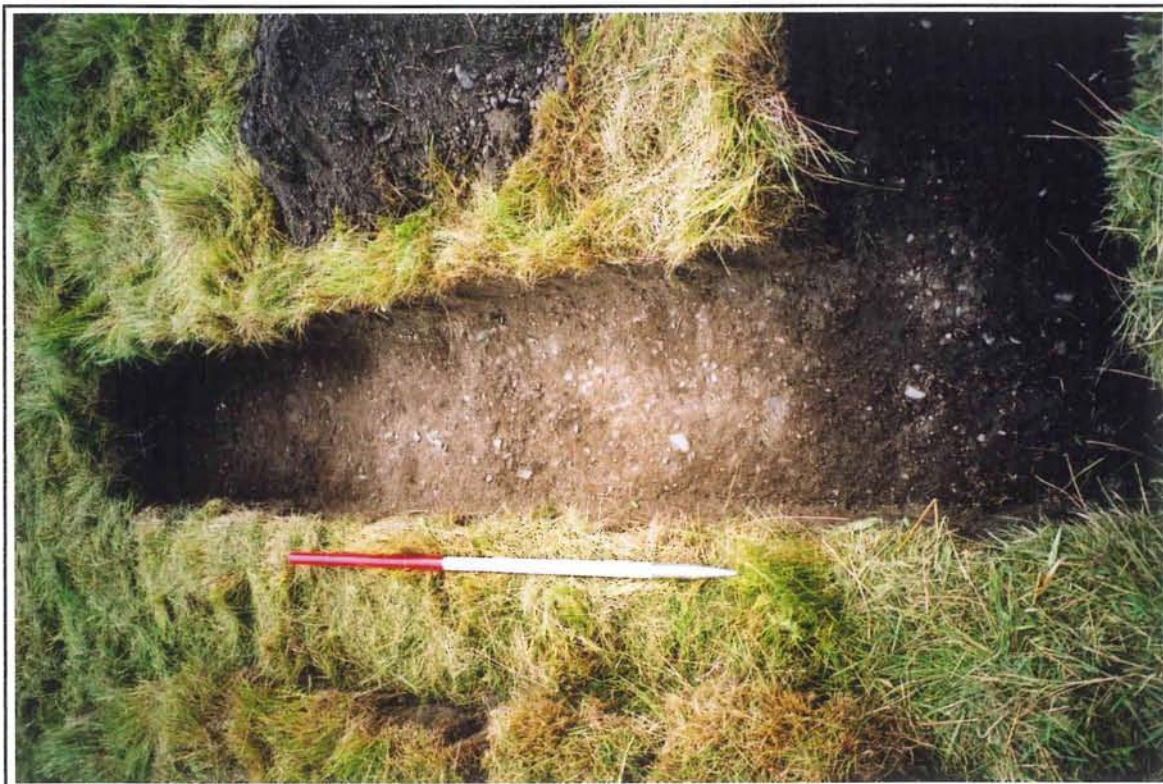
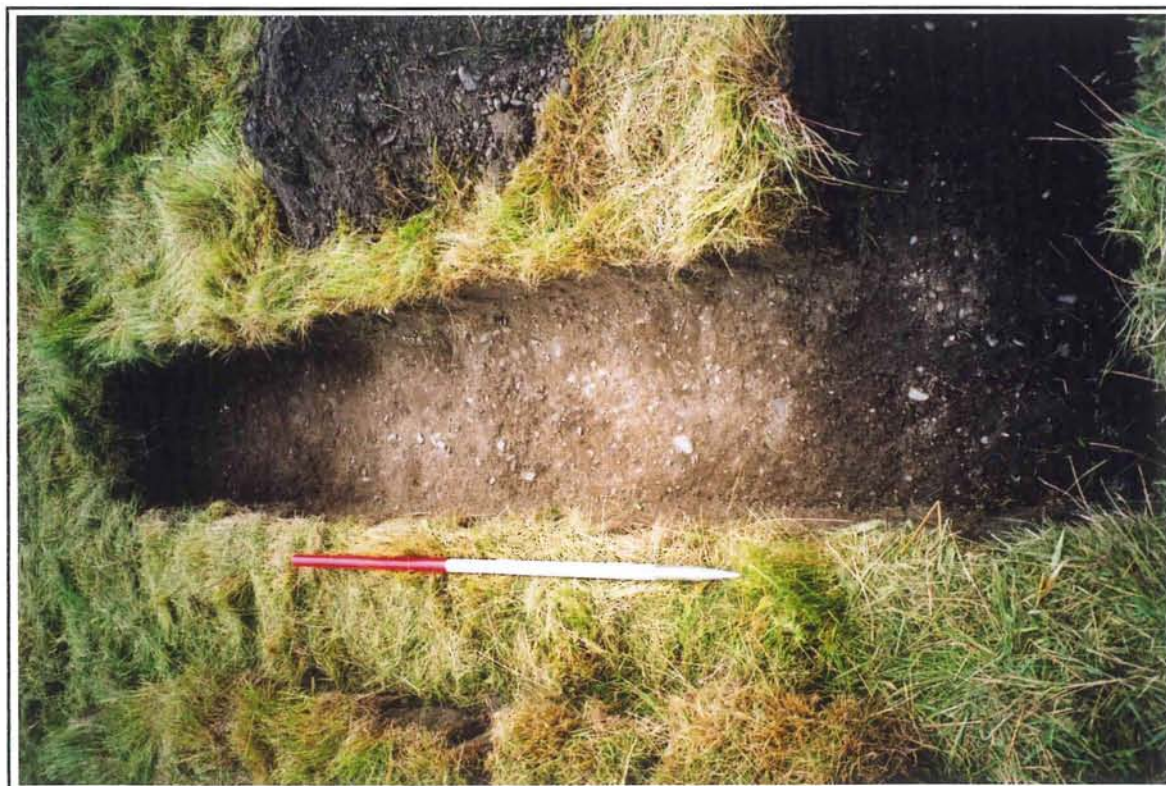
Plate 2 Trench 1 from the west showing north-south path. Photo CPAT 1479.1

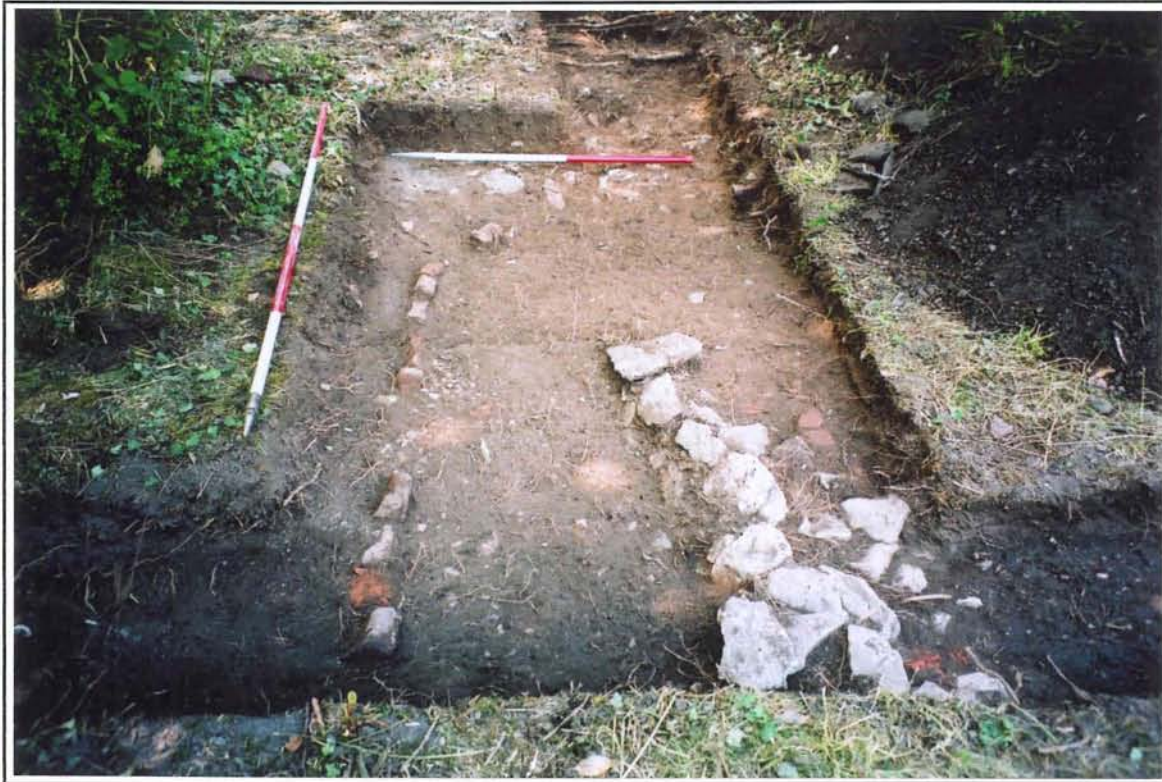
Plate 3 Trench 2 from the east showing brick edging (22) and collapsed wall (19). Photo CPAT 1479.18

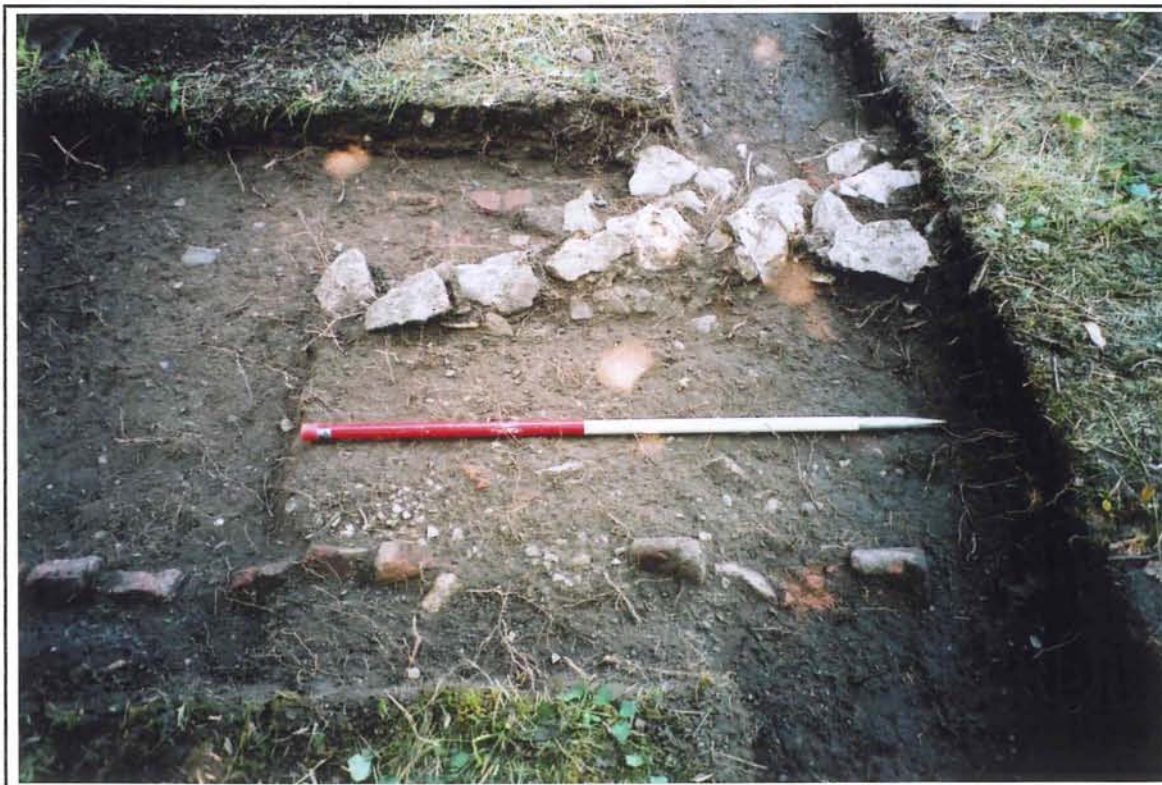
Plate 4 Trench 2 from the south showing brick edging (22) and collapsed wall (19). Photo CPAT 1479.20

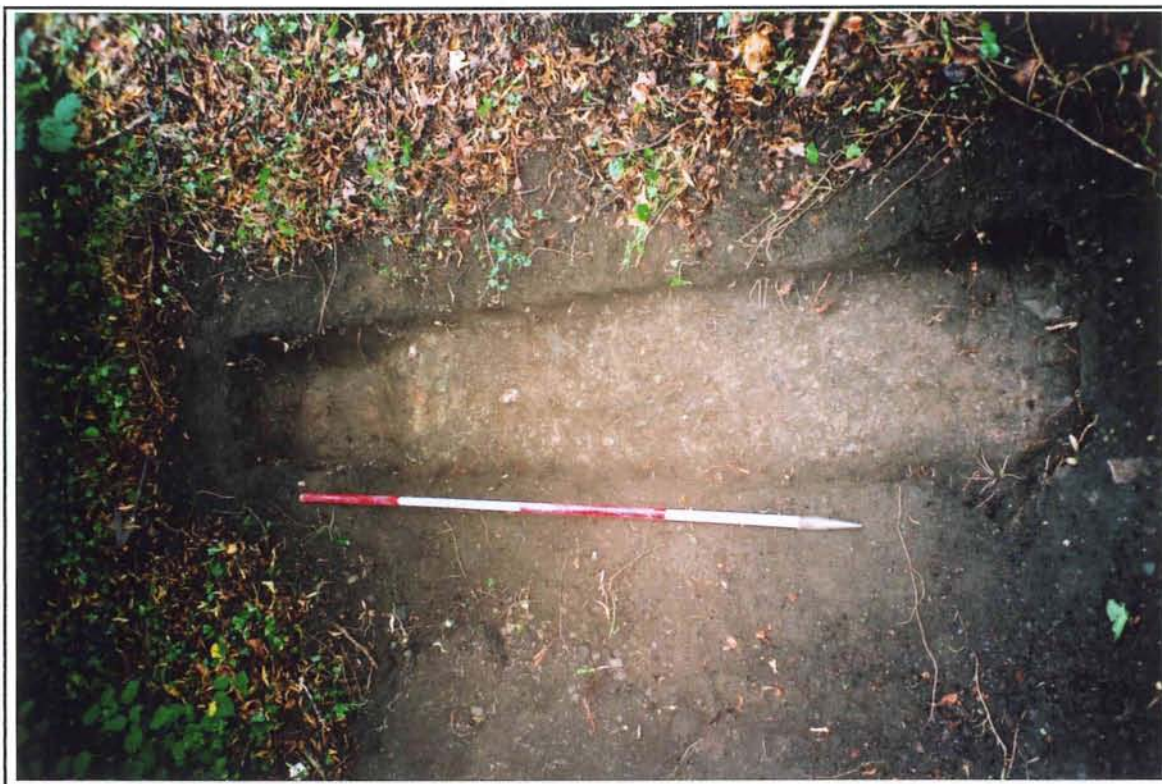
Plate 5 Trench 3 from the south showing perimeter path. Photo CPAT 1479.5

- 5.7 A small trench, measuring 2.8 x 0.5m wide, was excavated close to the boundary wall on the south side of the outer garden, with the intention of identifying the perimeter path.
- 5.8 The topsoil (5) was removed to reveal a well-preserved area of compacted gravel, representing the remains of the perimeter path. The path (6) was up to 1.75m wide and had a slight camber, being 0.08m below the ground surface in the centre and around 0.2m deep on either side. The southern edge of the path was around 1.1m inside the boundary wall.

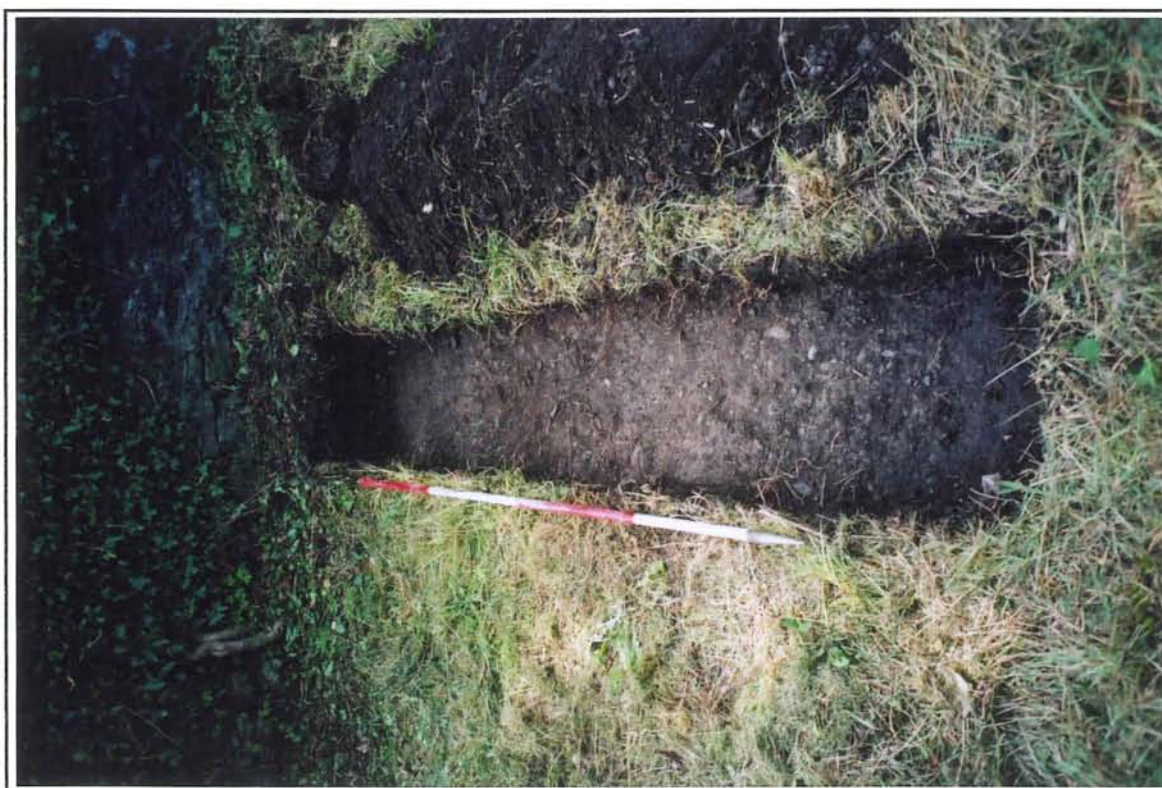
Plate 6 Trench 4 from the north-east showing perimeter path. Photo CPAT 1479.12

- 5.9 A small trench, measuring 2.8 x 0.5m wide, was excavated close to the boundary wall near the south-west corner of the outer garden, with the intention of identifying the perimeter path.
- 5.10 The topsoil (8) was removed to reveal a well-preserved area of compacted gravel, representing the remains of the perimeter path. The path (9) was up to 2.2m wide and had a slight camber, being 0.08m below the ground surface in the centre and around 0.2m deep on either side. The southern edge of the path was around 0.8m inside the boundary wall.
