Garth Brickworks, Trevor, Wrexham

ARCHAEOLOGICAL WATCHING BRIEF

CPAT Report No 680

N W Jones
December 2004

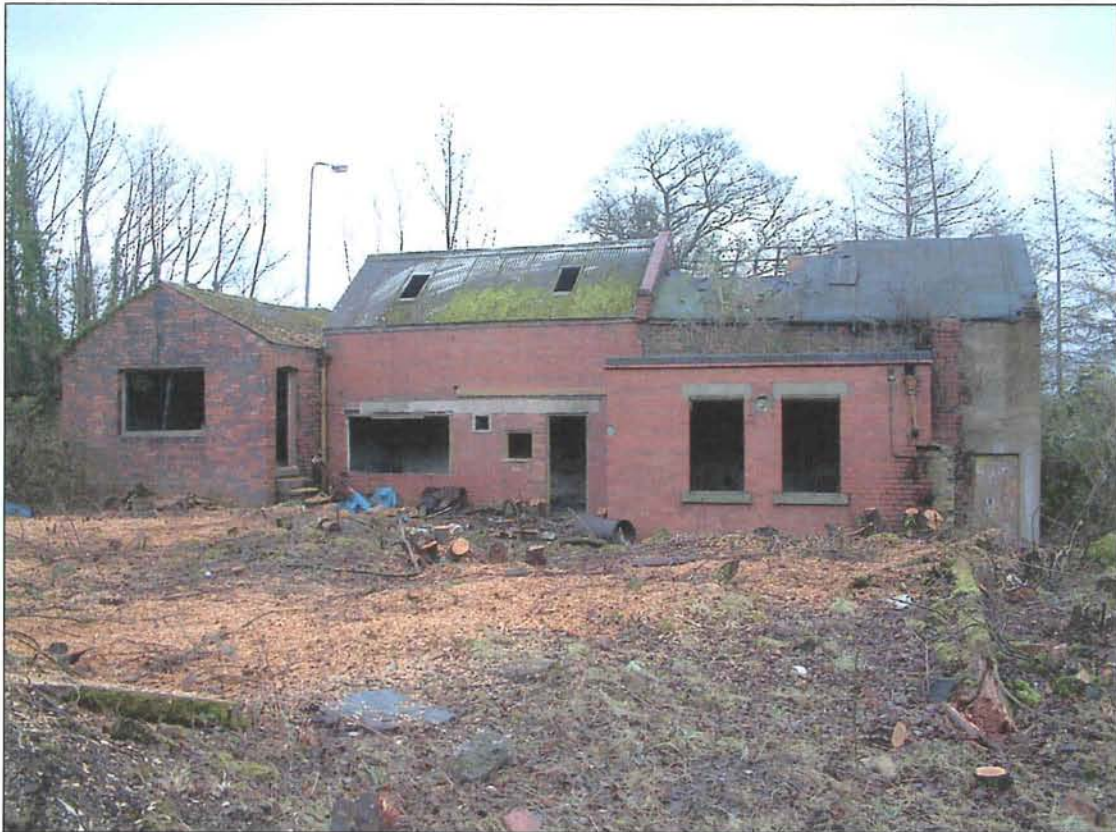
- 3.2 The brickworks office was located along the streetfrontage, to the east of the site entrance. There appear to be three main phases to the building, which is constructed in red brick with an asbestos roof. Originally appearing as two separate buildings, a central section was later constructed, possibly at the same time that an extension was added to the north-western end. The eastern part (6.6 x 5.0m) is single-storey with access via steps on the north-west corner and a side entrance on the south-east. There is a small concrete-roofed lean-to on the eastern side. The western part (7.2 x 4.5m) is two-storey, originally rectangular in plan and divided into two rooms, the western room having a door at the west end, which was later blocked, and a small fireplace and external chimney. An extension (5.0 x 2.8m), which removed the northern wall, has doors at the east and west ends. The central section (6.5 x 4.3m), like the extension, is in more modern red brick, and of two storeys with a simple, open rectangular plan.

Plate 1 Brickworks office buildings, structure 1. Photo CPAT 1819.02

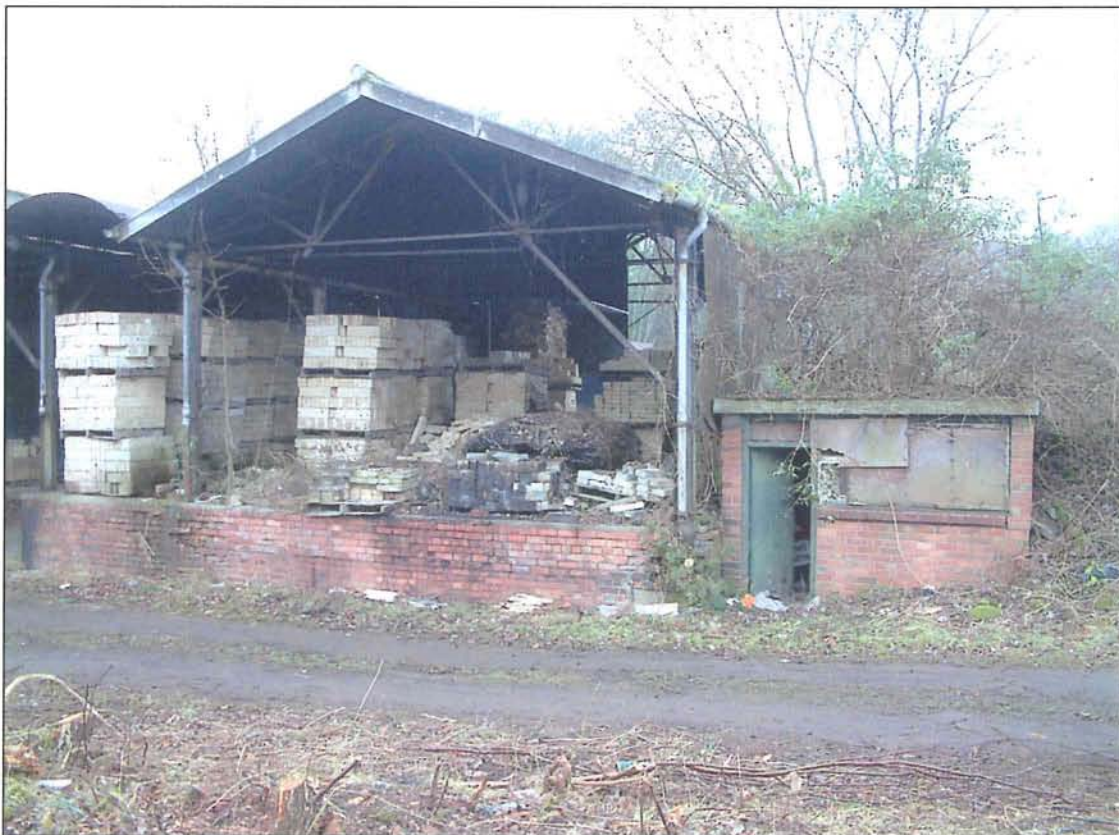
- 3.3 The Ordnance Survey map of 1912 (fig. 4) depicts a weighbridge along the brickworks railway, close to the entrance. A small red-brick building (3.5 x 2.6m) with a flat concrete roof survives at the northern end of a range of sheds and is likely to be associated with the weighbridge. A short section of the railway is visible close by.

- 3.4 A range of open-sided sheds of steel girder and corrugate construction lie to the west of the entrance, still containing stacks of bricks on wooden palettes. The western shed has a low stone and brick retaining wall along its rear, southern side, and an area of concrete hard-standing to the north which, through comparison with the Ordnance Survey map of 1963 (fig. 5), appears to indicate a further covered area.

Plate 2 Structures 2 and 3. Photo CPAT 1819.06

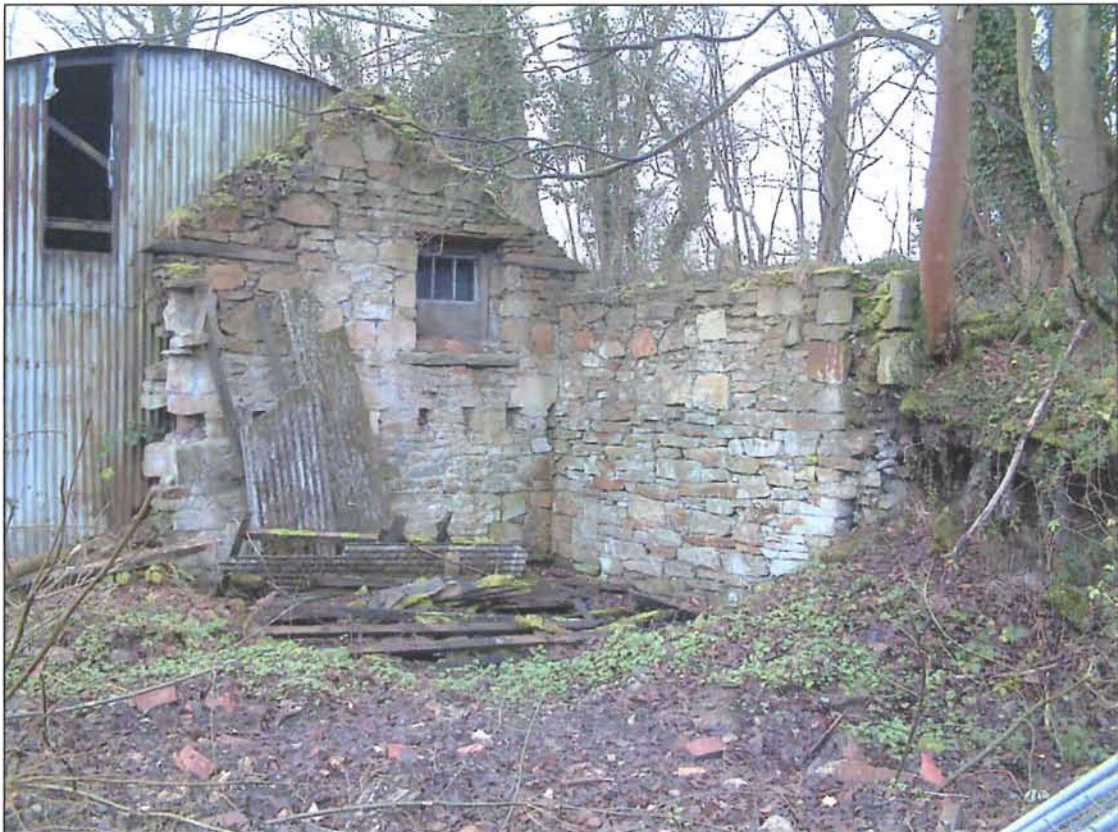
- 3.6 To the west of the sheds are the remains of a two-storey building of random stone construction, only the eastern gable (4.8m wide) and part of the southern wall of which survive. The building is depicted on the Ordnance Survey map of 1912 (fig. 4).

Plate 3 structure 5. Photo CPAT 1819.11

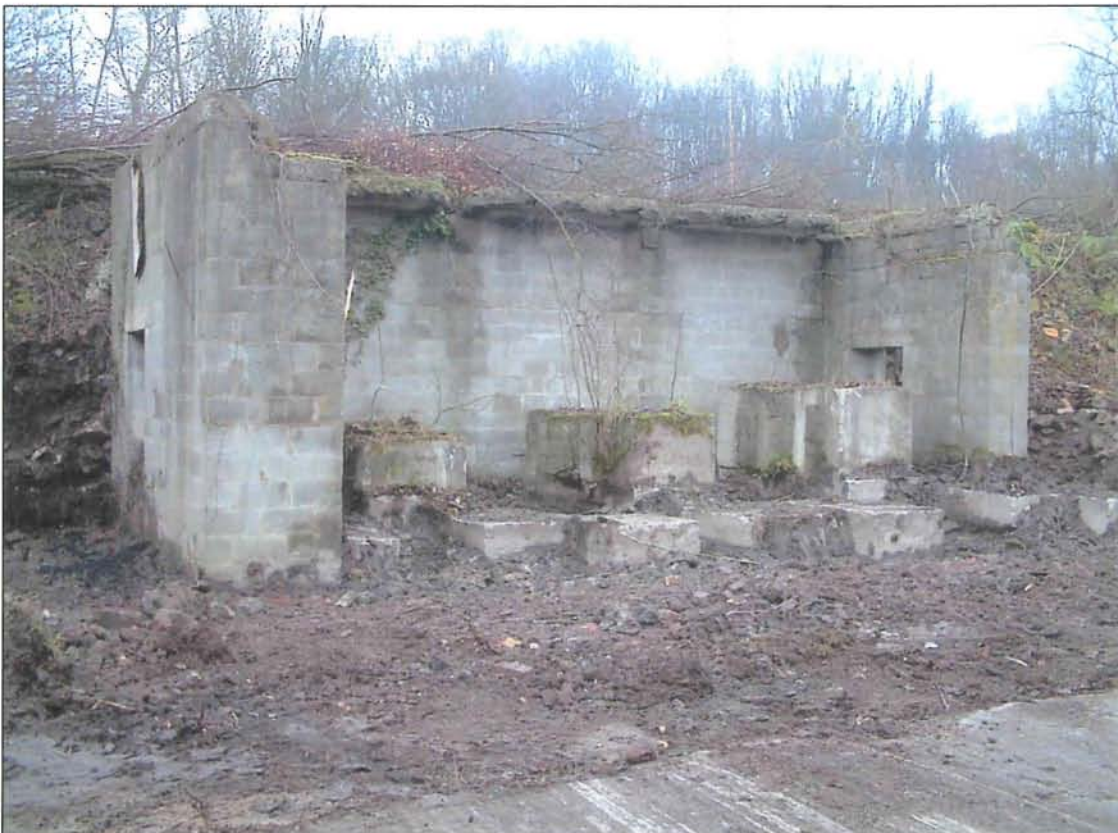
- 3.9 The shell of an open-fronted structure of block and concrete construction (10.8 x 5.6m) lies on the south-eastern side of an embankment. Concrete bases within the structure would have held crushing machinery, stone being loaded into the top from the embankment. The structure post-dates the Ordnance Survey map of 1963 (fig. 5).

Plate 4 Stone crusher, structure 8. Photo CPAT 1819.15

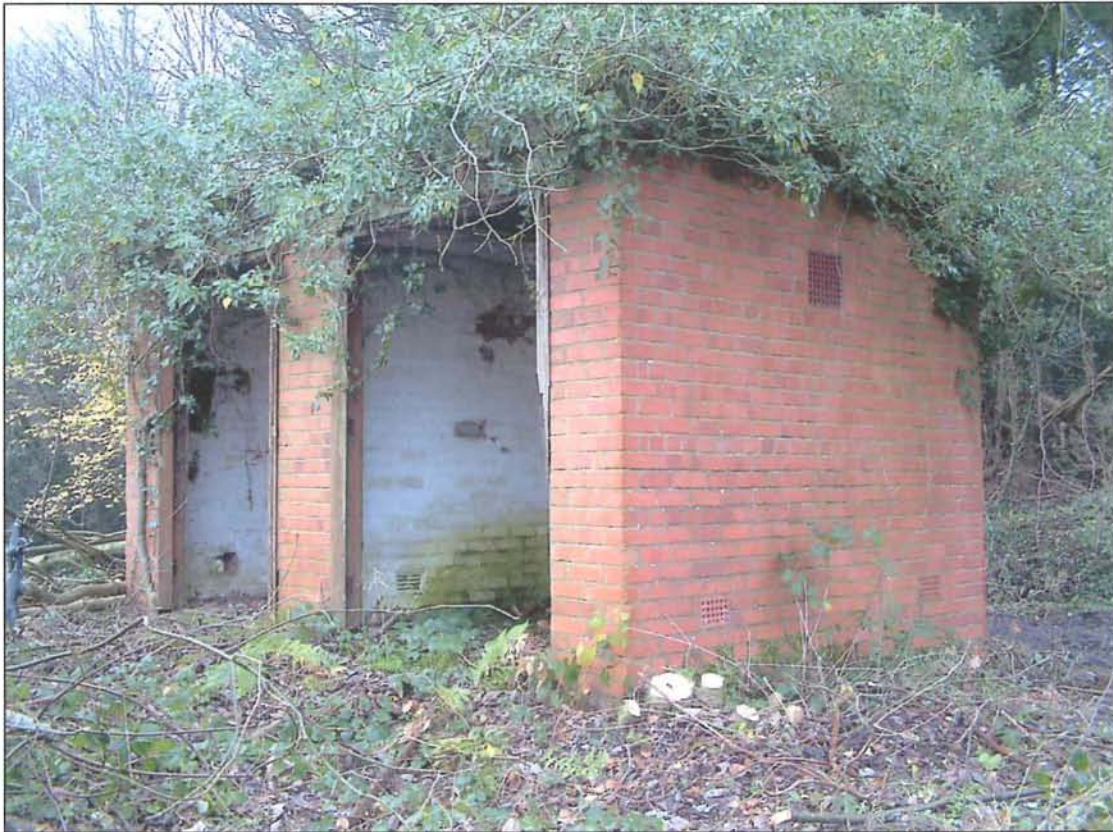
- 3.11 Towards the north-western side of the area is a small red-brick structure (5.2 x 3.3m) with a flat concrete roof, internal central division and double-doored front. The concrete floor has several exposed ducts.

Plate 5 Structure 10. Photo CPAT 1819.17

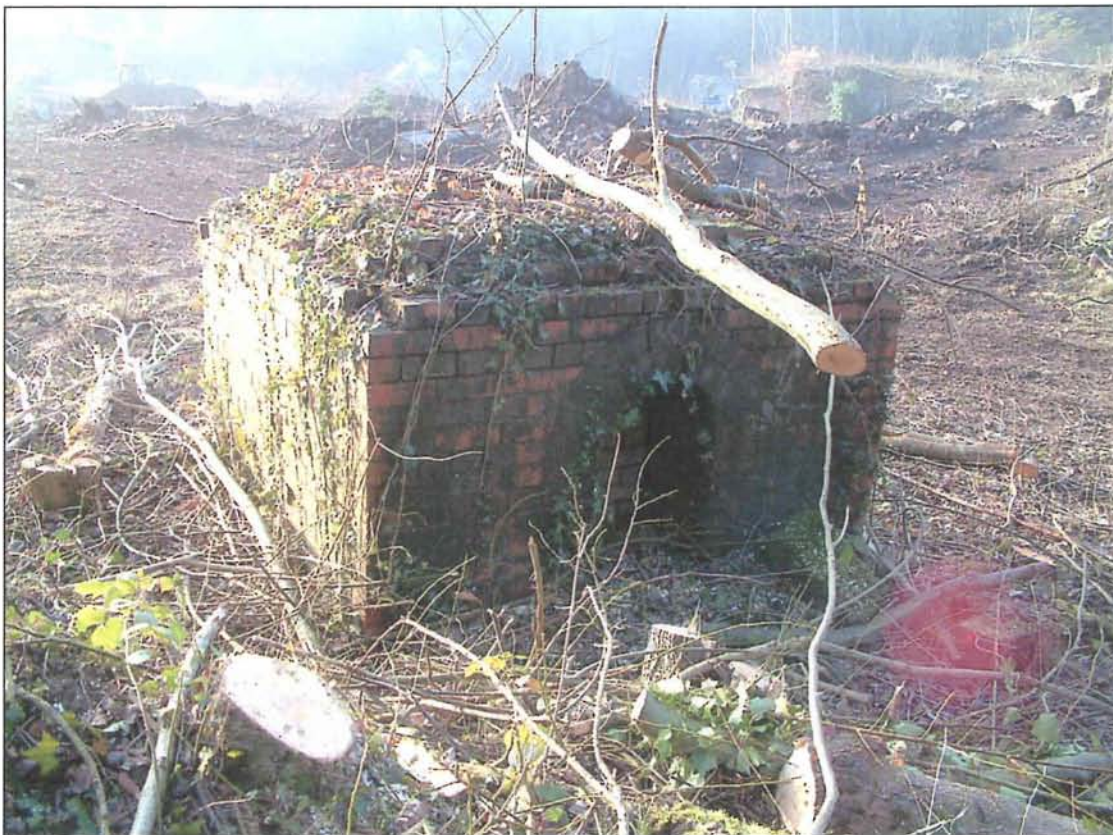
- 3.16 To the west of structure 14 is the base of a red-brick chimney, 2.2m square and 1.4m high, with an arched flue on the northern side.

Plate 6 Chimney base, structure 15. Photo CPAT 1819.33

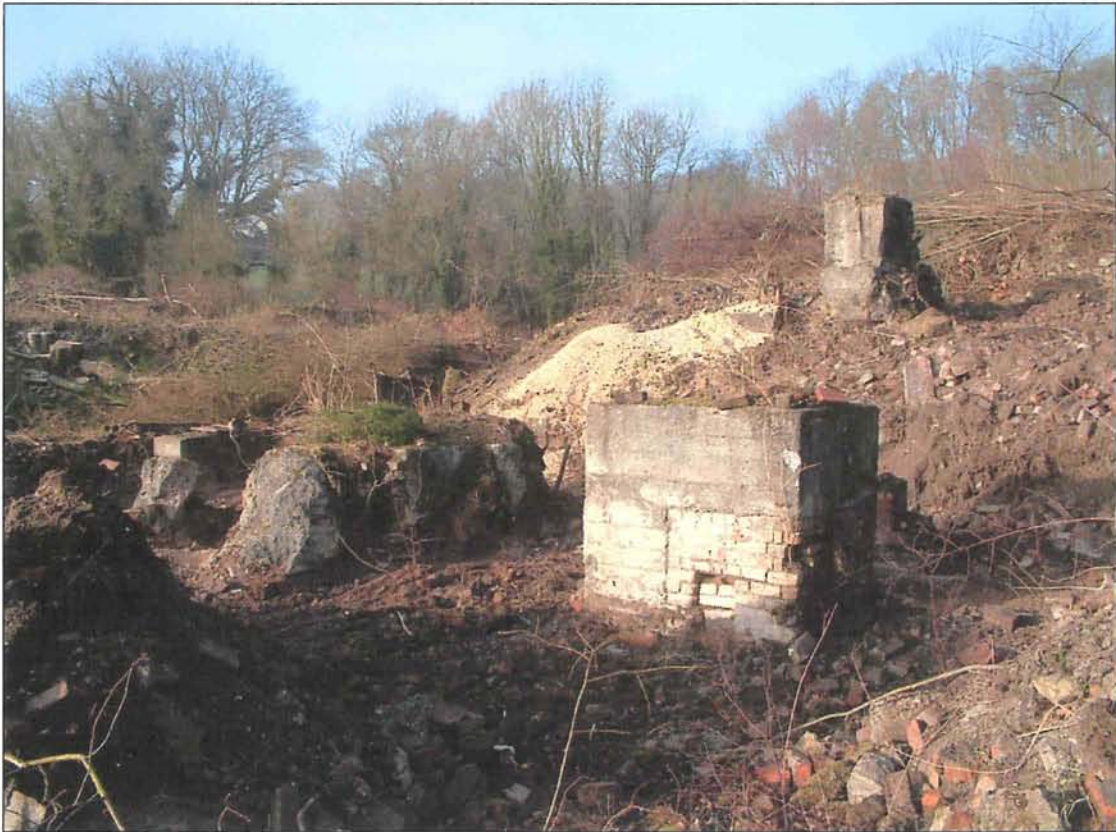
- 3.17 During its later years the main brickworks complex comprised an extensive range of buildings to either side of a railway siding which appears to have run right through the works. The eastern part included the access to the drift mine (fig. 5), and had previously included the terminus for the aerial ropeway (fig. 4). The northern end of the building survives in part, although largely buried beneath a large mound of demolition rubble. The visible remains include three large concrete bases, the most northerly of which is considerably higher than the rest of the complex and may be associated with the aerial ropeway.

Plate 7 Brickworks complex east, structure 16. Photo CPAT 1819.35

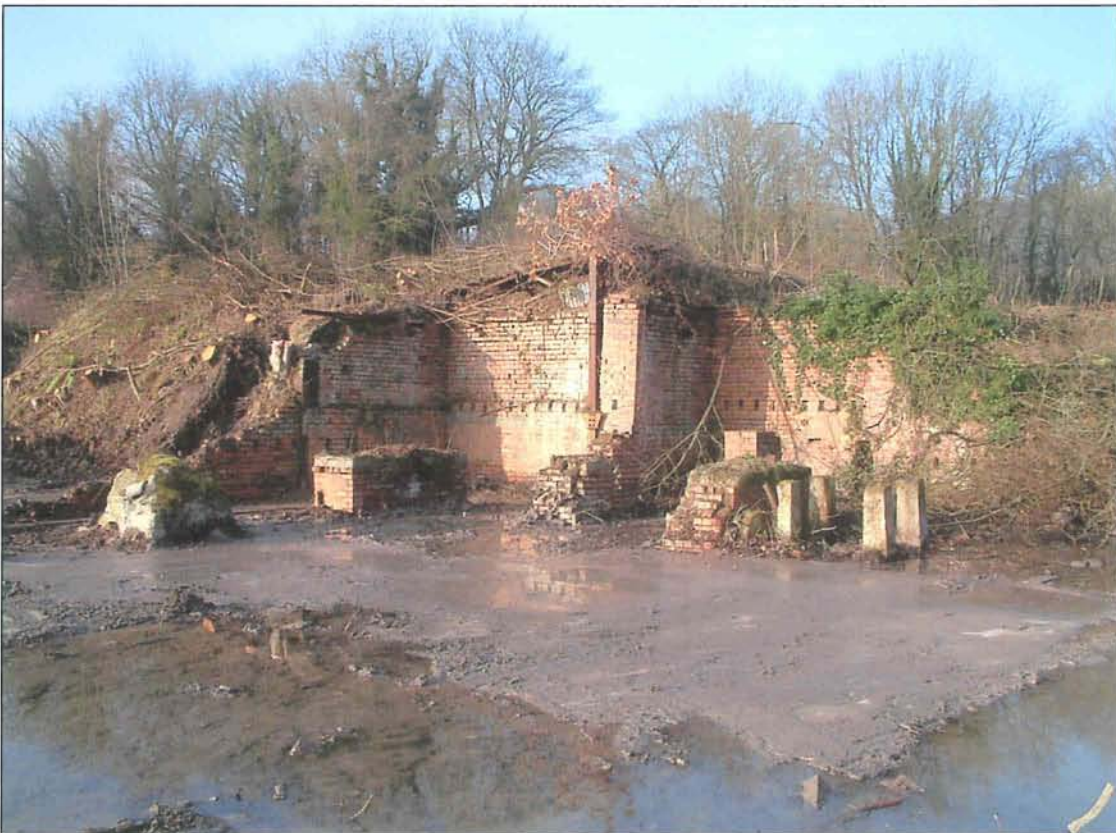
- 3.18 The western part of the main complex is rather better preserved, with red-brick walling standing to over 3m in height. A number of machine bases survive, including an unusual octagonal concrete base to the west of the main building. Along the eastern side of the building is a substantial concrete base beside which the railway siding was formerly located.

Plate 8 Brickworks complex west, structure 17. Photo CPAT 1819.38
