Ystum Colwyn Farm, Meifod, Powys

BUILDING SURVEY

CPAT Report No 646

N W Jones
July 2004

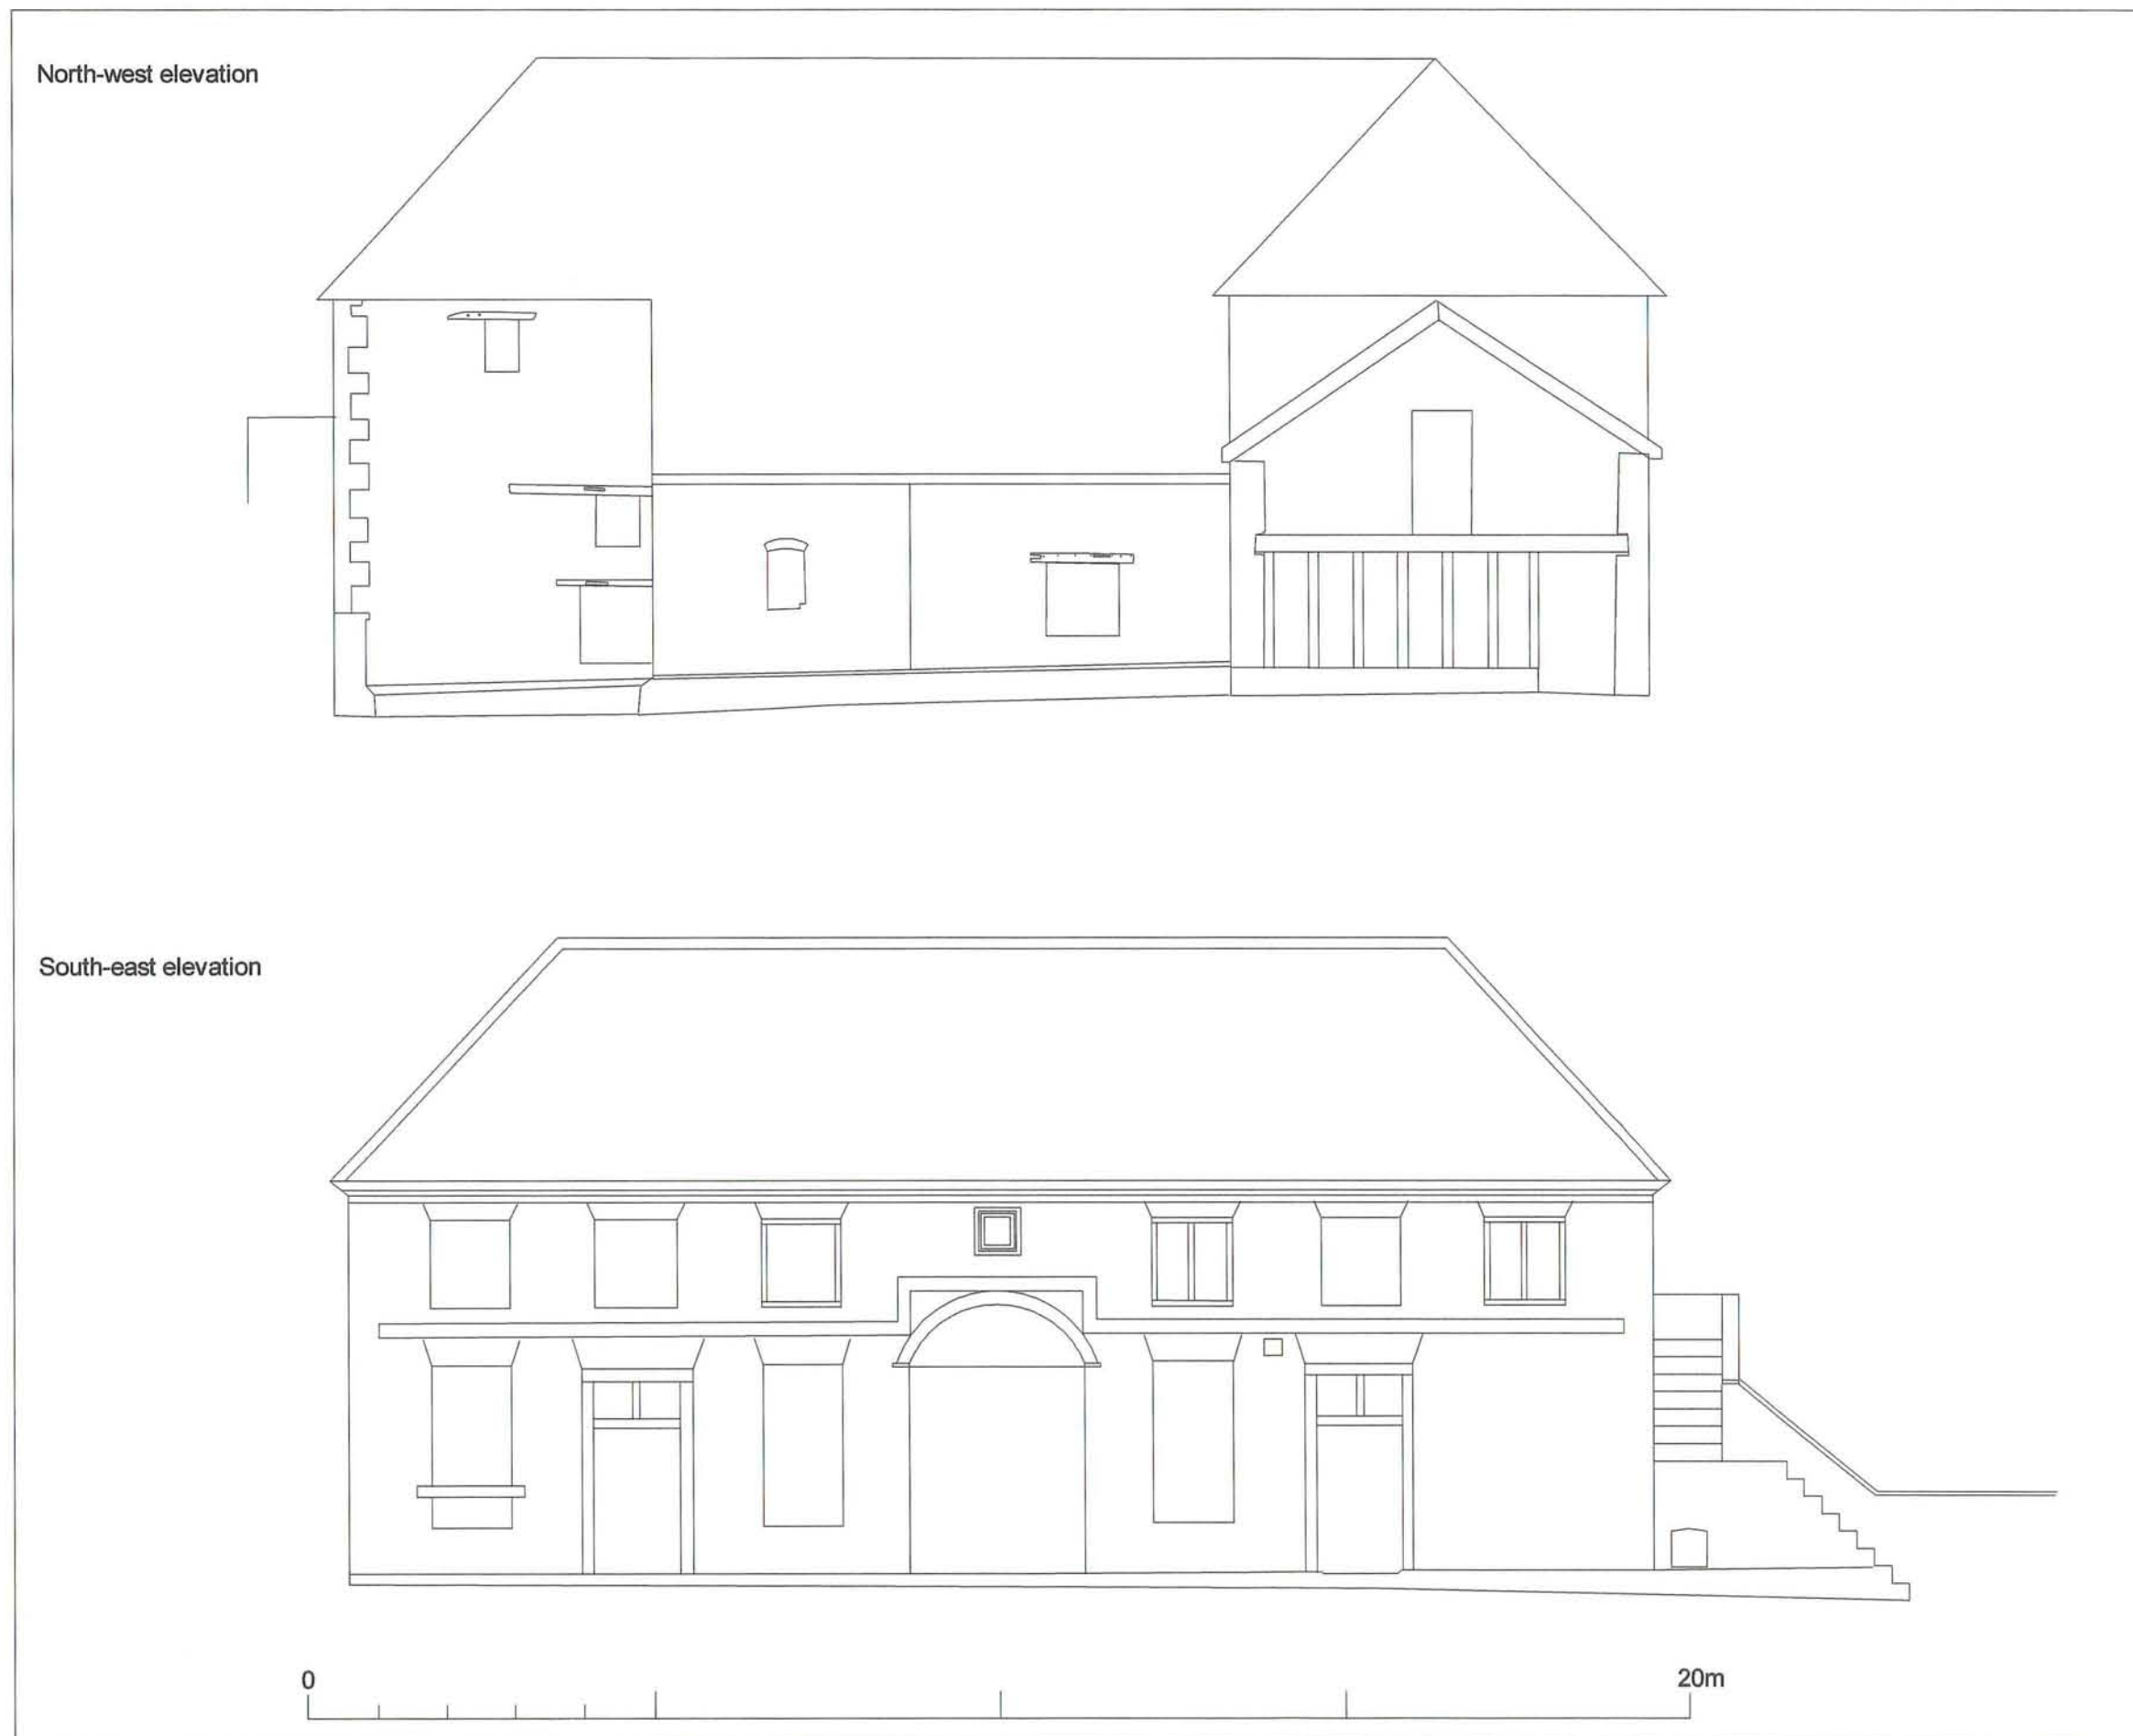
Fig. 4 Barn 1 south-east and north-west elevations, scale 1:100

- 3.2.3 The main range is largely of good quality, hand-made brick with a hipped slate roof. The main, south-eastern elevation (Fig. 4; Plate 1) is symmetrical and has a central double door under a brick arch on the ground floor with a single door flanked by windows to either side. Above the door is an inscribed sandstone moulded and fielded panel reading W / A M / 1721, the initials belonging to Arthur and Meriel Williams. Three of the ground-floor windows are now blocked. The first-floor has only three windows, although the symmetry is maintained by the use of a further three blind windows. There is a three-course plat band above the ground-floor windows which is repeated on the south-west and north-east elevations. Above the first-floor windows is a moulded timber cornice. The south-west elevation has a single, central

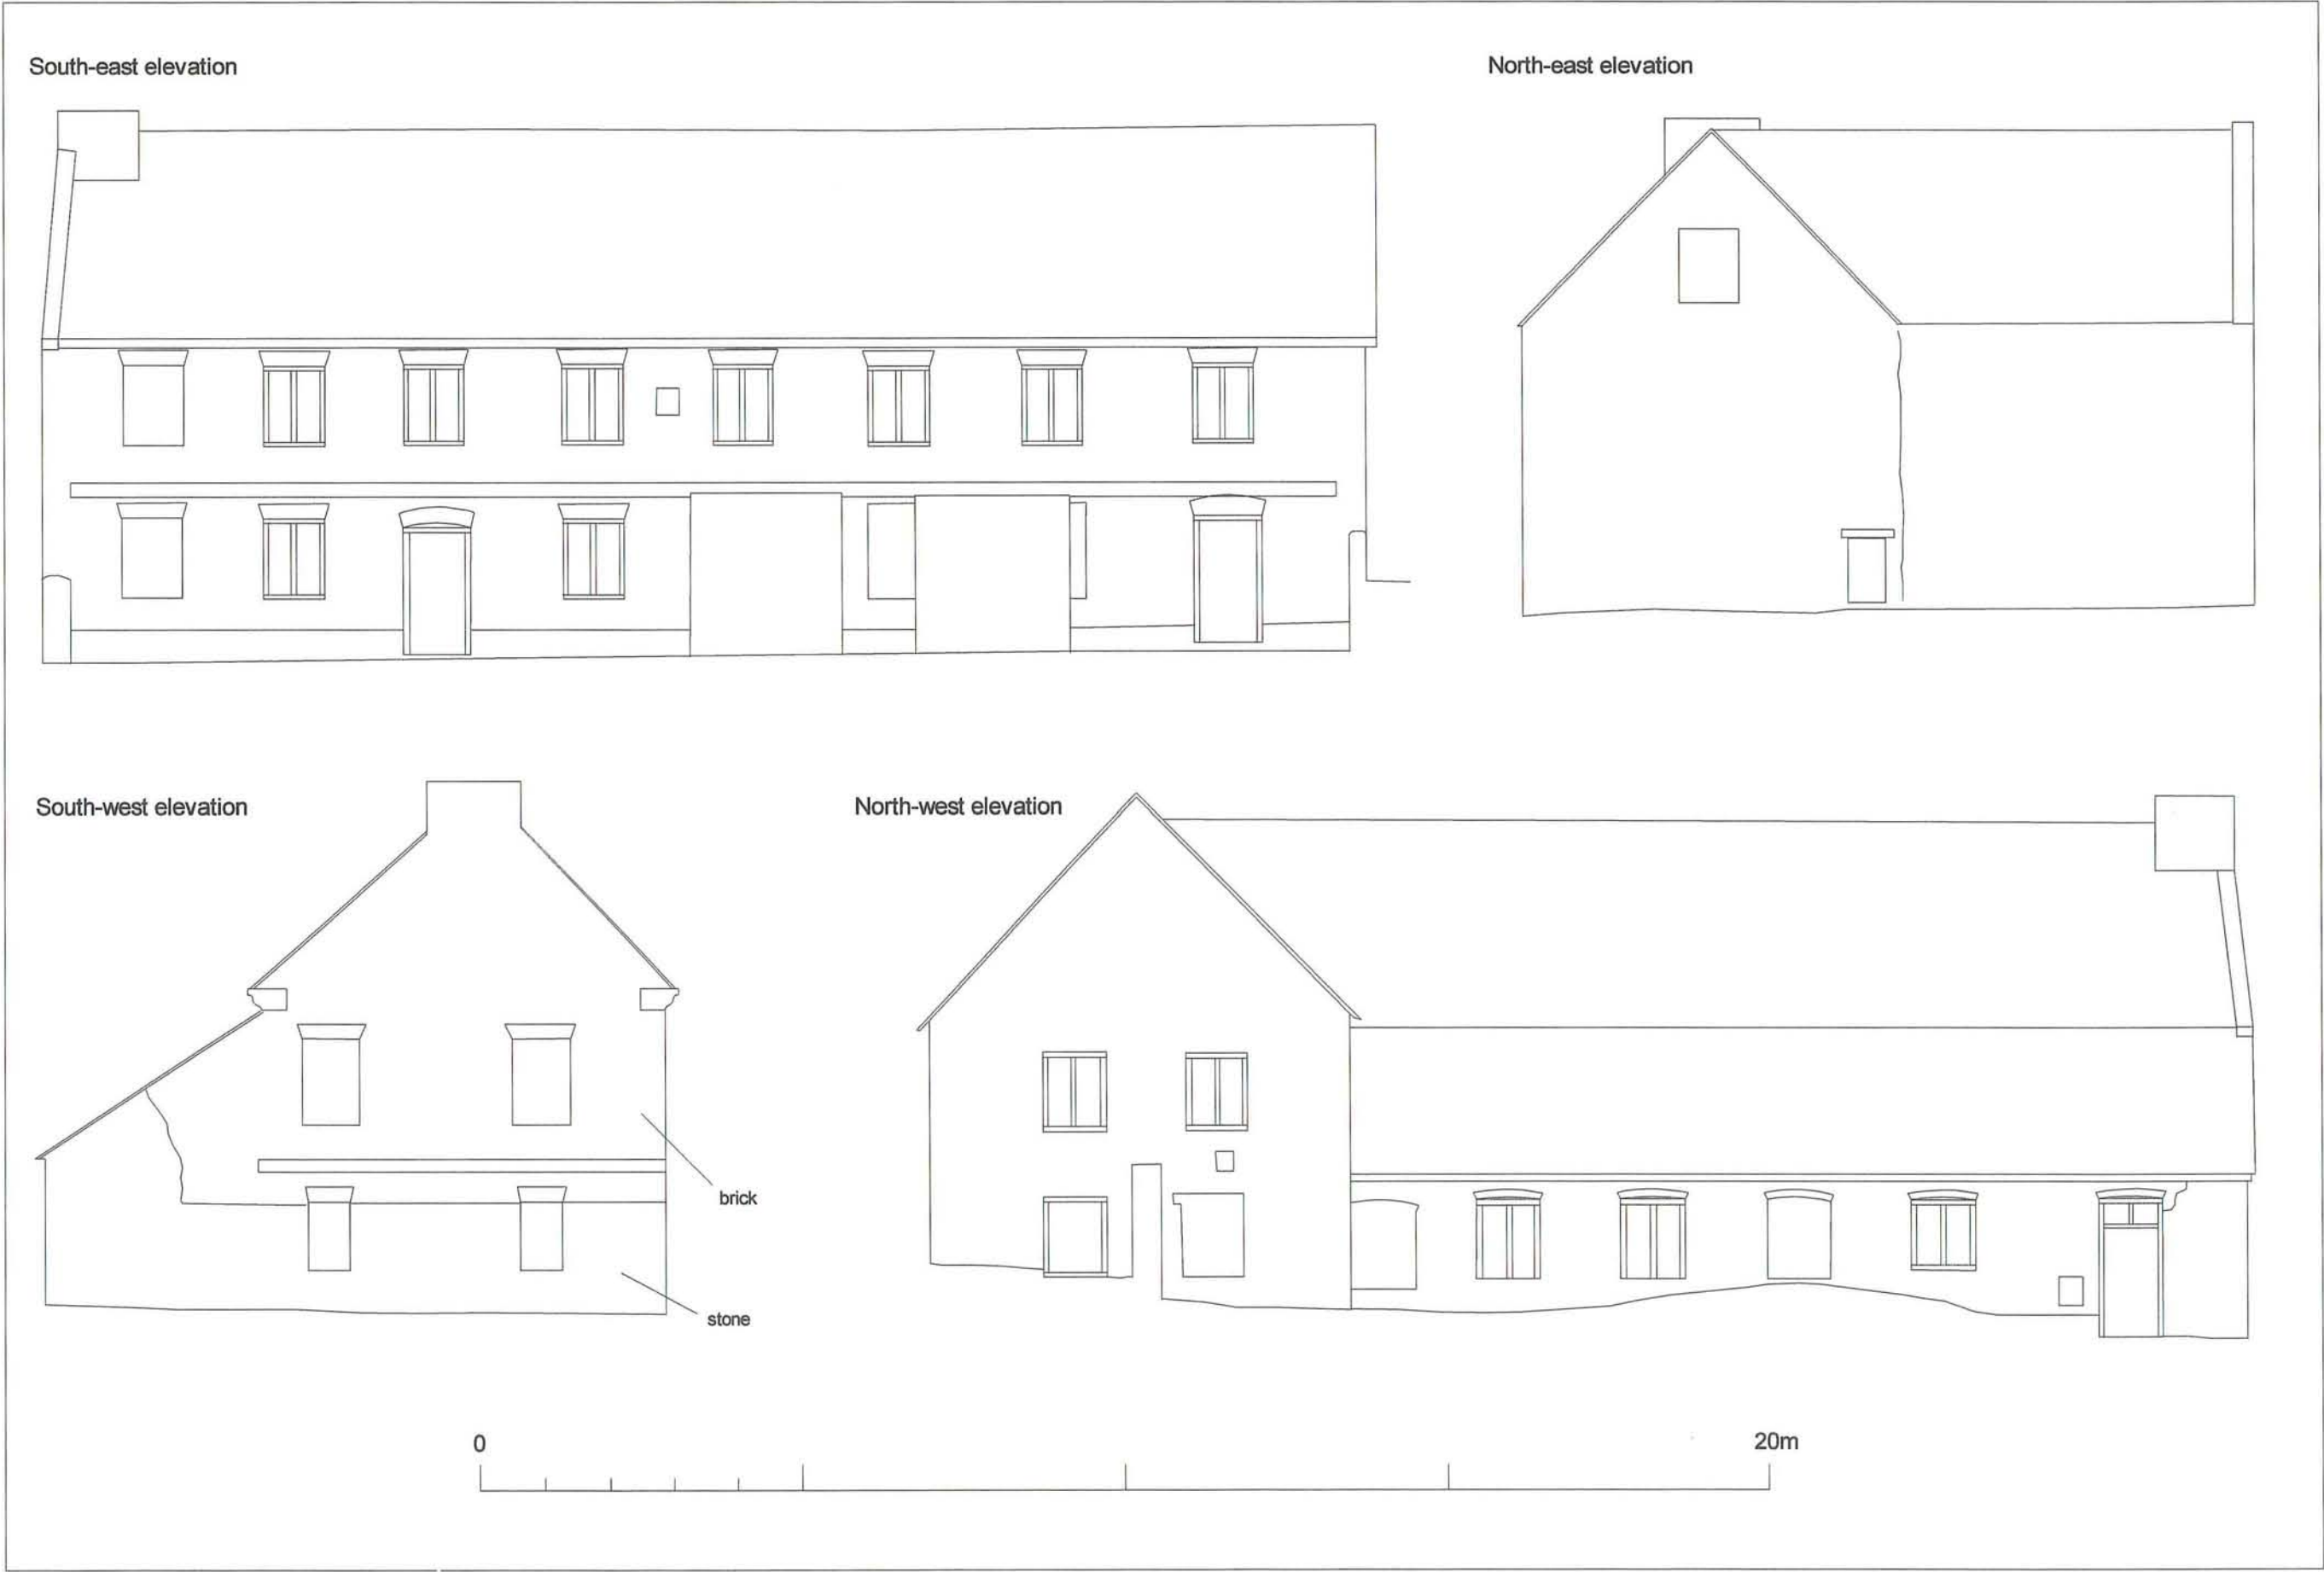
Fig. 9 Barn 2 elevations, scale 1:100

- 3.3.2 The main, south-east elevation is in good quality hand-made brick on a stone plinth, with dressed sandstone quoins at either end, and bears a date stone inscribed W / A + M / 1719, the initials again belonging to Arthur and Meriel Williams. It was originally constructed with eight window openings at first-floor level above a three-course plat band, with matching openings below of three doors and five windows. The two surviving doors have new arched heads and two wide modern openings have been inserted, removing the third door and part of two windows, which have been infilled. The roof is slate with a coped south-west gable on ogee-moulded kneelers. The brick chimney stack at the south-west end was originally around two metres higher than at present.

- 3.3.3 The north-east gable is in random stone with one window on the ground floor and one in the attic. There is little trace of a joint for the rear extension, although an internal change in wall thickness suggests that this is a later addition. The south-west gable is in random stone to the ground floor lintels with brick above and two windows at ground and first floor level. The masonry rises higher at the western corner, the whole suggesting that an earlier building has been incorporated into the structure.

- 3.3.4 The rear extension gable has two windows at first and ground floor levels, one of which is blocked, while the south-west side is only partly in stone, with what appears to be a later brick infilling incorporating a small first-floor window. The rear lean-to has a door at the south-west end which also marks a change in construction, with larger, better quality masonry extending to the gable end and smaller stonework along the majority of the elevation, suggesting that this section is a later addition. There are five windows, one of which is now blocked.

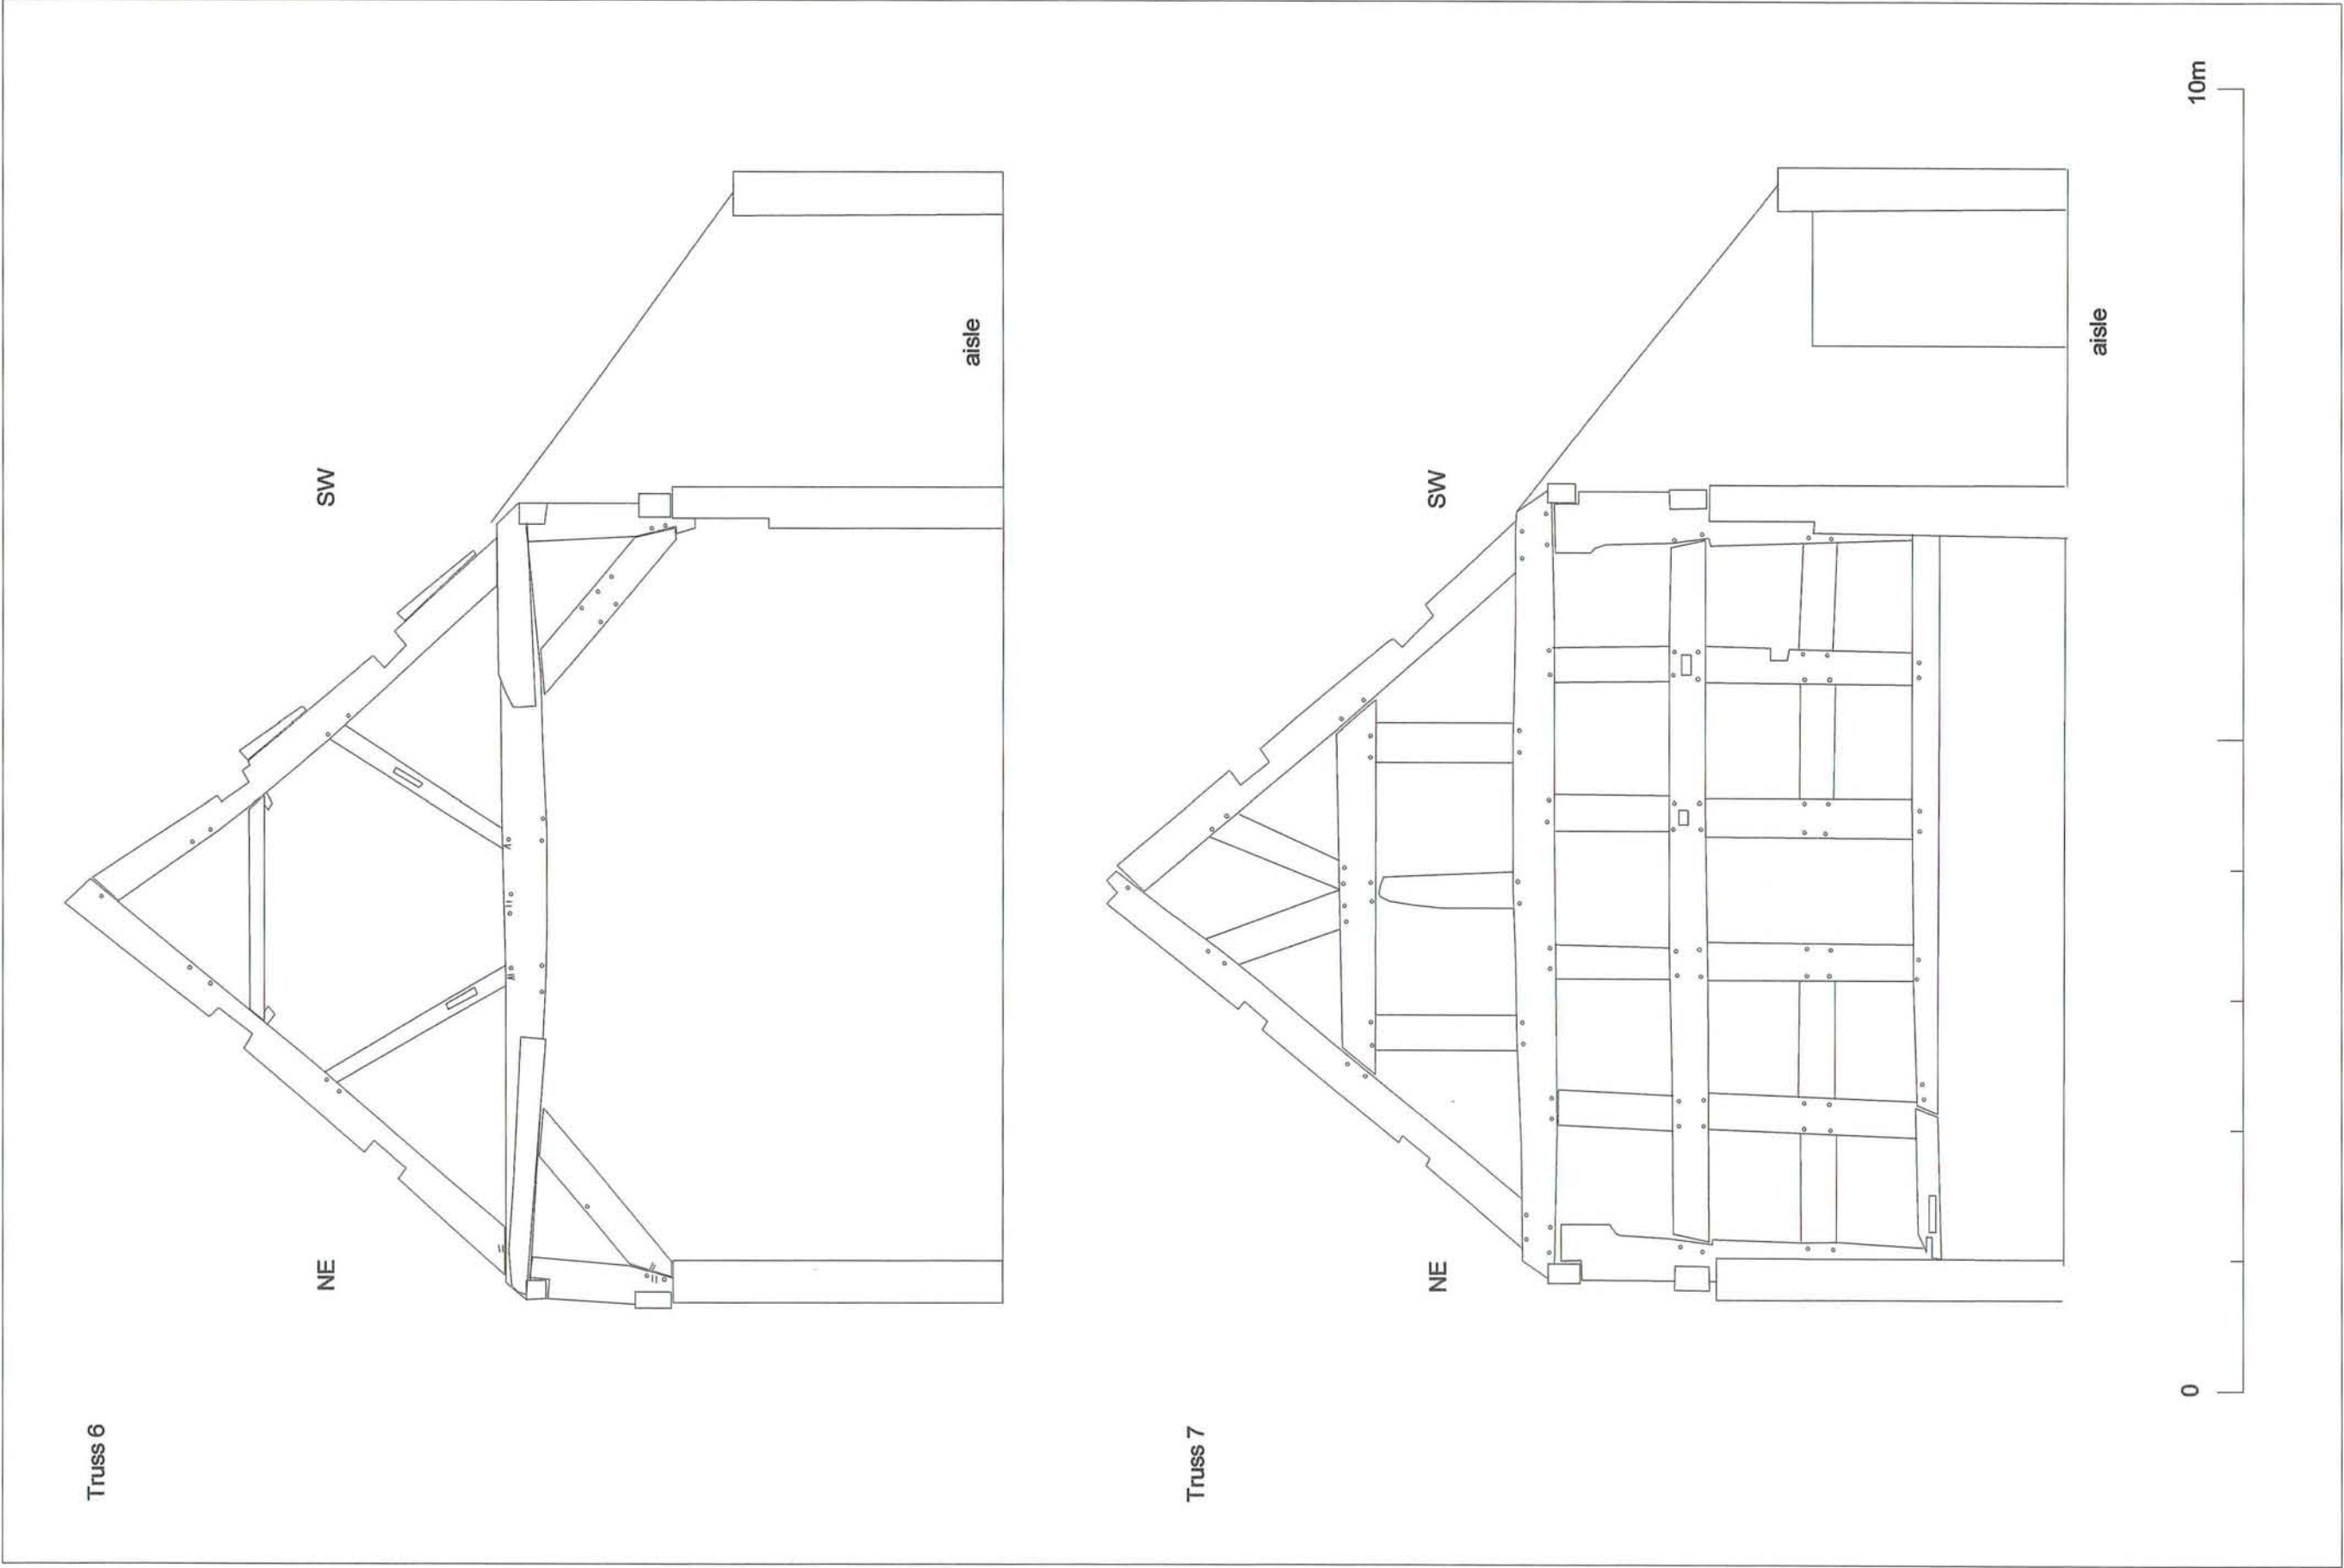
Fig. 14 Barn 3 Trusses 6 and 7, scale 1:100

- 3.4.7 Bays 6 and 7 appear to have been added in a single phase with box-framing surviving in the upper section of the side walls, with solid brick walling below. Both bays are now used as a single loose box, with a feeding trough on the north-west side and an access door and passage against Truss 5. A modern doorway has been roughly cut through the eastern brick side wall, also removing the wall post supporting the eastern end of Truss 6. The south-western end of the truss has a doorway below, leading into the aisle, which has removed the lower part of the wall post. The truss has been modified with the collar and braces now missing, having been replaced by smaller braces and a collar at a higher level (Fig. 14). The

- 3.4.8 Truss 7 is well-preserved, including the sill beam which rest on a stone sleeper wall (Fig. 14). The truss is in the same style as Truss 5 with jowled wall posts and box-frame panels which were originally infilled with wattle and daub, but are now externally weather-boarded.

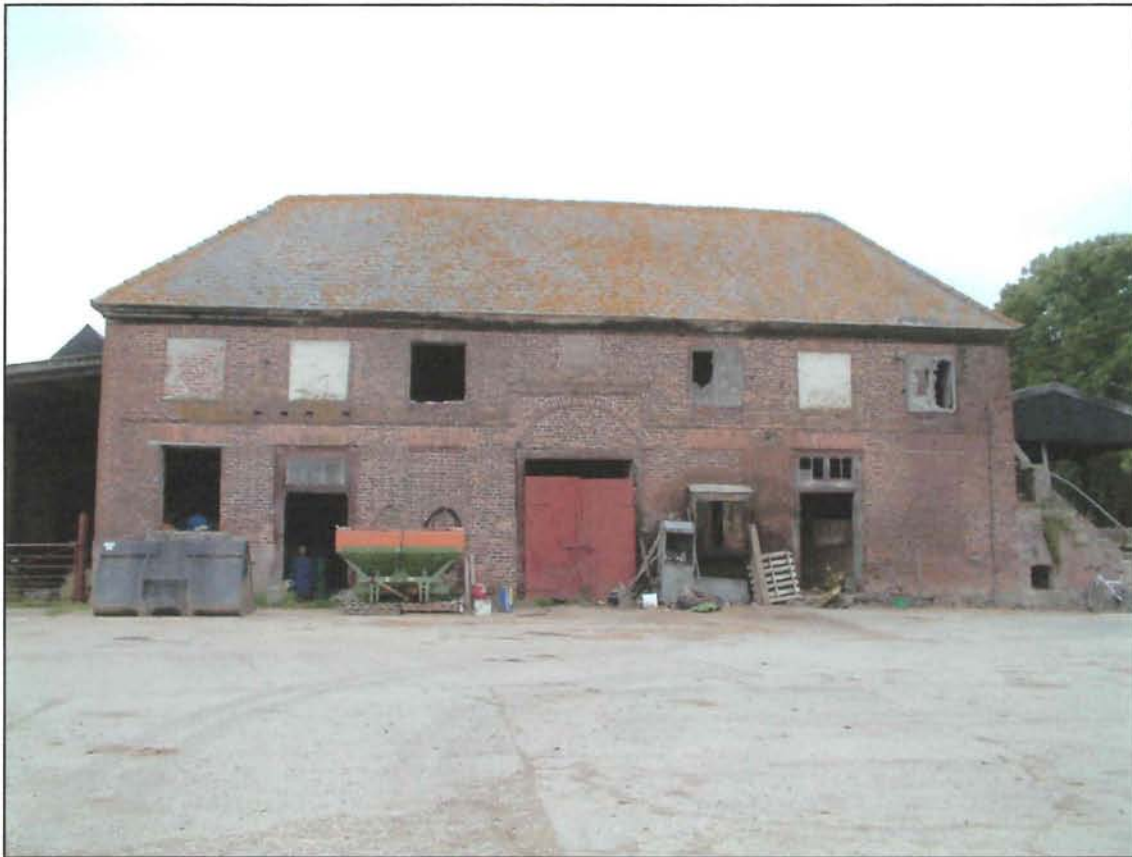
Plate 1 Barn 1 from SE. Photo CPAT 1682.47

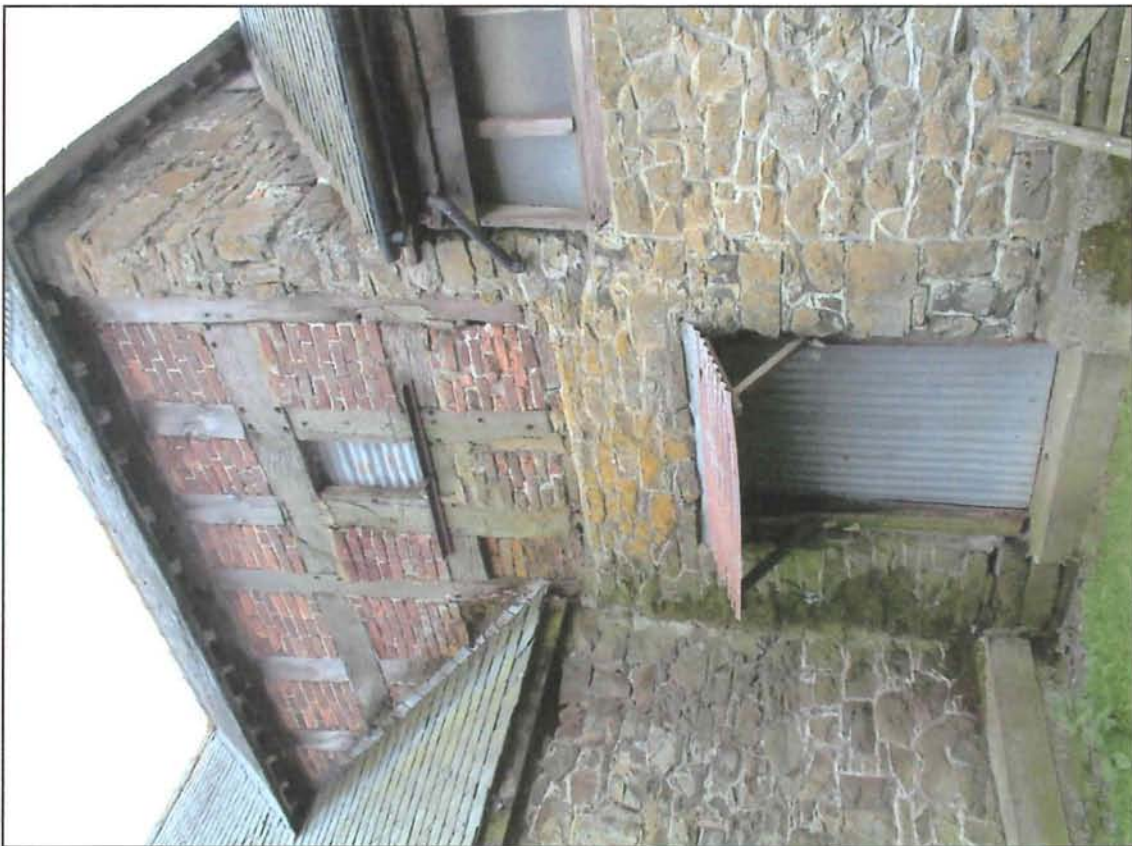
Plate 2 Barn 1 rear wing showing timber framing. Photo CPAT 1682.44

- 3.2.2 The surviving elements of the earlier structure form part of the north-west range of the building, comprising a stone-built north-western gable, now with a hipped roof, and the north-eastern wall, which is of random stone with timber-framing at first floor level (Plate 2). The framing is exposed on the north-east elevation and extends within a later lean-to extension (room G5) where peg-holes on the end post indicate that the framing originally extended further to the south-west. It is possible that the stone plinth on which the main brick range now stands is also part of the earlier structure.

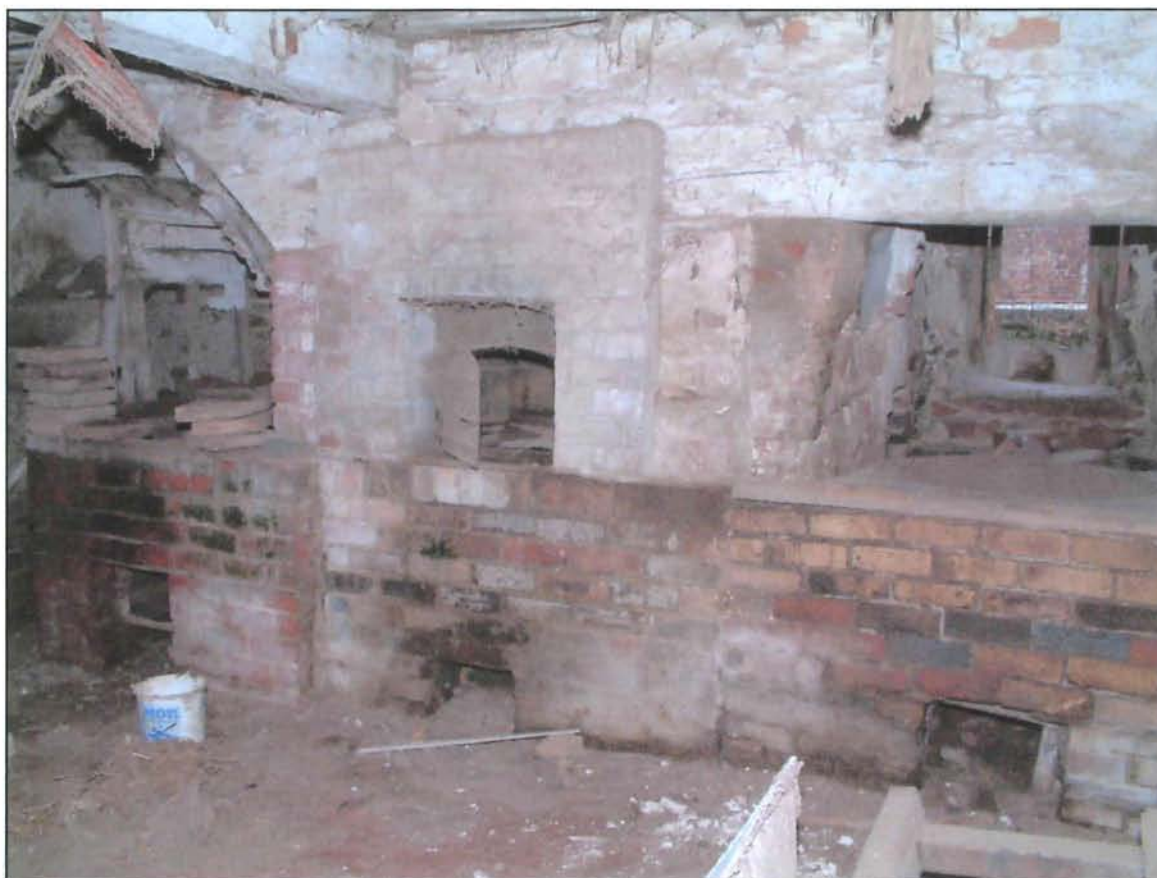
Plate 5 Barn 2 room G1, oven and boilers. Photo CPAT 1682.27

- 3.3.5 The room at the south-western end of the building (G1) has a large brick chimney with a timber lintel for an open fireplace, now infilled by the addition of a central oven with brick-built boilers to either side, behind which are small window openings (Plate 5). The floor is tiled and a chamfered ceiling beam supports the first-floor joists which formerly held a lathe and plaster ceiling. A wooden stair in the southern corner originally led to the first floor and attic, although the upper section is now missing. Two very substantial, dressed sandstone blocks lie against the north-east wall, resting on a sandstone plinth with two cut-outs, forming the base for a cheese press. Three malting kiln floor tiles are now built into the window sill. The rear wall is stone with doors to G5 and G6.

- 3.3.6 The room presumably originally functioned as the brewery, using barley grown on the farm to produce beer for the farm labourers. The malting season was traditionally from September to April and involved soaking the barley in water for up to two days before spread it thinly on a large floor, where it was left to germinate. After eight to ten days the germination was arrested and the barley dried in a kiln. The dry malt was then bagged for use or sale (Brunskill 1999, 100-101).

- 3.3.7 A secondary use would have been in the production of cheese, with the fire being used to heat the milk before curdling. The cheese would have been placed in the press for two days before being taken to a turning room and then the cheese room to mature. Later on, the bread oven was added, with the two boilers probably having been last used for washing clothes.

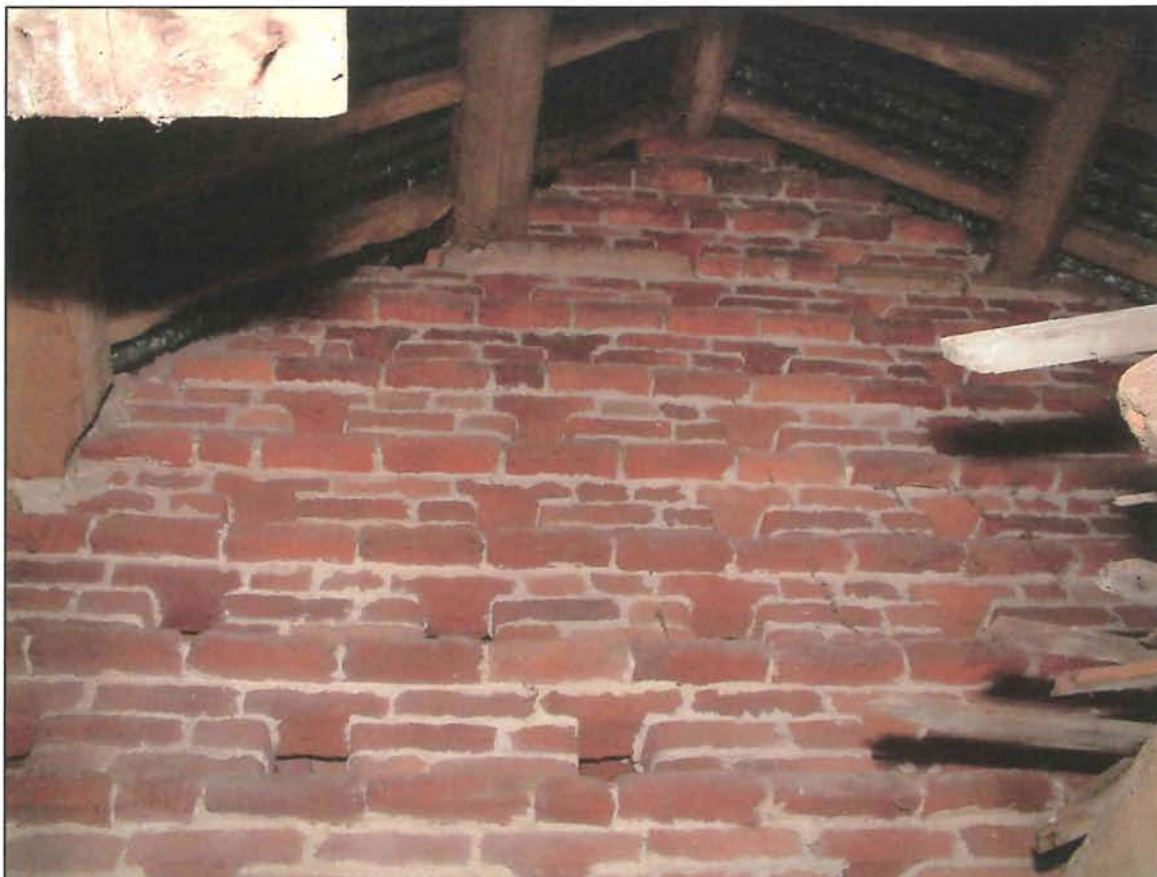
Plate 6 Barn 2 dovecote. Photo CPAT 1682.07

- 3.3.15 The attic of the rear wing has been purpose-built with a dovecote in either gable. The south-east gable is entirely in hand-made brick, while the north-west gable is stone externally with a brick interior. Both gables have a series of horizontal perching ledges with rows of openings leading to nesting boxes within the centre of the wall (Plate 6). A single timber between the upper purlins suggests the former presence of a small, framed turret, or glover, through which the birds would have gained access.

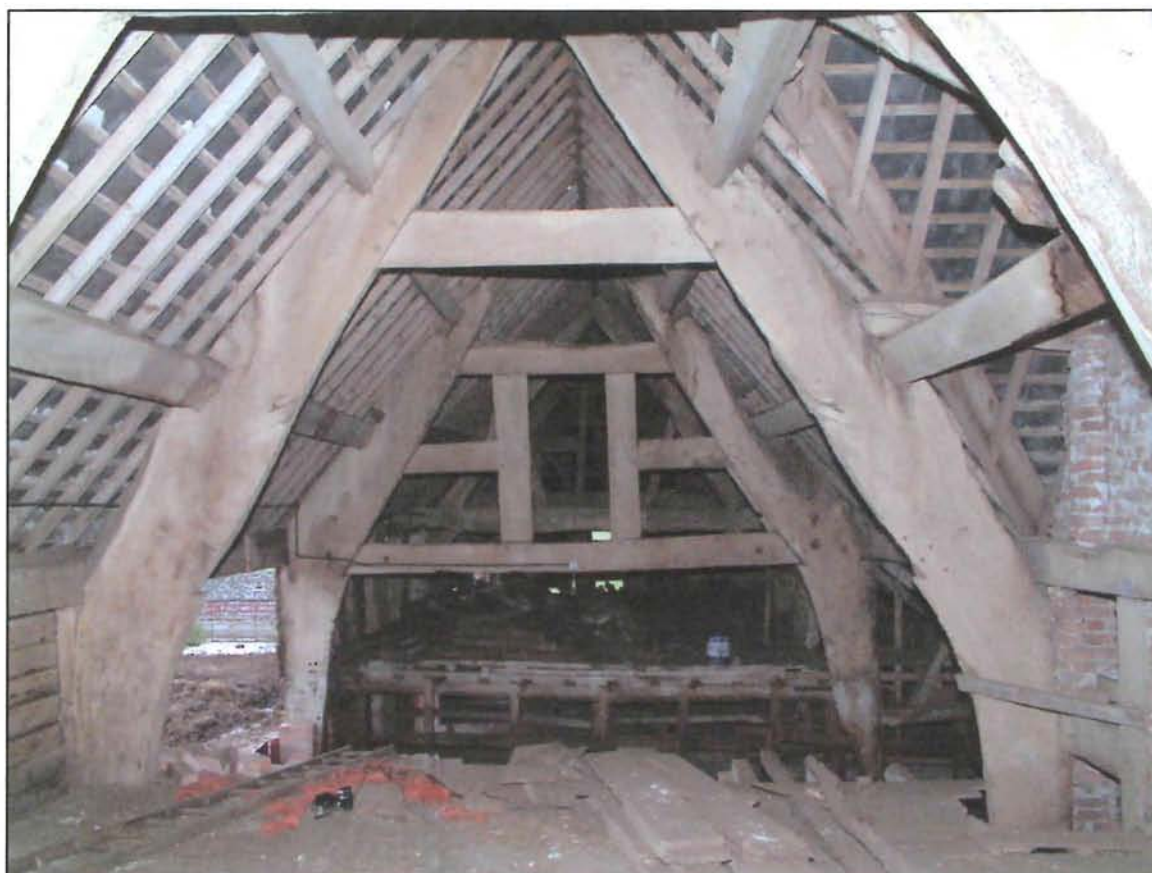
Plate 9 Barn 3 crucks, Trusses 2 and 3. Photo CPAT 1682.84

- 3.4.4 The south-eastern bay of the cruck-framed barn (Bay 3) now forms a passage to a later barn and fold yard at the rear. The cruck (Truss 3; Plate 9) is well-preserved, although the cruck heads are missing. The tie beam and collar survive, along with the framing for wattle and daub infill. The lower part of the framing is missing, although mortices and stave holes in the tie beam indicate that this was originally entirely infilled, forming the solid gable-end wall of the barn. Unlike Trusses 1 and 2, Truss 3 does not have cleats, but instead the wall plates were supported directly on the cruck blades.

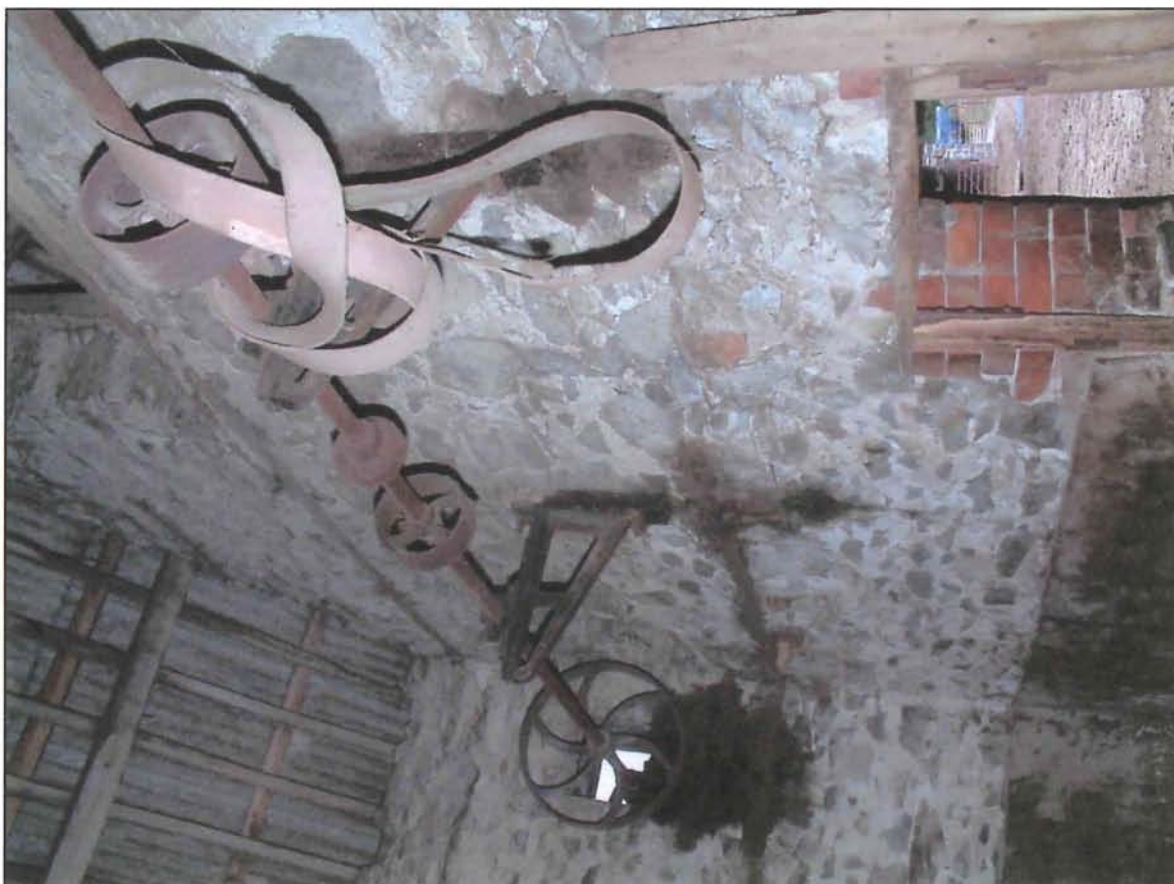
Plate 16 Barn 5 driveshaft. Photo CPAT 1682.69

- 3.6.1 The L-shaped barn is of random stone with a slate roof and has five bays, two in the south-eastern section and three in the longer north-western section. At the north-west end, Bay 1 comprises a shelter shed on the ground floor with an open front, a doorway through a stone partition to Bay 2 and a hay loft above. Bay 2 has ventilation slits at ground floor level, while Bay 3 has opposing doors, the south-western of which is now partly blocked to form a window. The two roof trusses are both king posts with angled braces supporting the principal rafters (Plate 14). At the north-western end of Bay 2, against the stone partition, a driveshaft has been inserted through openings in both side walls to drive fodder-cutting machinery powered by an external steam engine (Plate 16). This section of the barn would therefore have functioned as a mixing room for cattle fodder.
