## Nantygarw Lead Mine, Powys ARCHAEOLOGICAL GROUND SURVEY

N.W.Jones and P. Frost October 1997

Survey undertaken on behalf of Welsh Water Elan Trust

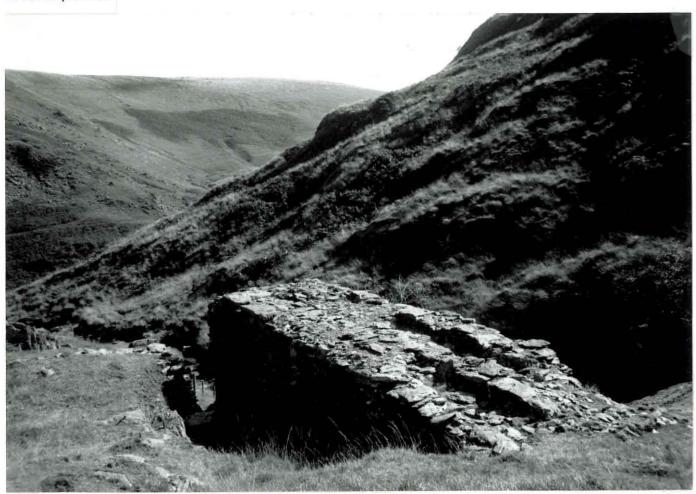
Plate 1 Wheelpit (PRN 12141) from NW. Photo CPAT 644.6

- Power was provided by a substantial wheelpit (PRN 12141; pl. 1) 117m to the east, the flat-rods presumably being carried on stantions for which some fixing bolts are still visible along the north side of the stream. The wheelpit measures 10.5 x 3.25m and survives to a height of 3.7m. The wheel appears to have been located on the north side of the wheelpit where some fixing bolts survive alongside a small platform (PRN 12140). The is no surviving evidence for a leat supplying the wheel and it would seem likely that water was drawn directly from the stream c. 55m to west, where there is a small waterfall, and laundered to the wheelpit. Several fixing bolts and a timber post along the north side of the stream may be associated with the launder. The tail-race presumably flowed directly over the entrance to a drainage adit (PRN 12142) which was cut in beneath the wheelpit and remains open for some considerable distance. The workings of the wheelpit are no longer clear although the balance-box (PRN 12152), measuring 1.4 x 0.6m, survives at the south-east corner. It is likely that some structural evidence relating to the transfer of power to the flat-rods has been lost due to collapse along the south side. Within the main structure of the wheelpit, three narrow rectangular slots, now infilled, show the position of a flywheel and gearing mechanism.

- 5.3 The condition of several structures, notably the wheelpit, shaft and smithy chimney are becoming increasingly unstable as time progresses. Although much of the main site is now covered with spreads of waste it would seem likely that this is actually aiding the preservation of those features buried beneath.

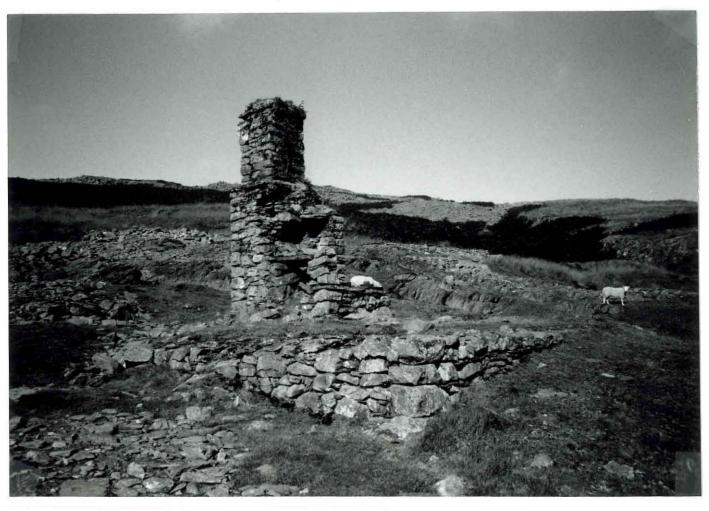
Plate 2 Smithy (PRN 12118) from S. Photo CPAT 644.13

- 4.8 The mine smithy (PRN 12118; pl. 3) consists of a rectangular platform measuring 10.1 x 8.55m, with the chimney and hearth set centrally within it. The chimney (PRN 12119) survives to its full height of 4.2m. A short length of leat (PRN 12125) runs south and east of the smithy as far as the level. It is possible that beyond this the leat followed the line of the track (PRN 12134).

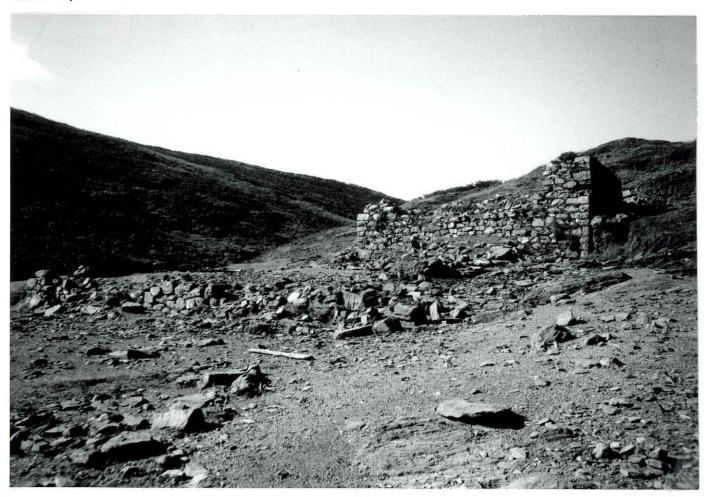
Plate 3 Greens Processing Mill (PRN 12115) from SE. Photo CPAT 644.17

- The Green's Processing Mill (PRN 12115; pl. 2) lies on higher ground 70m north-west of the shaft, 4.5 with a track (PRN 12132) leading to it. Power for the mill was presumably provided by water, although no wheelpit is visible. A leat was constructed in 1893 to carry water from Llyn Carw (fig. 1) 2km to the west (Bick 1991, 22), although this lies outside the area of the present survey, and a short length of leat (PRN 12151) is visible to the north-west of the mill. The surviving remains consist of three adjoining stone buildings (PRNs 12153-5), each of which would have housed machinery for different stages in the processing of the ore. The upper building (PRN 12153) measures 11.35 x 9.7m externally with walls surviving to a height of 4.3m. This substantial structure, which presumably housed the rolls crushers, is filled and surrounded by rubble with some suggestion of an internal wall dividing the building lengthways. The next building (PRN 12154) consists of a stone revetted platform measuring 15.7 x 11.35m with evidence of timber launders surviving. The final part of the structure (PRN 12155) is now partly buried by spoil, but consists of a stone revetted platform measuring c. 15 x 13.1m, with the remains of a machine base in the middle and a series of timber tanks and launders along the north-east external wall. To the south of the mill are large tips of jig and fine waste.

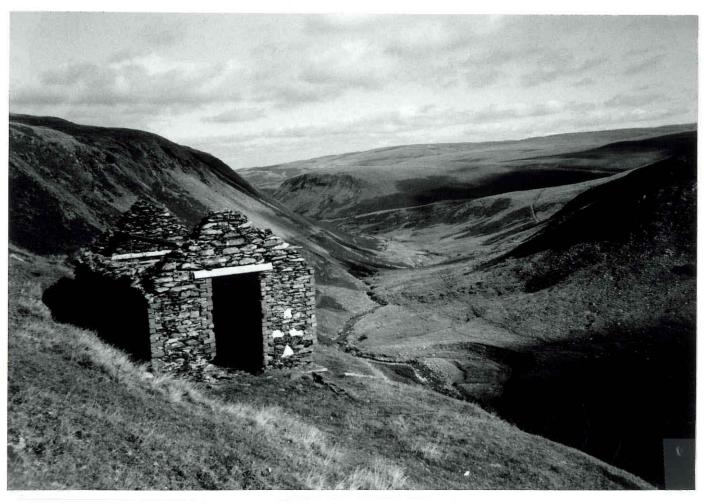
Plate 4 Magazine (PRN 12148) from SW. Photo CPAT 644.19

- 4.10 The mine magazine (PRN 12148; pl. 4) is located at some distance to the east, with a track (PRN 12149) leading to it. The building survives intact but without a roof, measuring 5.0 x 3.3m and standing to 3.3.m high.
