CPAT Report No 476

**Land off Bowling Green Lane,
Welshpool, Powys
ARCHAEOLOGICAL EVALUATION**

N W Jones and R Hankinson
May 2002

Report for Trustees of the Powis Estate

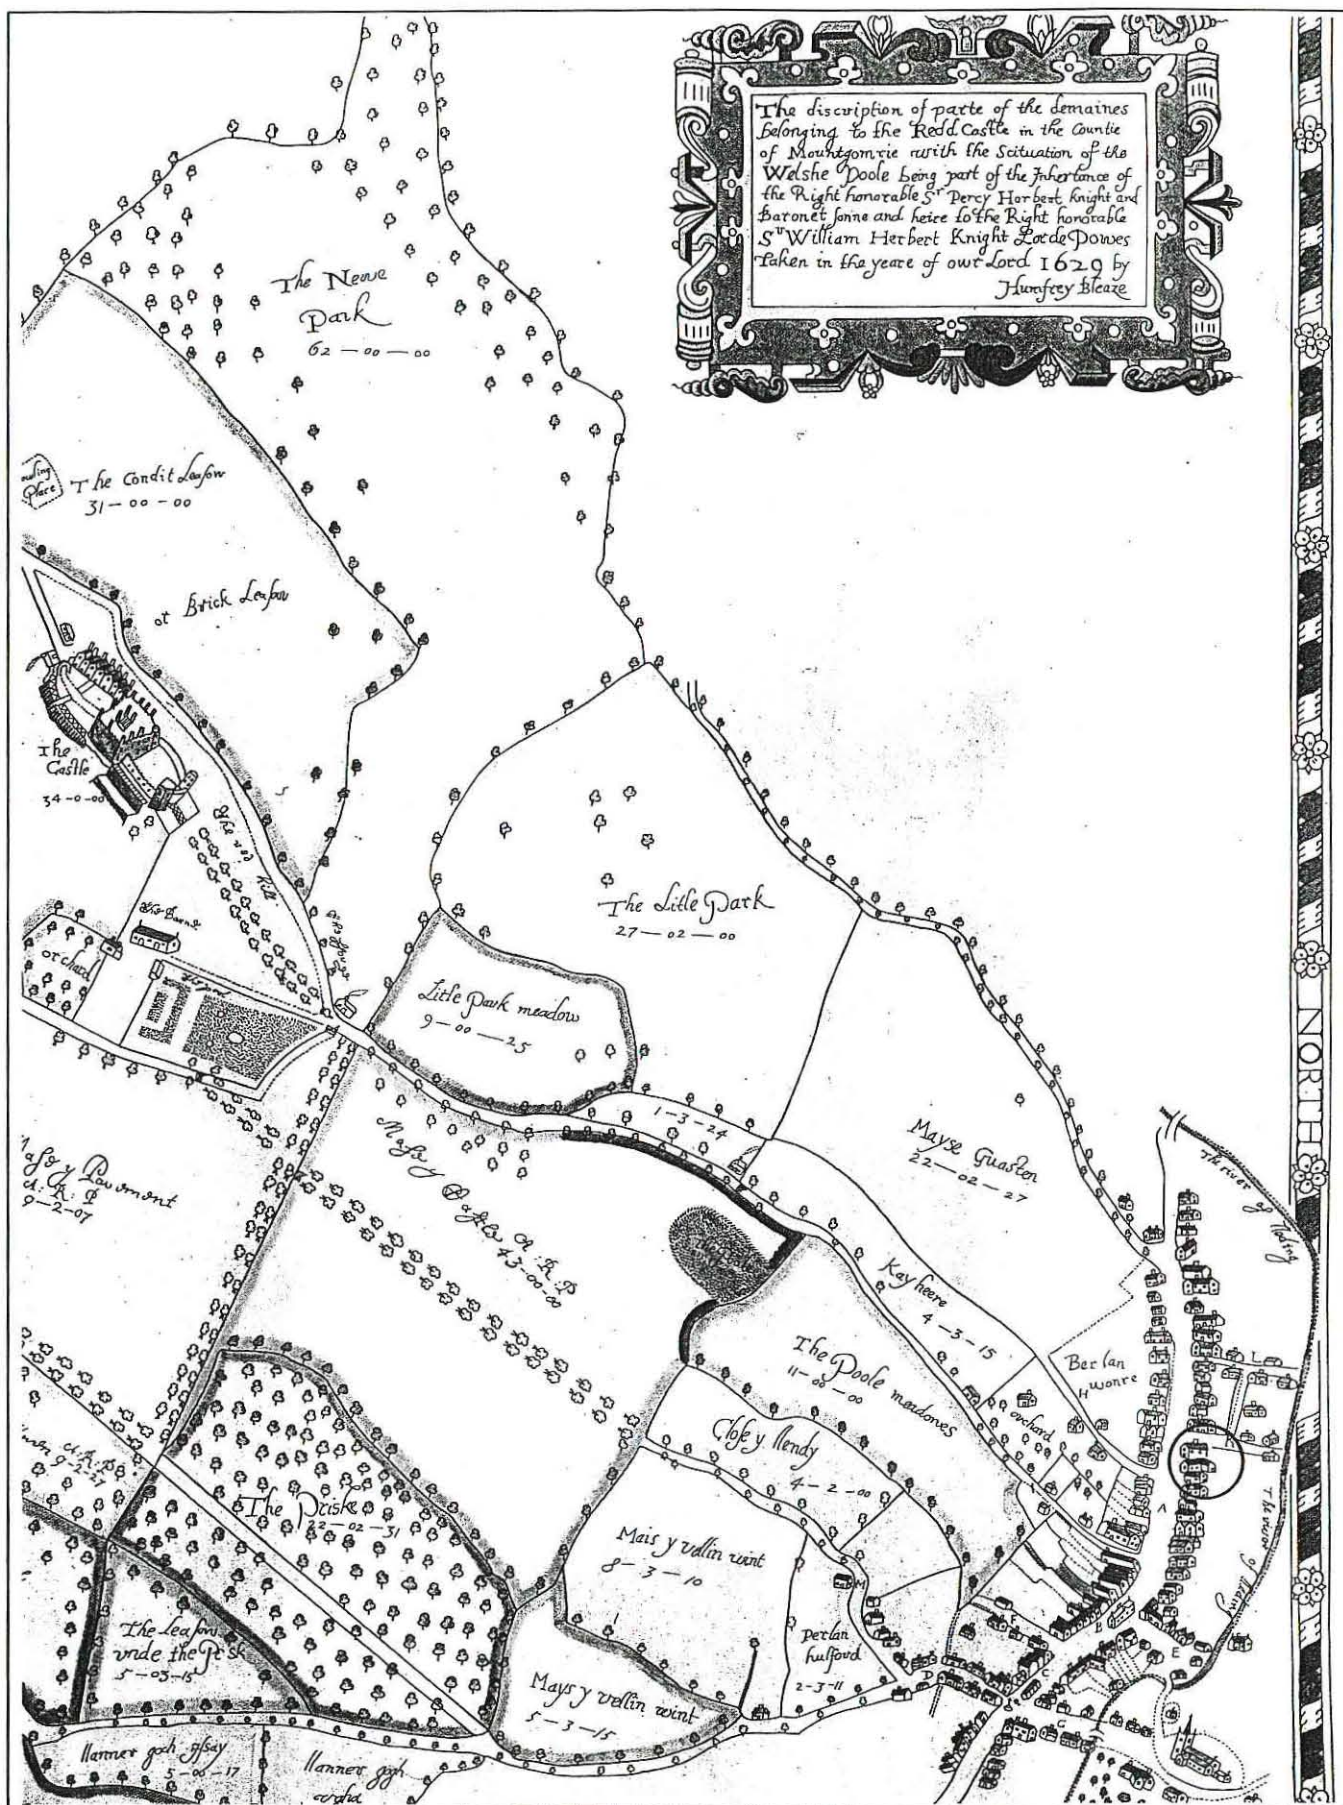
Fig. 3 Humfrey Bleaze's map of 1629 (taken from a later copy produced by the Powysland Club)

- 3.2 The earliest available source that related to the area of the proposal was a map of Welshpool drawn by Humphrey Bleaze in 1629 (Fig. 3). Although the map is not drawn with particular accuracy it is apparent that there were houses on the High Street frontage of the plot at the time; unfortunately no detail regarding the rear of the plots is shown on the map.

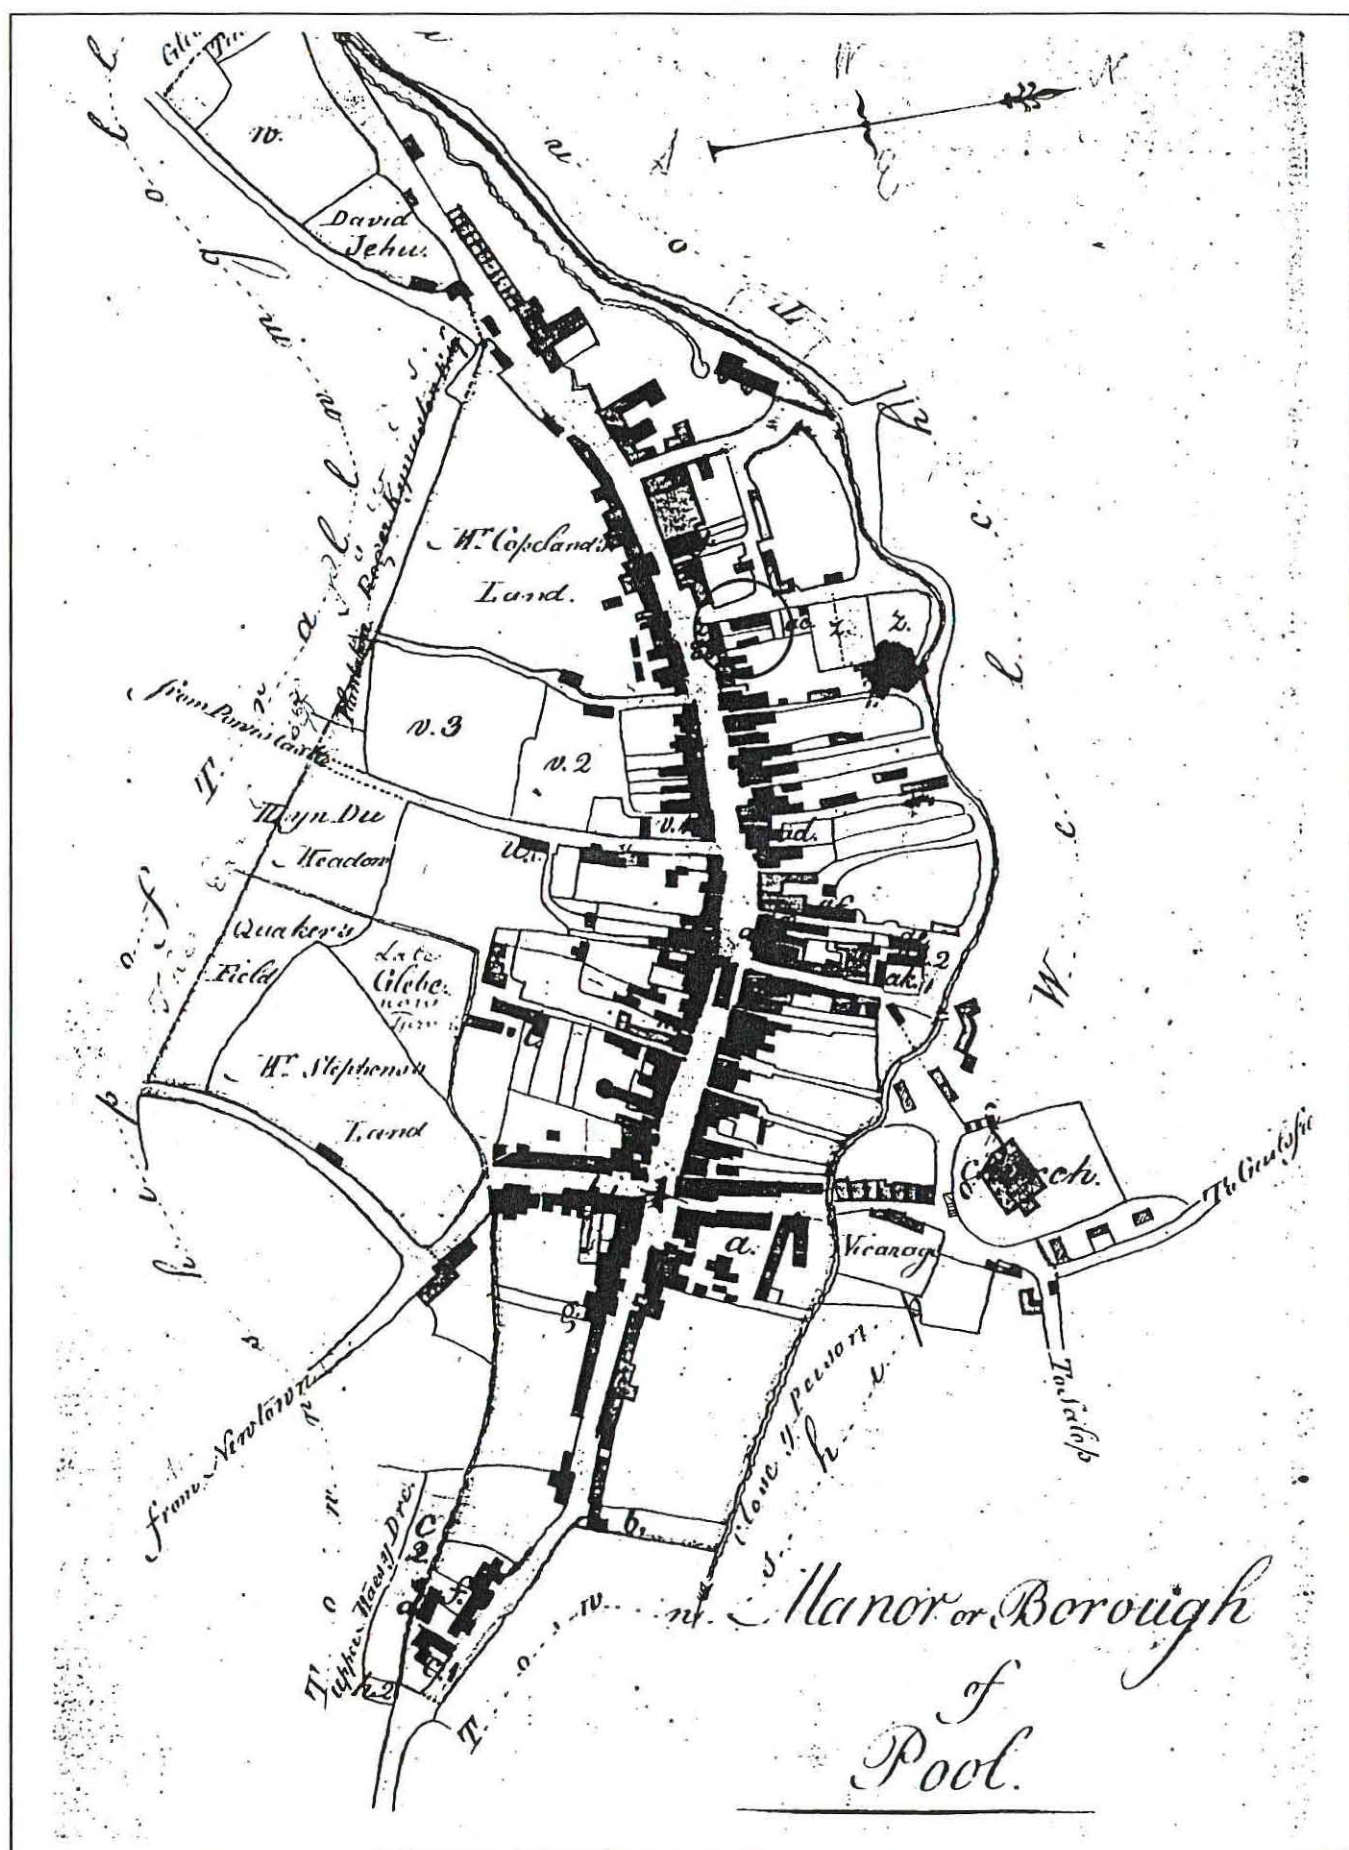
Fig. 4 Post-1780 Powis Castle estate map (NLW Powis Castle M17-18)

- 3.4 The first accurate cartographic depiction of the locality is provided by a post-1780 map of Powis Estate (NLW/Powis Castle/M17-18; Fig. 4); there is also a later version of this map dated 1800 (NLW/Powis Castle/M20; Fig. 5). The maps show two houses fronting onto High Street and a third,

called 'Bowling Green House', fronting onto Powell's Lane. In addition, the building to the rear of No 22 High Street is also depicted.

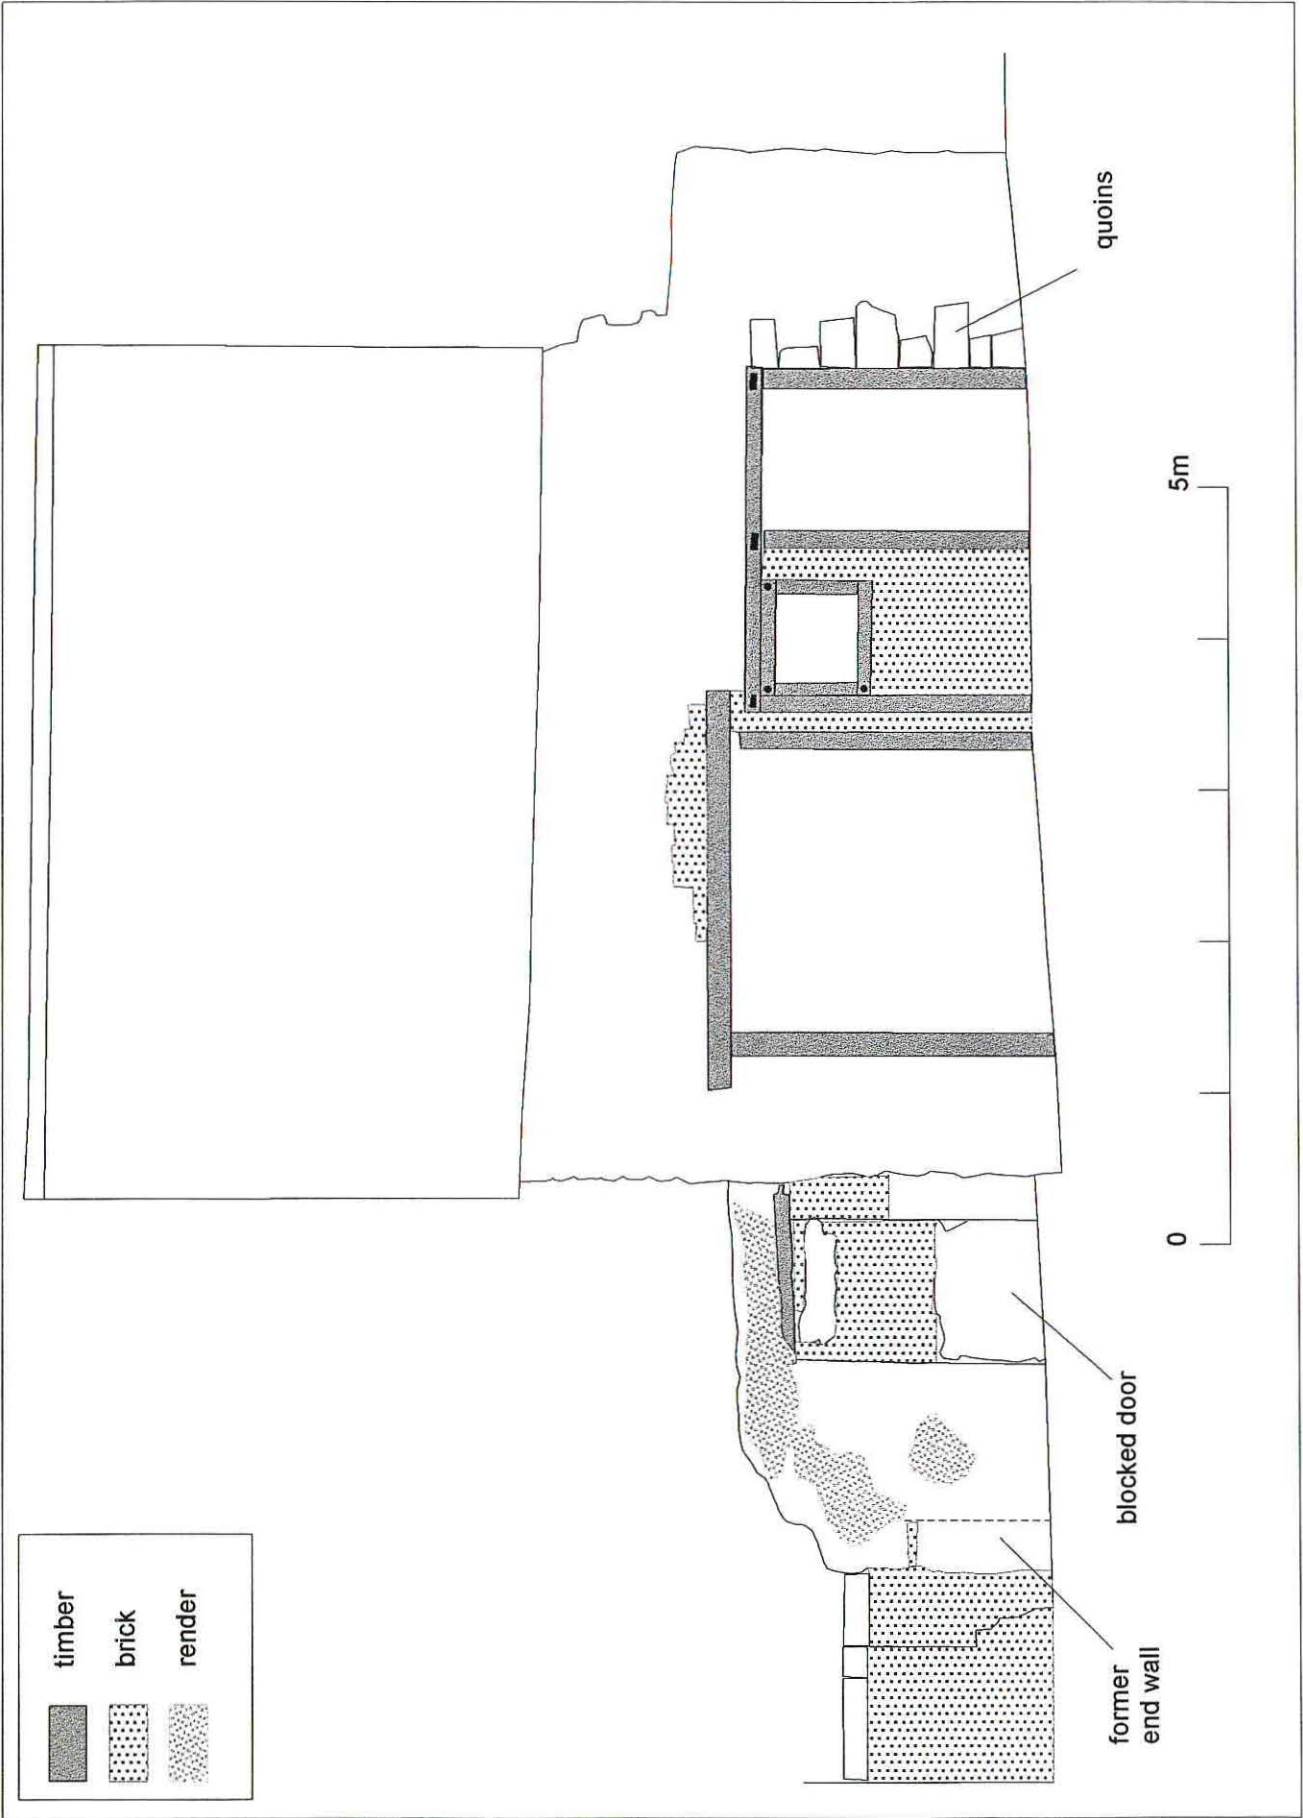
Fig. 8 West elevation, 1:50

- 4.4 It would appear that the west elevation (Fig. 8; Plate 2) was originally open along most of the ground floor. At the south end, the door jamb is formed by dressed quoins although the corresponding northern quoins have been lost. The south section is now accessed by a single door with a brick infilled panel to the north within which is a square window formed of pegged timber framing. The external lintel is not original and has three mortises. The interior has a more substantial lintel, also a later insert, although the original lintel survives and appears to run almost the entire length of the surviving structure, supporting the cross members for the first floor joists. The opening in the north section has been enlarged with a lintel inserted, with brick infill above.

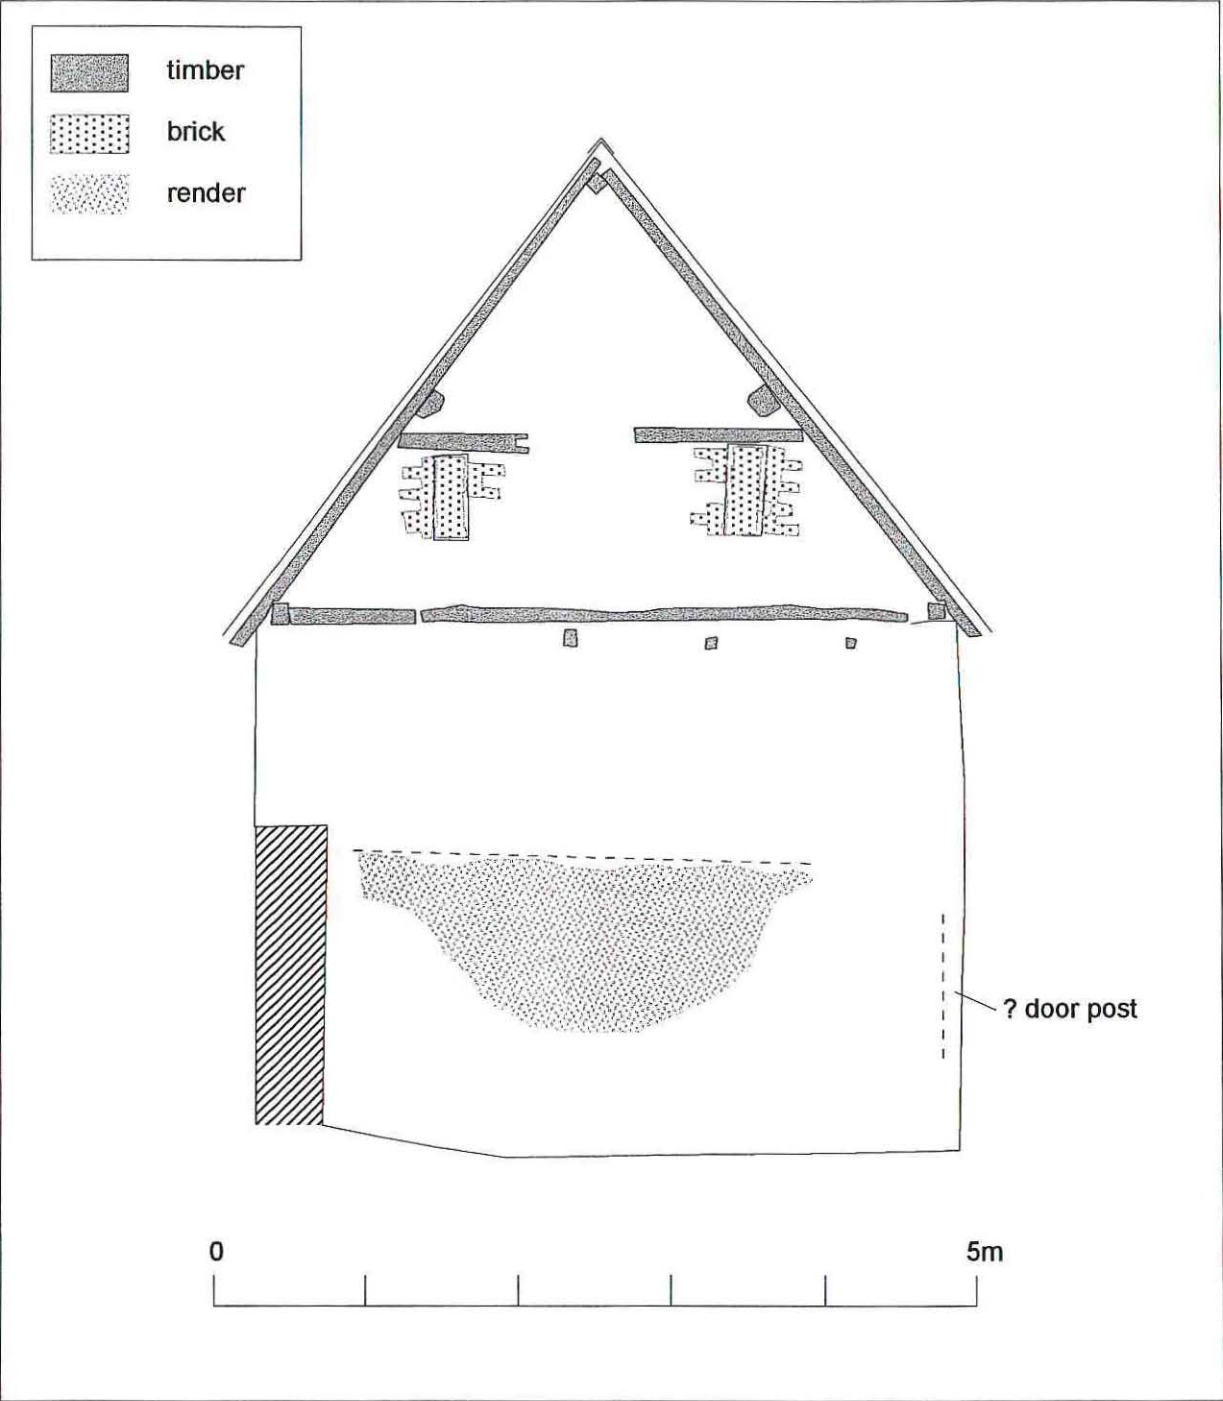
Fig. 9 North elevation, 1:50

- 4.5 The north elevation (Fig. 9; Plate 3) stands to 6.65m and is rather plain, with two ventilation slits at first-floor level. These appear to have been inserted and are partly faced in brick on either side, with reused timber lintels, and both are now blocked with brick. The bricks are all hand-made, measuring roughly 240 x 65mm, the same size, and presumably date, as those used to build the street frontage in c.1740. Below the slits are two horizontal timbers which may have been inserted and appear to be associated with a lean-to structure which formerly stood against the elevation. Below the timbers are traces of limewash. It would appear that this structure was reduced in height at some point and may have had a flat roof, the level of which can be traced as a line of cement mortar, with fragmentary

render below. Traces of cement mortar at the western end of the elevation mark the position of a timber, presumably forming part of a door frame.

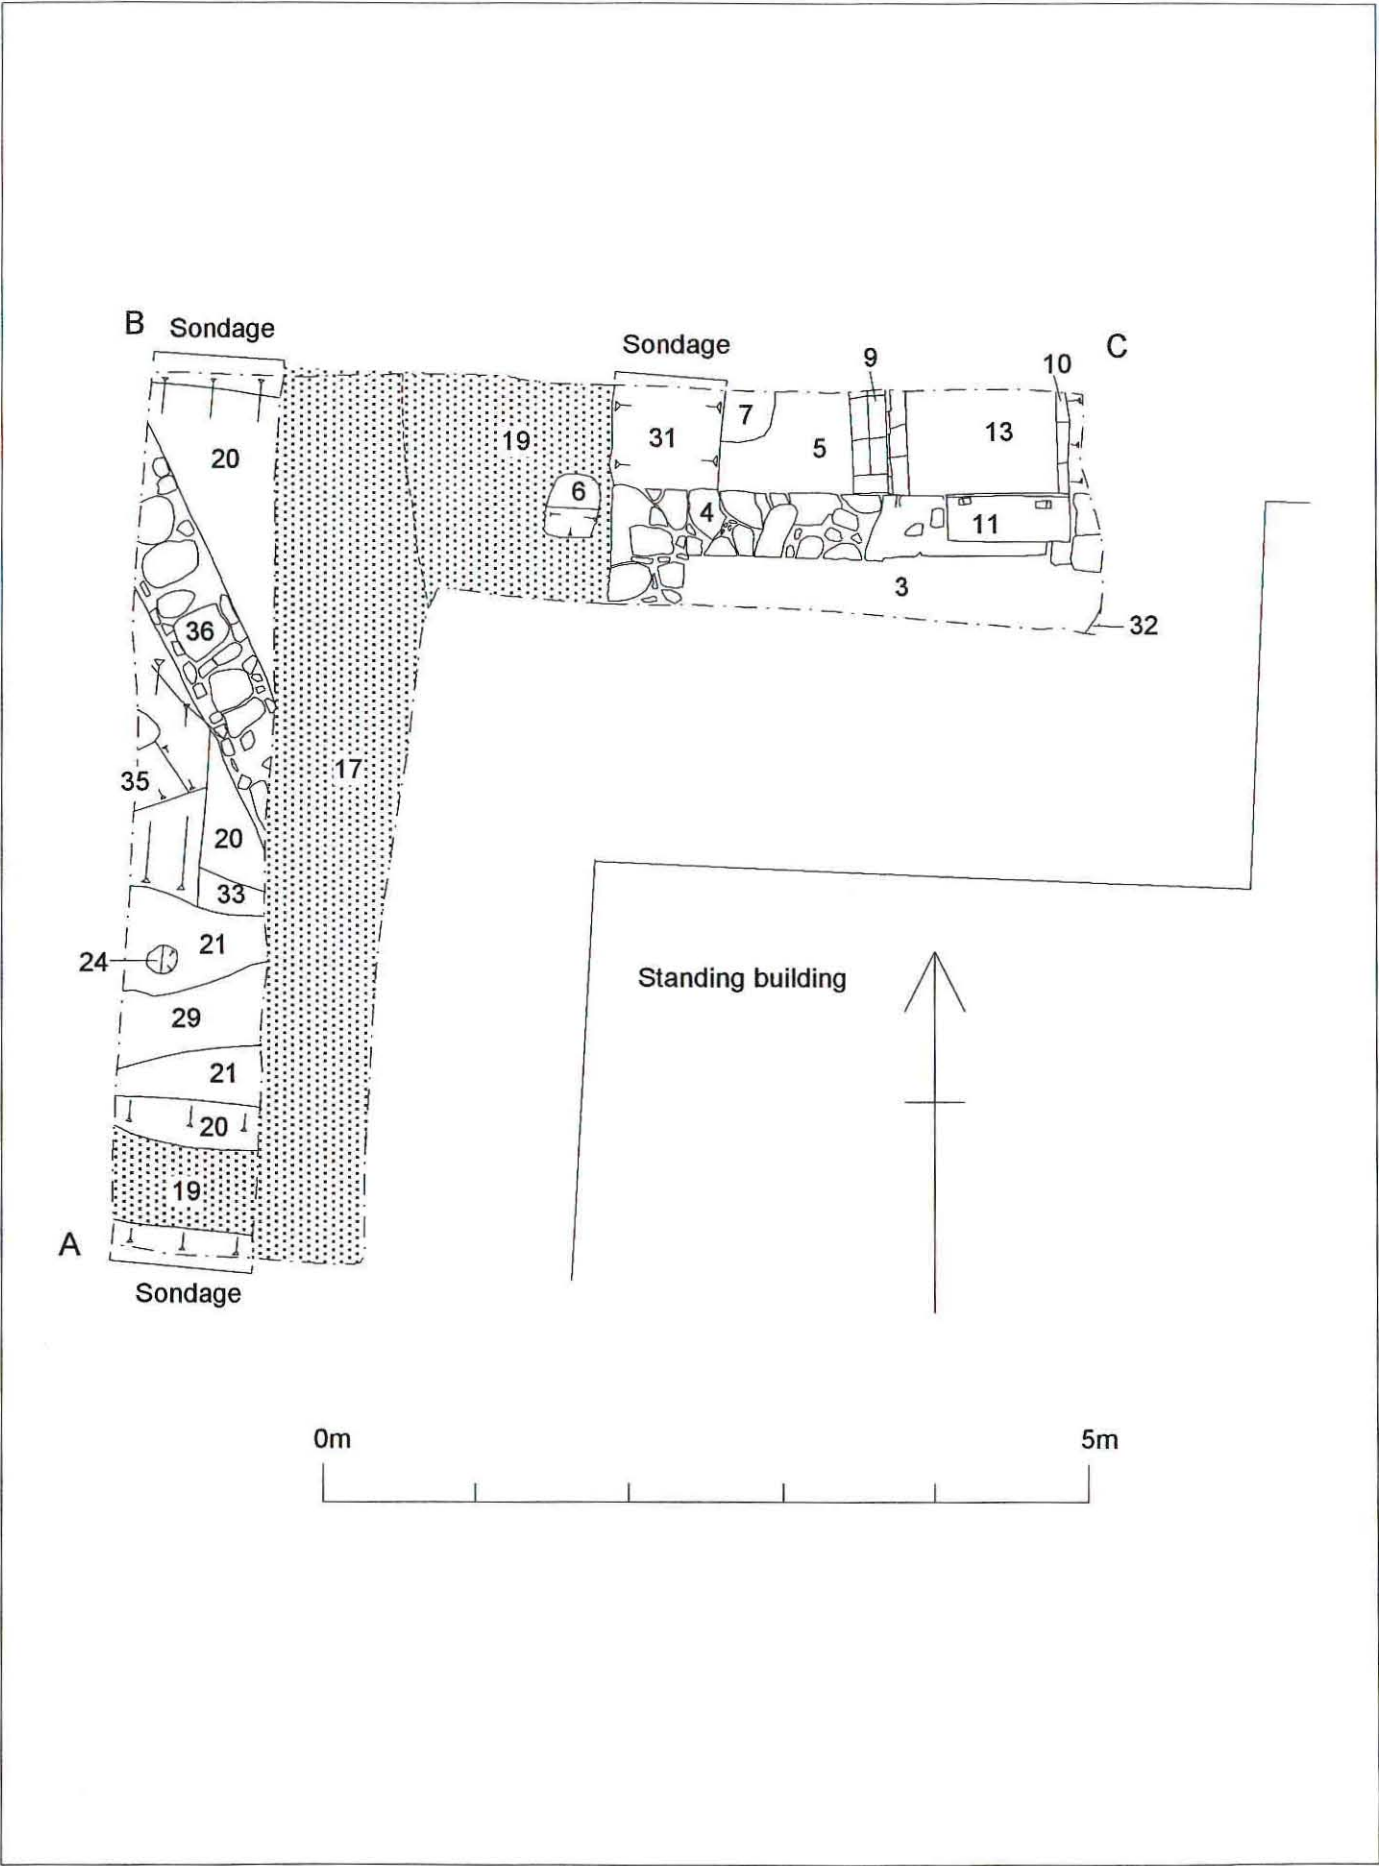
Fig.10 Trench plan Scale 1:50

- 5.1 The evaluation consisted of a single, L-shaped, machine-excavated trench, the size and position of which were determined following discussions with the client and curator. Machine excavations were undertaken under close archaeological supervision, initially onto the surface of the first recognisable archaeological horizon. A drawn, written and photographic record was maintained throughout (see Appendix 2).

- 5.2 The initial machining of the south arm of the trench removed a modern accumulation of material, up to 0.2m thick, consisting of a layer of chippings (1) resting on a very dark grey sticky silt (16). In the east arm of the trench, these deposits thinned out and were replaced by an underlying layer of loose dark grey gritty silt (2), up to 0.22m thick; this was also removed by machine. The removal of these modern deposits revealed a compacted layer of brick and stone (17) in the south arm of the trench which represented a former yard surface, and this was recorded and photographed prior to the excavation of a 1m-wide sondage against the west section of the trench by machine.

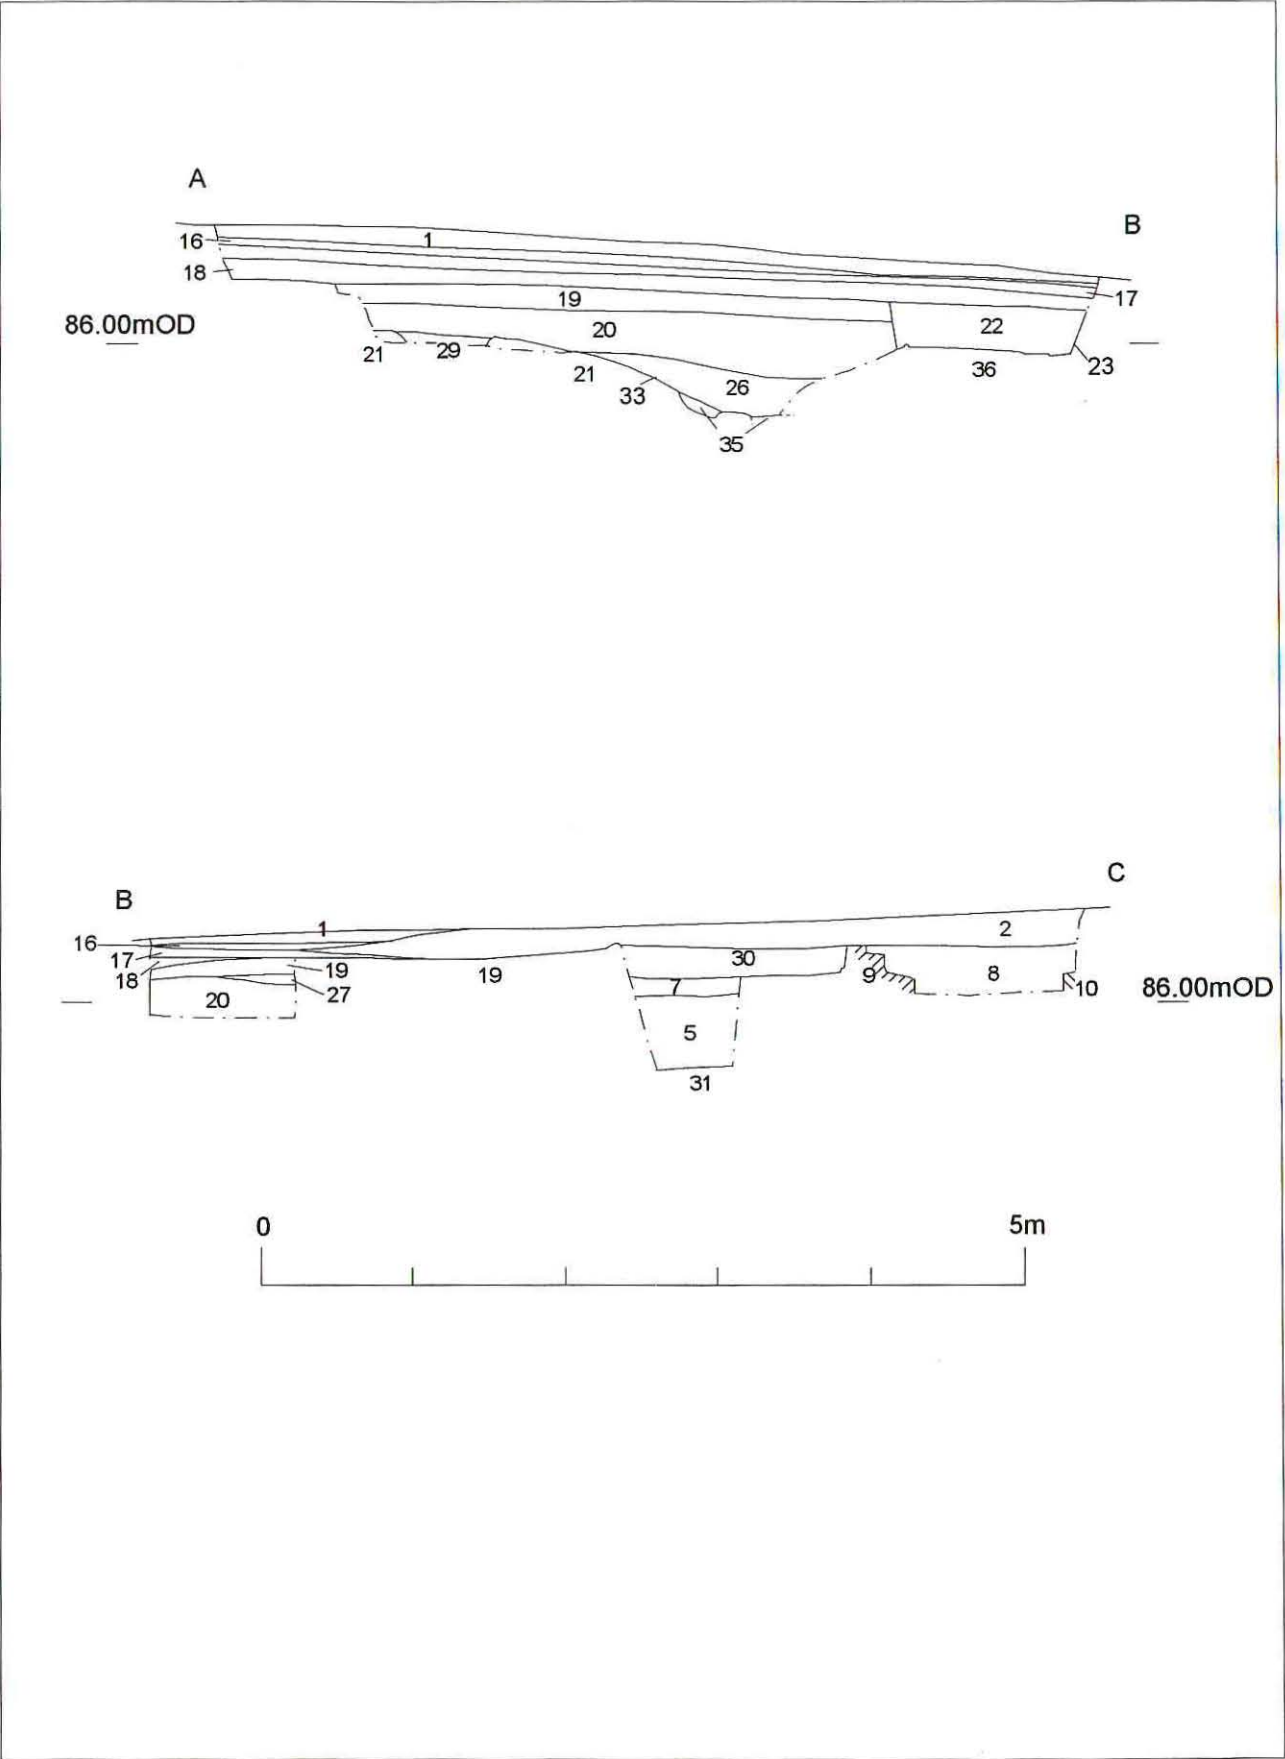
Fig. 11 Trench sections. Scale 1:50

- 5.3 Within the machine-excavated sondage, the removal of layer 17 demonstrated that it was up to 0.1m thick and overlay a layer of orange-brown clay (18), up to 0.15m thick, into which the stone and brick of layer 17 appeared to have been set. Layer 18 was also removed by machine and found to be underlain by a second former yard surface (19), c.0.1m thick, consisting of rounded stones set in a grey-brown silty matrix to form a cobbled surface. At the south end of the sondage a 0.7m-long section of layer 19 was left in-situ to aid recording with the remainder being removed by machine.

- 5.4 The removal of layer 19 revealed a layer of grey-brown clayey silt (20) containing finds ranging in date from the 17th to 19th century. Up to 0.3m of layer 20 was removed by machine with the remainder being excavated by hand to its maximum depth of 0.4m. At the south end of the sondage layer 20 was found to overlie a layer of pale yellowish-grey clay subsoil (21). This layer was presumed to be of natural origin, though some charcoal was present in its upper surface towards the central part of the trench; this may denote that the layer is artificial in origin, but it is perhaps more likely that it represents material compacted into the subsoil.

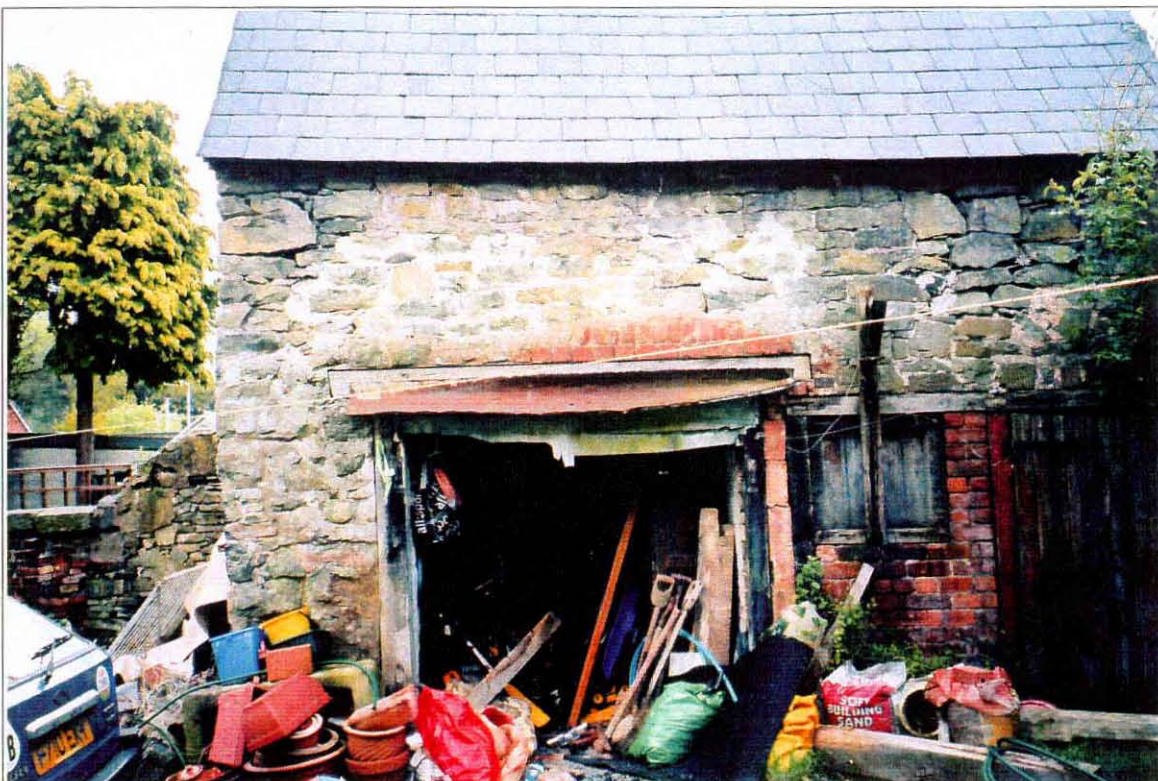
Plate 2 West elevation of existing building to rear of No 22 High Street. Photo CPAT 1193.03

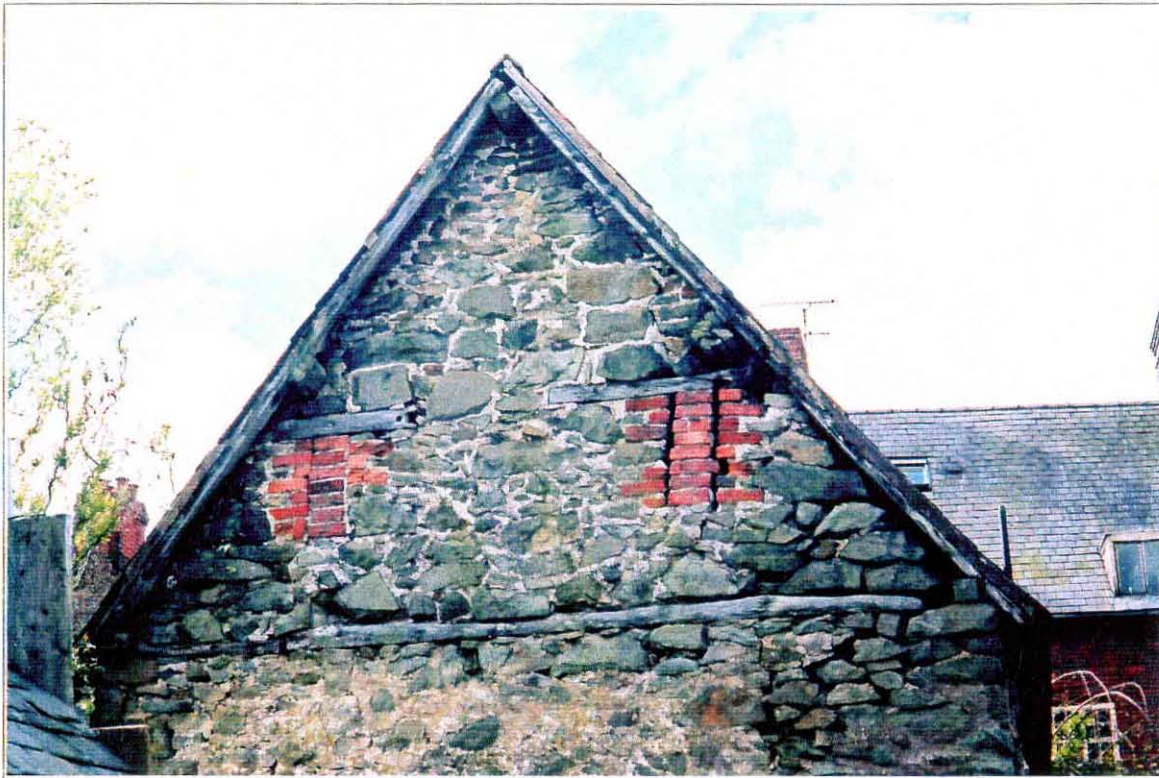
Plate 3 Upper part of north elevation of existing building to rear of No 22 High Street. Photo CPAT 1193.01

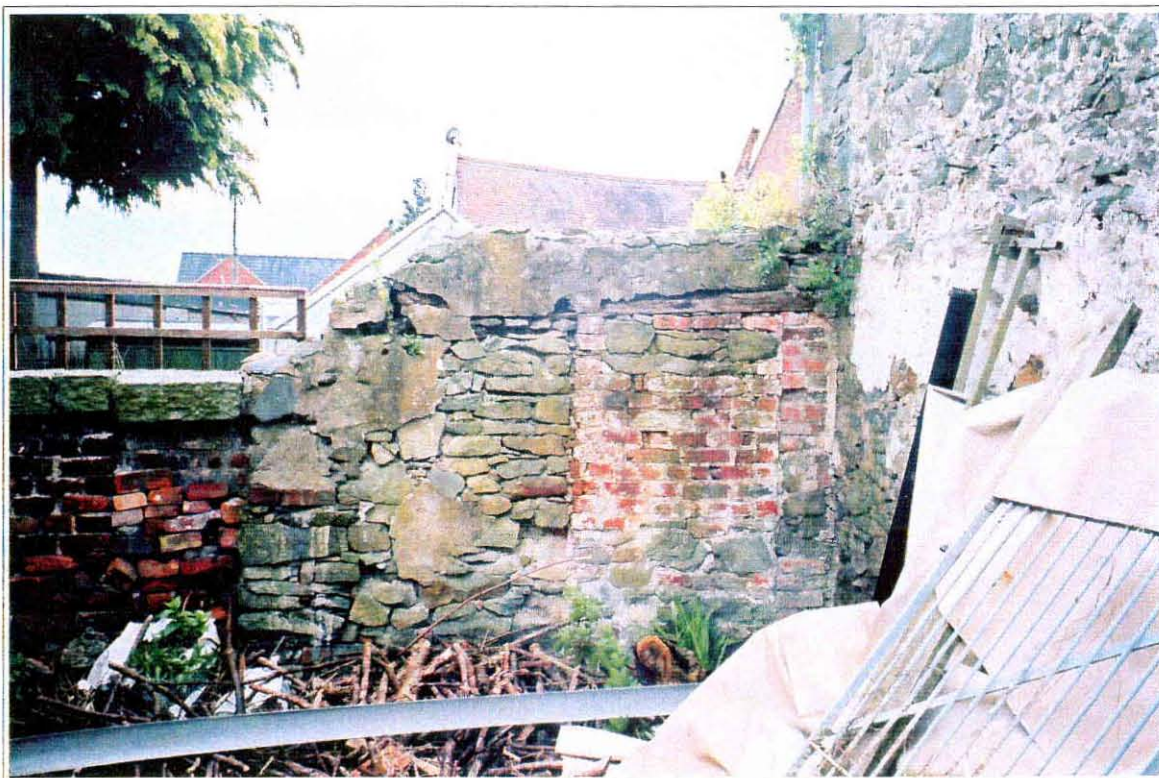
- 4.6 The lower part of the east wall of the lean-to survives (Fig. 8; Plate 4), measuring 2.6m in length, forming the boundary wall between 22 and 23 High Street. The random rubble build has a blocked doorway with timber lintel. The scar for the northern, end wall of the structure can be traced in the masonry.

Plate 4 East wall of former lean-to on north wall of existing building to rear of No 22 High Street.
Photo CPAT 1193.02

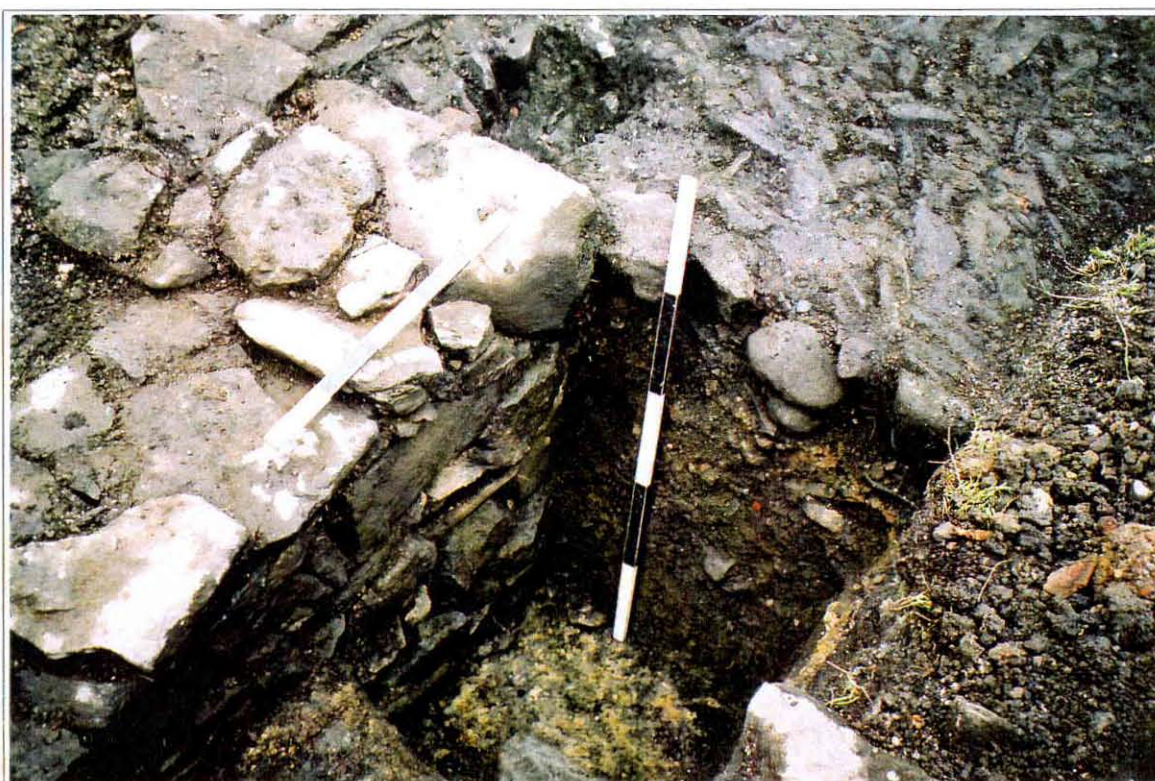
- 5.8 The main feature of the east arm of the trench was the wall of a lean-to structure on the north end of the existing building; the lean-to structure had already been identified by the desk-top study and its surviving east wall had been recorded during the building survey. A wall (4) forming a right-angle at the intersection of the north and west sides of the lean-to was constructed of random stones with no mortar, but apparently bonded with brown silt. Approximately 1.7m from the north-west corner, the north wall had been cut through by a drain (13) and then rebuilt using two large dressed stones with other stones set in lime mortar (11); one of the dressed stones was a re-used door jamb and retained some ironwork from two hinges. The drain, which had been cut through a layer of grey-brown clay-silt (5), had been lined on either side with brick (9 and 10). The interior of the lean-to was not completely investigated and excavations here were limited to the removal of a layer of plaster rubble (32), probably originally on the interior of the wall, which revealed a layer of grey degraded slate (3), evidently collapsed roofing material.

Plate 6 Hand excavated sondage against north wall (4) of lean-to from north-east. Photo CPAT 1190.10

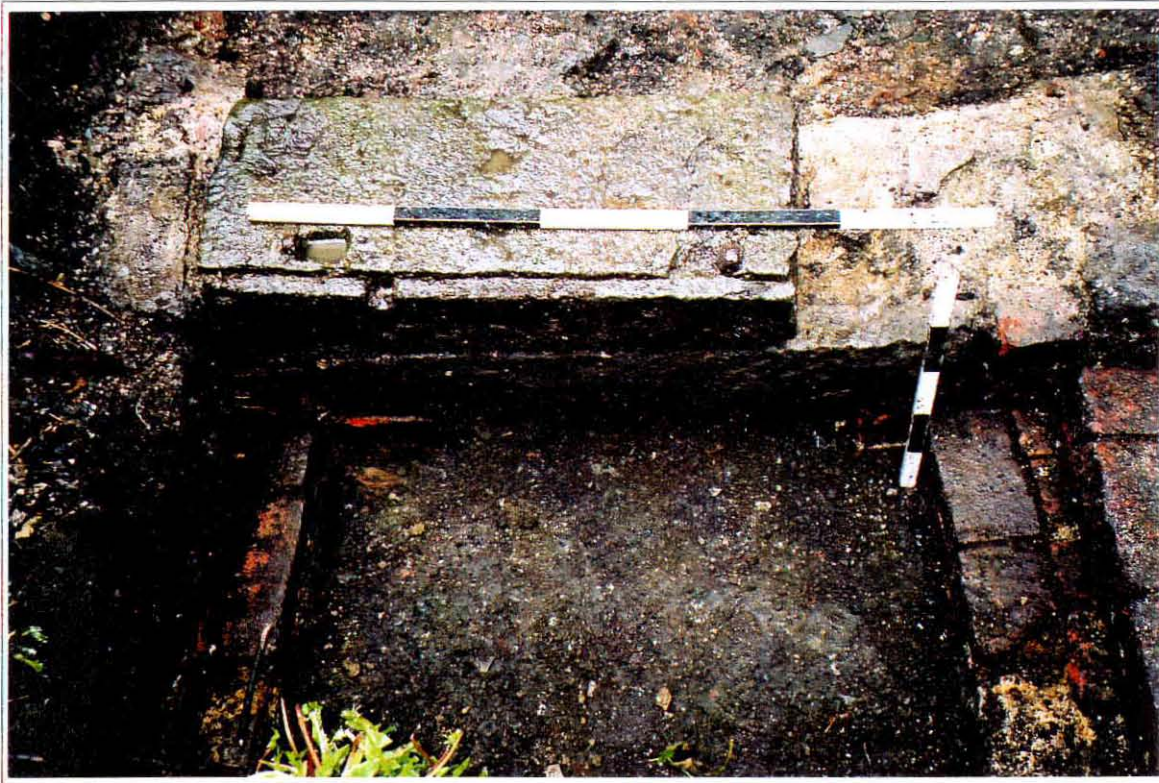
Plate 7 Drain (13) in north wall of lean-to from north. Photo CPAT 1191.07

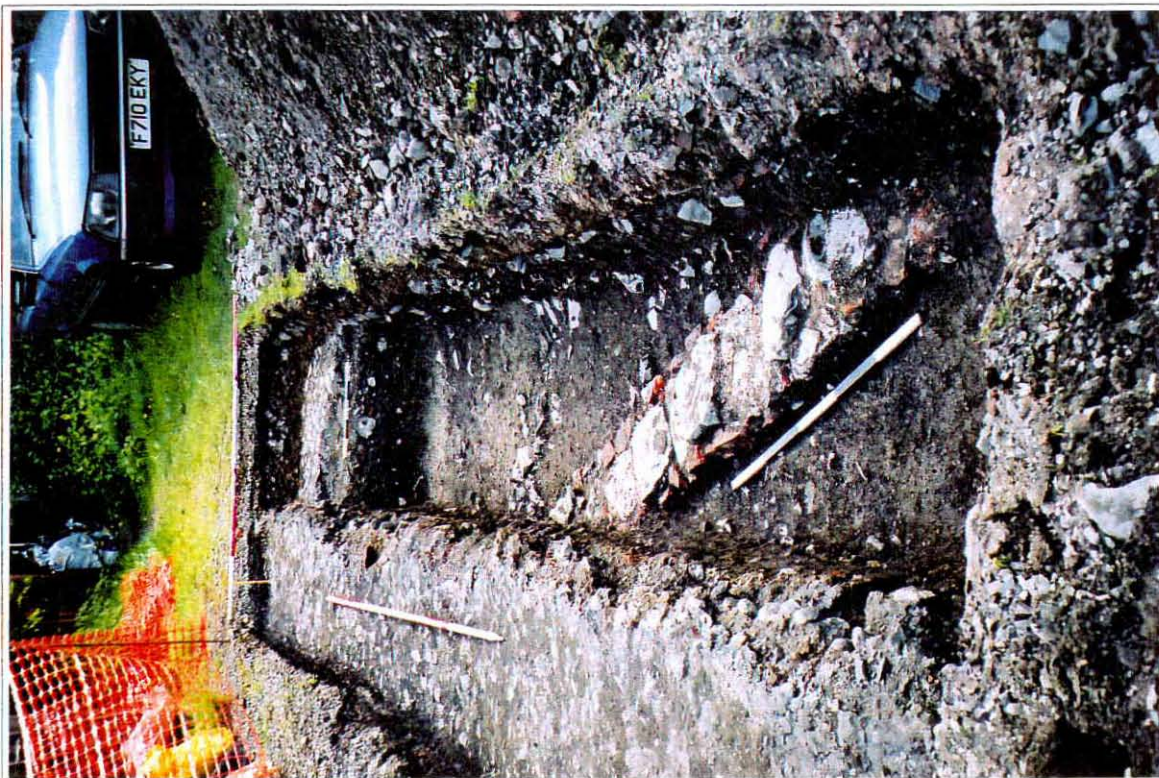
Plate 8 Machine excavated sondage against west section of trench from north. Photo CPAT 1191.08

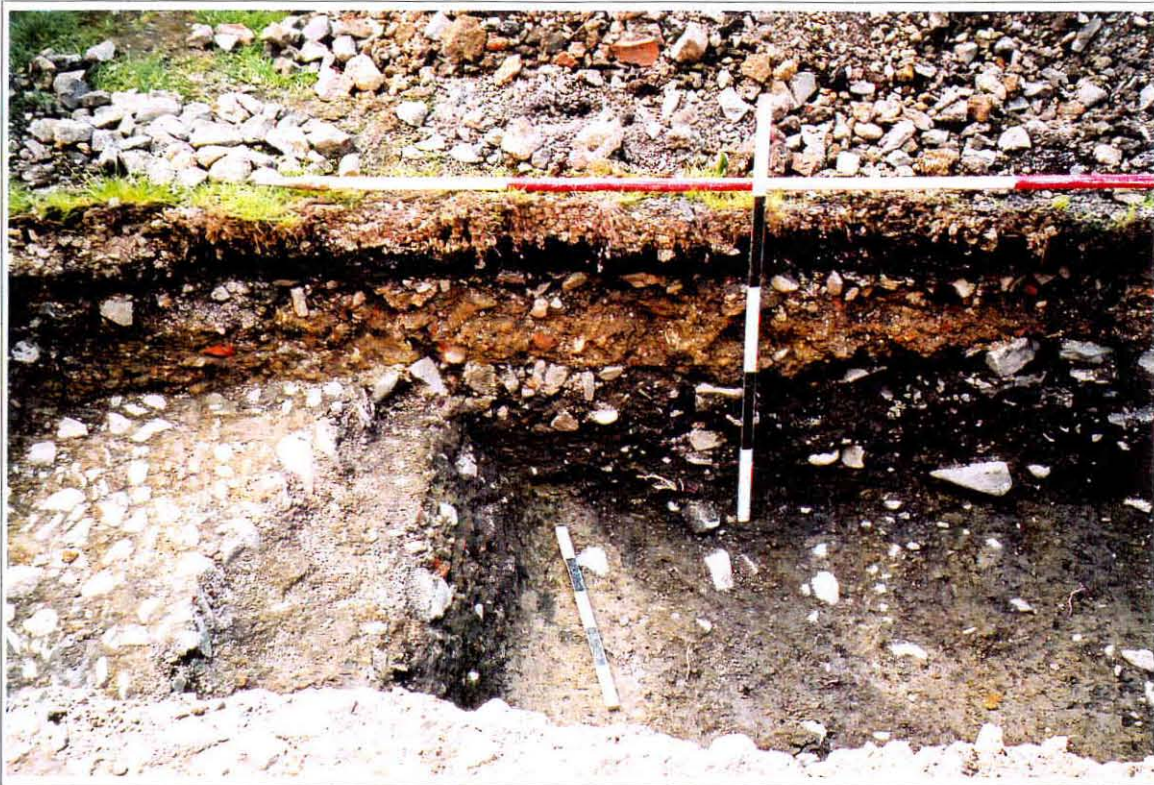
Plate 9 Sequence of yard deposits with gully (29) and scoop (24) in base of sondage from east.
Photo CPAT 1191.07
