CPAT Report No 476

**Land off Bowling Green Lane,
Welshpool, Powys
ARCHAEOLOGICAL EVALUATION**

N W Jones and R Hankinson
May 2002

Report for Trustees of the Powis Estate

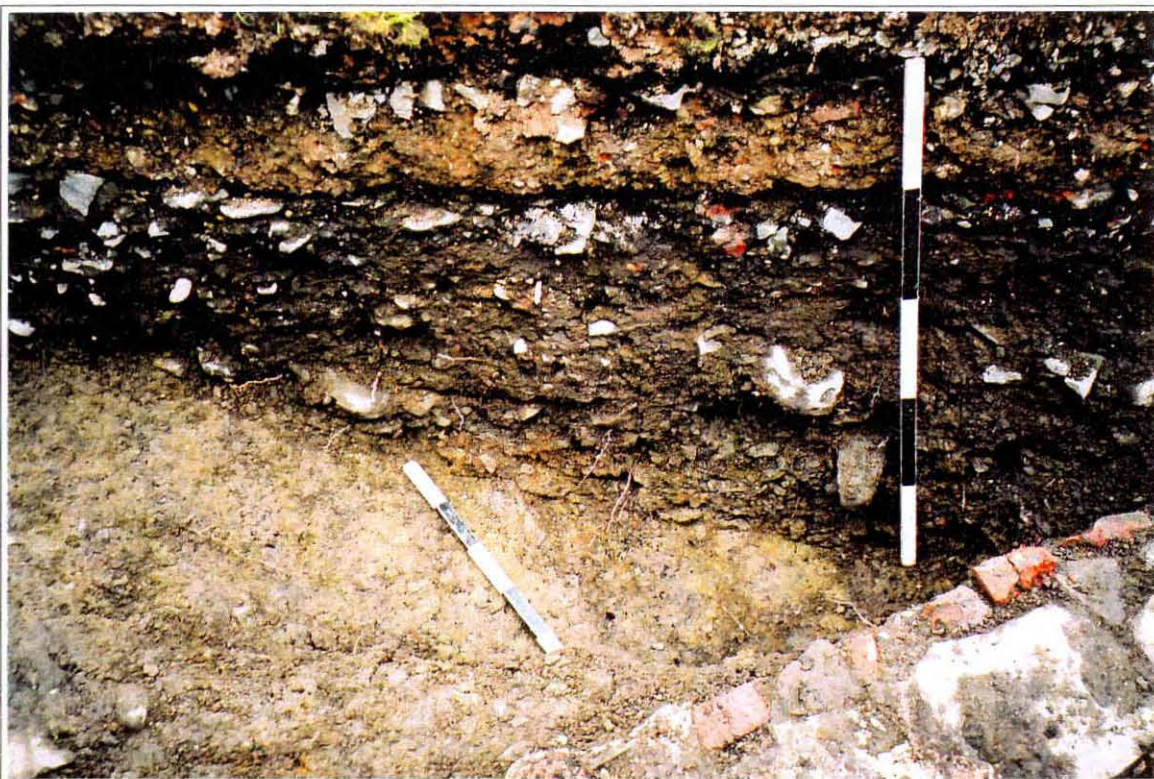
- 5.5 A small number of features had evidently been cut into layer 21, but none of these revealed any underlying stratigraphy, thereby supporting the contention that this may be natural subsoil. At the southern end of the base of the sondage, an irregular gully (29), generally 0.4m wide, crossed it in an east/west direction; this feature was not excavated as its fill (28) had already produced pottery of 17th-18th century date, but it appeared to have been sealed by layer 20. To the north of gully 29, a sub-circular scoop (24), 0.2m in diameter, was revealed which had been cut into layer 21; no dating evidence was present in its fill of brown silt (25). Further to the north, a probable broad gully (33), at least 0.3m deep, was revealed; only its south part was visible as the remainder was covered by a later drain (36). The fill (26) of gully 33 was composed of brown clayey silt and contained sherds of 14th or 15th-century pottery. At the base of gully 33, an anomalous gully (35), possibly L-shaped, and approximately 0.4m wide by 0.1m deep, was revealed; the fill (34) consisted of mixed pale brown clayey silt and contained fragments of daub and a single sherd of 14th or 15th-century pottery.

Plate 10 Section through fill (26) of gully (33) showing gully (35) in base from east. Photo CPAT 1191.11
