*Radnorshire Historic Settlements:  
Earthwork Survey 1995-6*

by N W Jones and W J Owen  
March 1996

**The Clwyd-Powys Archaeological Trust**  
7a Church Street Welshpool Powys SY21 7DL  
tel (01938) 553670, fax 552179  
© CPAT 1996

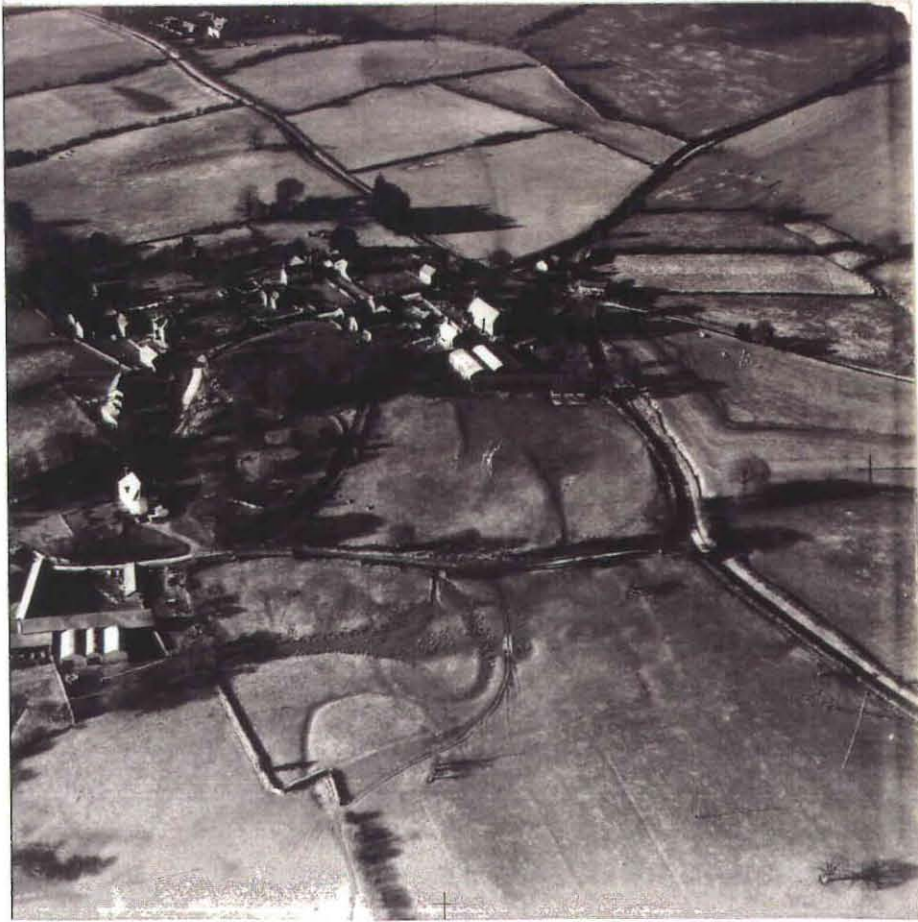
2.1 The surviving earthworks present an interesting and unusual example of a series of water meadows. The earthworks are clearly shown in an aerial photograph (Plate 1) taken in 1969, but have since been considerably reduced by ploughing in the eastern field.

Plate 1: Kinnerton from the SE showing shrunken settlement (PRN 33023) and water meadows (PRN 19349). Photo/copyright Cambridge University (AWO 96).

3.1 A series of slight platforms, tracks and field banks indicate the former existence of buildings and associated field systems which presumably form part of the medieval settlement. The earthworks fall into two groups, separated by a series of features associated with the former water meadows (see PRN 19349 below), a post medieval farmstead (PRN 4483) and a modern farm track, which may well have obscured evidence of further settlement earthworks. An aerial photograph (Plate 1) taken in 1969 shows many of the earthworks, which have been seriously denuded by ploughing since that time.

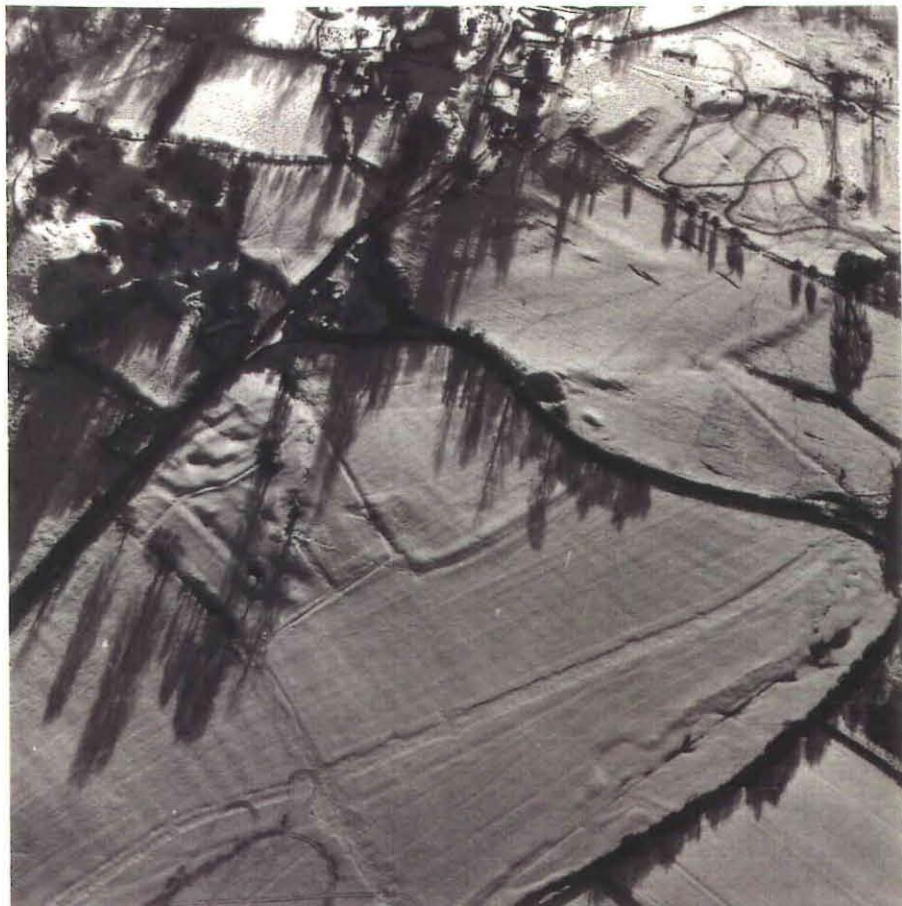
Plate 2: Old Radnor from the NE showing shrunken settlement earthworks (PRN 5296). Photo/copyright Cambridge University (CIJ 33).
