Pant Quarry, Halkyn, Flintshire
ARCHAEOLOGICAL ASSESSMENT

CPAT Report No 280

N.W.Jones, R.Hankinson & P.Frost
December 1998

Report for ASH Consulting Group

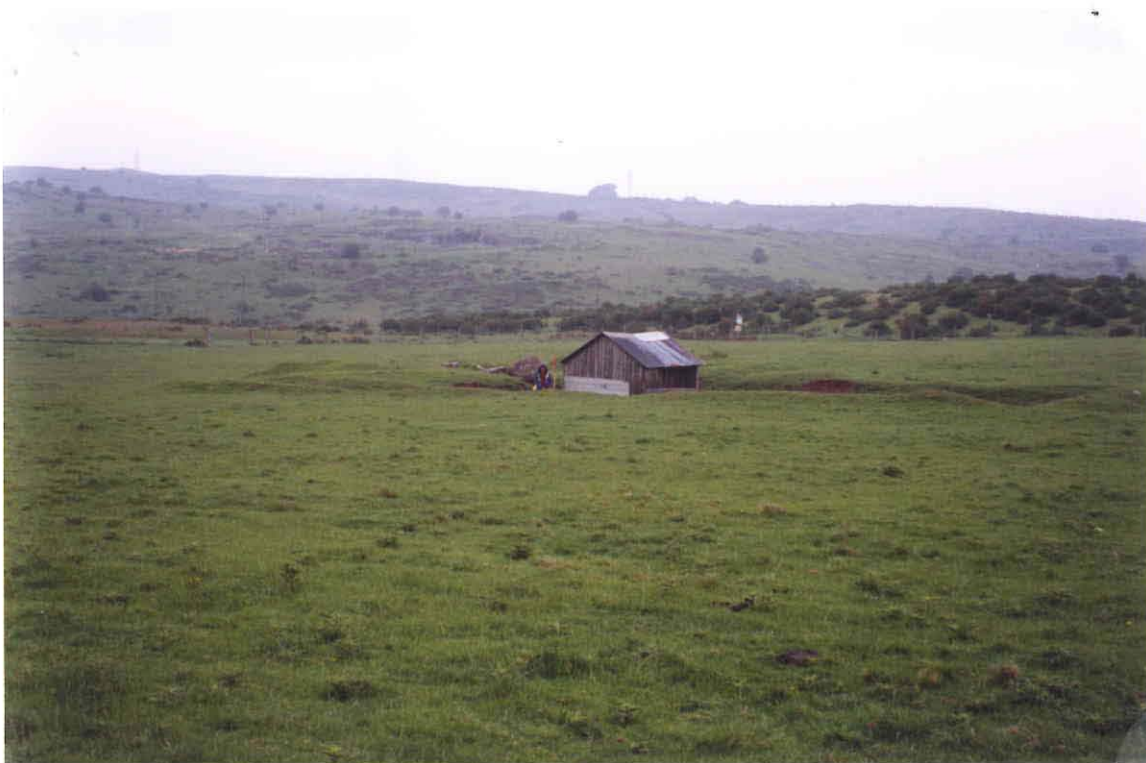
Plate 1. Site 1 from SSW. Photo CPAT 722.24

1 SJ1954870270 Bryn Siriol Reservoir
Square shaped reservoir measuring 17m x 17m internally x c.1.5m deep. Cut into ground level, with slight external bank, 2m wide x 0.3m high present on NE, SE, & SW sides. NW side defined by spoil resulting from excavation of reservoir. Area of spoil measures 15m NW/SE (max) x 37m NE/SW x 1.2m high. The spoil has been cut by a modern track leading to the N corner of the interior. Corrugated iron clad shed present in interior. At W corner of interior a gully approx 0.5m above the internal level heads in a NW direction towards the nearby shaft (Site No 2). The gully is cut into the SW end of the spoil and measures 1.2m wide x 0.3m deep x 10m long; it may have been disturbed to the NW or the water could have been carried by a launder. Presumably the reservoir acted as a store for water from, or intended for use in relation to, the shaft (Site No 2).

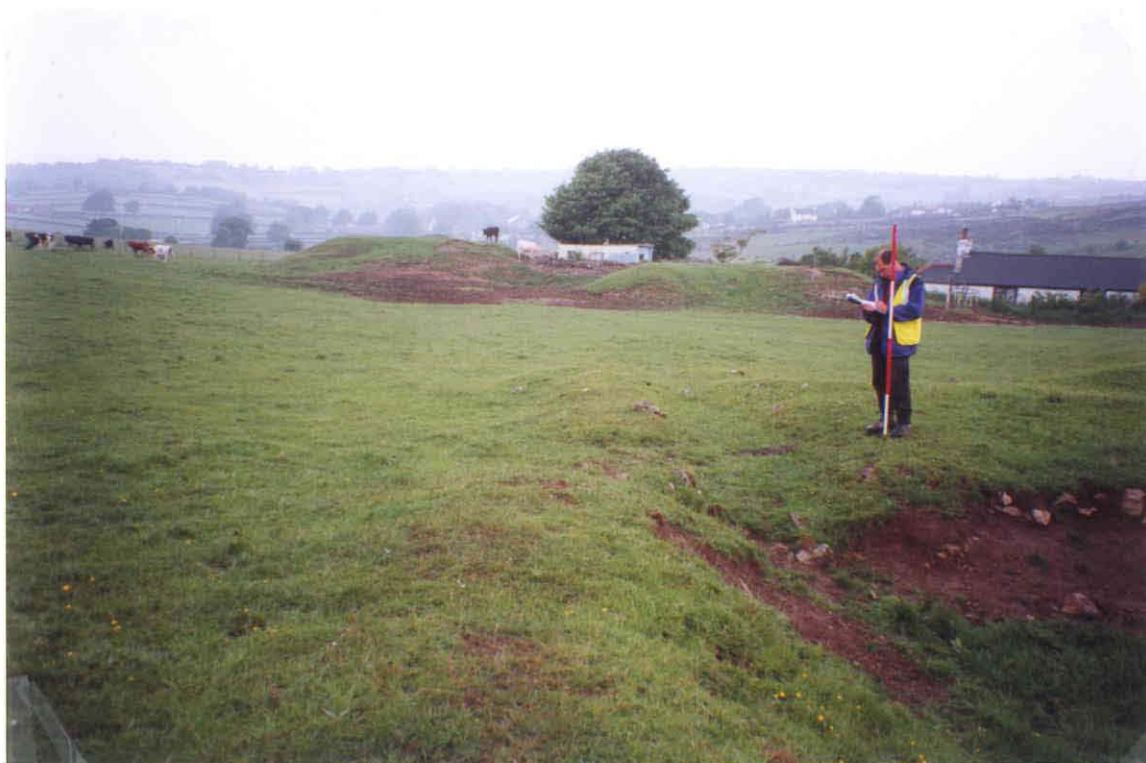
Plate 2. Site 1 gully at NW corner with Site 2 in background from SE. Photo CPAT 722.23

2 SJ1945870315 Bryn Siriol Shaft I
Shaft, now collapsed and partially filled with household and agricultural waste, located to S of Bryn Siriol house. Shaft collapse zone measures c.10m diameter and is located between two large spoil tips. A wall (Site No 3) to the N of the shaft extends for approx 16m. From the W spoil mound a line of 4 hollow iron rods extends towards the wall with two rods in-situ in the wall. Several iron rails lying loose. Local resident (related to owner of Bryn Siriol) commented that the W spoil mound contained a gypsy caravan (apparently containing old motorbikes !) which had been buried to provide an air raid shelter during World War II.
Depicted on third edition (1912) Ordnance Survey map.

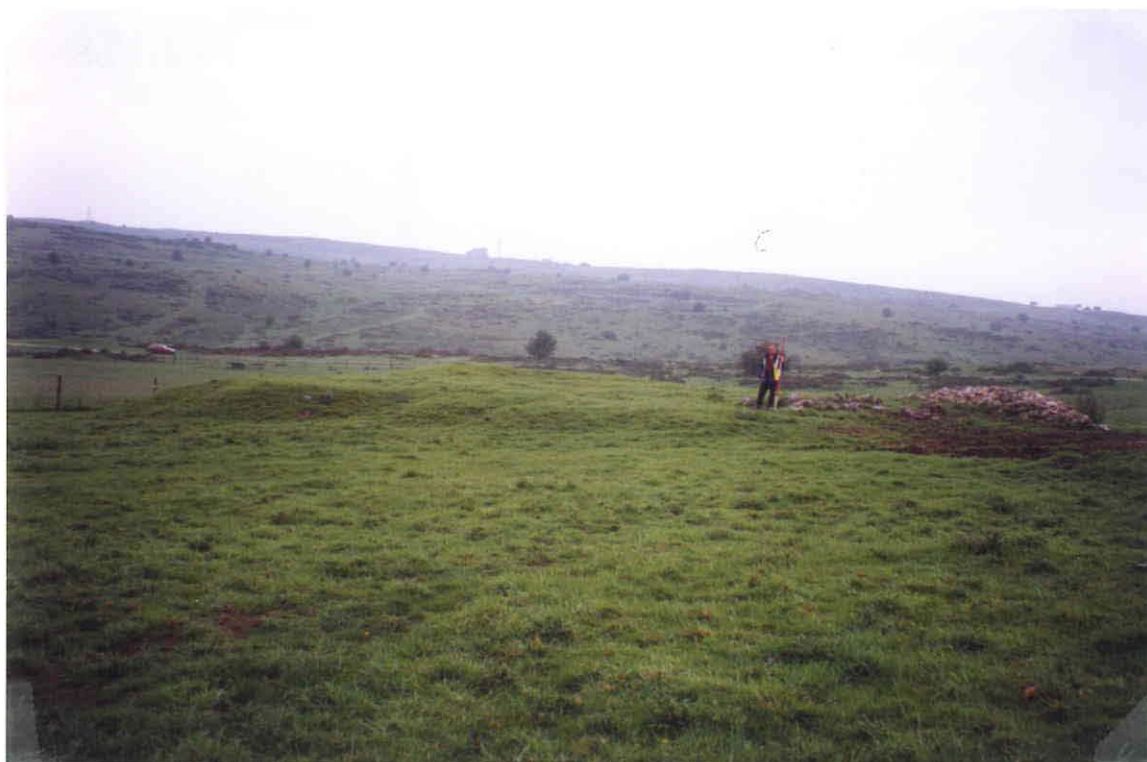
Plate 3. Site 7 from SW. Photo CPAT 722.19

7 SJ1935270286 Bryn Siriol Shaft V
Possible shaft present in large, partially levelled, spoil mound, measuring 30m E/W x 30m N/S x 2m high (max). Slight depression towards W part of mound may be the shaft. Shaft may form an alignment with other shafts (Site Nos 2 & 6). Depicted on first edition (1875) and third edition (1912) Ordnance Survey maps.
