Montgomery Canal Conservation Management Strategy

LANDSCAPE ARCHAEOLOGY ASSESSMENT

CPAT Report No 550

By N W Jones, R J Silvester and W J Britnell
August 2003

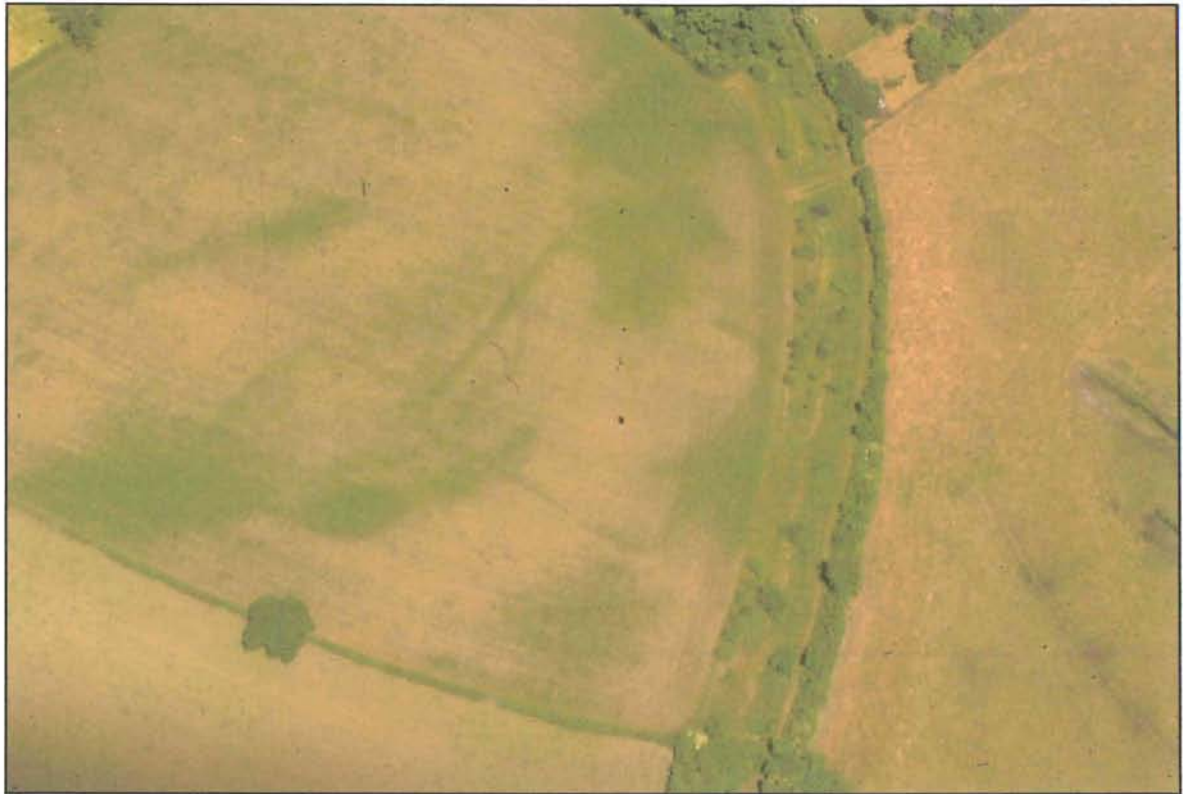
Plate 1 Crickheath Wharf Enclosure (SA 1079). Photo CPAT 84-c-105

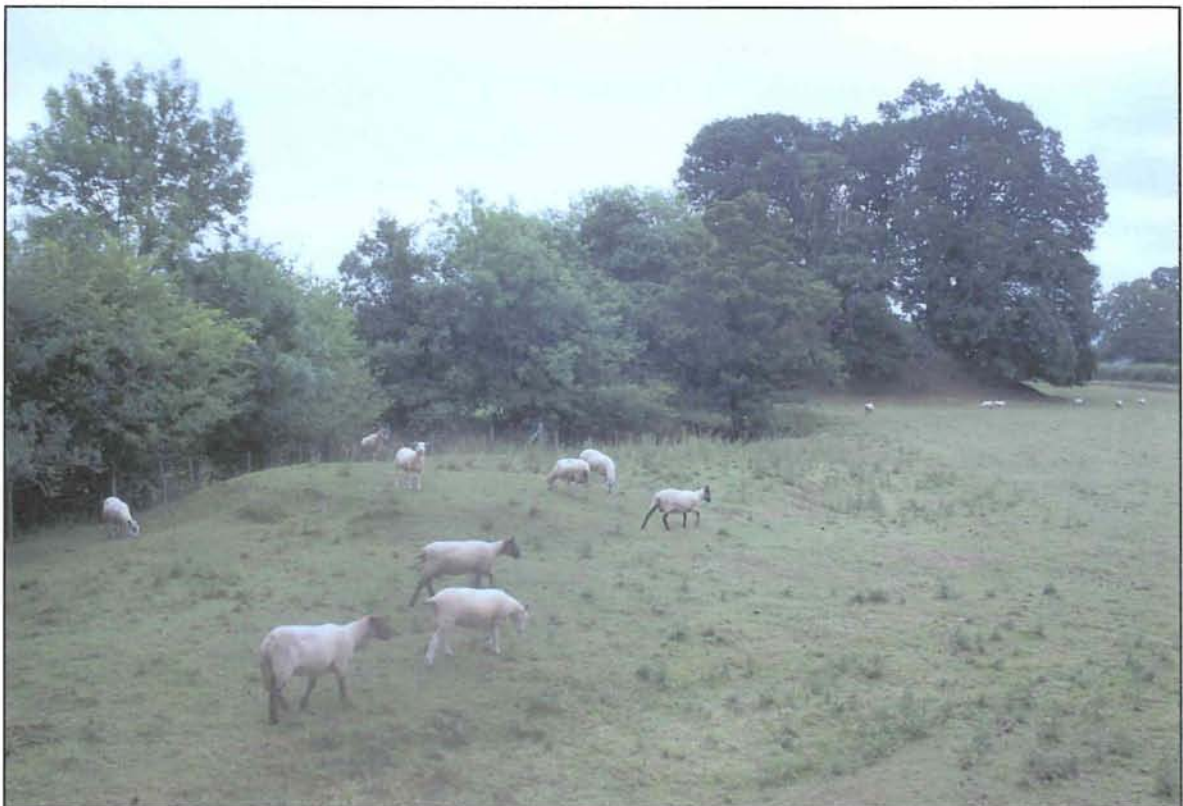
Plate 2 Upper Luggy House Platform I (PRN 8554) and Luggy Motte (PRN 110)
