Caergwrle Castle Fields, Flintshire

ARCHAEOLOGICAL ASSESSMENT
& MANAGEMENT REPORT

CPAT Report No 475

C H R Martin and A E Kennedy
April 2002

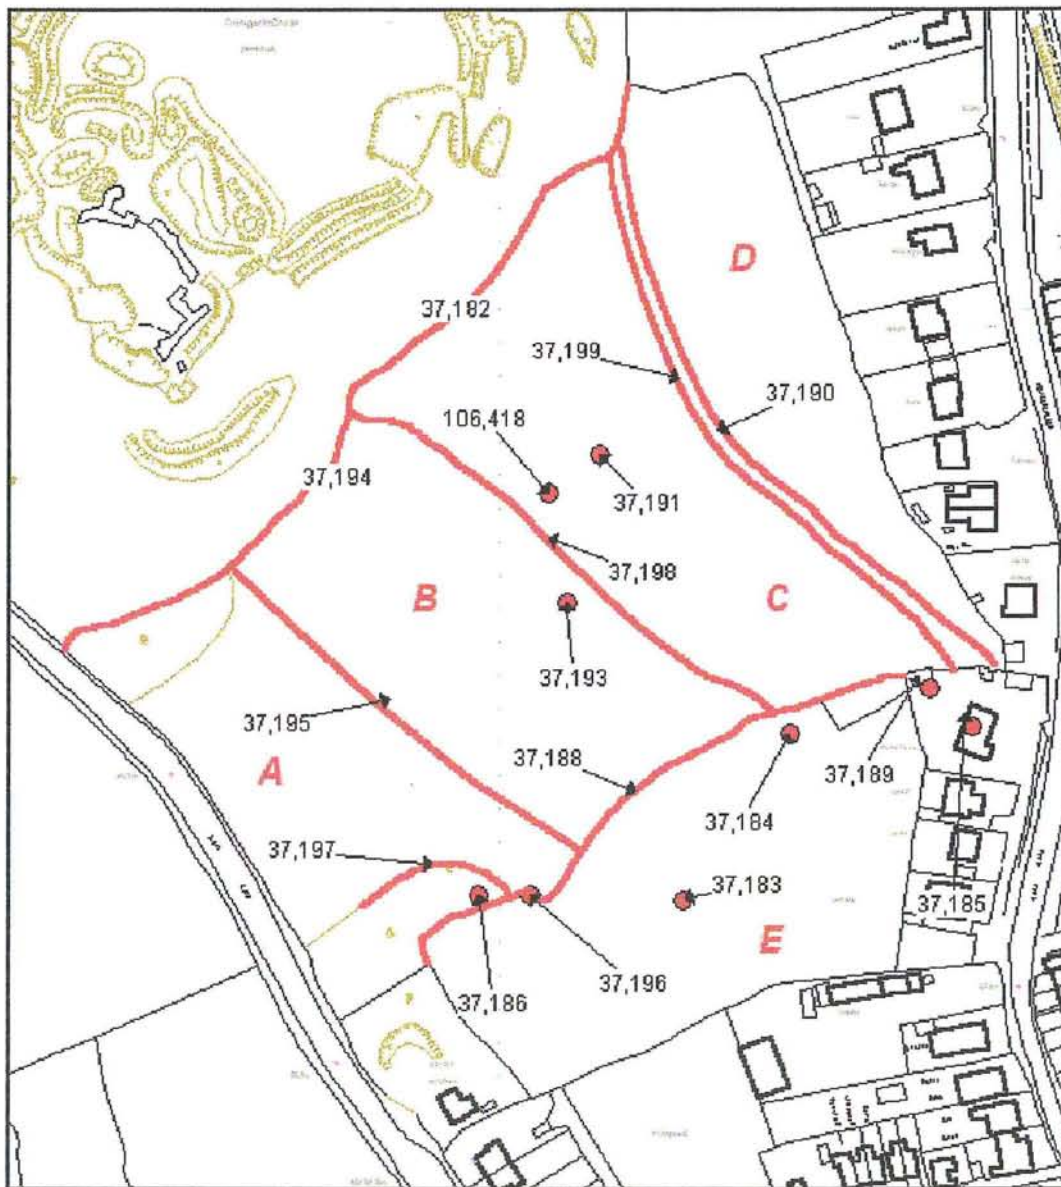
Figure 1: Location of sites mentioned in text

The group of five, similarly sized (approximately 150m by 50m), rectangular fields (labelled A - E on Figure 1), known as Castle Fields, lie to the south of and below Caergwrle Castle. B and C occupy a plateau on a ridge, which slopes progressively from north to south, with their long axis following the line of the ridge. These are flanked by fields A and D on west and east respectively, with field A occupying the steeply sloping west facing side of the ridge side while D occupies the slightly lower ground to the east, which gently slopes towards the River Alyn. Field E, which lies 'at right angles' to the others, occupies the ground beyond the break in slope at the southern end of the plateau and itself slopes quiet sharply to the south.

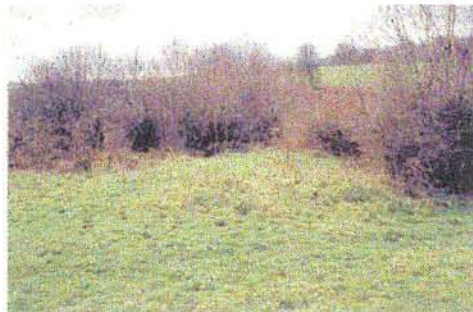
37185 Caergwrle Castle Fields, farmstead

A small densely overgrown enclosure, shown on the Tithe Map, and now marked on the ground by a much tumbled stone wall (PRN37197) and surrounded by a number holly trees, at the south western corner of Castlefields. It has the appearance of a paddock around a building and may mark a former house site or small farmstead. Presumably out of use by the mid C19th. (CPAT site visit, 22/03/02)

The site is relatively stable and ideally should be maintained in its present general condition. However the site is untidy (containing some rubbish and dead undergrowth) and limited clearance could be considered after consultation with CPAT. On no account should any structural remains or other stone be removed from the site nor any part of the site dug into.

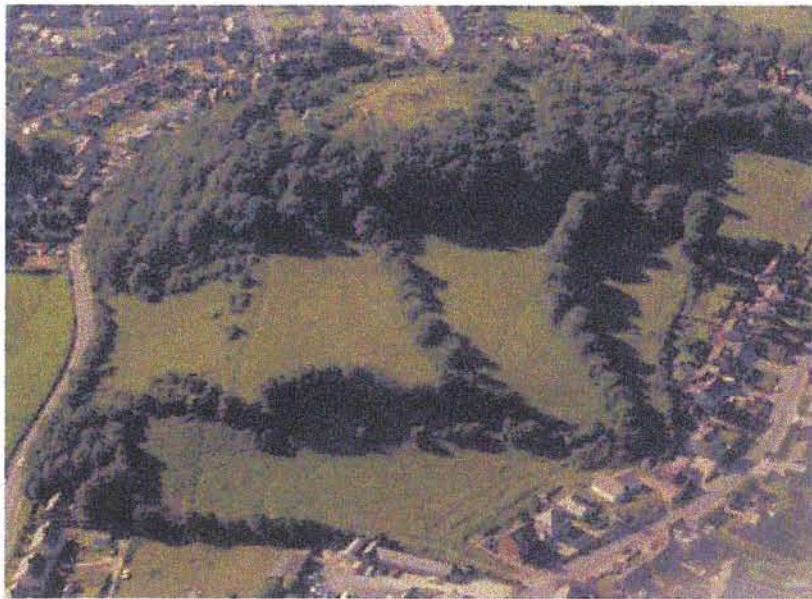
37184 Caergwrle Castle Fields, field system

System of what is now four, although until fairly recently has been five, rectangular fields. Sited on a small plateau below Castle Hill Caergwrle, the fields are demarked by low earth and stone hedge banks of some age. Hedgerow analysis of the surviving species of these hedges has suggested that the boundaries might have been in place for up to 600 years, although this is not corroborated by any field evidence. The boundary between the eastern most field and the rest is potentially the most interesting as it is a terraced trackway formed against a massive revetted lynchet (PRN37188 & PRN37199 respectively) and contains a number of now mature trees which show signs of extensive management and may even at one time have been part of a laid hedge. The four enclosures closest to the castle are reminiscent of small medieval strip fields running north west - south east (with one at a lower level running at right angles) and has the appearance of a small possibly medieval field system associated with the castle. The supposed presence of ridge and furrow (PRN37189) might add weight to this notion. (CPAT site visit, 22/03/02)

The field system as a whole is under a relatively stable pasture regime and should be maintained in this state, with stock being limited to prevent erosion. At the time of the visit, the fields were occupied by a single horse and while that stocking level is as low as it can be, horses are a significant cause of erosion and any increase in their number might well be detrimental to the site. Cattle in any numbers may be equally as damaging and the most acceptable alternative may a limited number of sheep. Ploughing should be avoided on any of the fields - if pasture renewal is necessary this should be achieved by other means.

Some of the scrub areas, away from the established hedge lines, could be cleared if required, but only after consultation with CPAT.

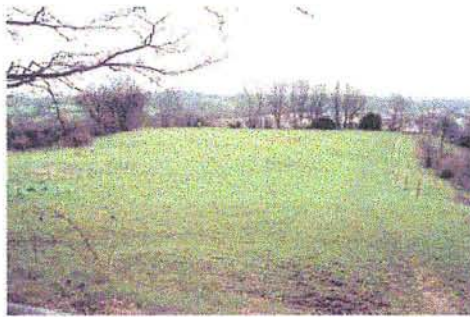
37198 Caergwrle Castle Fields, field system, boundary

Low bank forming one side of 'medieval strip field'. Topped by hedge and mature trees. (CPAT site visit, 22/03/02)

This hedge bank is in a generally stable condition, and should be maintained in this state. From an historic environment perspective, the most important element here is the bank rather than the hedge - as the earthwork is a non-renewable resource (unlike the hedgerow). Therefore extra care must be taken to avoid damaging the bank in any future maintenance work. The hedgerow and its trees will require attention in due course (and certainly before the bank suffers any damage from wind throw or the like) but, as long as none of the distinctive species are unnecessarily removed, this may be undertaken with relative safety. In any maintenance operation the earthwork bank on which the hedge sits should be left undisturbed - stumps should be left to rot in situ rather than being dug out be, no new access ways should be cut through the bank, no part of the bank should be leveled.

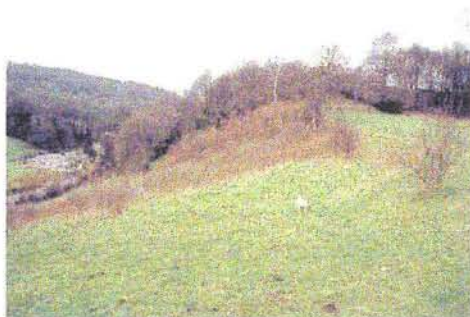
37195 Caergwrle Castle Fields, field system, boundary

The line of a former field boundary shown on the Caergwrle Tithe Map and early OS editions. Apart from a vague line of isolated hedgerow trees there is now no indication on the ground of its original form - there is no obvious bank surviving and this boundary may never have been more than a hedge. The boundary has now been replaced by a post and wire fence slightly to the east of its original line. (CPAT site visit, 22/03/02)

The line of this field boundary has little or no physical presence and no specific management recommendations are made here. However prior consultation of CPAT should be made before any significant disturbance across its line.

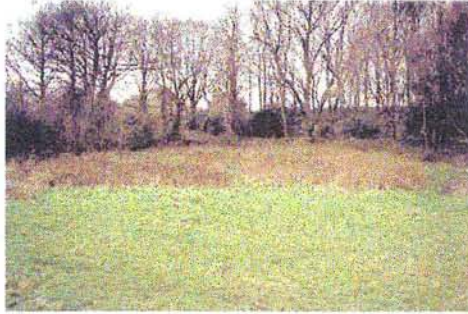
37194 Caergwrle Castle Fields, field system, boundary

A substantial earth bank, revetted in places with stone towards its western end, marking the junction of the potential medieval field system PRN37184 and the base of Caergwrle Castle Hill. The bank is now topped by a low dry stone rubble wall which has no appearance of great age, and which has now been replaced by a post and wire fence. It is different in character from the other boundaries of the field system (which are mostly low hedge banks). (CPAT site visit, 22/03/02)

This boundary is in a generally stable condition, and where possible should be maintained in this state. As with the hedged boundaries any repairs to the wall and fence line must be achieved with a minimum of damage to the underlying bank - stumps should be left to rot in situ rather than being dug out, no new access ways should be cut through the boundary, no part of the bank should be leveled, any repairs to the wall should be done only with stone from an agreed source.

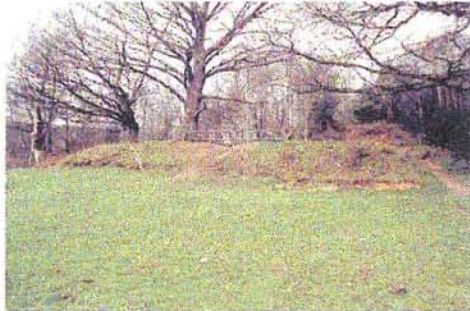
At the boundary's west end, the post and wire fence has been damaged and replaced by a temporary arrangement of scaffold poles. Considerable erosion has occurred at this point where the footpath crosses the fence line. Consideration should be given to consolidating the path here and inserting a gate or stile to avoid this scar spreading further.

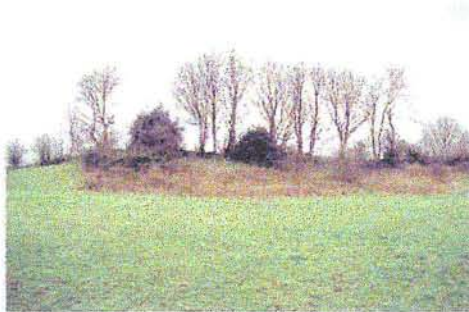
37186 Caergwrle Castle Fields, field system, boundary

Field boundary formed of a stone and earth bank, and sporting a number of mature trees, running along the crest of the scarp above the lower of the Castlefields fields and marking the edge of the small plateau to the south east of the castle. The boundary is shown on C18th and C19th maps and be part of small medieval field system centered on the plateau. (CPAT site visit, 22/03/02)

This hedge bank is in a generally stable condition, and should be maintained in this state. From an historic environment perspective, the important element here is the bank rather than the hedge itself - as the earthwork is a non renewable resource (unlike the hedgerow). Therefore extra care must be taken to avoid damaging the bank in any future maintenance work - stumps should be left to rot in situ rather than being dug out be, no new access ways should be cut through the bank, no part of the bank should be leveled.

The hedge row and its trees will require attention in due course (and certainly before the bank suffers any damage from wind throw or the like) but, as long as none of the distinctive species are necessarily removed, this may be undertaken with relative safety.

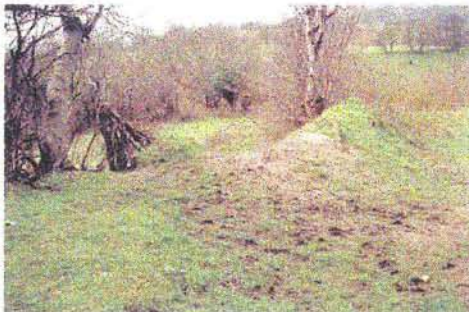
37196 Caergwrle Castle Fields, field system, gateway

A small but sharply defined earth bank joining two sections of apparently older revetted field banks. The bank occupies a distinct elbow in the line of this older revetted bank and appears to have resulted from the 'modern' blocking of a gateway (the bank is still in use as a crossing point of his boundary by the field path - and consequently suffering considerable erosion). This 'gate' may be related to the adjacent house site PRN37185 and enclosure PRN37197.

No gap is shown in the field boundary on the Caergwrle Tithe Map so the blocking is presumably earlier than the mid C19th and may relate to an adjustment of the field pattern following the demise of the adjacent house site and paddock. (CPAT site visit, 22/03/02)

This former gateway still acts as a crossing point of the field boundary PRN37186 and north-south the footpath across the site. Traffic on this path is causing erosion. Without considerable effort to consolidate the bank here and then work to maintain the crossing point it is difficult to see how this erosion can be controlled. Given that the bank blocking the gateway is relatively modern consideration might be given to re-excavating the gateway and creating a new pathway through the boundary at this point. Excavation would need to be done under archaeological conditions.

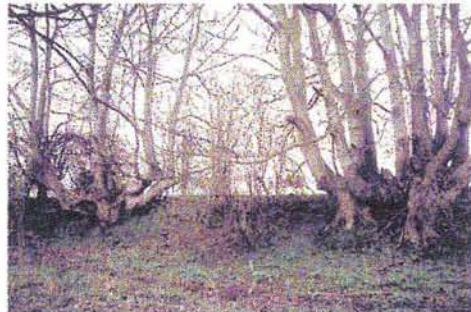
37199 Caergwrle Castle Fields, field system, lynchet

A significant earth bank formed against north-eastern side of a field. The bank could in part be a lynchet, formed by the movement of ploughsoil downhill from the field to the south west. In places it has been revetted in stone and at several places along its length it is topped by several mature trees which show marked signs of past management and may in fact be the remains of a laid hedge. The bank marks the south western edge of a possible trackway PRN37188. (CPAT site visit, 22/03/02)

This hedge bank is in a generally stable condition, and should be maintained in this state. This boundary is most remarkable for the number of, now mature, 'trees along the crest of the bank. Each of these trees, which now survive as massive 'coppiced' stools with considerable re-growth, have clearly been managed. The most recent re-growth is now quite large and takes the form of short lengths of near-horizontal boughs with branches sprouting vertically from their ends. These trees are historic features in themselves and should be further studied and recorded.

The bank forming the boundary is also of considerable interest and must be preserved. As with the other hedged boundaries in the field system, maintenance work on the hedge and trees should aim to avoid damaging the bank - stumps should be left to rot in situ rather than being dug out be, no new access ways should be cut through the bank, no part of the bank should be removed, any repairs to the revetment should be done only with stone from an approved source and after appropriate survey and recording.

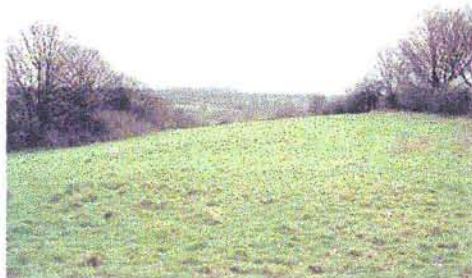
37189 Caergwrle Castle Fields, ridge and furrow

An area of ridge and furrow field system noted in a Clwyd County Council site record relating to the find of an iron key (PRN106418 - "found . . . in a field noted for its ridge and furrow"). The original source of this reference is not known and no convincing trace of ridge and furrow earthworks can now be seen on the ground. Vague striations are visible on CPAT air photos but these run across the major axis of the field - an alignment along this axis might be expected if this were ridge and furrow. However this field falls within what was almost certainly a small medieval field system associated with the castle so the presence of ridge and furrow here might not be unexpected. (CPAT site visit, 22/03/02)

As this site could not be identified in the field, no specific management advice can be offered here. Future aerial survey may identify the remains of this feature.

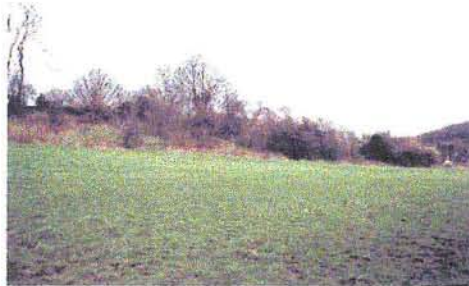
37190 Caergwrle, Castle Farm, abandoned field

Small field shown on Tithe Map but not now apparent on ground - although a slight kink in the boundary PRN37186 indicates where it joined this feature. Probably related to Castle Farm immediately to south. (CPAT site visit, 22/03/02)

This site has little or no archaeological presence and no specific management advice is offered here.
