Back Lane, Montgomery:
ARCHAEOLOGICAL EVALUATION

CPAT Report Title: Back Lane, Montgomery: Archaeological Evaluation	
CPAT Project Name Back Lane, Montgomery	
CPAT Project No 686	CPAT Report No 189
Confidential (yes/no)	draft/final Final

by D. Murphy
July 1996

Report prepared for D.E. Mills, Building Contractor

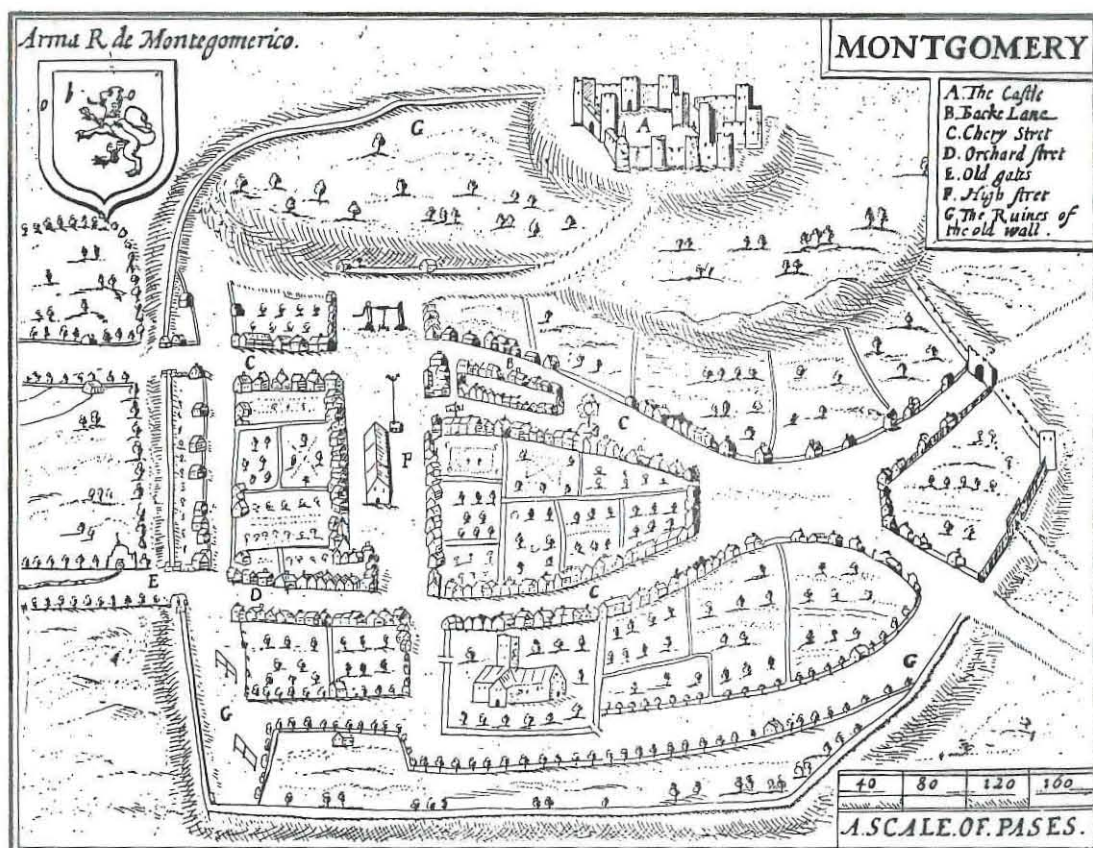
Fig. 2 Speed's Map of Montgomery

- 3.2 The present town of Montgomery originated as a planted town overlooked by the castle, the construction of which began in 1223. The new borough was enclosed by substantial defences and received its charter in 1227, after which it appears to have been a sizeable borough throughout the medieval period. By the early 17th century, however, the town appears to have experienced a decline, as illustrated by the many vacant plots depicted by Speed in 1610 (Soulsby 1983, 185-7).

- 6.1 According to the cartographic sources consulted (Speed 1610; Tithe 1839; and Ordnance Survey 1st edition 1886) the proposed area of building development appears to have been a vacant or garden plot for nearly 400 years. This assumption has been largely confirmed by the evaluation which revealed no evidence for occupation in the form of structural features which need necessarily date to later than 1610, with the exception of several modern garden features.

- 6.4 Although the yard area remains essentially undated, if the evidence presented by Speed is accepted it would seem possible that the plot had been abandoned by 1610, with this phase of occupation therefore of likely late medieval or early post medieval date. The pottery assemblage from pit 0115

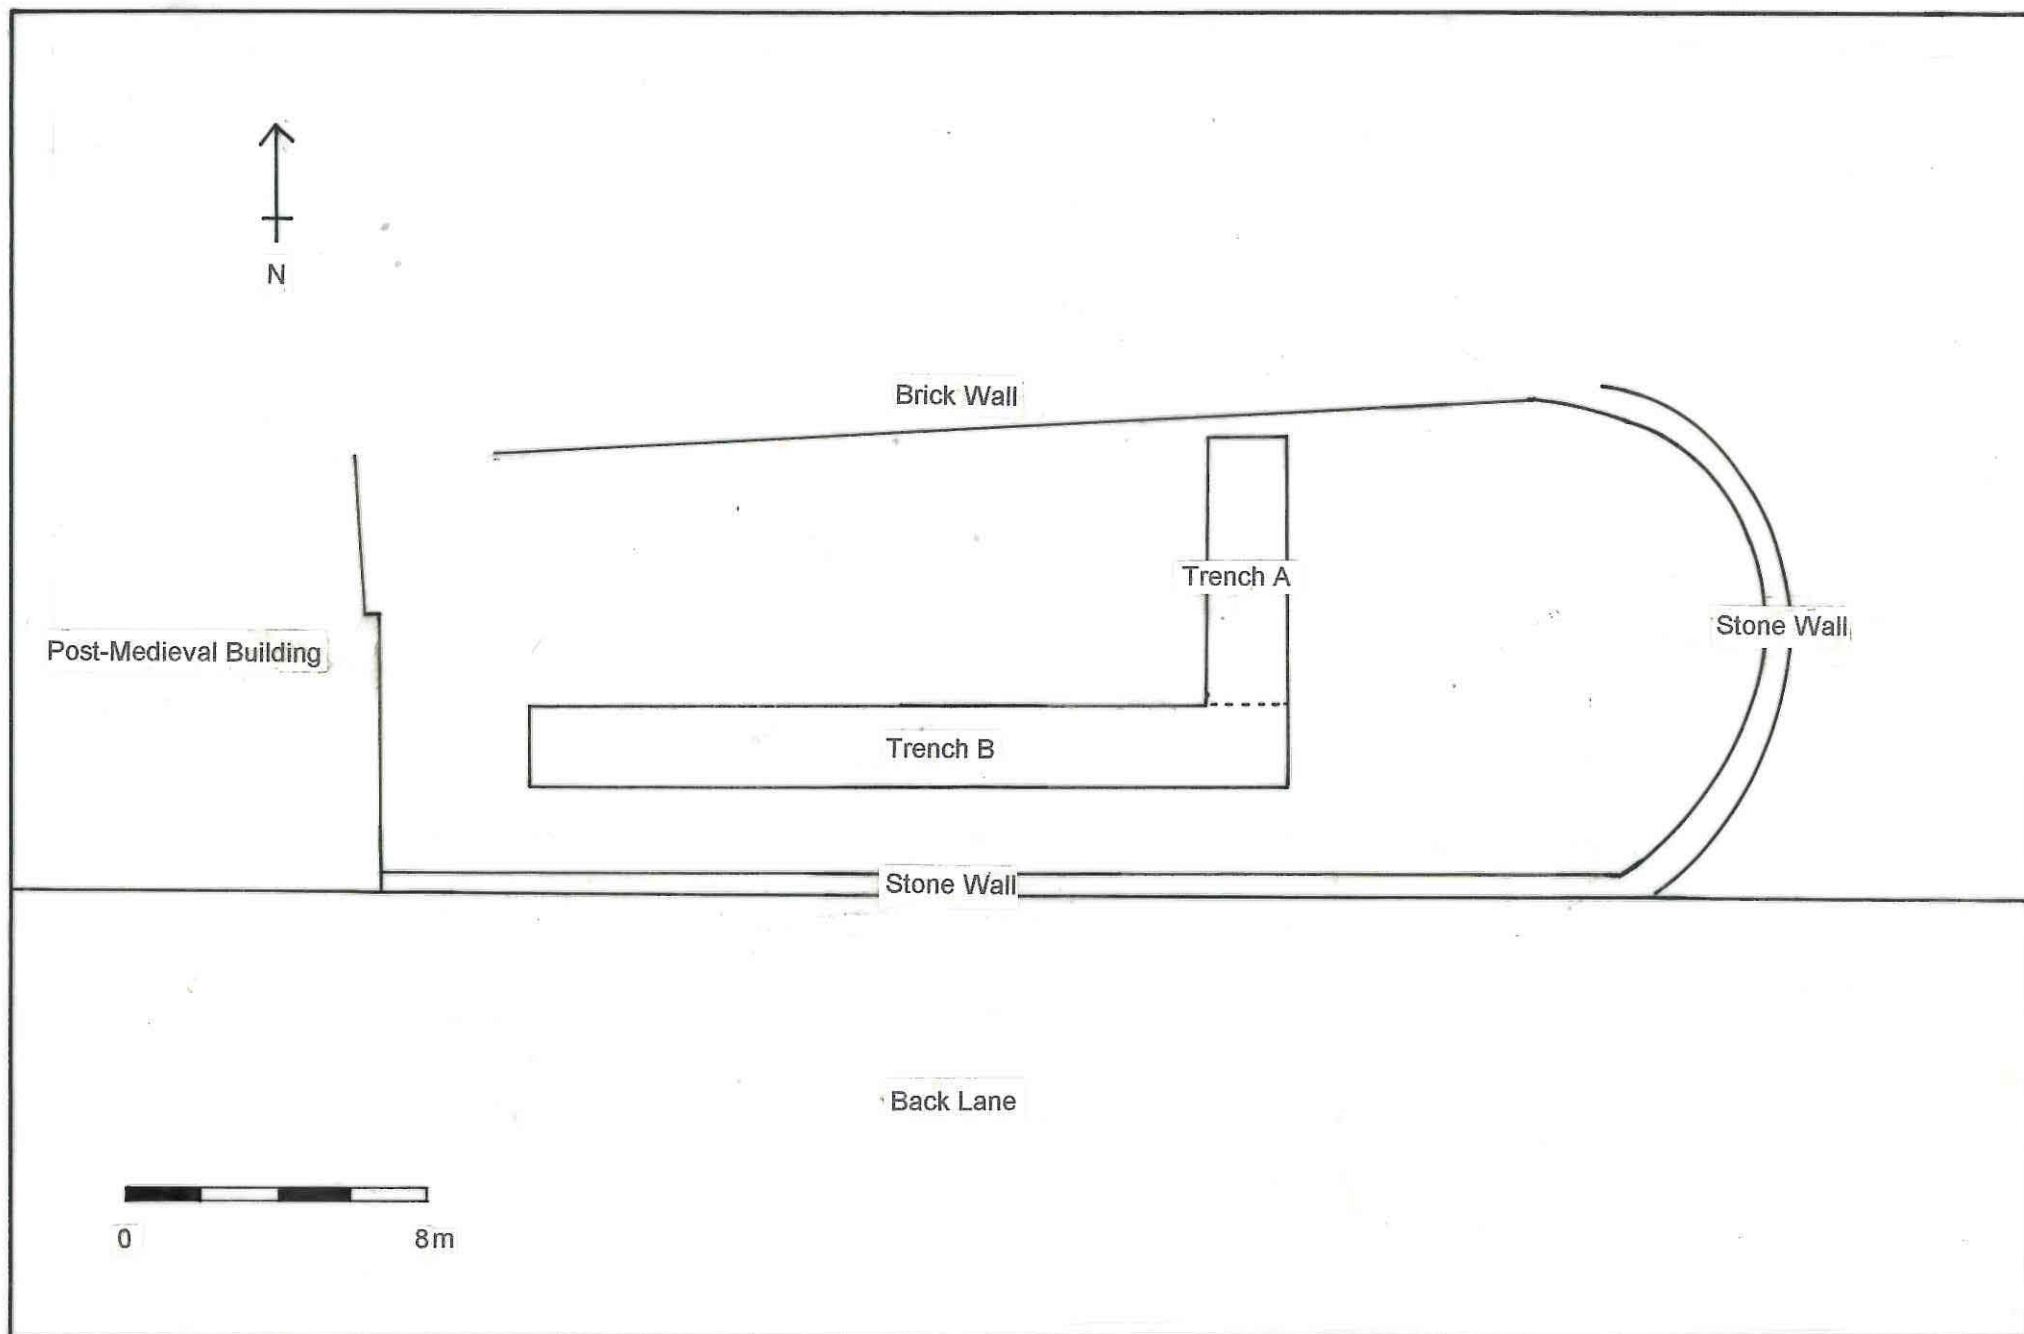
Fig. 5 Trench Location 1: 200

- 4.1 The Brief specified that a 20 x 7 x 2m L-shaped trench should be excavated across the area of the proposed building works (Fig. 5).
- 4.2 The trench was initially excavated by machine to remove the modern and post-medieval overburden. Subsequent excavation and cleaning was carried out manually. A full written, drawn and photographic record was maintained throughout. Numbers were allocated to each archaeological context identified and appear in brackets in the following descriptive text and illustrations.

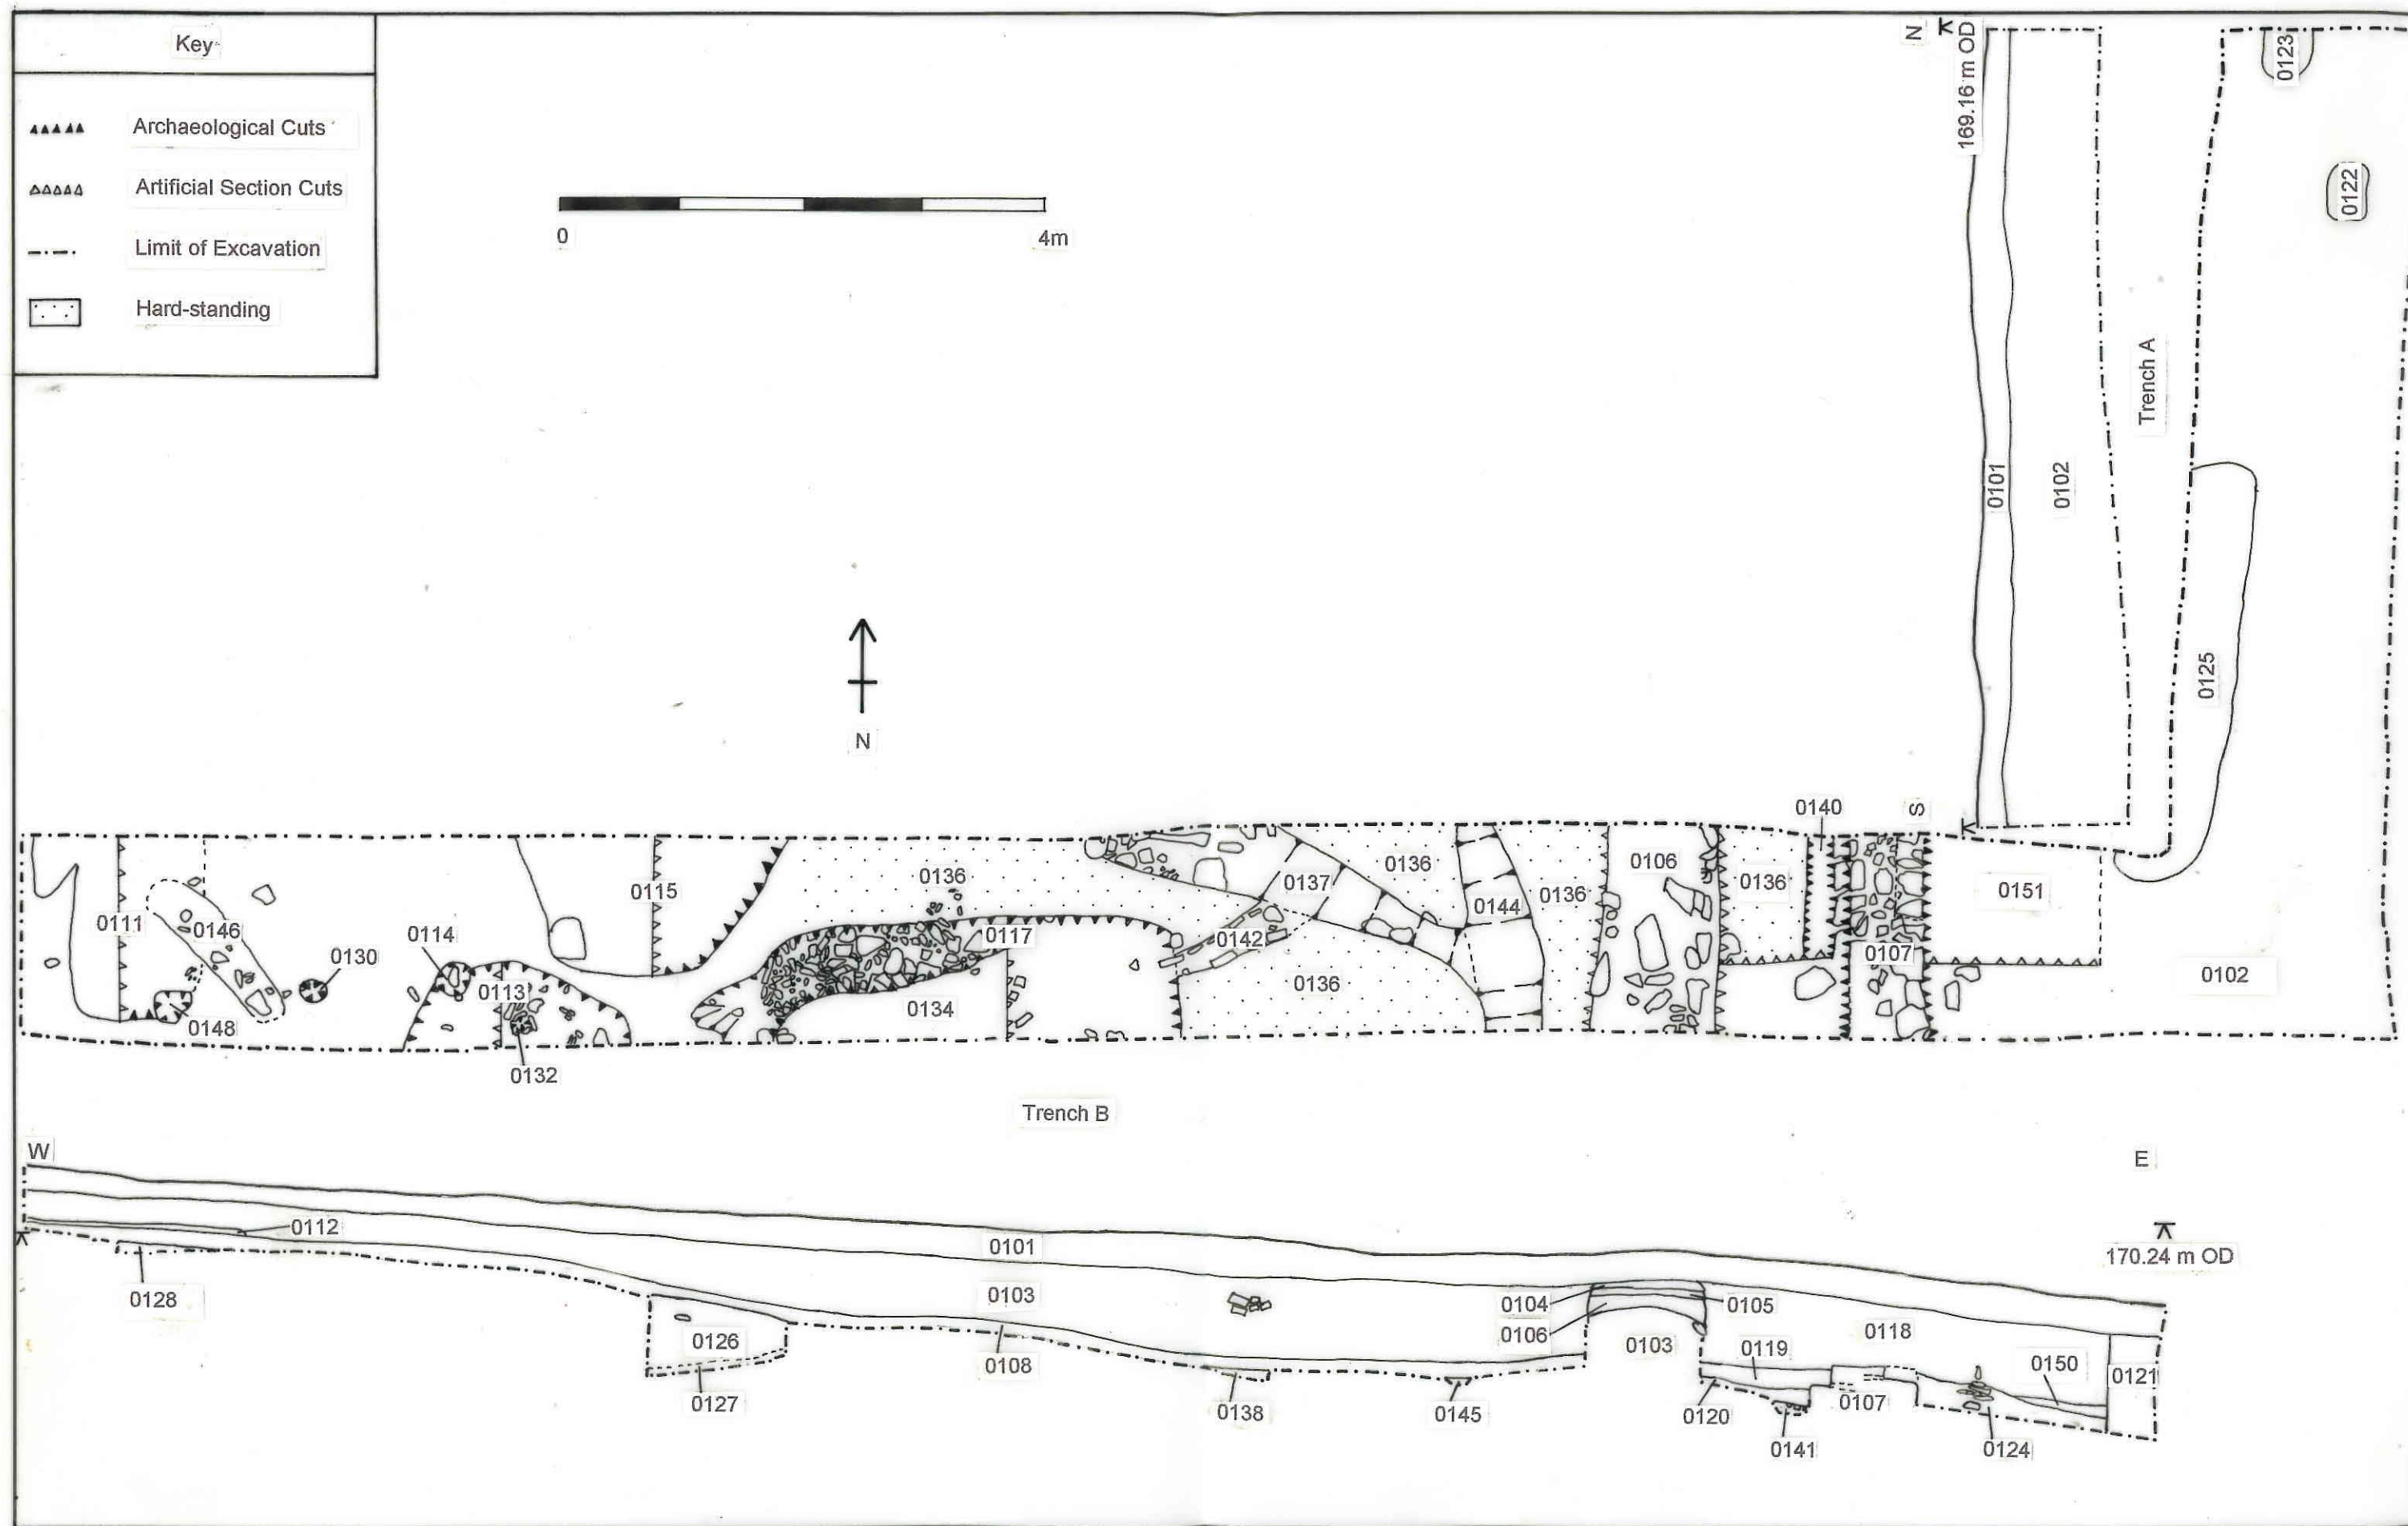
Fig. 6 Trench Plan and Sections 1: 50

- 4.3 Trench A (7 x 2m; Fig. 6)**
- 4.3.1 The trench was mechanically excavated to a depth of 0.25 metres to remove the dark brown loam (0101) that had been formed by modern gardening activities.

- 4.4 Trench B (20 x 2m; Fig. 6)**
- 4.4.1 The trench was again mechanically excavated to a depth of 0.25m to remove the dark brown loam (0101) that was formed by modern gardening activities.

- 4.3.2 The southern end of the trench was then mechanically excavated further to the Health and Safety maximum of 1.2m to remove post-medieval and modern overburden (0102). Archaeological deposits encountered in this trench were of post-medieval and modern date, demonstrating substantial dumping and levelling at this end of the plot. At the south-western corner a large amount of post-medieval material had been dumped into a pit (0125). This pit had been cut through the modern and post-medieval overburden, indicating that it was fairly recent.

- 4.3.3 The northern end of the trench was mechanically excavated to a depth of approximately 0.9m. Two modern pits (0122; 0123) were found to have been cut into the post-medieval and modern overburden (0102).

- 4.4.2 A layer of modern and post-medieval overburden was mechanically excavated to a depth of 0.45m at the western end and to the Health and Safety maximum of 1.2m at the eastern end, leaving a baulk between 13.35m and 14.35m from the western end. This baulk was left because a path (0104) was found on removing the dark brown loam (0101). Subsequently, a 0.06-0.08m layer of purple decomposing slate (0105) was found beneath the path and above an unbonded stone wall (0106). The wall was sitting on and within the modern and post-medieval overburden (0103) and it is likely that this wall is therefore of relatively recent date.

- 4.4.3 Following the natural ground-slope and running parallel to the trench, approximately 0.075m to the south of the northern baulk, was an intermittent linear trench cut (0109), 11.2m long and 0.2m wide. This trench was cut through modern and post-medieval overburden (0108) and contained pottery of possible medieval date in addition to modern pottery. The medieval pottery is therefore residual.

- 4.4.4 The pit (0125) found in Trench A continued round into Trench B, approximately 0.45m to the west of the corner joining the two trenches. To the west of this feature was a well-built stone wall (0107), faced on both sides and bonded in yellow-brown clay. The foundation trench (0140) was cut into the natural ground (0110), and contained two sherds of pottery of medieval pottery. The wall had slumped heavily and all that remained intact were the lower three courses.

- 4.4.5 A series of gullies (0137; 0142; 0144) were situated to the west of the unbonded stone wall. A smaller gully (0142), running downslope from south-west to north-east, joined, or was cut by, a larger gully running downhill from north-west to south-east. The larger gully then joined, or was cut by, another gully running north to south parallel to the natural ground-slope. It was impossible to distinguish the exact relationship between all these gullies due to the homogeneity of the brown clayey-silt fill of all three features. The only finds to be recovered came from the fill of the, larger gully (0137) and consisted of two sherds of pottery of post-medieval date and one sherd of probable medieval date.

- 4.4.6 Flanking the gullies was an area of hard-standing, composed of small stones less than 0.05m in diameter which had been rammed into the existing natural to provide a firm surface. The hard-standing and the gullies, which provided drainage, may have been contemporary, while the clay-bonded wall (0107) further to the east would appear to be later as the foundation trench appears to have been cut through the hard-standing.

- 4.4.7 A large pit (0117), 4m in length, had been cut through the hard-standing and one of the gullies (0142). A dump of large stones was revealed once the clay capping (0134) to this pit had been removed. The very steep edge to this pit was extremely well defined and the brown clayey-silt fill (0135) found in the eastern portion peeled off easily to reveal the natural subsoil. Finds in this layer included post-medieval bricks, pottery, clay tobacco pipes and glass, six cattlehorns, several pieces of roofing slate, two iron nails and a large piece of medieval pottery. At a depth of 1.6m below existing ground level the ground became waterlogged. This is likely to have been a rubbish pit.

- 4.4.8 A bowl-shaped pit (0115), 2.1 x 1.2m, was located to the north-west of the waterlogged pit. It was half-sectioned and the eastern half excavated (0126 & 0127) to its maximum depth of 0.7m. Finds included a small assemblage of medieval pottery and some animal bone.

- 4.4.9 To the south-west of the previous feature was a thin spread of gravel (0113), through which two post-holes (0114 & 0132) had been cut, the latter having vertical stone-packing on three of its four sides. No finds were discovered on half-sectioning the gravel layer to its maximum depth of 0.07m below the natural subsoil. A piece of modern pottery was found in the first post-hole to the north-west (0114). No finds were excavated from the post-hole in the centre of the gravel (0132).

- 4.4.10 Further west was a single post-hole 0.2m in diameter and 0.2m deep in which was found a small fragment of brick, a small nail and a fragment pottery of post-medieval date.

- 4.4.11 At the far western end of the trench were a shallow cigar-shaped gully (0146) and a shallow pit. Both were devoid of finds. Above these features was a shallow sub-rectangular pit, 1 x 1.5m, which had been cut into the natural subsoil at the western end. Finds recorded from this feature included decomposing slate and modern brick and pottery.
