Llanymynech Golf Clubhouse

ARCHAEOLOGICAL WATCHING BRIEF

CPAT Report No 241

W.G.Owen
September 1997

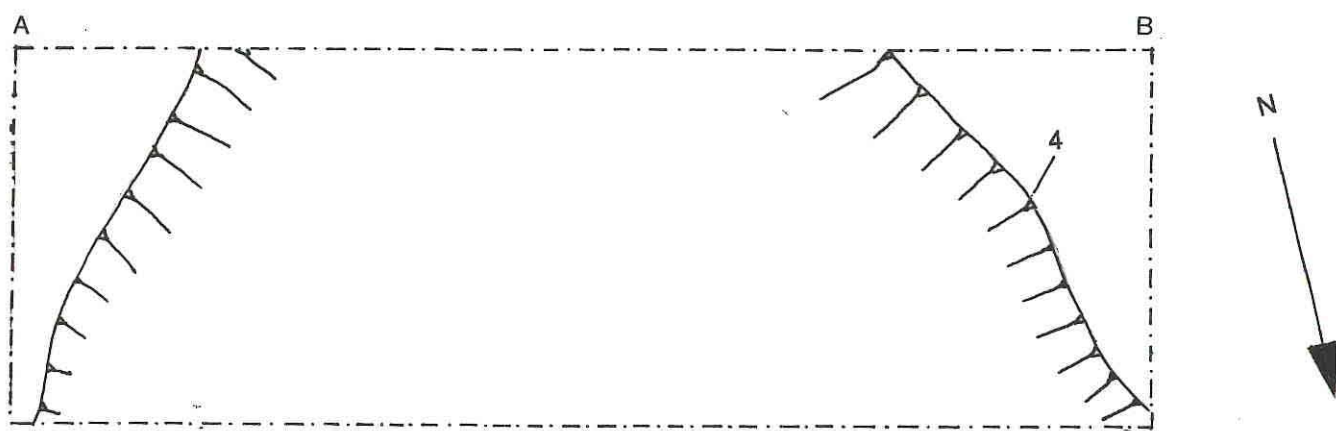
Fig. 3

- 4.3.1 Removal of the tarmac (1) and its stony base exposed a layer of material 0.12m thick consisting of stone, coal fragments, cinders and brick fragments contained in a fairly friable grey clay (2). Below this at the eastern and western ends of the trench, this overlay a thin, lighter grey layer max 0.04m thick (3) which may have represented an old ground surface. No finds were recovered from it. Removal of layers 2 and 3 exposed a feature interpreted as either part of a pit or gully (4) max. 0.30m deep the fill of which (5) consisted of a dark grey, loose, loamy clay containing stone, brick fragments and cinders above a thin layer of mottled grey clayey silt (6). Artifacts recovered from the fill of this pit consisted of iron objects and sherds which were of a late post-medieval or modern origin.

Trench B plan and sections

- 5.1 The sole feature of any archaeological interest was the pit or gully uncovered in Trench B. Artifacts recovered from its fill indicated that it was of a late post-medieval date. It is assumed that this feature relates either to a levelling phase prior to the construction of the original clubhouse or to the farm known to have occupied this location before that time (A. Lewis *pers. comm.*).
