The Old Mill, Felin Newydd, Waen, Nantglyn, Denbighshire ARCHAEOLOGICAL WATCHING BRIEF

WG Owen August 1999

Report for Jones Peckover on behalf of Mr and Mrs Brockley

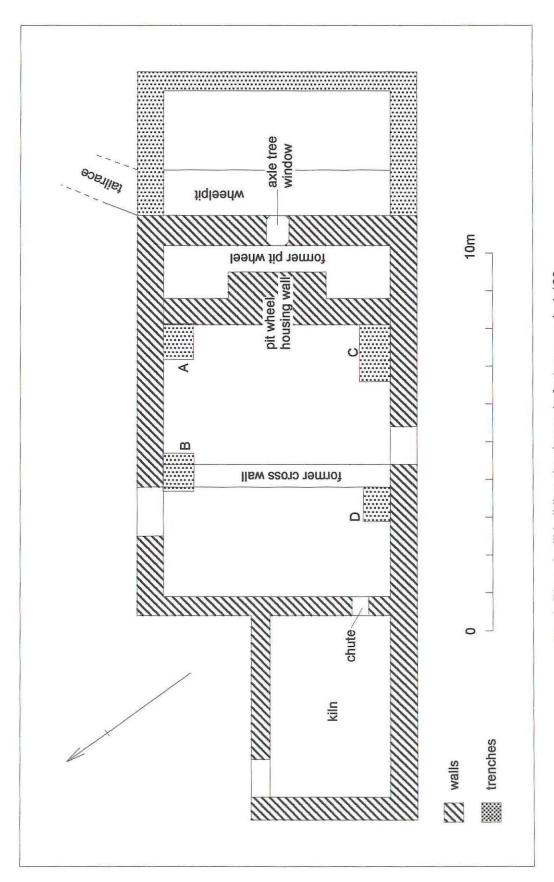
Fig. 2 Plan of mill building showing main features, scale 1:100.

3 WATCHING BRIEF (fig. 2)

- 3.9 Within the mill house four stantion pits were excavated manually (fig 2). Pits A and B, adjacent to the north-eastern wall, were both excavated to a depth of 1.10m. In both cases the fill consisted of a brownish grey, stony clay loam extending to a depth of 1.0m, beneath which, and extending beyond the limits of excavation, was a grey stony clay apparently closely similar to the natural subsoil exposed in the external foundation trenches. Both pits showed that the main wall of the building consisted of coursed stone, extending to a depth of 1.0m below the present surface, with no foundation trench visible. The position of a former cross wall, which was visible at ground level, was revealed in Pits B and D to be a more superficial structure extending to a depth of 0.25m below the surface. Pits C and D, adjacent to the south-western wall, were excavated to a depth of 0.37m and 0.30m respectively. The fill in both cases was quite different in colour and texture to that of Pits A and B, being of fairly coarse brown-reddish brown clay loam. In pit C, it was seen that the extension to the pit-wheel housing wall exceeded the depth of the excavation.

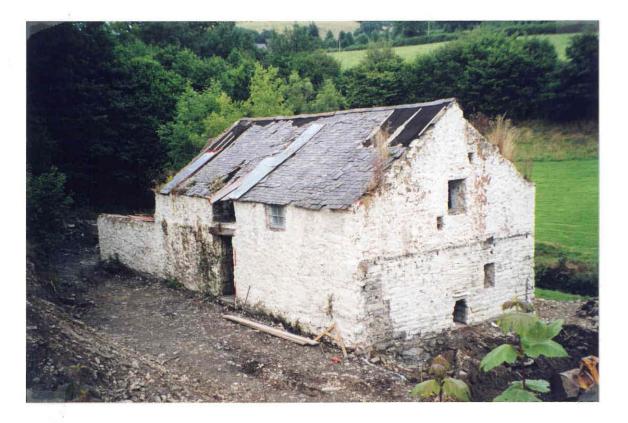
Plate 1 The mill house from S. Photo CPAT 837.1

- 3.1 The watching brief was undertaken over a two-day period, the 10th 11th August 1999.
- 3.2 The building consists of the mill house (plate 1) within which are the remains of some of the internal wooden mechanisms. At ground level at the south-eastern end are the remains of the pit-wheel housing wall which formerly supported the horizontally aligned pit-wheel tree or axle and the vertically aligned main shaft and its associated great spur wheel and crown wheel. Centrally placed in the south-eastern wall of the mill is the axle tree window arch (plate 2), which connected the milling machinery to the waterwheel outside, via the pit-wheel. At roof level there remains the wooden sack hoist pulley and its housing below (plate 3) which, at upper floor level, is the trapdoor used to lower the milled grain from the attic. A millstone of the French burr type was also in the mill house but not in situ. Also within the mill house in its north-western part are the remains of a cross-wall of unknown function.

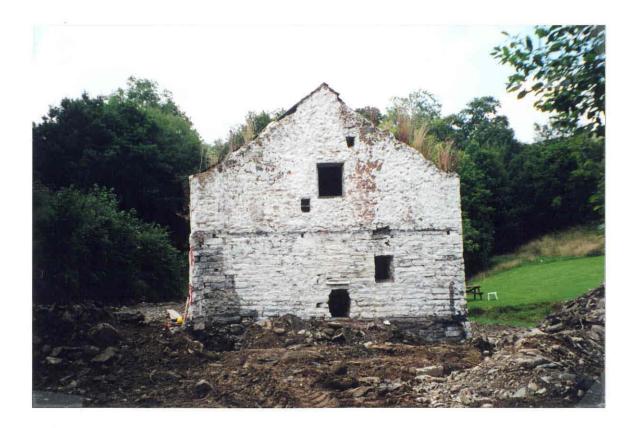
Plate 2 Mill house SE wall showing axle tree arch. Photo CPAT 837.5

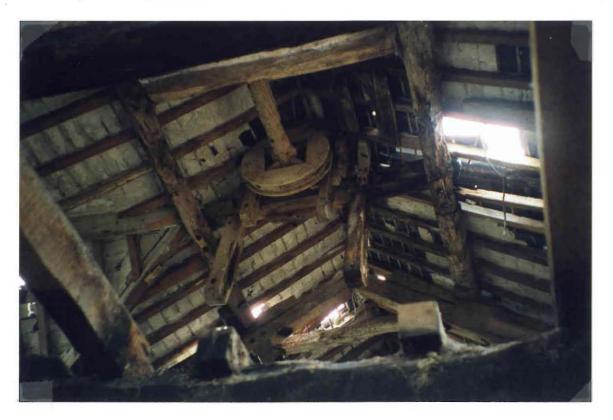
Plate 3 Pulley hoist and housing. Photo CPAT 837.16

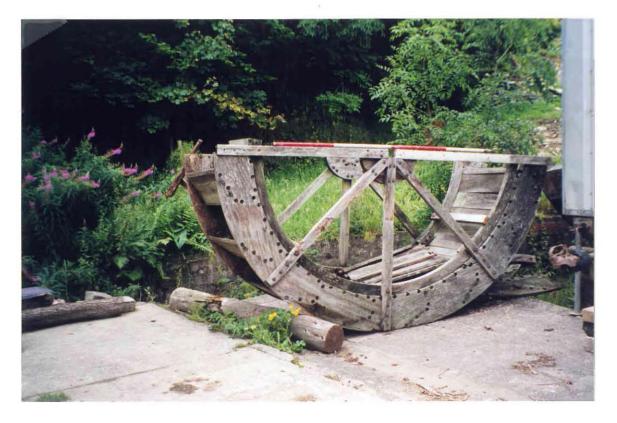
Plate 4 Remains of timber water wheel. Photo CPAT 837.14

- 3.4 The wheelpit at the south-eastern end of the mill had been infilled and the wheel removed. The overshot wheel was formerly fed by launders from the millpond situated to the south-west of the mill. This pond was fed by a leat which ran a distance of some 300m from a weir upstream (fig. 1). The remains of a wooden water wheel (plate 4) stands some 40m downslope of the mill which may have, at some time, been used at the mill but it is thought not to be the original wheel used (Mr Brockley pers. comm.)

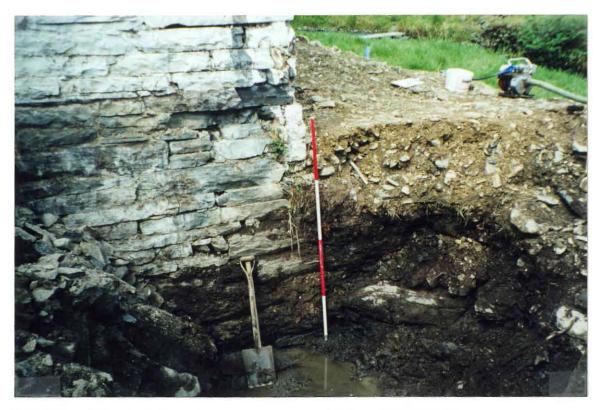
Plate 5 NE end of wheel pit and tailrace from SE. Photo CPAT 837.12

- 3.5 Foundation trenches excavated at the south-eastern end of the mill house varied in depth from 1.10m to 1.25m and were 0.60m wide. The foundation trench on the north-eastern side, however, was excavated to a depth of 1.80m and reached the level of the dressed shalestone base of the wheelpit and tailrace. At this depth excavation also exposed one vertical wall of the tailrace channel (plate 5) which was seen aligned at an oblique angle to the wheelpit. Also exposed in section was the outer structural wall of the wheelpit (plate 6). This was 1.5m high and max. 0.70m wide and consisted of

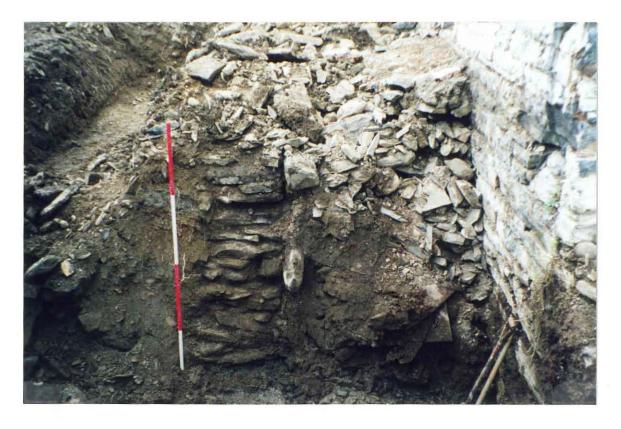
Plate 6 Remains of wheelpit outer wall from NE. Photo CPAT 837.10

- horizontally lain unbonded shalestone slabs of varying thickness. The wheelpit measured 1.30m wide and 1.80m deep.
- 3.6 The south-western trench also exposed the outer structural wall of the wheelpit. Here, however, the wall, which was up to 0.80m wide, extended to a depth of only 0.50m below the ground surface and rested on the natural clay subsoil.
