Offa's Dyke, Coedpoeth, Wrexham

ARCHAEOLOGICAL WATCHING BRIEF

CPAT Report No 438

W G Owen
October 2001

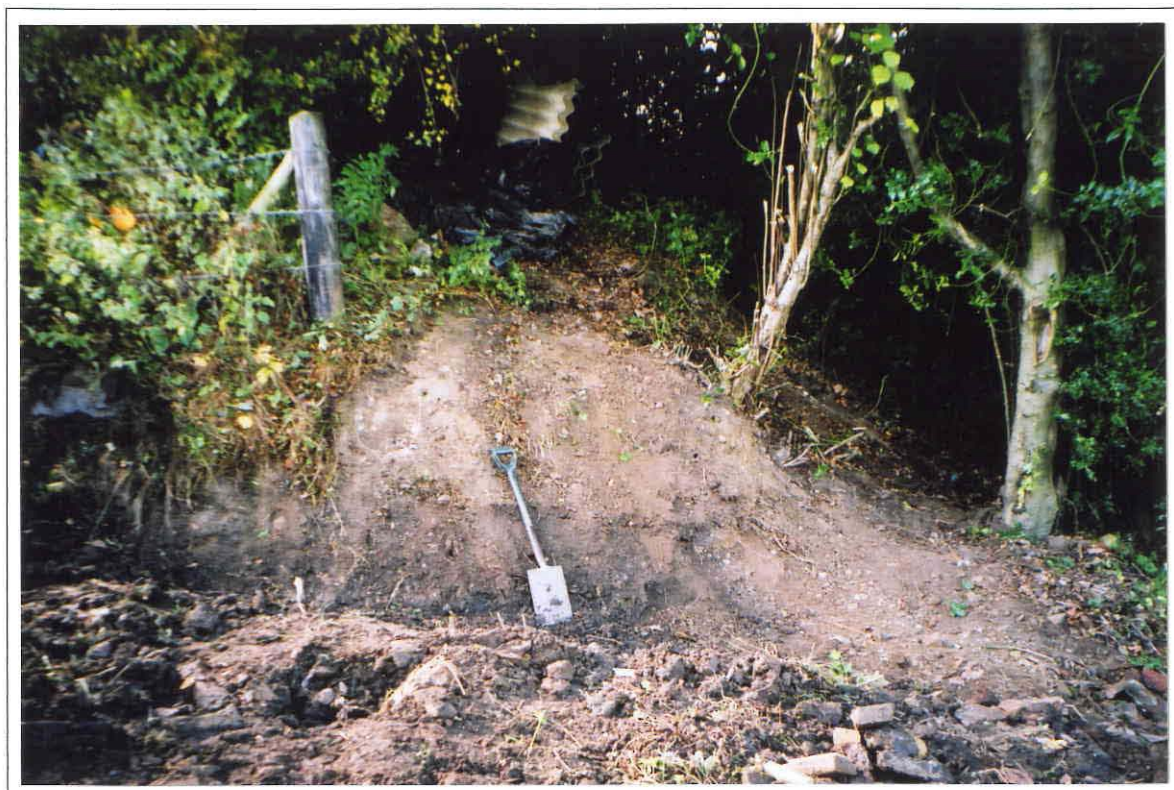
Plate 1 Exposed northern terminus of Offa's Dyke after removal of rubble and topsoil. Photo CPAT 1107.5

- 2.1 Rubble consisting mainly of builders' waste was first removed both mechanically and manually from the area immediately to the north and the east of the terminal of the dyke where it was thought to have been truncated. In addition, a proportion of sapling growth was thinned out. The cleaned area revealed the apparent profile of the dyke and, on the eastern side, an area of compacted brownish-yellow silty clay probably represented the surface of the dyke. At this point, removal of the rubble showed the dyke, which was 1.8m high and 5.5m wide, to have a regular profile with no clear evidence that it had been damaged in recent times other than by tree root growth (plates 1 and 2). It was realised that without creating a vertical surface, thus damaging the dyke, it would not be possible to produce a drawn section. Following discussions with Dr Kate Roberts, Cadw: Welsh Historic Monuments, it was agreed that a measured drawn section could be omitted and that a photographic record would suffice.

- 3.3 Clearance of rubble from the area around the terminus of the dyke revealed an even profile with no clear evidence of a cut surface on the northern terminal, or on the eastern side immediately adjacent to the access track. It would seem, therefore, that the dyke may not have been truncated during the construction of the access track, as had been previously assumed, and that the present terminal may correspond with that observed by Fox.

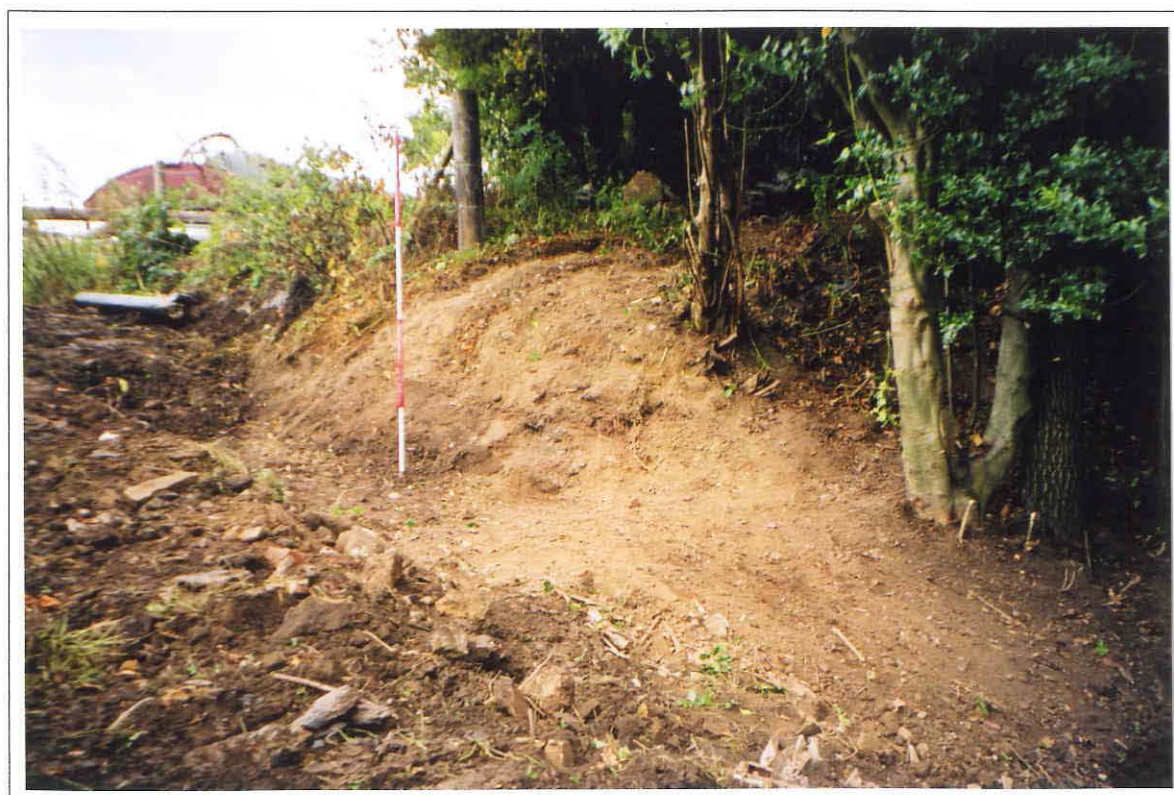
Plate 2 Exposed northern terminus of Offa's Dyke after removal of rubble and topsoil. Photo CPAT 1107.9

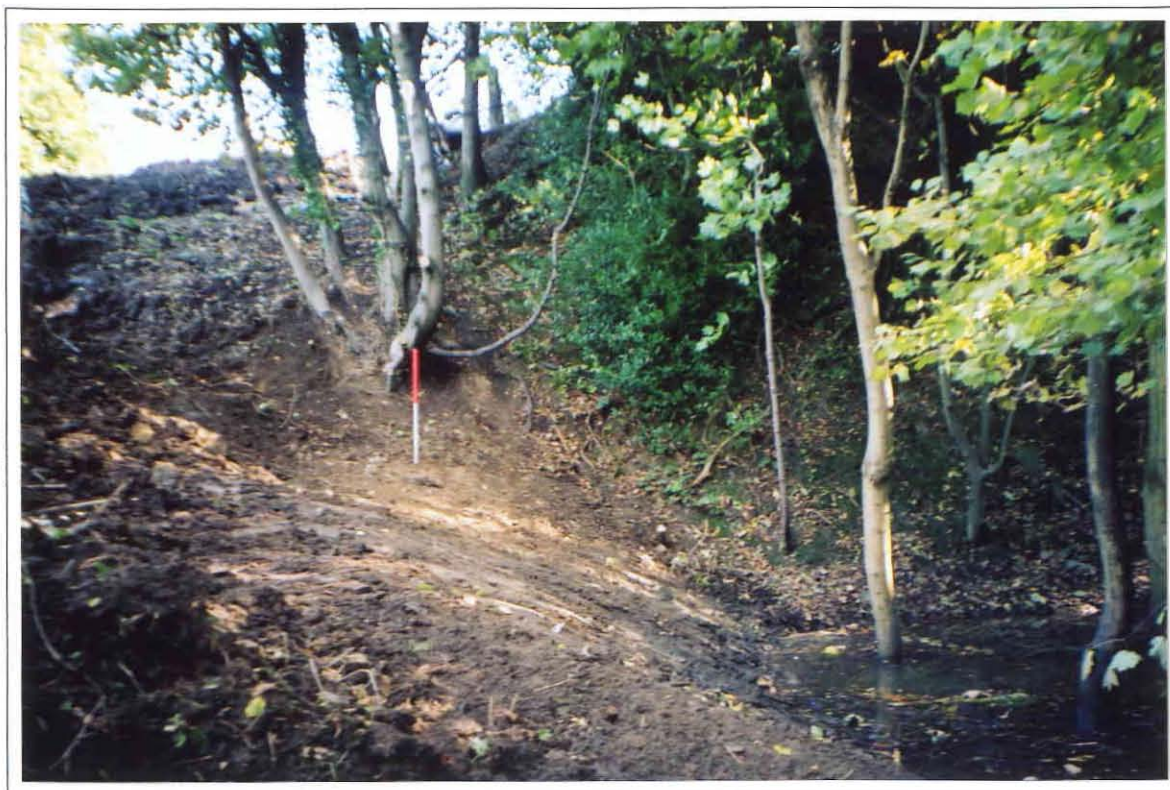
- 2.3 During the course of removing rubble from the western side of the trackway and to the east of the ponded ditch, at a point some 5.0m downslope of the dyke terminal, a 2m length of apparently undisturbed, compact light brown soil was uncovered (plate 3) which graded evenly to the pond surface. At its northern end this surface was succeeded by further rubble. The thickness of this rubble layer became apparent during the course of excavating an east-west aligned ditch (plate 4) for the installation of a pipe to drain the ponded area. This showed that the rubble layer was at least 1.5m thick and that it may have been deposited in two phases. There was no evidence of the light brown soil surface described above in the material excavated or in the exposed sections of this channel.

Plate 3 Ponded area on west side of Offa's Dyke. Photo CPAT 1107.14
