# *Neuadd Felin, Talgarth, Powys*

## EVALUATION REPORT

September 1991

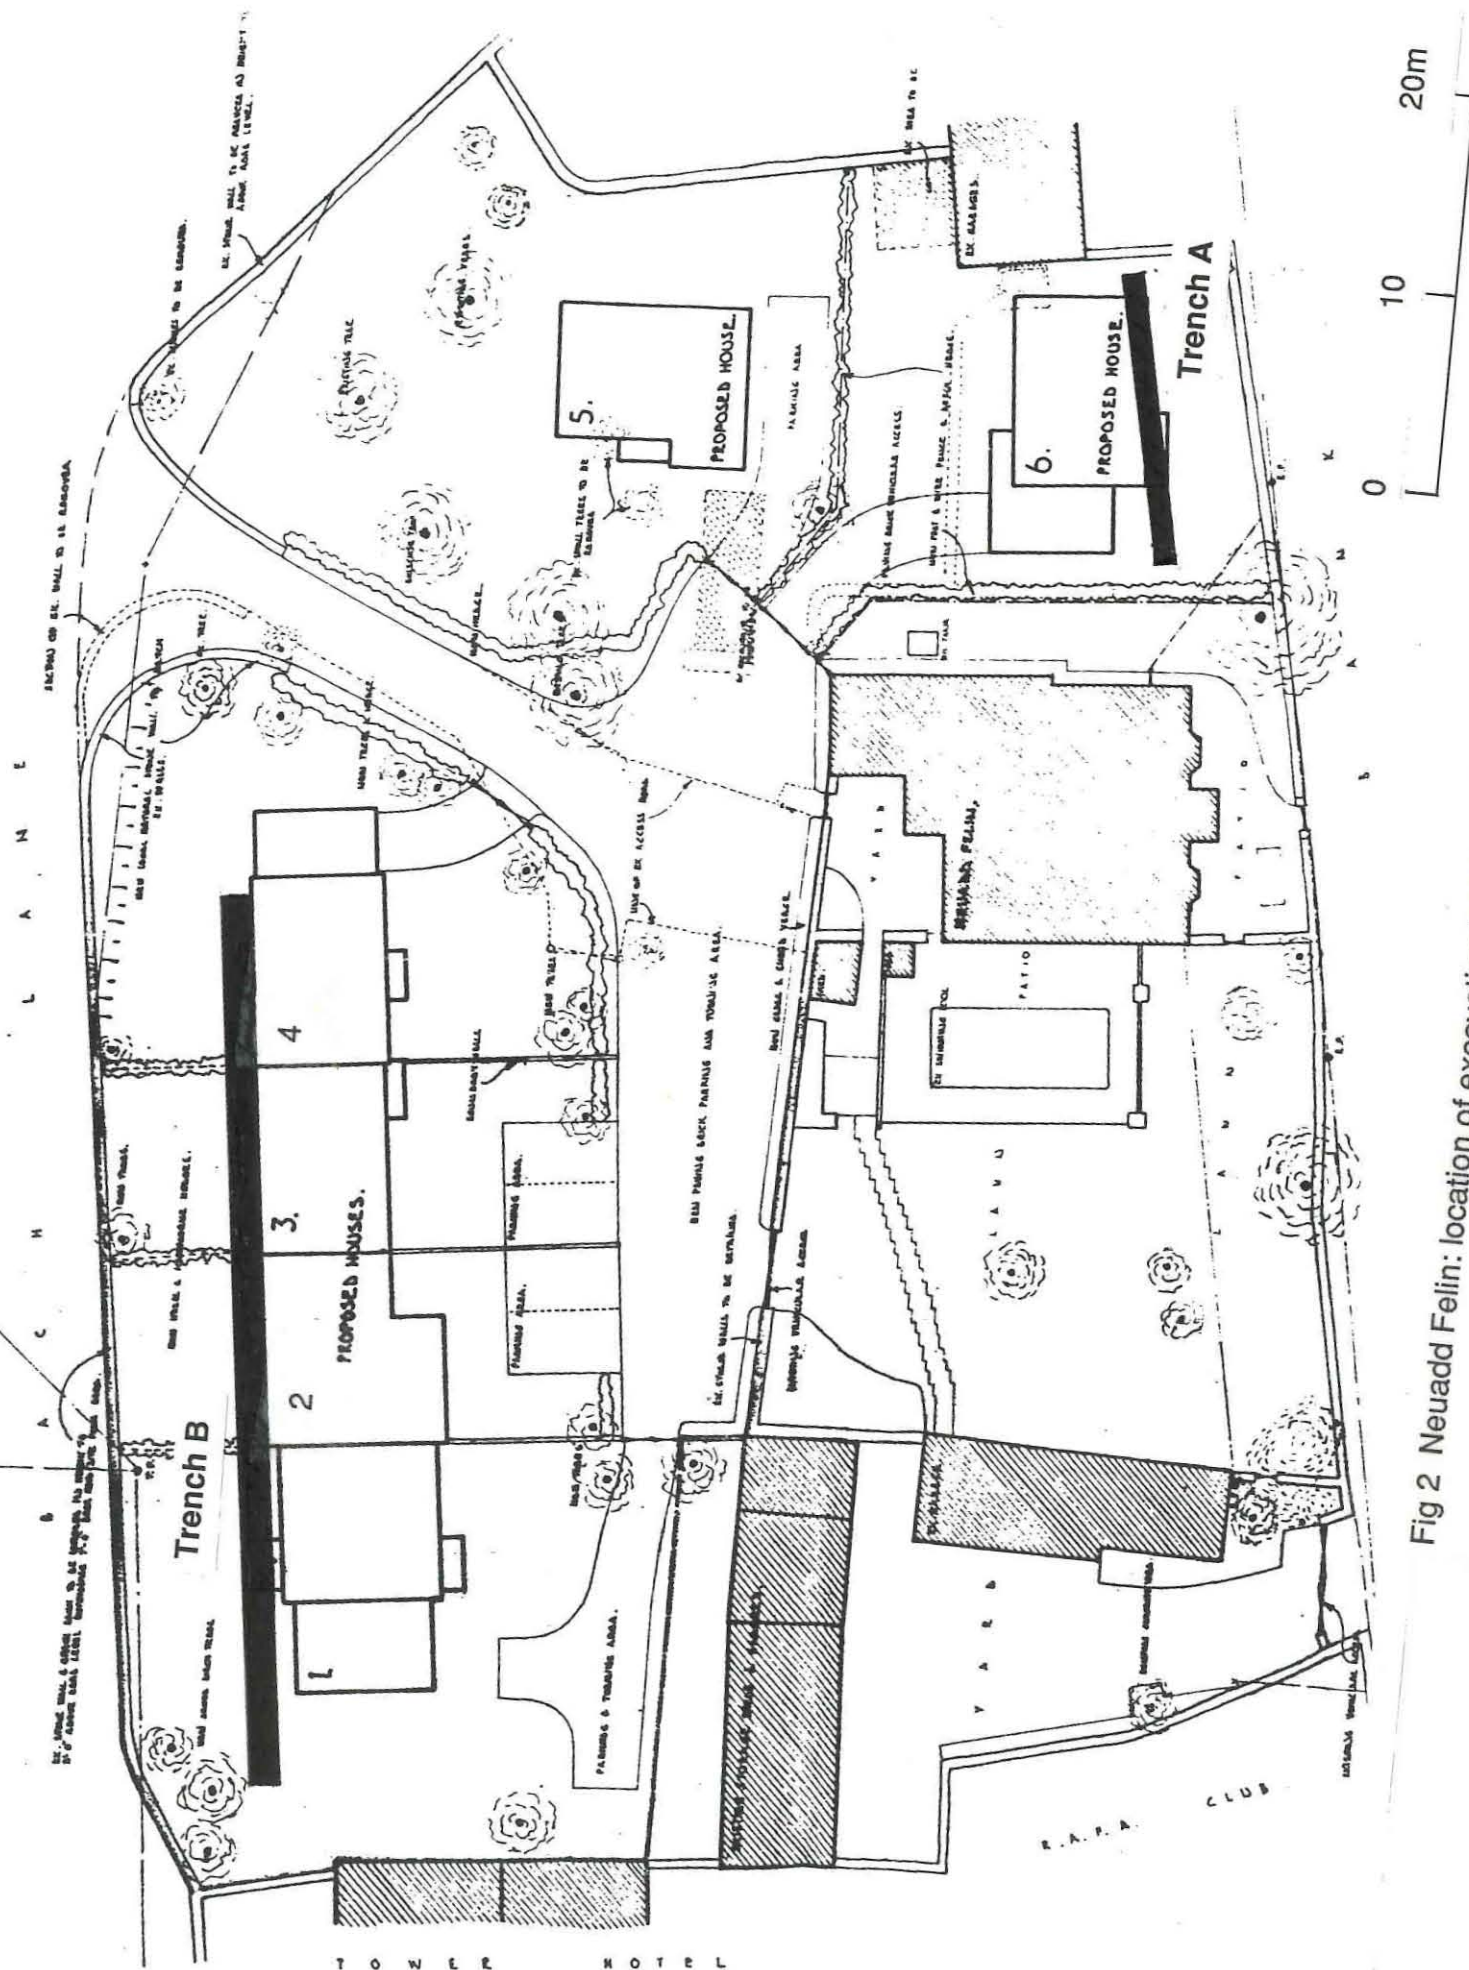
Fig 3. Archaeological features

*Trench A (14.5 x 1.5m. Fig 3). Numbers in brackets refer to Fig 3.*

The top 40cm of dark brown, humic garden soil was removed by machine. Beneath this was a layer of brown silty loam, probably an older garden soil, containing both medieval and post-medieval pottery sherds. This layer was removed by hand to reveal the top of a wall (12), 60cm wide, built of flat angular stones, running north-south ie. at a right angle to The Bank. Immediately to the west of this wall was a layer of angular stones approximately 50cm thick, packed with brown silty soil similar to the layer above, but also containing a considerable amount of animal bone, nails and some micaceous sandstone roof-tile fragments. The best interpretation of this stone is that it is the "tumble" resulting from the demolition or collapse of the upper part of the adjacent wall. The wall itself still survived to a height of approximately 30cm.

Beneath the stone "tumble" at a depth of approximately 90 cm and overlying the reddish natural silty clay was an orange-brown compact silty layer with some smears of charcoal, which contained a few sherds of medieval pottery and small lumps of fired clay. Cut into this layer and therefore of a later date, was a small, undated pit (39) and a large pit (37) in excess

of 1.2m long and partly underlying the wall. The fill of the larger pit contained charcoal, small stones and exclusively medieval cooking pot sherds. The wall appeared to have been built immediately over the top of this obviously medieval pit with no layers of build-up in between, and this may indicate that no great length of time passed between the filling of the pit and the building of the wall. A section of the wall was dismantled, but the only find built into it was a roughly circular pierced stone, possibly a loomweight.

The brown silty soil to the east of the wall was removed and at approximately 55cm below the ground surface a stoney "dirty" reddish-brown silty-clay surface was revealed, not dissimilar to the "natural" silty clay to the west of the wall. It contained no datable finds, but a little charcoal. Although not an entirely undisturbed horizon, the small patches of silty soil and flecks of charcoal within this layer may well be due to root disturbance and the layer was not examined further. A "step" down of 28 cm in the level of this layer was observed c40cm to the east of the wall, which may have been cut as a foundation trench for the wall or may even pre-date it. A few possible small post holes were observed cut into this layer, but only one larger feature was noted: an undated roughly circular, fairly shallow stone-filled pit (19) with a diameter of c.60 cm. The function of this is uncertain, but it may have served as a foundation, perhaps for a timber post.

*Trench B (44m x 1.5m. Fig 3) Number in brackets refer to fig 3*

The top 40 cm of topsoil was removed by machine, together with the top 20cm or so of the layer beneath it (context 34), a compact silty layer with small stones, containing post-medieval pottery sherds. The surface was cleaned by hand and several features of post-medieval date were revealed. The westernmost 4m of the trench was taken up by a dark brown layer containing glass, coal and other fairly modern domestic debris. Over the length of the trench the level of the present day ground surface falls by around 2m from east to west, and it became evident that the level of the "natural" silty clay subsoil fell similarly, but by a greater amount. It is possible that this modern debris was dumped at the western end in an attempt to level out the slope of the land.

At 23m from the eastern end of the trench, a number of large, mostly flat stones appeared to form a line north-south across the trench and may have been the foundation of a wall. The relationship of these stones with context 34 was uncertain.

The remainder of context 34 was removed by hand to an average depth of 60cm below ground surface over most of the trench. This revealed a slightly "dirty" red silty clay surface, still containing some charcoal, but with undisturbed, clean red silty clay beneath it. Several features were revealed cutting into this "dirty" red layer:

A pit (29), diameter c1.35m, depth c15cm, which contained exclusively medieval pottery, iron, fired clay, and micaceous sandstone fragments.

A gully (31) with sloping sides, c80cm wide at the top, running roughly N-S across the trench.

Two postholes (24 and 43), with diameters of 34cm and 20cm.

Further to the west of these features was an area of angular stones, some of them micaceous sandstone, set in a grey-brown silty soil. A grey-brown silty soil layer was

revealed beneath this, containing small lumps of charcoal, fired clay and burnt bone, and lower still was a layer of small angular close-set cobbles (23) forming a good surface, embedded in the natural red silty clay beneath. These layers may be best interpreted as a cobbled floor surface, perhaps of a yard, since there are no post holes present in the excavated area large enough to suggest the presence of a building. In time, a layer of dirt and burnt debris had built up, and had been subsequently covered with another layer of stone to form another hard surface.

The results of the evaluation work revealed evidence of medieval occupation in both areas examined within the area of the proposed development. It is felt that the features identified in Trench A are indicative of the presence of medieval domestic buildings fronting onto The Bank. The pits certainly suggest domestic activity and the substantial wall foundation uncovered may well be that of a medieval dwelling.

Features in Trench B, such as the gully and postholes, may indicate the boundaries between burgage plots. The presence of the medieval pit and stone surfaces in this area are indicative of some medieval activity, but perhaps not so intensive as that in the area of Trench A.
