Excavations at Whitford Church, Clwyd

by **D Thomas**

July 1993

Report prepared for Cadw

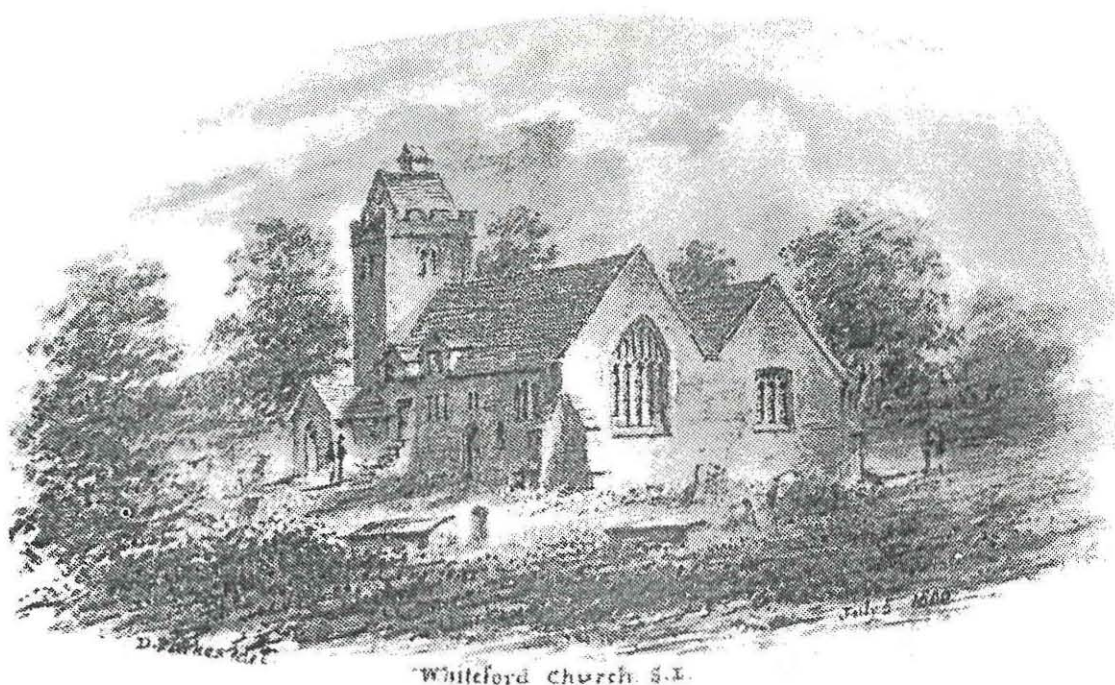
Fig 2. WHITFORD CHURCH c.1800, from Southeast. Copy of print by Moses Griffiths. (Taken from Davies (1953), pl. 3).

2.2 The oldest part of the present church building is the north aisle which is a survival of the early 16th-century church built in late perpendicular style, which is depicted in an illustration by Moses Griffiths dating from 1800 (Fig 2). The rest of the building is a
