Coed y Brenin Archaeological Assessment

CPAT Report No 282

June 1998

Report for Forest Enterprise

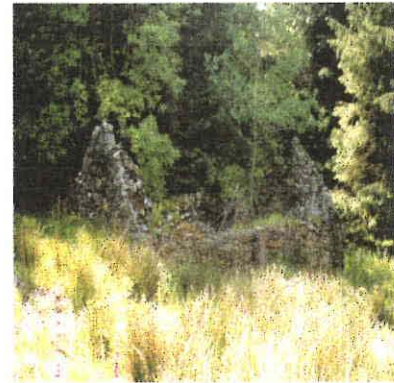
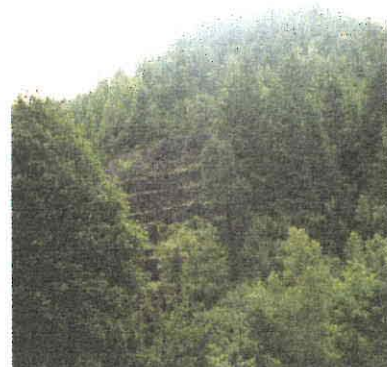
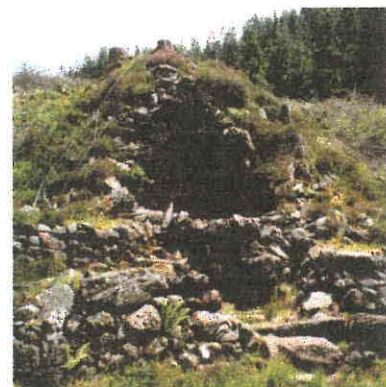
Cover Illustration, from top;
House Site, Coed y Brenin
Glasdir Copper Mine
Hermon Turf Mine

The kiln structure is a well preserved example of a kiln used to burn peat to extract copper ore.

Kiln for burning peat to obtain copper. A substantial structure with arched flue entrance and stone built furnace. Vitrified remains on inside of furnace.

Close to FE road. Otherwise in good condition.

Prevent damage from passing vehicles.
